# RPA & Associates, LLC.

HISTORIC ASSESSMENT  
 NO. 190224-HA

JOB	DATE
312 PINO ROAD, SANTA FE, NM 87505	02/19/2024

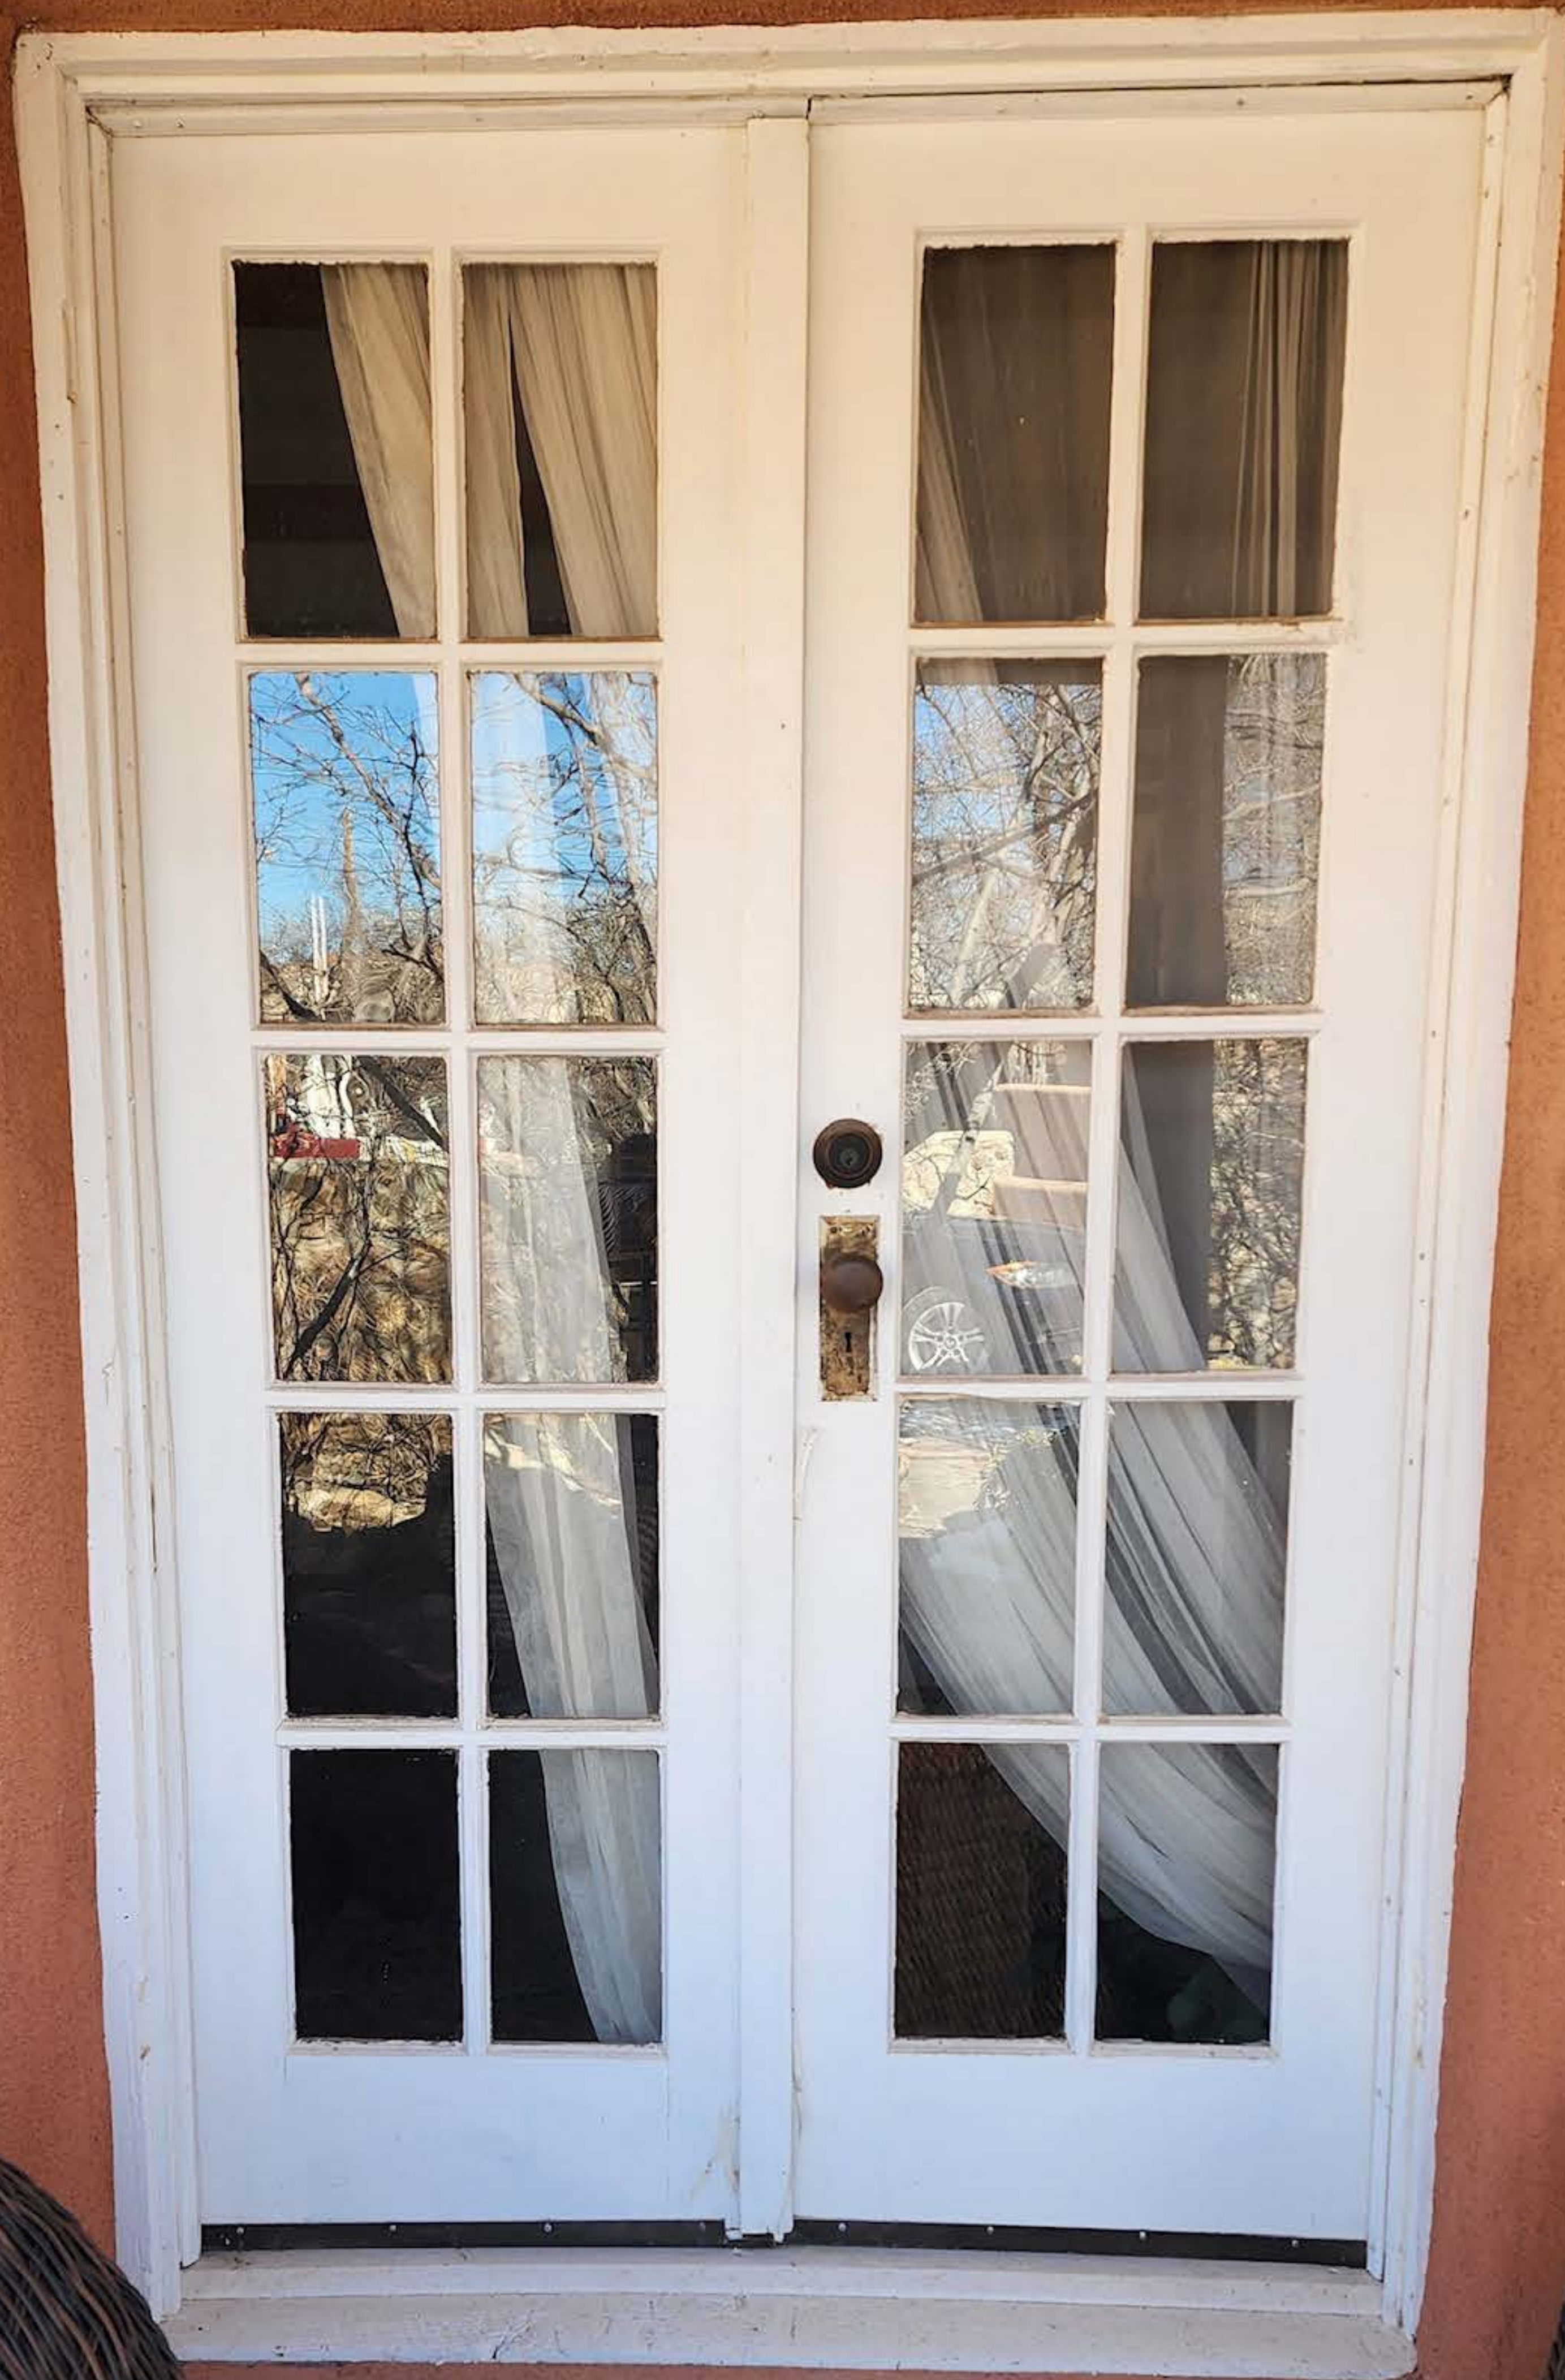
West  
Elevation  
DR#1

Doors 1, 2, 3, & 4 DO NOT meet the criteria to be considered historic.

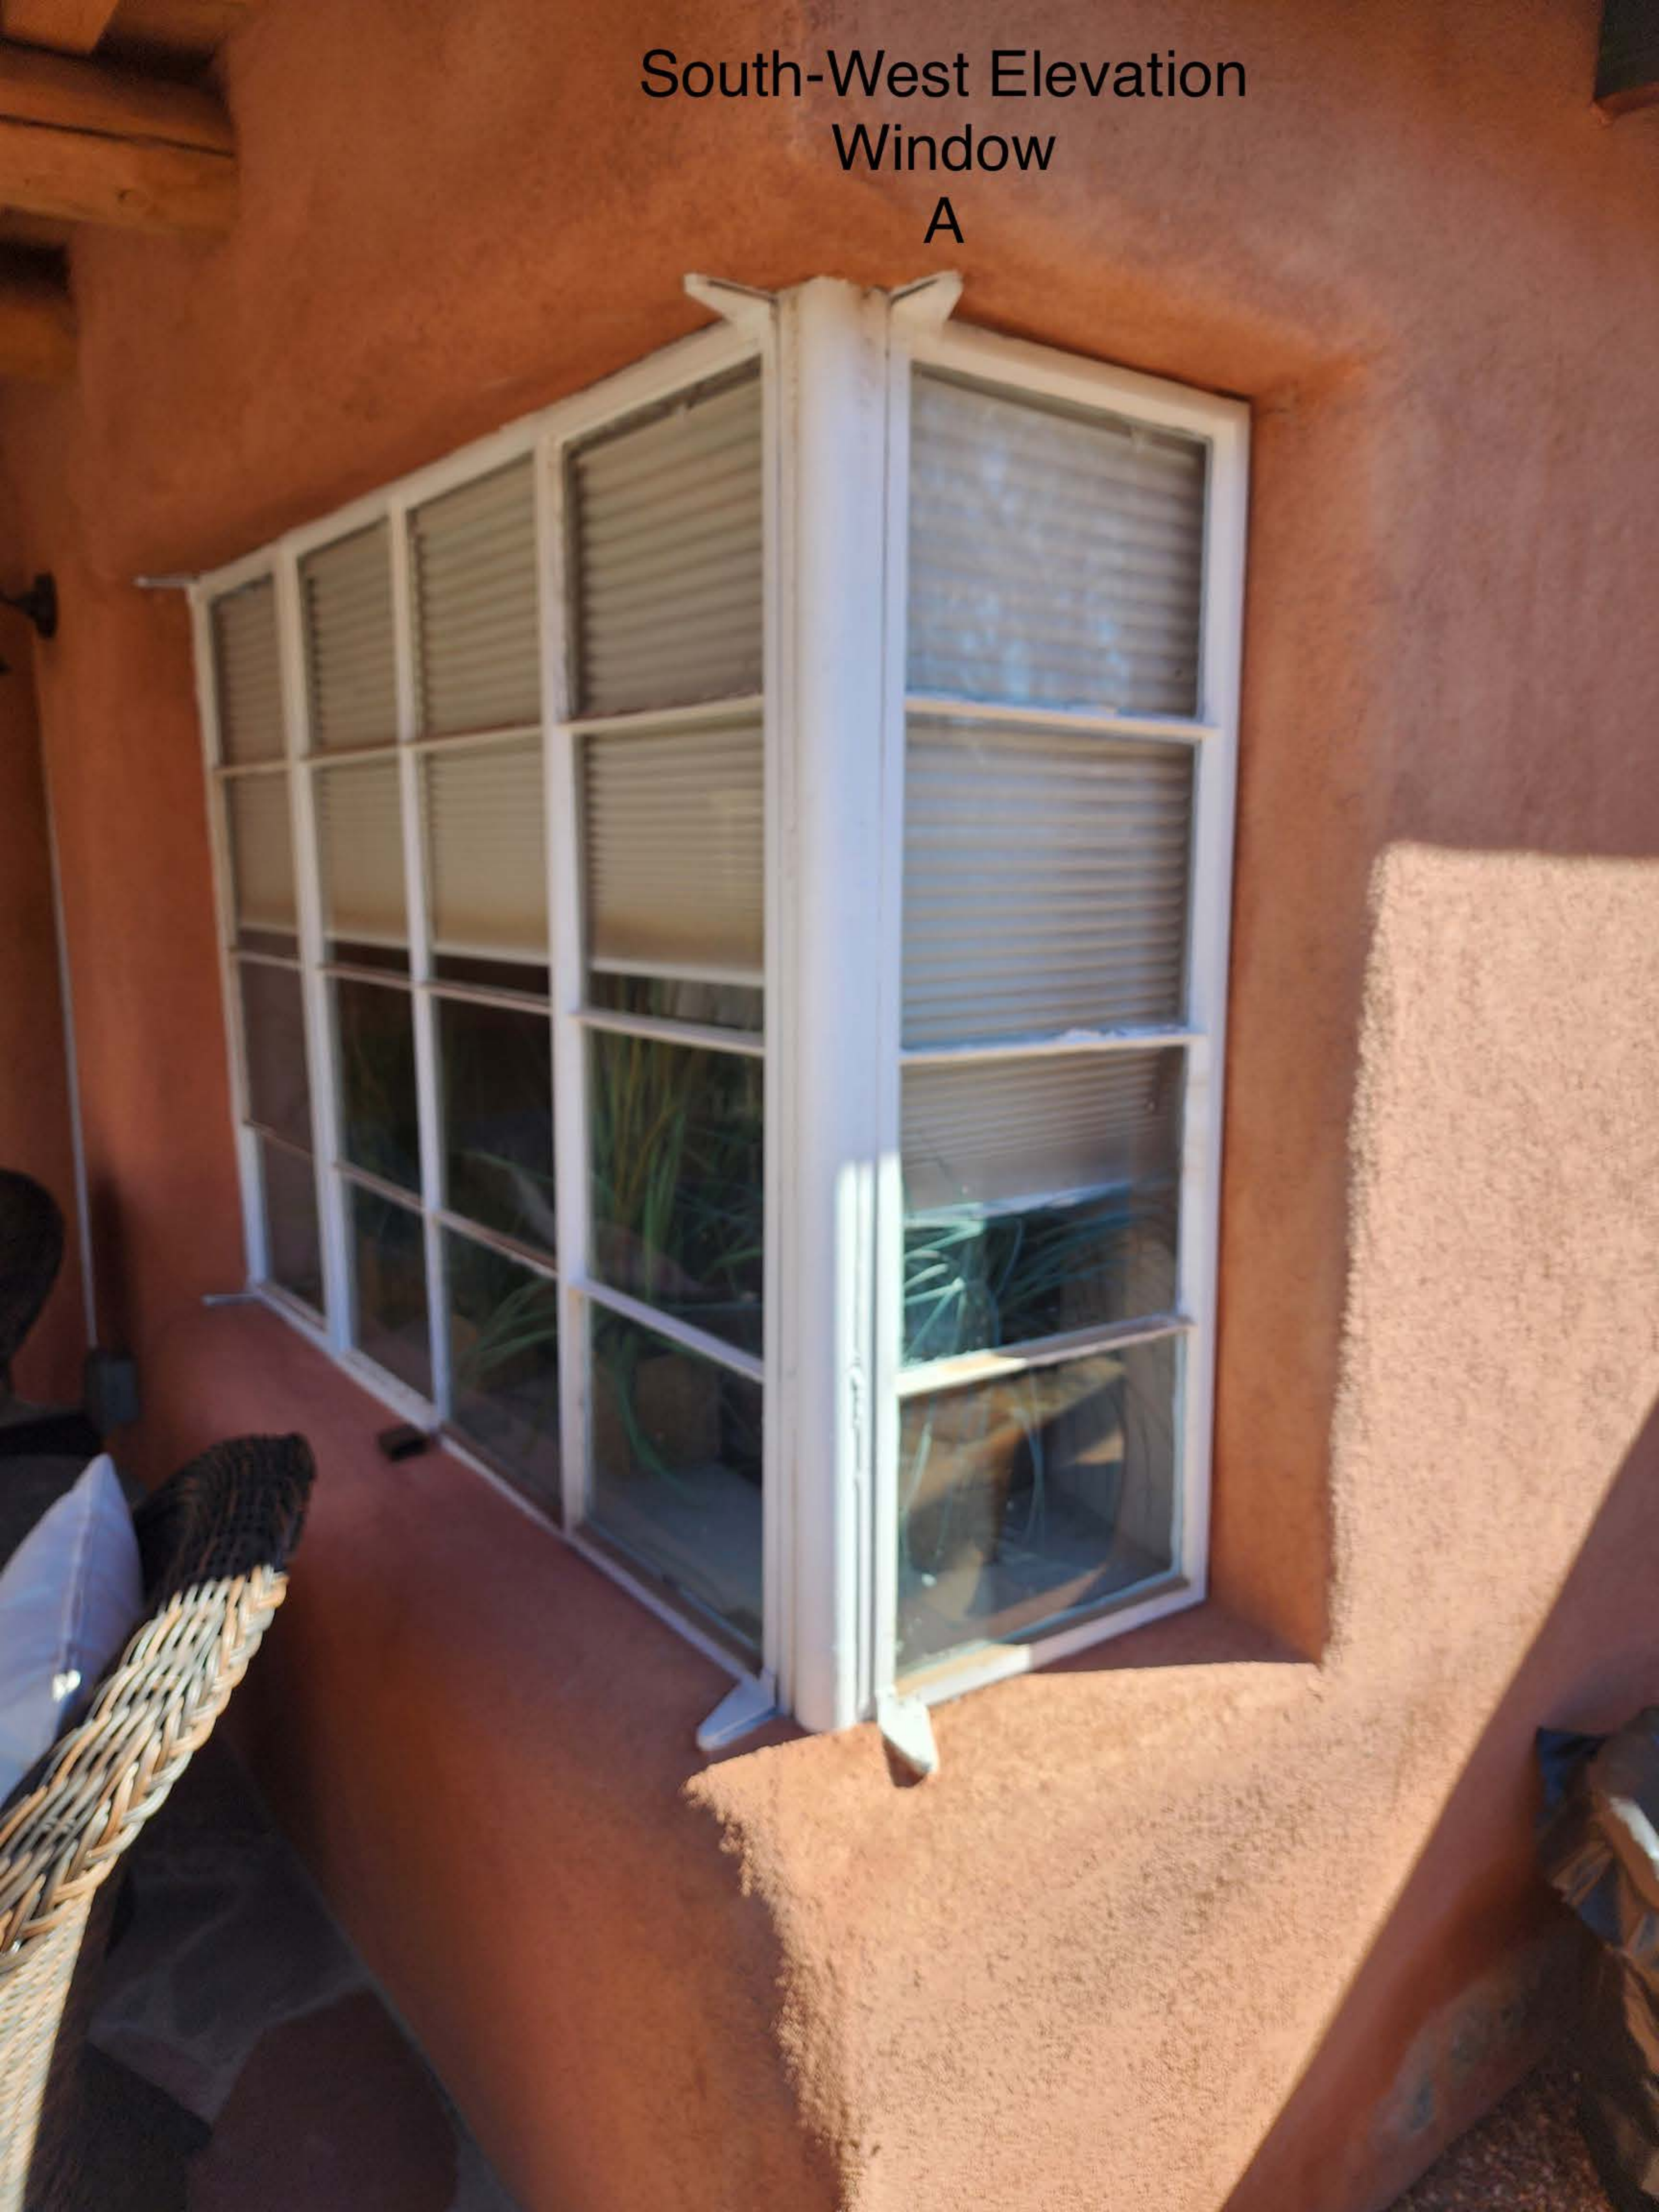
South-West Elevation  
Window  
A

Window A is historic.

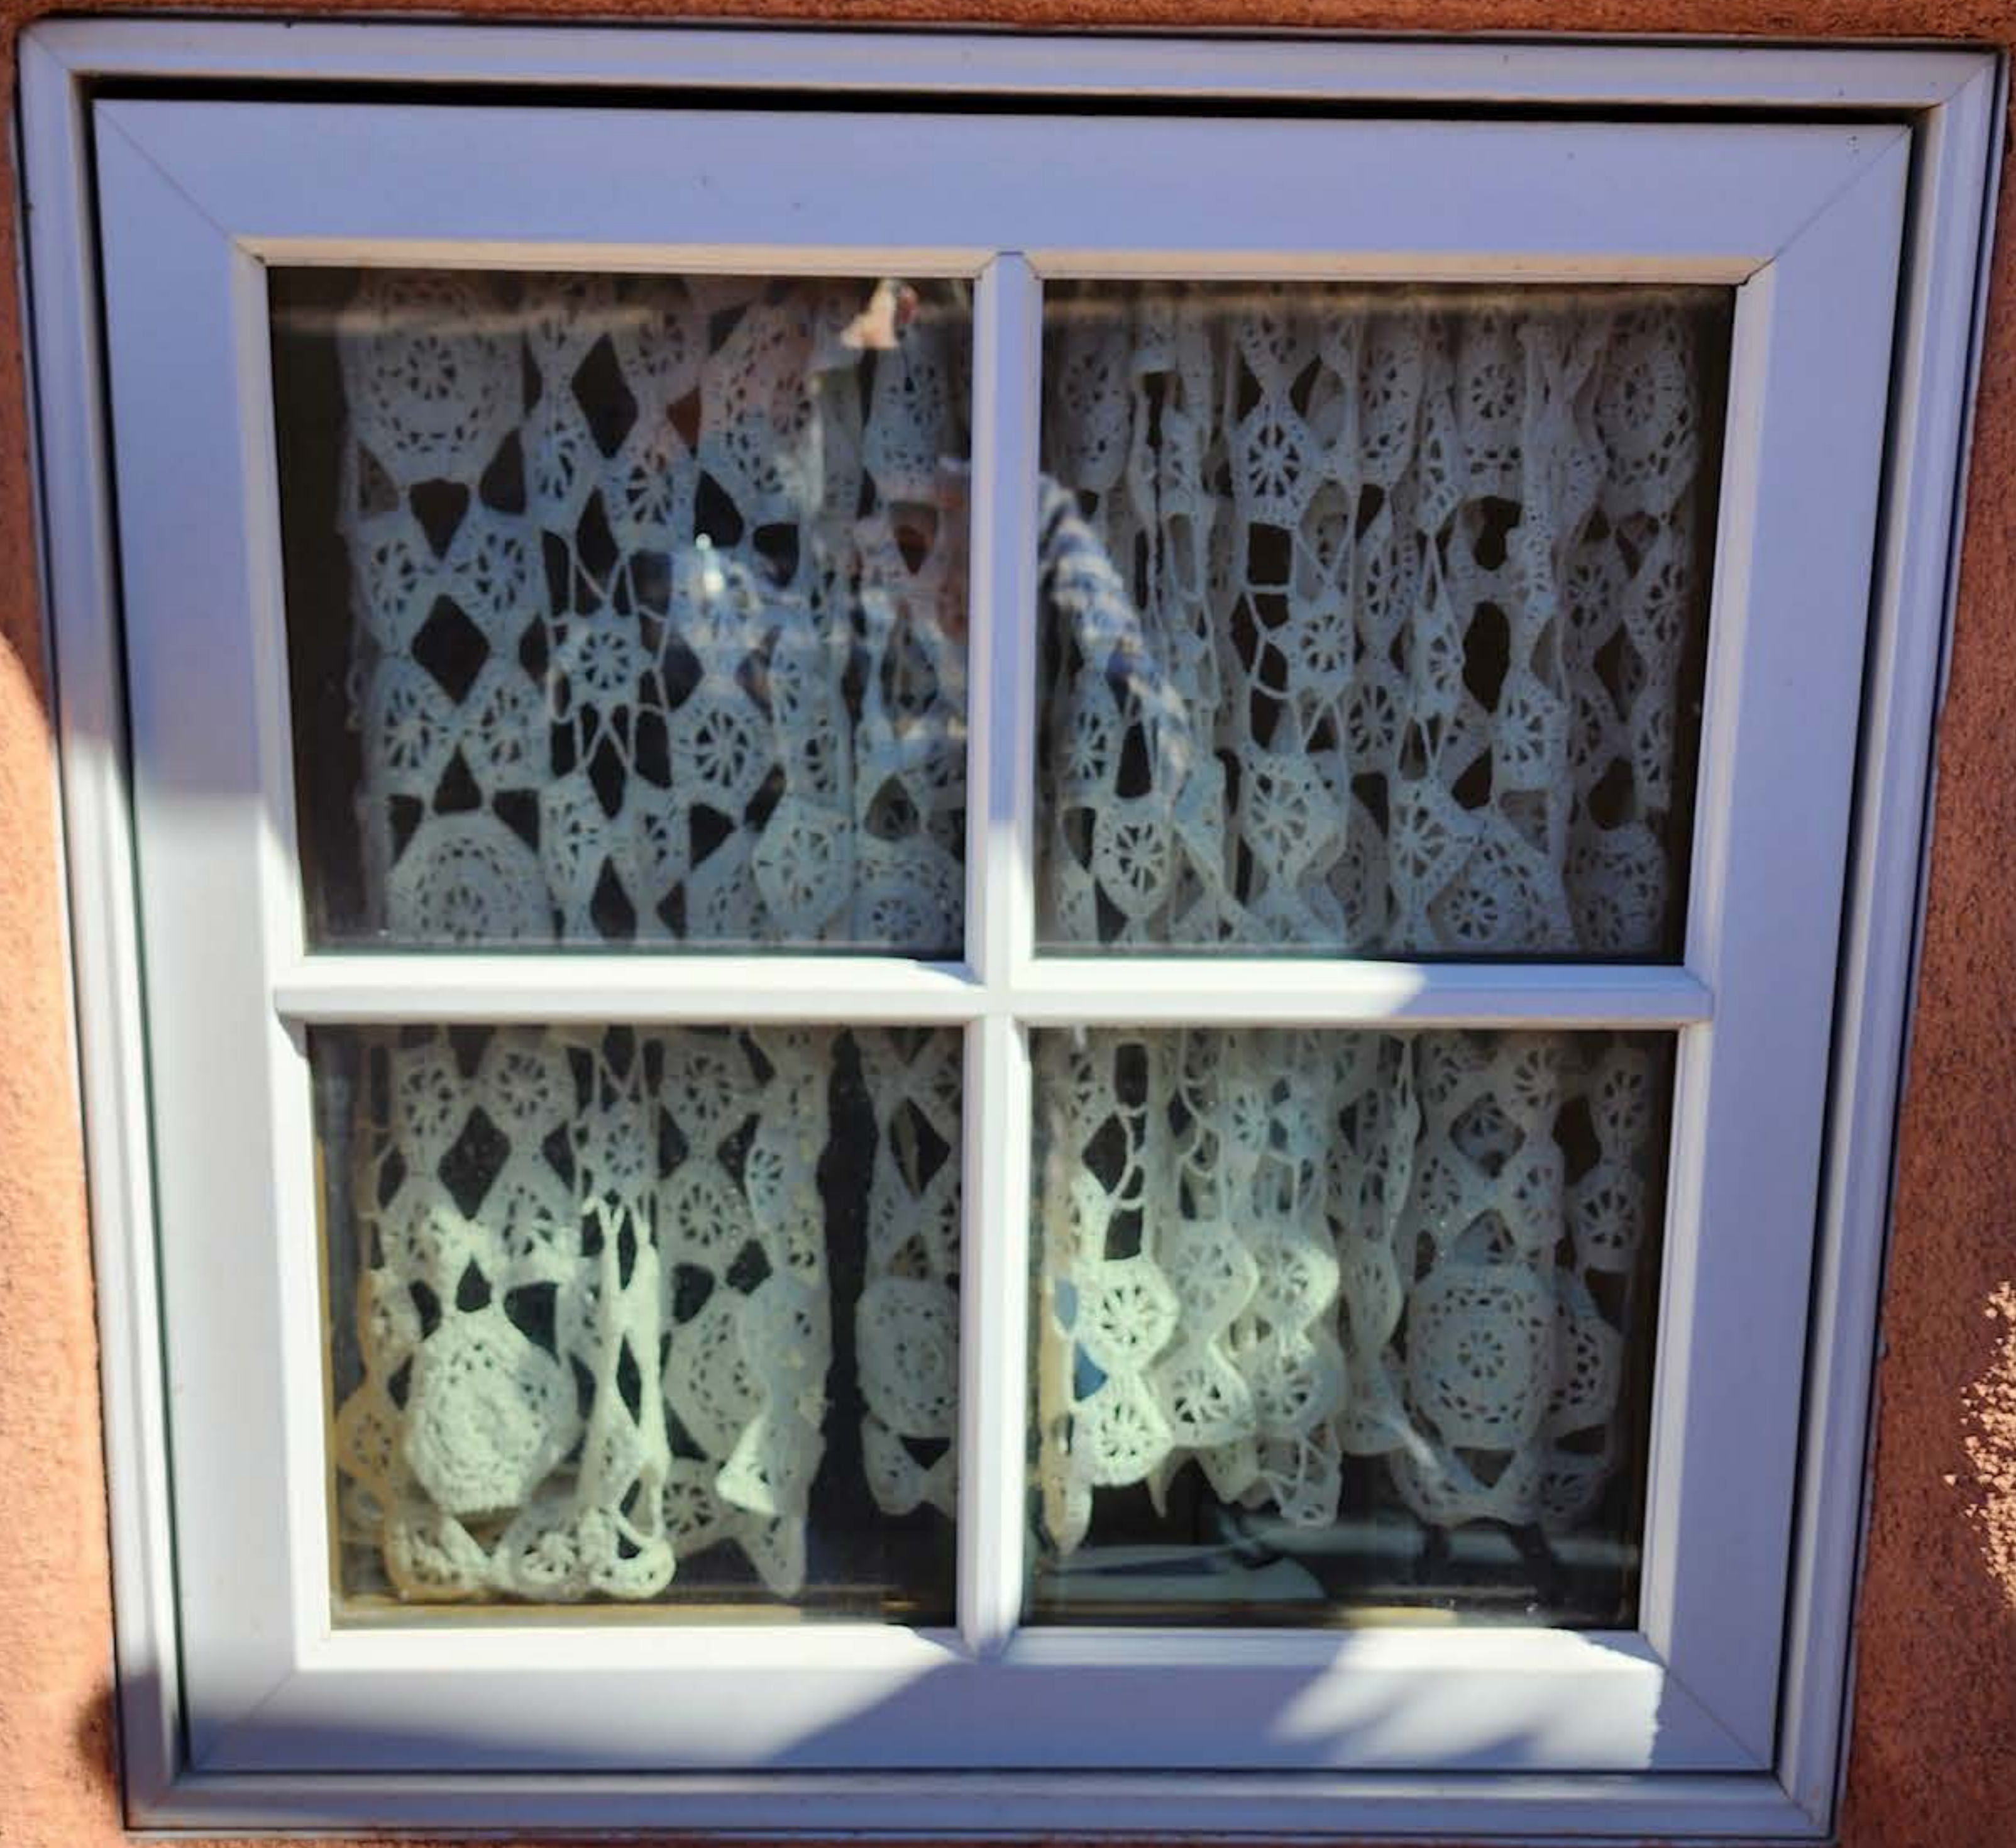
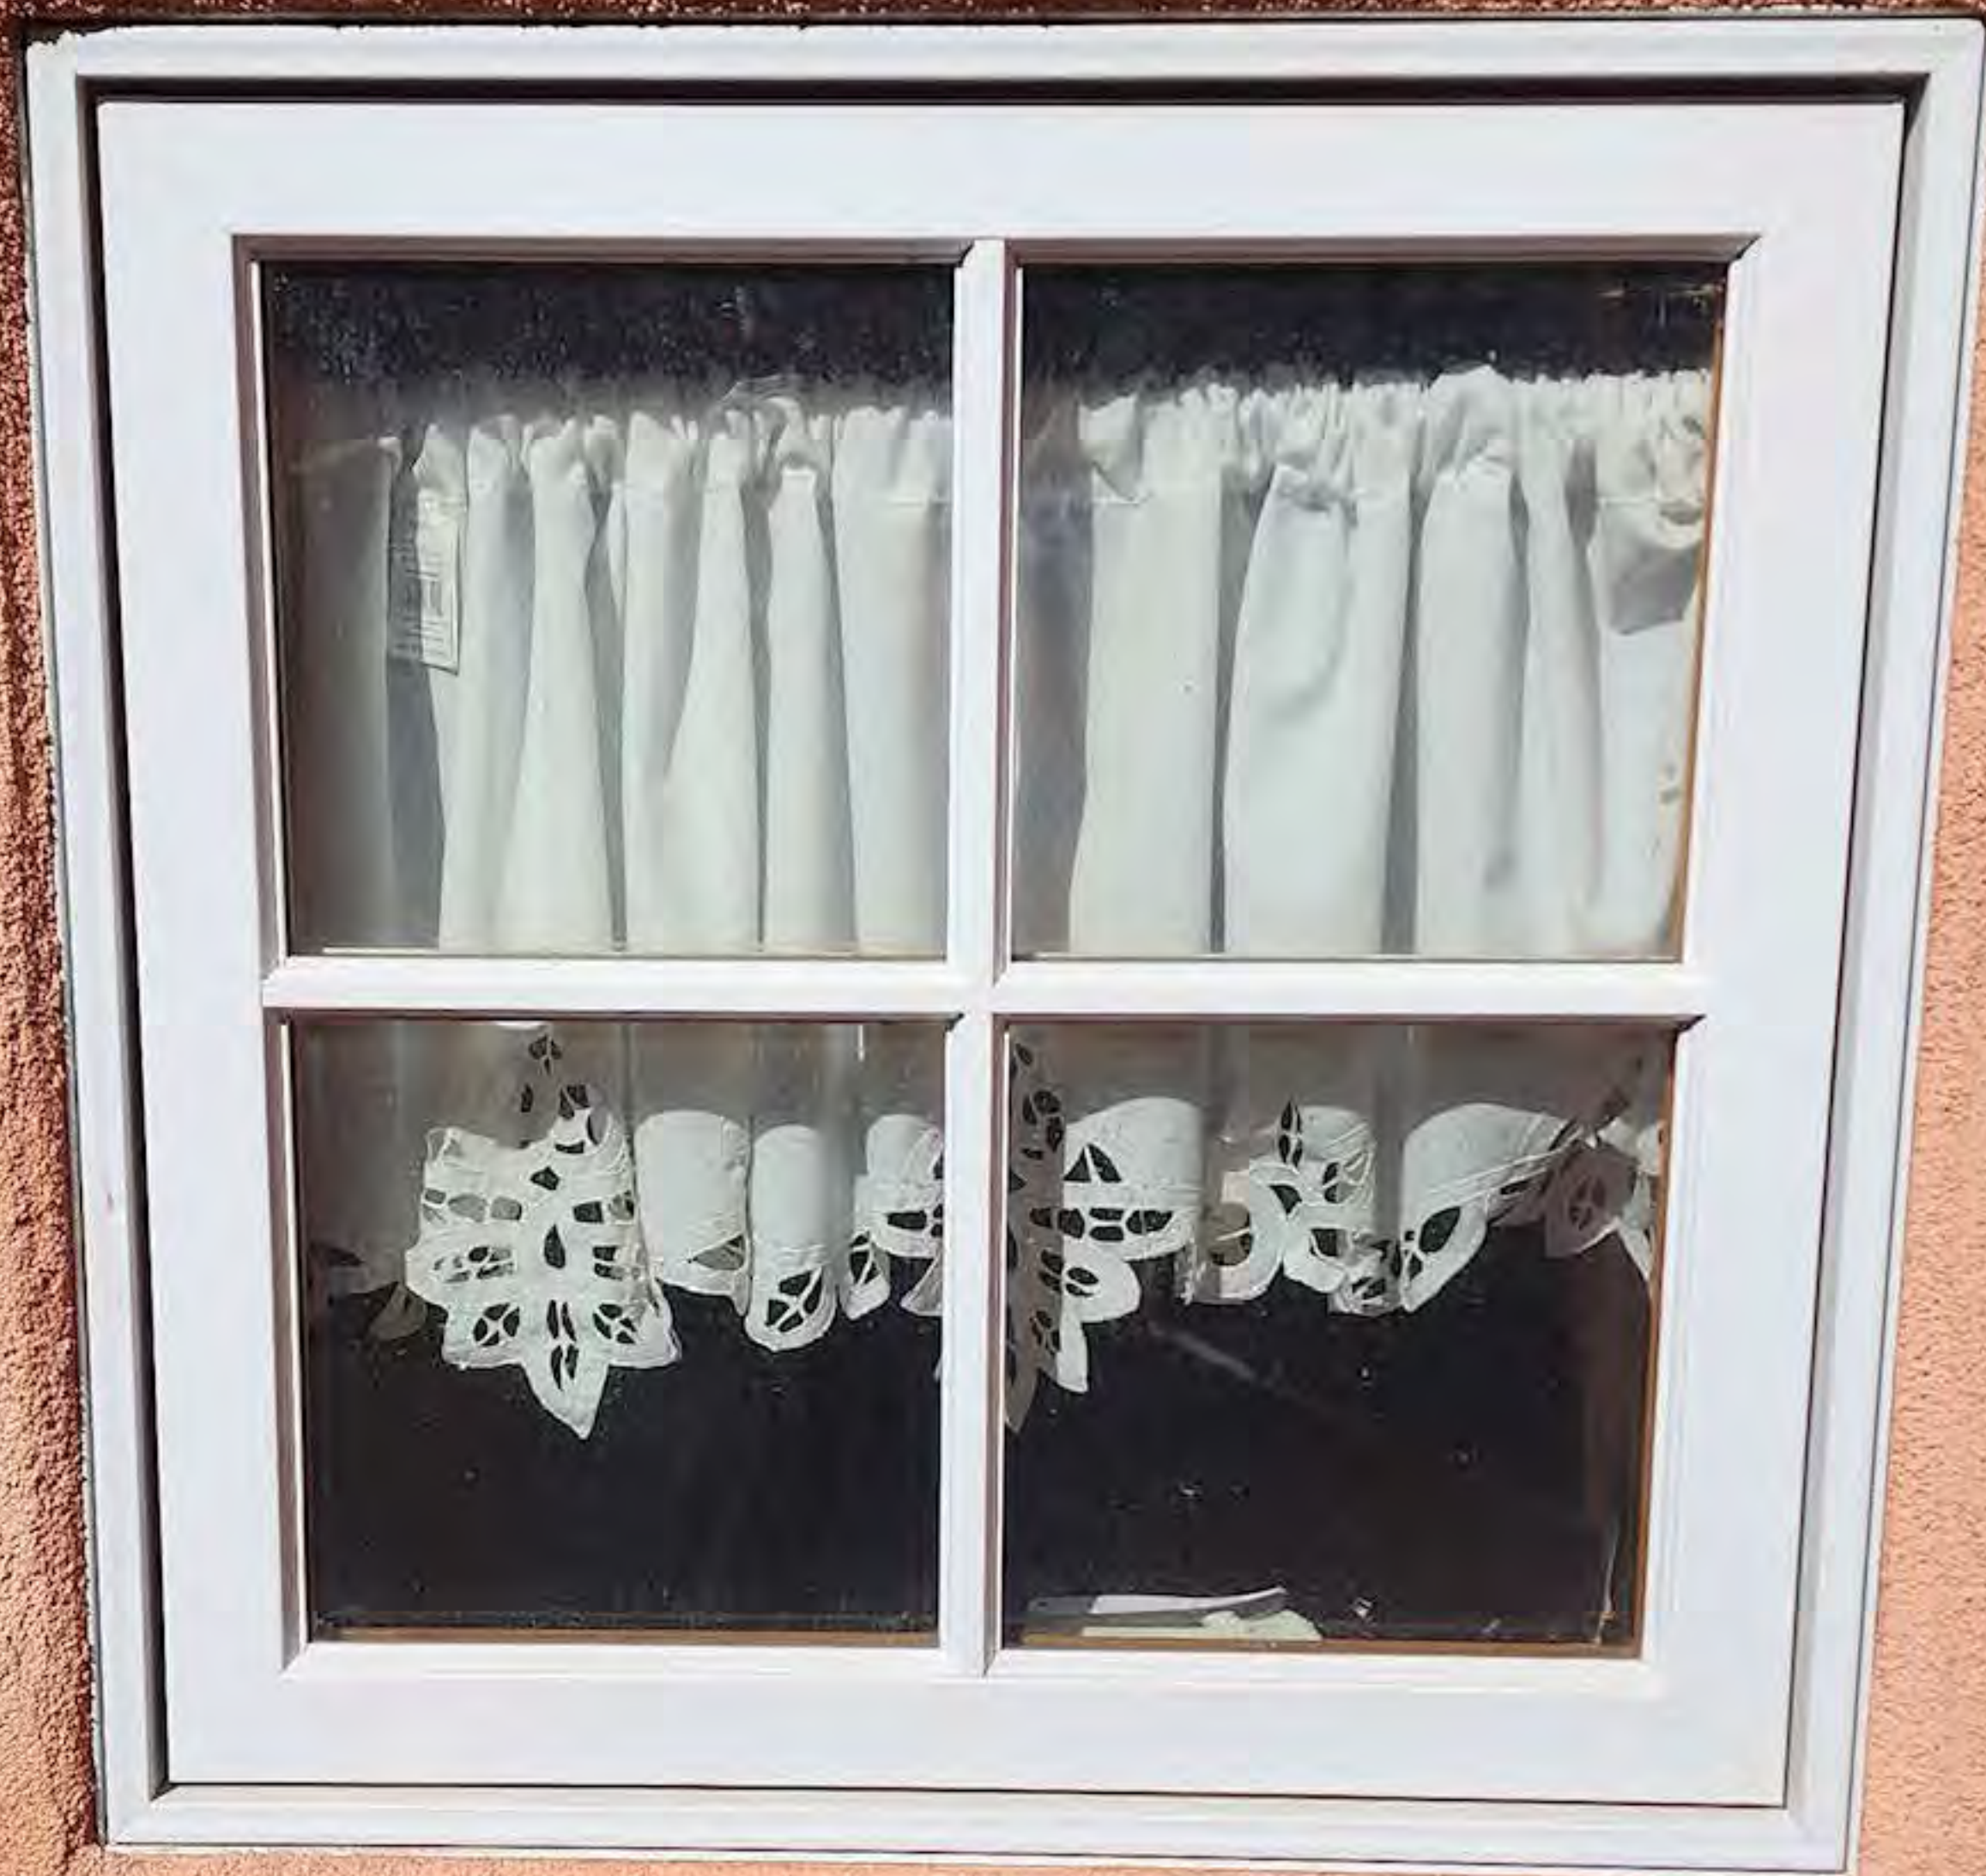
South Elevation  
Window  
B

Windows B, C, D, E & F, DO NOT meet the criteria to be considered historic.

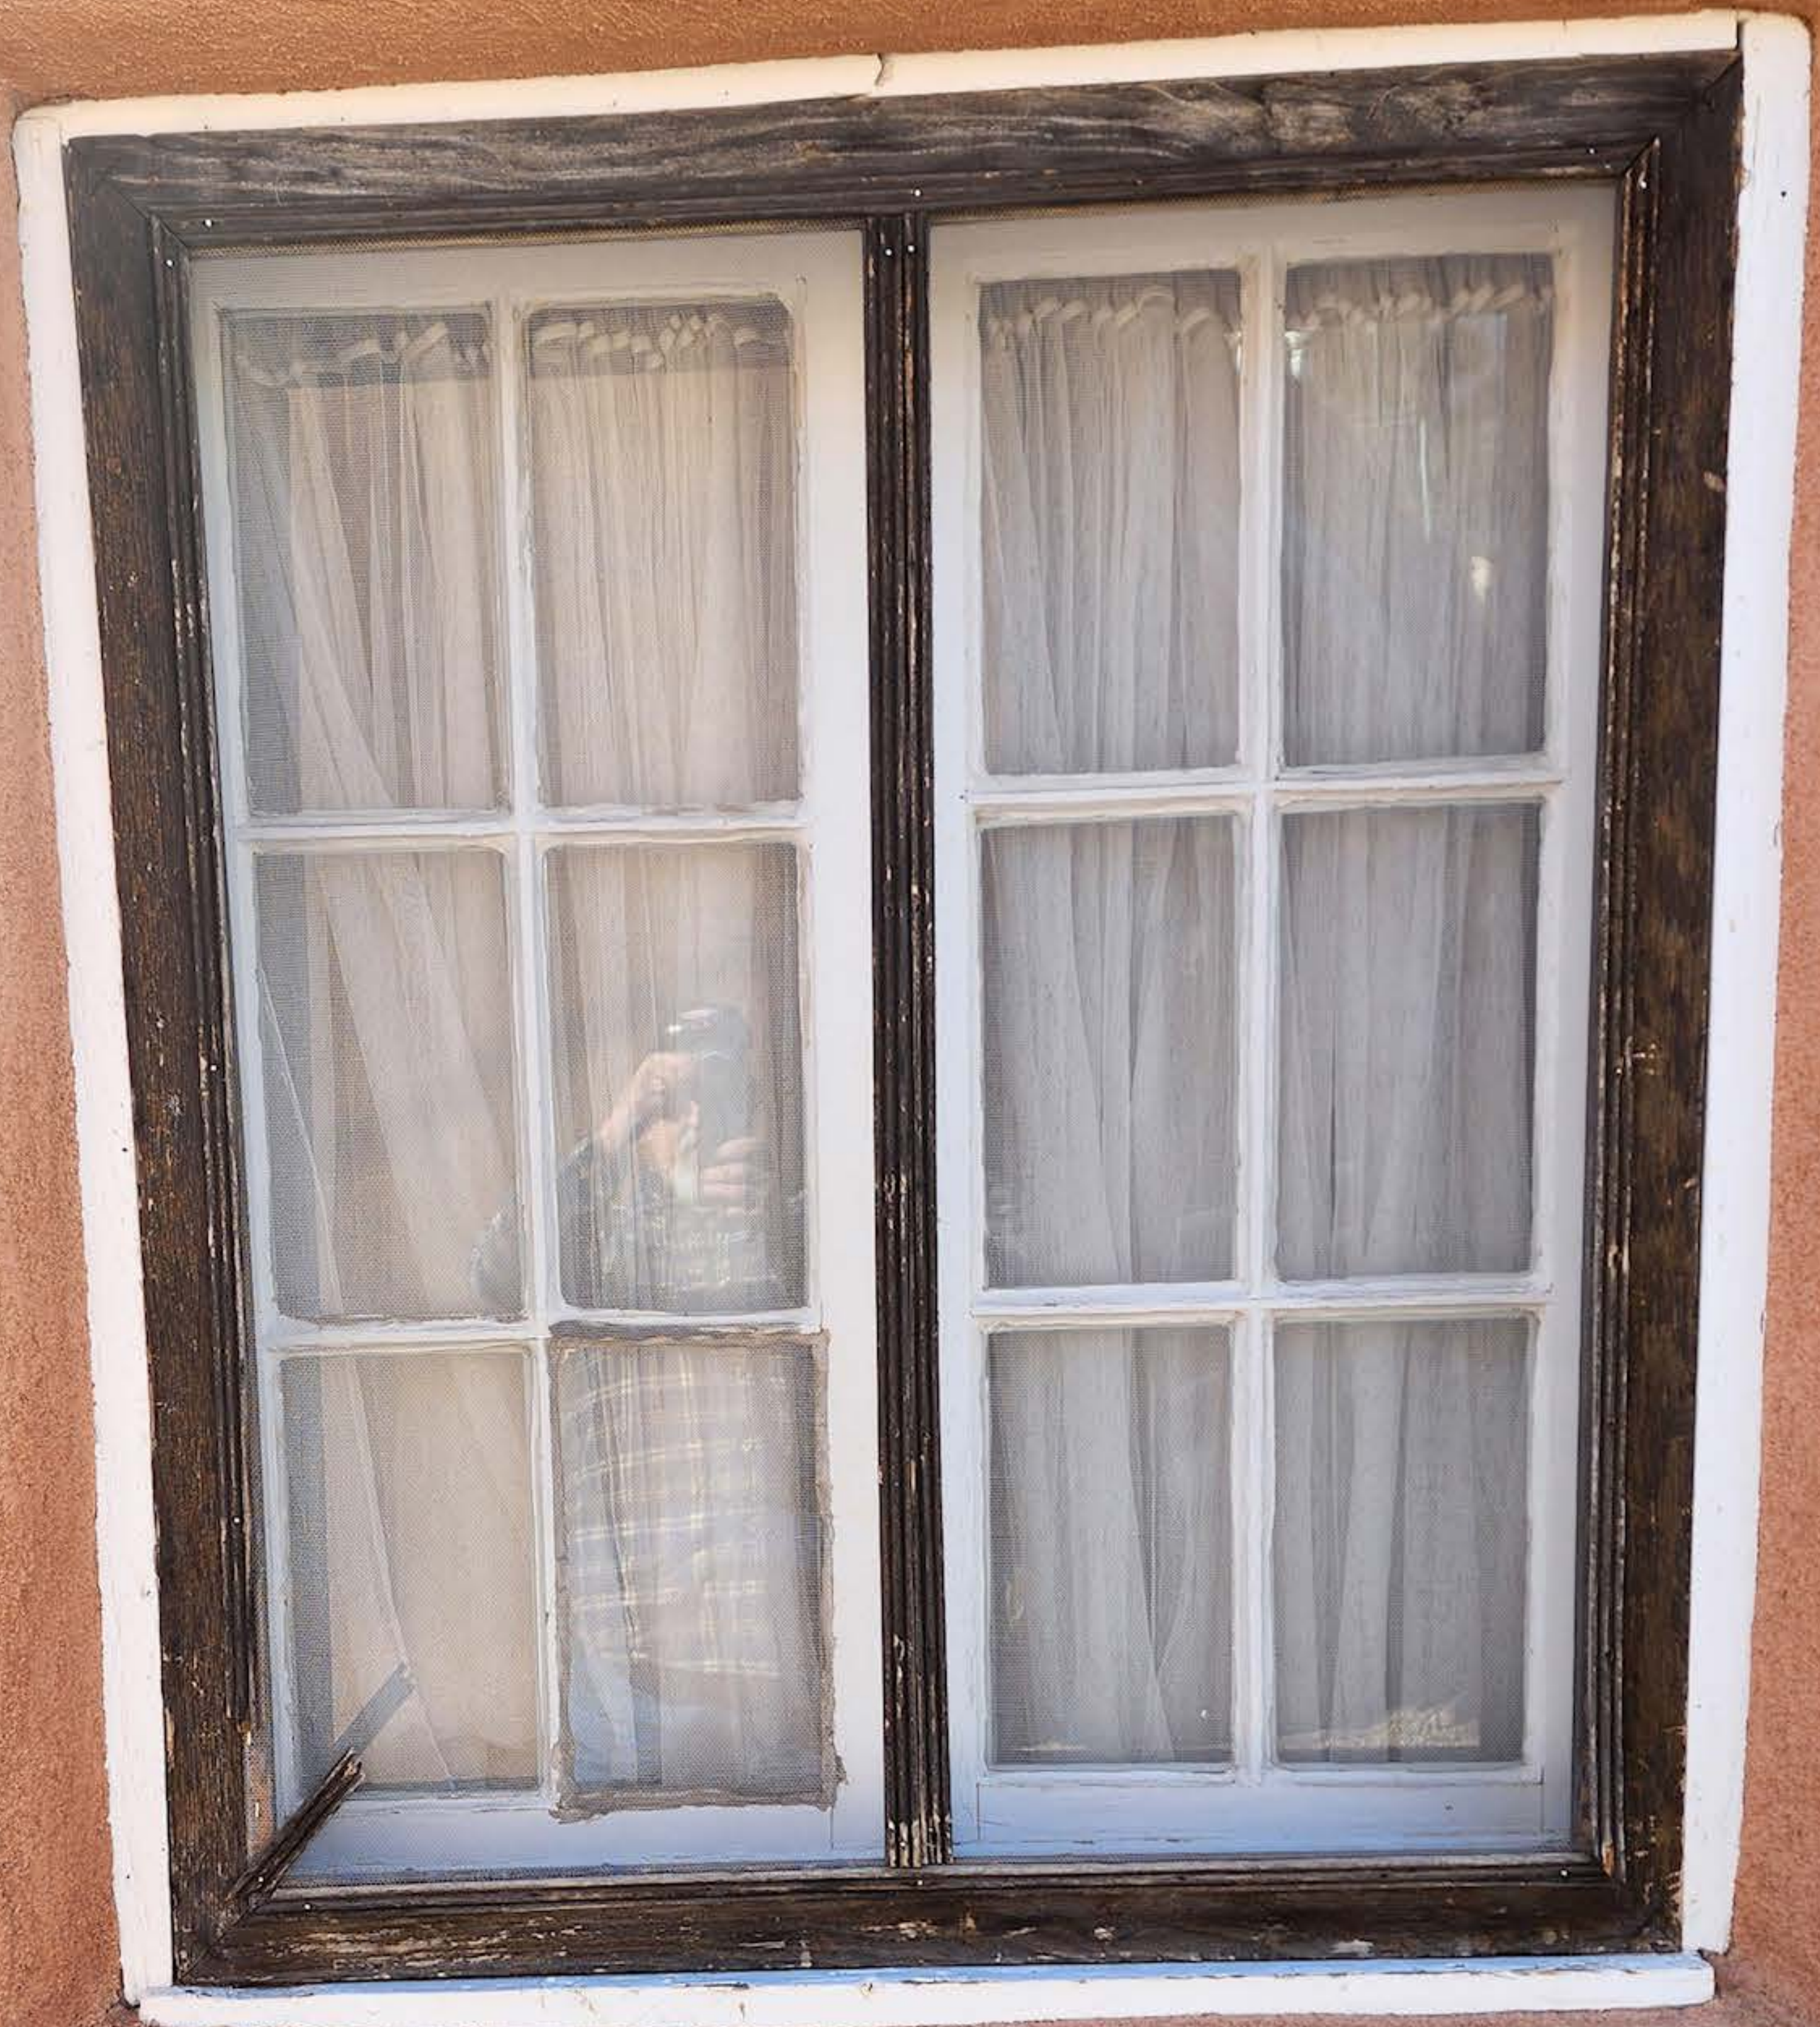
North  
Elevation  
Window  
G

The bucks for windows G, H & I are historic however the sashes are barn sashes that have exterior and interior blind stops that were replaced in the late 1980's, early 1990's and are non-historic. The drip cap is a cove mould from the 1980's that has a mill finish aluminum weatherstripping.

To replace the windows, the weatherstripping and rotted sashes will need to be removed, leaving the historic buck. The windows will need to be replaced in "like and kind" (inswing, all wood, divided lite casements).
