# RPA & Associates, LLC.

HISTORIC ASSESSMENT  
 NO. 190224-HA

JOB	DATE
312 PINO ROAD, SANTA FE, NM 87505	02/19/2024

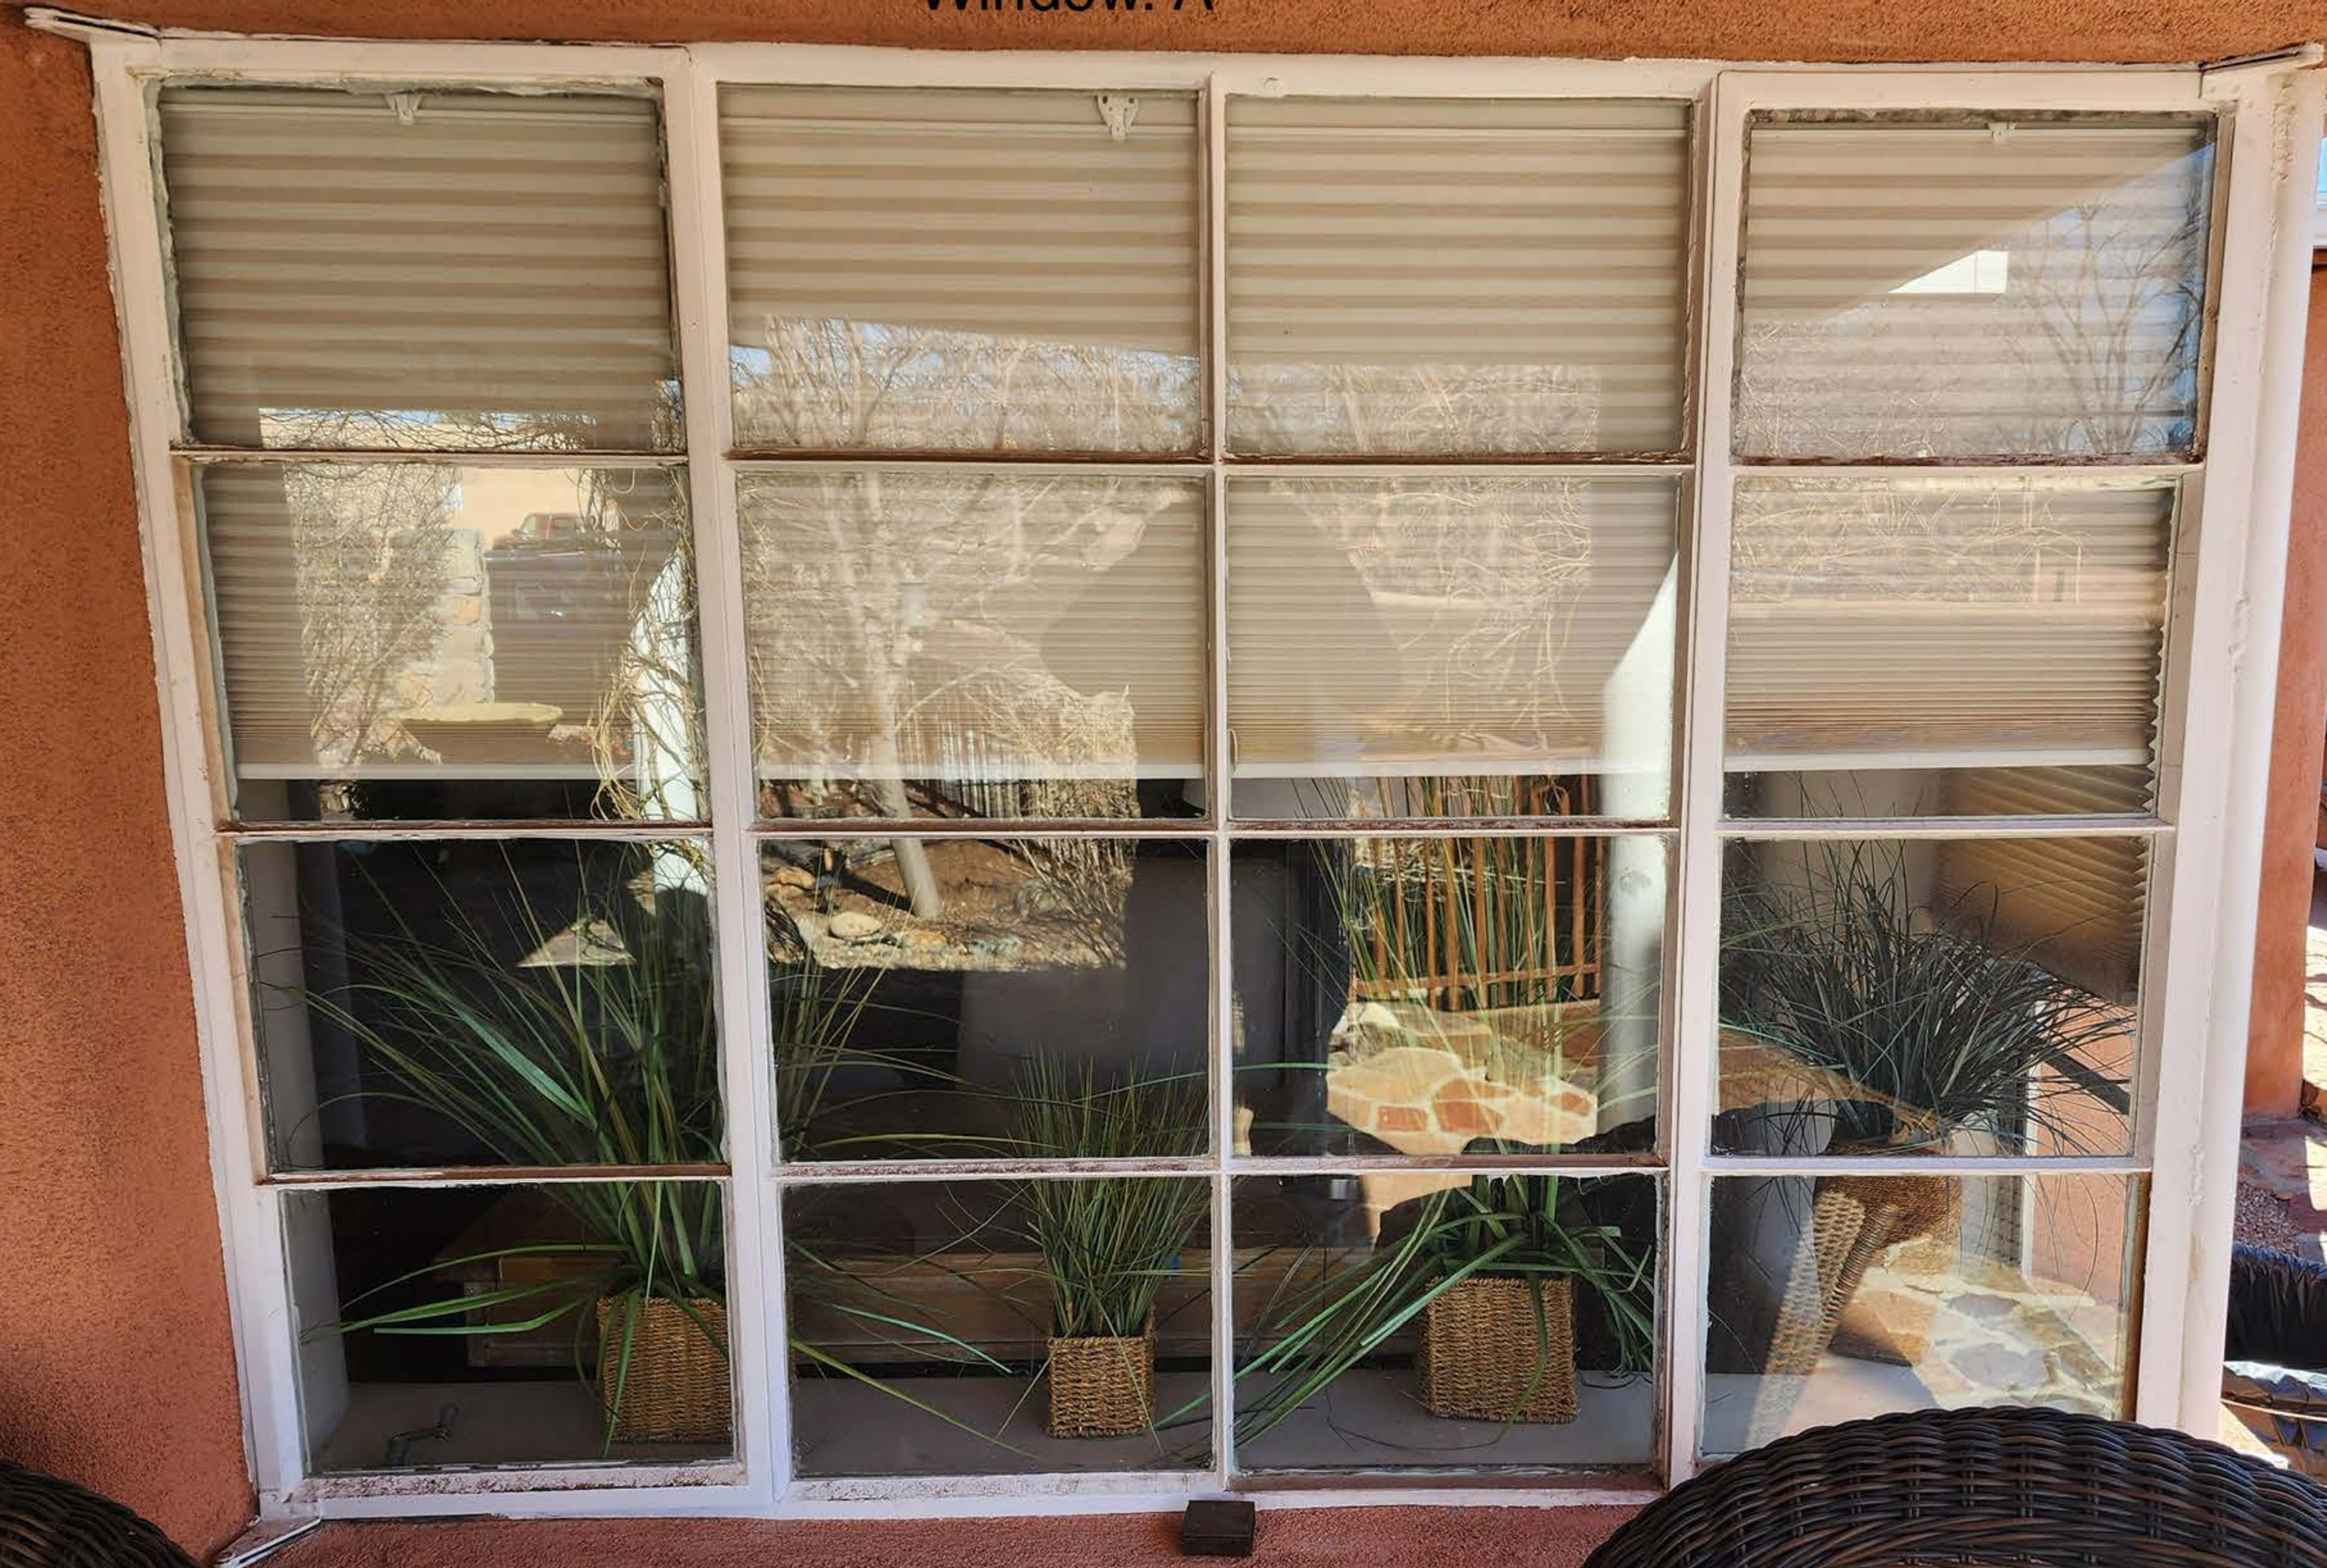
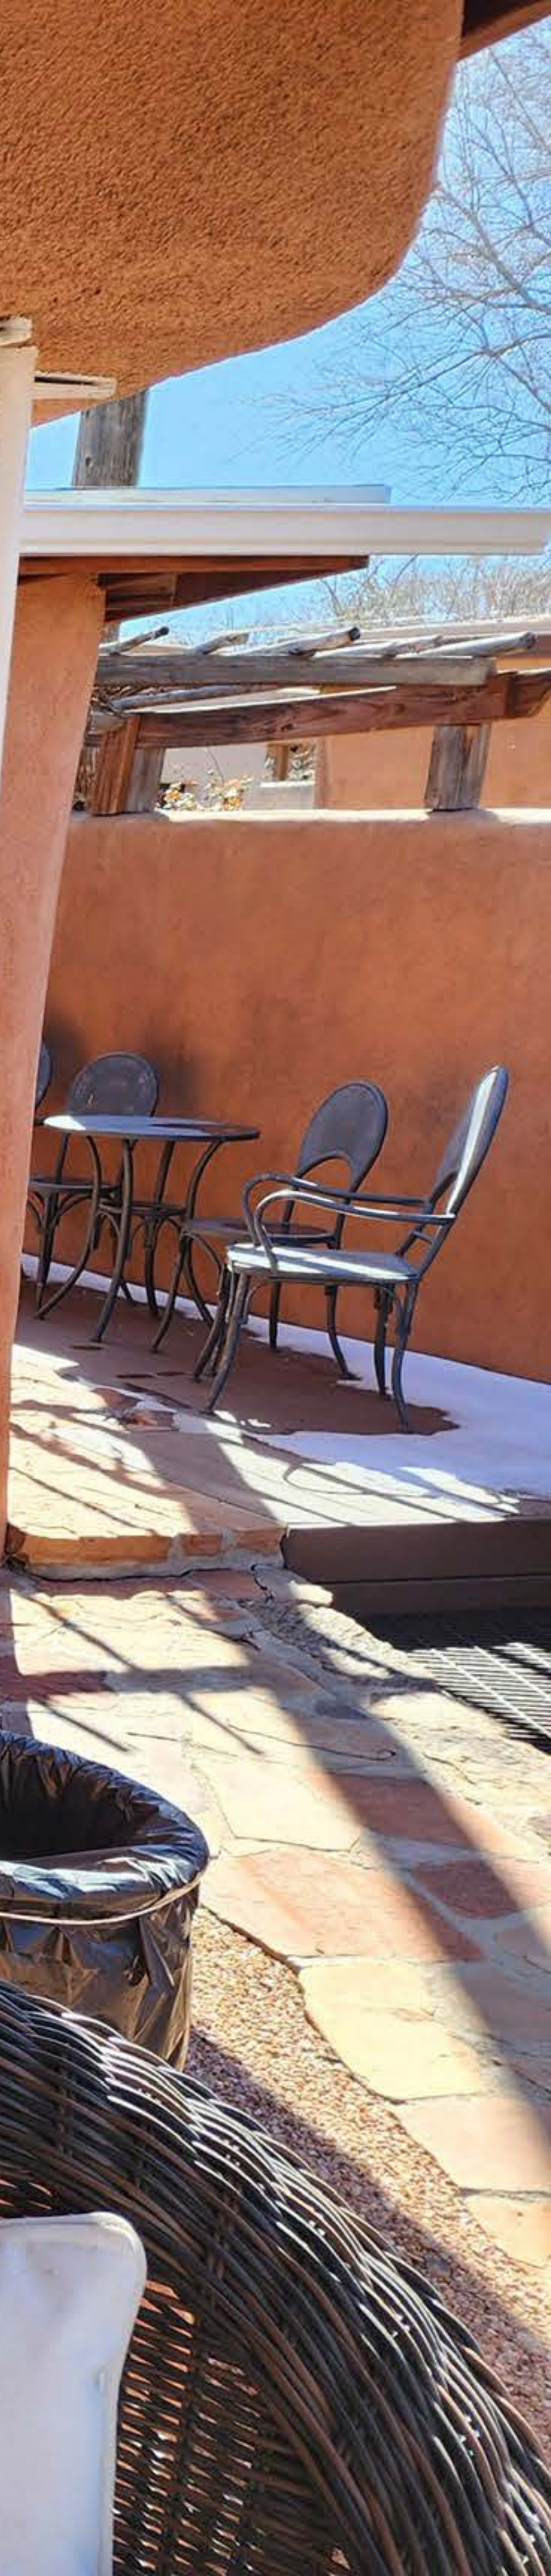
South-West Elevation  
Window. A

Window A is historic.

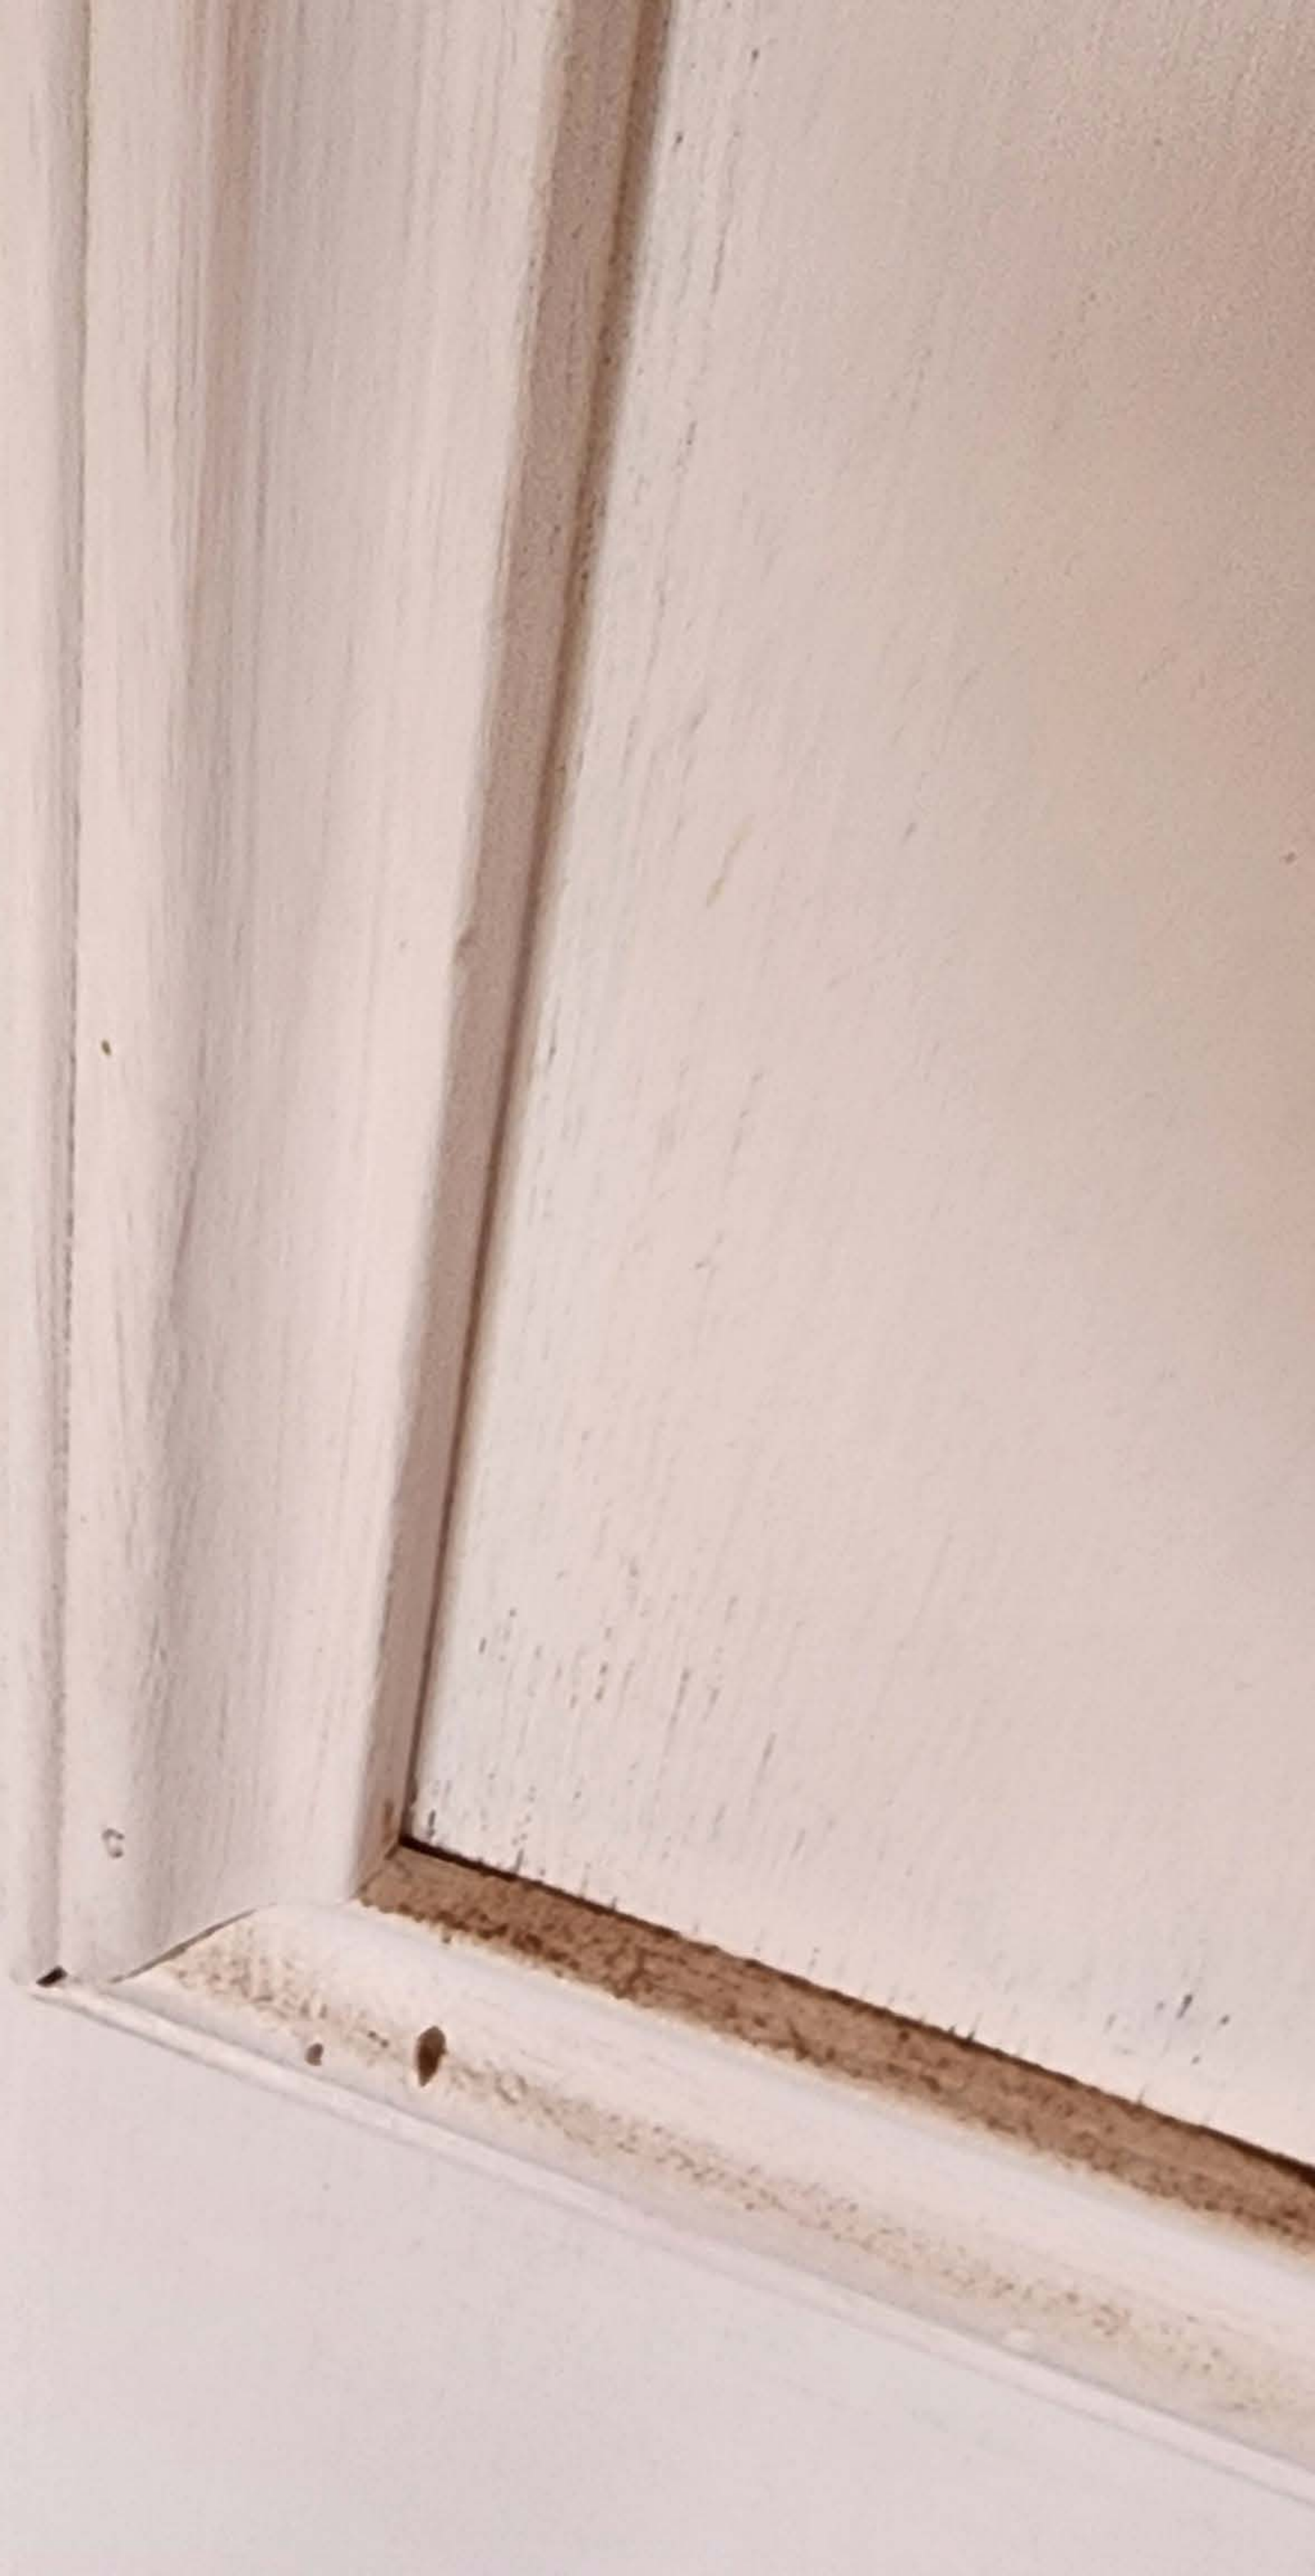
Door #2  
Showing year and  
mfg.
