Historic Cultural Properties Inventory (HCPI) Base Form (FORM 1)

For HPD Office use only: HCPI No. _____ District No. _____ NRHP ___ SRCP ___ Criteria <u> </u> A <u> </u> B <u> </u> C <u> </u> D		
1. Name of property: 619 West Alameda	2. Location: 619 West Alameda, Santa Fe, NM	3. Local Reference Number: Santa Fe ID #:

7. Previous Survey Date(s): N/A		
8. Name of Project: HDRB Status Review		
9. Lat/Long: 35.689134, -105.950314		
10. Photo Information: May 12, 2025		View: Looking northeast from sidewalk
<p>11. Brief Description of the Property: This building is located in the City of Santa Fe, on a small city lot on West Alameda, in the Westside-Guadalupe Historic District. Early documentation on the property is scarce. Reportedly, the house was built in 1943, but no actual documentation of this exists. The building is a small, simple, low Pueblo Revival style structure, with a flat roof. It is approximately square, measuring about 26-1/2 feet in either direction. The exterior walls are constructed of adobe and pen tile. The setback, size, scale, style, and detailing of the building is somewhat typical of other buildings on the street. A small rectangular wood framed addition had

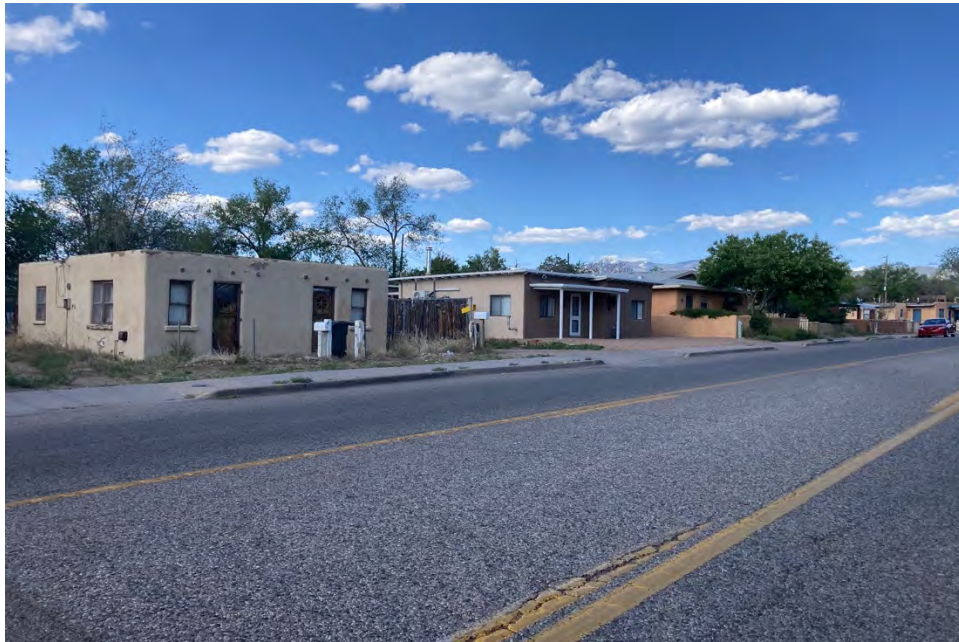
View from street – looking northeast - May 2025

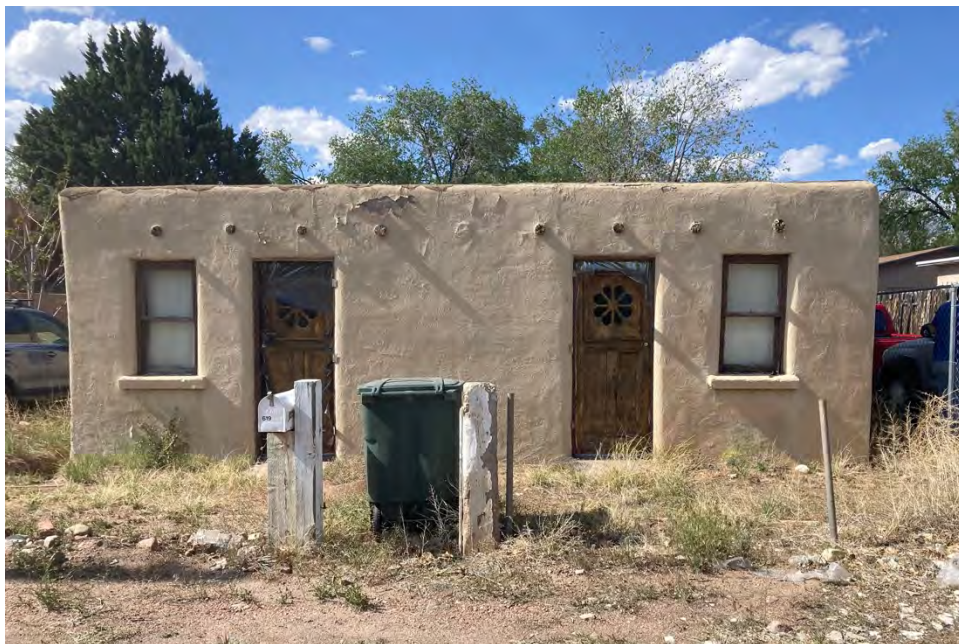
There are small, short projecting viga ends visible on the front façade of the building, which may be the remains of an original viga roof/ceiling structure for the front portion of the building. The stubs of the vigas can be seen on the interior of the front wall, and both sides of the rear wall of the original building, suggesting that the vigas have been cut off at the interior surface of the walls and removed. The rear façade has projecting roof/ceiling joists.

South façade – looking north – May 2025

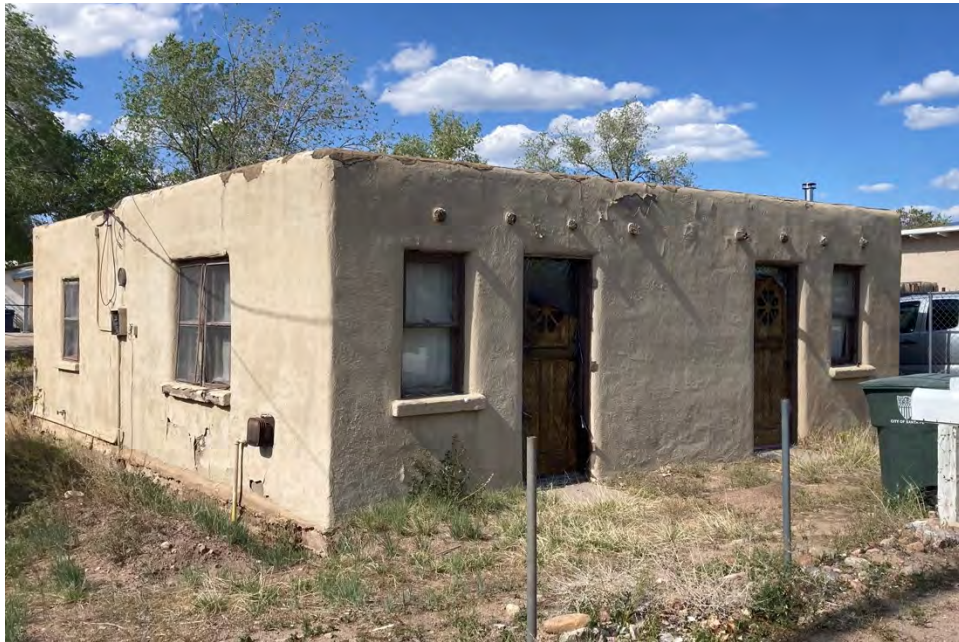
Southwest corner – looking northeast – May 2025

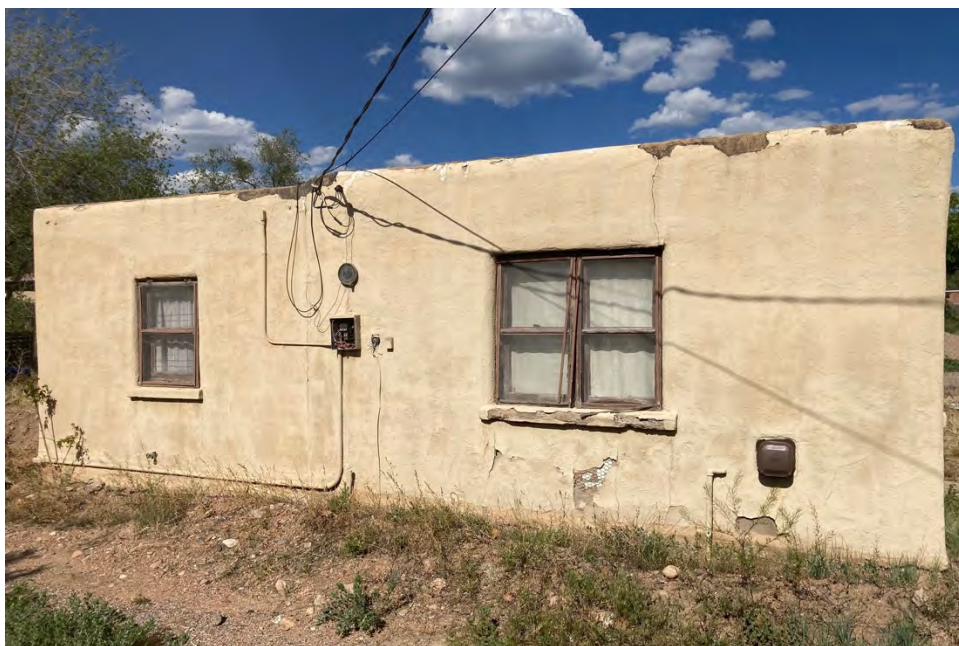
West façade – looking east – May 2025

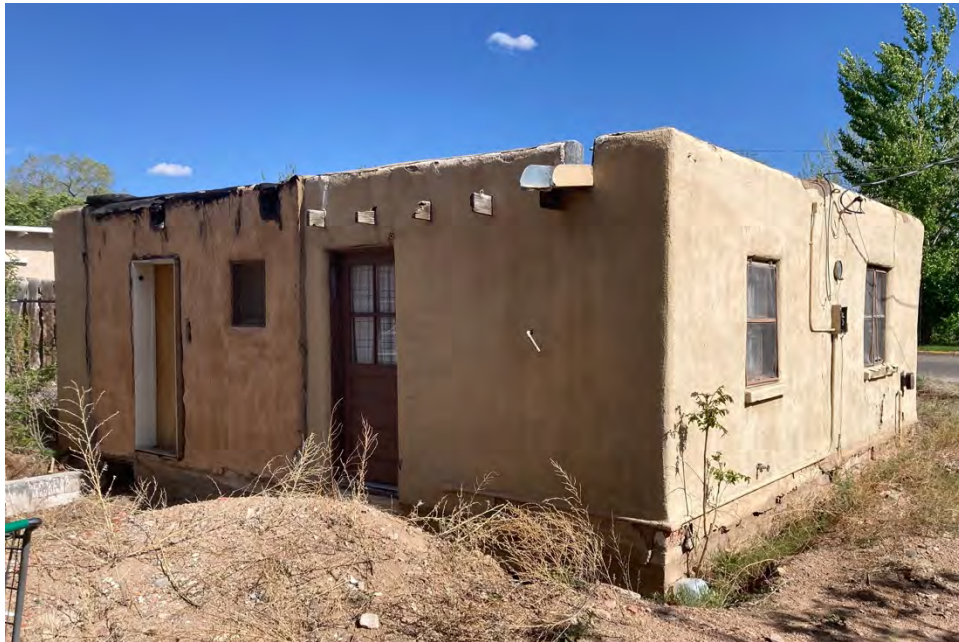
Northwest corner – looking southeast – May 2025

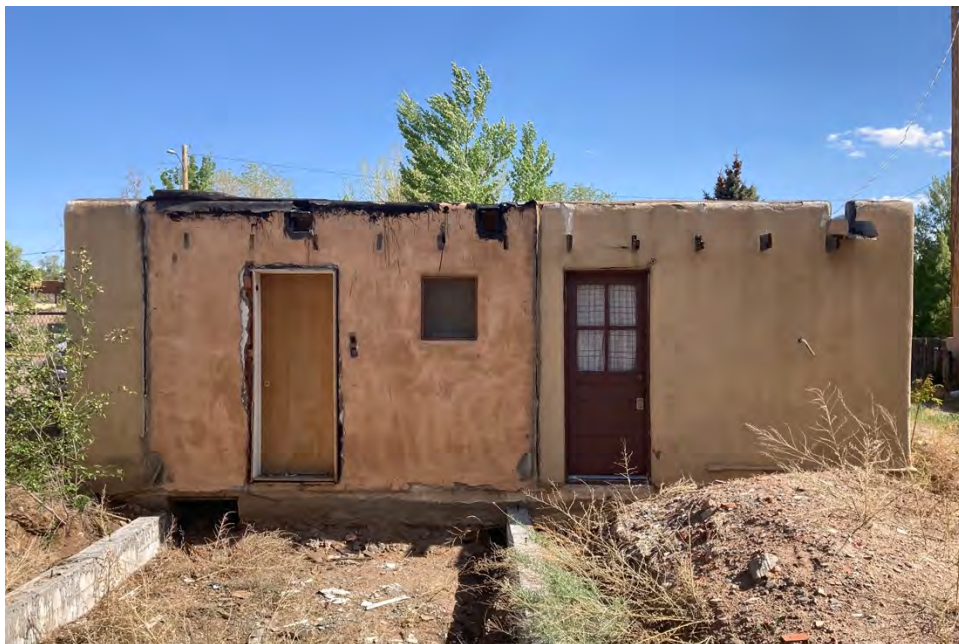
There is also a small square opening in the north wall, recessed similar to the double hung windows, with a painted wood frame, which appears to have been a wood window. The window appears to have been removed, and the opening is covered with wood framed window screening on the exterior, and what appears to be gypsum board on the interior. (This may be the back side of the bath tub surround. It is not weather proof, but was enclosed in the wood framed addition, until the addition collapsed.)

North façade – looking south – May 2025

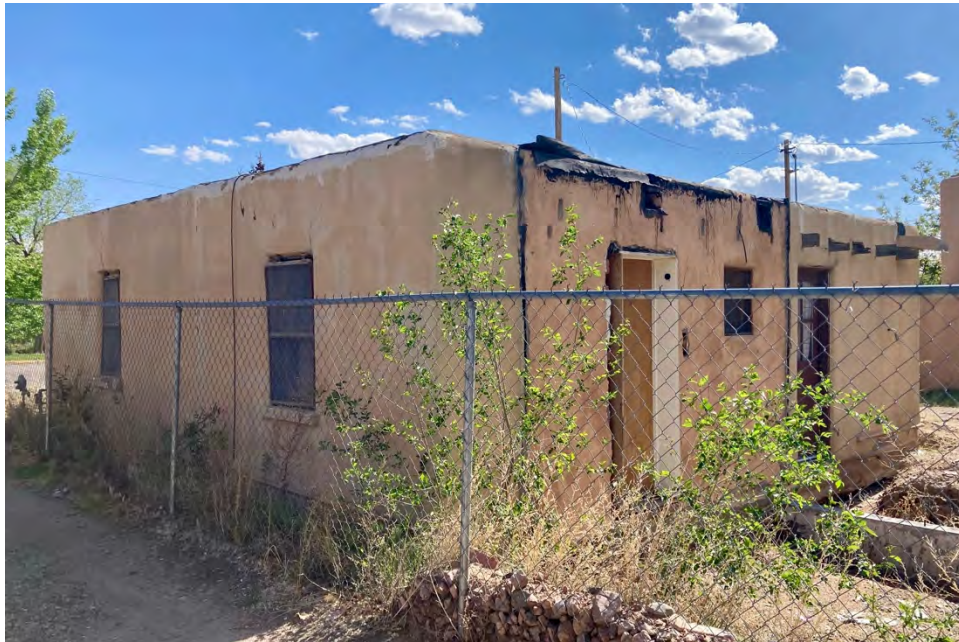
Northwest corner – looking north – May 2025

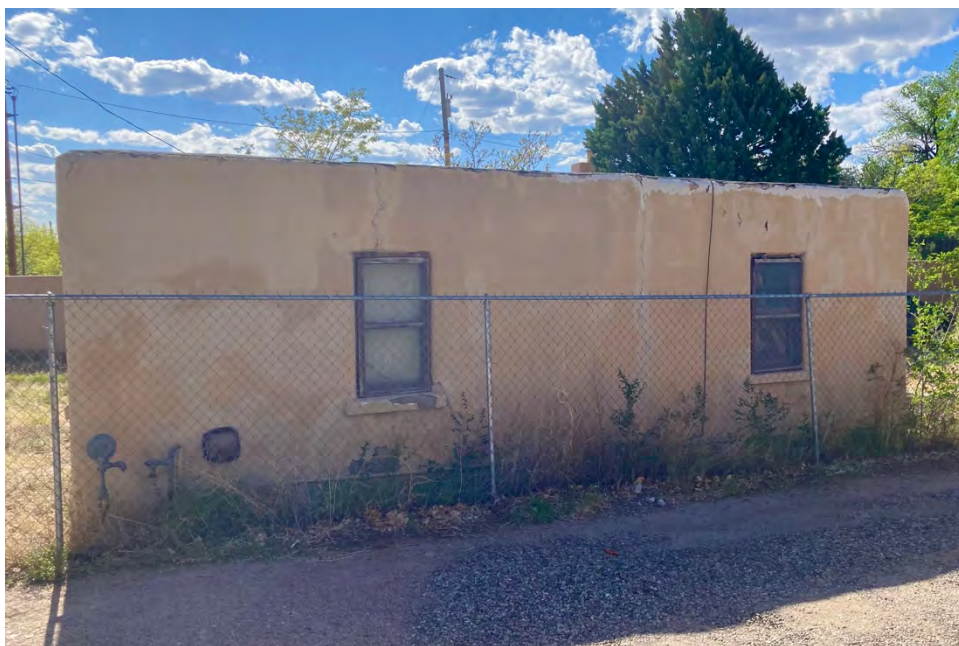
Another door is visible at the rear – on the east side. This door was installed to provide access into the rear addition. This door is a modern hollow core wood door, in a crude wood frame, that is set in a rough opening that was cut into the pen tile.

East façade – looking west – May 2025

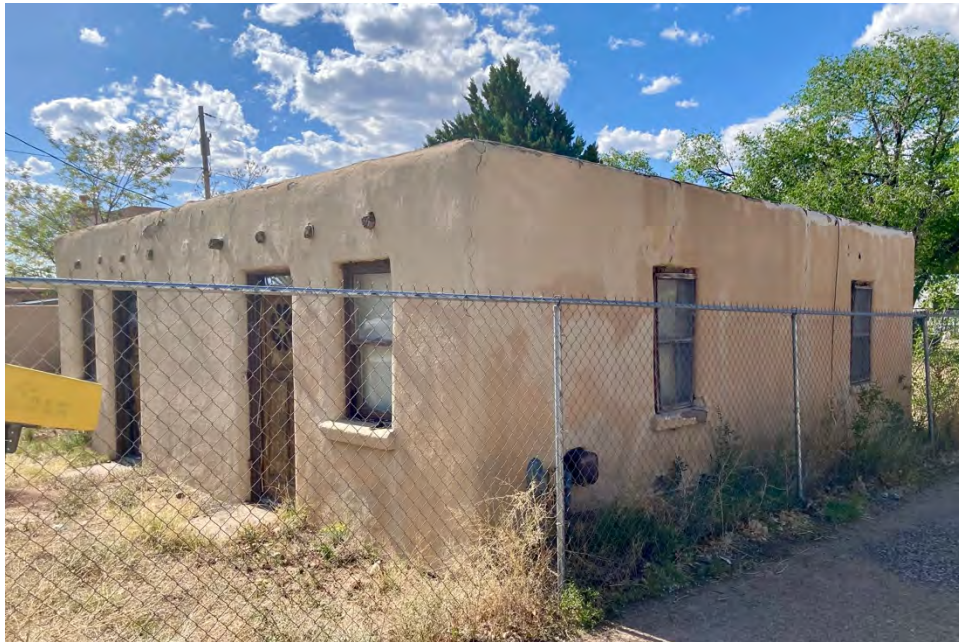
Southeast corner- looking northwest - May 2025

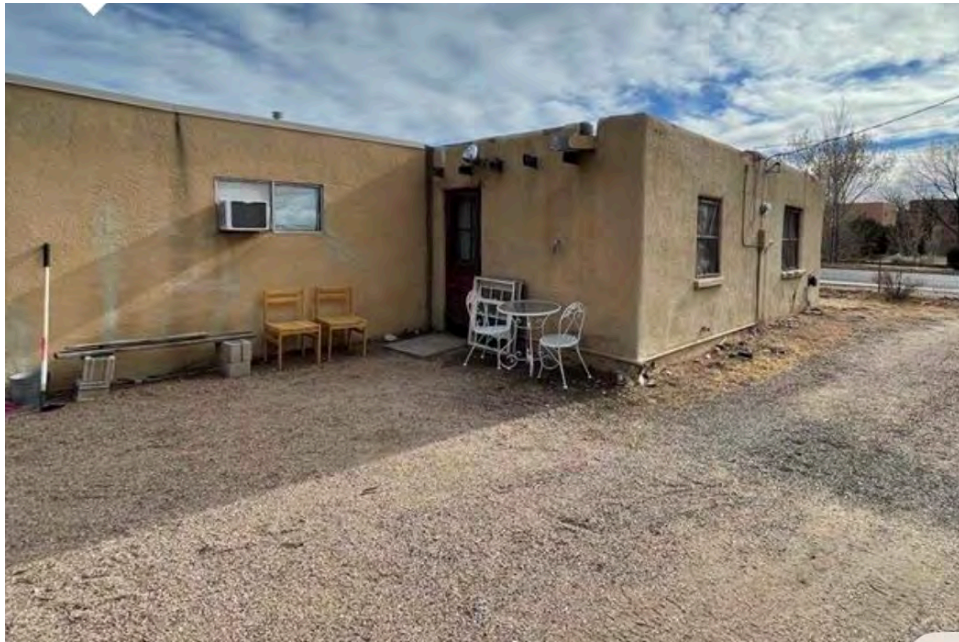
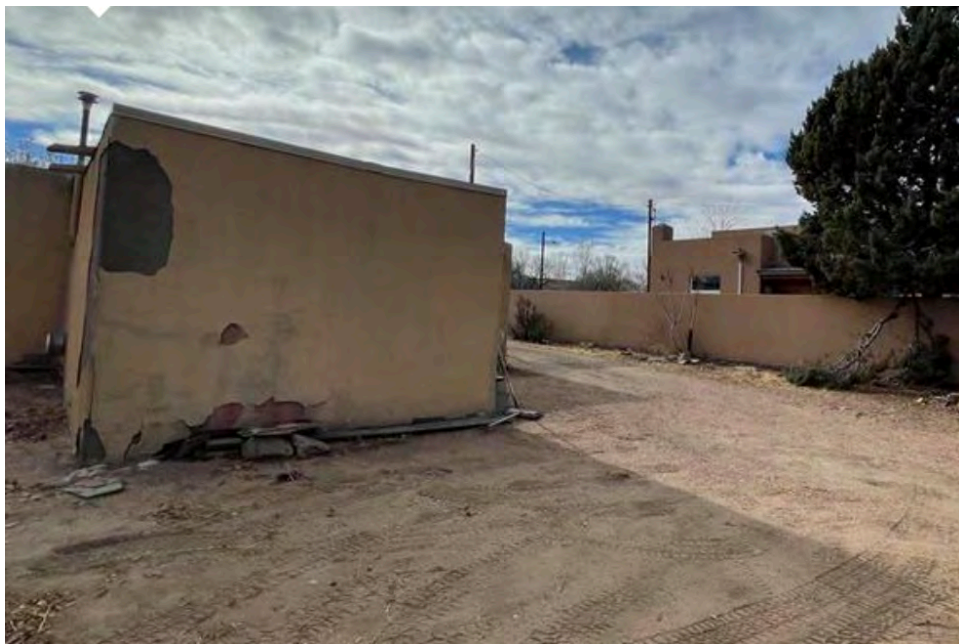
The building is a small, simple, low Pueblo Revival style structure, with a flat roof. It is approximately square, measuring about 26-1/2 feet in either direction. The setback, size, scale, style, and detailing of the building is somewhat typical of other older buildings on the street. A small rectangular wood framed addition had been added to the north side of the building, but it collapsed in late 2024 or early 2025. All that remains of this addition is the foundation.

Wood framed addition – pre collapse - 2023

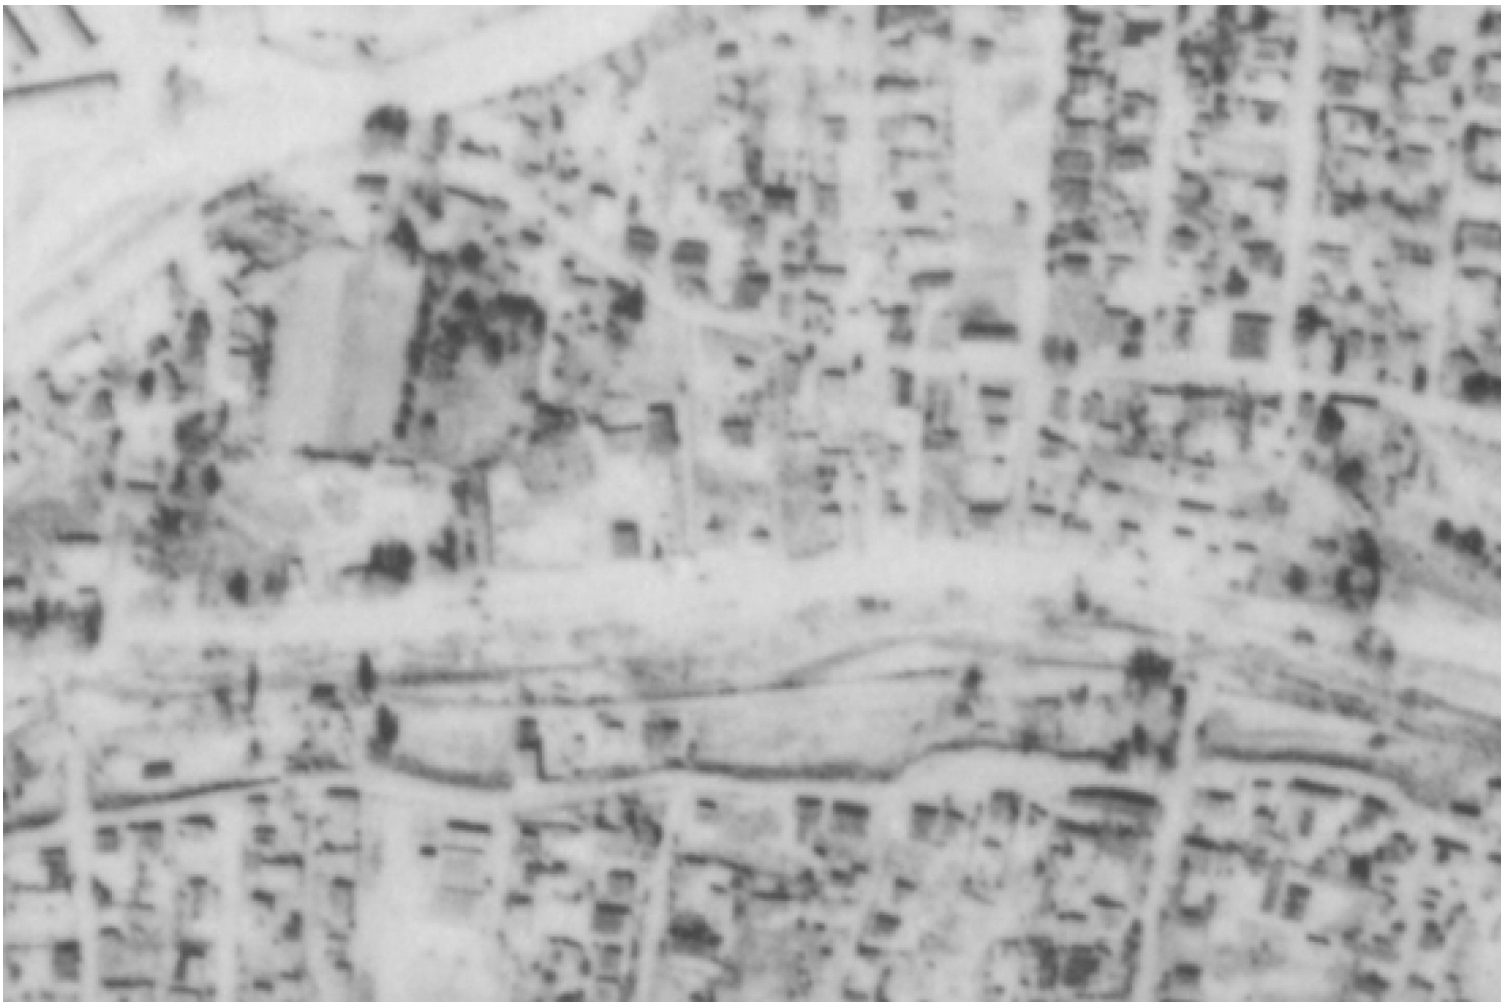
Aerial view – 1948 – appears to show a building on the property

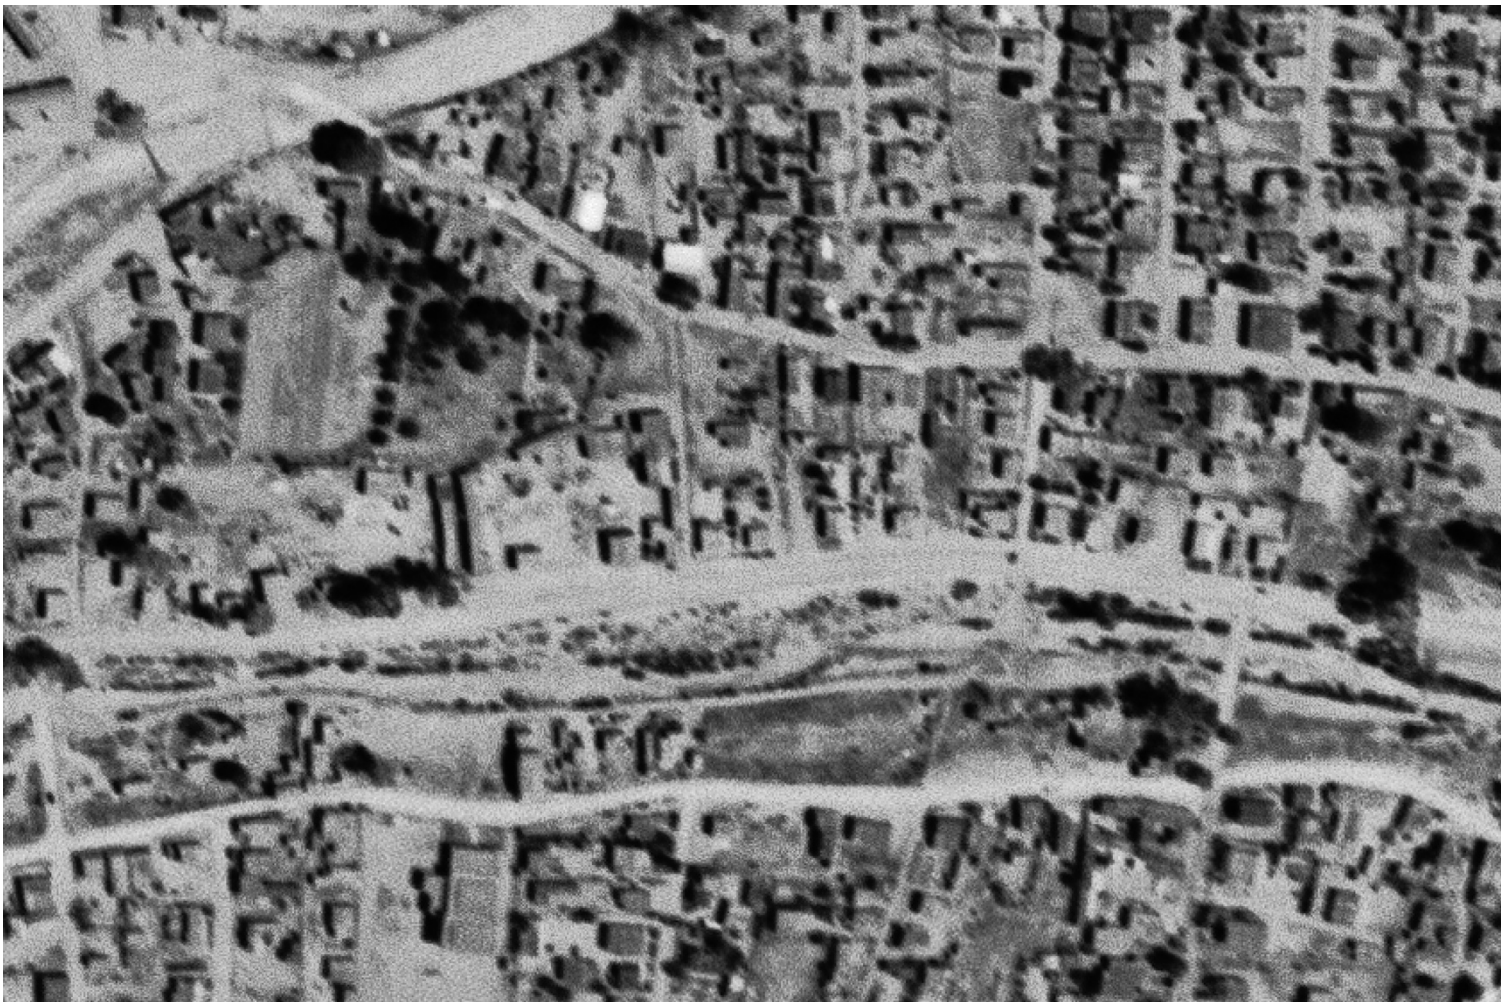
Aerial view - 1951 - appears to show a square building

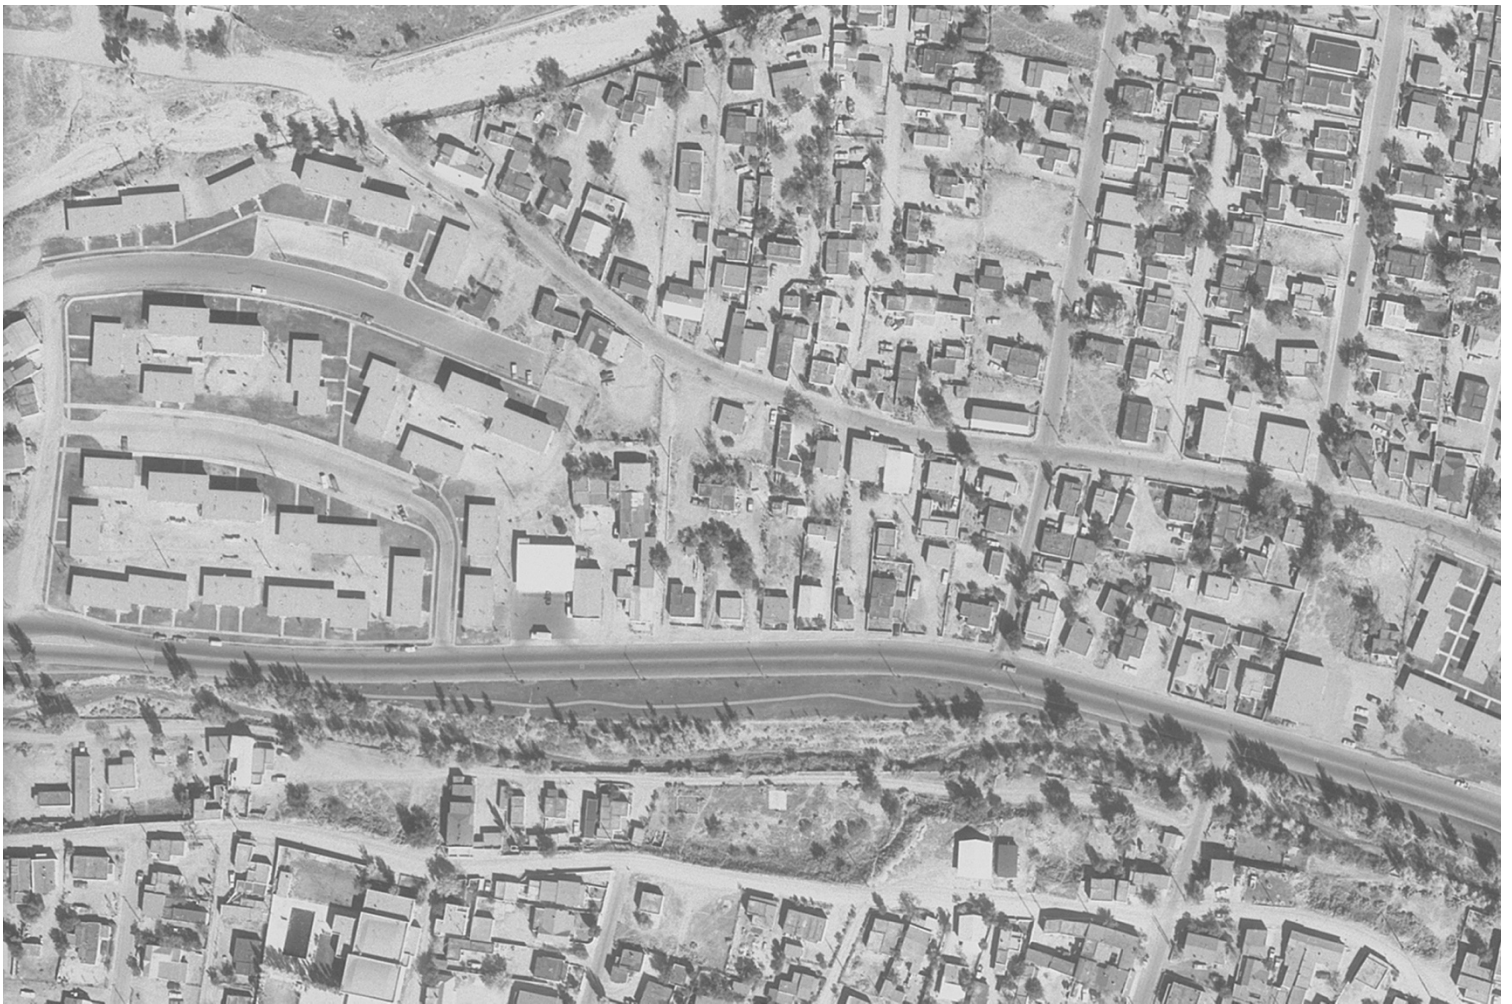
Aerial view - 1967 - clearly shows a square building

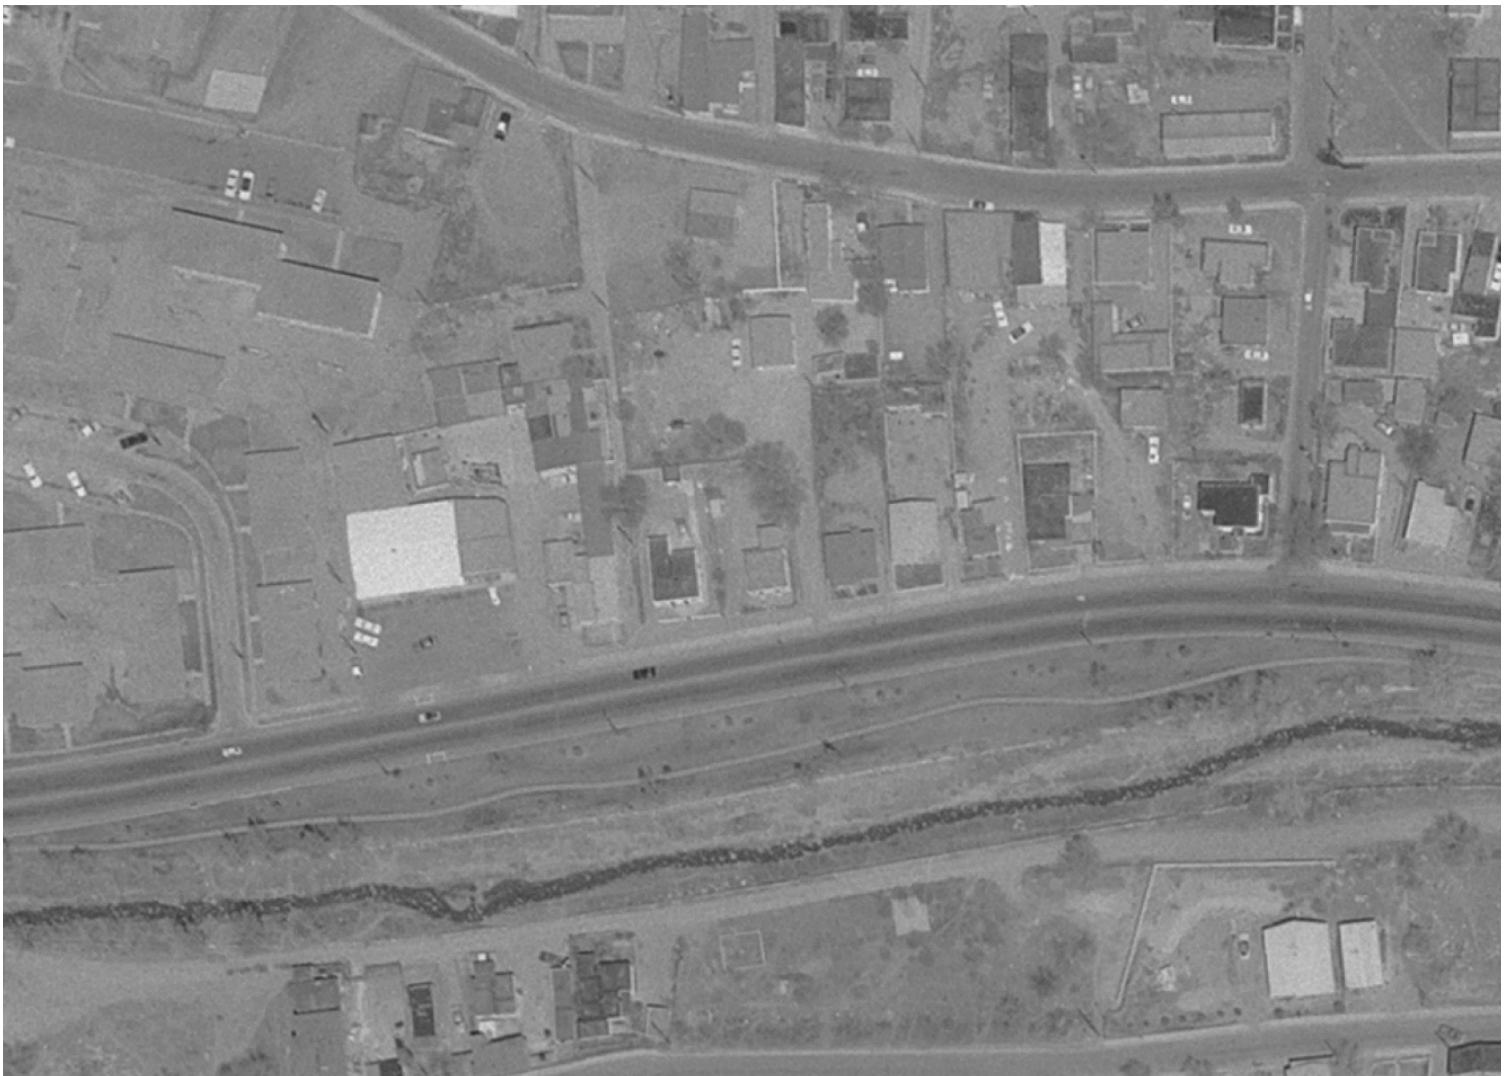
Aerial view – 1975 – clearly shows the third addition
