# Historic Cultural Properties Inventory (HCPI) Base Form (FORM 1)

| 1. Name of property:<br><br>Ramon and Ophelia Gonzales House<br>-Garage- | 2. Location:<br><br>829 West Manhattan Avenue<br>Santa Fe:<br>Westside-Guadalupe Historic District | 3. Local Reference Number:<br>N/A <i>H-2610.1</i><br>4. County: Santa Fe |
| 8. Name of Project:<br><br>HDRB status review | | |

**Recommended Noncontributing  
Structure to the Westside-  
Guadalupe Historic District,  
October 12, 2015.**

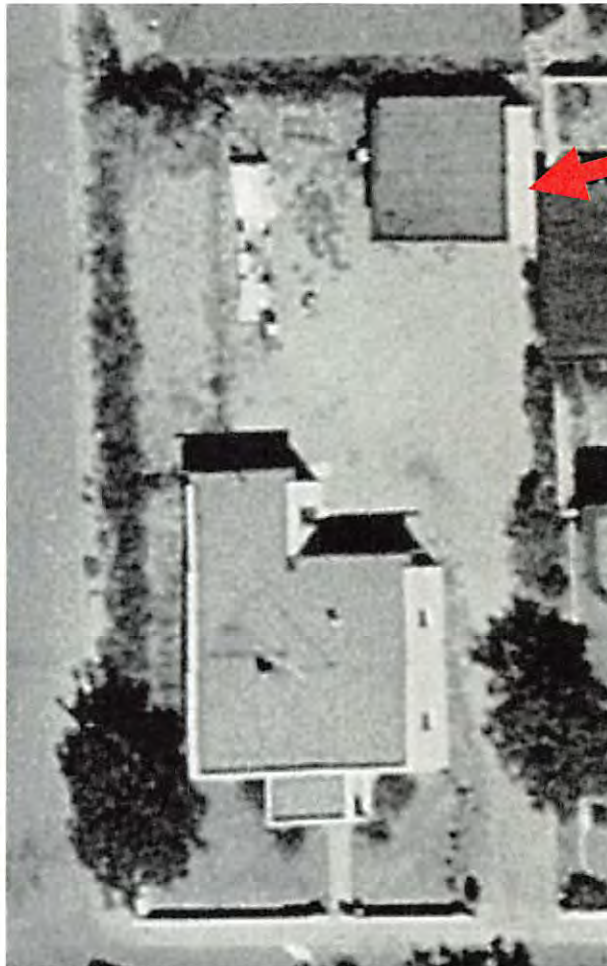
Figure 3: 1978 aerial photograph, courtesy NMDOT. Arrow indicates a probable roofed structure attached to east elevation.

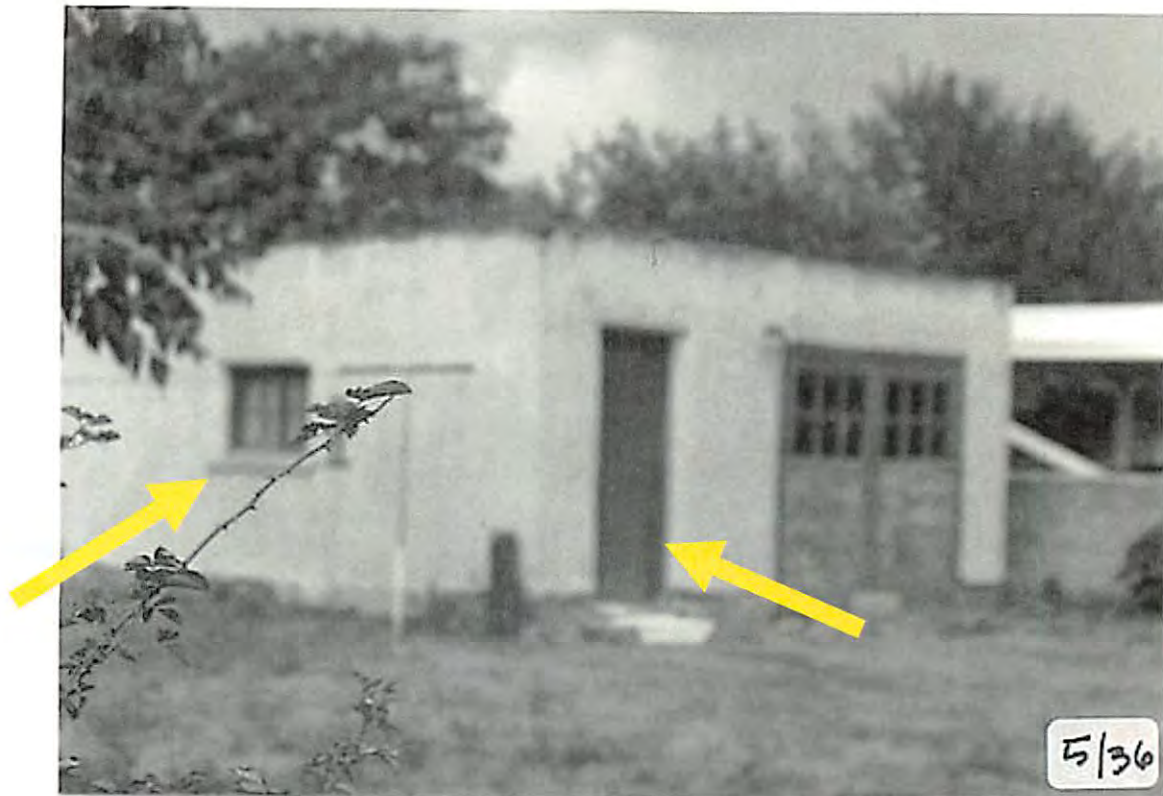
The garage was photographed but not surveyed as part of a 1998 state-sponsored resurvey of 97 structures, including garages and “rear” buildings, in the Westside-Guadalupe Historic District.<sup>iii</sup> The single, grainy photograph shows a structure with a different cladding and a different garage door than what is found today (Figure 4).

The garage opening contains what appears to be hinged or side-hung wooden carriage doors with two rows of lights at the top of each door. The west elevation window appears to be the same sliding sash current to the building. However, below the window is a discernable heavy sill that is mostly obscured today by stucco.

Figure 4: Copy of photograph from 1998 Historic Building Inventory form. Left arrow indicates shadow line of exposed sill.

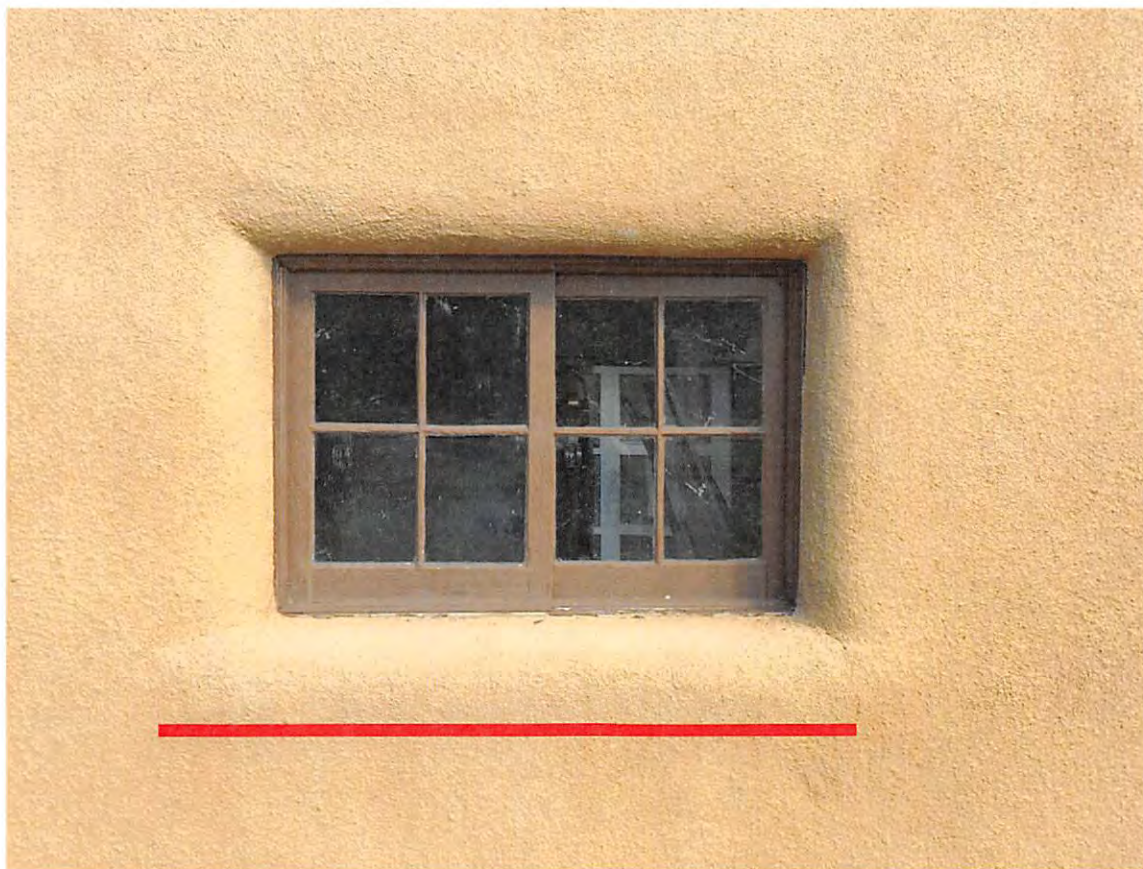
In c.2006, when the property was being prepared for sale, both the house — which in 1998 had a “peach-tan brocade” wall cladding — and the garage were re-stuccoed with a thick cementitious stucco with a sand-finish buckskin color coat.<sup>iv</sup> The re-stuccoing changed the vernacular character of the garage, giving it a Spanish-Pueblo Revival treatment that was never historically characteristic of the structure.

Figure 7: West elevation window, facing east.  
Line indicates location of sill obscured by recent stucco application.  
October 6, 2016.
