Pafuth Residence Window Assessment

1295 Cerro Gordo

Pafuth Residence Window Assessment Summary

April 20, 2026

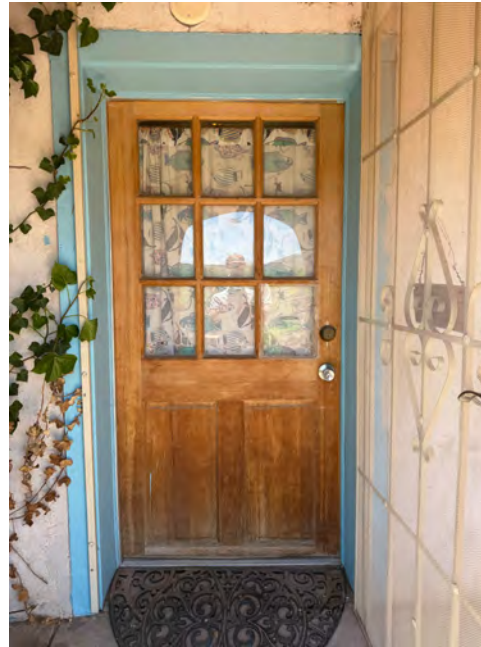
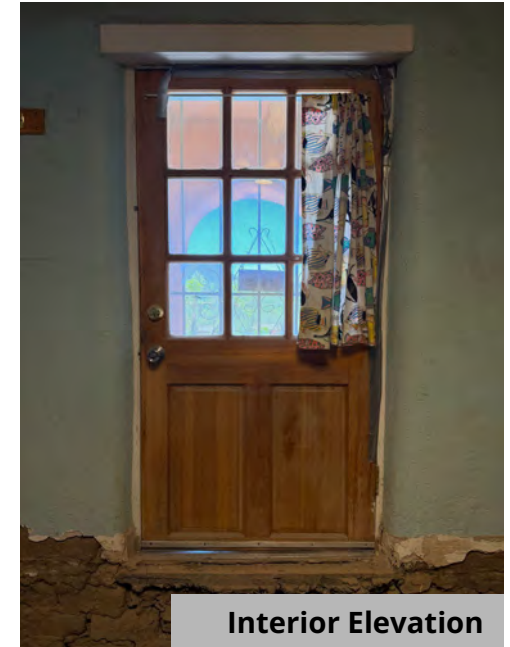
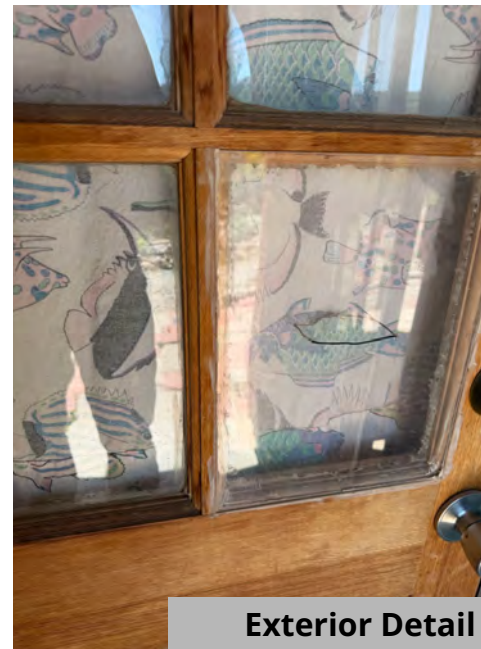
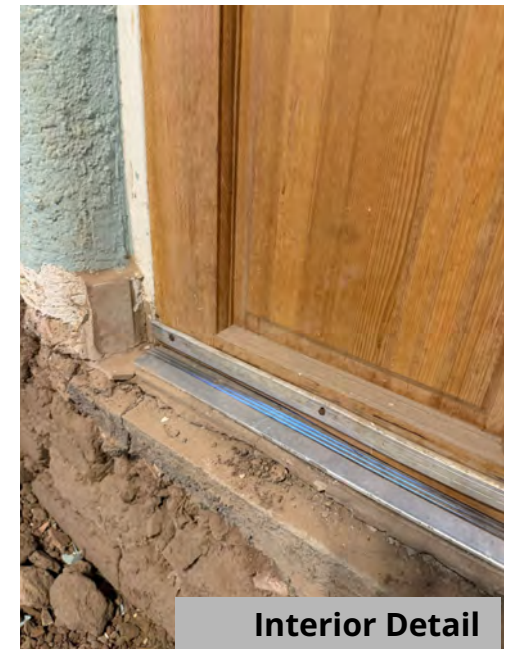
The Entry door is modern and has been replaced in the 1990's. The bottom rail has been cut to a point that compromises the integrity of the door. The hardware is modern, inexpensive, unremarkable and worn out.

DOOR #D1 - Entry		
INFO	Description Vintage	½ Light 9 over 2 Raised panels wood door c 1990
	Size	36" X 72-¾"
	Type	Single Swing Door
	Overall Condition	Poor
FRAME	Material	Wood
	Moulding Profile	Square
	Jamb Condition	Good
	Threshold Condition	Poor Worn Aluminum
	Shape	Straight
	Exterior Trim & Stops	Good
	Paint	Good
SASH / PANEL	Material	Wood
	Moulding Profile	Ogee
	Bottom Rail Condition	Poor Cut to compromise integrity of the door.
	Rails and Stiles	Fair
	Mullions	Fair
	Shape	Good
	Glazing Putty & Paint	N/A
FUNCTION	Operators/Hinges	Poor
	Handel/Hardware	Poor Worn
	Locks	Poor Worn
	Weatherstripping	Poor
<p>Notes: The door was replaced at some point and is not believed to be original to the Jamb</p> <p>Recommendations:</p> <ul style="list-style-type: none"> Replace Door Panel and extend jamb or replace Door and Jamb

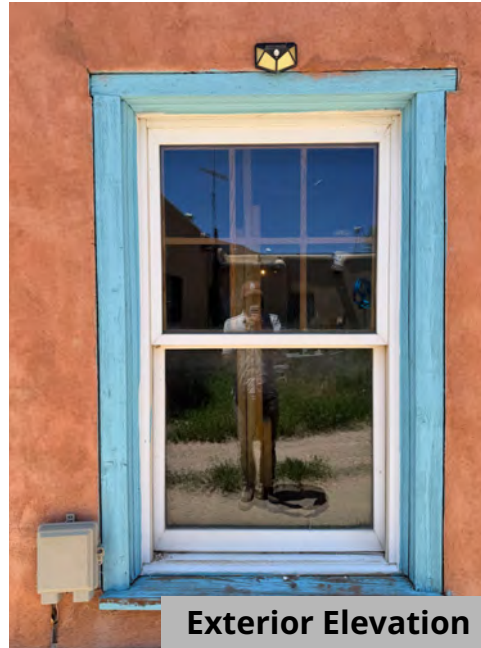
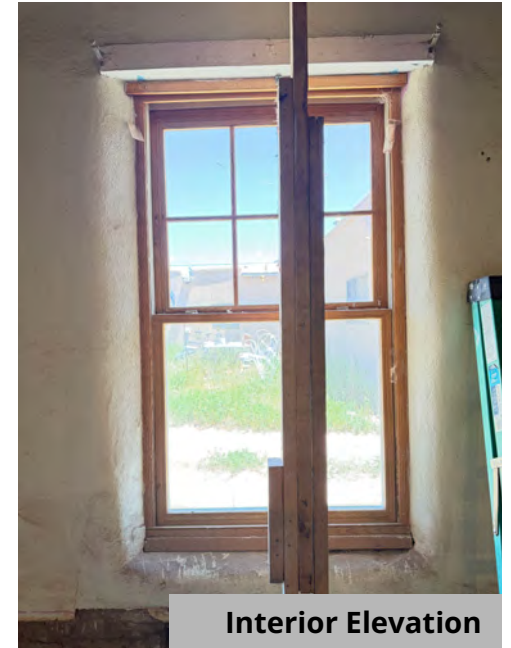
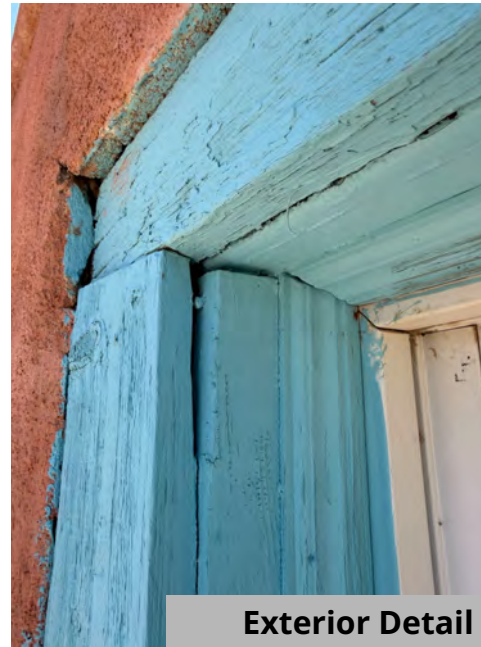
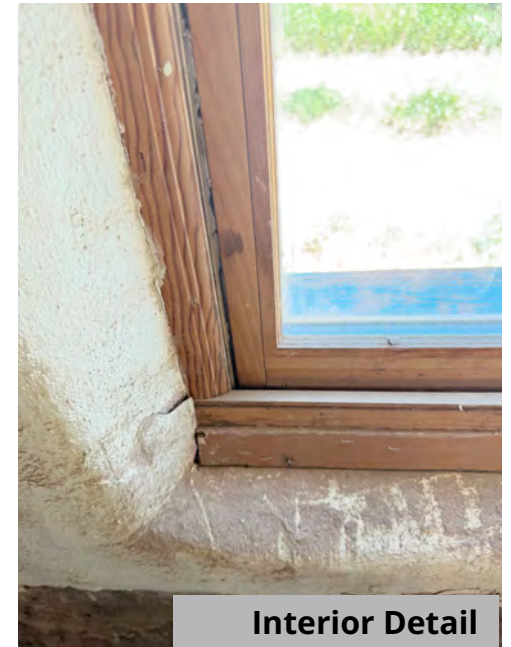
WINDOW #W3 - Bedroom

The Bedroom window is modern and unremarkable. It is installed in what is probably the original sized opening and most likely within the original trim.

INFO	Description	1 over 1 Finger jointed Wood Double Hung
	Size	38" X 66"
	Type	Double Hung
	Overall Condition	Fair
FRAME	Material	Finger Jointed Wood
	Moulding Profile	Square
	Jamb Condition	Fair
	Threshold Condition	Fair
	Shape	Straight
	Exterior Trim & Stops	Poor
	Paint	Poor
SASH / PANEL	Material	Wood and Aluminum
	Moulding Profile	Square
	Bottom Rail Condition	Fair
	Rails and Stiles	Fair
	Mullions	N/A
	Shape	Straight
	Glazing Putty & Paint	None
FUNCTION	Operators/Hinges	Poor
	Handel/Hardware	Fair
	Locks	Fair
	Weatherstripping	Poor

Notes:
Modern window made of finger jointed wood installed into what is most likely a historic window frame. The Mullions are an applied grill

- Replace

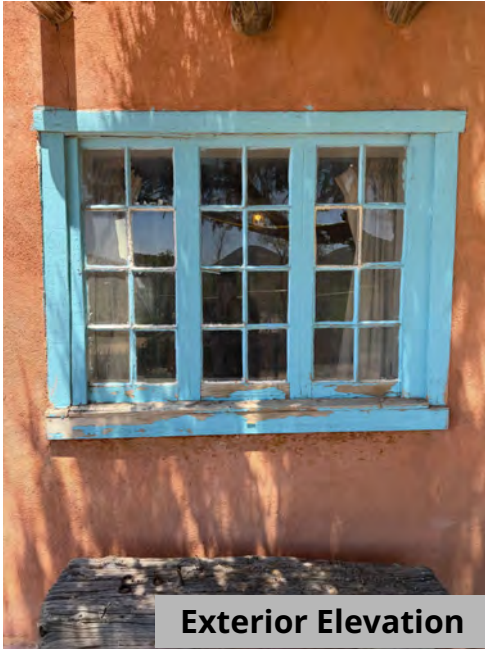
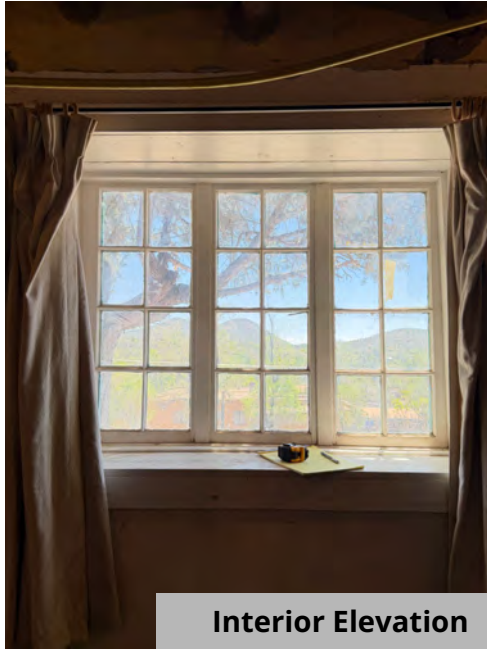
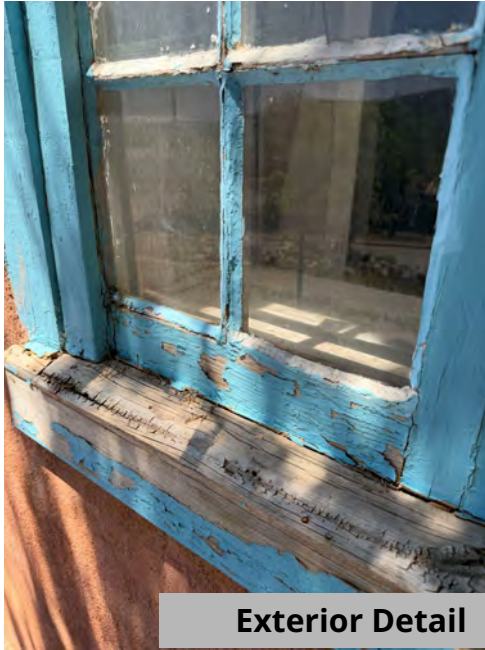
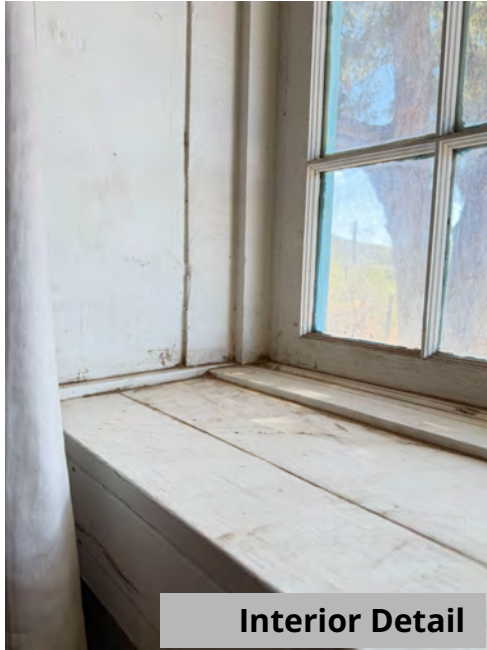
The Living room window is a series of sashes connected and fixed in place probably by nails and the opening is severely out of square and probably has been for some time. The window is cased in an adobe opening.

WINDOW #W4 - Living Room		
INFO	Description	(3) 8 lt. Sashes Fixed
	Size	54" X 40" (3) 18" X 40"
	Type	Fixed
	Overall Condition	Poor
FRAME	Material	Wood
	Moulding Profile	Square
	Jamb Condition	Poor
	Stool Condition	Poor
	Shape	Straight
	Exterior Trim & Stops	Poor
	Paint	Poor
SASH / PANEL	Material	Wood
	Moulding Profile	Ogee
	Bottom Rail Condition	Poor
	Rails and Stiles	Poor
	Mullions	Fair
	Shape	Straight
	Glazing Putty & Paint	Poor
FUNCTION	Operators/Hinges	None
	Handel/Hardware	None
	Locks	None
	Weatherstripping	None
<p>Notes: Arrangement of 3 sashes fastened together and fixed. Exterior wood condition is severely degraded</p> <p>Recommendations:</p> <ul style="list-style-type: none"> • Replace
