Historic Cultural Properties Inventory (HCPI) Base Form (FORM 1)

1. Name of property: Lugarda Sparr House/ Halla Residence	2. Location: 878 East Palace Avenue Downtown and Eastside Historic District – Santa Fe	3. Local Reference Number: Santa Fe ID: H-2935 4. County: Santa Fe Parcel # 12625792

8. Name of Project: HDRB Status Evaluation		
9. Lat/Long: 35.6811028,-105.926169		
10. Photo Information: Giulia Caporuscio, photographer. Photo 1: View of property from East Palace Avenue.

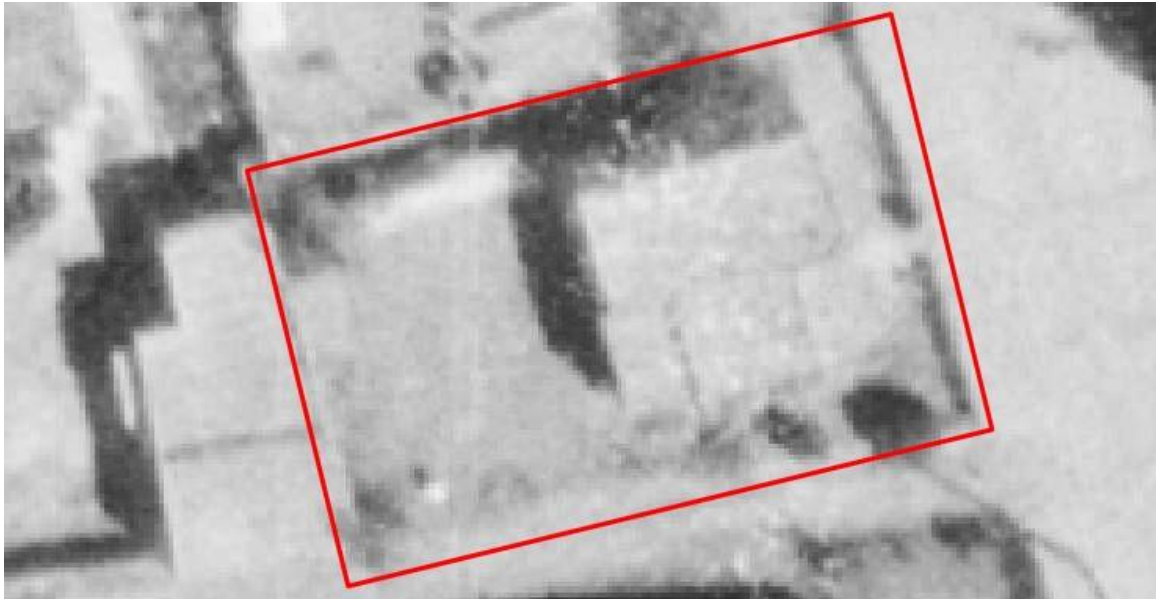
Figure 4: 1966 aerial photograph. Note low wall along the alley. Source: May 2, 1966, Sheet 16.

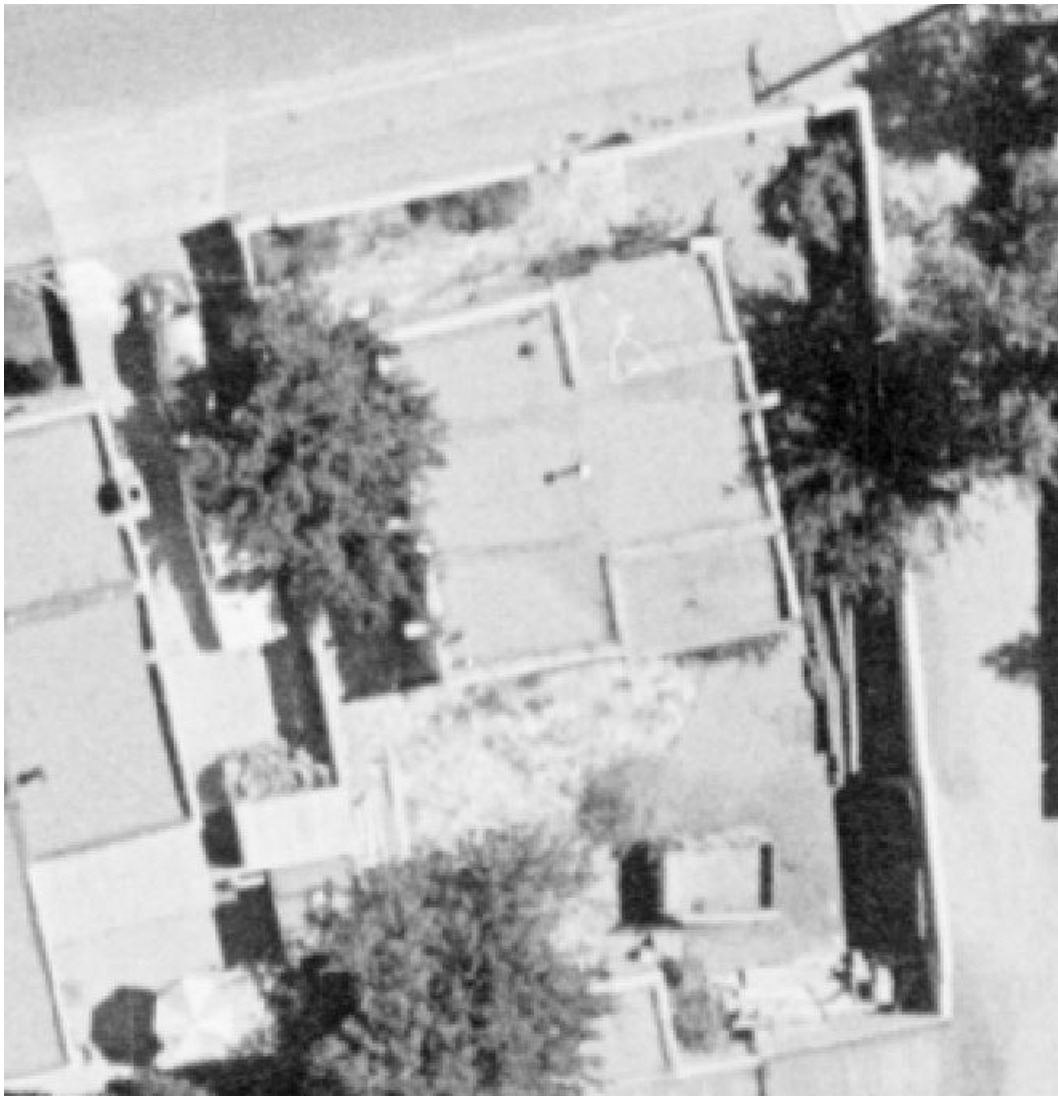
Beyond the wooden gate, one encounters an unassuming façade composed of a door and two windows (Photo 2). The portal — which once lent interest to the house — was enclosed in the 1970s to create the bedroom (Photo 3).¹ This involved shifting the entry to the exterior and installing two small windows (Photo 4). A chimney was erected at the addition’s corner, mimicking a similar chimney at the opposite end of the façade. The portal enclosure may have also coincided with a change of the parapets. Comparing aerials from the 1970s with current conditions shows that the once discontinuous sections have been connected at a uniform height, with a piece extended at the southwest corner (Fig. 6 & Field 15).

Figure 6: 1978 aerial photograph. Note discontinuous parapet line; compare with current aerial in Field 16. Note also wall along alley. Source: September 11, 1978, Sheet 75.

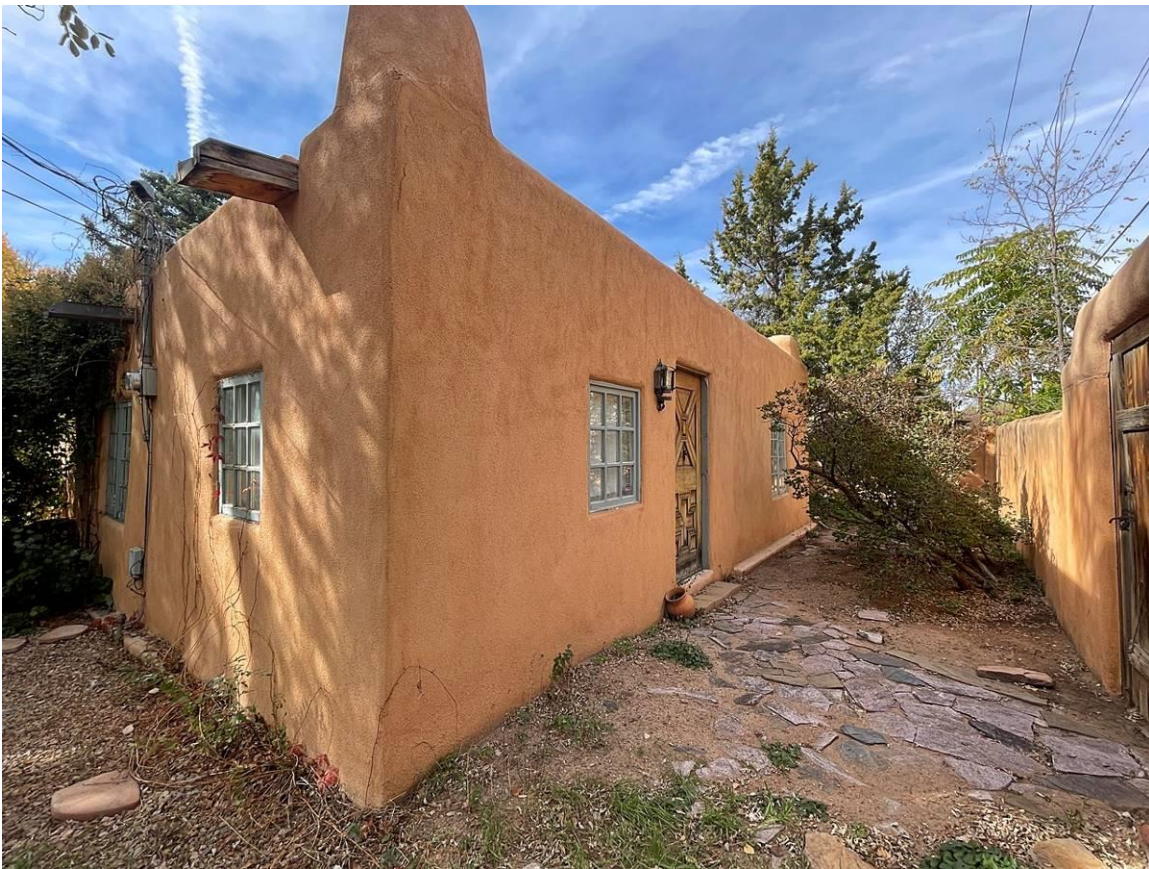
Photo 2: East oblique angle. Camera facing northwest.

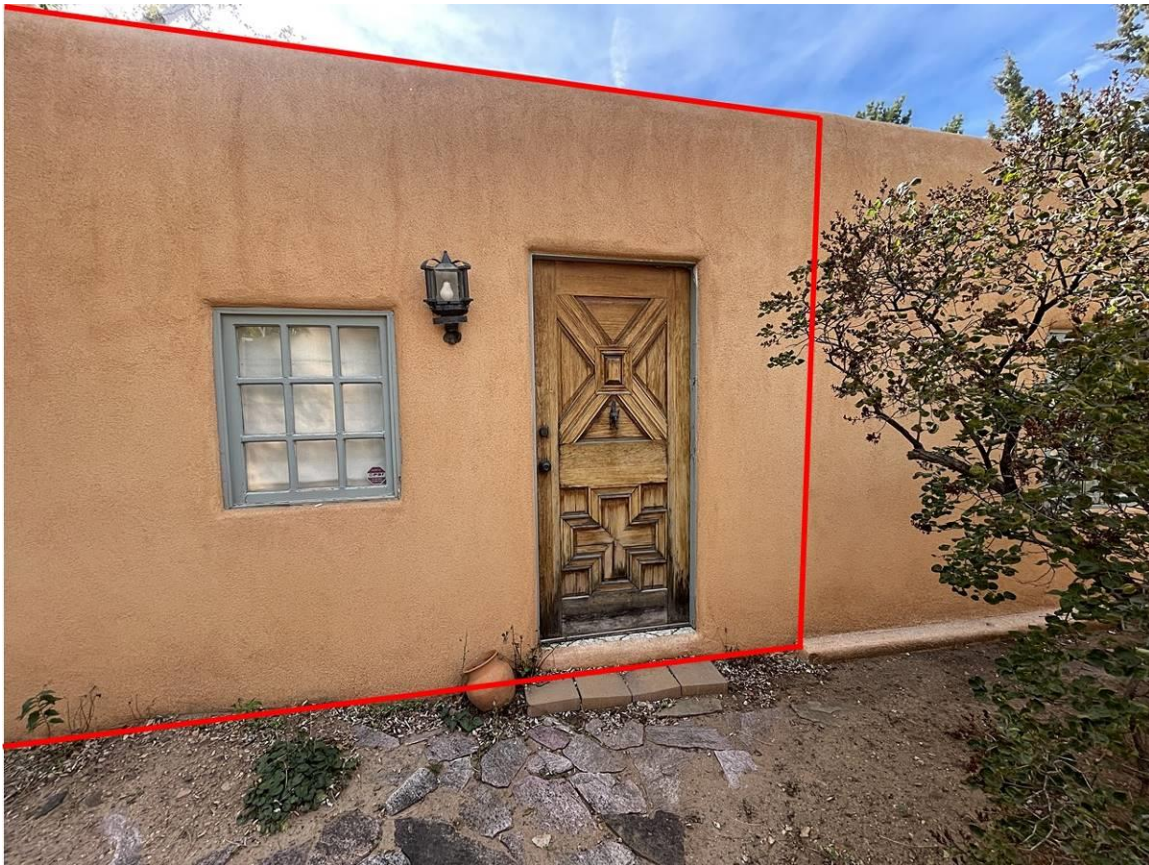
¹ Marilyn Halla, email to John W. Murphey, October 23, 2024. The infill portal is detected by a slight offset at the wall, the new windows, and the change in parapet.

Photo 3: East elevation, south end. 1970s portal enclosure highlighted. Camera facing northwest.

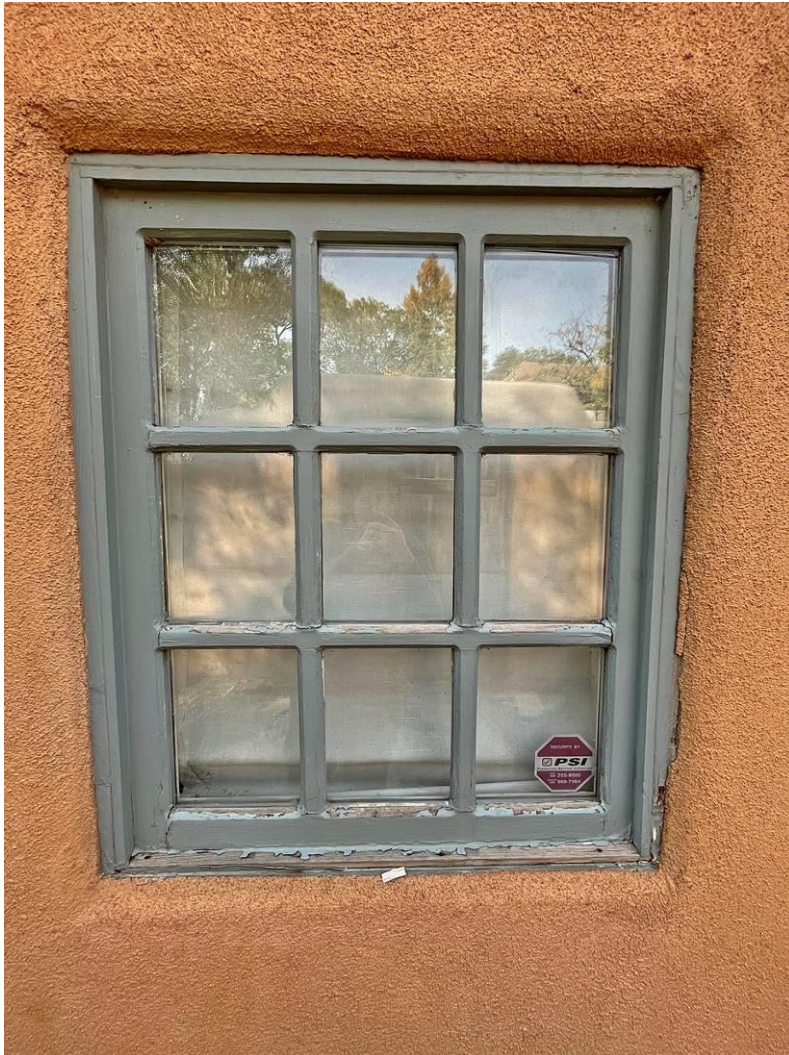
Photo 4: East elevation, portal enclosure. Non-historic window. Camera facing southeast.

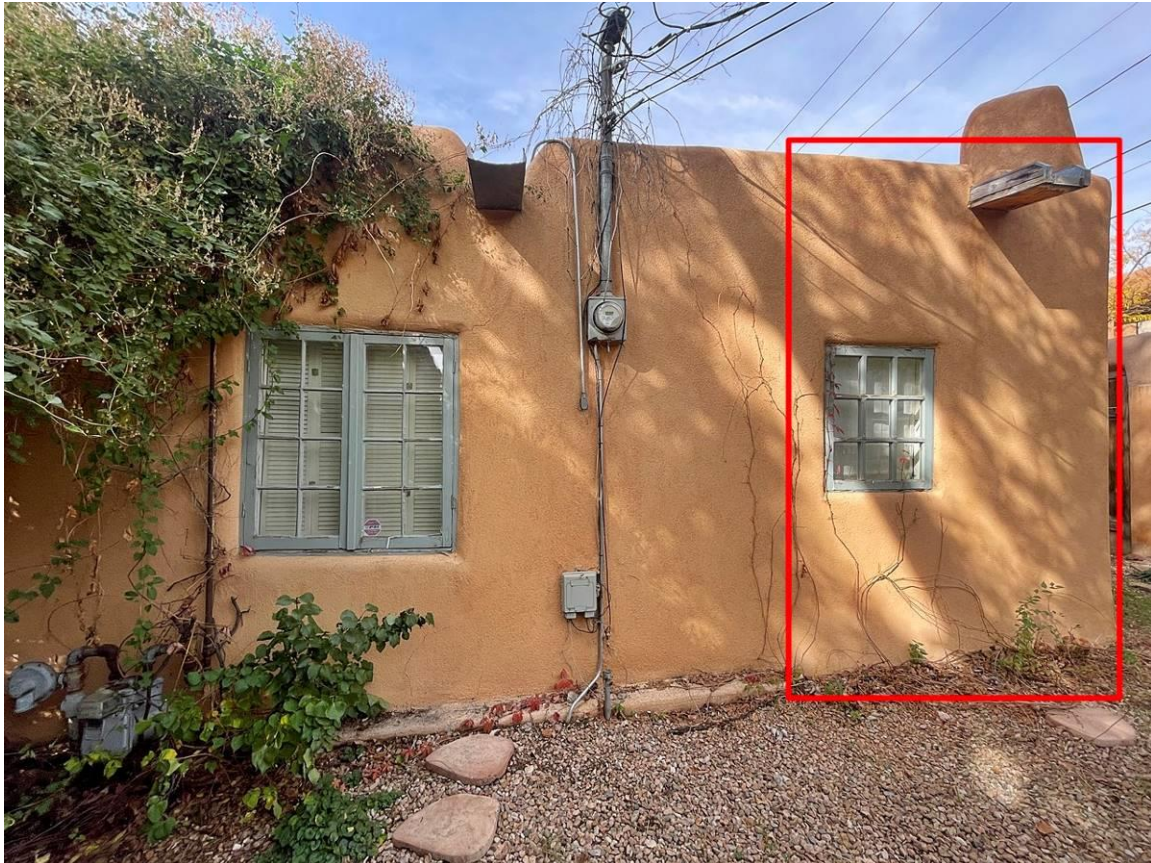
The south elevation begins at the east end with the enclosed portal (Photo 5). Beyond the addition is an older pair of eight-light wood casements. The single-glazed windows open outward by small barrel hinges (Photo 6). Similar windows are found on the north elevation. In both instances, they are deteriorated. Their age is indeterminate, but they

Photo 5: South elevation, east end. 1970s portal enclosure highlighted. Camera facing northeast.

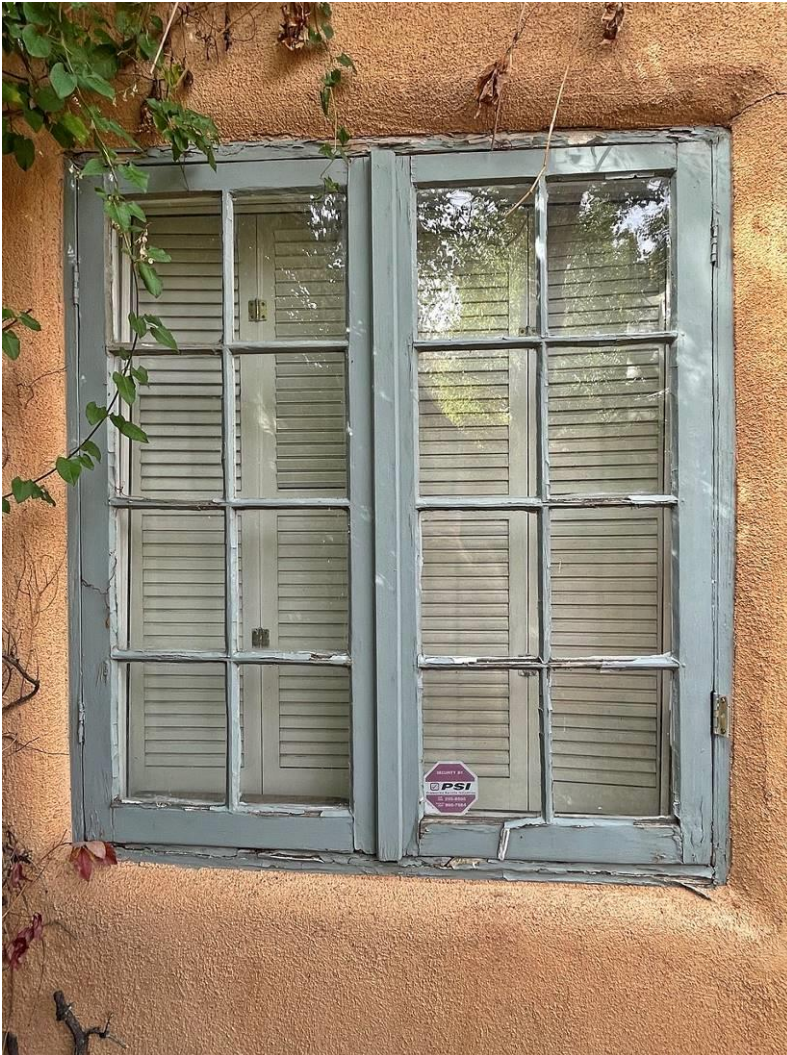
do not date to the 1930s. The elevation moves west through an overgrown bush, terminating at its connection with the enclosed porch (Photo 7).

Photo 6: South elevation. Older casement window.

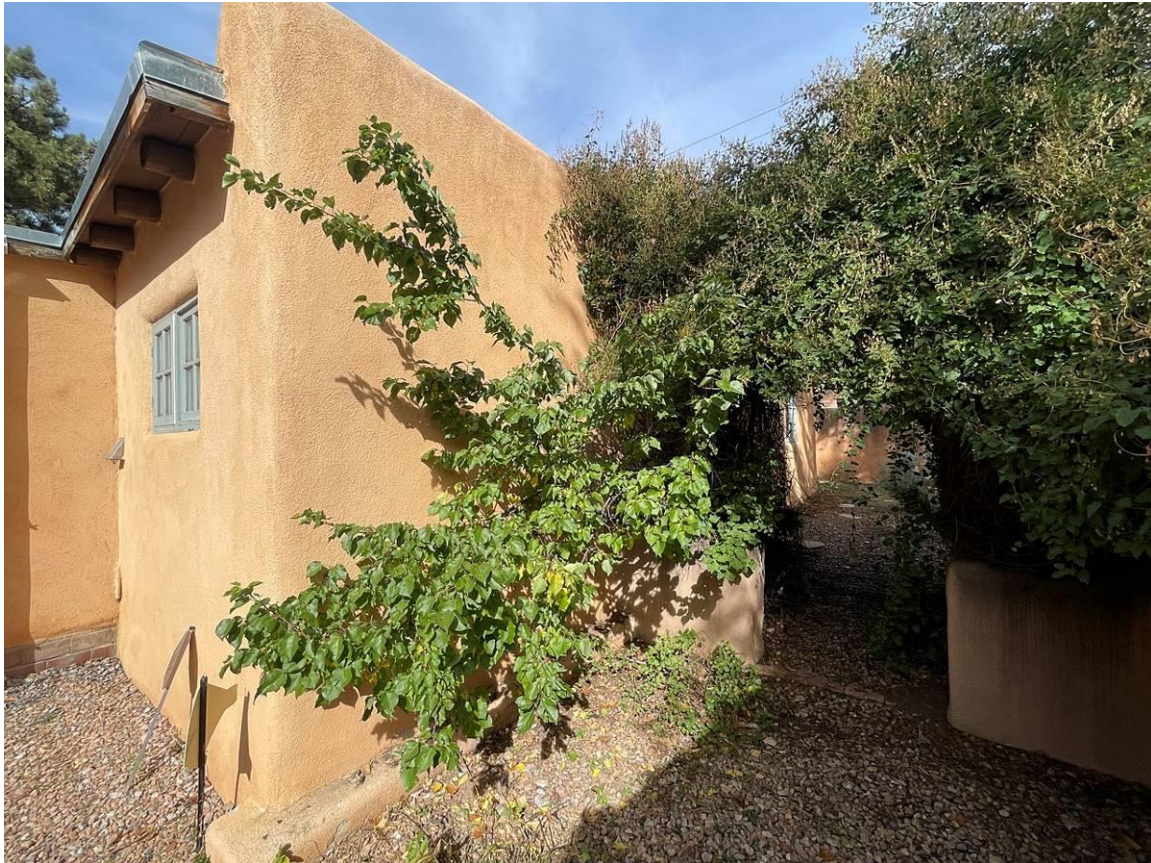
Photo 7: South elevation, at southwest corner. Enclosed porch at left. Camera facing northeast.

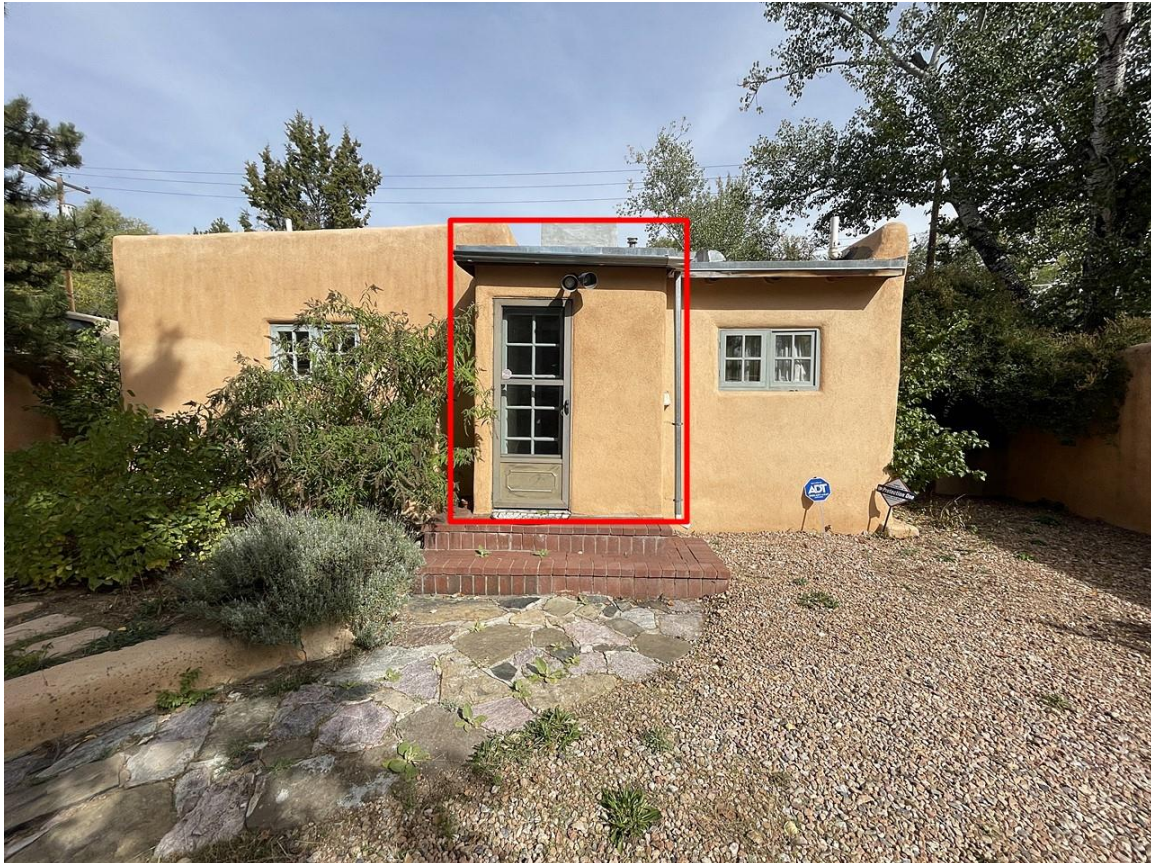
The west façade is split into two sections. The south holds what appears to have been a porch that was enclosed at some point (Photo 8). A non-historic multi-light wood door at the center opens to a laundry room. To the south, representing the original porch, are two, four-light wood windows at the bathroom. These windows, along with the same units north of the door, are not historic.

Photo 8: West elevation. Enclosed porch highlighted. Camera facing northeast.

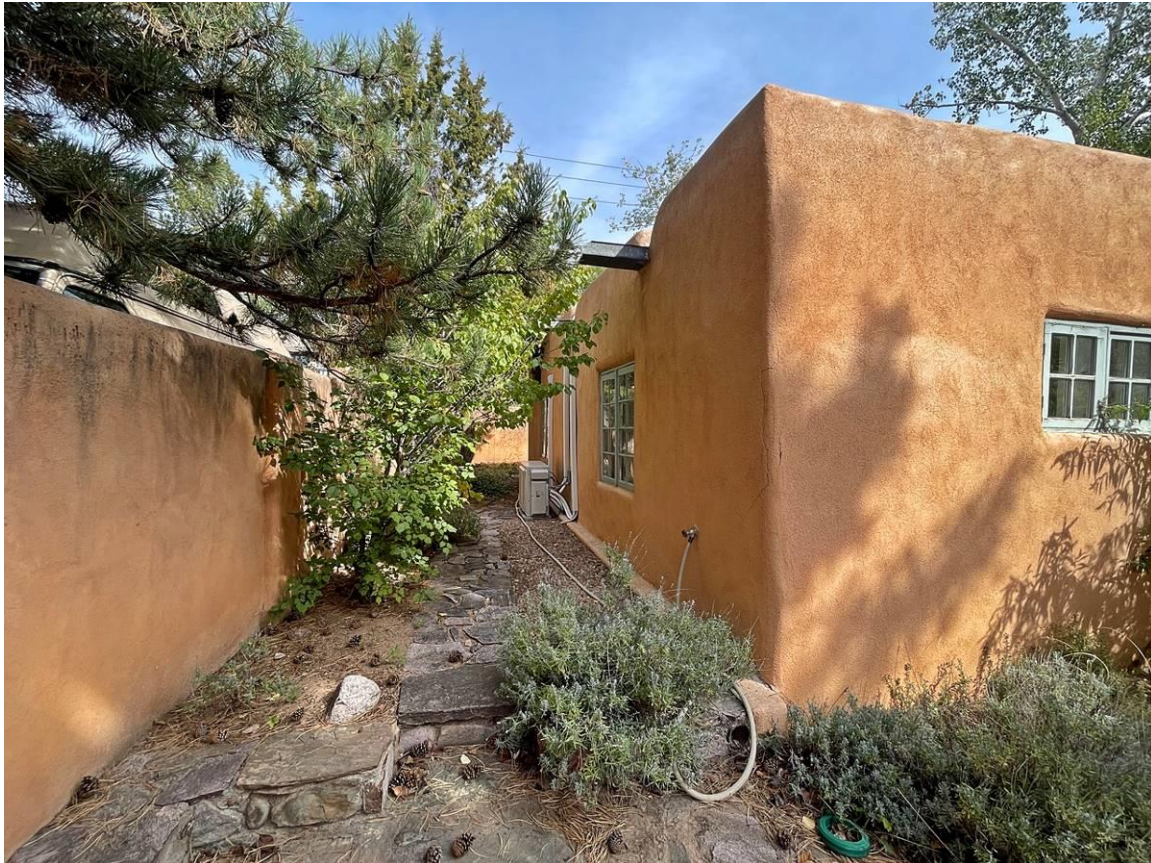
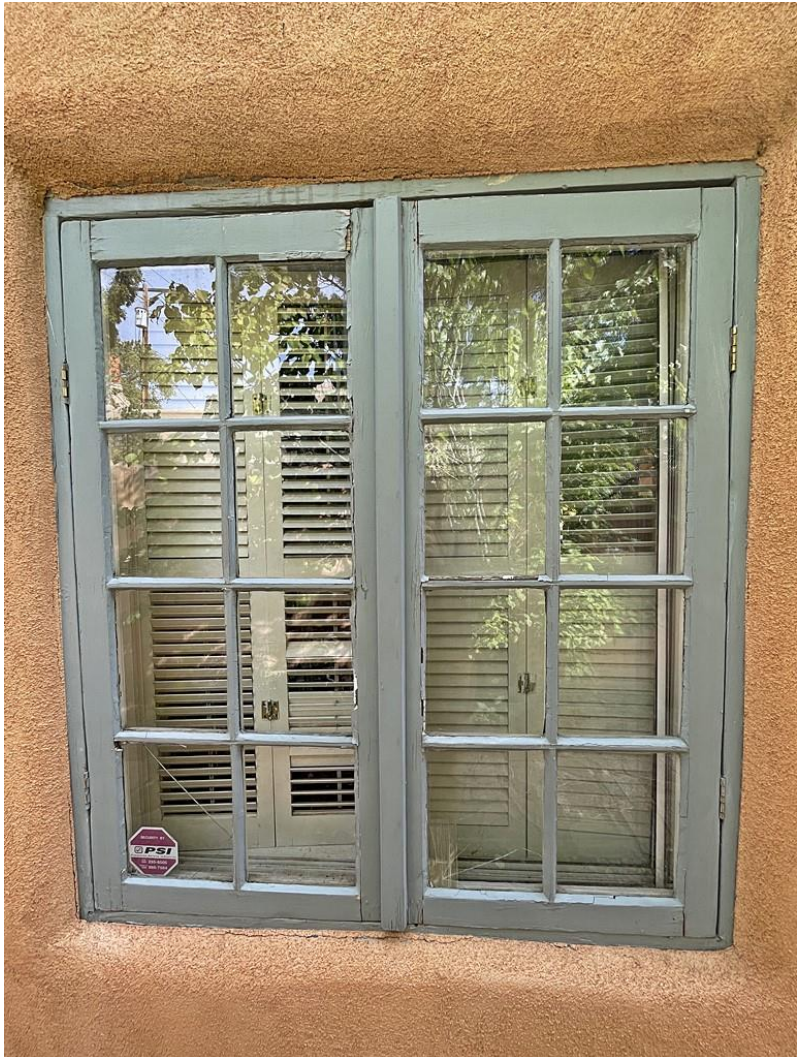
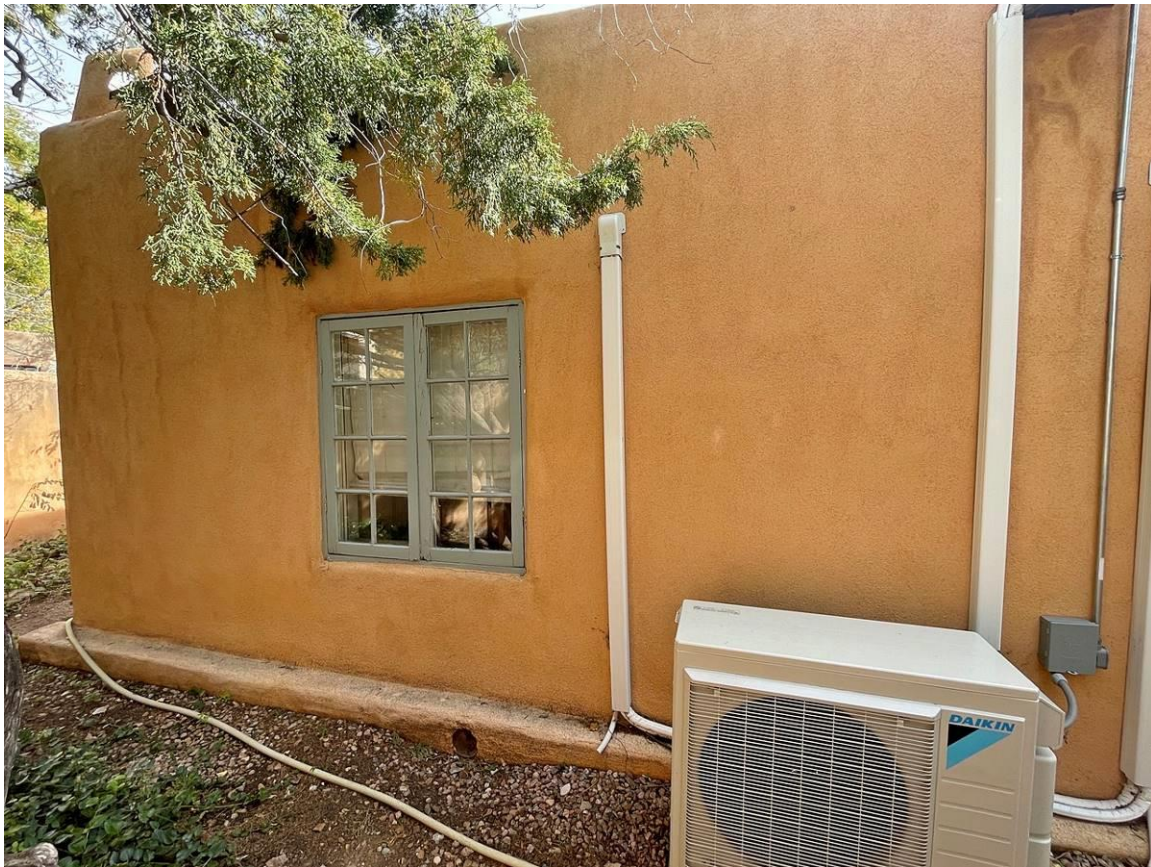
Looking onto a property wall, the north elevation contains two groups of eight-light casement windows (Photos 9-11).

Photo 9: North elevation. Camera facing east.

Photo 10: North elevation. Older casement windows.

Photo 11: North elevation, northeast corner. Camera facing southeast.

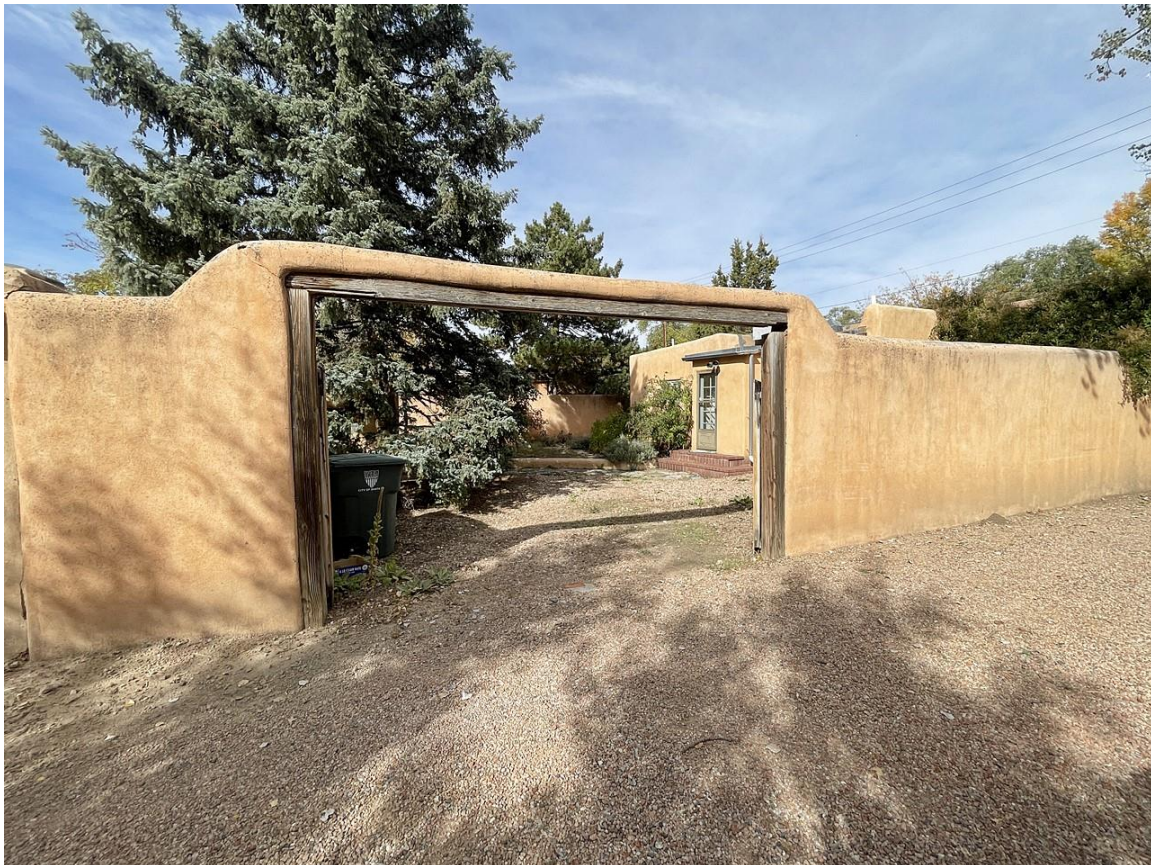
Based on a 2019 survey plat, the east and south yard walls are part of the property. The east wall (Photo 1), measuring 62” to 92” tall, may have started as a much shorter wall which gained in height in the 1970s. This lower wall appears on a 1966 aerial photograph (Fig. 5) and seems to have stayed at that height through at least 1973 (Fig. 6). By 1978, it had gained height to match a new wall built along the alley (Photo 12 & Fig. 7). The alley wall measures between 62” and 102” above finished grade. Neither is considered historic.

Photo 12: Alley wall. Camera facing northeast.
