RPA & ASSOCIATES, LLC | WINDOW & DOOR CONDITION AND INTEGRITY CODES

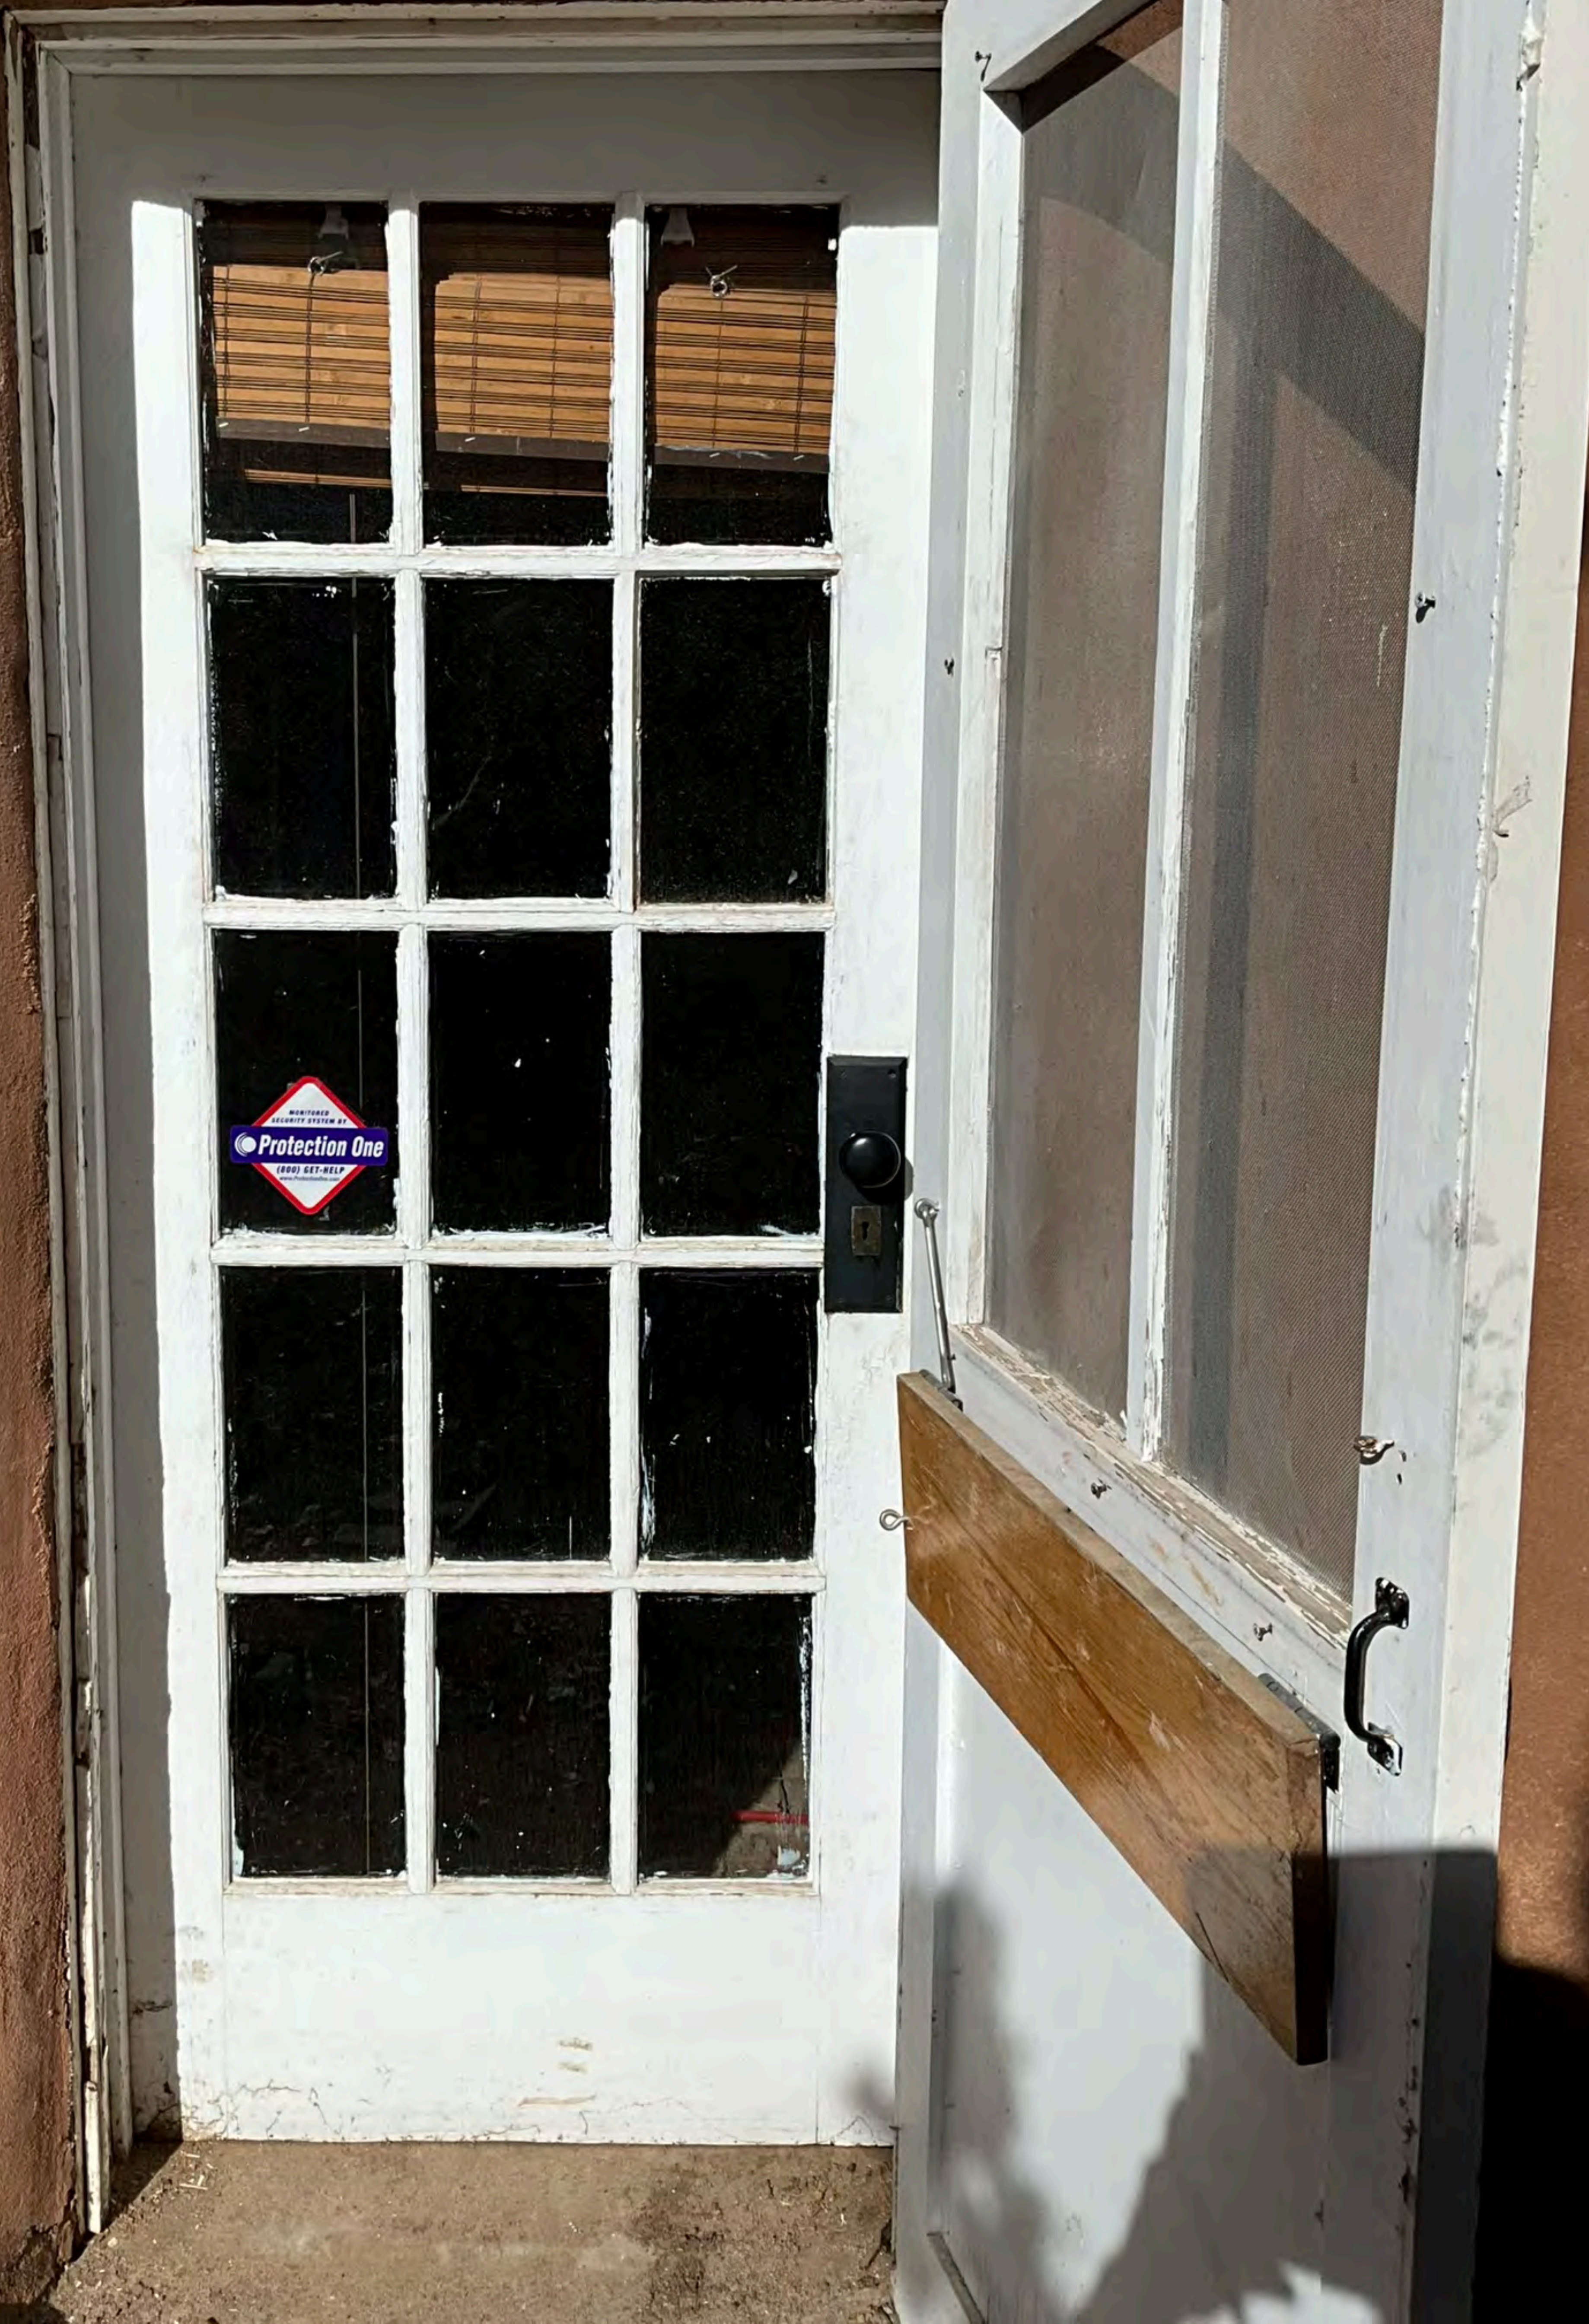
South
Elevation
Door #1

Door #1 is non-historic, 1989 Simpson fir door with wood bead and air gun nails. The screen is non-historic mechanical nails and plywood panel.

I would suggest replacing in like and kind all four windows and one door to that era either all wood or clad exterior/wood interior and divided light to meet the historic code.

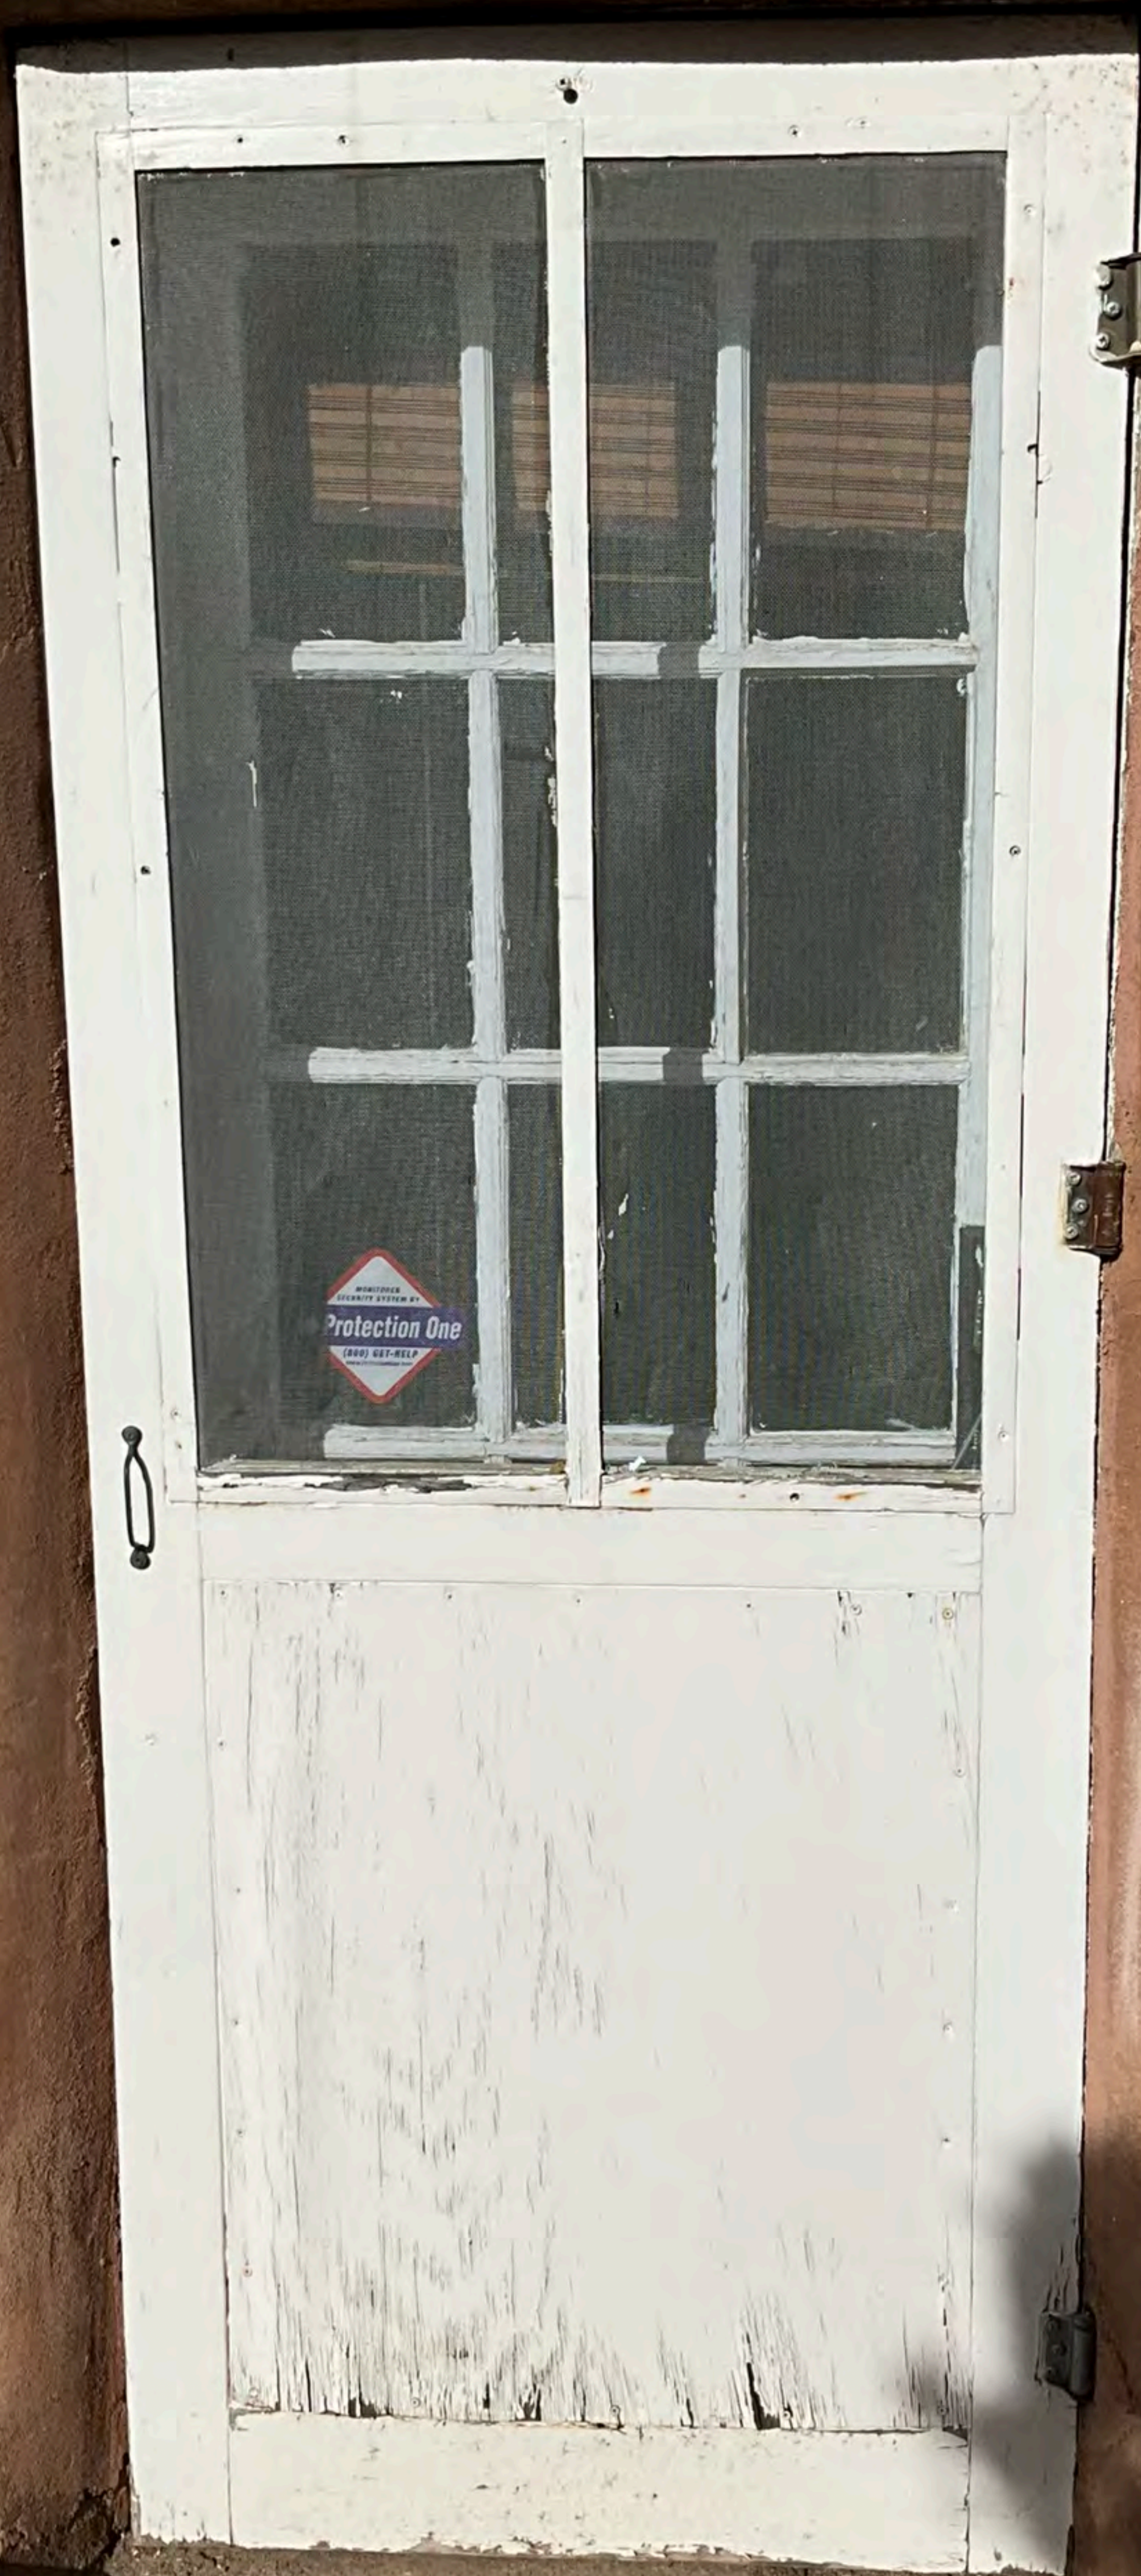
South
Elevation
Screen door
#1

All window screens and door #1 screen are non-historic. They are shop made with air nails.

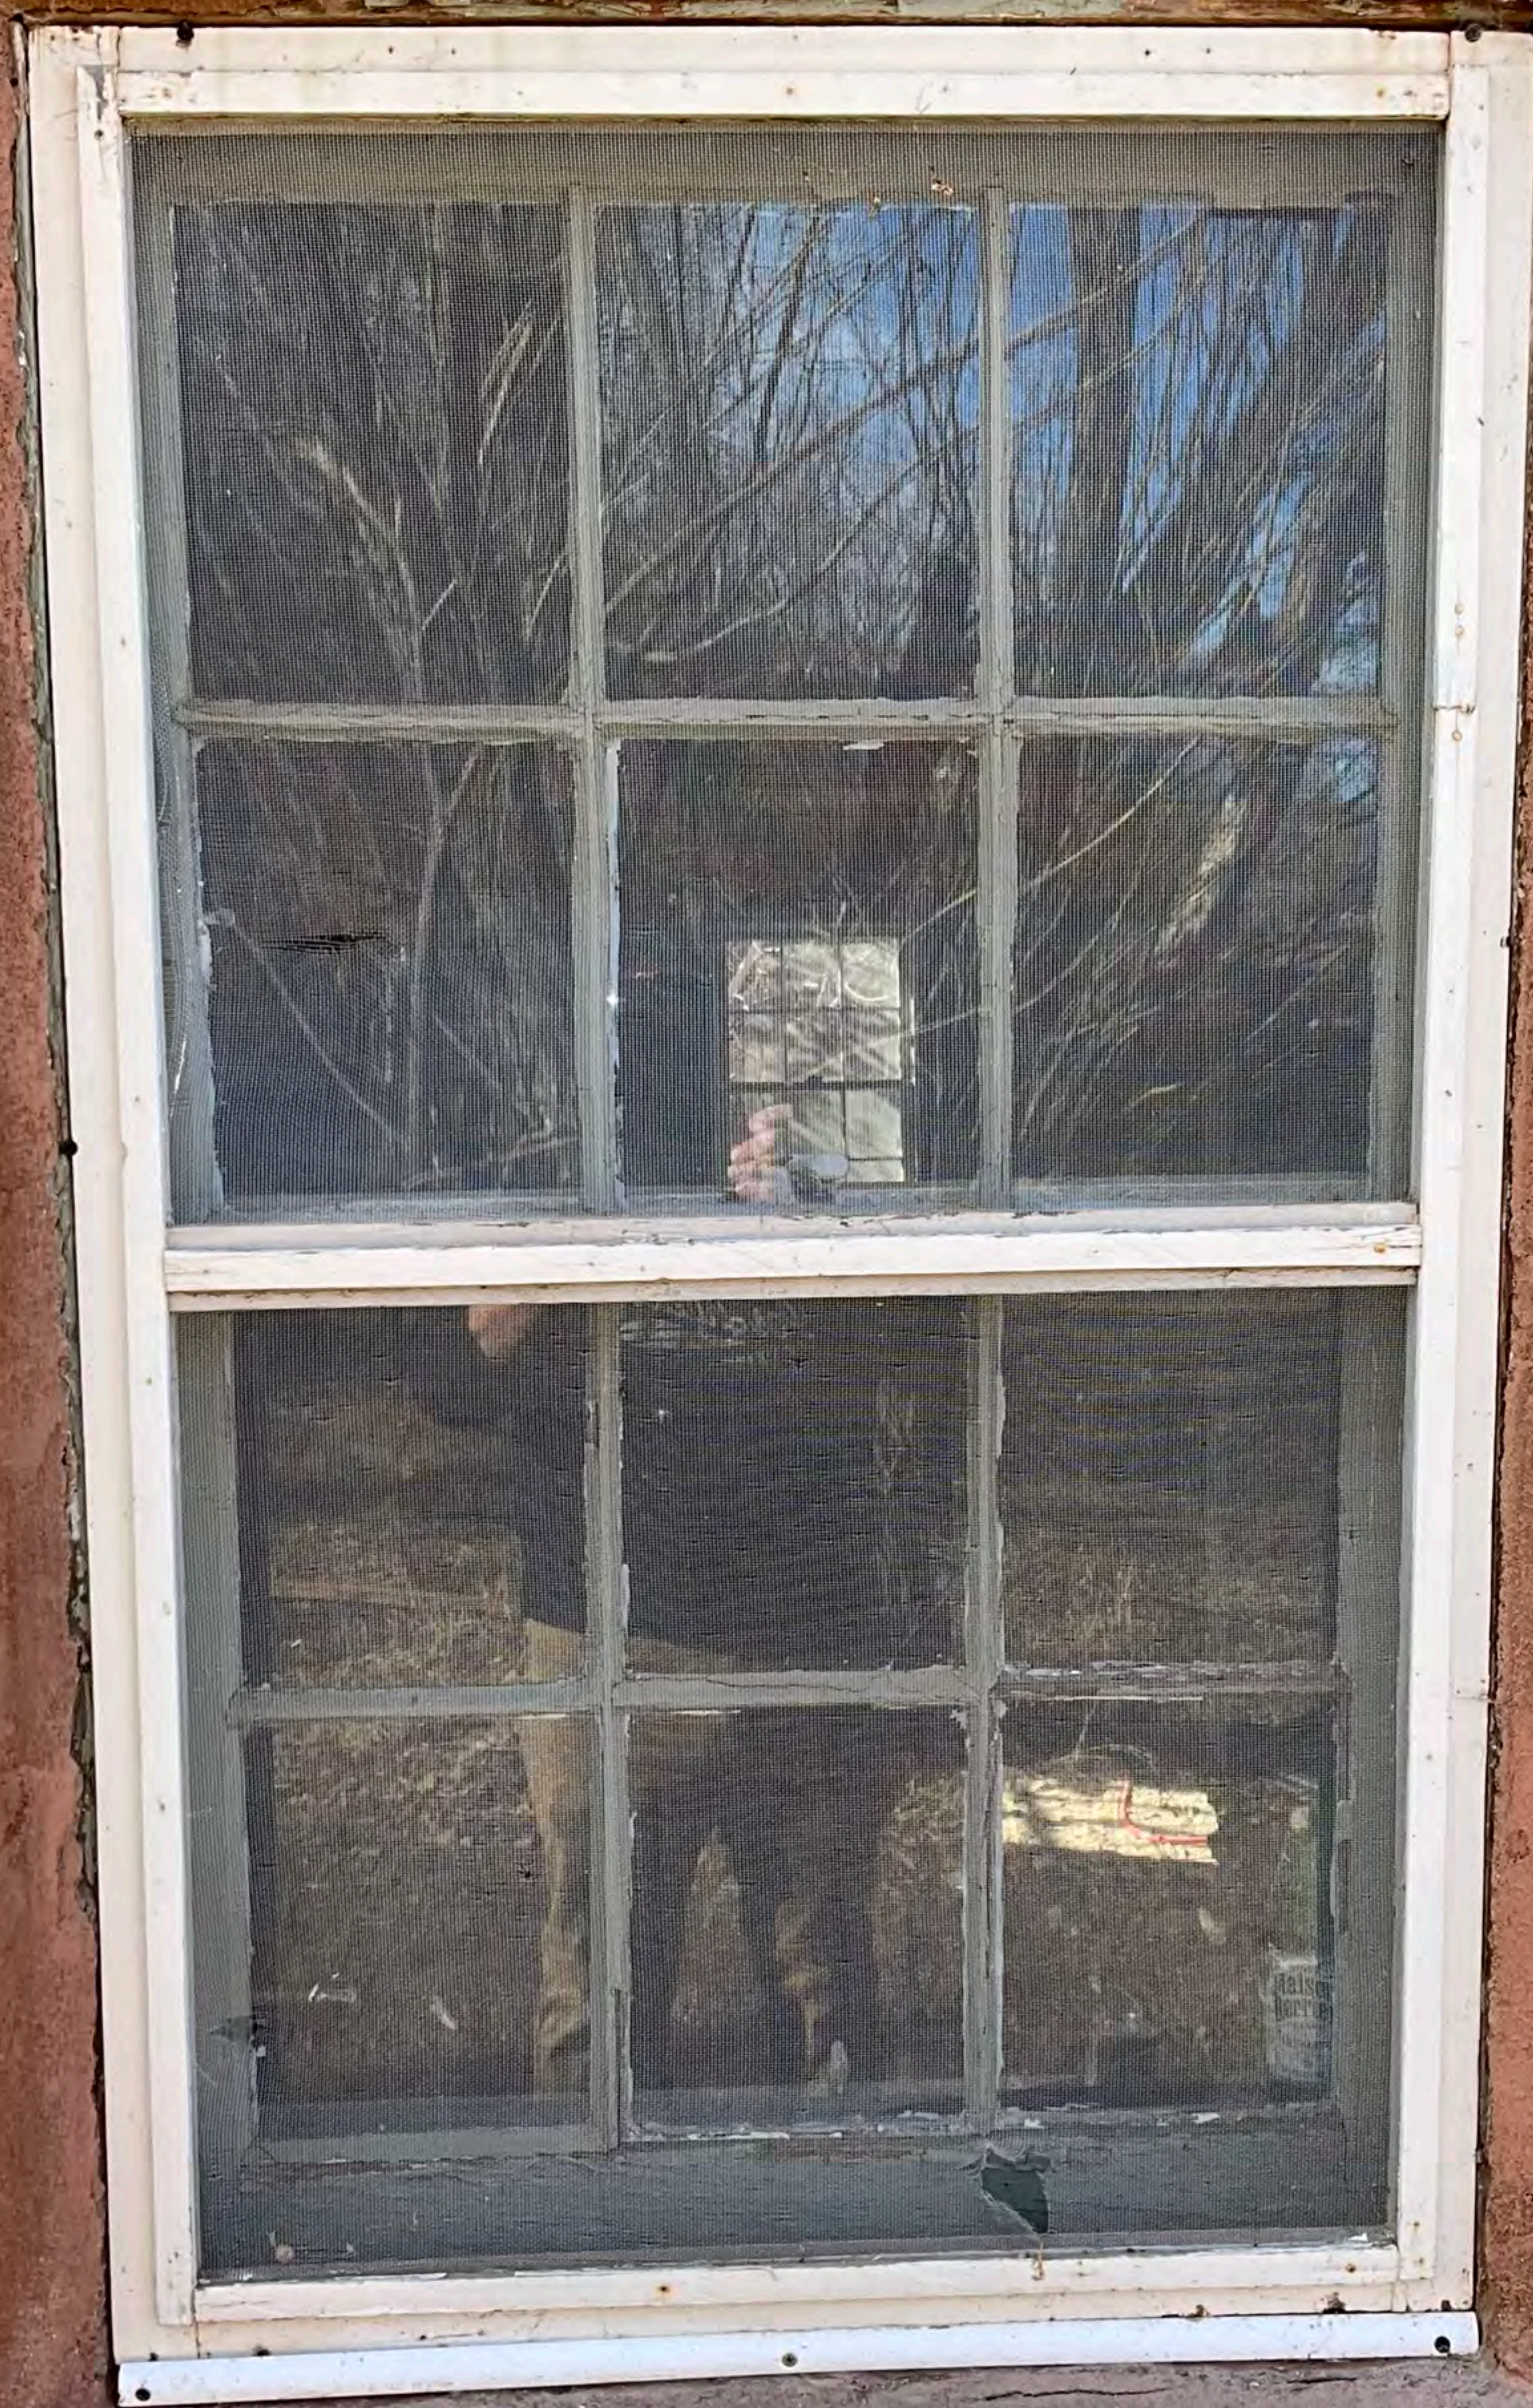
South Elevation
Window A

Window A and B are historic. Note, that though the sills are buried in the wall with a flush concrete sill added to exterior. Since sills are flush it is allowing water to run back into the adobe wall causing damage.

The historic windows A and B would have to be removed to repair which would destroy the windows upon removal. Windows C and D are non-historic.

To resolve this issue, the window would need to be removed, and the sills replaced and protrude slightly to exterior like they were originally. The problem is the windows perimeter jamb is also the buck for the opening, meaning the window would be destroyed during removal. Therefore, a new window will need to be made in like and kind for the two windows.

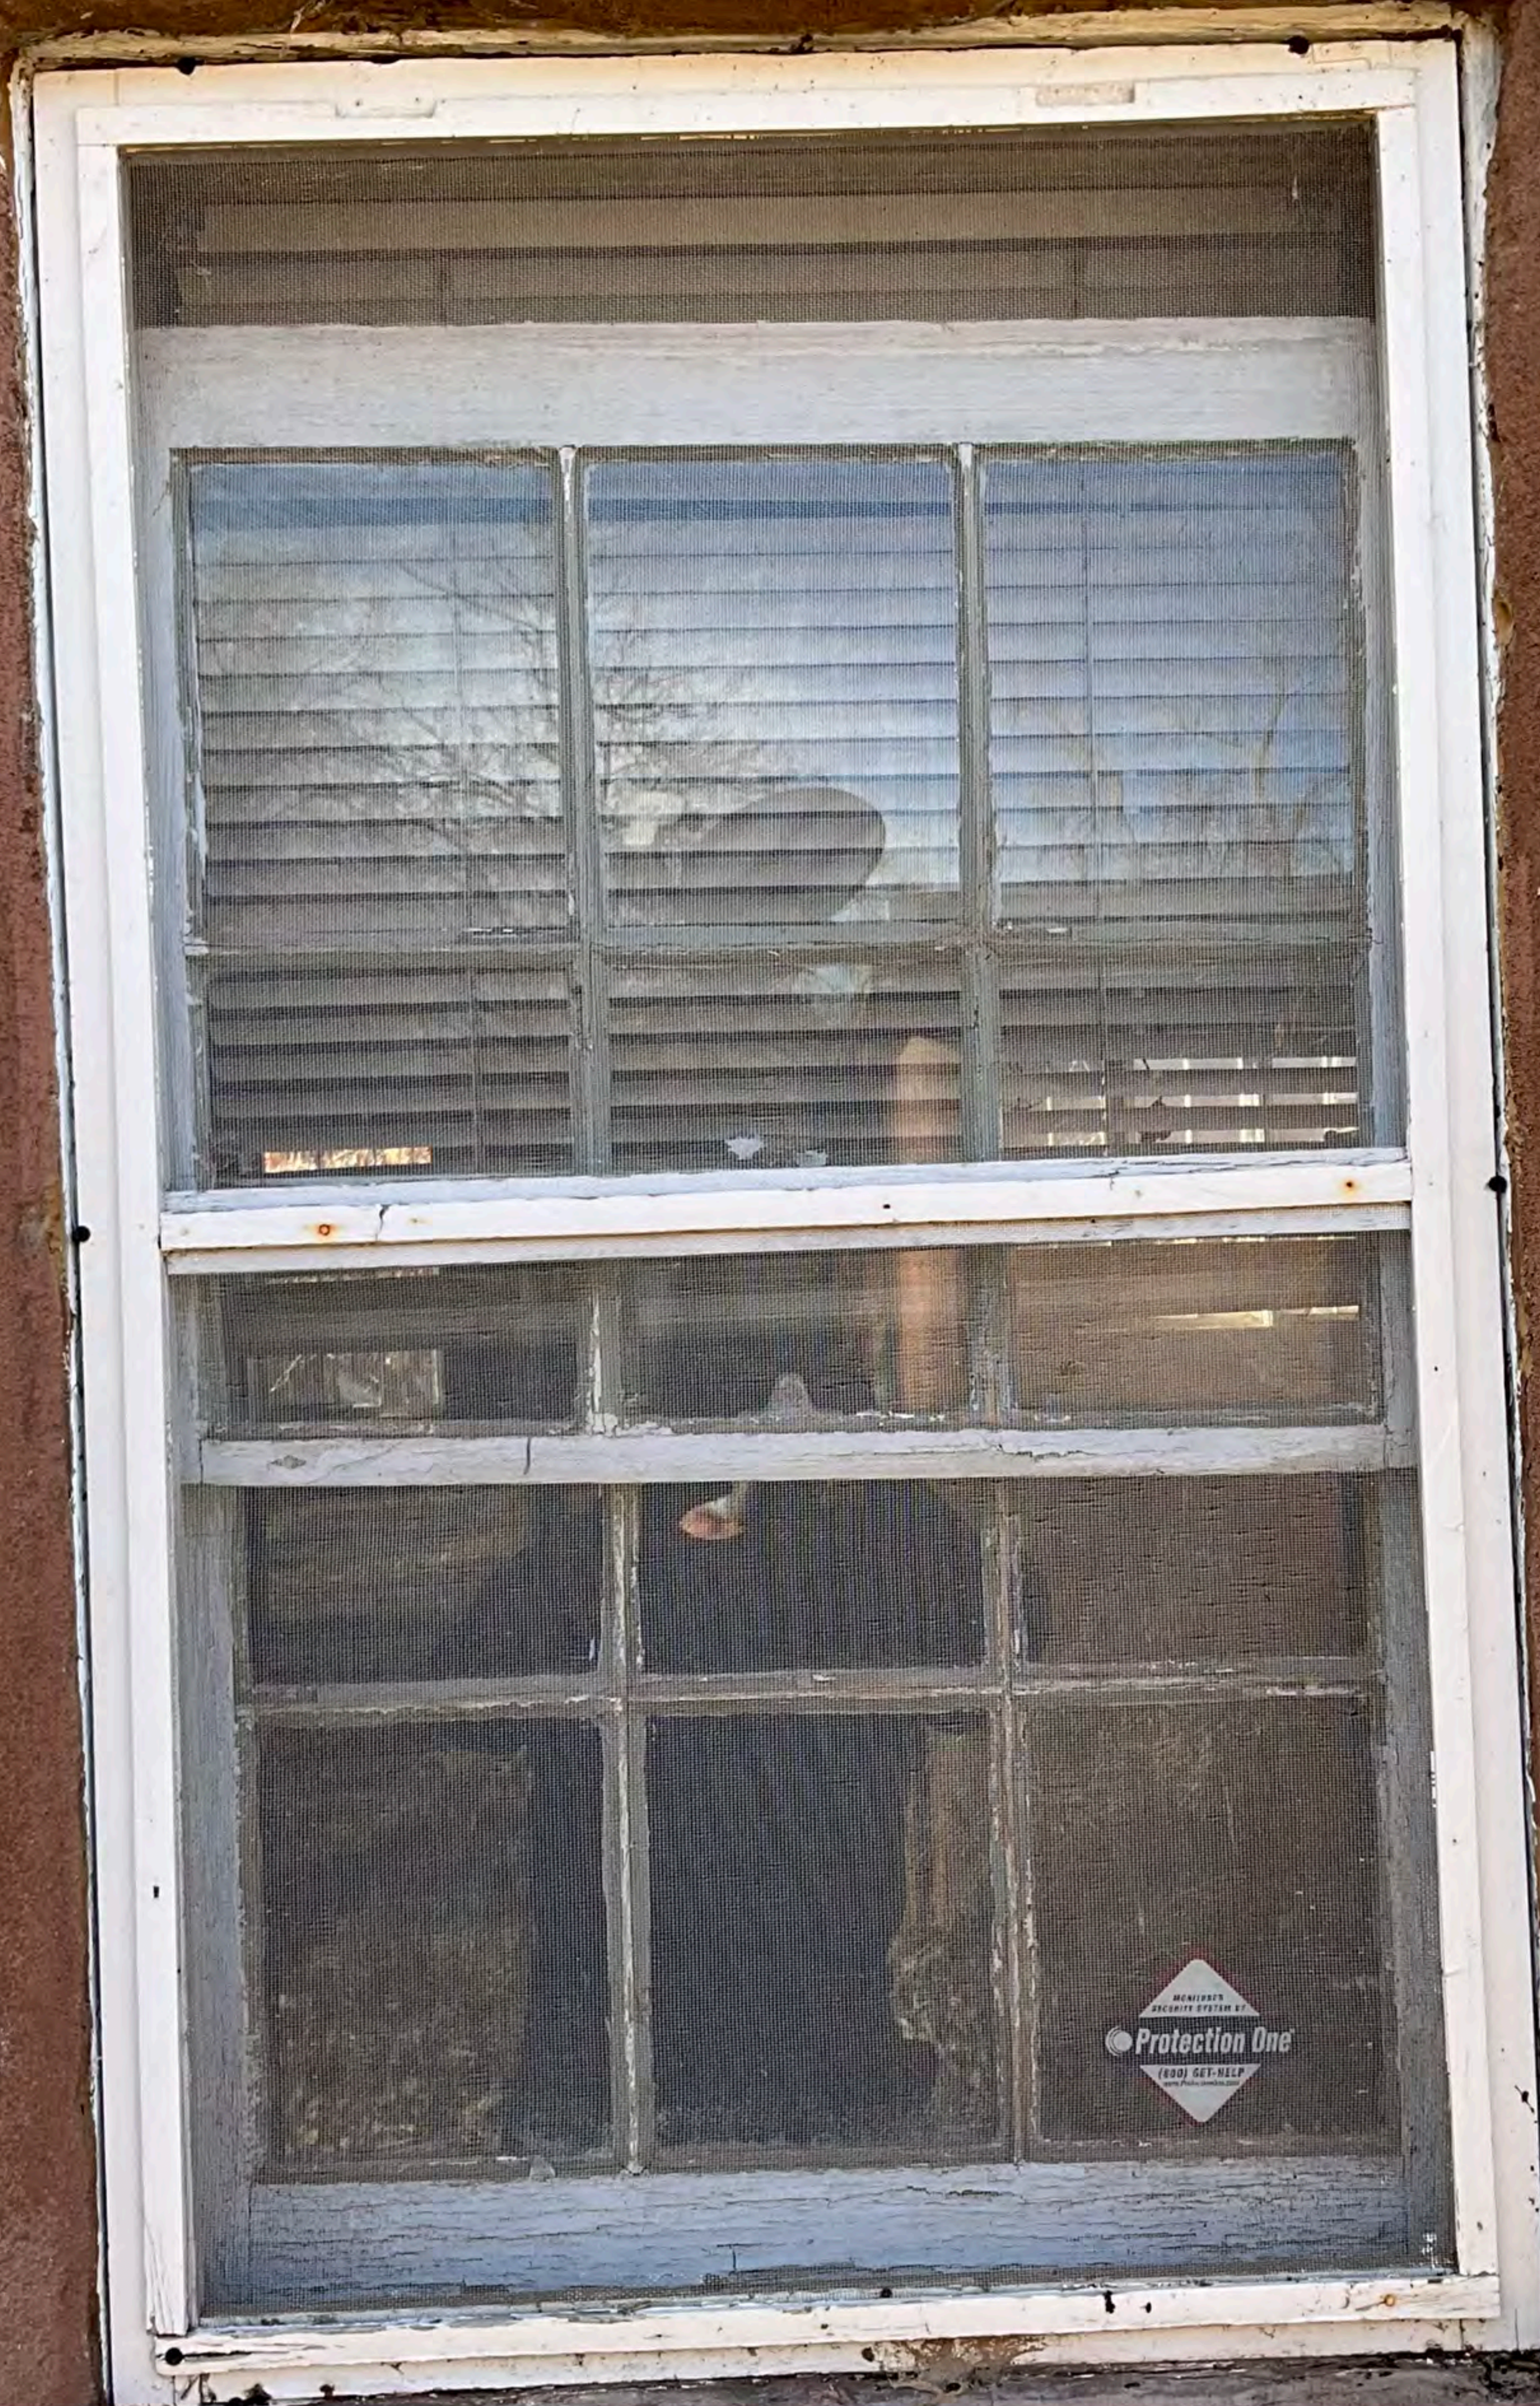
East
Elevation
Window
D

Window D has historic jambs, but the sashes are not original. The top sash is a bottom sash installed upside down. This is the reason the sashes don't align at the check rail. The sill and rail widths are different from the windows A and B. Window C sashes are typical to barn sashes from Empire Builders Supply. The sashes are approximately from 1985 or newer.

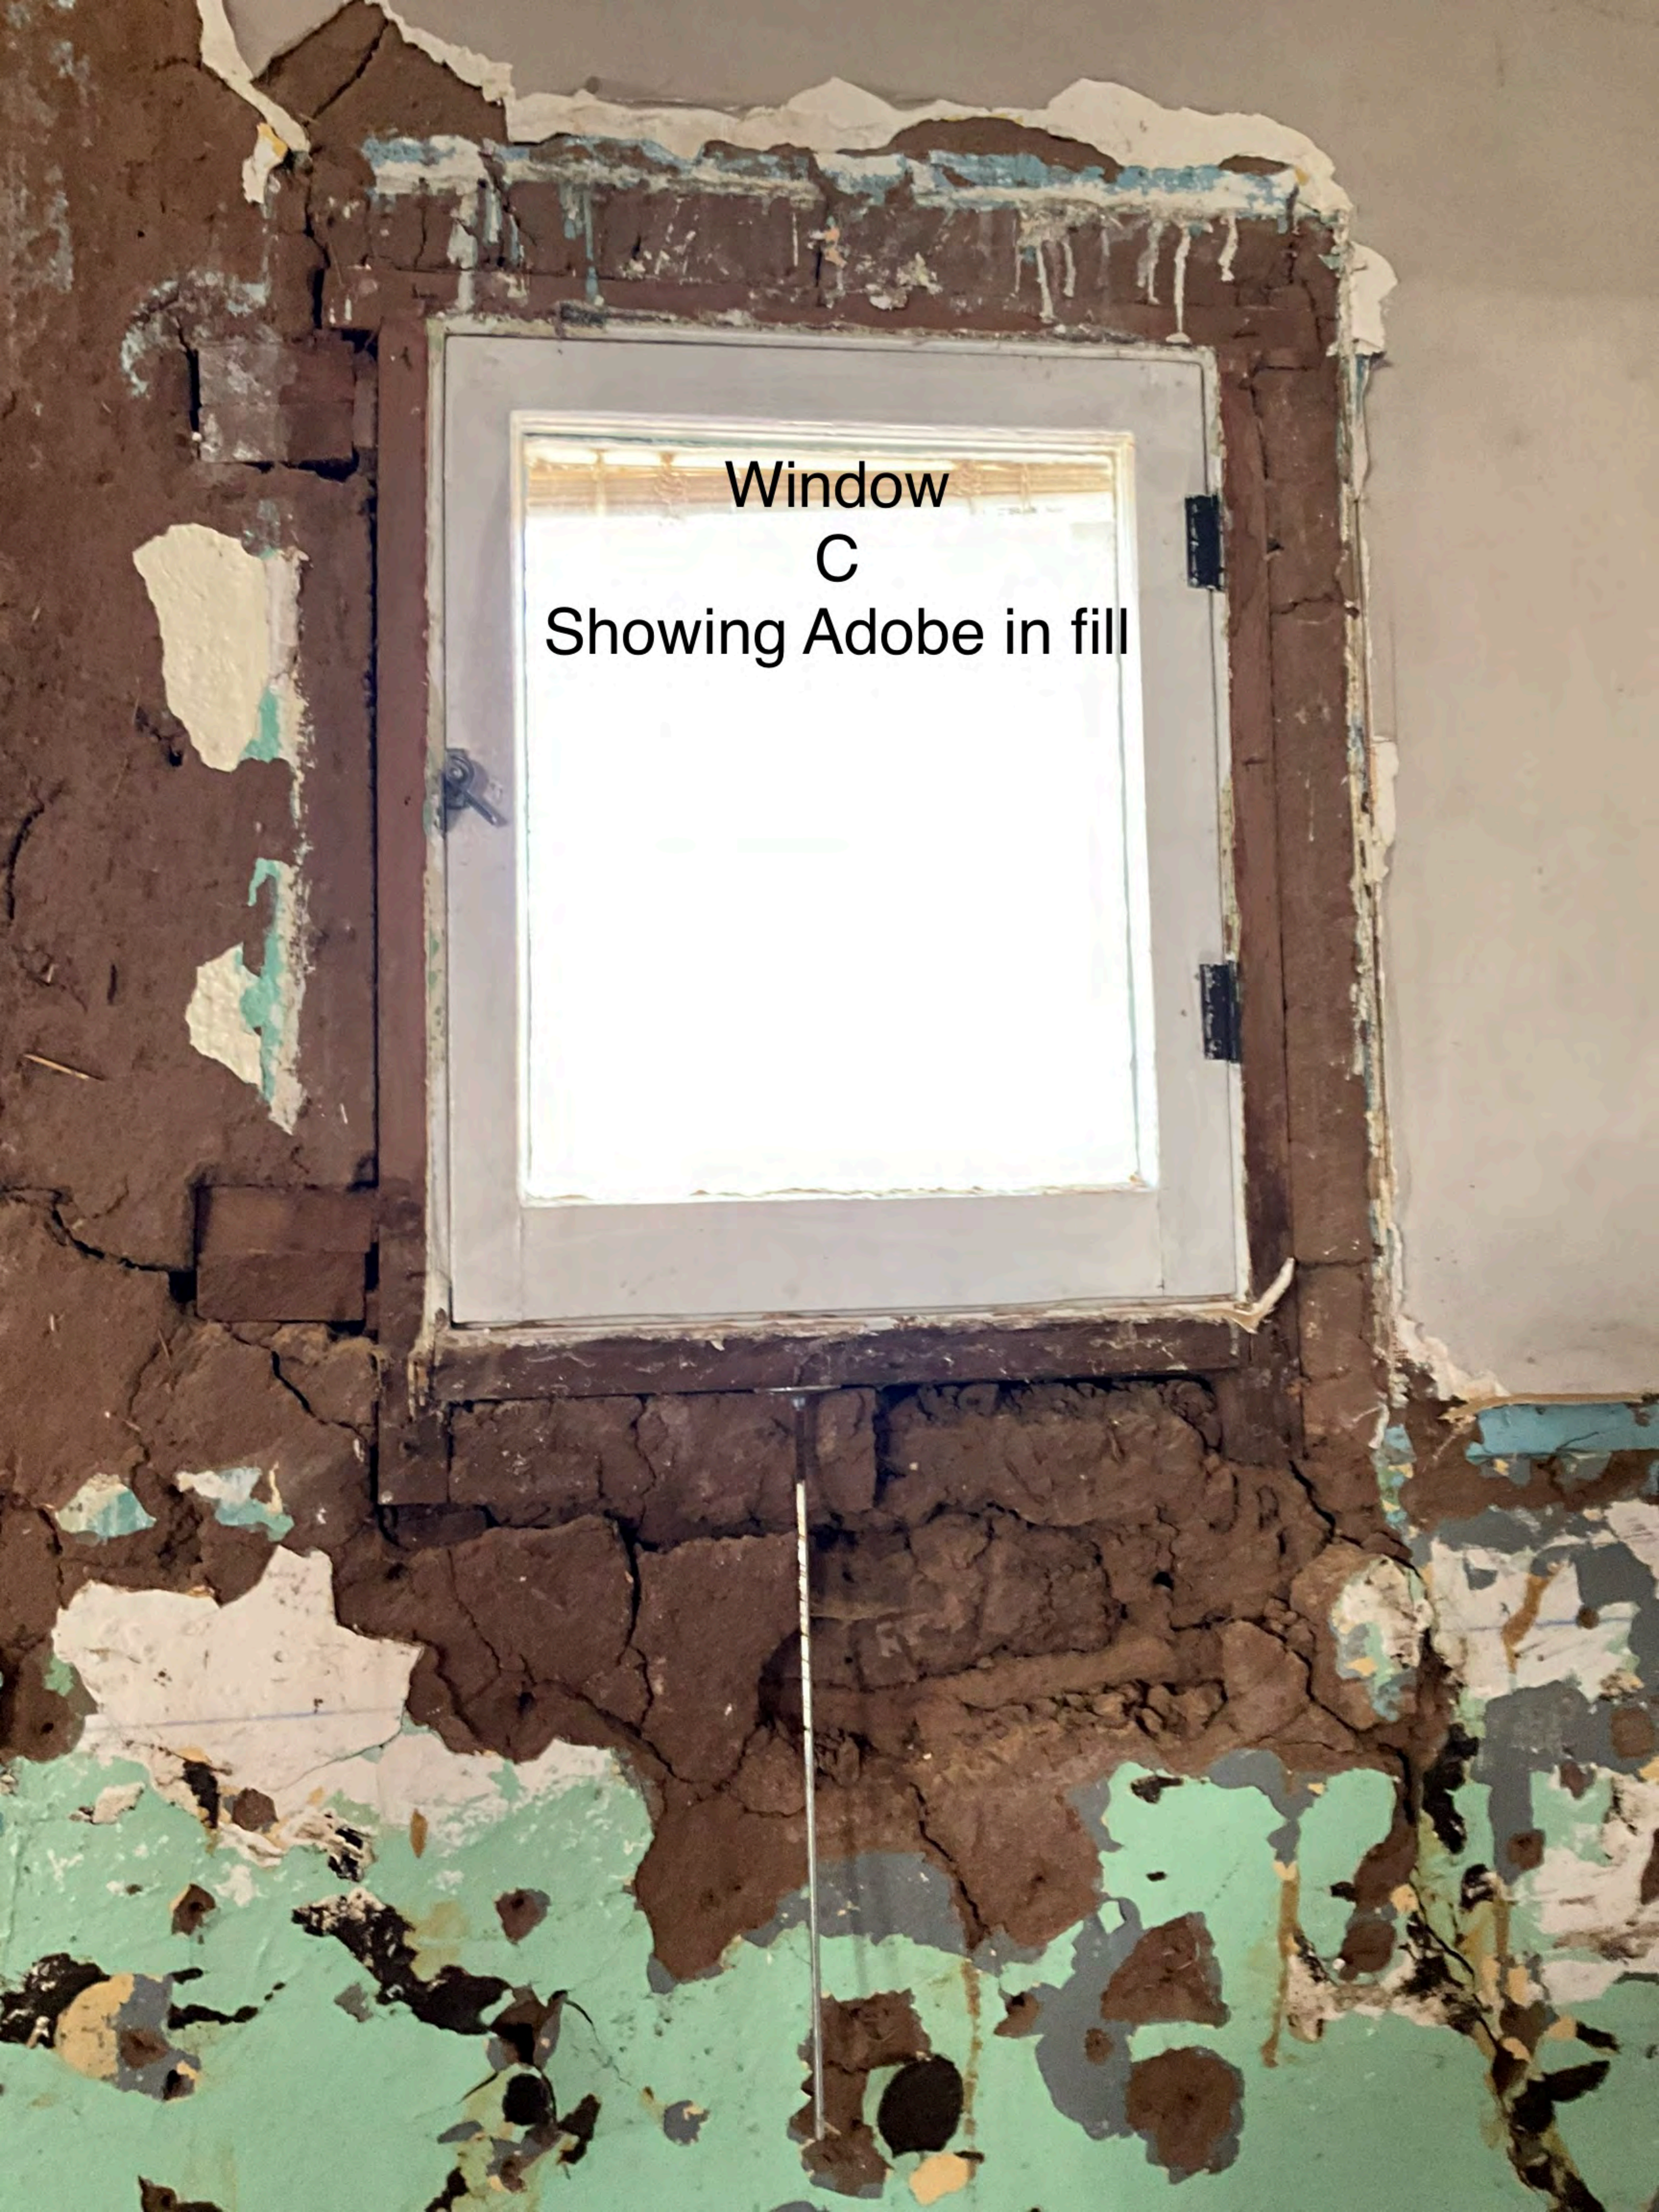
Window C is non-historic, a shop made one light sash, mechanical nails, glass, has no divided light. Adobe shows signs of being filled in, looks to be an added window. The window was probably the size of A and B originally.

Window
C
Showing Adobe in fill
