Birgfeld Window Assessment

512 Abeyta St

Window Assessment Summary Birgfeld Residence

July 31 2024

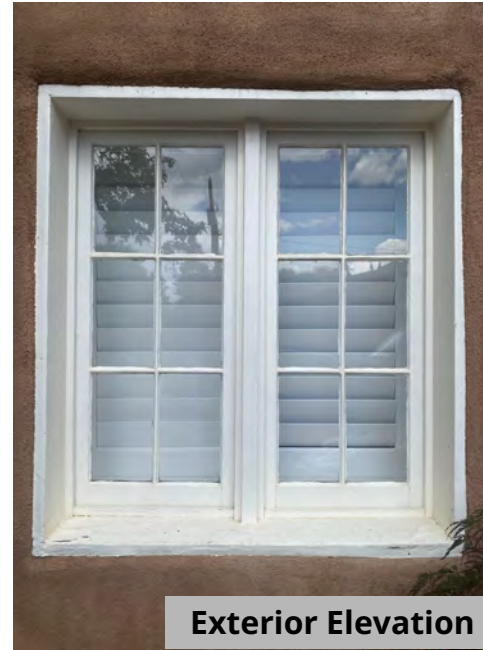
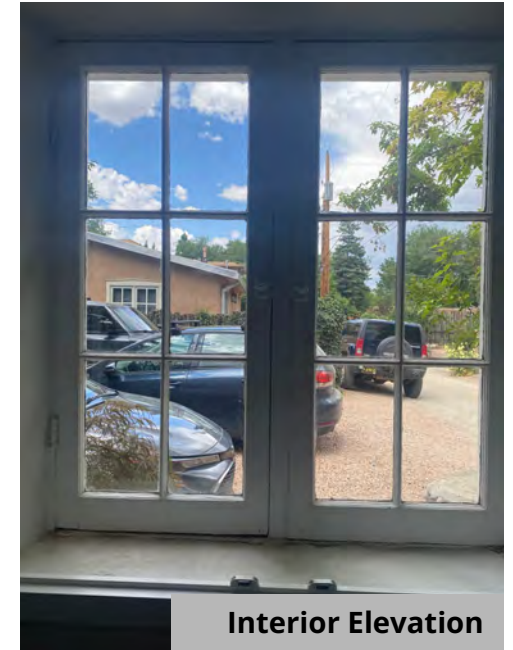
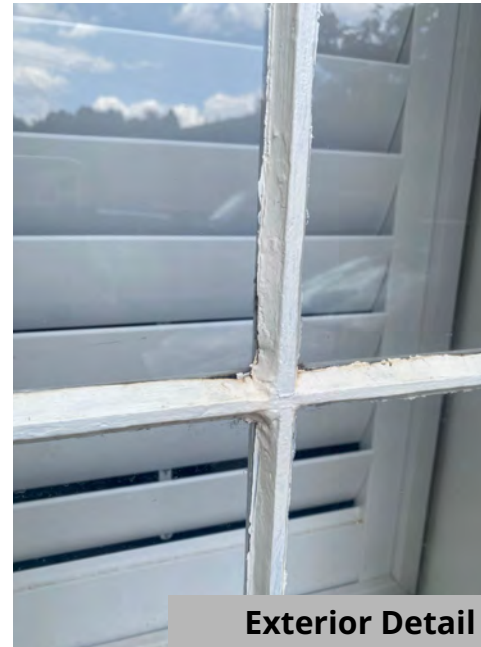
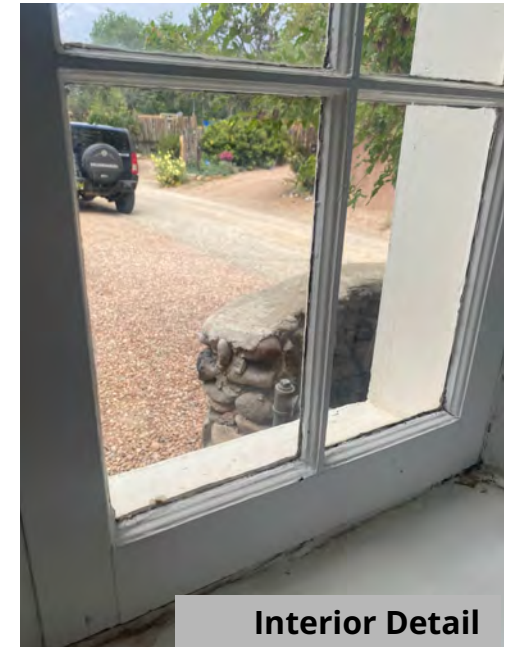
WINDOW W1 - Office		
INFO	Description	8 Lite Double Casement
	Size	38"X42"
	Type	Casement
	Overall Condition	Good
SASH	Material	Wood
	Moulding Profile	Ogee
	Bottom Rail	Good Condition
	Rails and Stiles	Good Condition
	Mullions	Good Condition
	Shape	Good Condition
	Paint	Good Condition
FRAME	Material	Wood
	Moulding Profile	Square
	Jamb Condition	Good
	Threshold Condition	Fair
	Shape	Straight
	Exterior Trim and Stops	Good
	Paint Condition	Good
FUNCTION	Operators/Hinges	Poor
	Handel/Hardware	Fair
	Locks	Fair
	Weatherstripping	N/A
Notes: Needs Sill Repair

Recommendation: Restore W1, W2, W3, and W8 Repair wood as necessary Add Balances and Weatherstrip Replace W4, W5, W6, and W7. Restore D2 and Weatherize

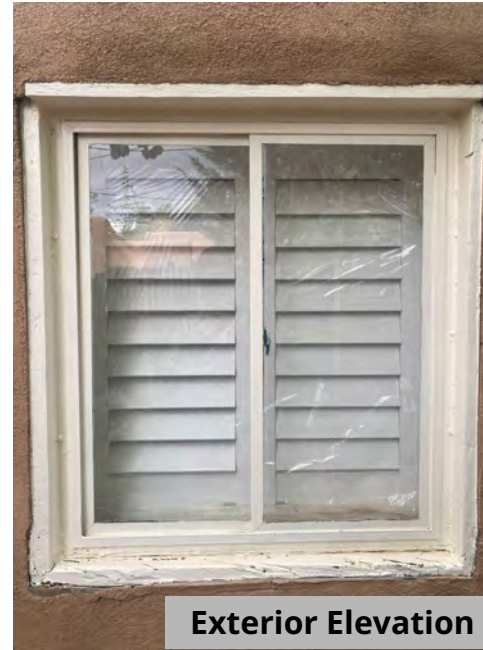
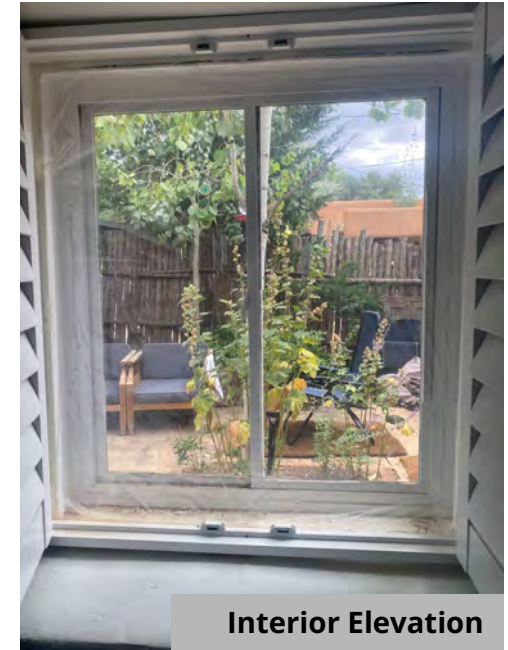
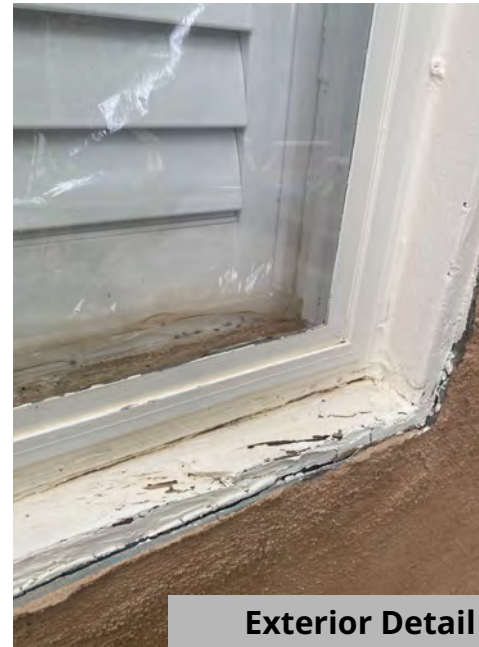
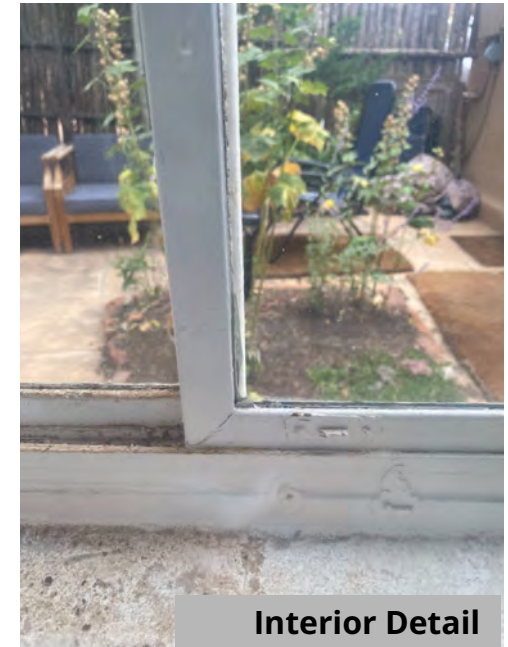
WINDOW W2 - Entry		
INFO	Description	2 lite Sliding Storm Sash
	Size	32"X36"
	Type	Sliding Storm Sash
	Overall Condition	Poor
SASH	Material	Aluminum
	Moulding Profile	Square
	Bottom Rail	Fair Condition
	Rails and Stiles	Fair Condition
	Mullions	Fair Condition
	Shape	Fair Condition
	Paint	Fair Condition
FRAME	Material	Wood
	Moulding Profile	Square
	Jamb Condition	Fair
	Threshold Condition	Poor
	Shape	Warped
	Exterior Trim and Stops	Poor
	Paint Condition	Poor
FUNCTION	Operators/Hinges	Poor
	Handel/Hardware	Poor
	Locks	Poor
	Weatherstripping	N/A
Notes: Storm Sash No Sash Present Recommend Replacement

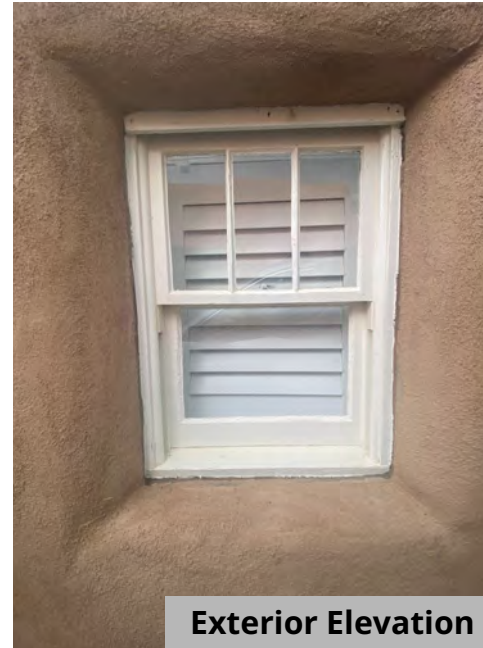
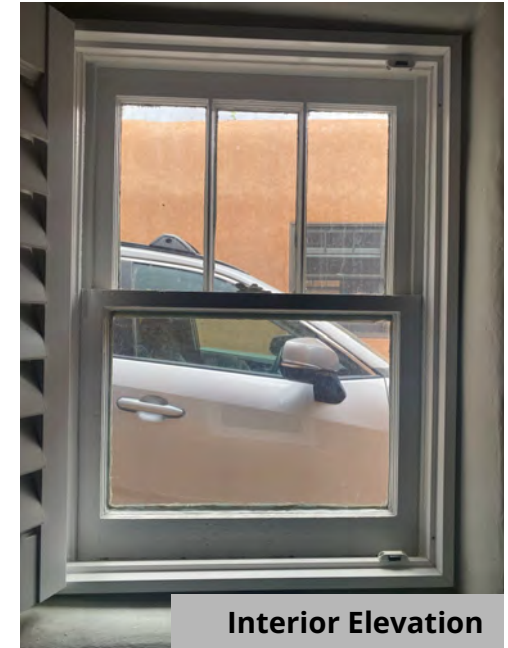
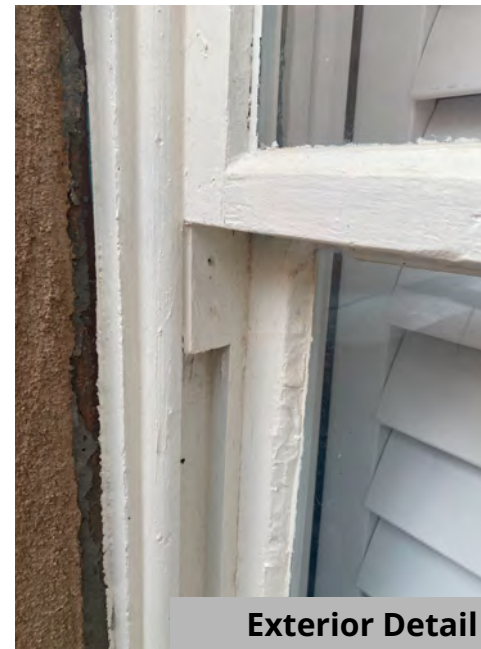
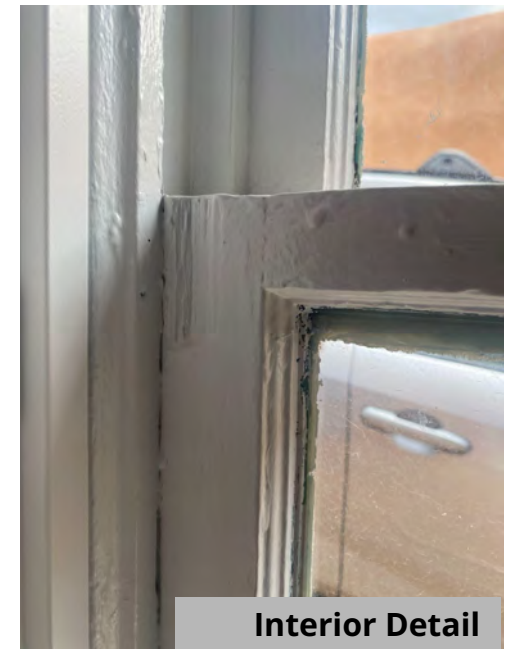
WINDOW W3 - Kitchen		
INFO	Description	3 over 1 Lite
	Size	25"X36"
	Type	Single Hung
	Overall Condition	Good
SASH	Material	Wood
	Moulding Profile	Ogee
	Bottom Rail	Good Condition
	Rails and Stiles	Good Condition
	Mullions	Good Condition
	Shape	Good Condition
	Paint	Good Condition
FRAME	Material	Wood
	Moulding Profile	Square
	Jamb Condition	Good
	Threshold Condition	Fair
	Shape	Straight
	Exterior Trim and Stops	Good
	Paint Condition	Good
FUNCTION	Operators/Hinges	None
	Handel/Hardware	None
	Locks	Fair
	Weatherstripping	N/A
Notes: No Balances Painted Shut

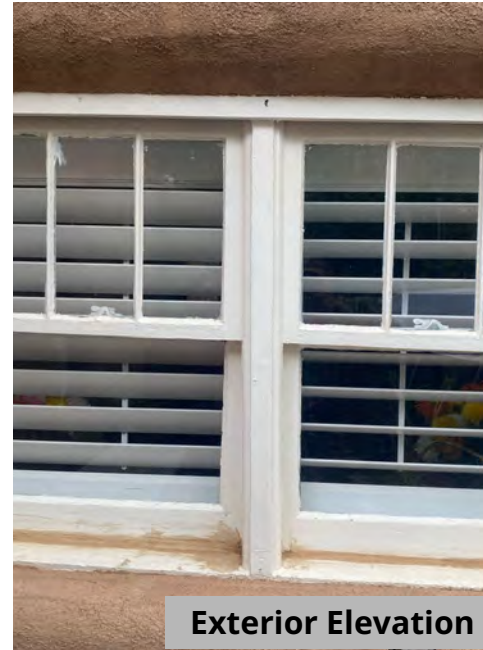
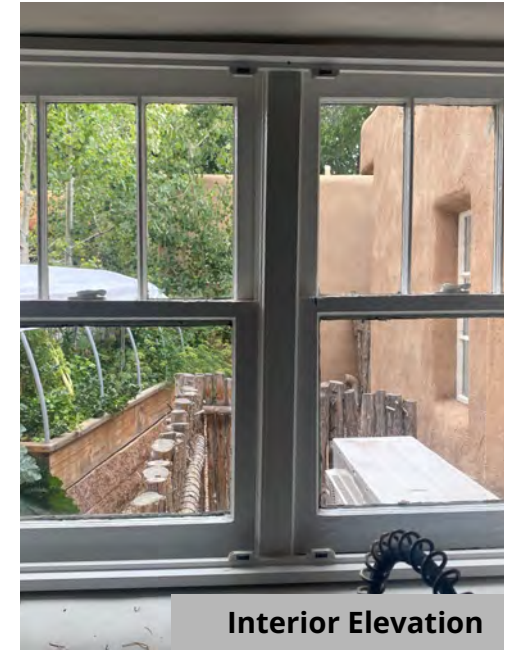
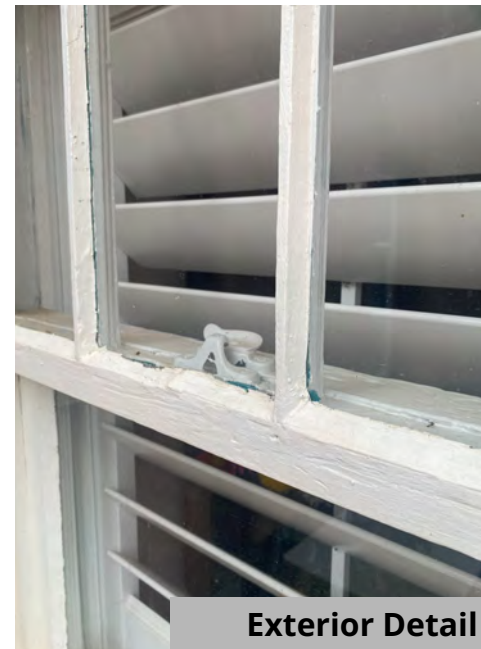
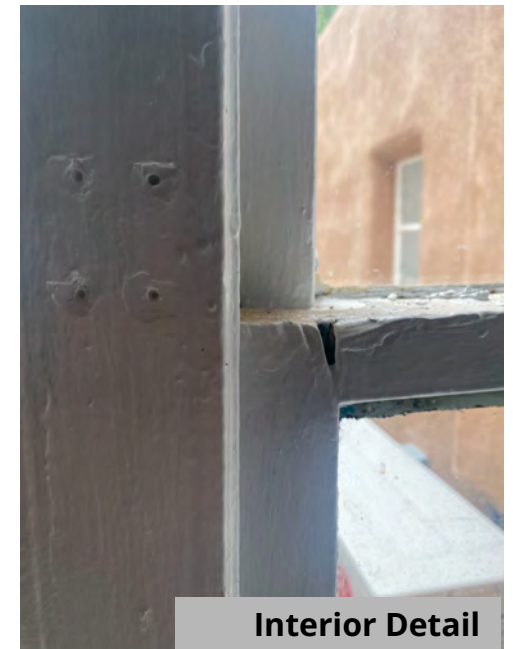
WINDOW W4 - Kitchen		
INFO	Description	(2) 3 over 1 Lite
	Size	50"X36"
	Type	Single Hungs
	Overall Condition	Fair
SASH	Material	Wood
	Moulding Profile	Ogee
	Bottom Rail	Poor Condition
	Rails and Stiles	Poor Condition
	Mullions	Fair Condition
	Shape	Warped
	Paint	Good Condition
FRAME	Material	Wood
	Moulding Profile	Square
	Jamb Condition	Good
	Threshold Condition	Fair
	Shape	Straight
	Exterior Trim and Stops	Poor
	Paint Condition	Poor
FUNCTION	Operators/Hinges	None
	Handel/Hardware	None
	Locks	Poor
	Weatherstripping	N/A
Notes: No Balances Painted Shut

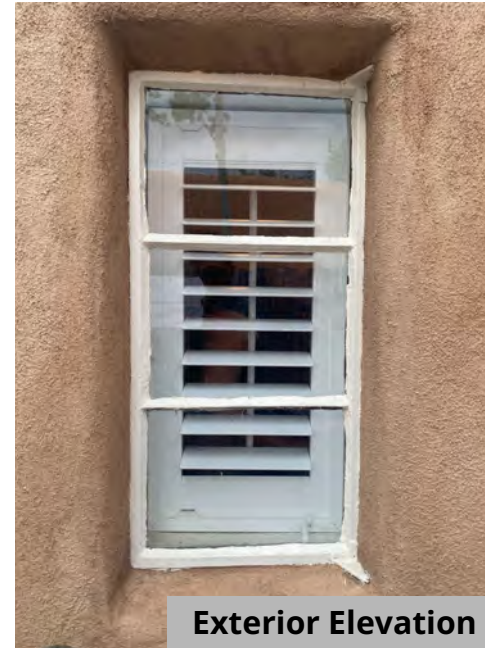
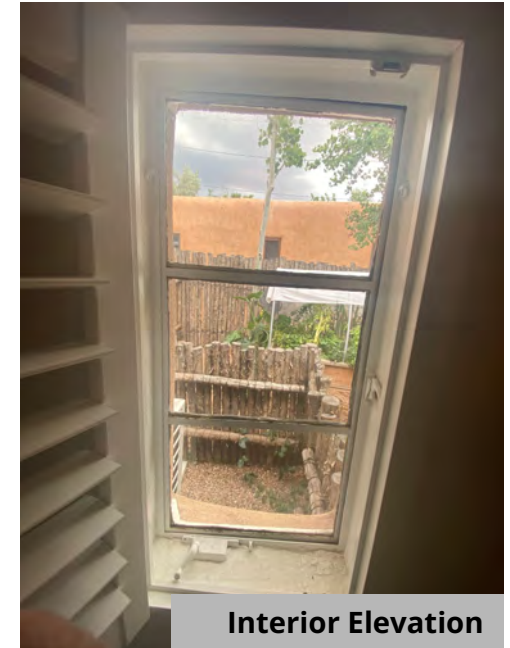
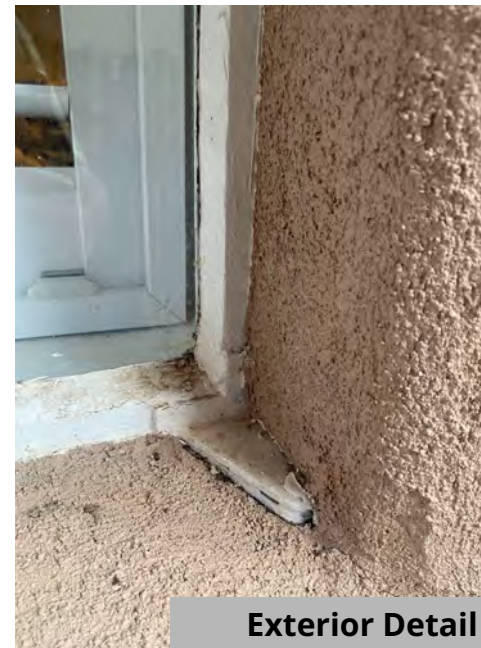
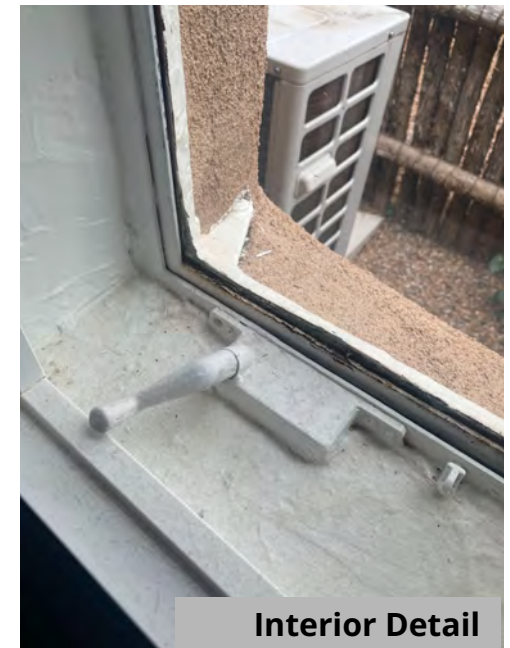
WINDOW W5 - Bedroom		
INFO	Description	3 Lite
	Size	18"X36"
	Type	Casement
	Overall Condition	Poor
SASH	Material	Steel
	Moulding Profile	Flat
	Bottom Rail	Fair Condition
	Rails and Stiles	Fair Condition
	Mullions	Fair Condition
	Shape	Straight
	Paint	Fair Condition
FRAME	Material	Steel
	Moulding Profile	Flat
	Jamb Condition	Fair Condition
	Threshold Condition	Fair Condition
	Shape	Straight
	Exterior Trim and Stops	None
	Paint Condition	Fair Condition
FUNCTION	Operators/Hinges	Poor
	Handel/Hardware	Poor
	Locks	Poor
	Weatherstripping	N/A
Notes: Non Functional

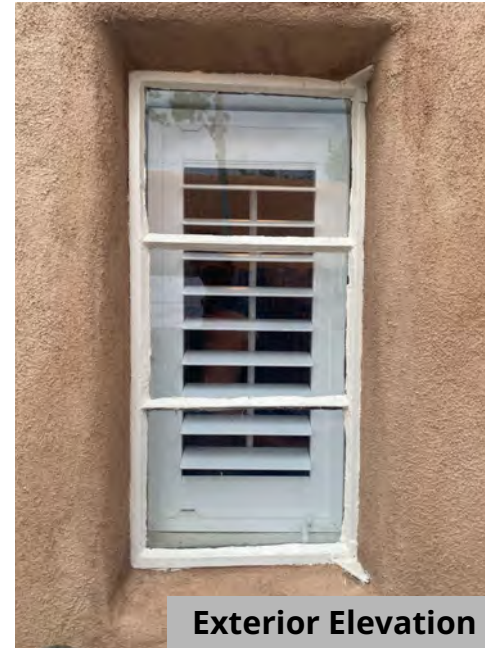
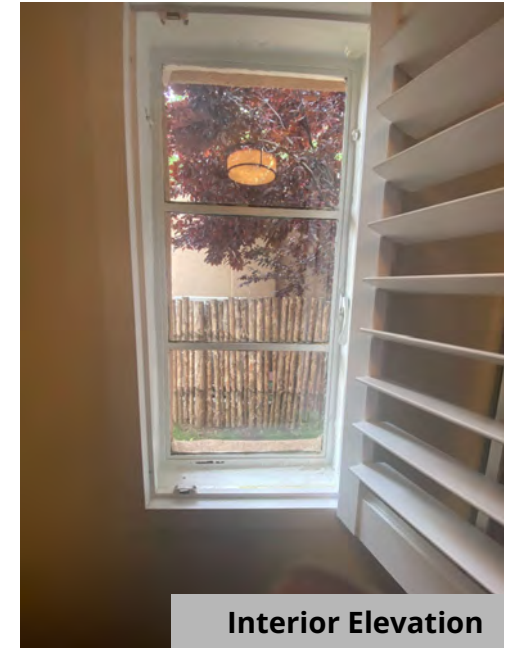
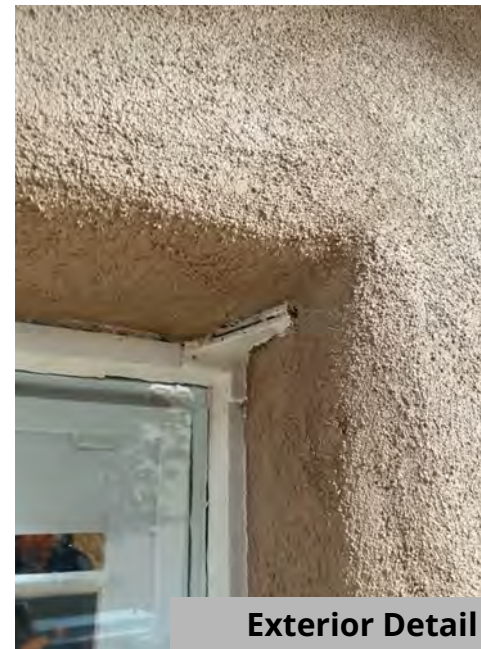
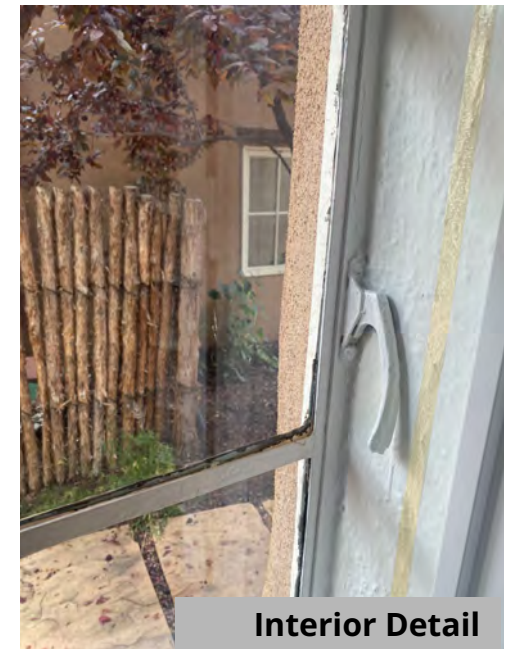
WINDOW W6 - Bedroom		
INFO	Description	3 Lite
	Size	18"X36"
	Type	Casement
	Overall Condition	Poor
SASH	Material	Steel
	Moulding Profile	Flat
	Bottom Rail	Fair Condition
	Rails and Stiles	Fair Condition
	Mullions	Fair Condition
	Shape	Straight
	Paint	Fair Condition
FRAME	Material	Steel
	Moulding Profile	Flat
	Jamb Condition	Fair Condition
	Threshold Condition	Fair Condition
	Shape	Straight
	Exterior Trim and Stops	None
	Paint Condition	Fair Condition
FUNCTION	Operators/Hinges	Poor
	Handel/Hardware	Poor
	Locks	Poor
	Weatherstripping	N/A
Notes: Non Functional

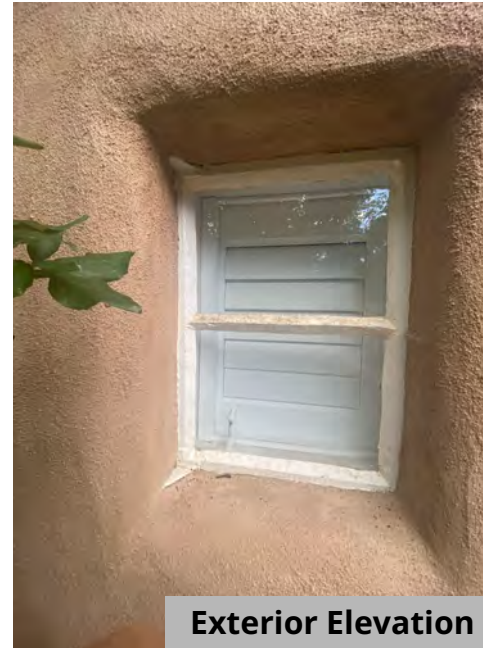
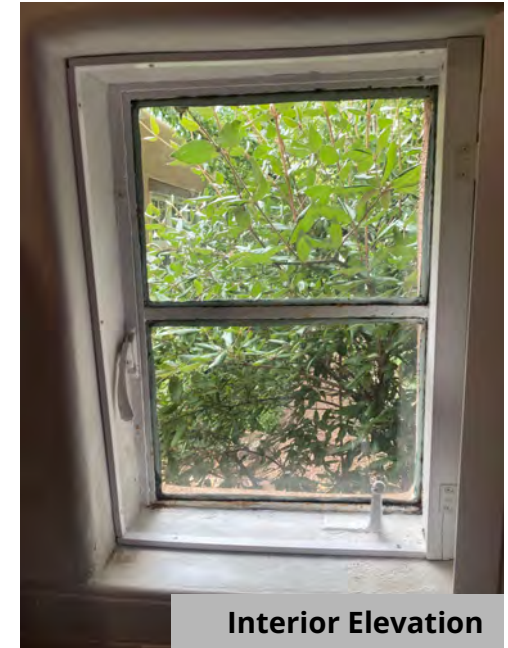
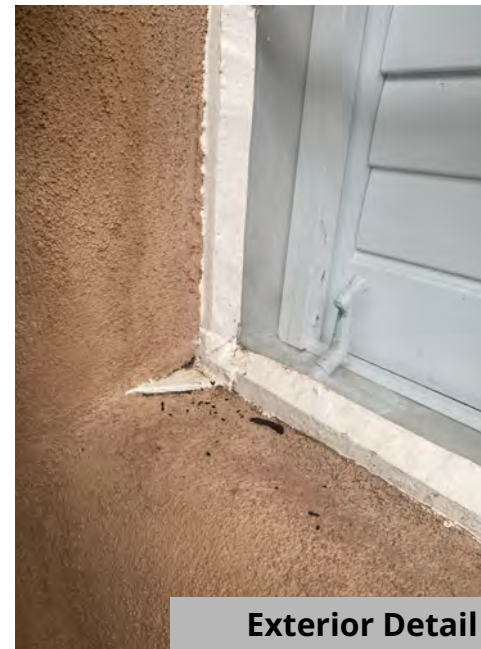
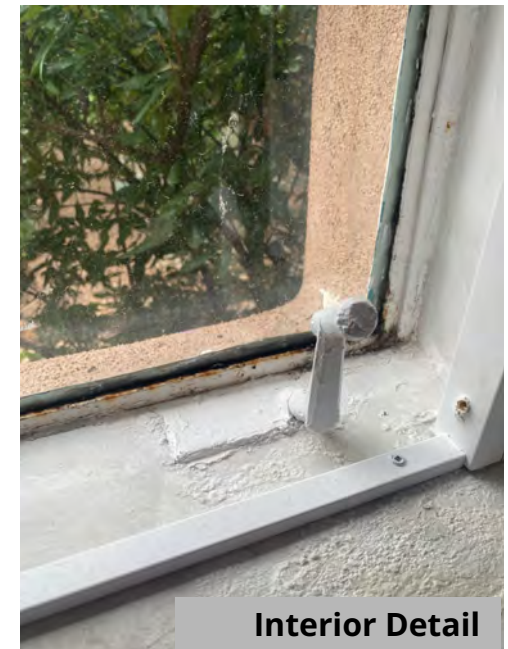
WINDOW W7 - Bathroom		
INFO	Description	3 Lite
	Size	18"X36"
	Type	Casement
	Overall Condition	Poor
SASH	Material	Steel
	Moulding Profile	Flat
	Bottom Rail	Fair Condition
	Rails and Stiles	Fair Condition
	Mullions	Fair Condition
	Shape	Straight
	Paint	Fair Condition
FRAME	Material	Steel
	Moulding Profile	Flat
	Jamb Condition	Fair Condition
	Threshold Condition	Fair Condition
	Shape	Straight
	Exterior Trim and Stops	None
	Paint Condition	Fair Condition
FUNCTION	Operators/Hinges	Poor
	Handel/Hardware	Poor
	Locks	Poor
	Weatherstripping	N/A
Notes: Non Functional

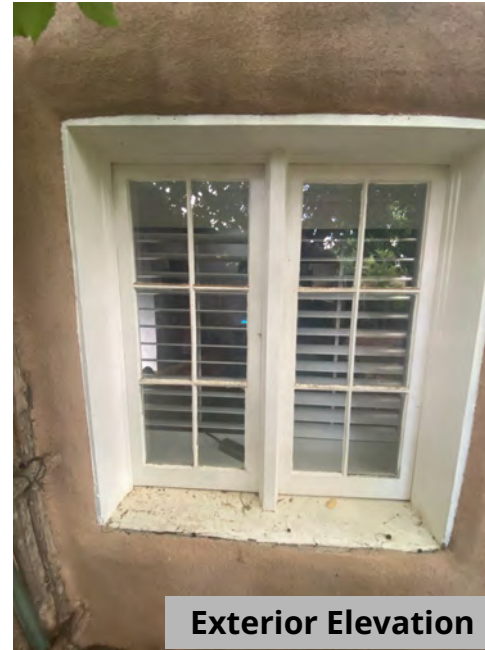
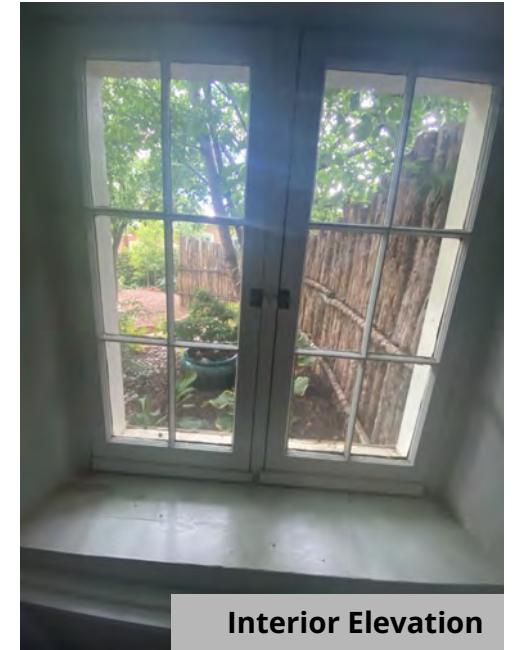
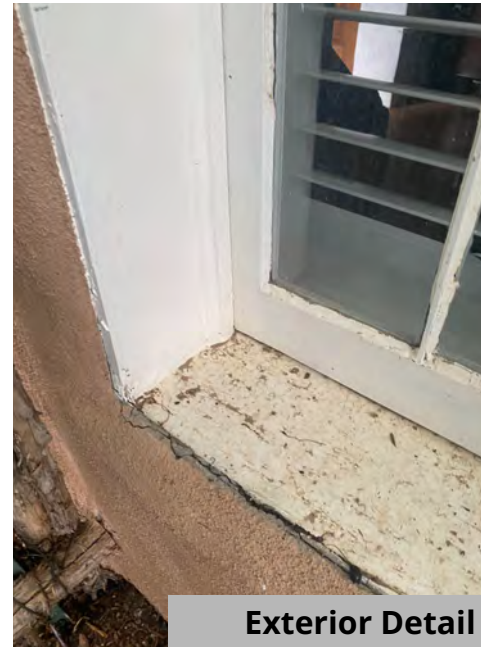
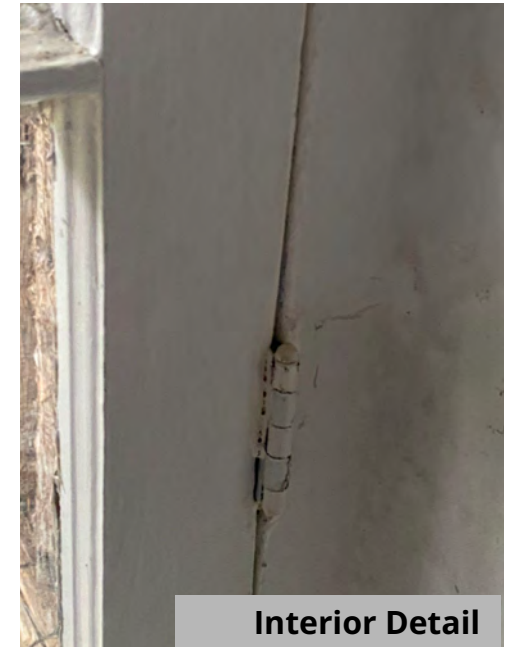
WINDOW W8 - Living Room		
INFO	Description	8 Lite Double Casement
	Size	38"X42"
	Type	Casement
	Overall Condition	Good
SASH	Material	Wood
	Moulding Profile	Ogee
	Bottom Rail	Good Condition
	Rails and Stiles	Good Condition
	Mullions	Good Condition
	Shape	Good Condition
	Paint	Good Condition
FRAME	Material	Wood
	Moulding Profile	Square
	Jamb Condition	Good
	Threshold Condition	Fair
	Shape	Straight
	Exterior Trim and Stops	Good
	Paint Condition	Good
FUNCTION	Operators/Hinges	Poor
	Handel/Hardware	Fair
	Locks	Fair
	Weatherstripping	N/A
Notes: Needs Sill Repair

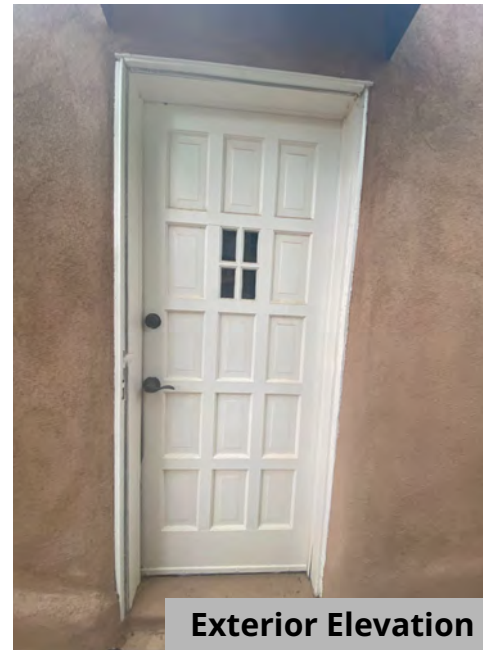
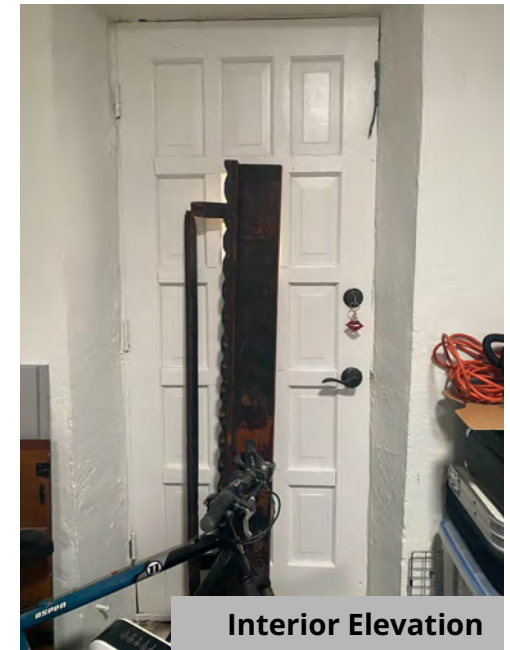
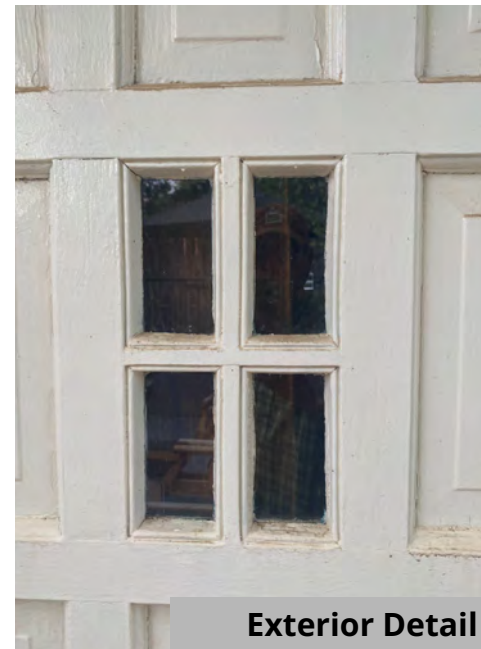
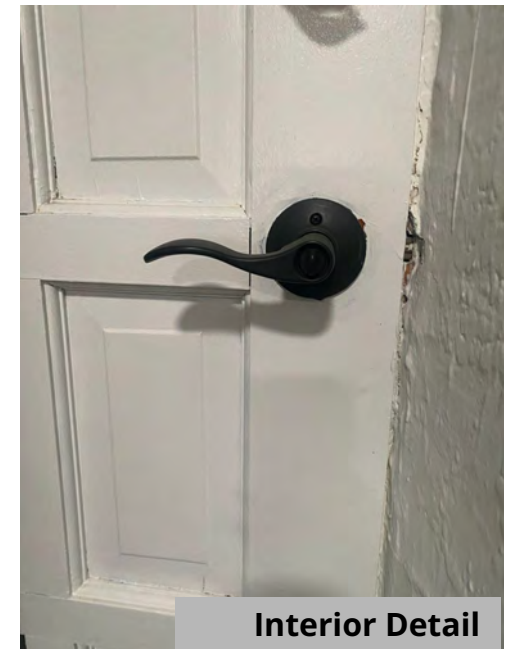
Door D2 Office		
INFO	Description	Single with Deco lite
	Size	32"X80"
	Type	Single Frame and Panel
	Overall Condition	Good
Panel	Material	Wood
	Moulding Profile	Raised Panel
	Bottom Rail	Good Condition
	Rails and Stiles	Good Condition
	Mullions	Good Condition
	Shape	Warped
	Paint	Good Condition
FRAME	Material	Wood
	Moulding Profile	Square
	Jamb Condition	Good
	Threshold Condition	Fair
	Shape	Straight
	Exterior Trim and Stops	Poor
	Paint Condition	Fair
FUNCTION	Operators/Hinges	Poor
	Handel/Hardware	Poor
	Locks	Poor
	Weatherstriping	N/A
Notes: Needs Refit and rehang
