Historic Cultural Properties Inventory (HCPI) Base Form (FORM 1)

1. Name of property: Atanacio and Feliciano Vigil Property Arturo Vigil House	2. Location: 925 Acequia Madre Street Downtown and Eastside Historic District – Santa Fe	3. Local Reference Number: Santa Fe ID: Old # 051611486 4. County: Santa Fe Parcel # 12919936

8. Name of Project: HDRB Status Evaluation		
9. Lat/Long: 35.6791526,-105.92438		
10. Photo Information: John W. Murphey, photographer. Photo 1: Front elevation, view from Acequia Madre, camera facing north.

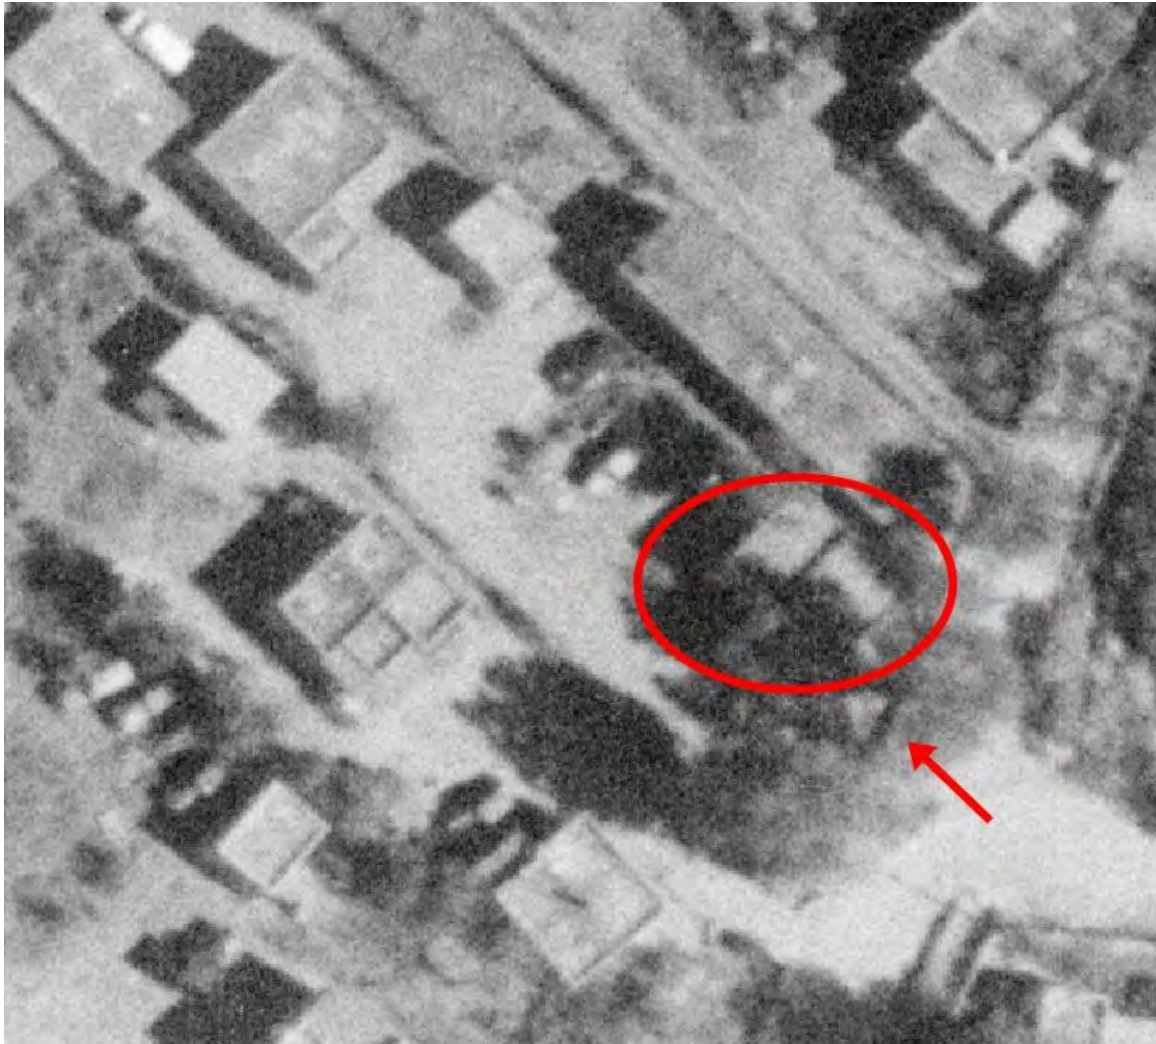
Fronting the property is a low stuccoed block wall that may be the structure that appears on a 1958 aerial (Fig. 3). The 10” thick wall measures 45” high from the outside grade (Photo 1). It continues below grade on the other side, working as a retaining wall. Its wide opening, filled with wrought iron fence, seems uncharacteristic of wall construction of the pre-war period. The opening may indicate an alteration made in the 2000s.

Figure 3: November 10, 1958, aerial photograph.
Note presence of lower north addition and street wall, indicated by an arrow.

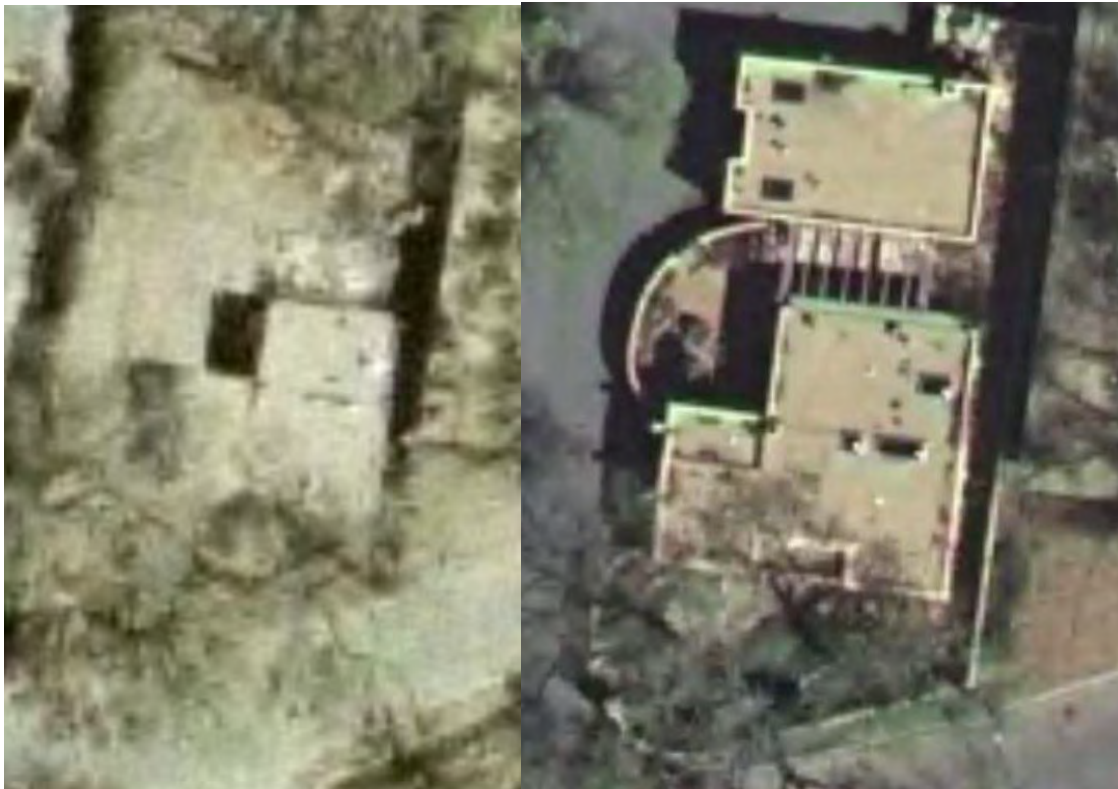
An intimate brick-lined courtyard defines the building’s northwest corner (Photo 11). This feature was likely introduced in the early 2000s (Fig. 7). Double-glazed doors from the kitchen give access to the porch. Judging by their location and design they are probably not original fenestration. The remainder of the west façade, representing the original core of the house, is a solid wall (Photo12).

Figure 7: 2001 (left) and 2005 (right) aerial photographs. Note the introduction of curved privacy walls in the 2005 image.

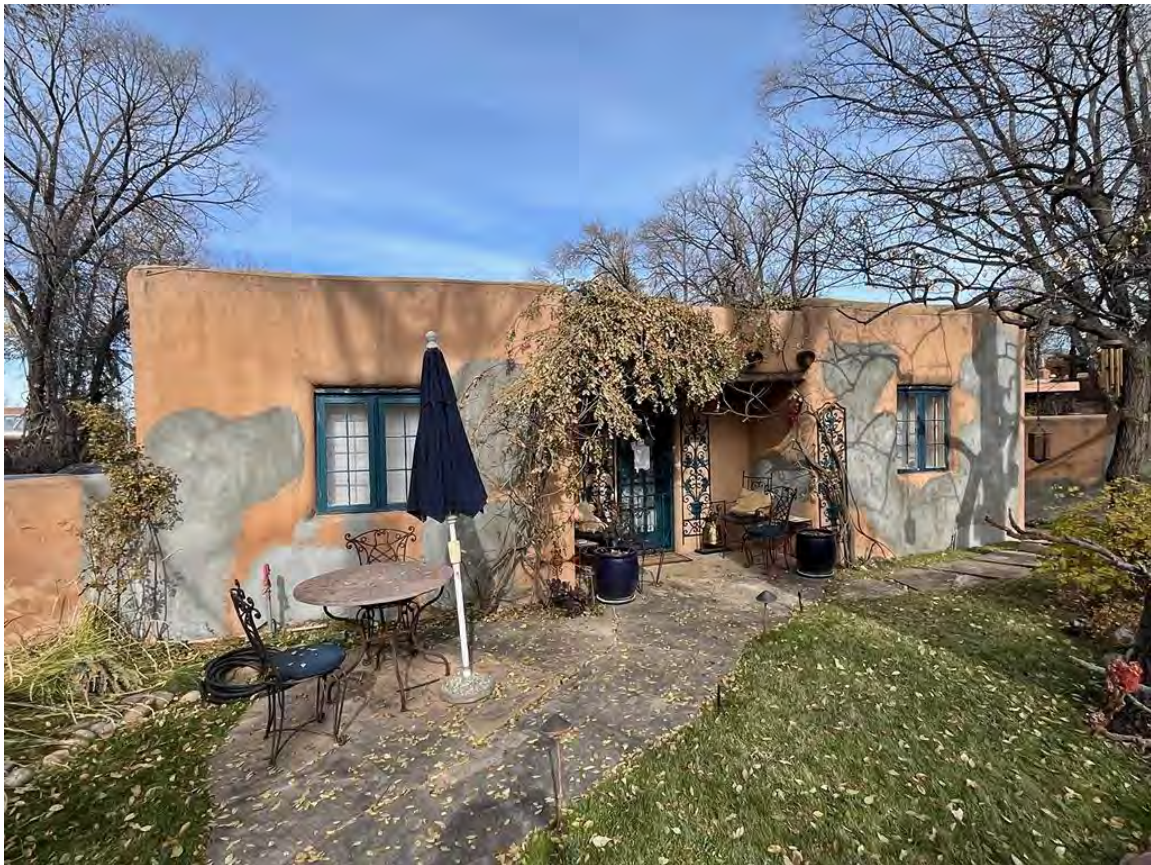
The façade is characterized by strict symmetry, presenting a rough approximation of a centered recessed portal design (Photo 2). This scheme was explored in the 1920s following the New-Old Santa Fe Style competition. Unlike most buildings from that era, this house shows more of the Pueblo Revival style.

Photo 2: South (front) elevation. Camera facing northeast.

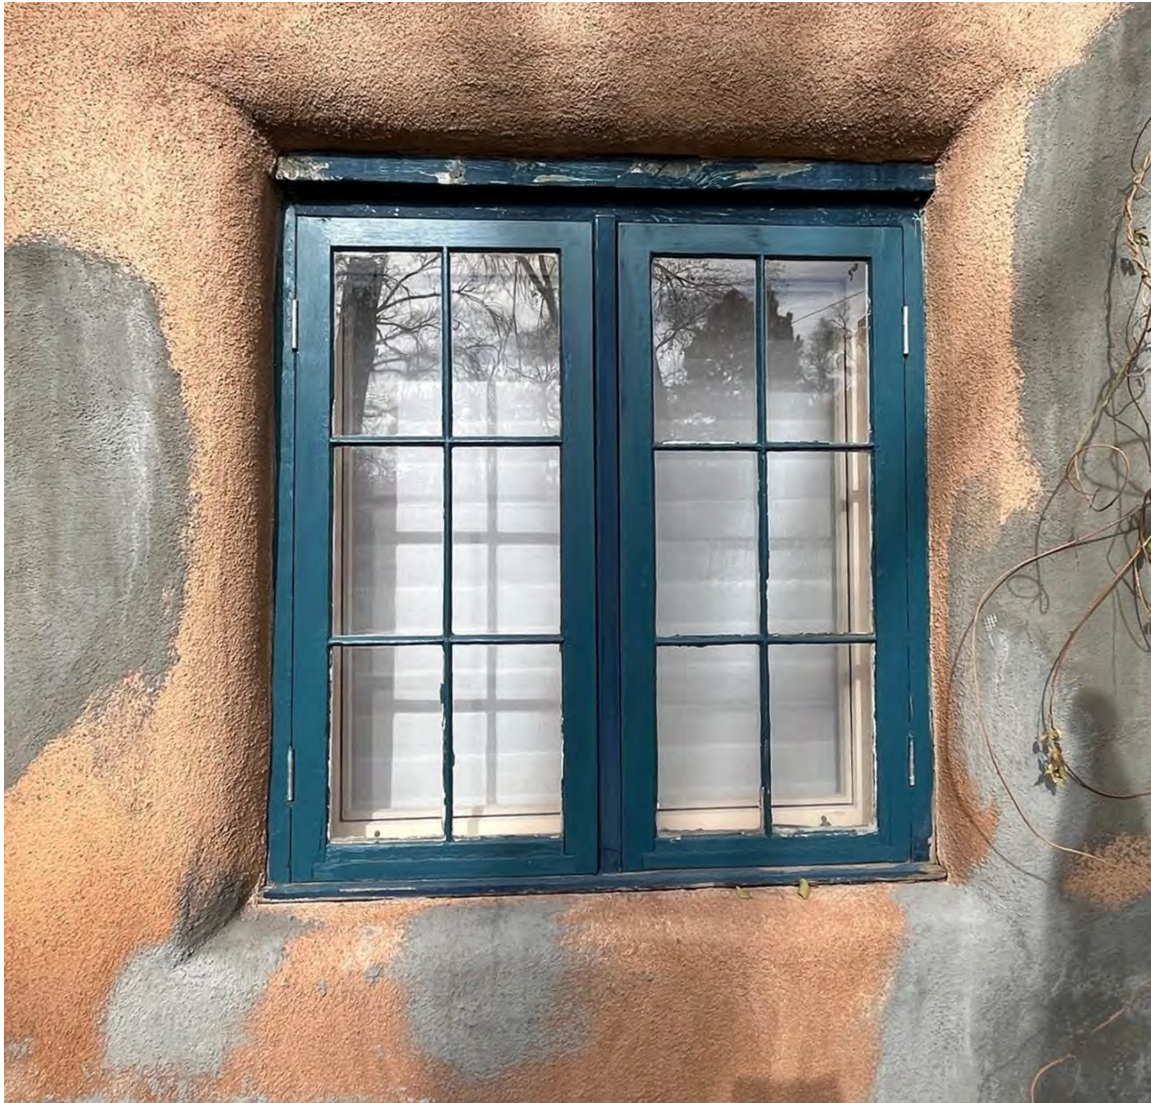
The two openings, each measuring approximately 40”x 45”¹, contain six light wood casement windows (Photo 3). These windows, with their construction details and geared “crank-out” operation, are replacements. They are situated about 5” back from the wall within bull-nosed openings.

Photo 3: South (front) elevation. West window. Camera facing north.

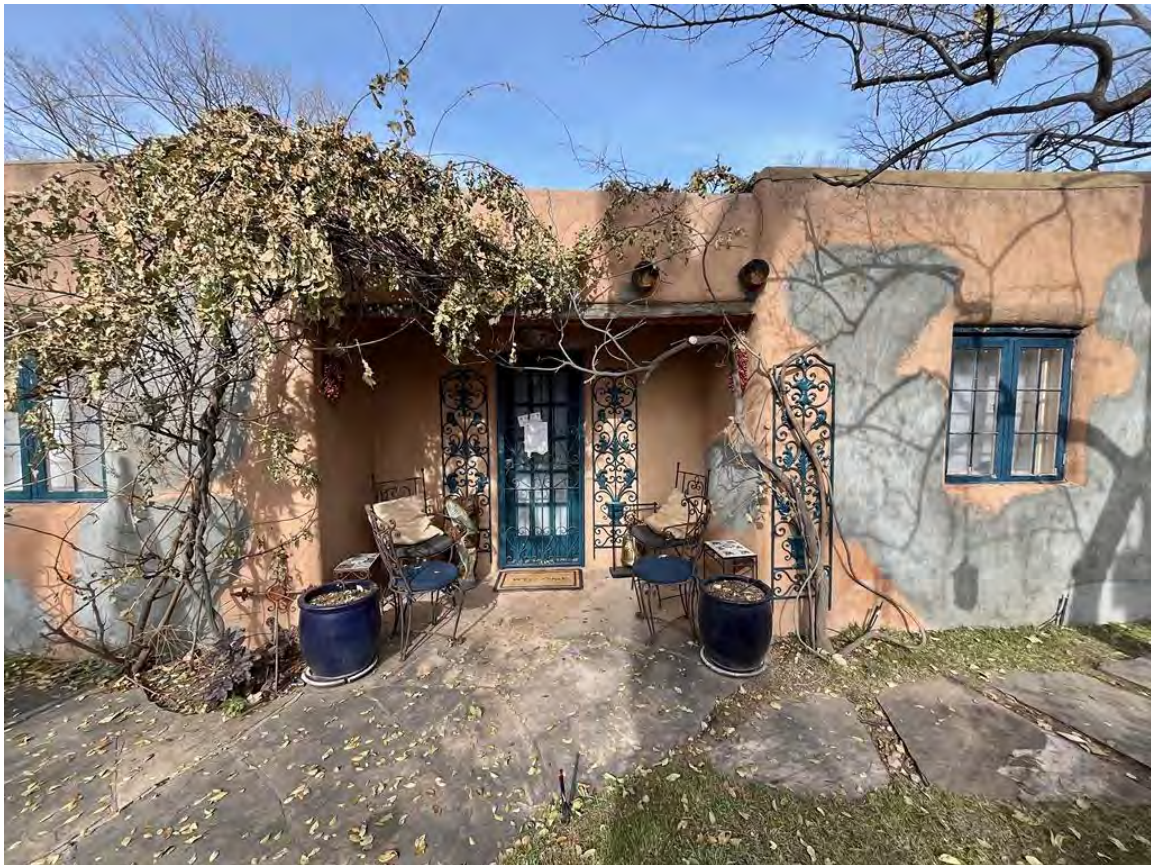
At the center of the façade is the recessed porch, which features a 400-square-foot void and a non-historic entry door (Photo 4). Although the decking has been replaced, the beam appears to be historic (Photo 5).

Photo 4: South (front) elevation. Recessed portal. Camera facing north.

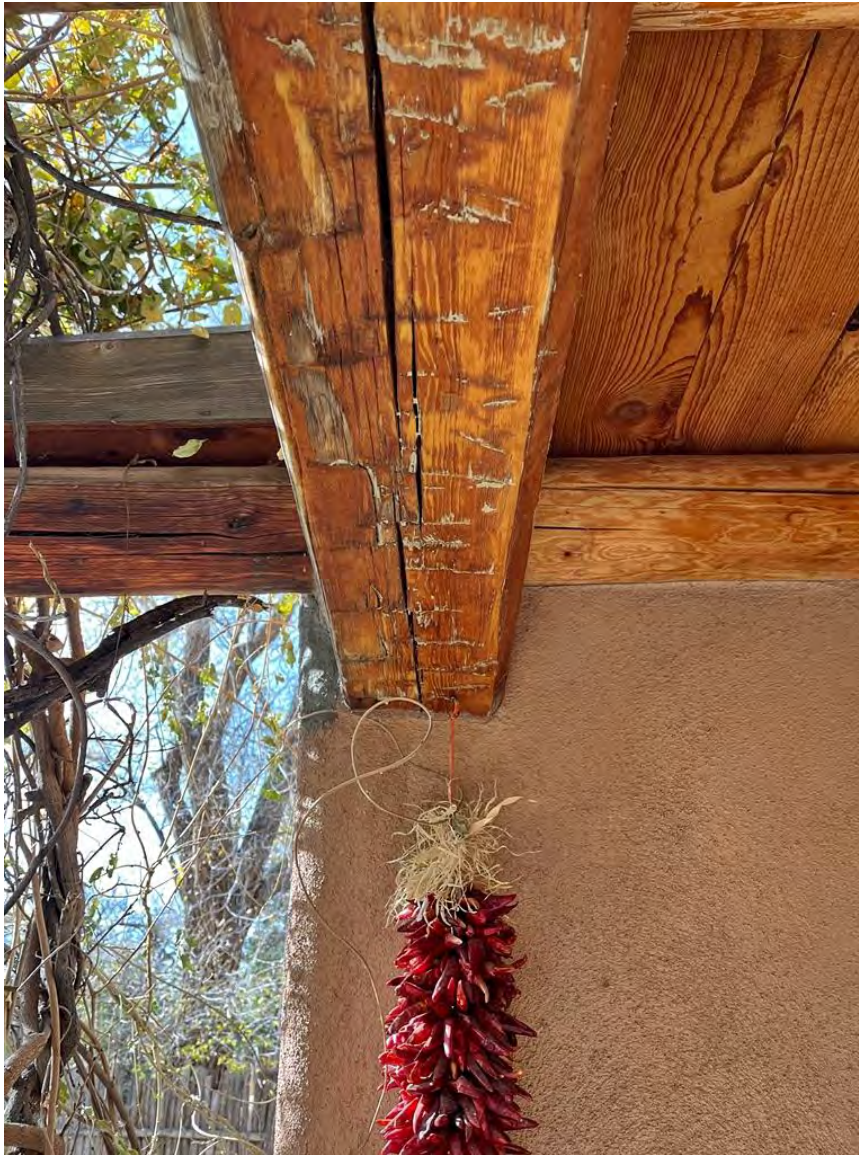
Photo 5: South (front) elevation. Recessed portal decking and beam. Camera facing up.

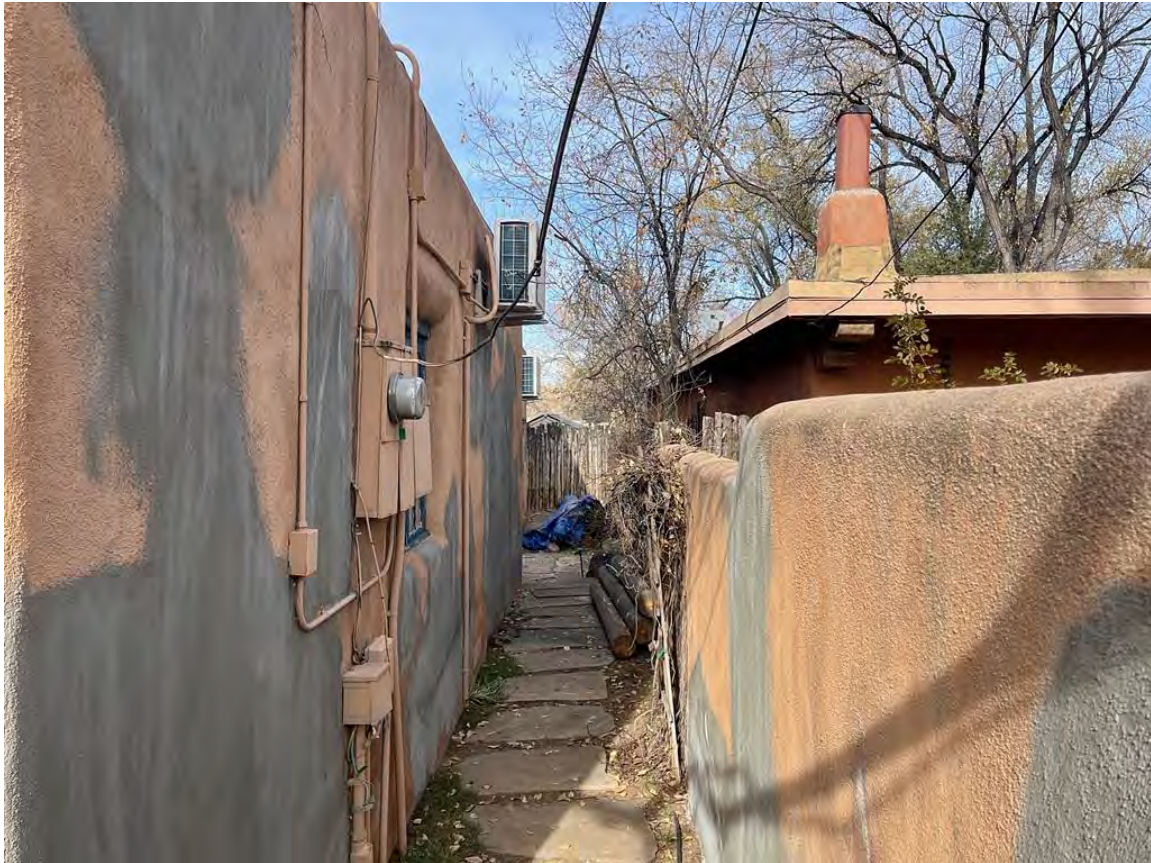
The east elevation sits close to the neighboring property (Photo 6). It is plain, holding the home’s utilities, and has only one opening. Like the front of the house, it is fitted with a pair of six-light casement windows (Photo 7). These, too, are not original. At about 16’ from the facade, the original house ends. North of this point (beginning with a 2” offset), is a lower volume erected before 1958 (Photo 8).

Photo 6: East elevation oblique. Camera facing north.

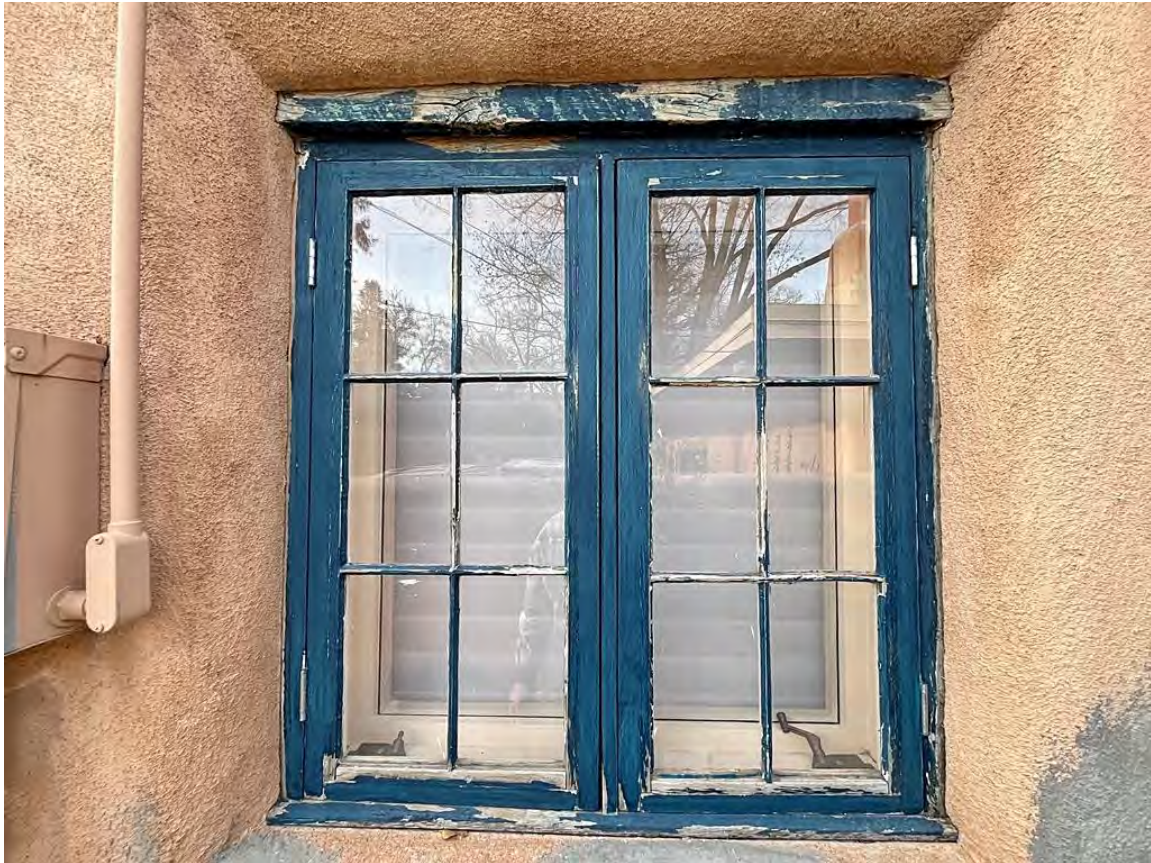
Photo 7: East elevation. Window. Note geared crank-out hardware. Camera facing west.

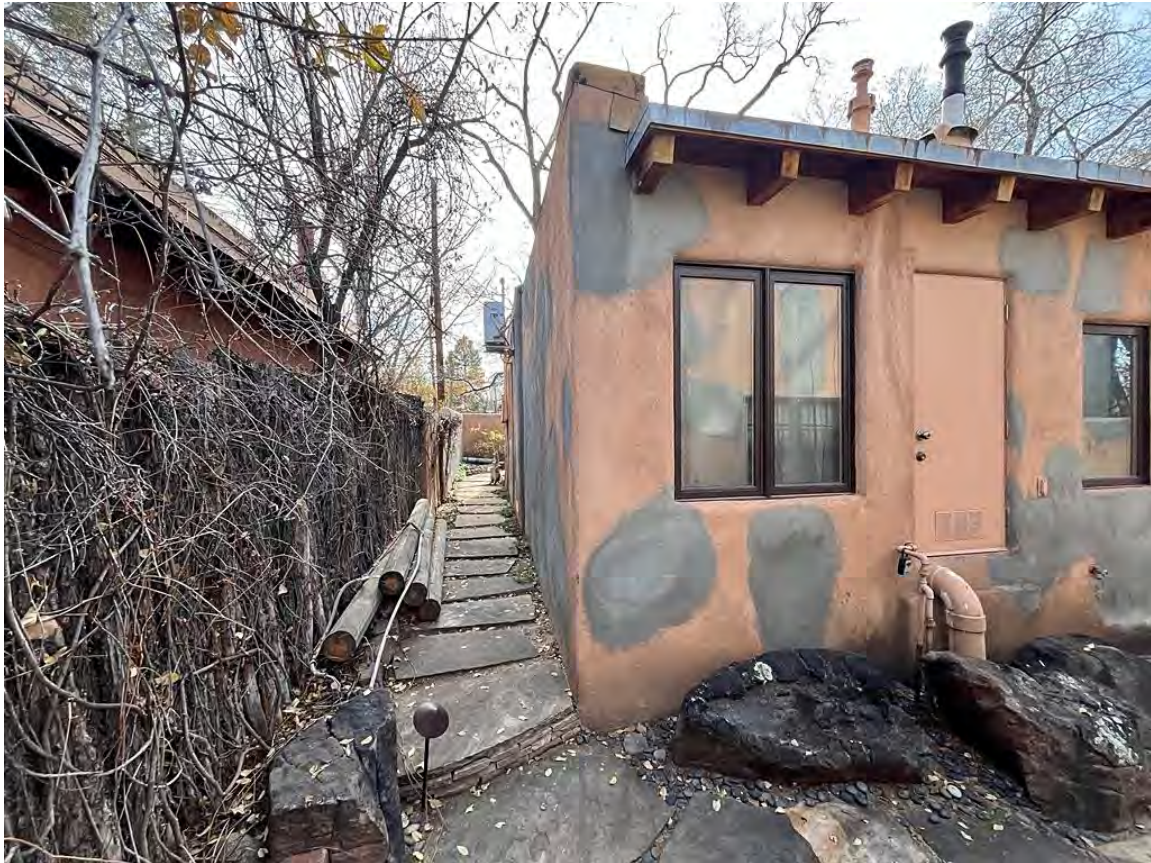
Photo 8: North elevation. Northeast corner. Camera facing southwest.

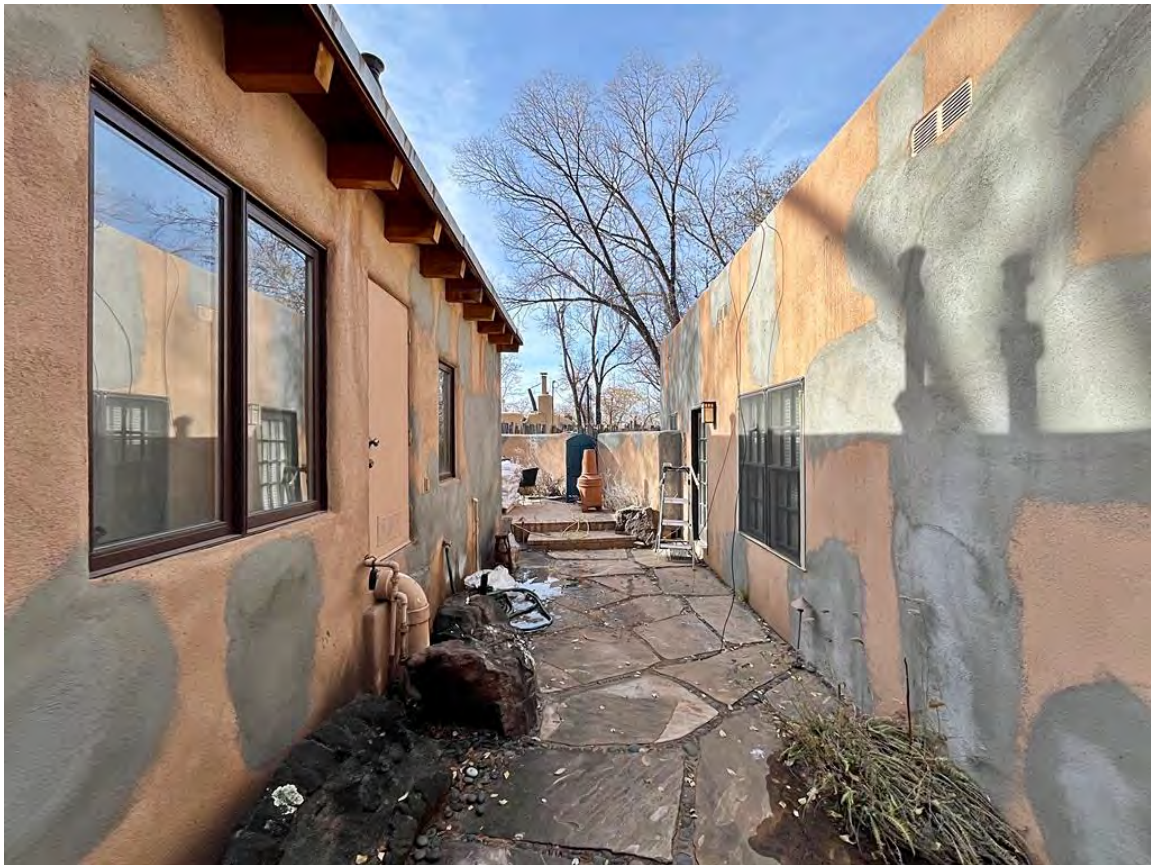
Facing the guesthouse, the north side of the home reveals modifications (Photo 9). These begin with tall single-light clad casement windows bookending a mechanical room door (Photo 10). Cresting the façade is an overhang of recent construction. Up until recently, a roofed structure, creating shelter, connected the house to the guesthouse (Field 16).

Photo 9: North elevation oblique. 2003 guesthouse at right. Camera facing west.

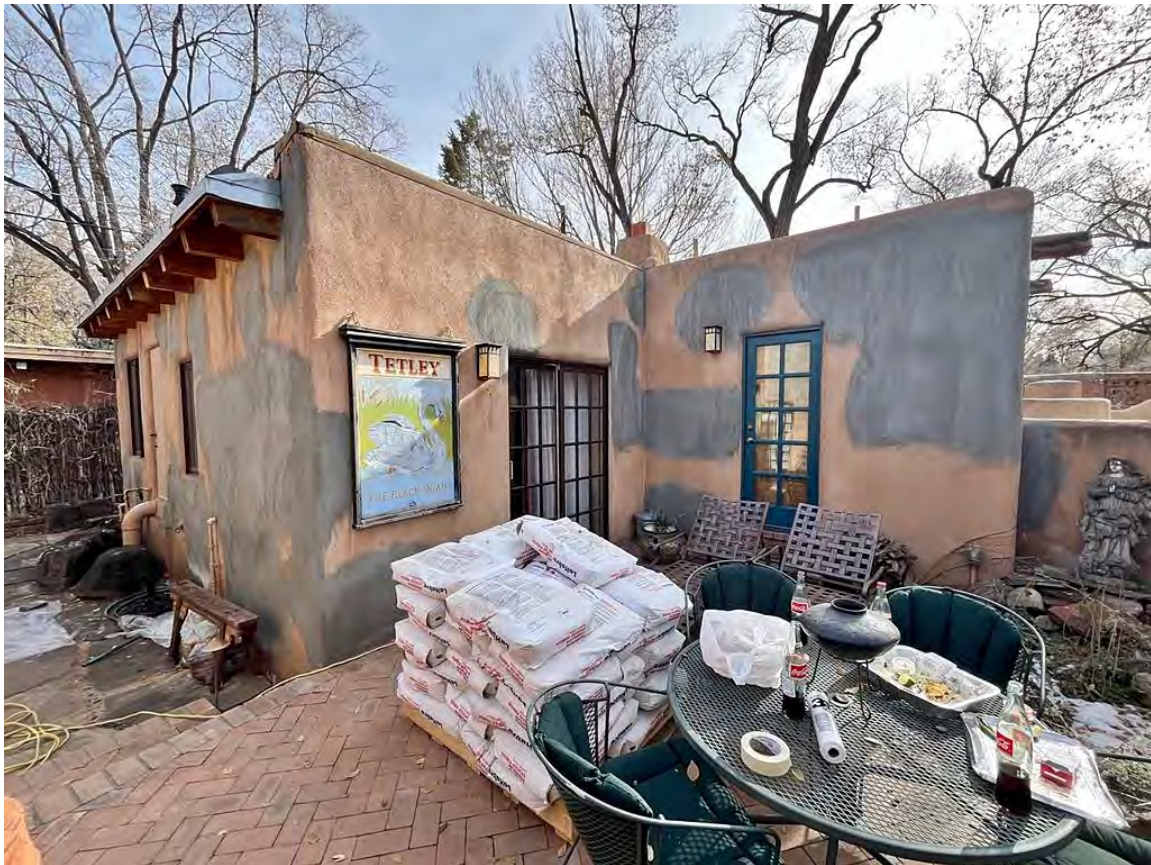
Photo 11: Northwest (patio) elevation. Camera facing southeast.

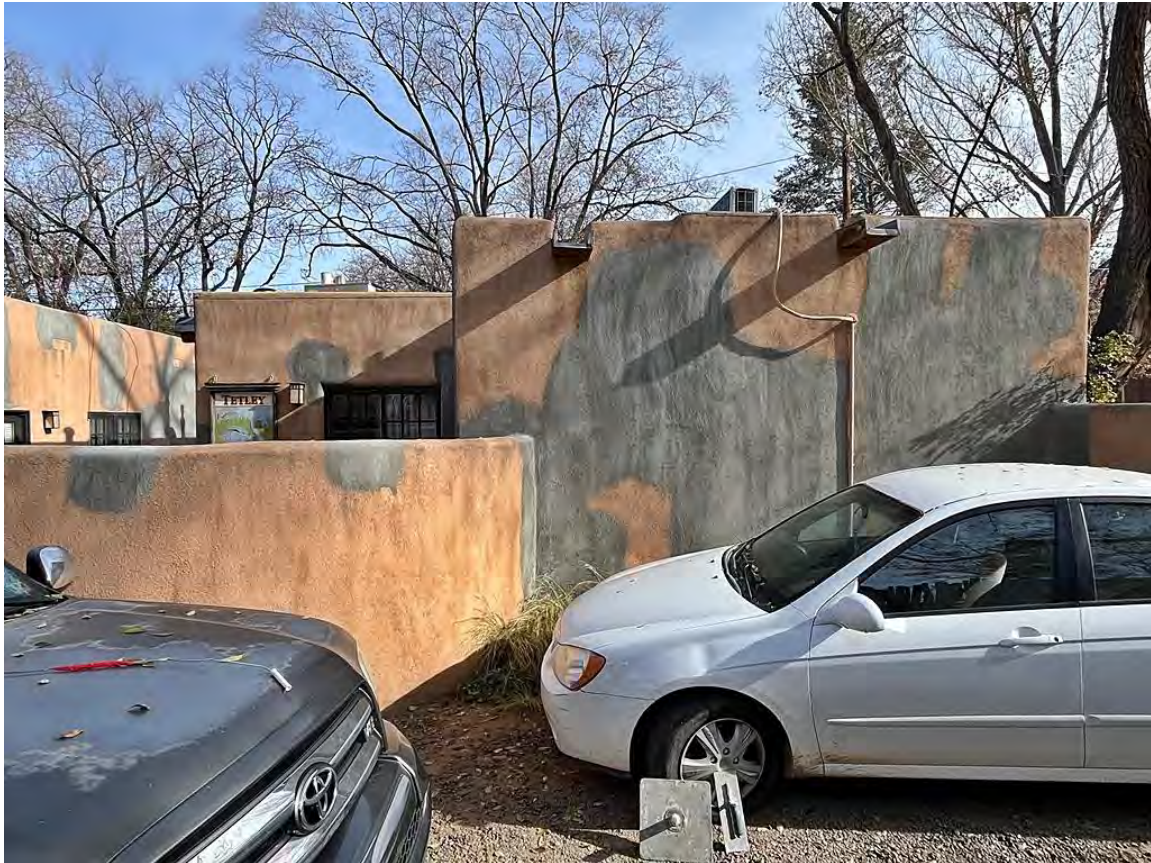
Two sets of curved privacy walls are found on the west side of the house (Photos 12 & 13). The thick walls, which rise 60” and 65½” above the outside grade, were erected around the time of the guesthouse project.

**Photo 12: West elevation. Camera facing east.
 Note curved wall was constructed in c.2002.**

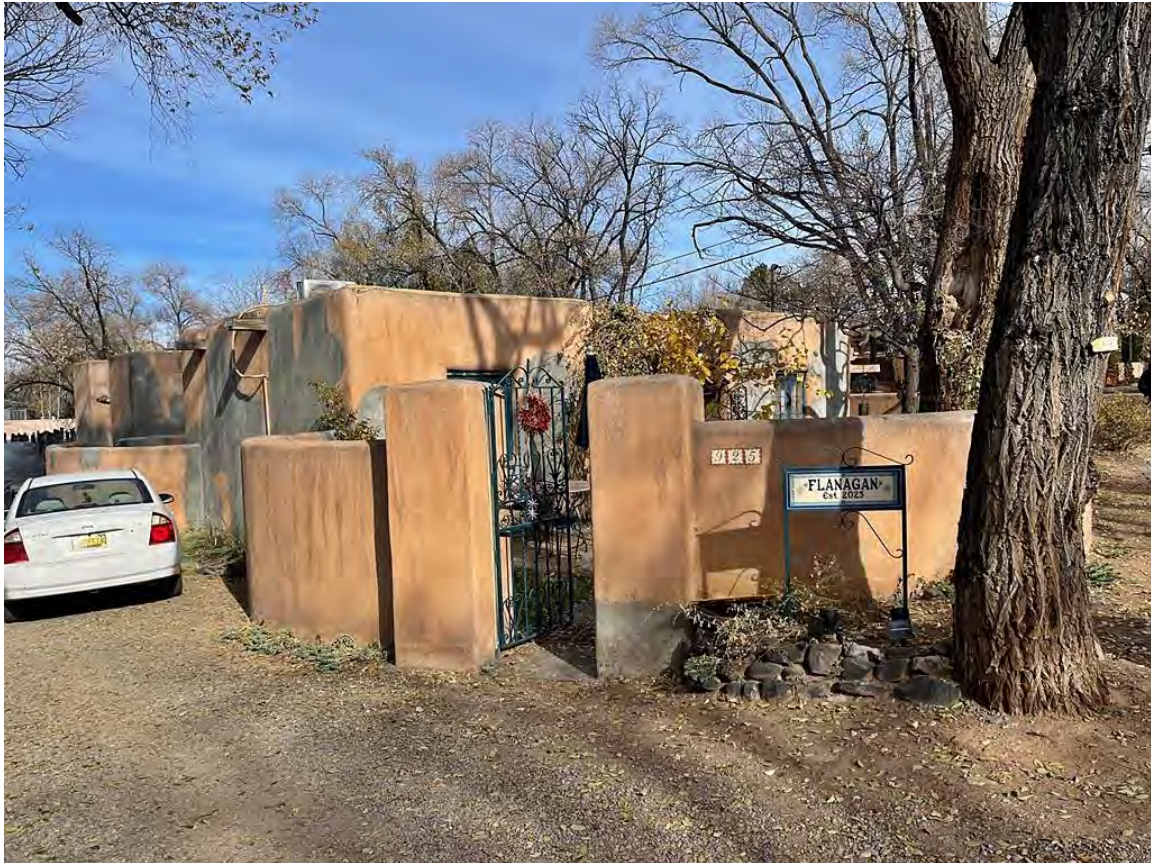
Photo 13: Entry gate and curved wall. Camera facing northeast. Note gate and wall were erected in c.2002.
