Historic Cultural Properties Inventory (HCPI) Base Form (FORM 1)

For HPD Office use only:	
HCPI No. _____	District No. _____
NRHP _____	SRCP _____
Criteria	A B C D
1. Name of property: Cleofes and Arabella Romero House	2. Location: 137 East Santa Fe Avenue Downtown and Eastside Historic District -- Santa Fe

6. Date of Survey: February 27, 2025	
7. Previous Survey Date(s): <input checked="" type="checkbox"/> Yes: Date unknown <input type="checkbox"/> No:	
8. Name of Project: HDRB Status Evaluation

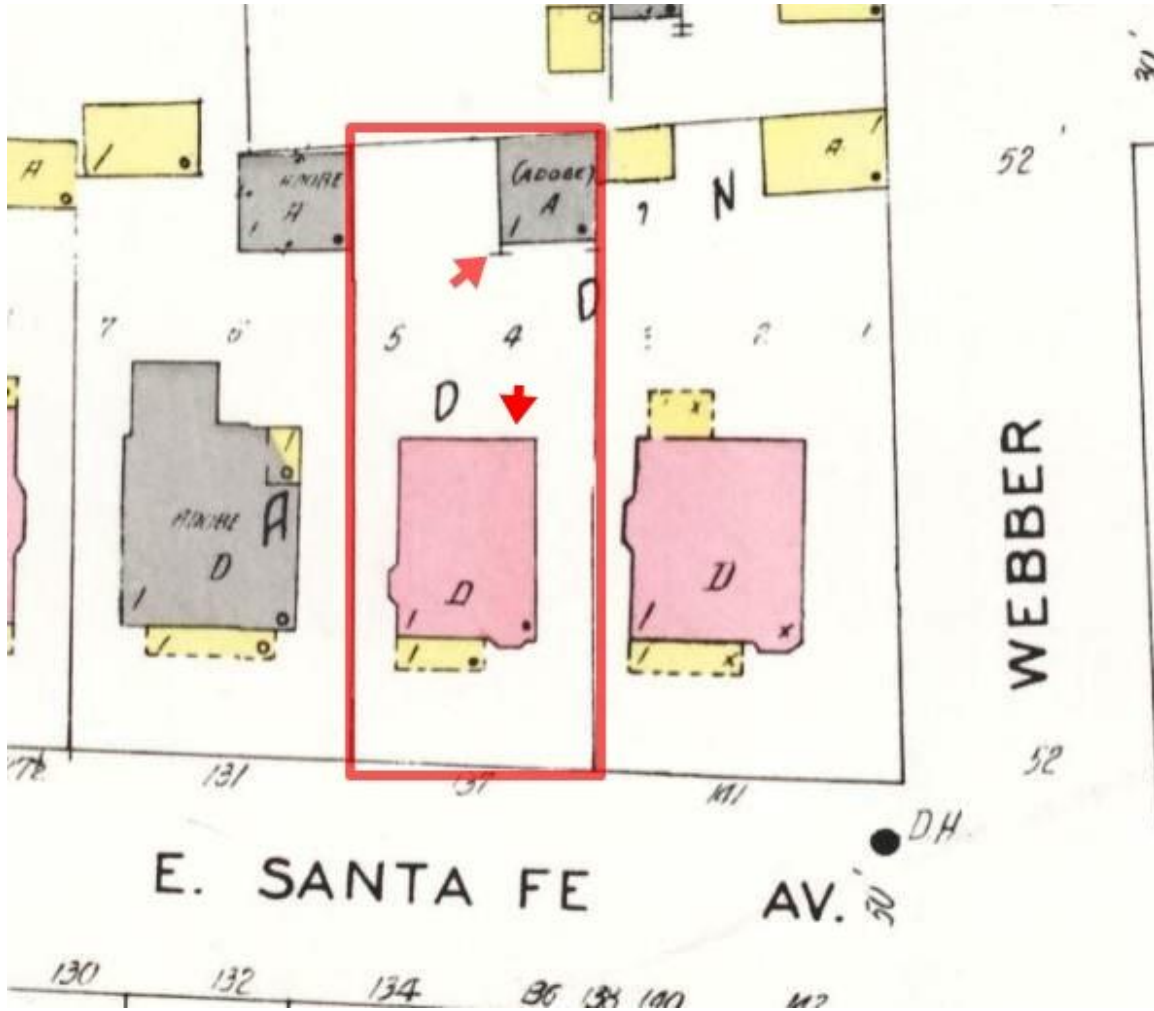
A mudroom caps the north end of the elevation (Photo 7). Constructed between 1948 and 1958 (Figs. 5 & 6), the frame extension is sheathed with vinyl cladding molded to look like German siding. It has two 3/1 wood hung sash windows of a different style.

Figure 5: 1948 Sanborn Fire Insurance. Note adobe garage in northeast corner and absence of the mudroom.

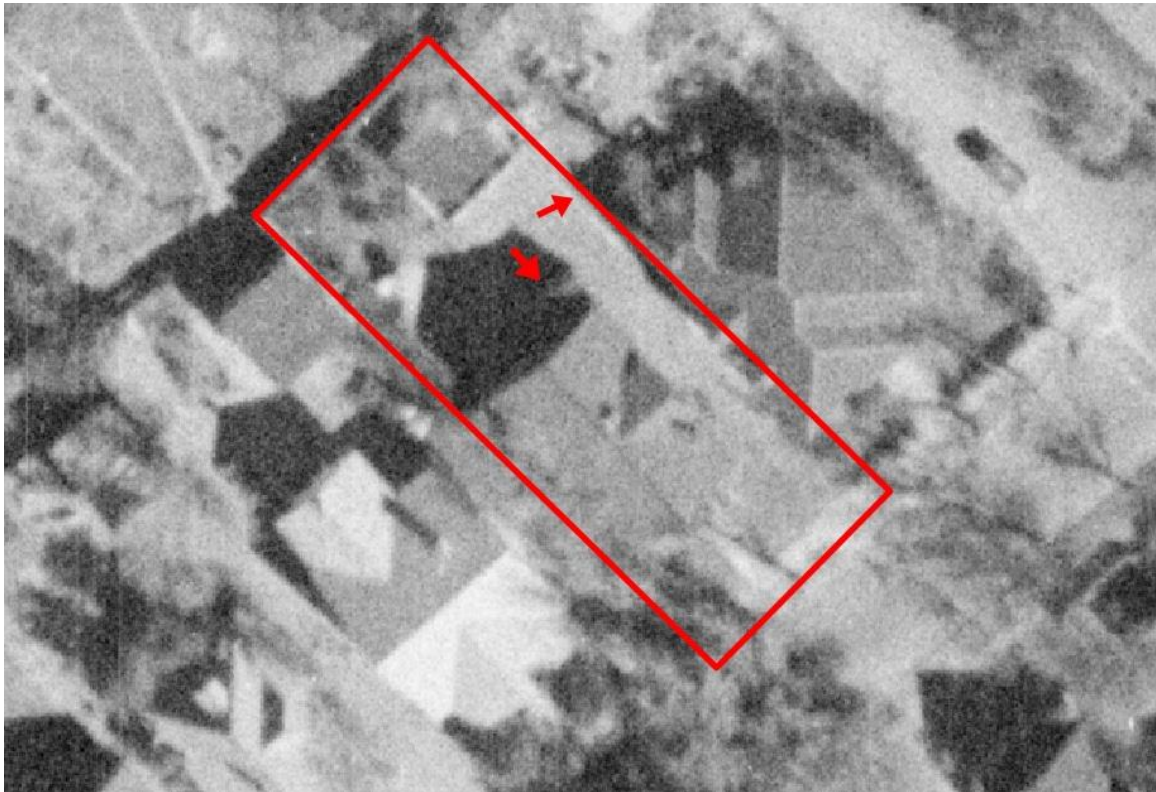
Figure 6: November 10, 1958, aerial photograph.
Note structure along east property line and mudroom.

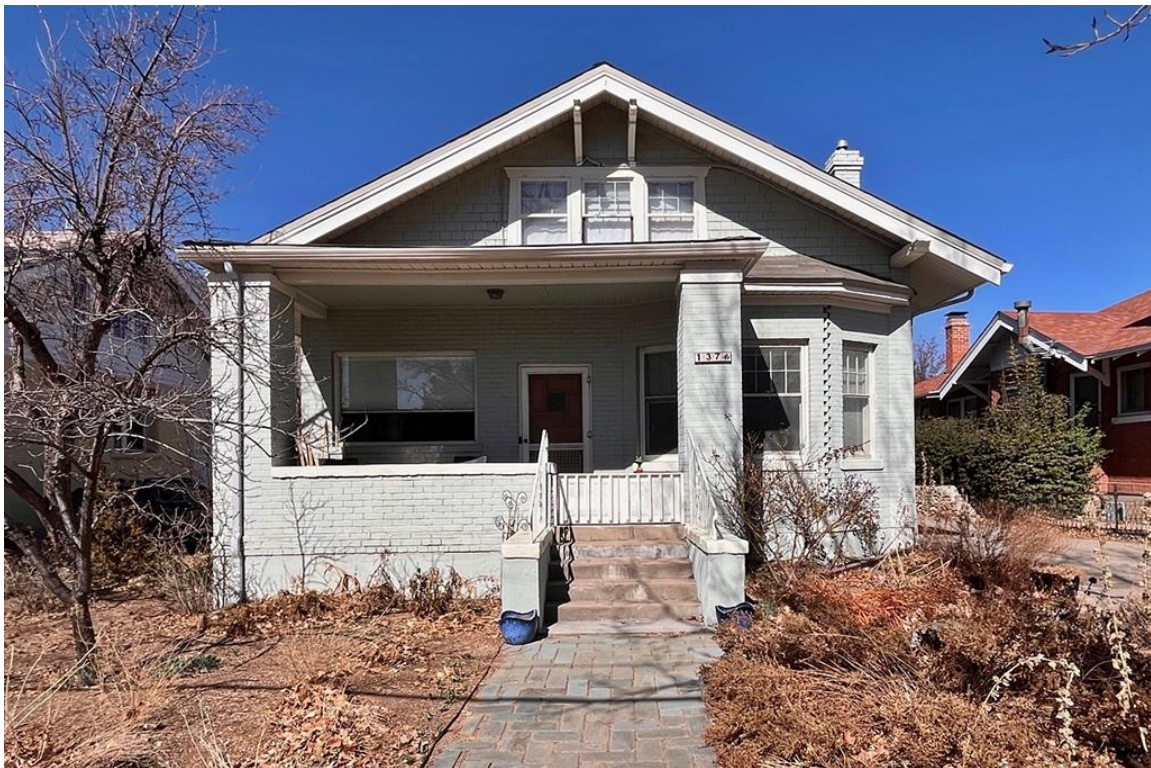
The character-defining features of this building are prominently displayed on the street-facing elevation (Phots 1 & 2). The lower half is characterized by a three-sided bay window and a somewhat plain porch. Four steps lead up to the porch which has a flat roof supported by sturdy, square brick posts (Photo 2). A wooden boxed beam runs between the two posts, hiding the top plate. A solid brick balustrade, topped with cement coping, surrounds the porch. The roof decking is made of painted beadboard.

The upper half of the façade reveals the Craftsman details, including tripartite 6/1 windows, patterned shingles, knee braces, and exposed beams (Photos 1 & 2). Their display is far more restrained than the California-style Craftsman bungalows found one block to the east. The modern soffit mars eaves line.

Photo 2: Front (south) façade. Camera facing north.

The recommendation is to maintain Contributing status for the house, designating the south elevation as the primary façade, given that it expresses the highest level of architectural character.

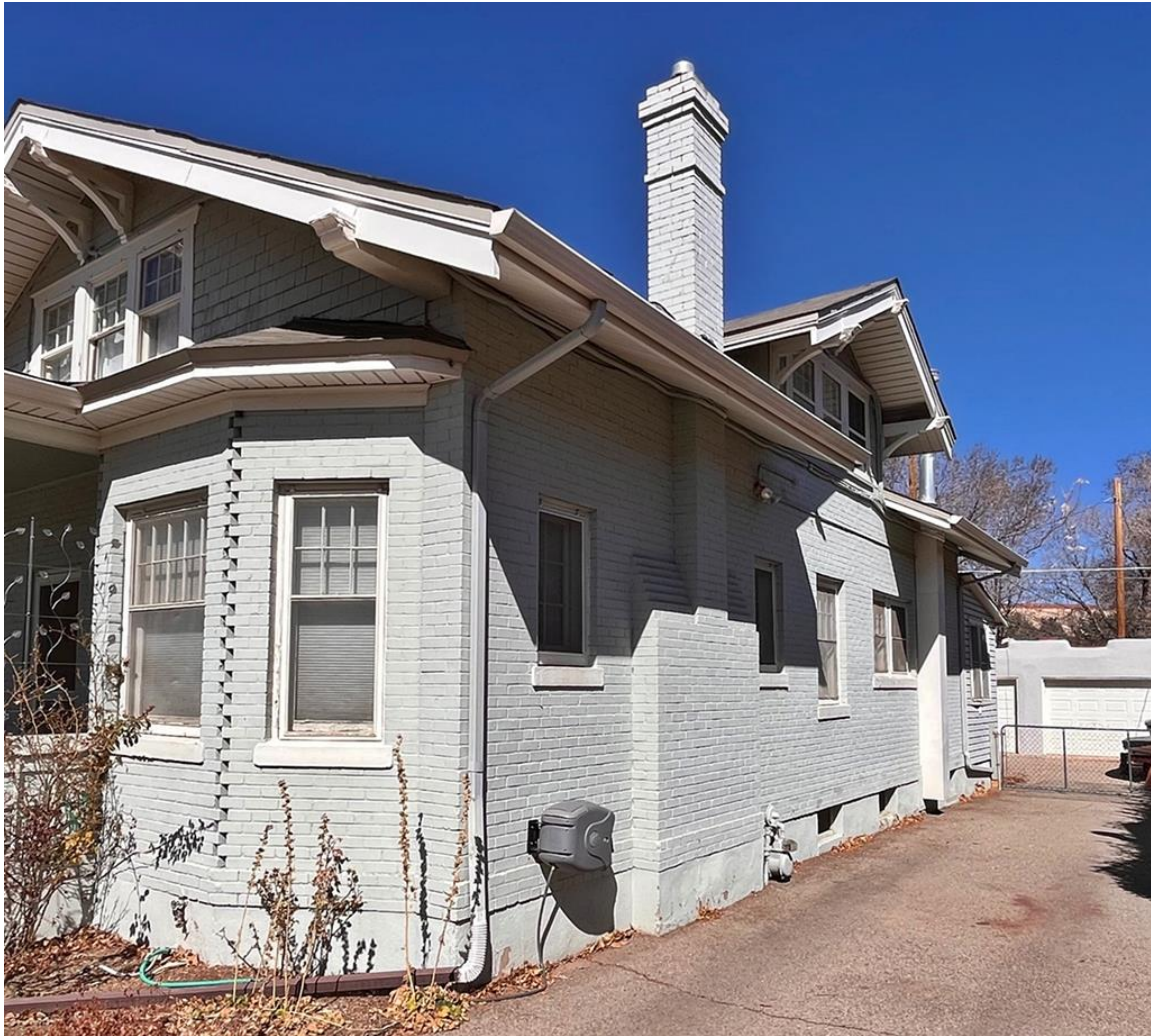
The composition is completed by a bay window (Photo 4). This architectural feature consists of three brick walls joining at an angle, with a cavity between the connecting stretchers (Photo 5). The openings hold older wood hung sash windows in a 6/1 and 10/1 light pattern. Heavy concrete sills terminate their openings. Similar windows in 6/1, 8/1, and 10/1 light patterns are found throughout the house and discussed below.

The east elevation looms over the driveway with a mixture of windows (Photos 4 & 6). Near the south end, a brick chimney scales the wall with its tall stack breaking through the eave. The windows are primarily 8/1 hung sash with 6-light, inswing casements flanking the chimney. Sitting below the water table are three wood cellar windows. The dormer is pierced with a tripartite window holding a 6/1 hung sash. Three knee braces are distributed evenly underneath the eave.

Photo 4: Bay window and east elevation. Camera facing northwest.

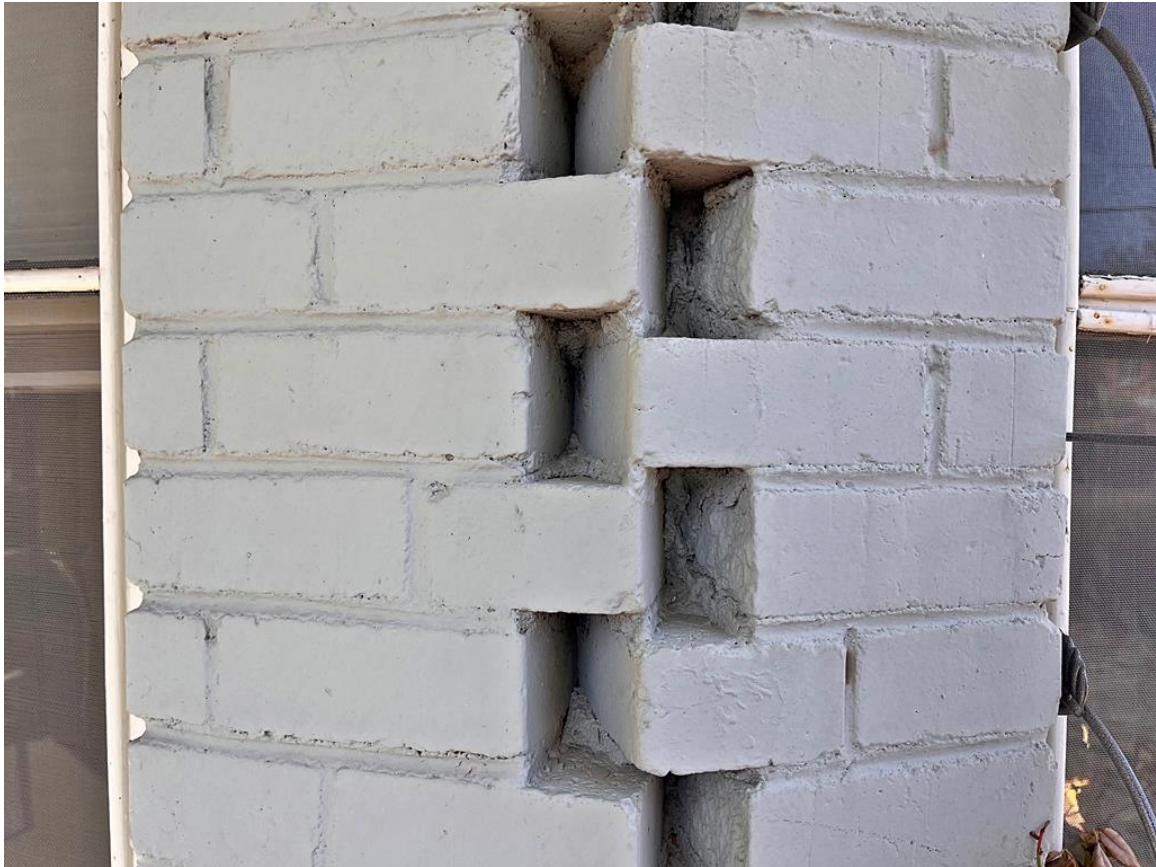
Photo 5: Bricks at the bay window. Camera facing northwest.

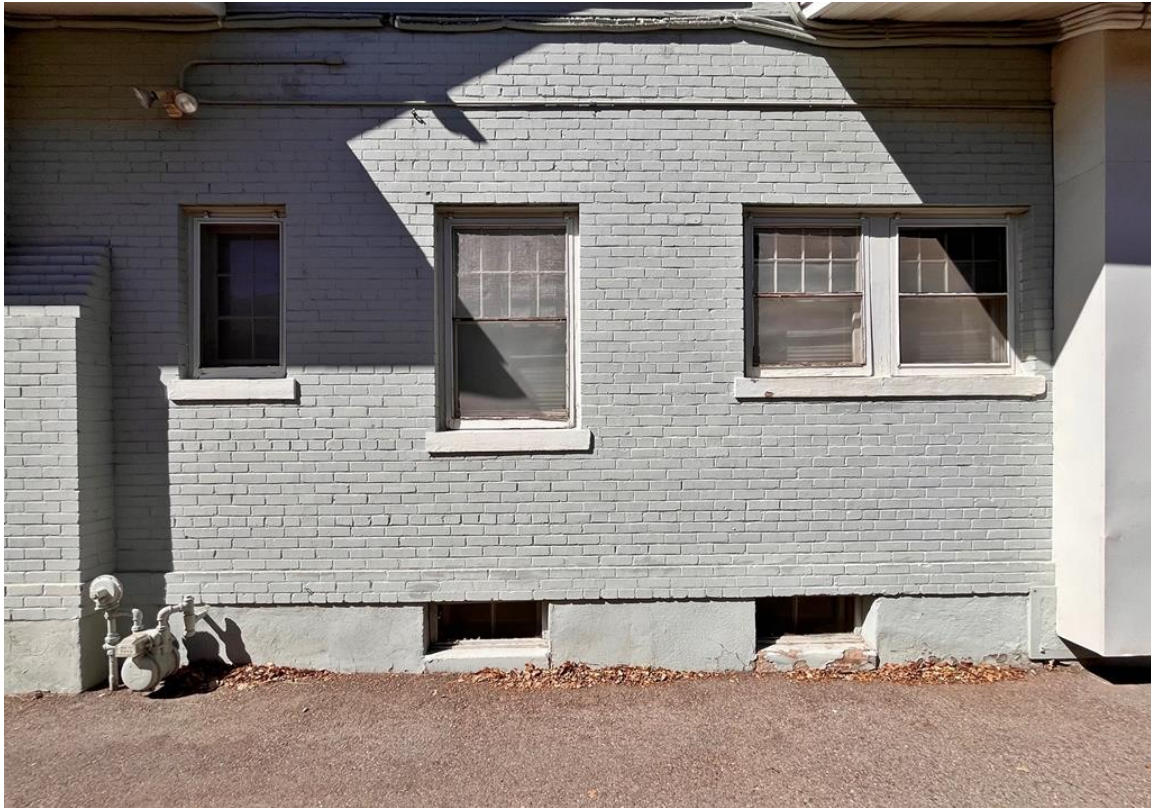
Photo 6: East elevation windows. Camera facing west.

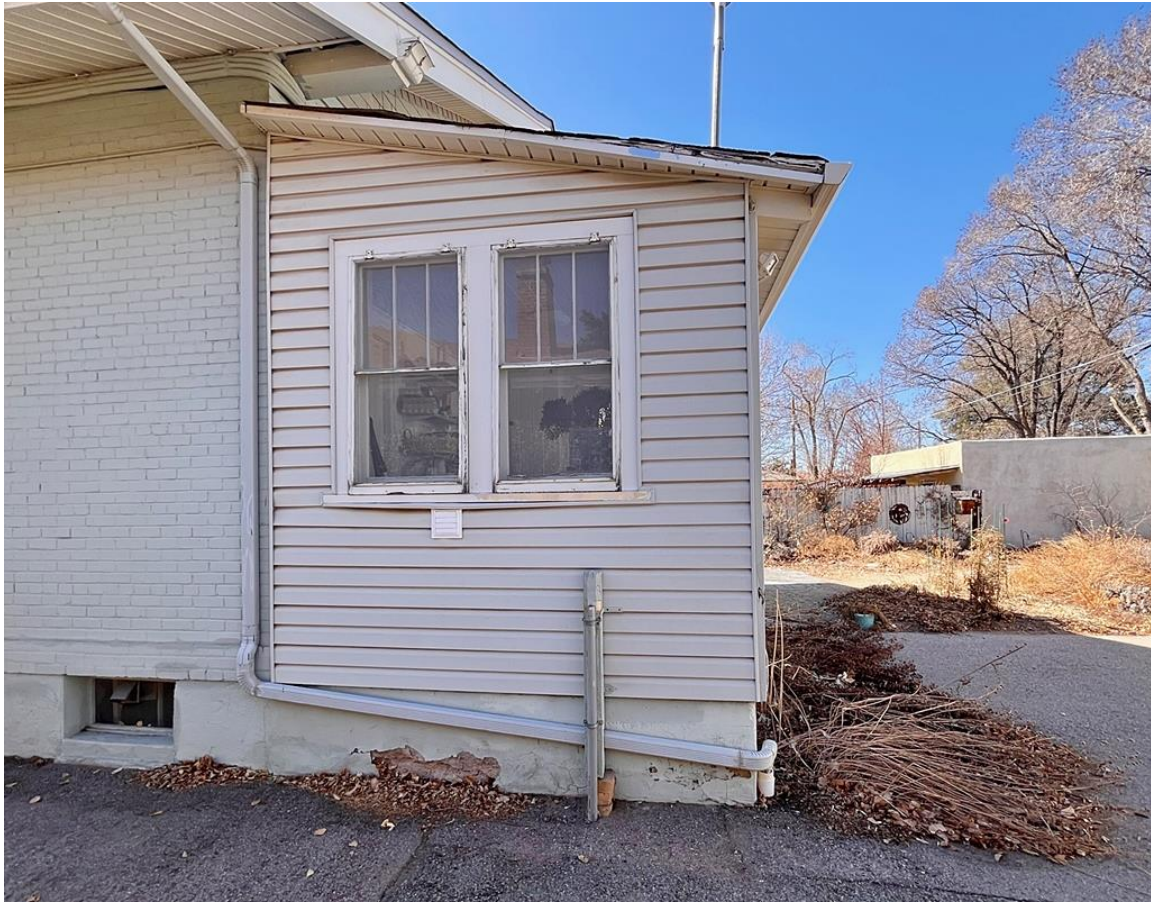
Photo 7: East elevation of mudroom addition. Camera facing west.

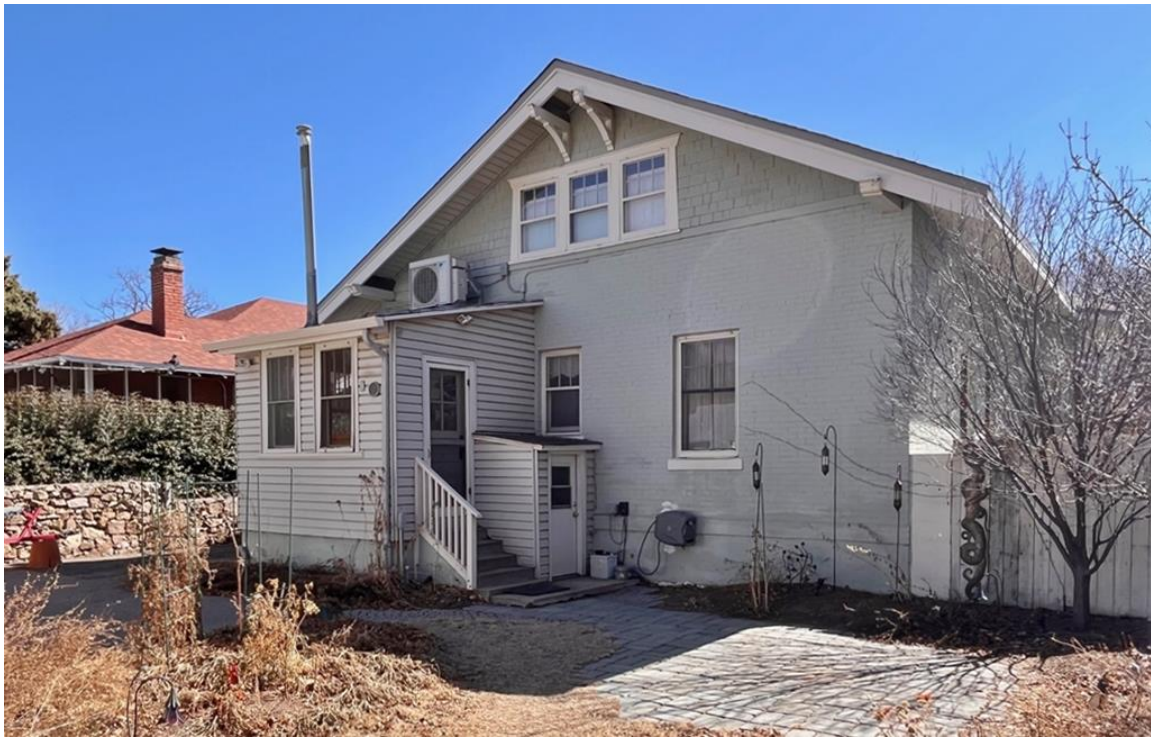
The back side of the house repeats the same gable composition as the south façade (Photo 8). The lower half of the building has two sash windows and a vinyl-sided entry to the basement.

Photo 8: North elevation. Camera facing southeast.

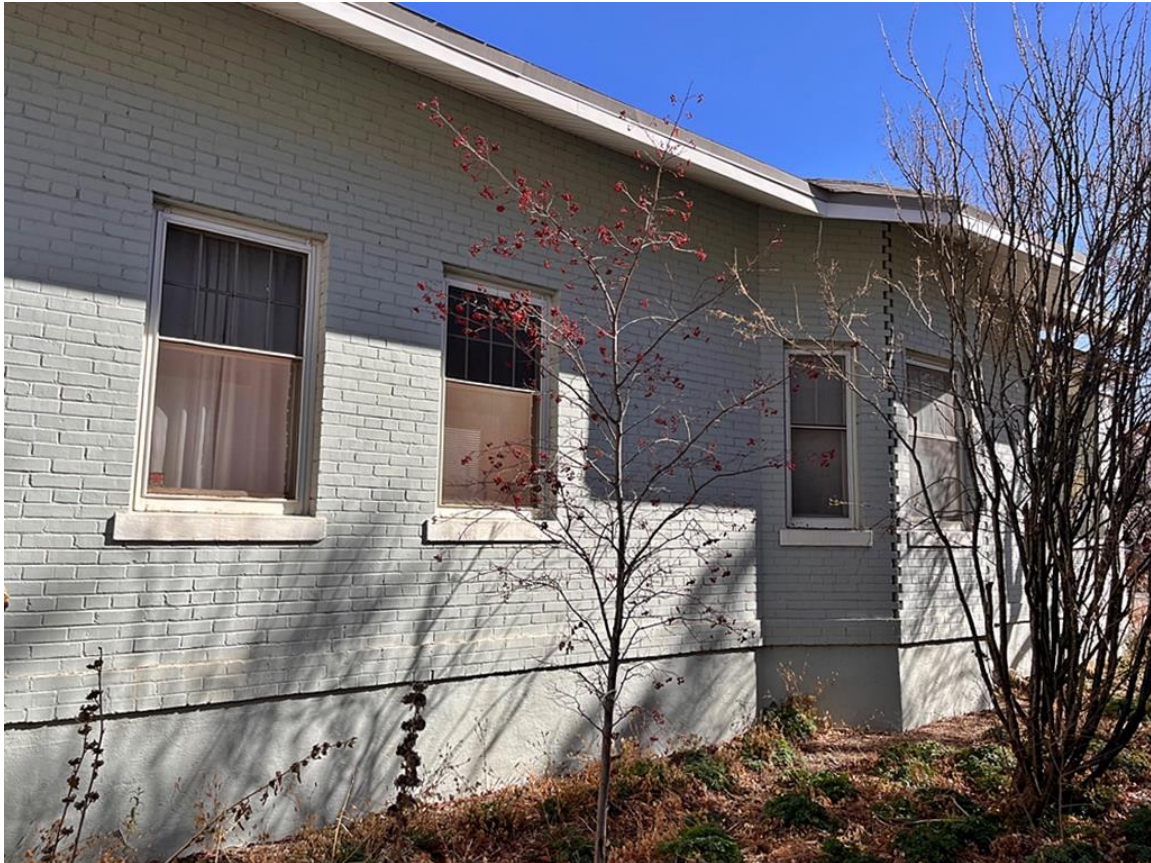
Two additional windows — 8-light hung sash — are located at the north end (Photo 9). The water table is made of a different arrangement of bricks, and the raised foundation reaches its highest point on this side at 26 ½” above the ground.

Photo 9: West elevation. Camera facing southeast.

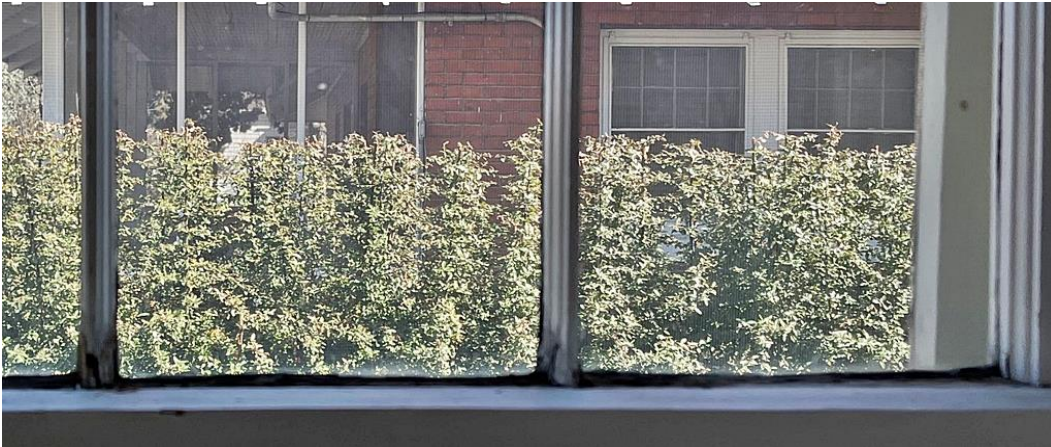
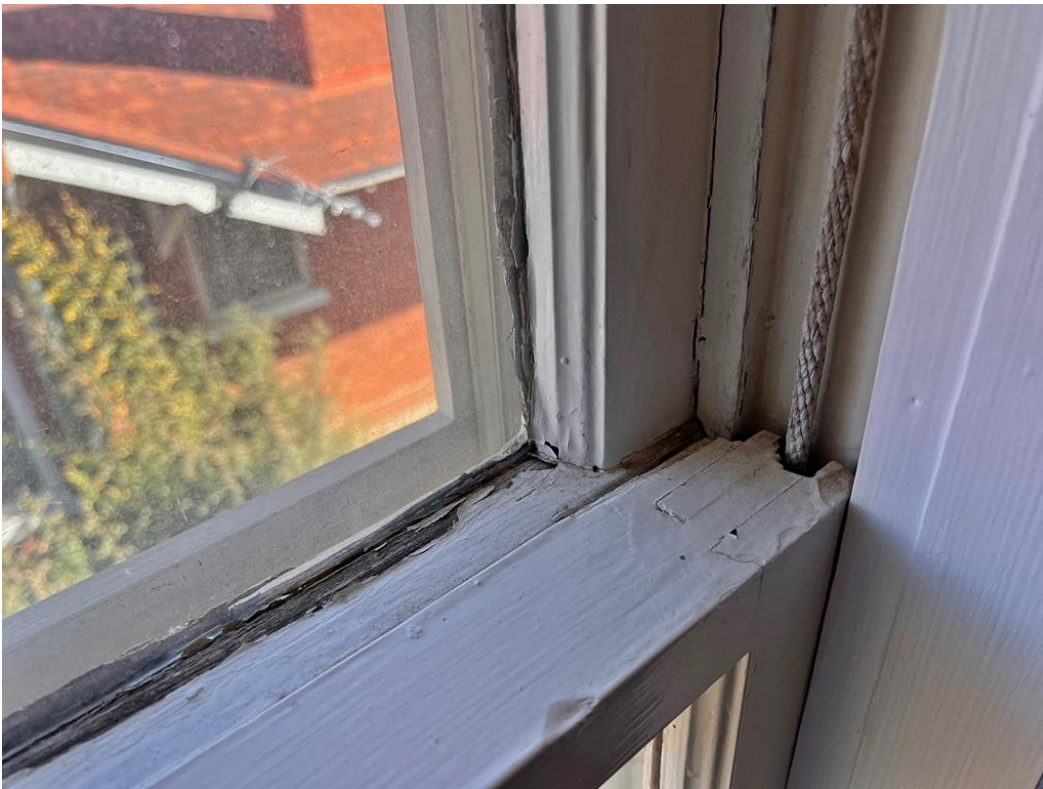
The wood hung sash windows generally share the same design. A window examined at the east dormer had mortise and tenon connections between the rail and stile (Photo 9). The window’s interior muntins had a molded profile with a 1/8-inch thick endpoint (Photo 9). Additionally, the rails and stiles had molded edges (Photo 9).

Photo 9: Details of east dormer widow.

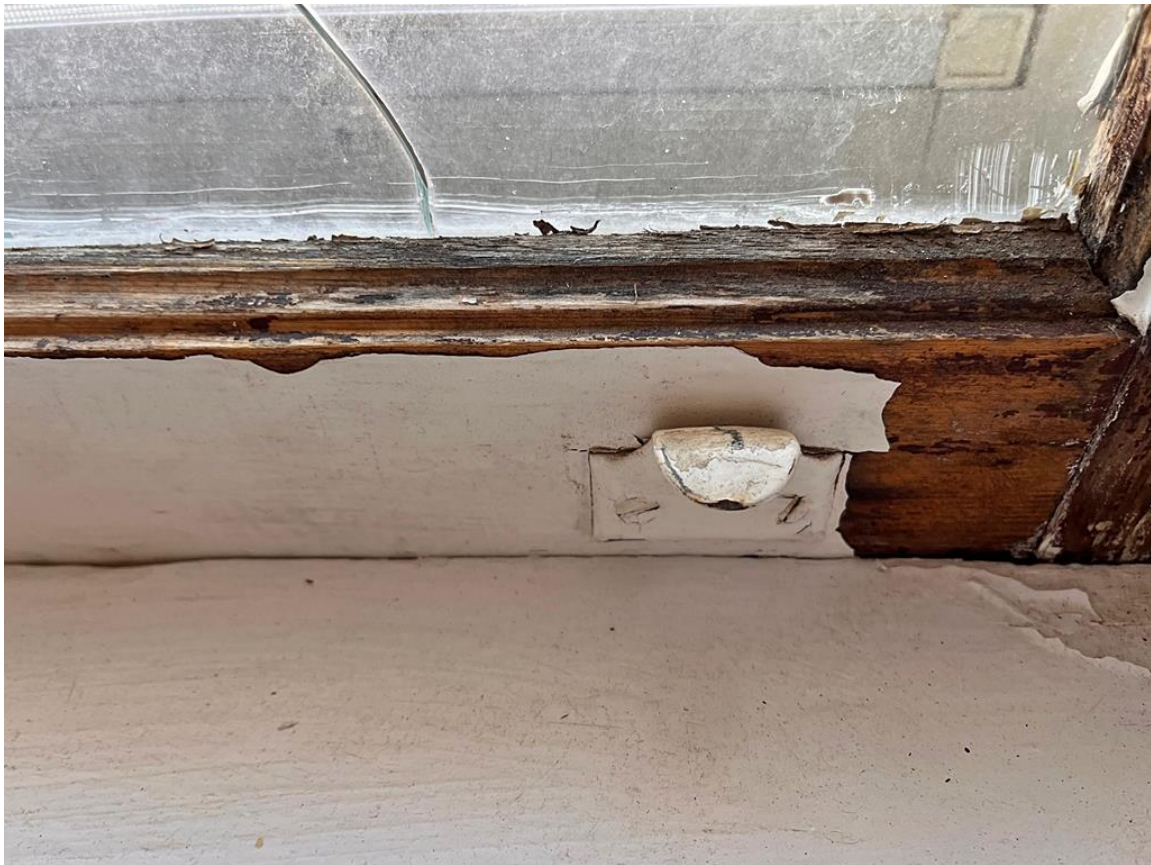
A deteriorated area of the lower rail revealed only one layer of paint (Photo 10).

Photo 10: Deterioration of east dormer window.

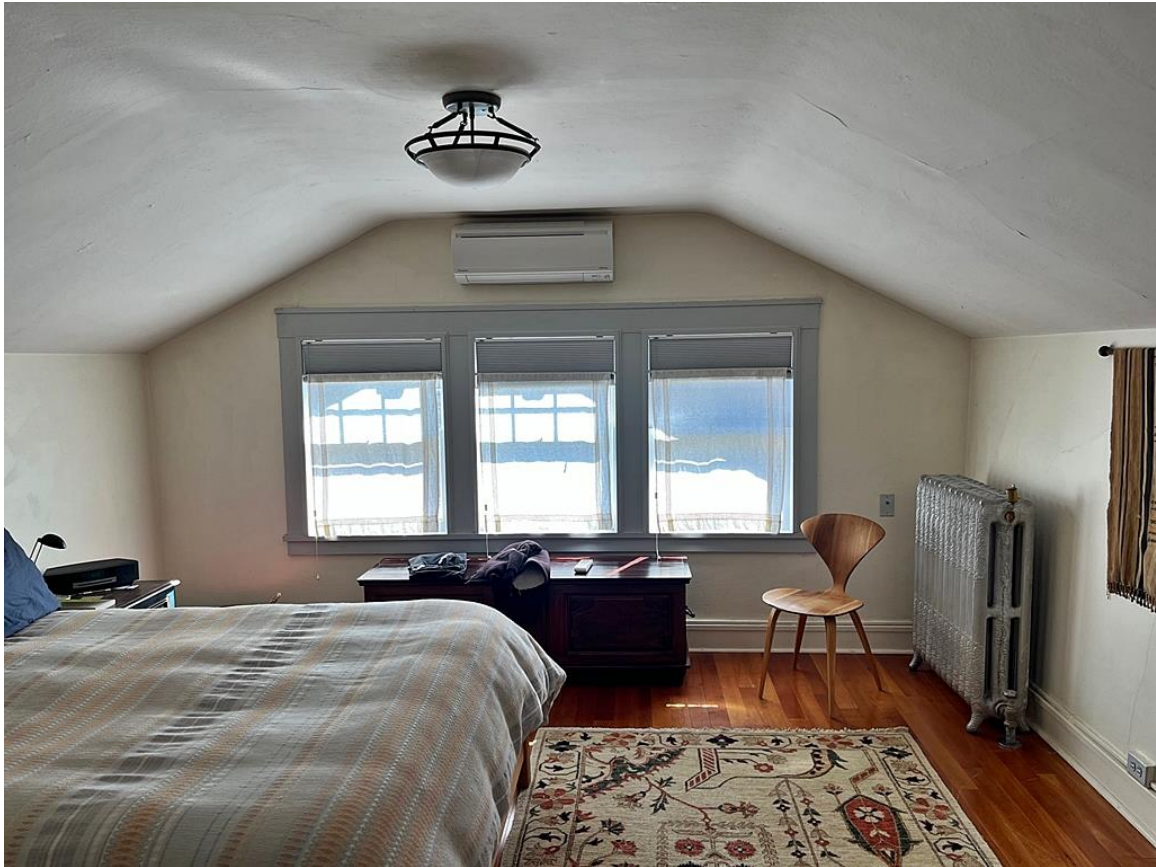
The interior reveals alteration, with typical Craftsman elements — built-in cabinets and shelves — missing. The kitchen has been expanded, and the living room/dining room area has an altered floor plan. The upper level is more original. Reached by a straight run of stairs, it has three-angle plastered ceilings, hardwood floors, and old cast-iron radiators (Photo 11).

Photo 11: East gable room. Camera facing south.

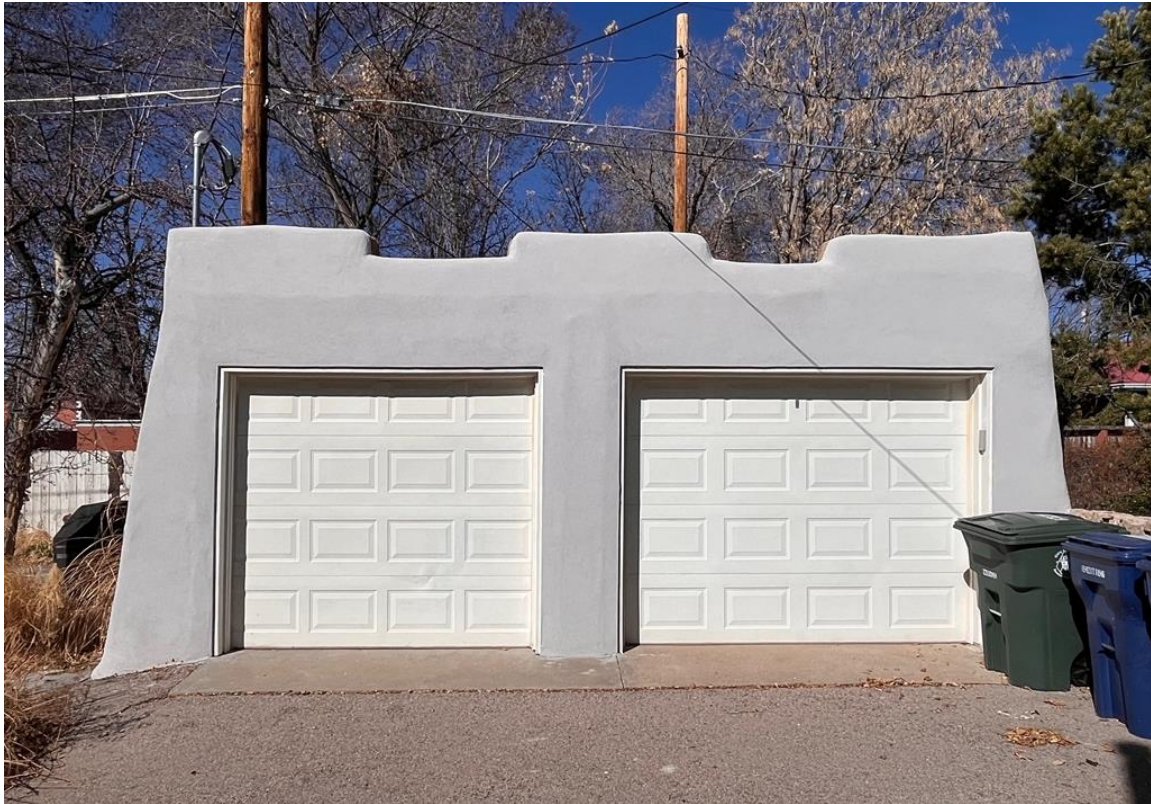
An adobe Pueblo Revival-style garage sits at the end of the driveway (Photo 12). Erected between 1930 and 1948, the two-bay garage has modern raised panel doors. The only windows are two sets of 6-light sash on the north side which have had their glass panes removed and replaced with painted wood (Photo 13). The raised parapet and battered corners on the façade appear exaggerated and may have been added later.

Photo 12: Garage, south elevation. Camera facing north.

For the same reason, the south elevation of the garage is recommended as the primary façade.

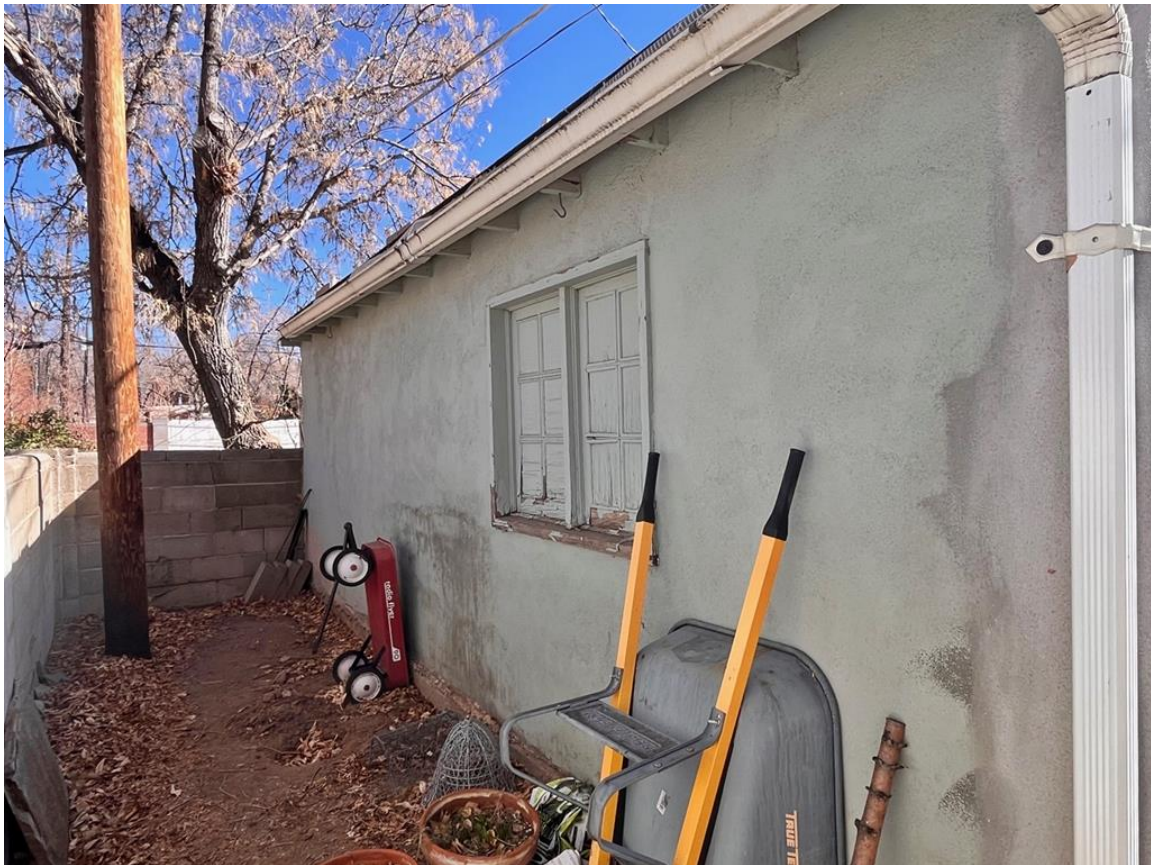
Photo 12: Garage, north elevation. Camera facing southeast.

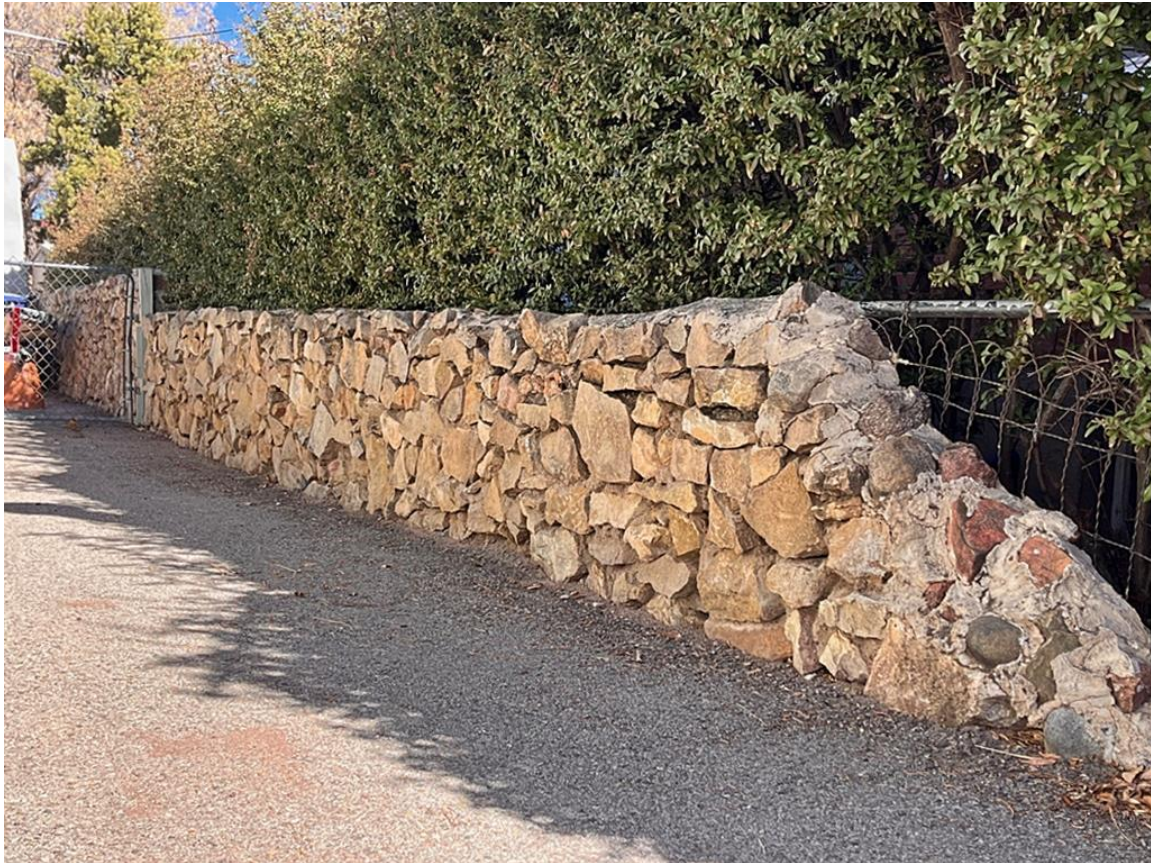
Photo 14: East property wall. Camera facing northeast.

The east property wall appears historic and is recommended for Contributing status.
