Field Observation Report

Report Date	04/03/2025, Thursday	AECOM Inspector	Seth McVey, PE
Report Number	Report No. 1	Contractor	Concrete Coring Company
CoSF Project Number	N/A	Contractor	Terracon
NMDOT Bridge Number	Bridge No. 8388	Contractor	RoadSafe

As part of AECOM’s agreement with the City of Santa Fe for Construction Engineering and Inspection services for the bridge carrying Cerro Gordo Rd over the Santa Fe River (Bridge No. 8388), AECOM and its subconsultant performed concrete coring services of the bridge superstructure on April 3, 2025. These deck cores were taken to evaluate the condition of the existing bridge to determine if the extent of repairs detailed in the repair scoping report, developed by WSP dated 6/25/2024, are sufficient. Five (5) concrete cores were taken at the following locations:

BRIDGE NAME: CERRO GORDO RD. OVER SANTA FE RIVER
 LOCATION: BRIDGE SITE

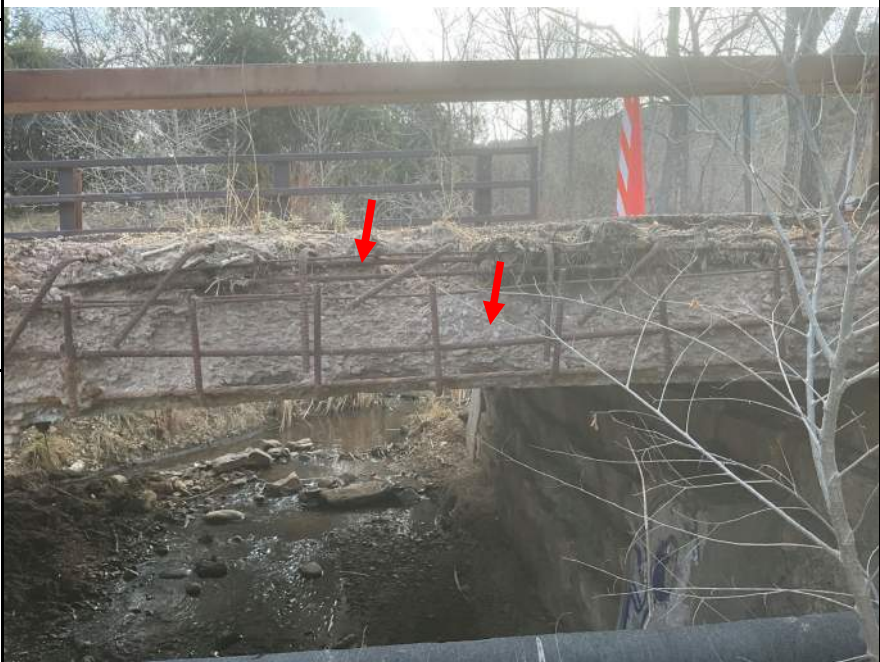
Photo No.	6

The 2023 BIR indicated severe spalling, delamination, scaling, and exposed reinforcement with section loss of the top flange of the girder along both exterior faces of the exterior girders. AECOM observed these defects and found that the defects have worsened (see **Photos 6 & 12-16**). The bridge railing posts are

Location	Southwest Edge of Deck (looking East)	
Description	Severe Spalling Exposing Reinforcement with Corrosion and Section Loss

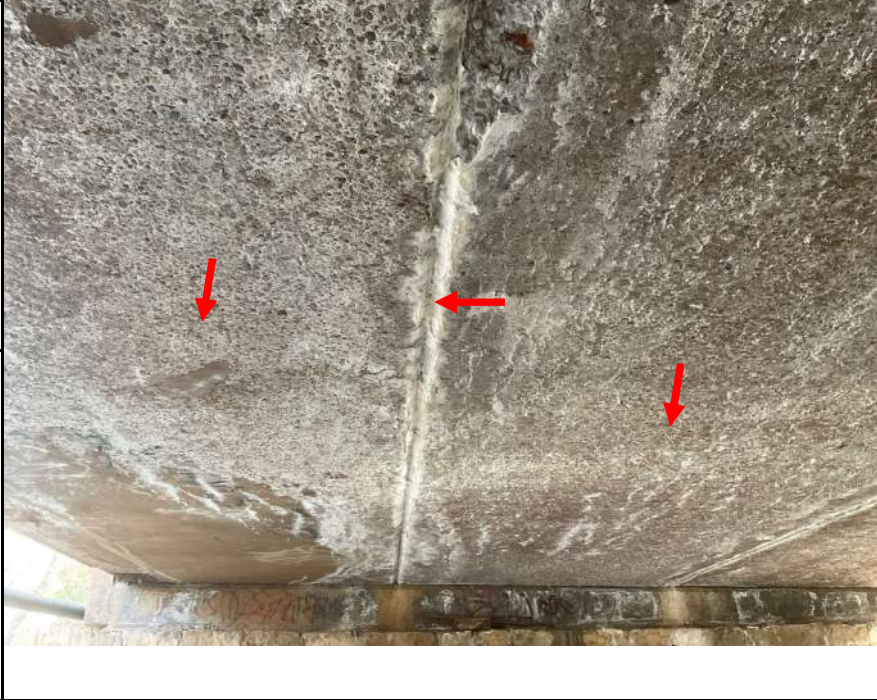
Photo No.	7	
Location	Deck Soffit, Joint Between West Girder and Center Girder at South End (looking Up and North)

Description	Severe Efflorescence & Minor to Moderate Abrasion

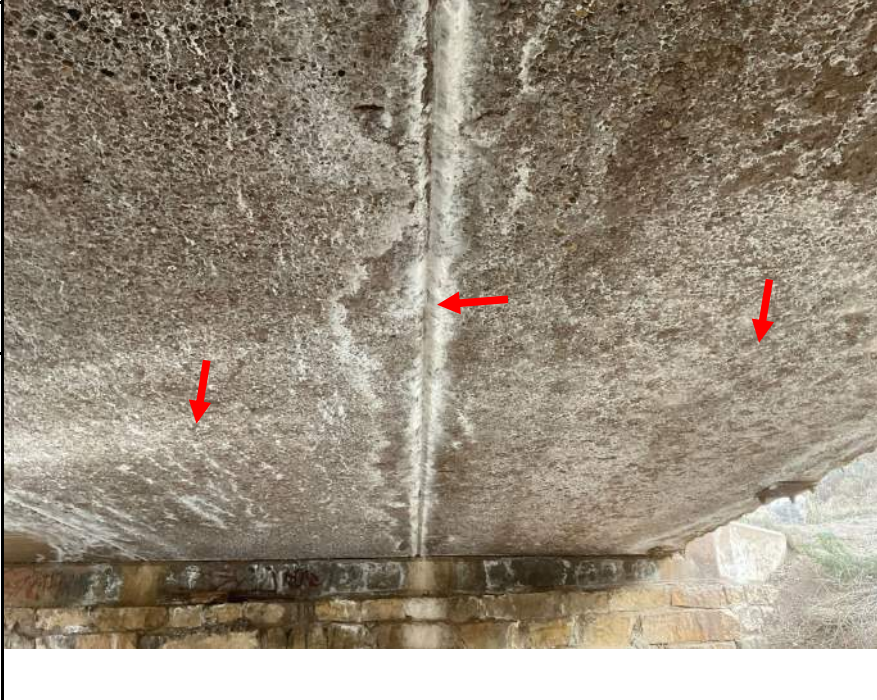
Photo No.	8	
Location	Deck Soffit, Joint Between East Girder and Center Girder at South End (looking Up and North)

Description	Severe Efflorescence & Minor to Moderate Abrasion

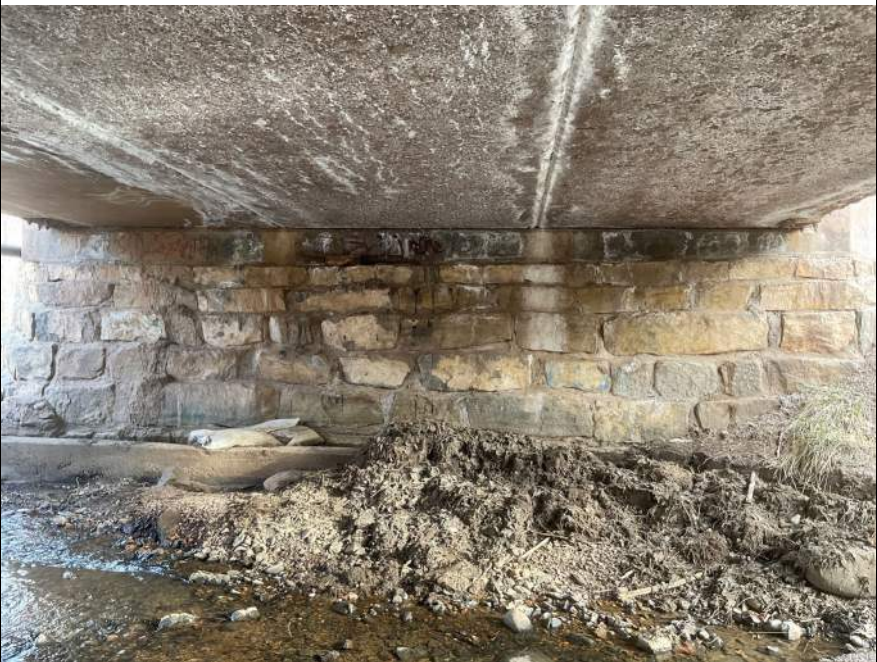
Photo No.	10

compromised because of the lack of integrity of concrete holding the posts in place (see **Photos 17 & 18**). The condition of the bridge rails was observed to be in general conformance with the most recent inspection report (see **Photo 19**). The girder soffit was observed by AECOM to exhibit minor to severe efflorescence (see **Photo 9**), particularly at the joints between the girders (see **Photos 7 & 8**). The condition of the masonry abutments was observed to be consistent with the 2023 BIR, with moderate mortar loss, broken rocks, water staining, cracks, and efflorescence (see **Photos 10 & 11**).

Location	South Abutment (looking North)	
Description	Typical North Abutment

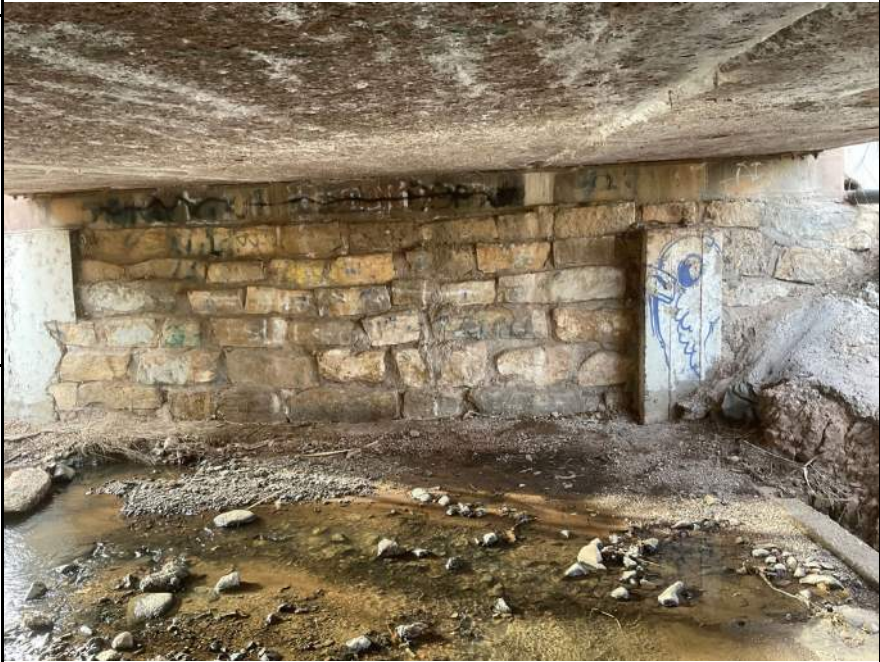
Photo No.	11

Location	North Abutment (looking South)	
Description	Typical South Abutment

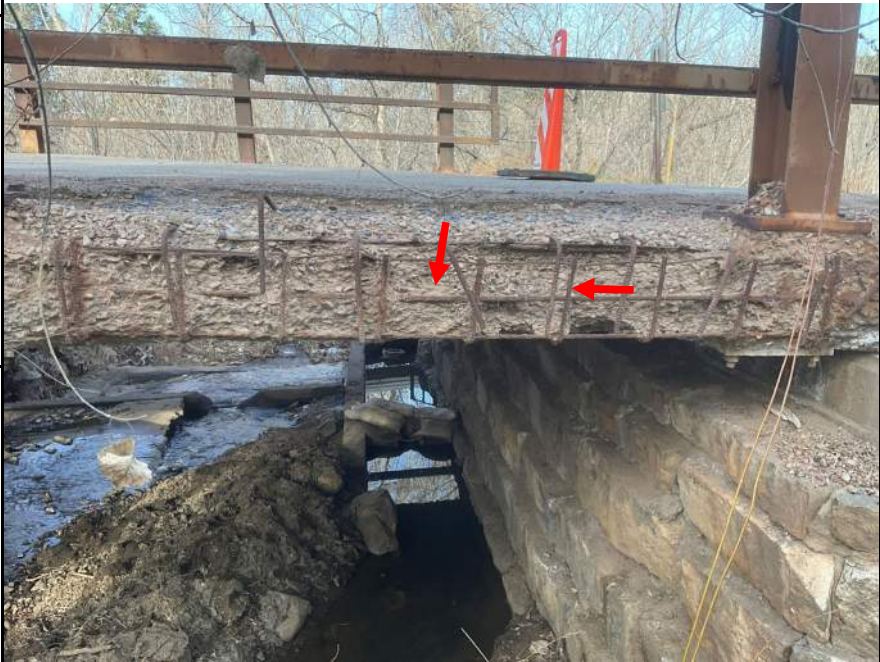
Photo No.	12

Location	Northeast Edge of Deck (looking West)	
Description	Severe Spalling Exposing Reinforcement with Corrosion and Section Loss

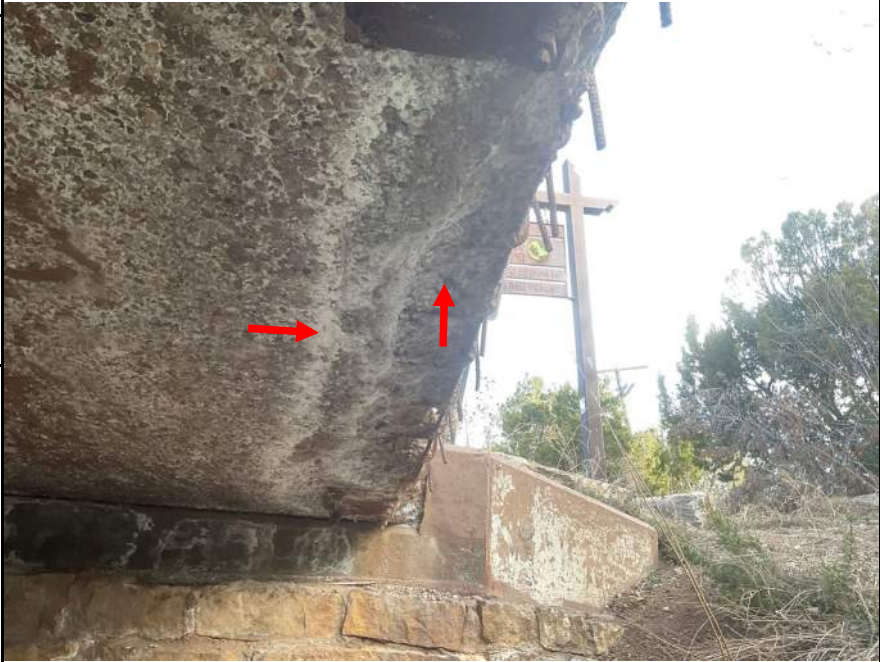
Photo No.	13

Location	East Edge of Deck Near Midspan (looking Up and North)	
Description	Typical Condition of Edge of Deck Soffit

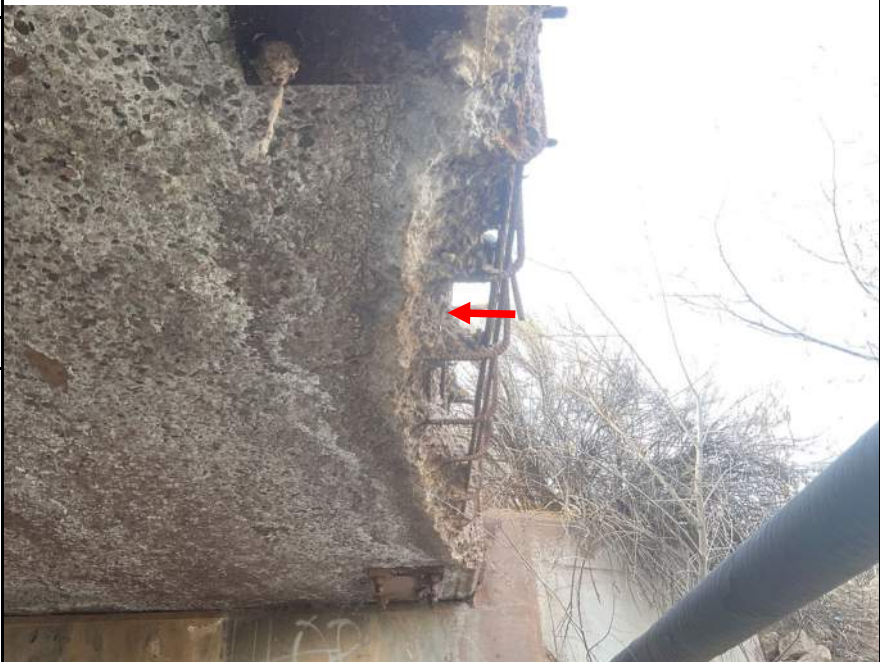
Photo No.	14

Location	West Edge of Deck Near Midspan (looking Up and South)	
Description	Typical Condition of Edge of Deck Soffit

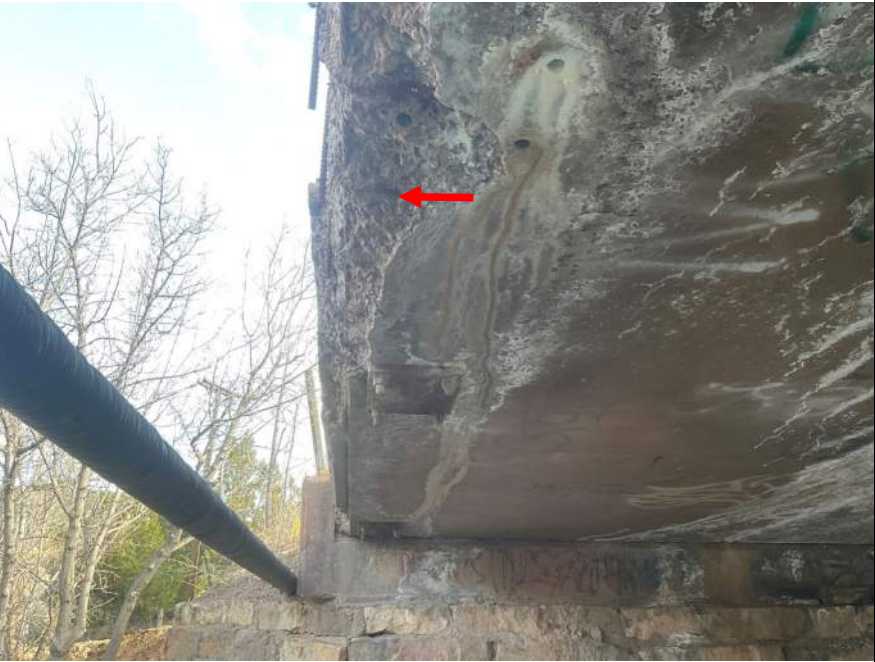
Photo No.	15

Location	West Edge of Deck Near Midspan (looking Up and North)	
Description	Typical Condition of Edge of Deck Soffit

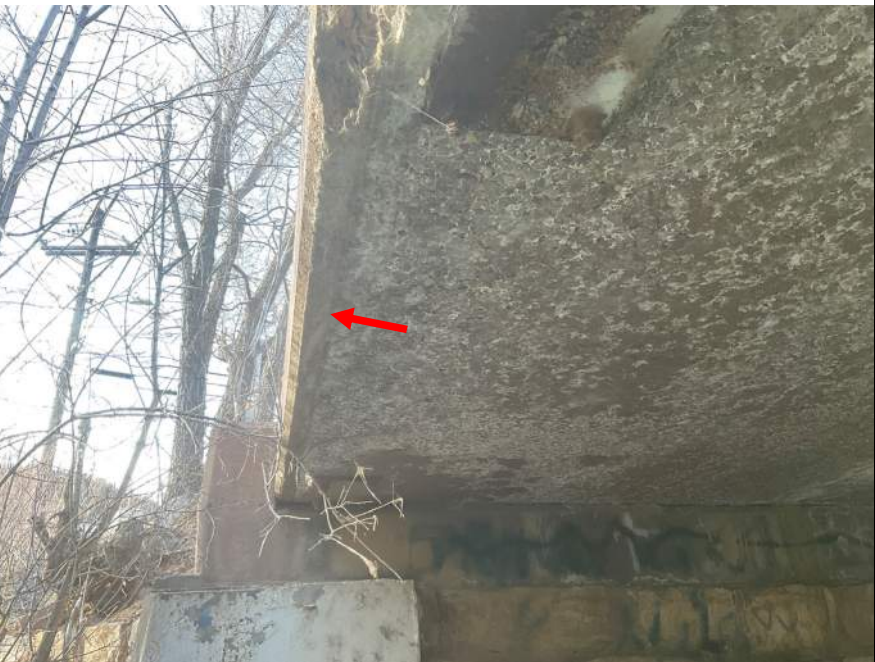
Photo No.	16

Location	East Edge of Deck Near Midspan (looking Up and South)	
Description	Typical Condition of Edge of Deck Soffit

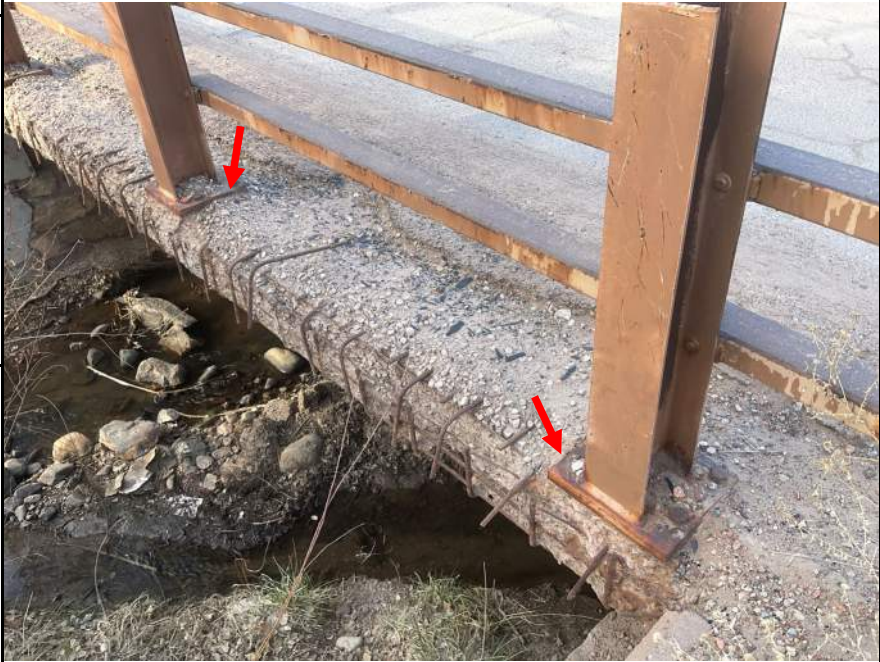
Photo No.	17

Location	Northeast Corner of Bridge (looking Down and Southwest)	
Description	Typical Condition of Railing Base Plate

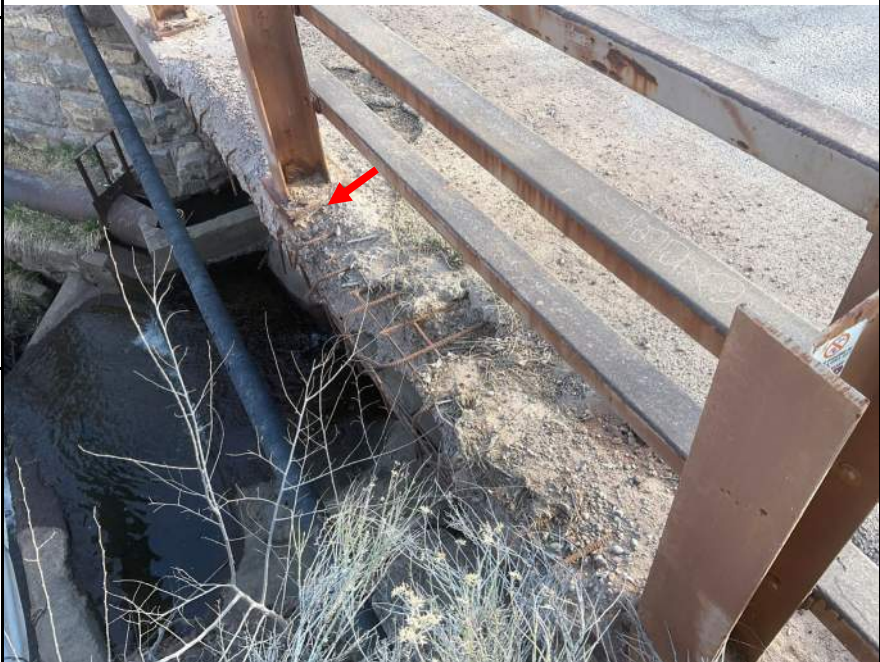
Photo No.	18

Location	Southwest Corner of Bridge (looking Down and Northeast)	
Description	Typical Condition of Railing Base Plate

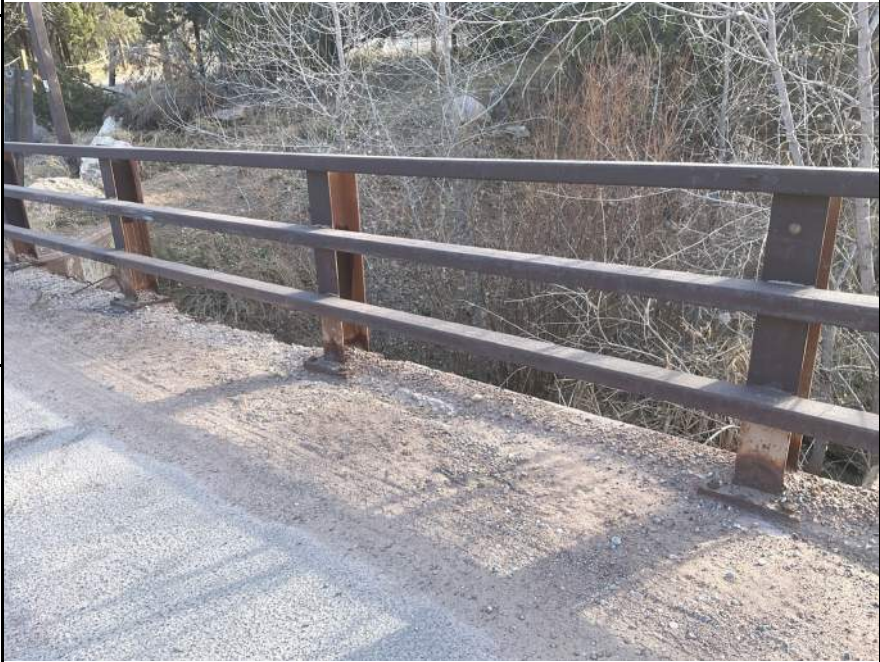
Photo No.	19

Location	Bridge Deck (looking Northeast)	
Description	Typical Condition of Railing

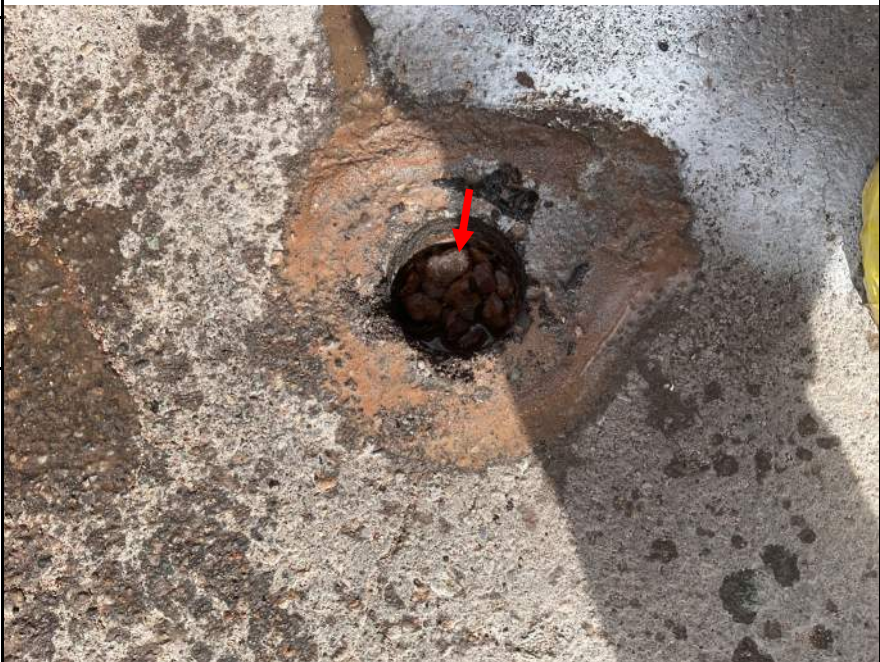
Photo No.	24

In addition to the observations noted above, the cores revealed that the condition of the concrete of the exterior girders is poor. The cores attempted at the southwest corner of the bridge (west girder near the south abutment, cores #1 & 2) were inadequate due to the concrete spalling and crumbling during drilling (see **Photos 24 & 29**). A 5" long core (core #3) was obtained near midspan of the center girder (see **Photo 25**). The concrete of this core appears to be in fair condition; however, Terracon will verify the concrete strength at location #3 with further testing of this core. The concrete core taken near the midspan of the west girder and west EOD (core #4) showed delamination in the concrete up to a depth of approximately 8" into the girder (see **Photo 26**). The core at the northeast corner (core #5) also exhibited poor concrete, as the concrete spalled and crumbled during drilling. This location, however, showed that for approximately 2" of the concrete at the bottom of the 11" core was intact (see **Photo 28**).

Location	Southwest Corner of Bridge, Coring #1 (looking Down and West)	
Description	Condition of Concrete After Coring, Concrete Observed to Not Hold Together to Obtain a Core

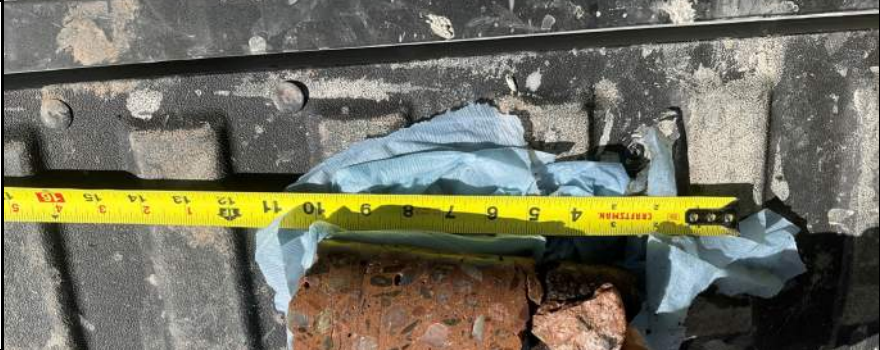
Photo No.	25	
Location	N/A

Description	Core #3 from Center of Bridge at Center Girder

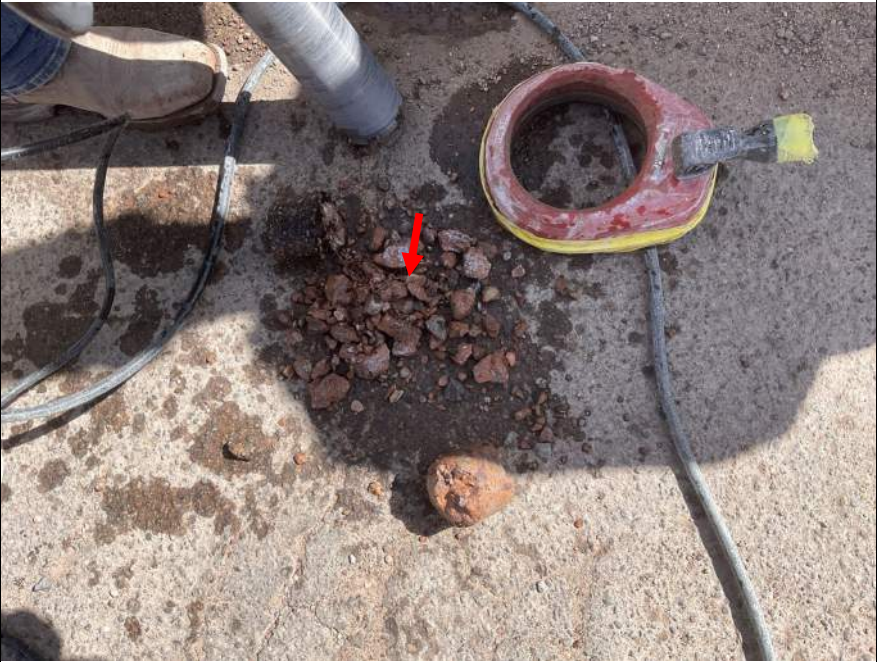
Photo No.	27	
Location	Northeast Corner of Bridge (looking Down and East)

Description	Condition of Concrete After Coring #5, Concrete Observed to Not Hold Together to Obtain a Core

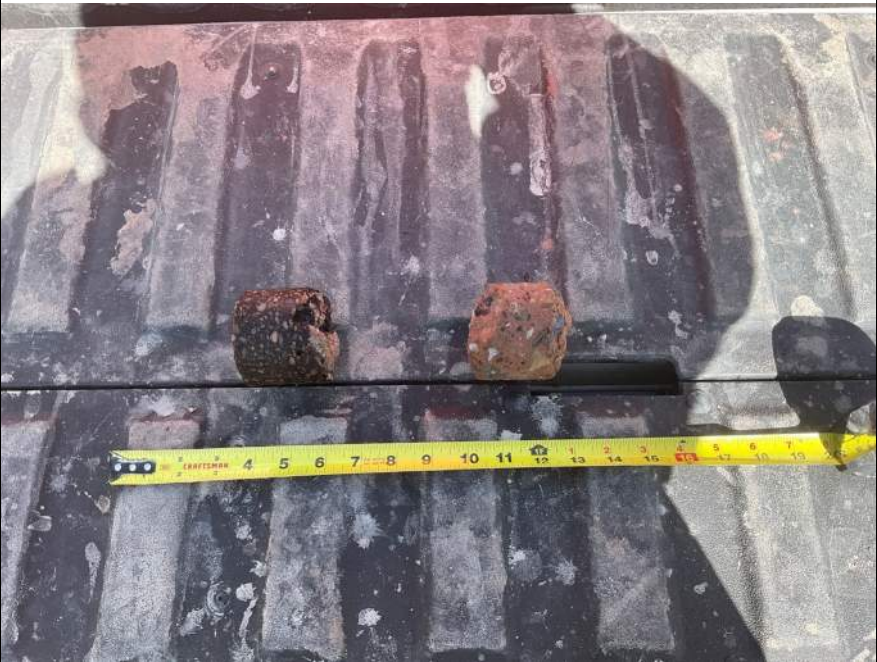
Photo No.	28	
Location	N/A

Description	Core #4 from Northeast Corner of Bridge

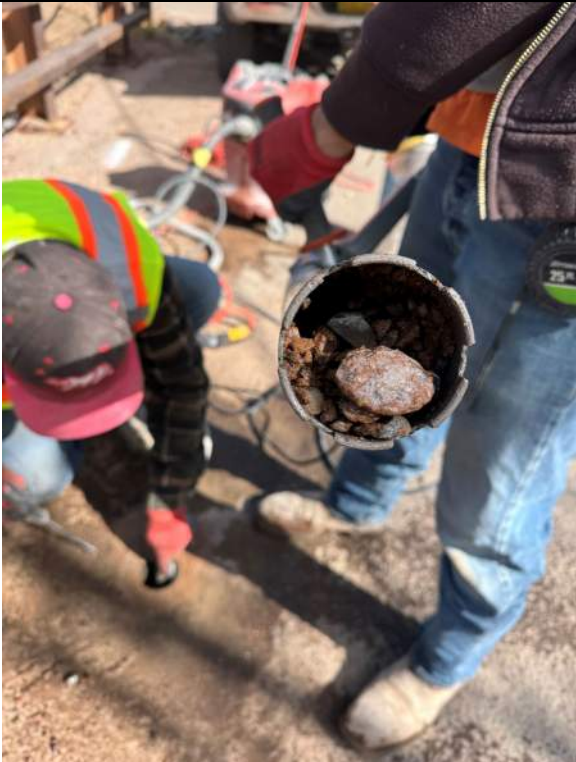
Photo No.	29

Location	Southwest Corner of Bridge (looking North)	
Description	Core #1 Concrete in Drill
