# City of Santa Fe, New Mexico

## Historic Inspection Report

**ITEM & ISSUE**  
248 Rodriguez

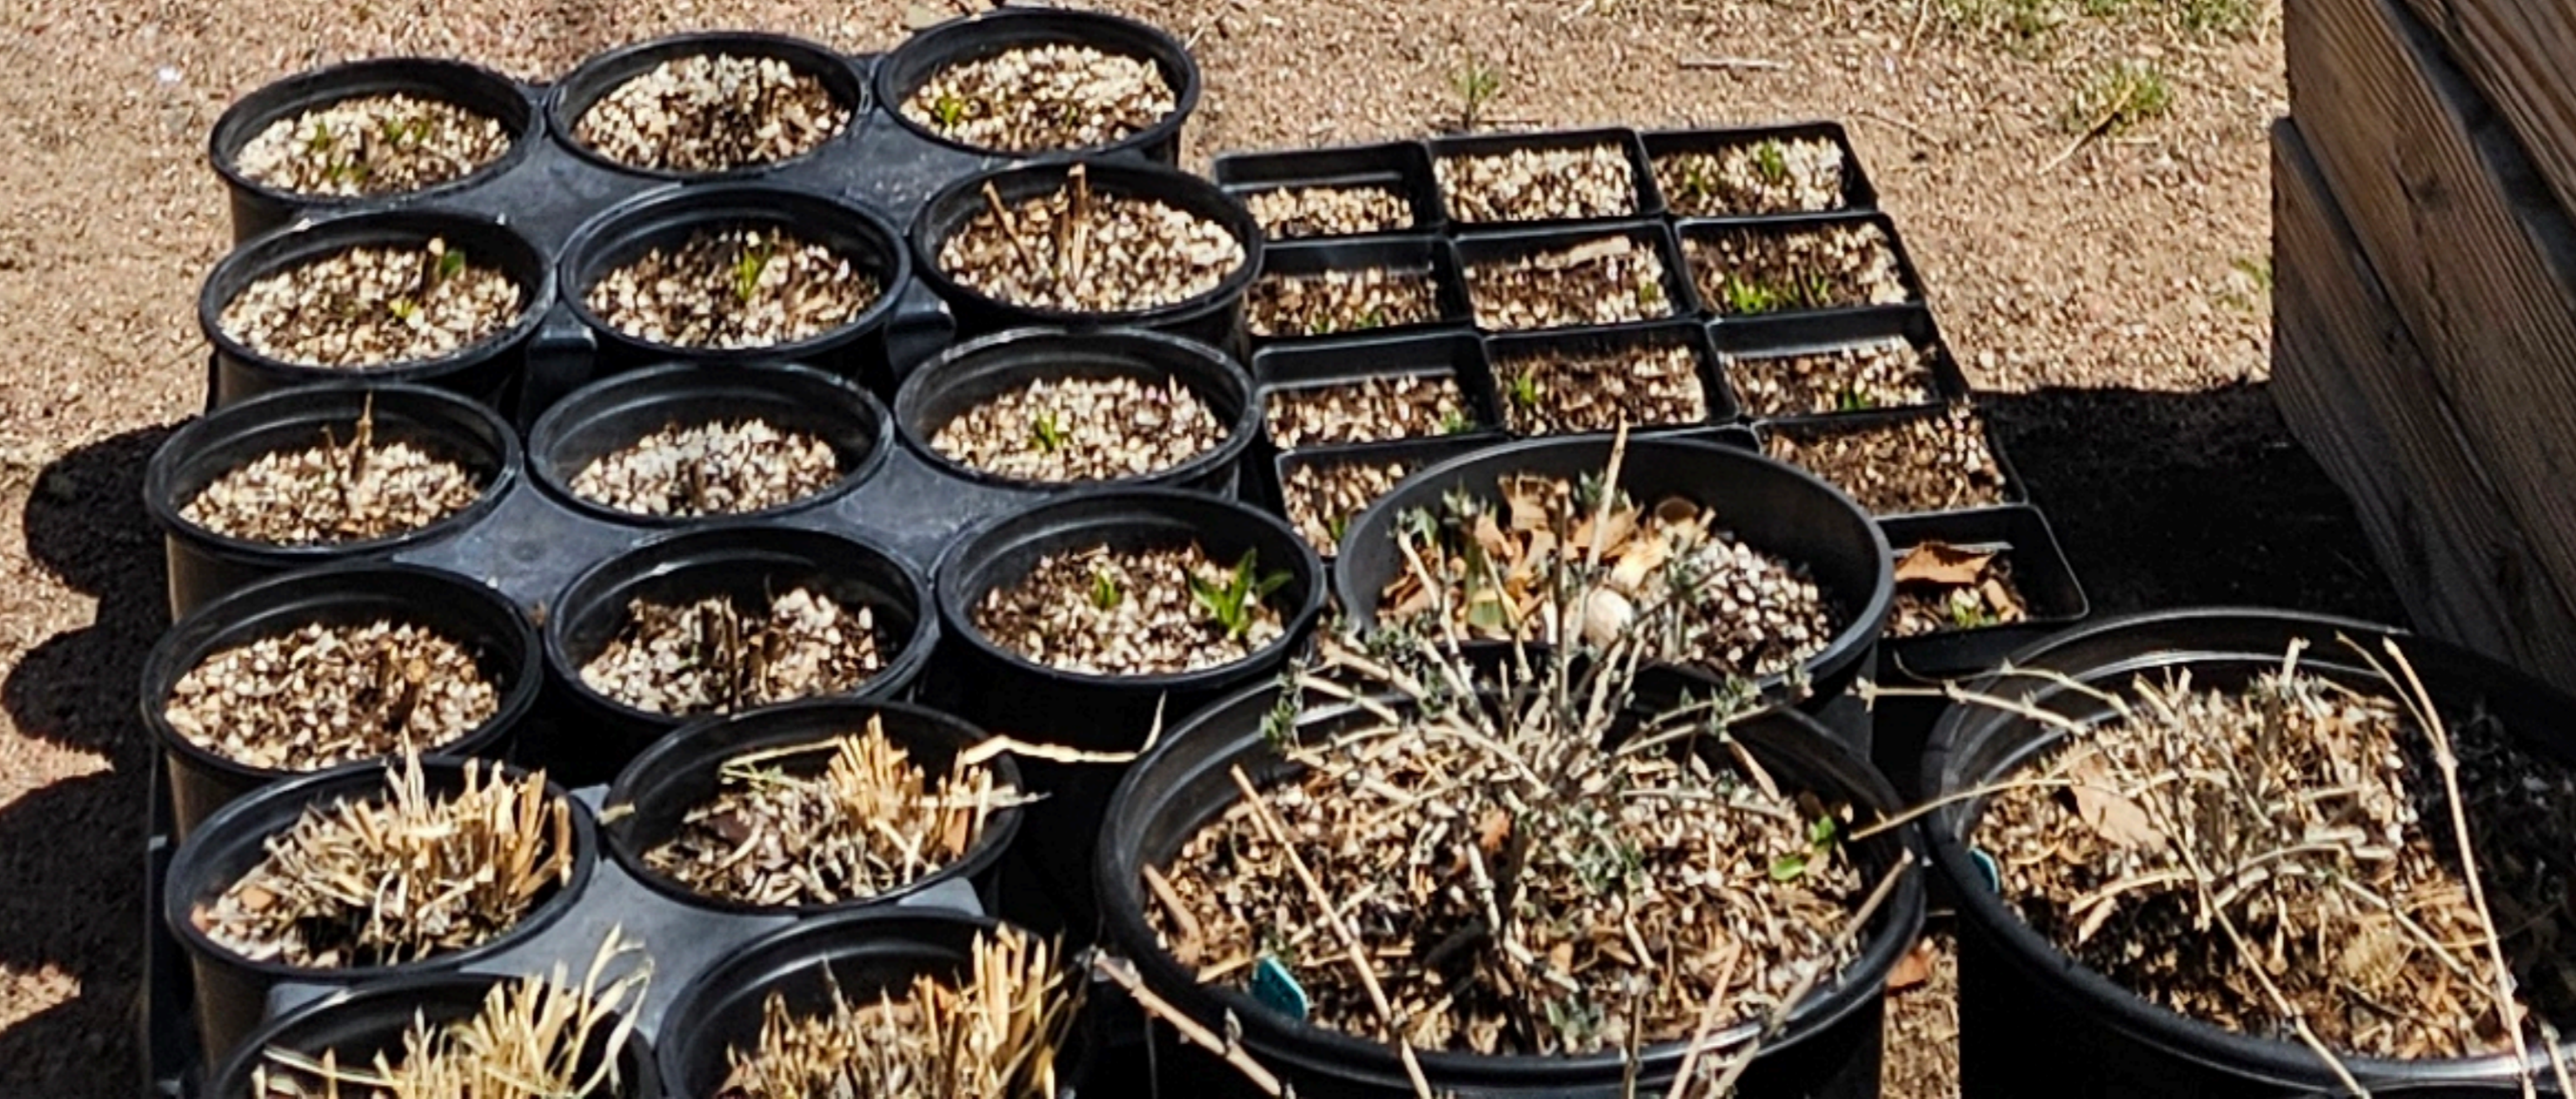
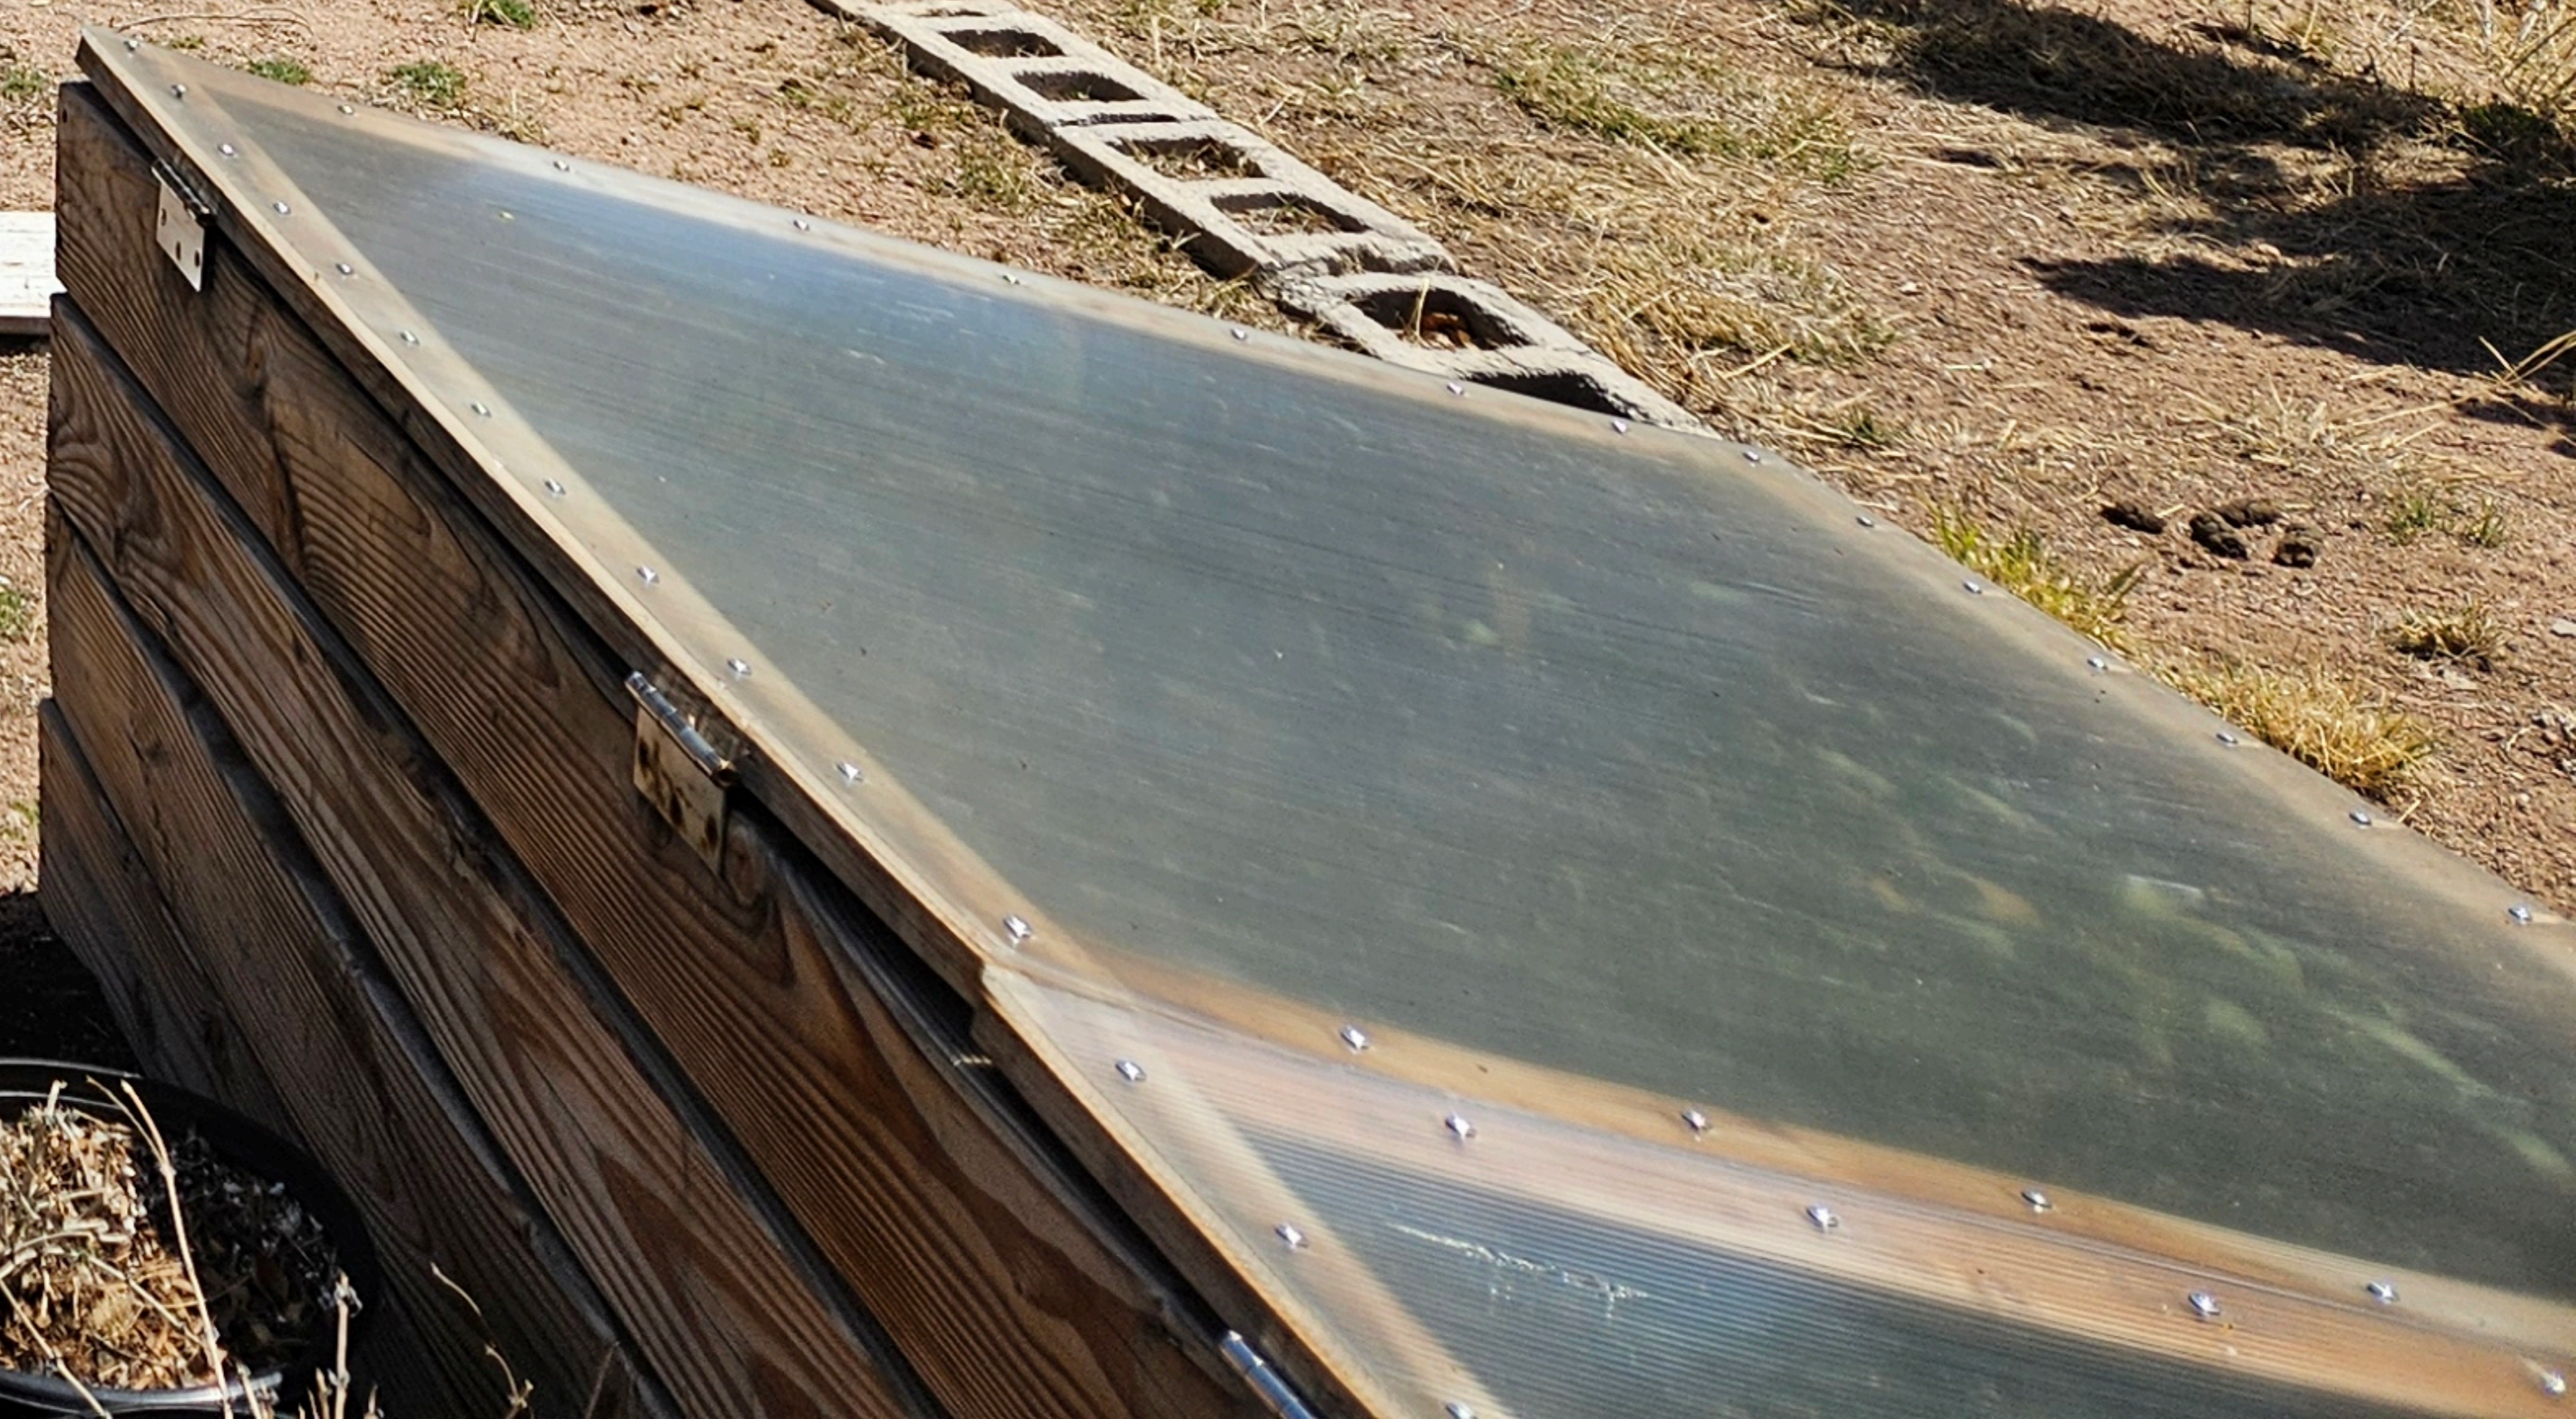
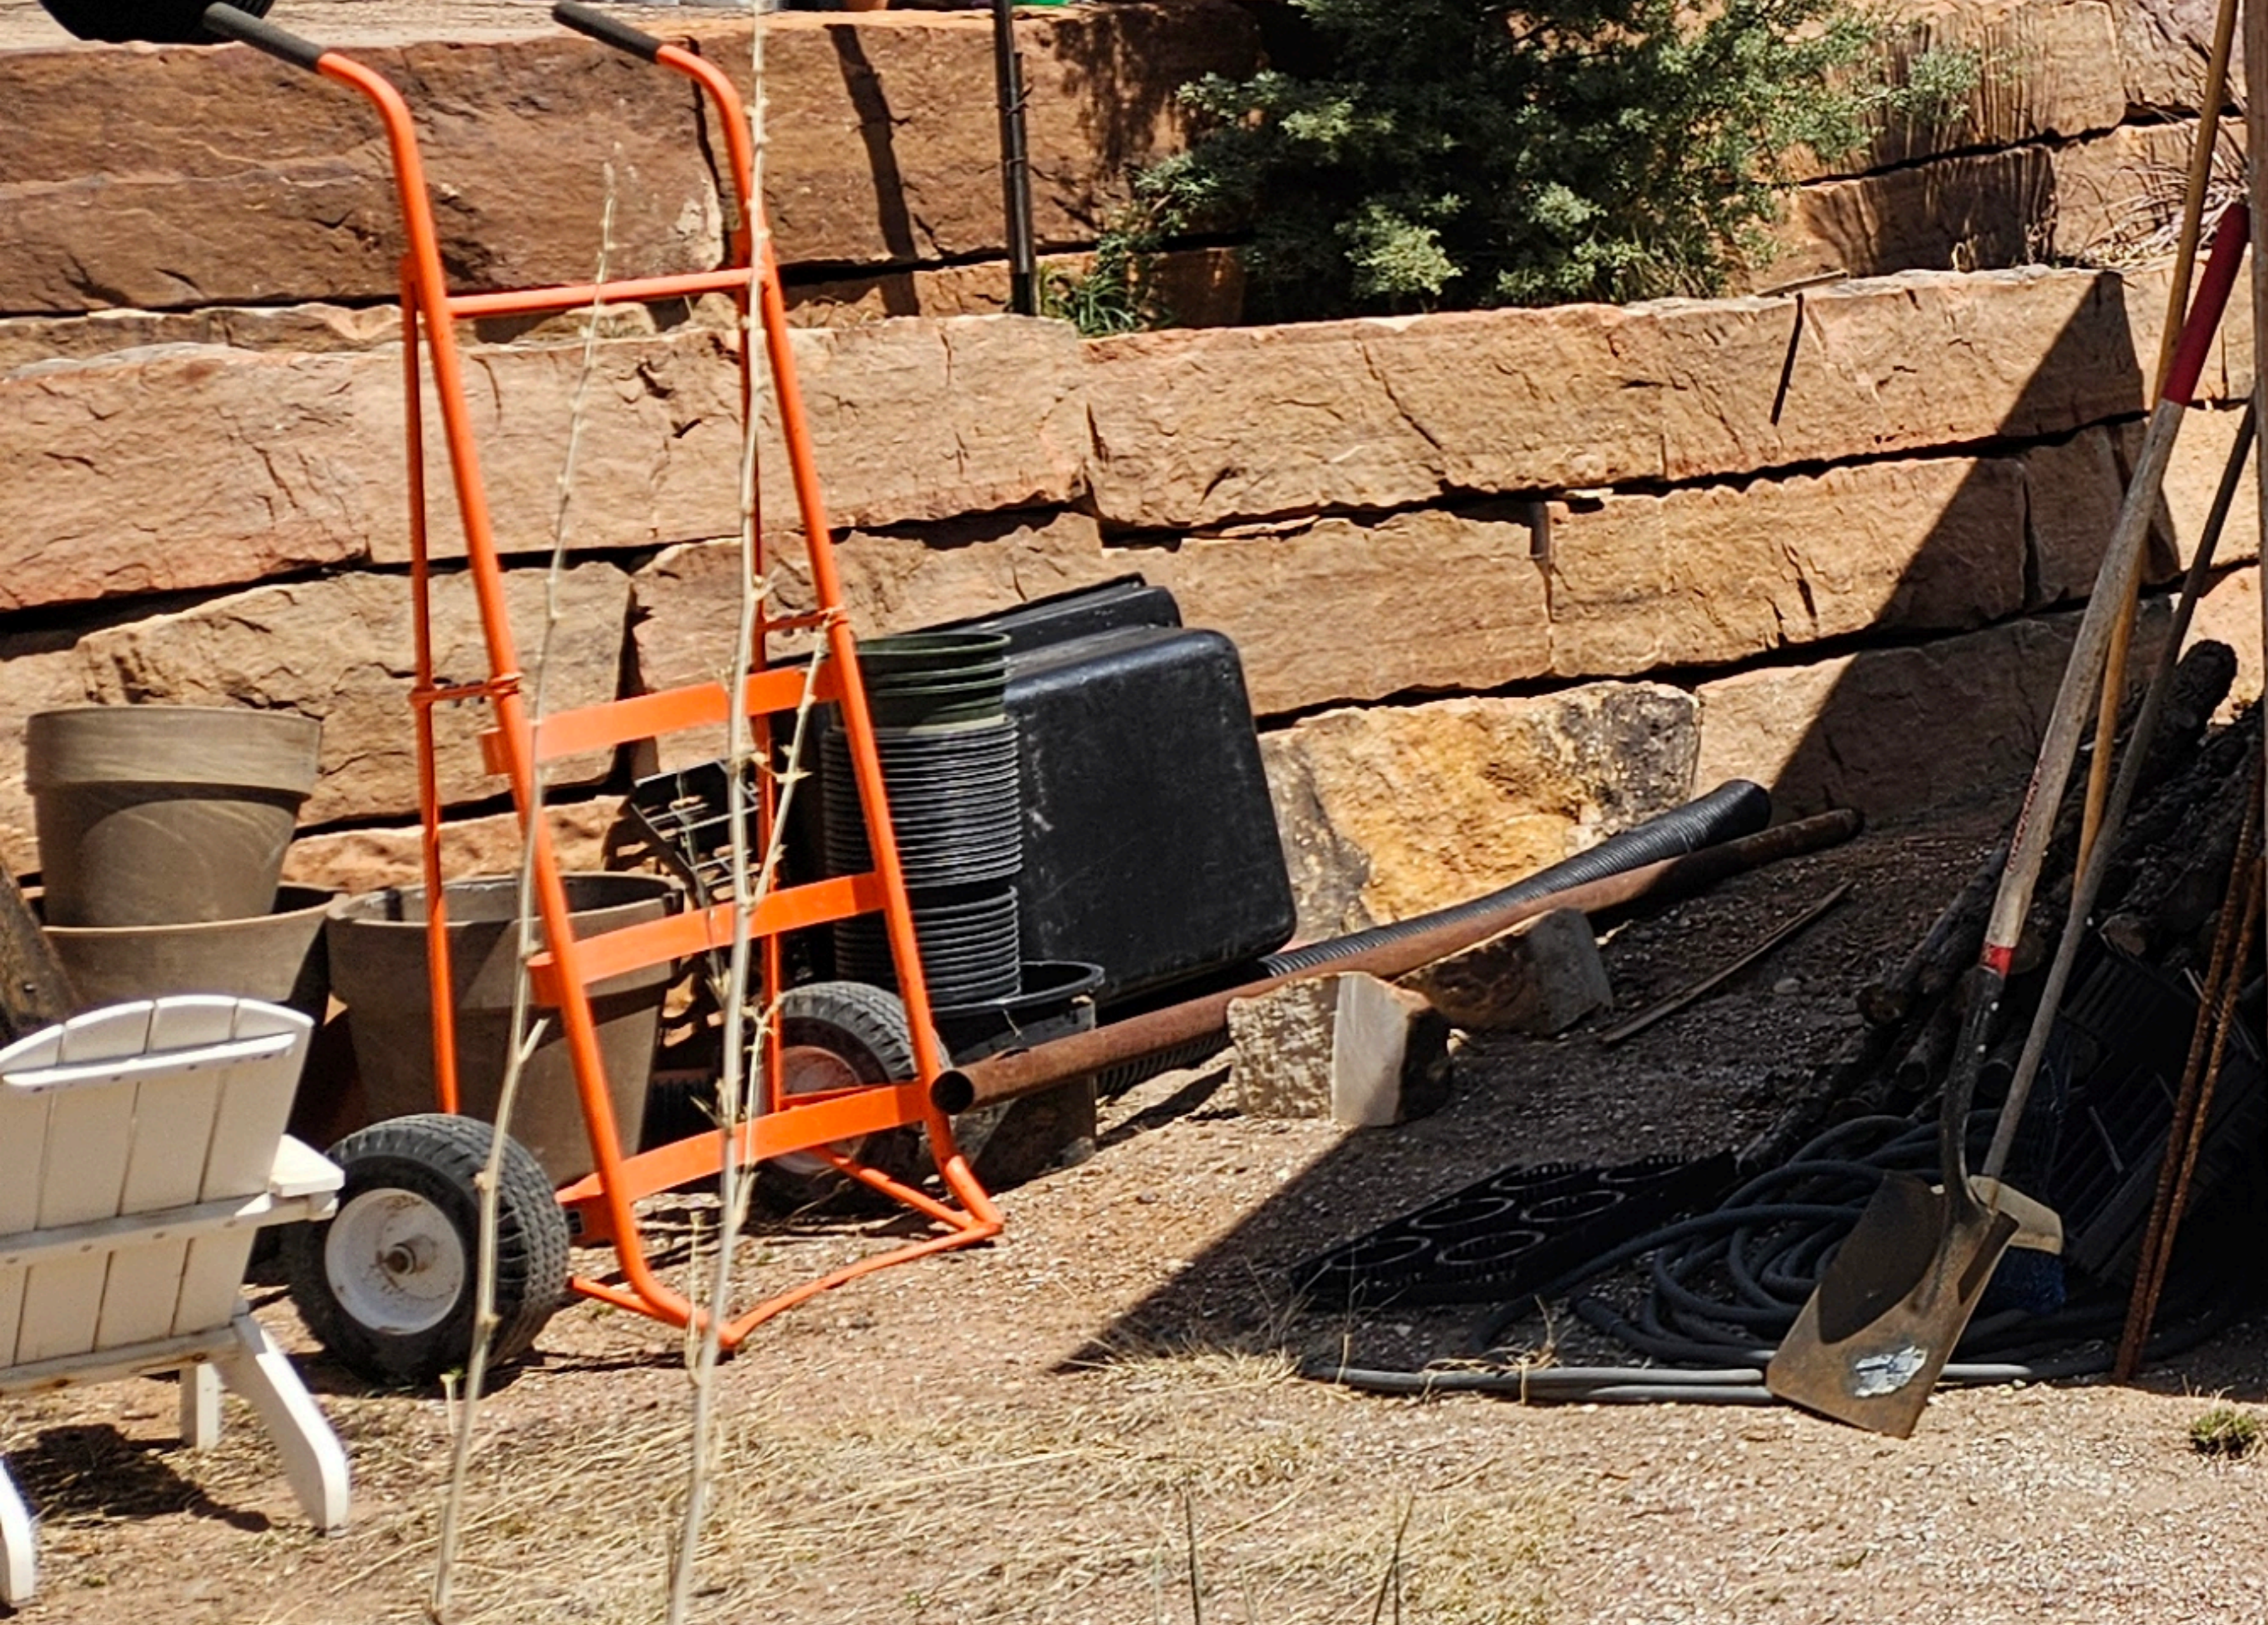
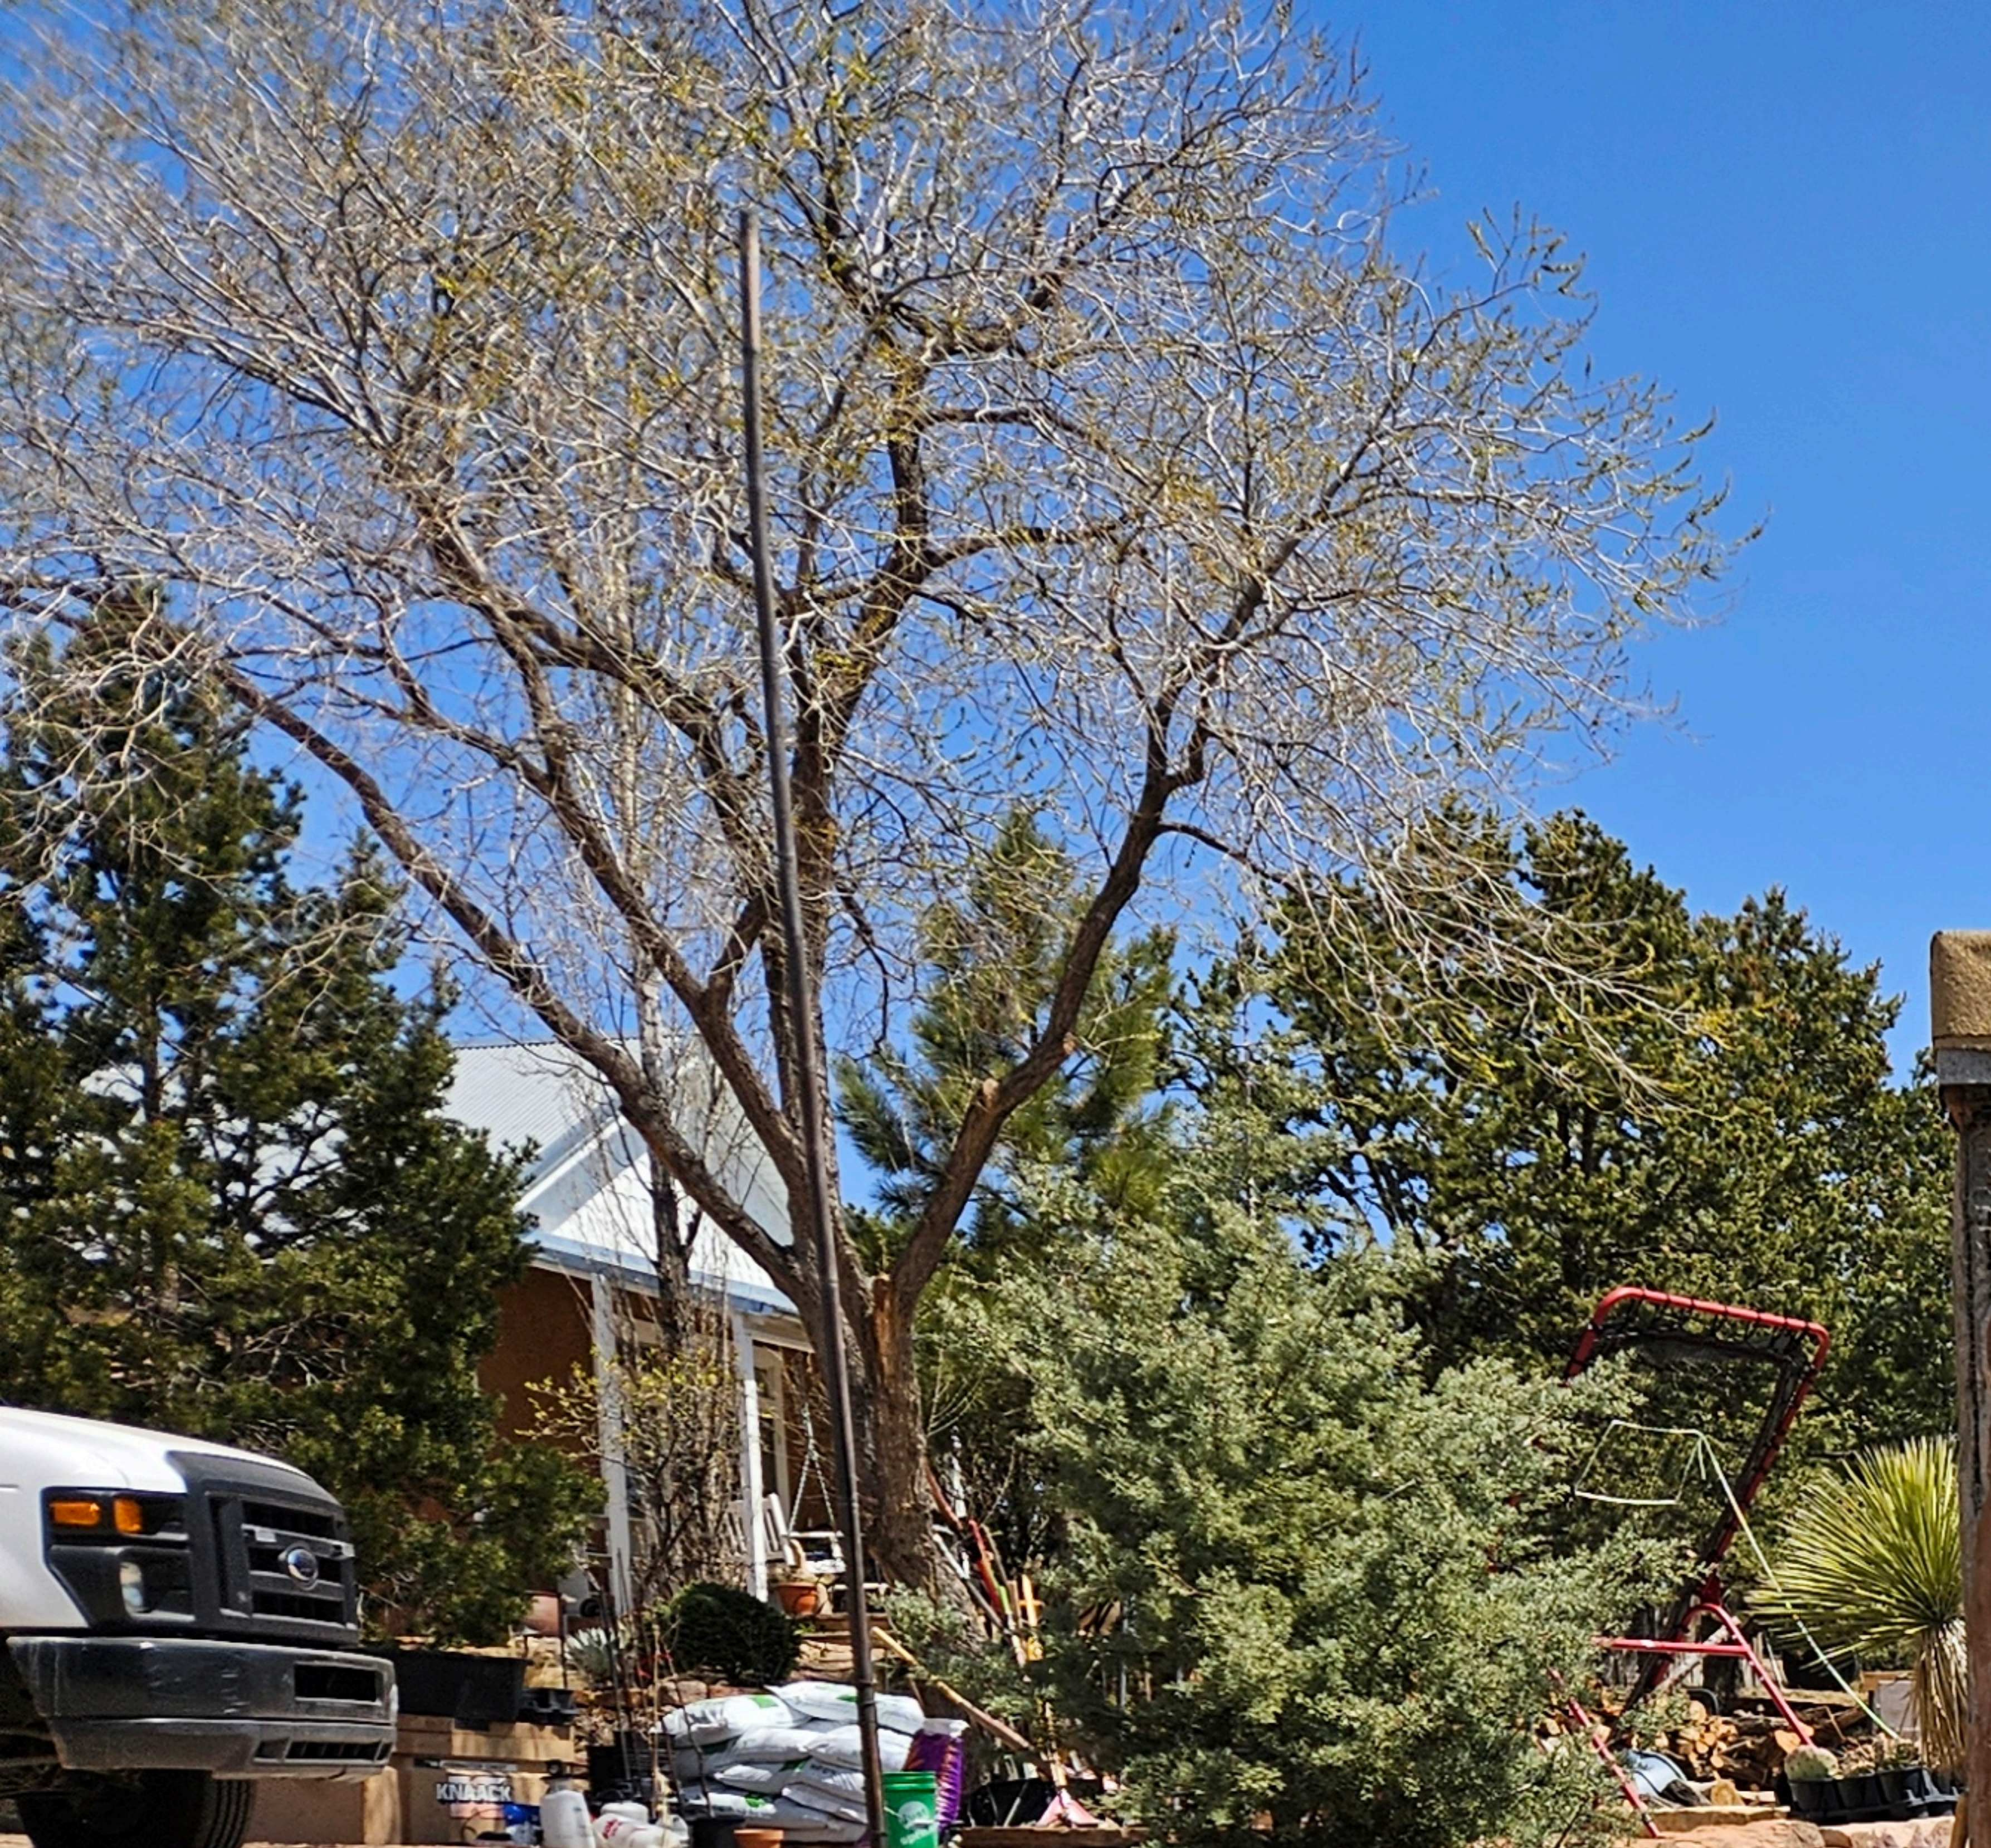
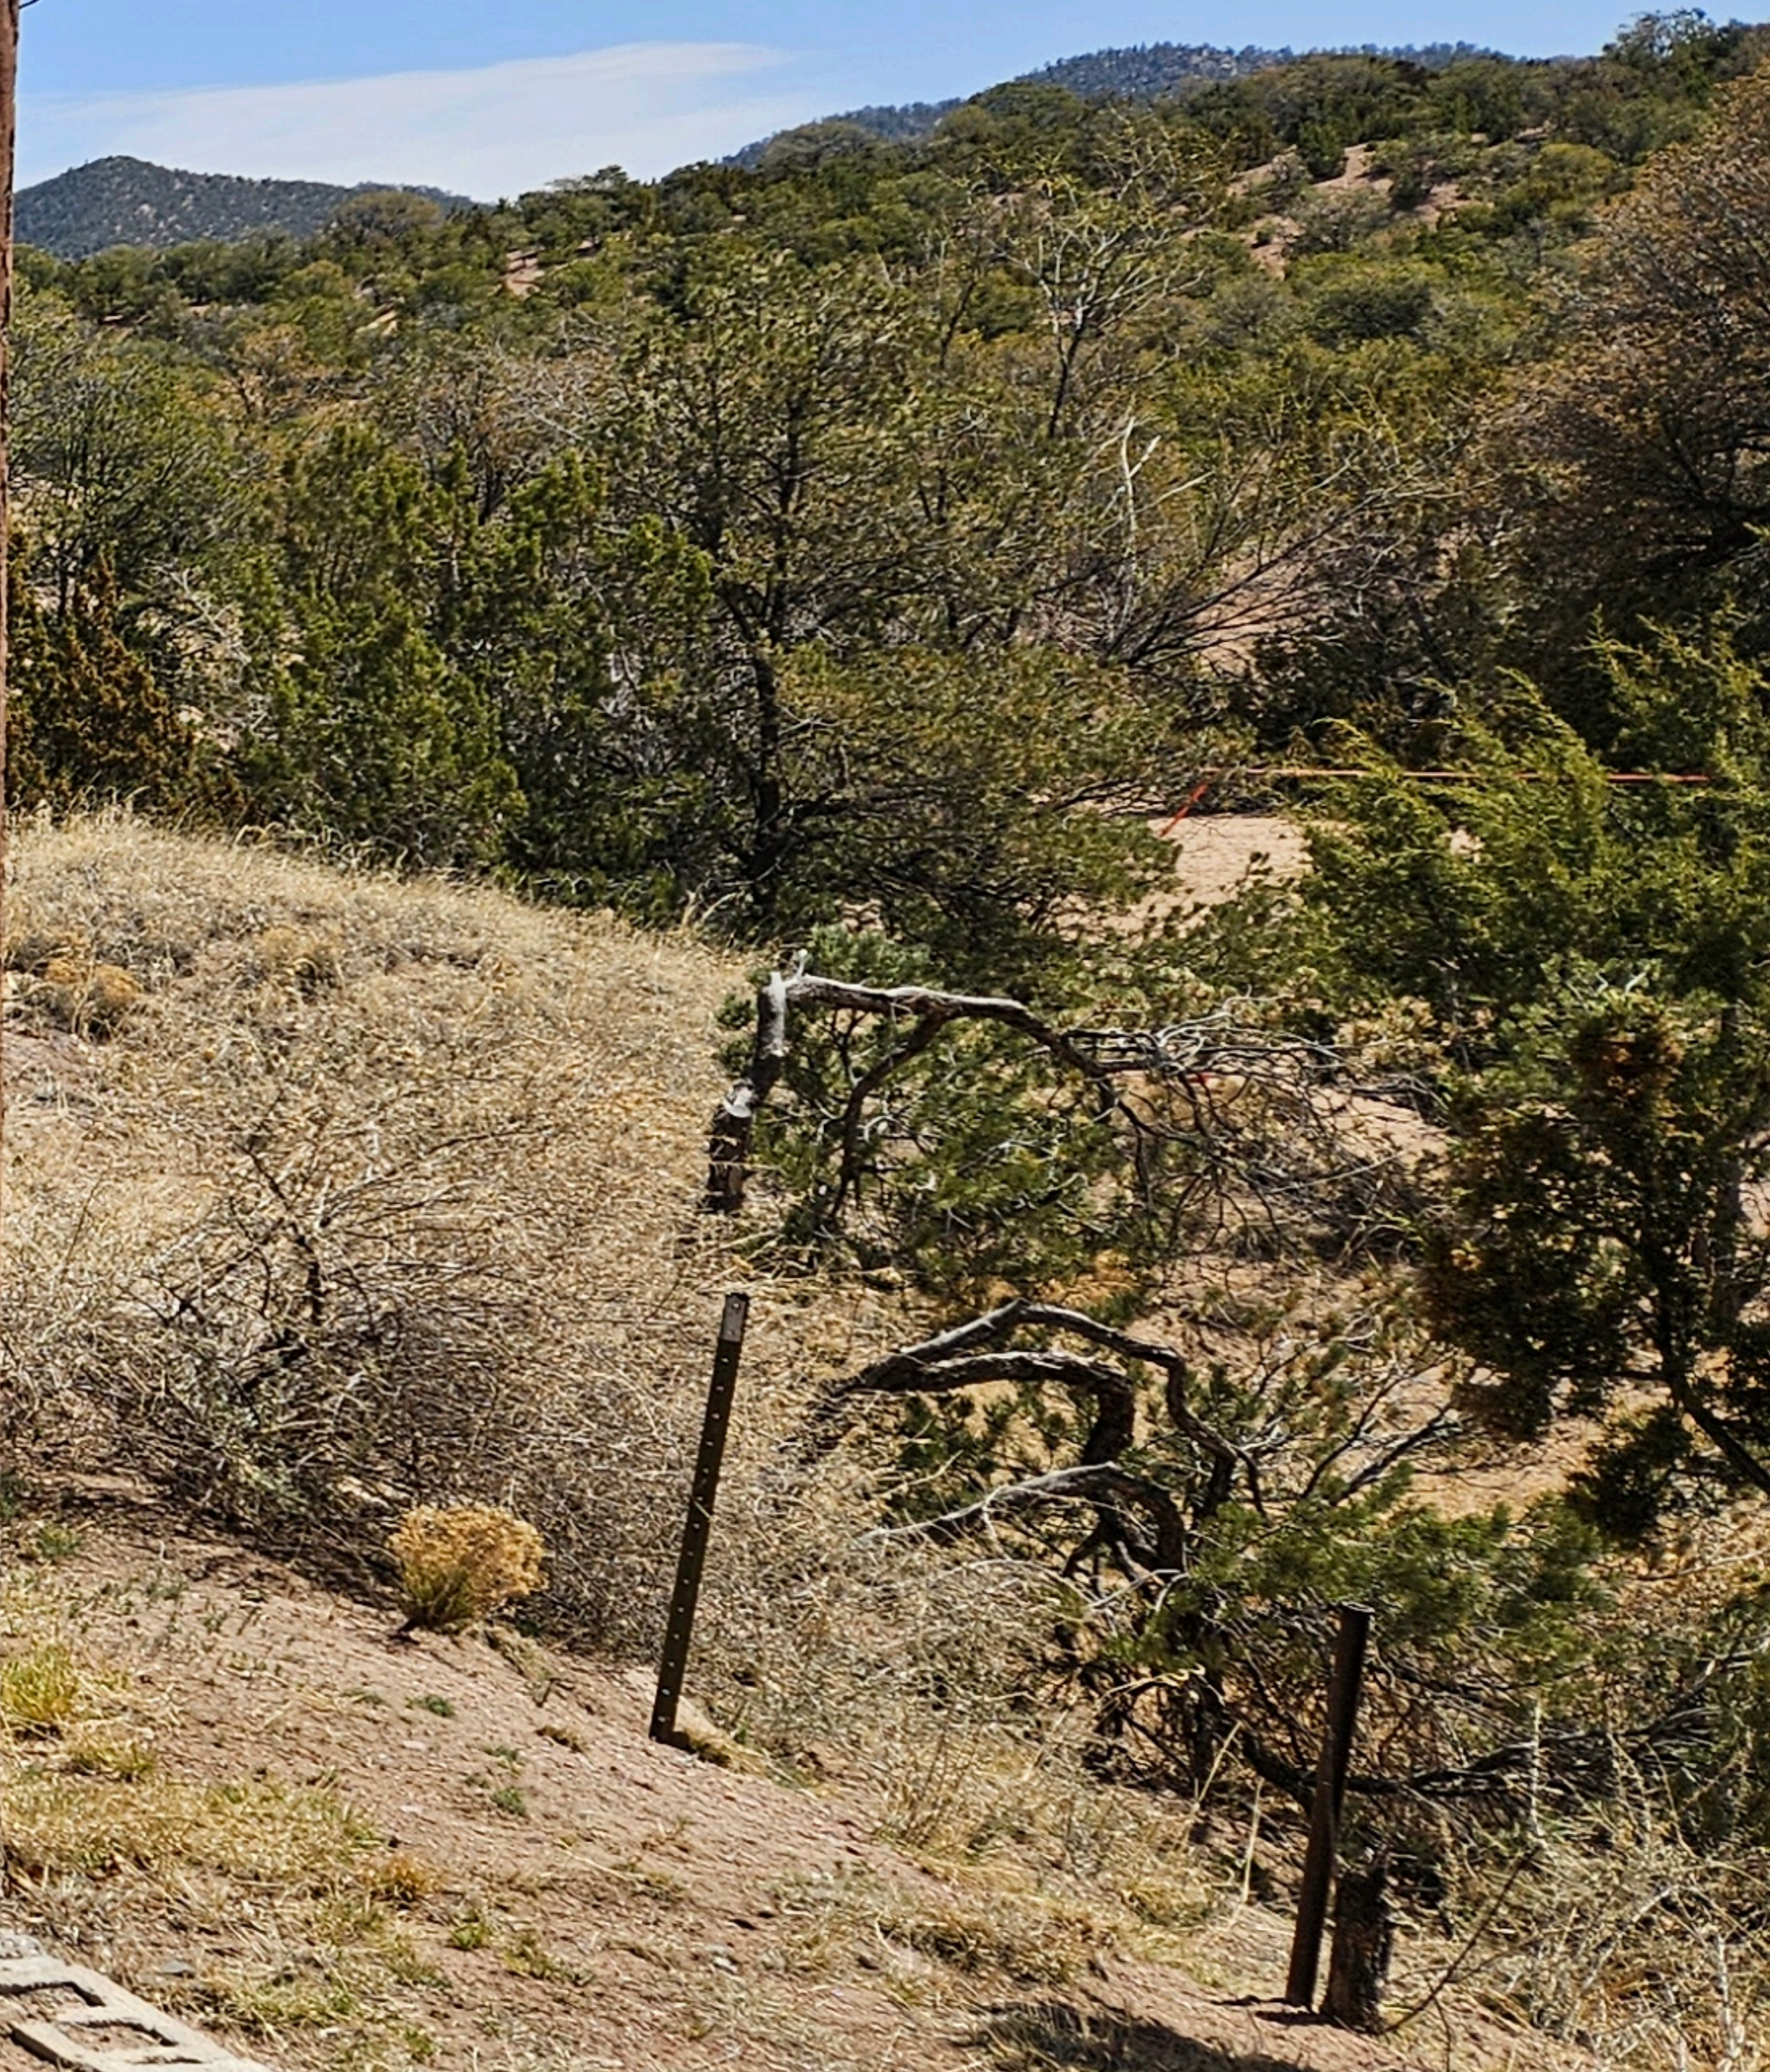
An inspection was carried out on April 24, 2025, at the above-mentioned address. The shed is built out of wood frame construction with exterior stucco. The stucco is deteriorating and coming apart from the structure at the upper area, signs of water leaking into the structure from the transition of stucco to roof, on the south side of the structure meter was replaced at some time and signs of electrical short in the wall caused some minor damage to the structure the old locations of meter were not properly repaired. Roofing system is a torch down material over existing roof covering improper flashing on the edges of the roof.

The overall condition of the structure is in poor and in disrepair
