**Historic Cultural Properties Inventory Survey
907 Don Miguel Place
Santa Fe, NM**

051600223 (H1869)

**Santa Fe Planning Division
Historic Design Review Board**

August 15, 2006

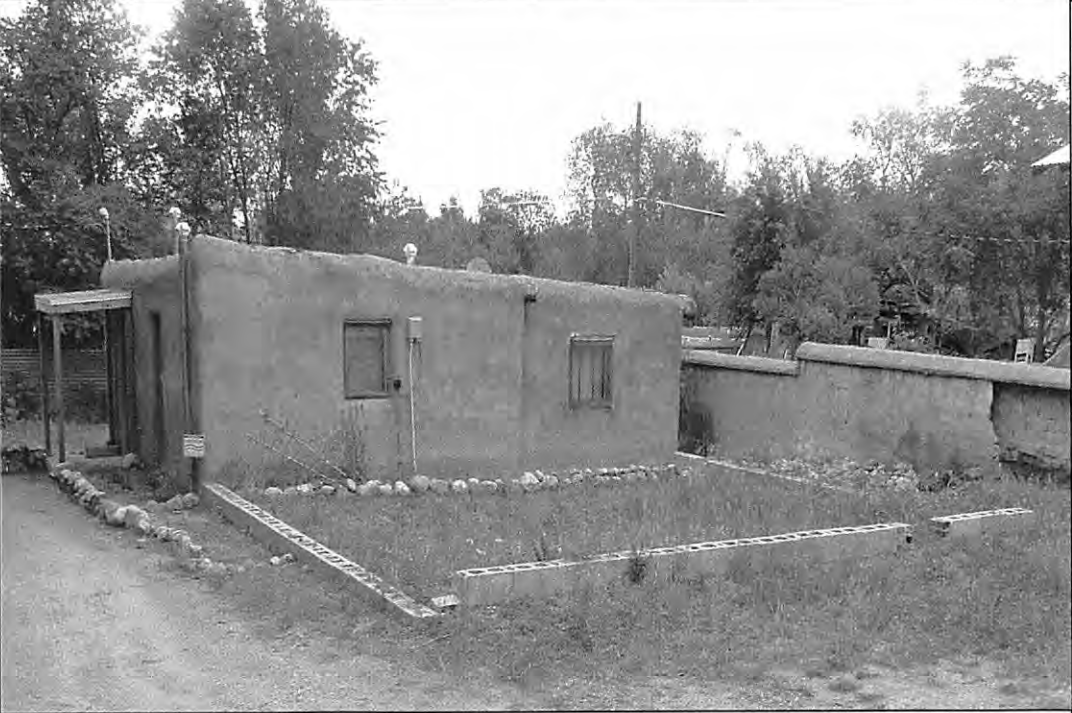
8. Name of Project: Lisa Ortiz Family		
9. UTM NAD 27 Zone: 13S Easting: 416534 Northing: 3948275 Elevation: 7,153 ft. amsl		
		1. View north of south elevation with stem wall alteration (ArcCom 07-20-06).

- a. south elevation cinder block stem wall on south elevation believed to be post-1983 based on plan sketch on HCPI for of 06-16-83;
- b. west elevation front door portal believed to be post-1983 based on plan sketch on HCPI for of 06-16-83;
- c. west elevation metal casement window replacement (date not known);
- d. south elevation window removal without replacement (plaster covered; date not known).

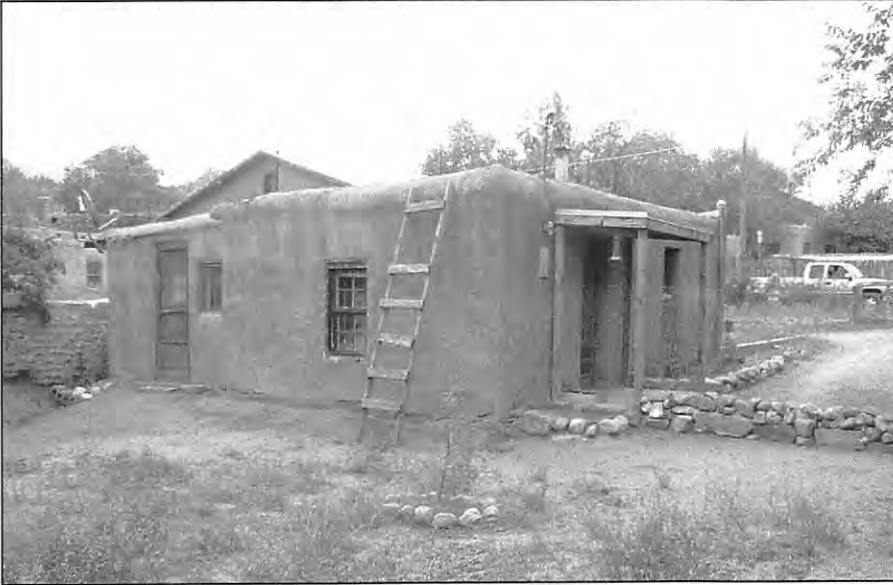
2. View south of north (left) and west (right) elevation. Frame portal on west elevation is a post-1958 alteration (ArcCom 07-20-06).

#2. Portal (4 x 4 feet) on concrete pad on front door, west elevation. Date: pre--1983. Known Estimated Source: HCPI survey for of 06-16-1983 does not indicate stem wall. Aerial photo of 1958 does not indicate stem wall.

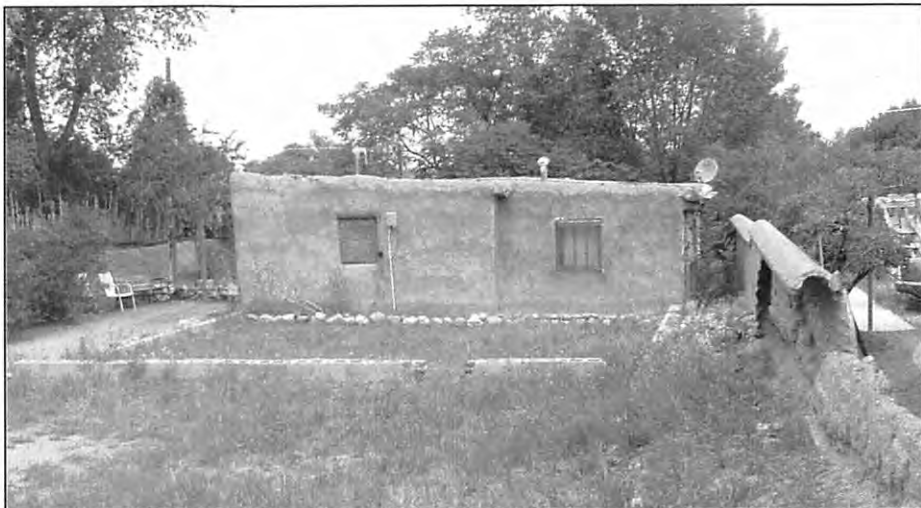
#4. south elevation window removal without replacement (plaster covered). Date: Not known Known Estimated Source:

3. View north of south elevation. One window was removed and plastered over at an unknown date. Shadow of plastered window is visible between two existing windows on south elevation (ArcCom 07-20-06).

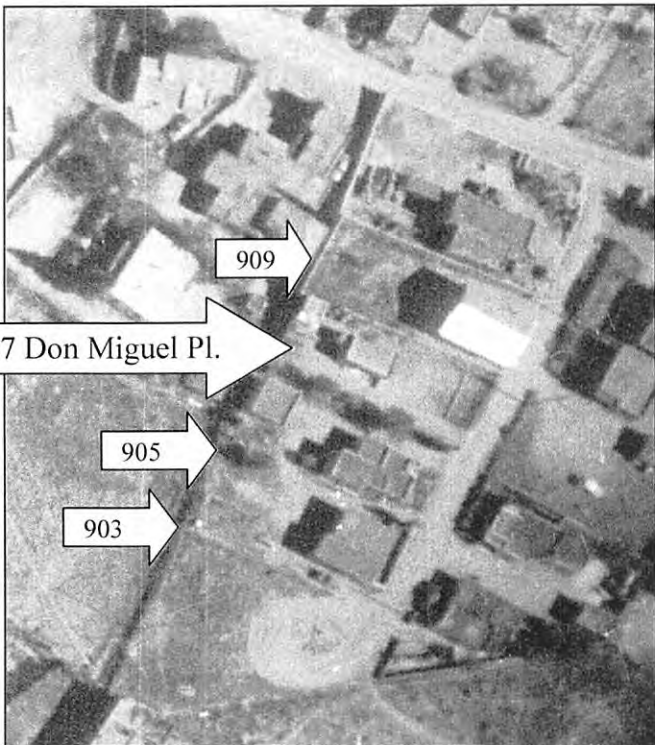
1958 NMDOT Aerial Photograph shows the absence of concrete block stem wall alteration (NM DOT 11-10-58).

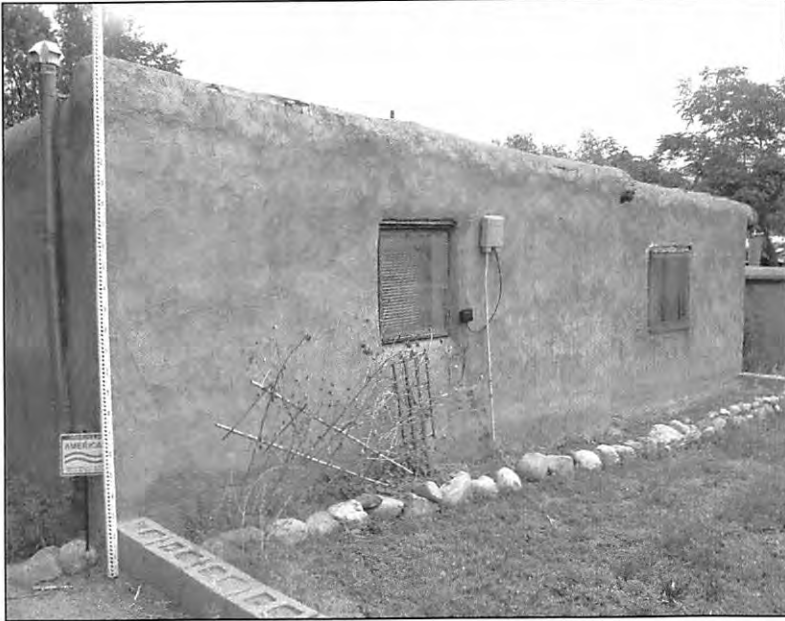
#1. Concrete block stem wall (25.6 x 25.8 feet) Date: pre-1983. Known Estimated Source: HCPI survey for of 06-16-1983 does not indicate stem wall. Aerial photo of 1958 does not indicate stem wall.

4. View northeast of south elevation. Concrete block stem wall is a structural, post-1958 alteration . Elevation at southwest corner measures 2.5 meters (8.2 feet), (ArcCom 07-20-06).

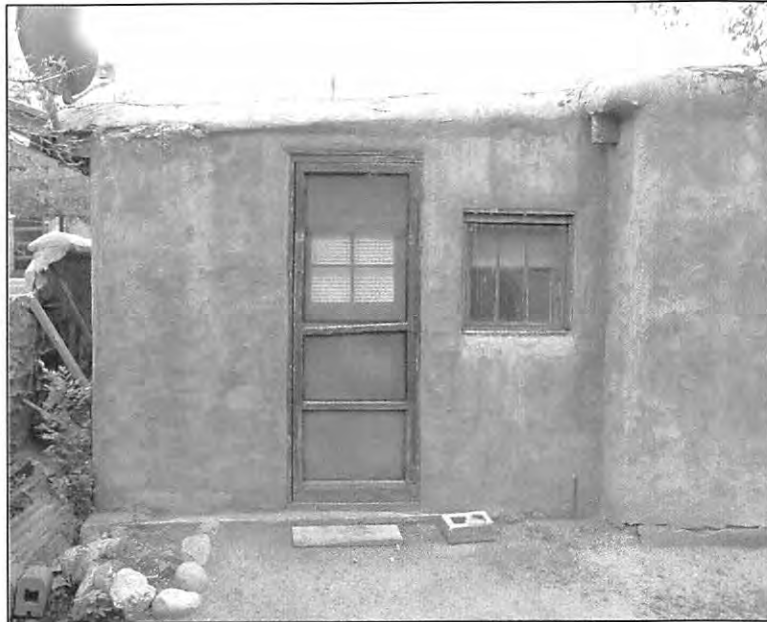
5. View south of northeast half of north elevation. Door and window appear to be unaltered (ArcCom 07-20-06).

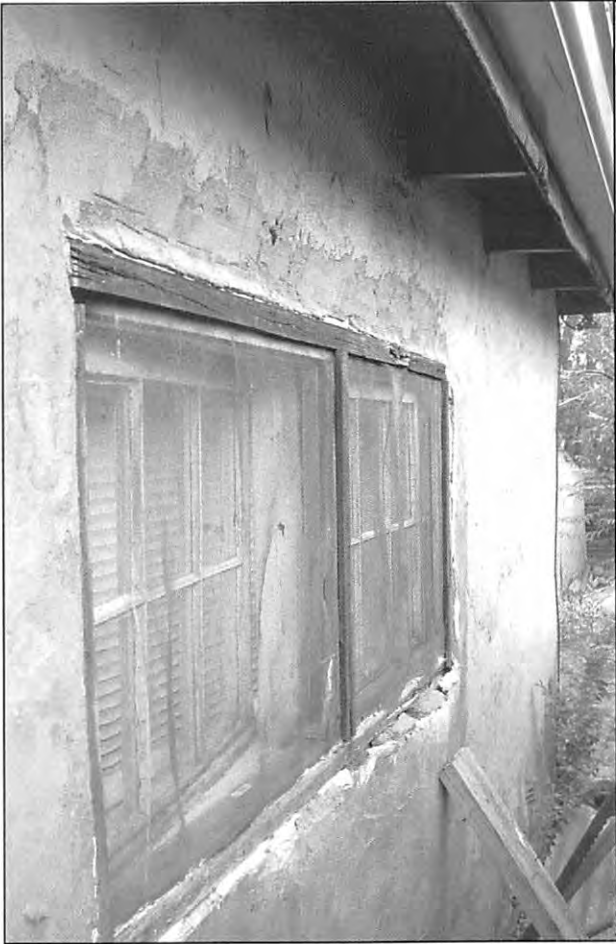
6. View north of portion of east elevation. Windows appear unaltered. Plastered adobe is in poor condition (ArcCom 07-20-06).

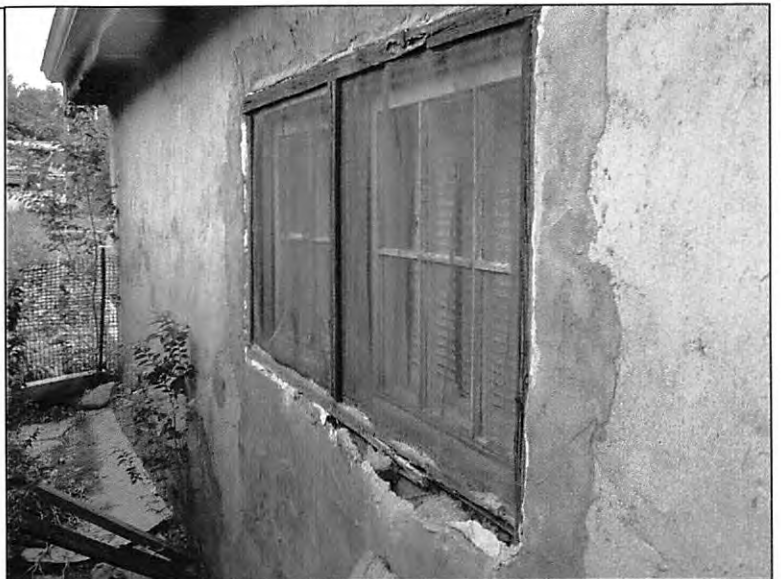
7. View south of portion of east elevation (same windows as in previous photo 6). Windows appear unaltered. Plastered adobe is in poor condition (ArcCom 07-20-06).

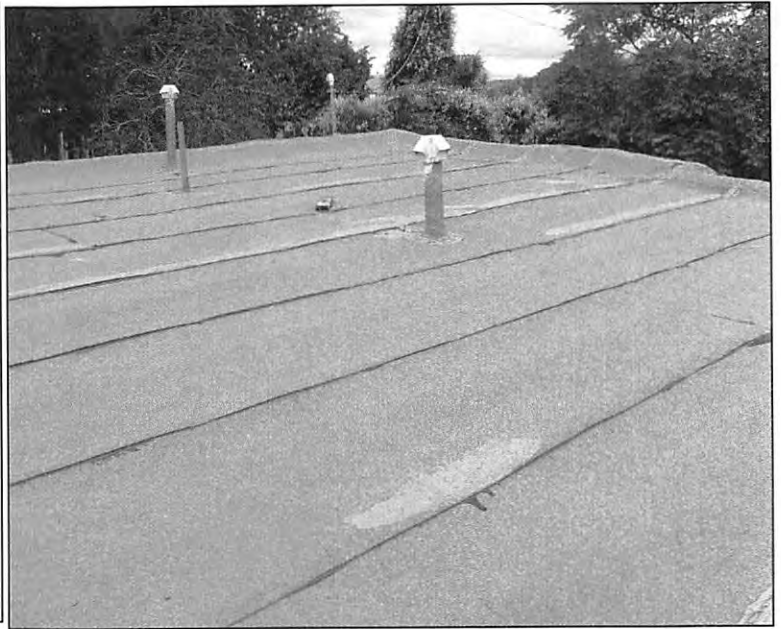
8. View northwest of rolled composition roof (ArcCom 07-20-06).

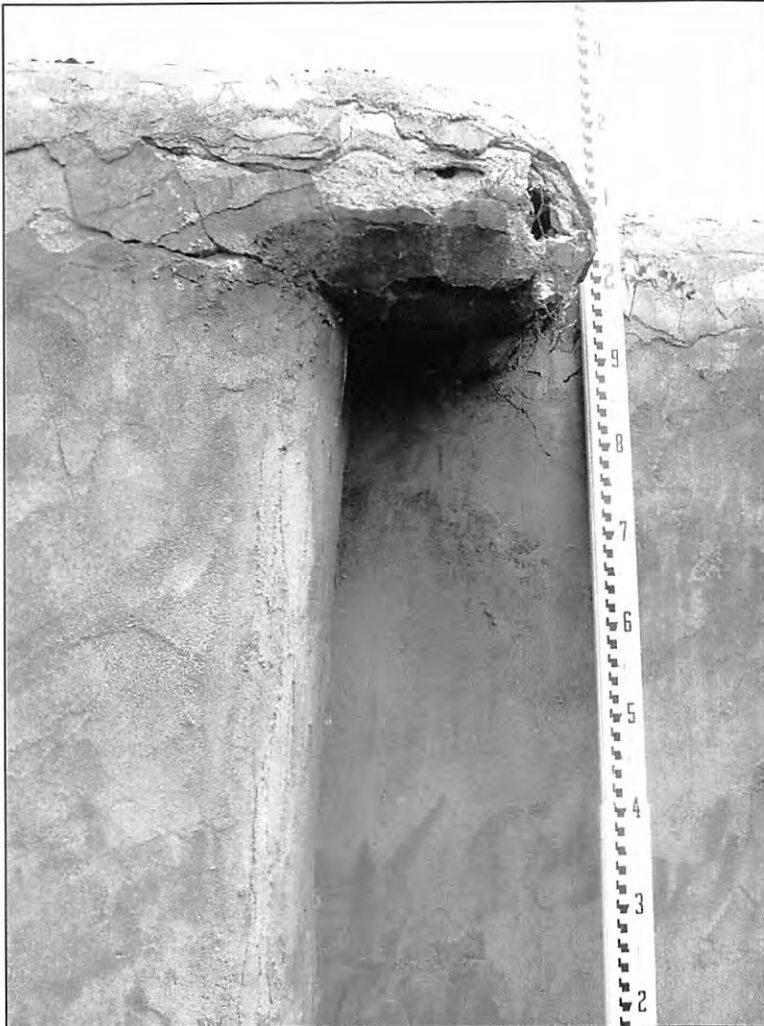
9. View north of roof-wall joint indicates adobe, mesh wire, and plaster construction. A near mid-point on the south elevation, rood measures 2.1 meters (6 feet 7 inches), (ArcCom 07-20-06).
