Re: case # 2025-010350-HDRB: property at 907 Don Miguel Place,
Downtown and Eastside H.D.

907 Don Miguel Pl

Window Condition Assessment

Prepared by:
Scott Ernst
12/9/2024

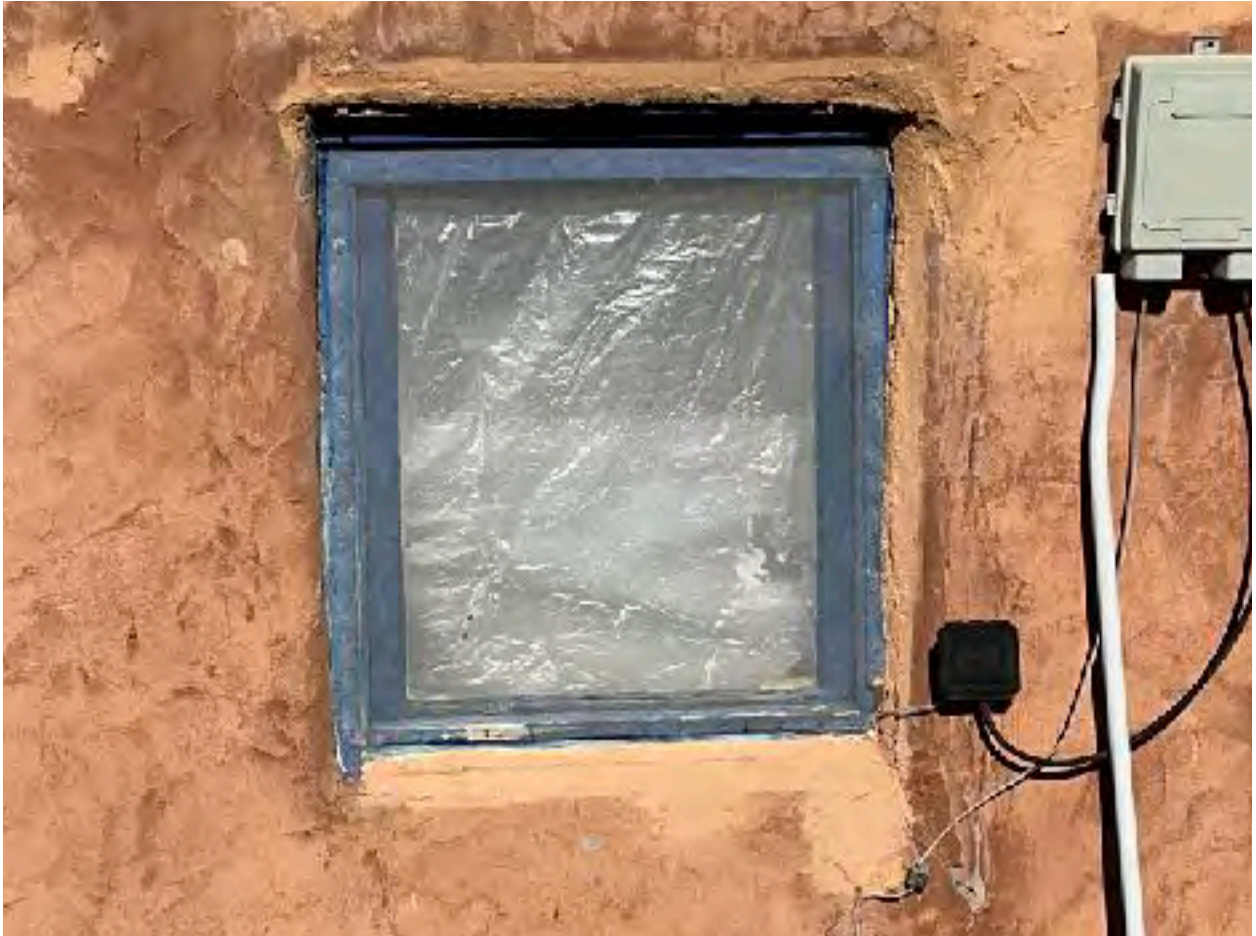
South Window #1

1 Lite fixed sash

22" x 26"

This is a barn sash that has been mounted in a rough buck with applied stop. The paint is peeling but neither the sash or the buck appears to have any rot. There is screen stapled to the exterior of the of the buck.

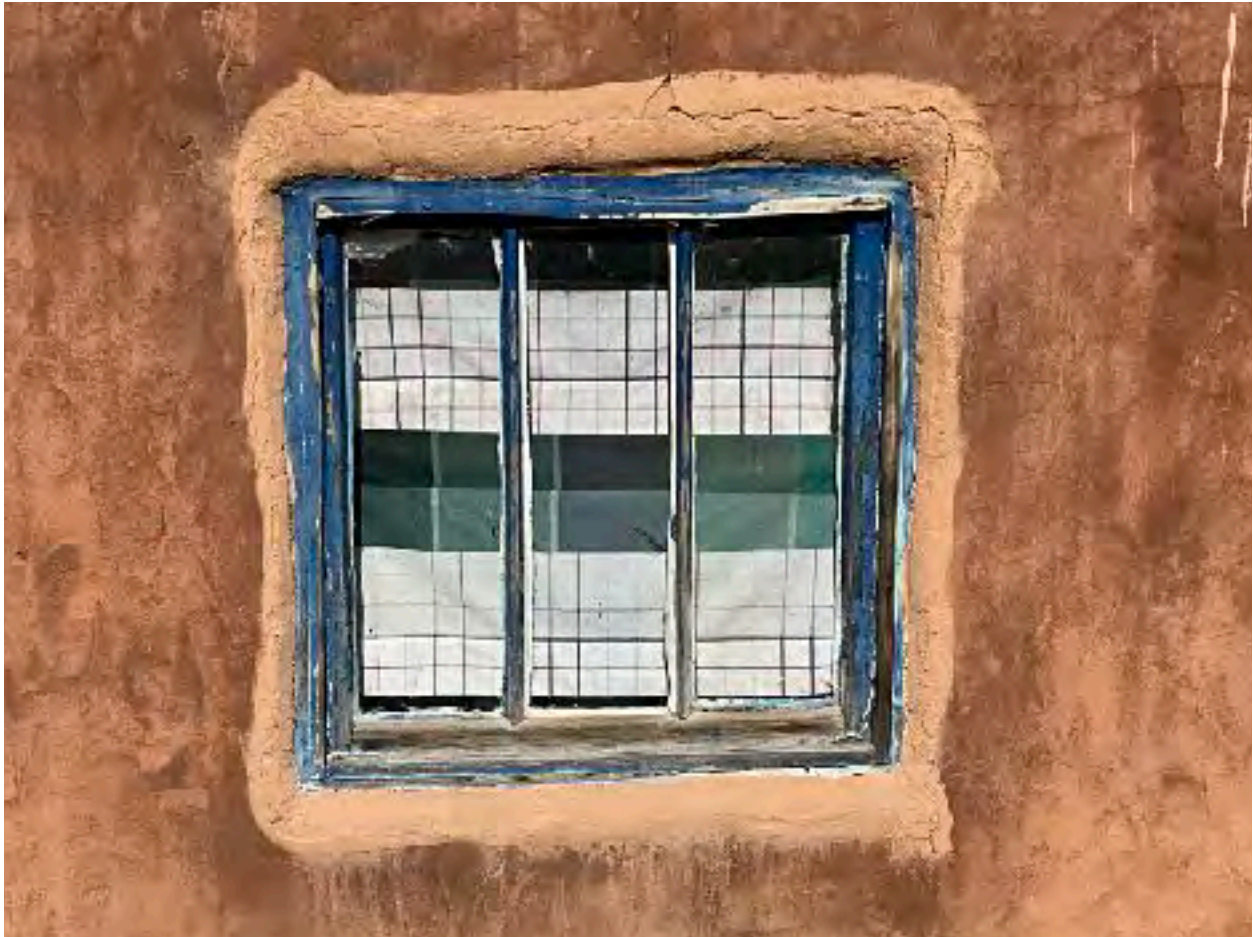
South Window #2

Fixed 3 lite sash

28" x 28"

This appears to be a reused upper sash from a double hung window. It is mounted in the opening inside out and is held with applied stop. The paint is peeling and the joints are open and loose.

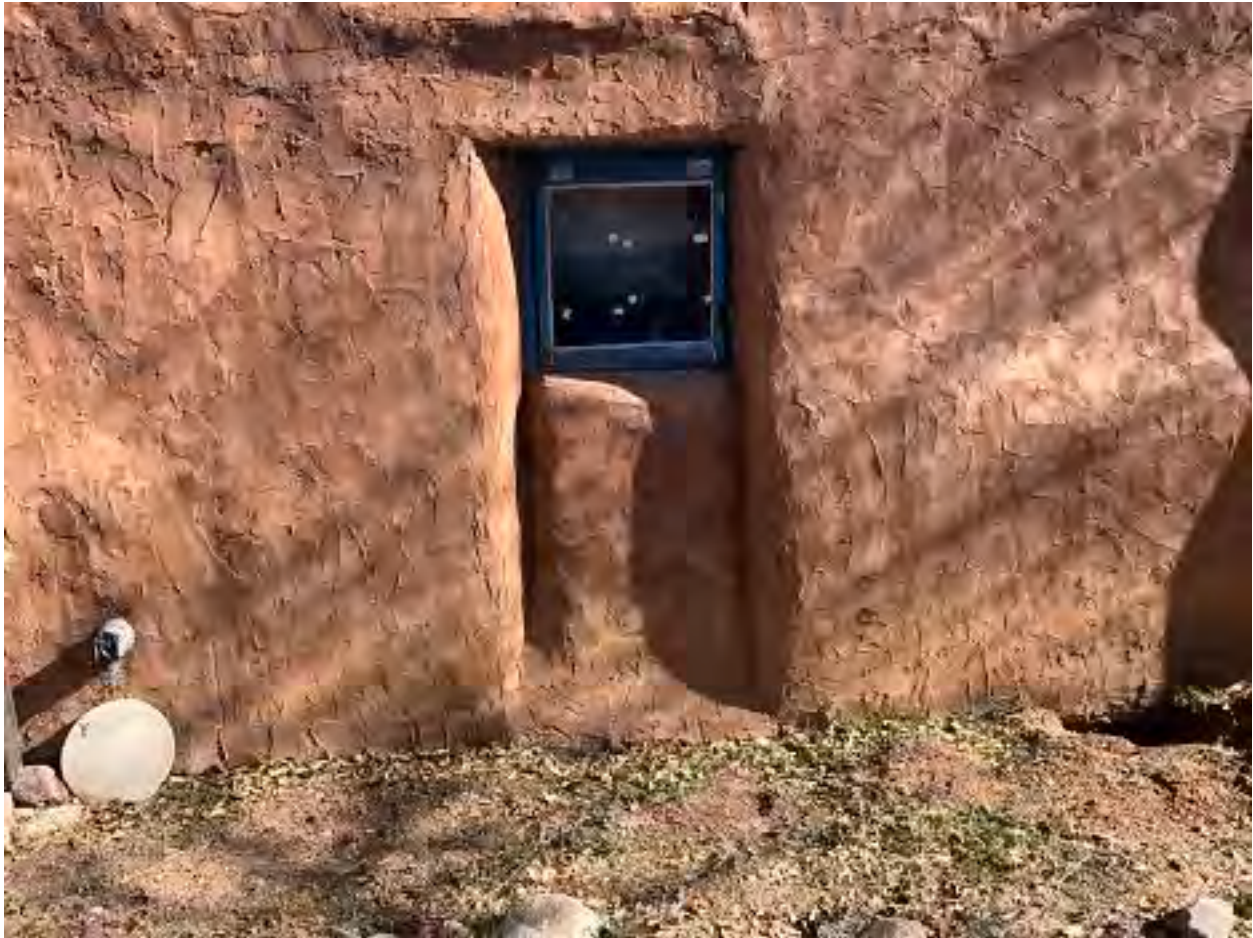
West Window #1

Awning window

23" x 23"

This is another barn sash that has been installed in the opening. It is small for the opening, suggesting that it is a poorly done replacement. It was first hinged as a casement and then rehinged to be an awning window. This opening looks like it was probably a door at some point, so neither the sash or the opening as a window would've been original.

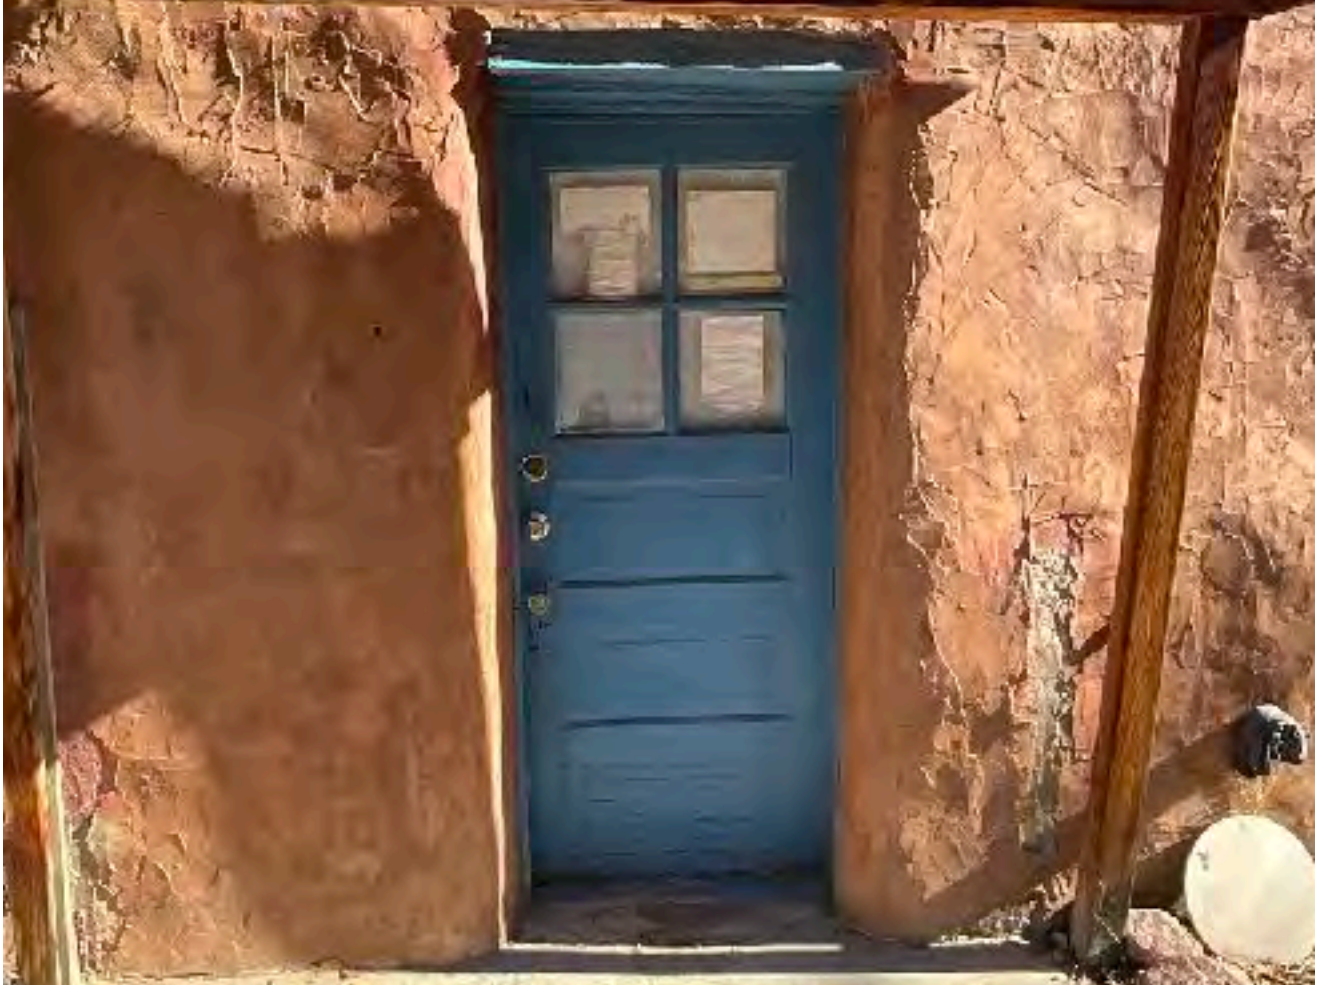
West door #1 29" x 70"

This door looks to have been repurposed from somewhere else. It's bottom rail has been cut down to make it fit into the 70" opening and it still has a vintage knob in a location that would've been appropriate in it's original location, but is now too low. Another knob has been installed above it

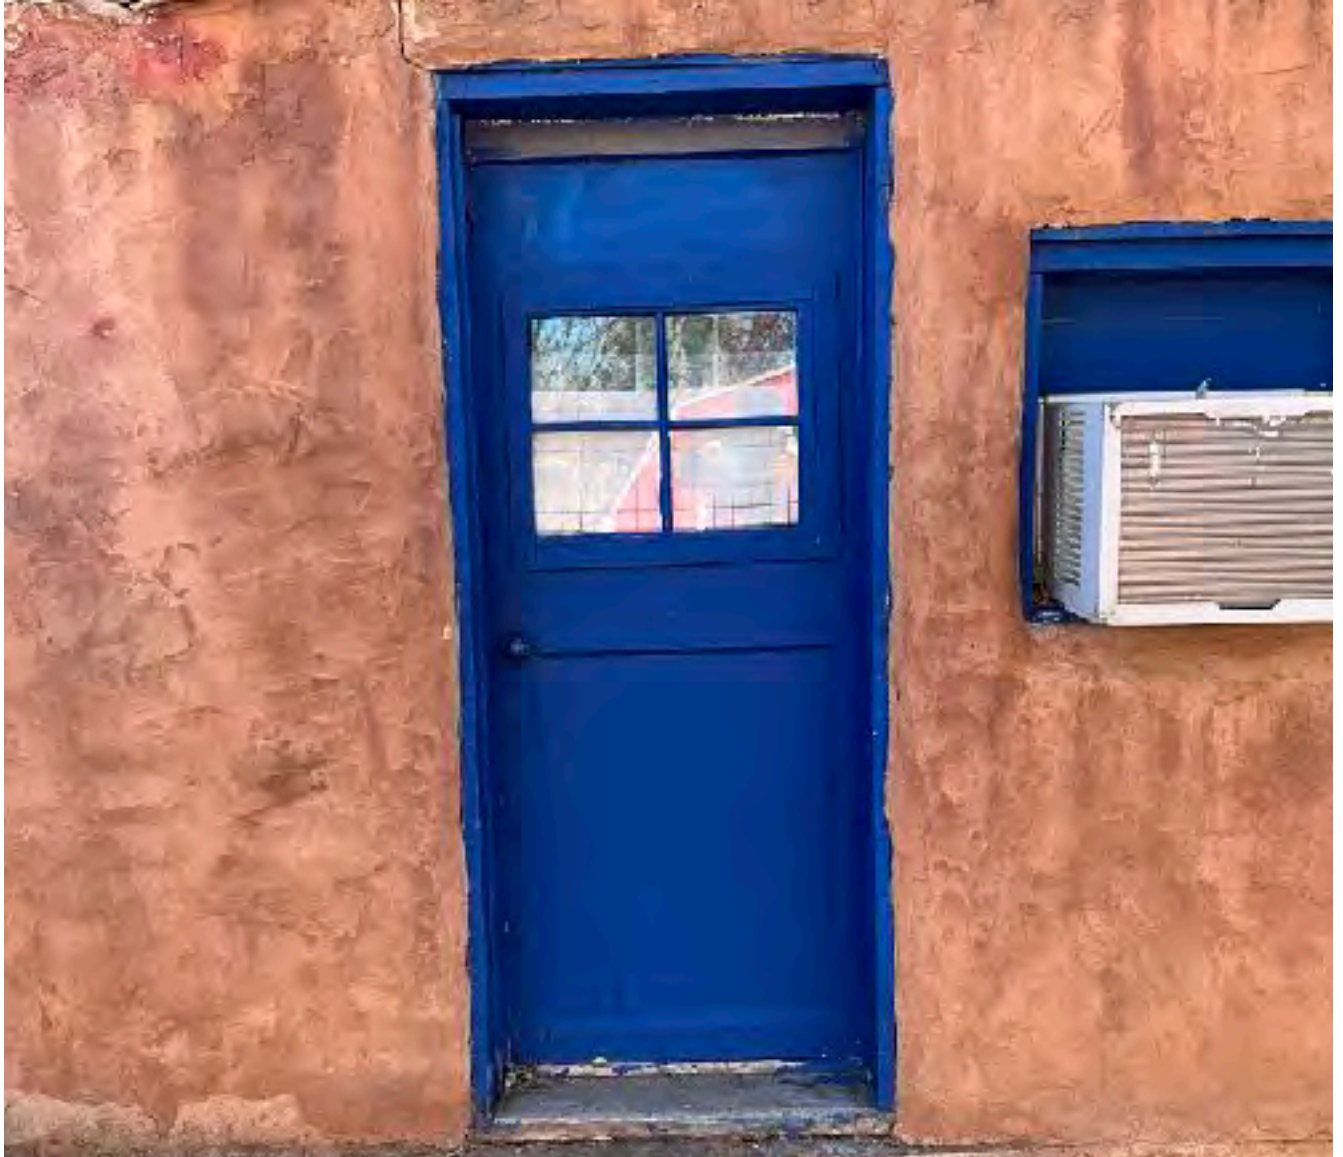
North door #1
28" x 70"

This door also seems to have been repurposed from another site. It is hung upside down and has had it's former top rail cut down to make it fit into the 70" opening.

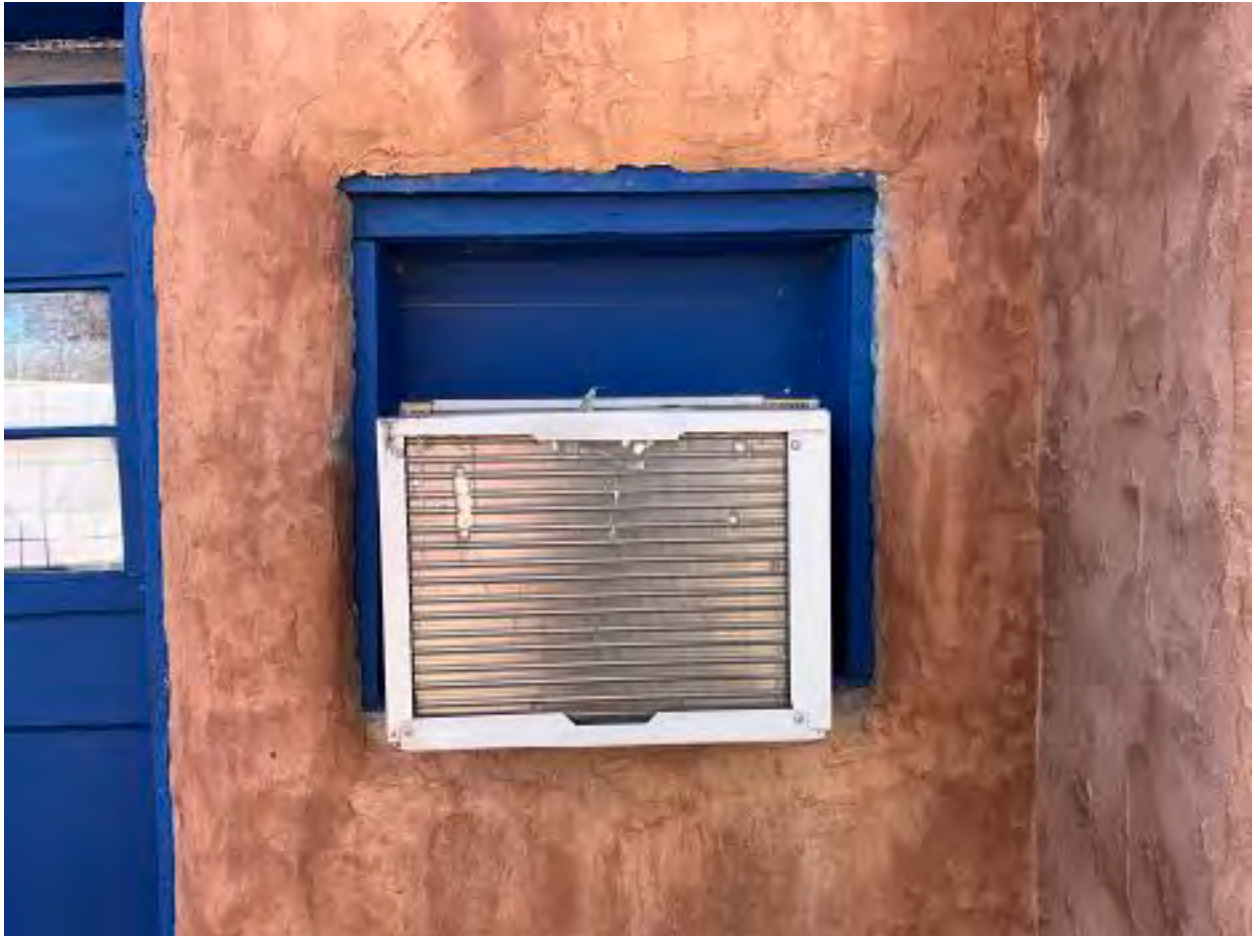
North Window #1

24" x 24"

Whatever was in this opening originally has been replaced with an AC unit.

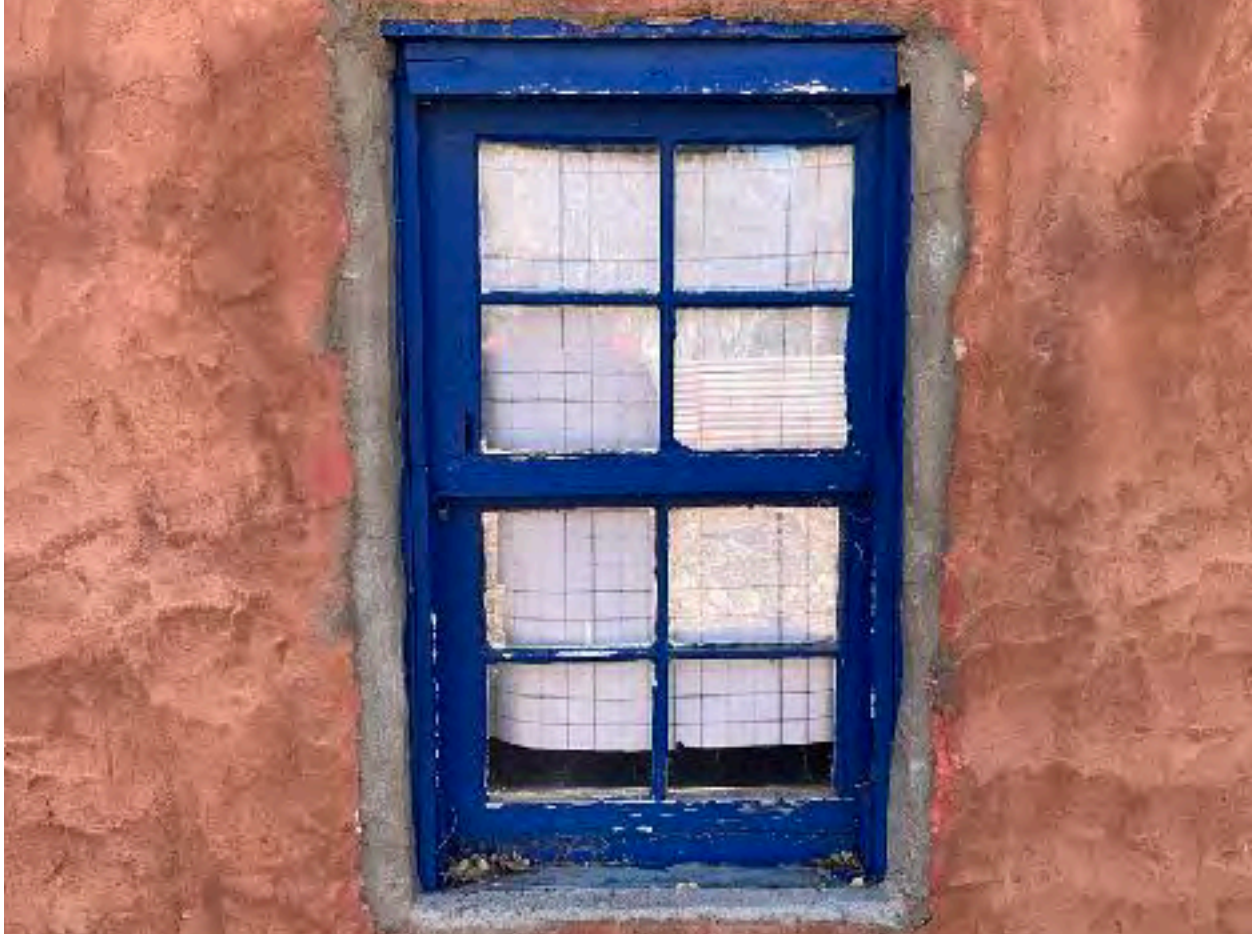
North Window #2
Double hung
24" x 42"

This is a real Frankenstein of a window. The sashes are both parts of bigger sashes that have been cut off at a muntin and had a new stile added next to the muntin. The gap between the muntin and stile is filled with caulk. Both sashes are sideways and the opening has been packed out to fill in the space that the sashes wouldn't fill.

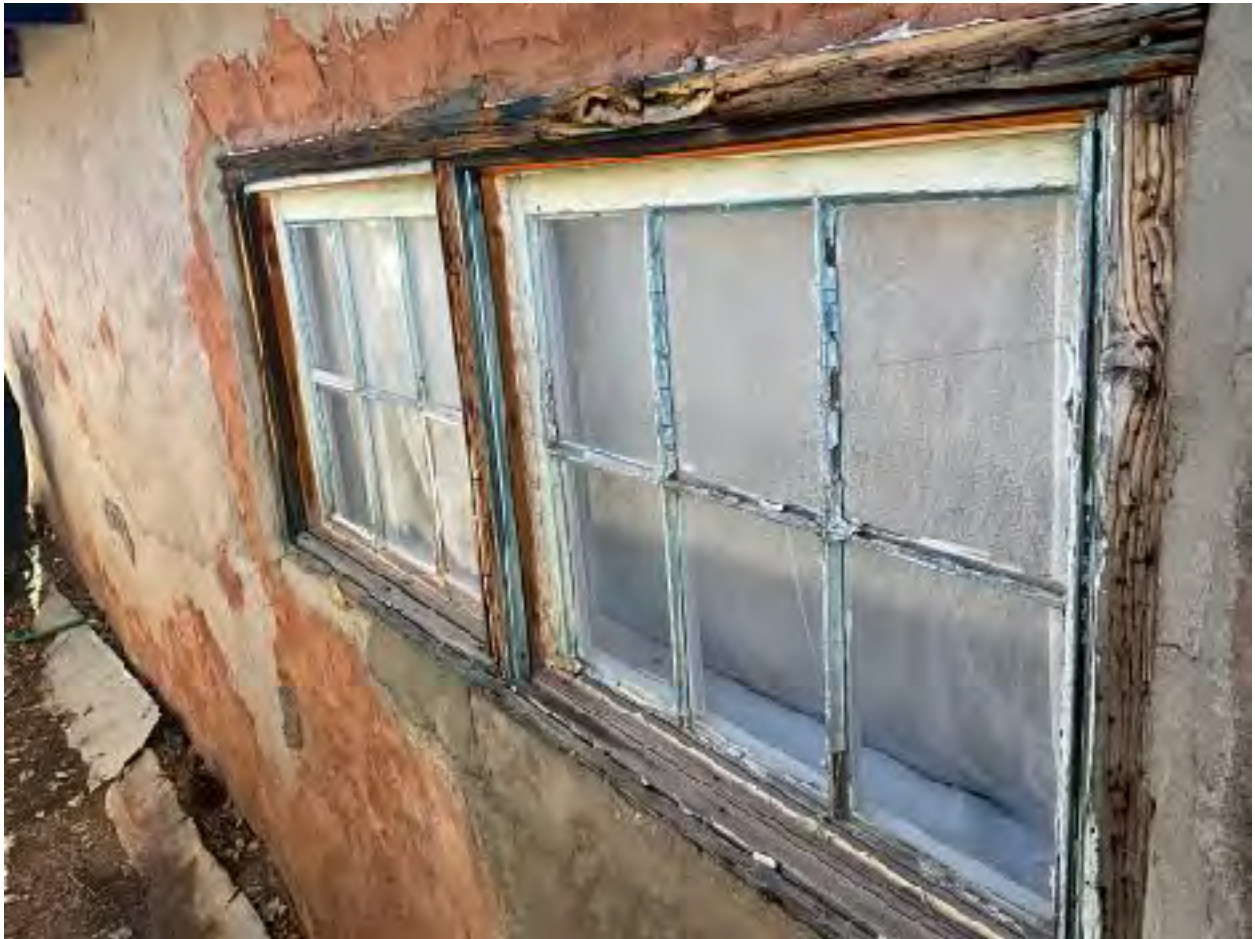
East Window #1

Fixed
28" x 24"

The sashes in this opening are hung upside down and are held in with random stop. The paint is peeling, the glazing compound is shot and they have had some random repairs done to them.
