Luchini Trujillo Structural Engineers, Inc.

May 07, 2025

Re: Residence @ 515 Paseo Del Peralta, Santa Fe, New Mexico 87505

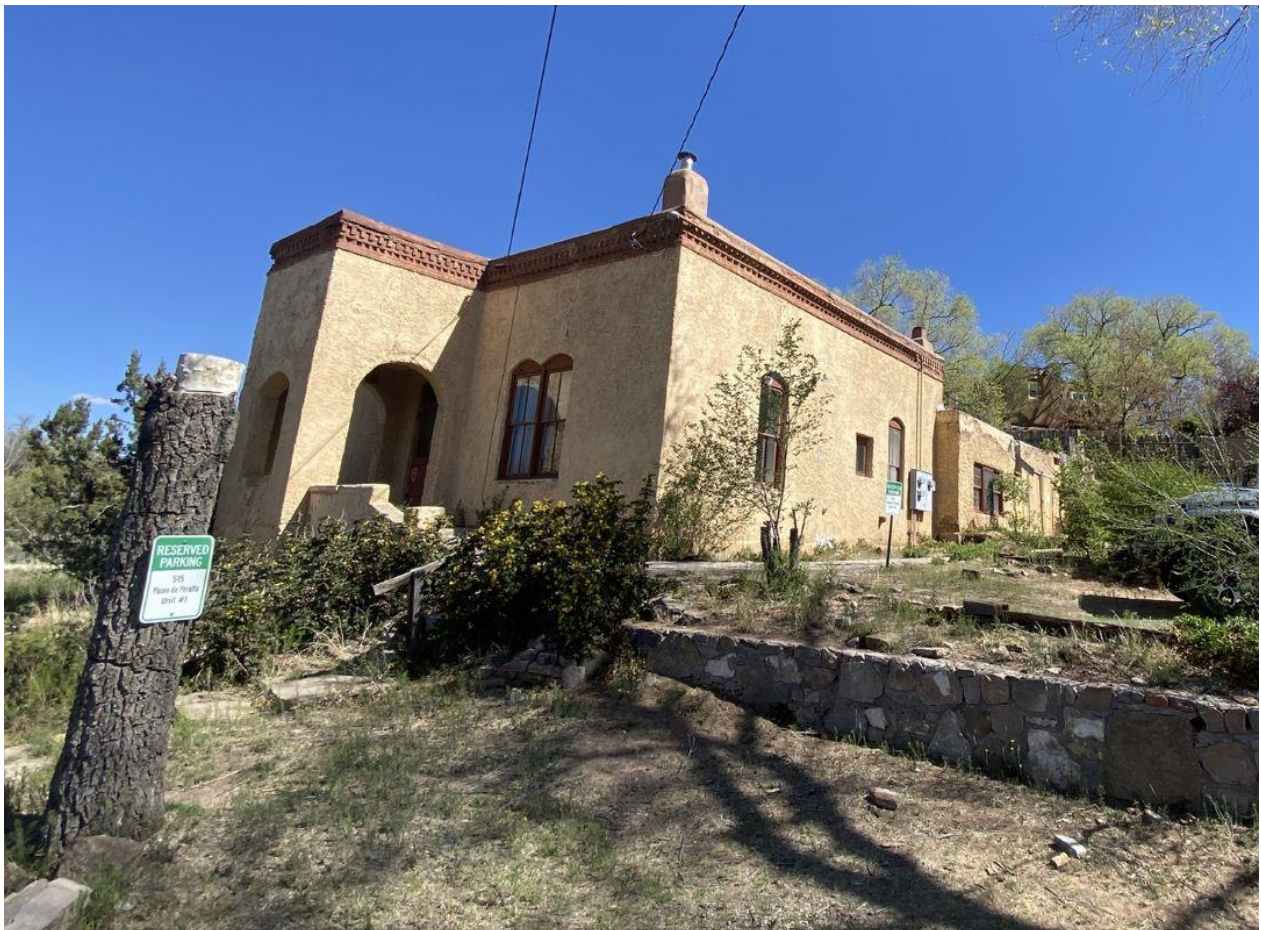
This letter is to acknowledge that I conducted a site visit on April 16, 2025. The purpose of the site visit was to observe the existing condition of the residence and provide an overall opinion regarding its structural integrity. The attached floor plan has been provided by DNCA Architects and is used to identify locations of structural damage herein. The floor plan includes identification of floor framing information and observed structural deficiencies/concerns throughout the property.
