Re: Request for Status Review of the existing adobe structure @ 619 West Alameda, Santa Fe, NM 87501.

Historic Cultural Properties Inventory (HCPI) Base Form (FORM 1)

Historic Cultural Properties Inventory (HCPI) Detail Form (FORM 2)

Historic Cultural Properties Inventory (HCPI) Continuation Sheet

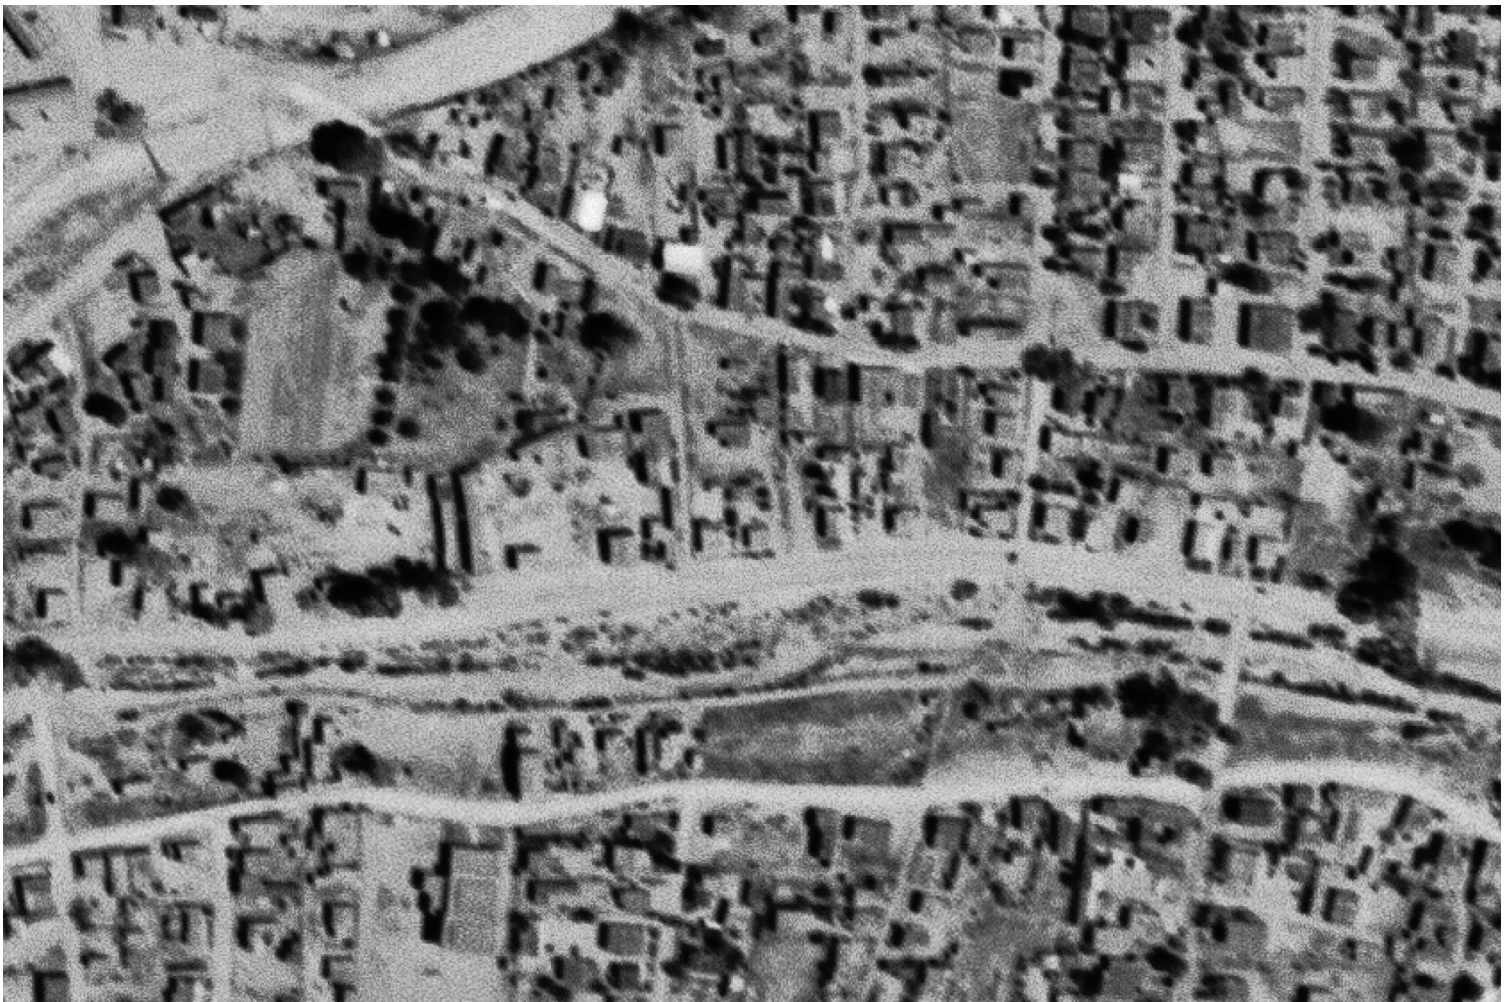
Aerial view - 1951 - appears to show a square building
