Historic Cultural Properties Inventory (HCPI) Base Form (FORM 1)

For HPD Office use only: HCPI No. _____ District No. _____ NRHP _____ SRCP _____ Criteria <u> </u> A <u> </u> B <u> </u> C <u> </u> D		
1. Name of property: Rosina Chavez House	2. Location: 423 A West San Francisco Street Downtown and Eastside Historic District Santa Fe	3. Local Reference Number: Santa Fe ID: N/A 4. County: Santa Fe Parcel # 10468150

6. Date of Survey: February 27, 2025		
7. Previous Survey Date(s): <input type="checkbox"/> Yes: No: <input checked="" type="checkbox"/>		
8. Name of Project: HDRB Status Evaluation

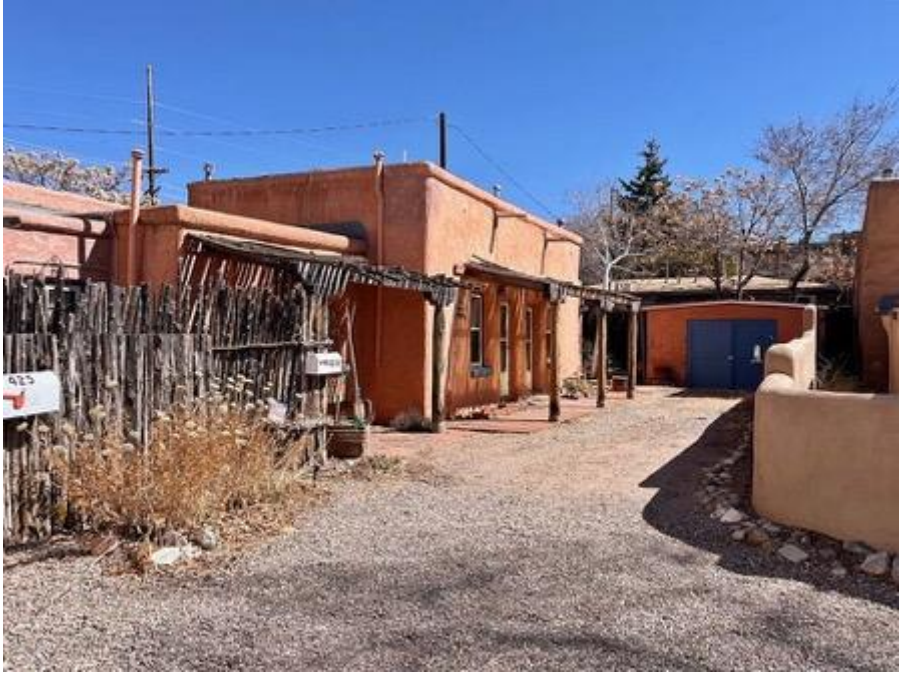
9. Lat/Long: 35.689145,-105.9446937		
10. Photo Information: John W. Murphey, photographer. Photo 1: View of south elevation. Camera facing northeast.

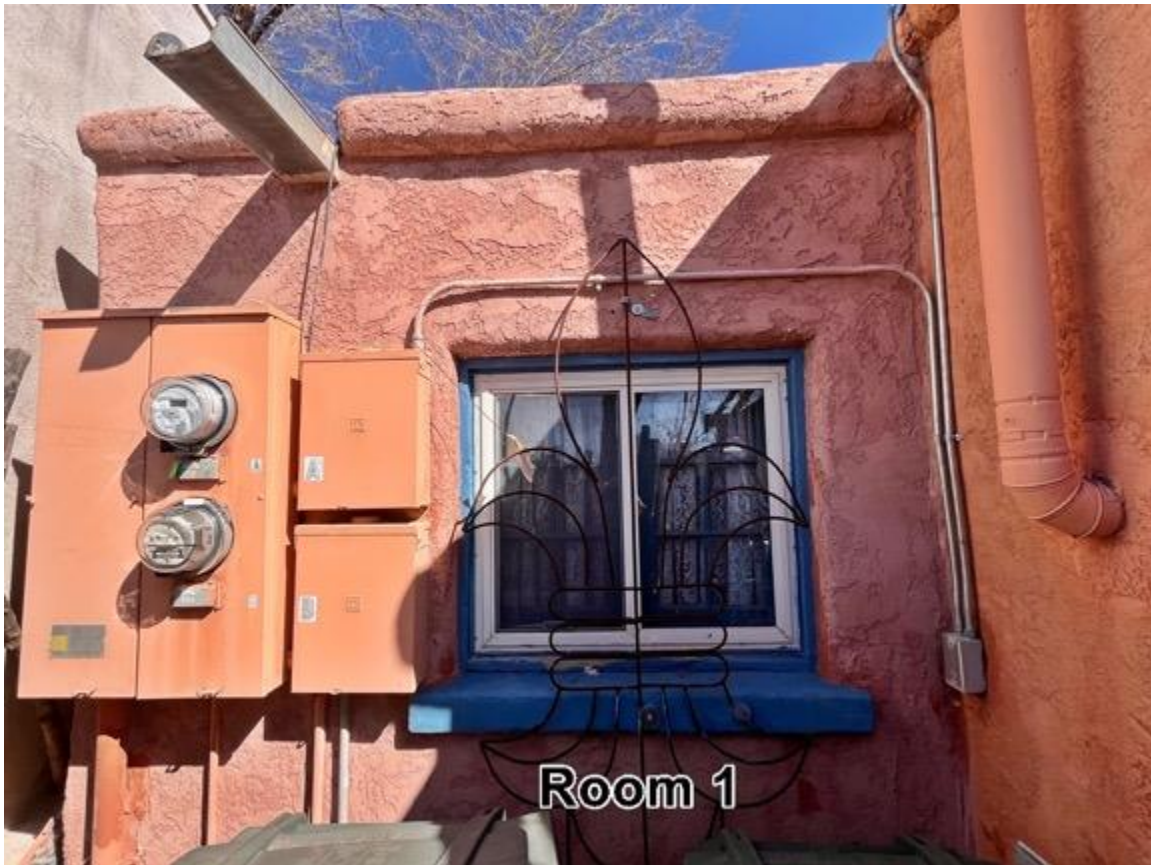
Photo 7: Room 1. Camera facing north.

The building begins at the west end with Room 1, likely the youngest and least visually appealing addition (Photo 7). Constructed after 1948, this room is approximately 56 square feet and contains a bathroom. It is made of hollow tile construction (Photo 8) and was updated during the 1990s renovation. The room has a single opening with two replacement wood casement windows, each with six lights (Photo 9). The presence of two electric meter boxes suggests the building was once divided into two separate

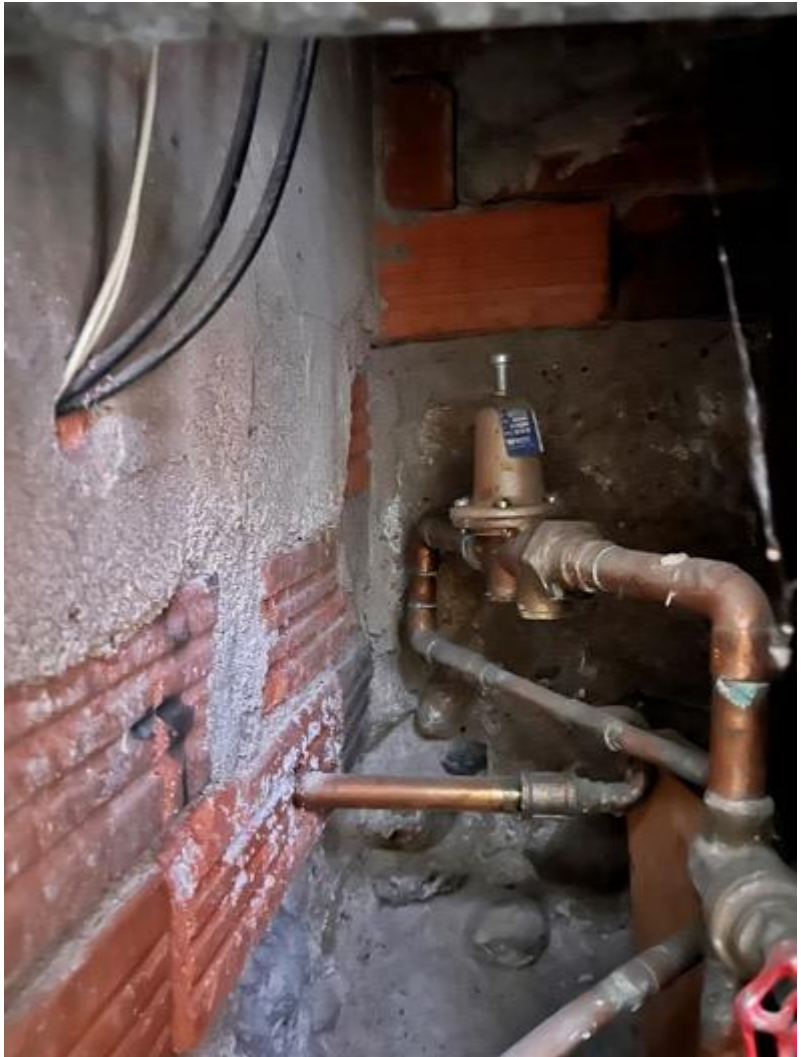
Photo 8: Room 1. Interior showing tile construction behind the plumbing access door.

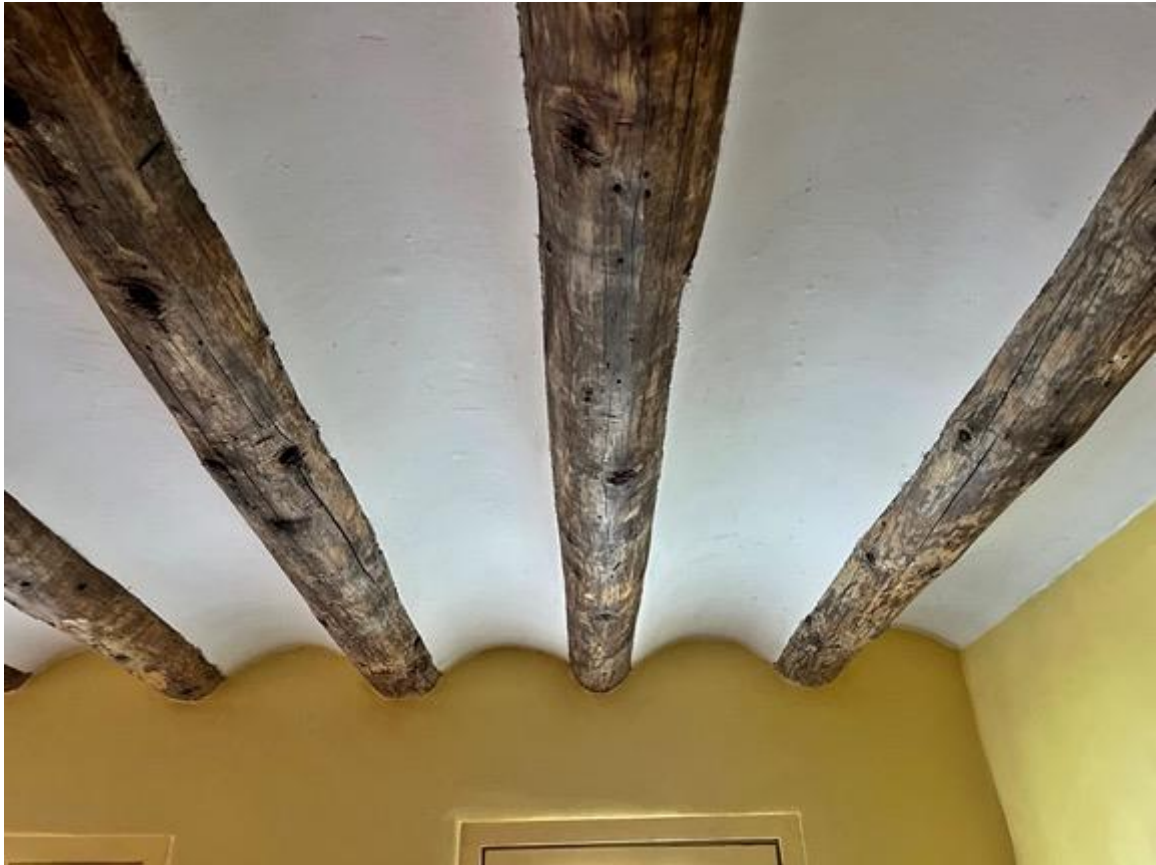
The next room to the east historically served as a kitchen during the Rosina Chavez period. This approximately 114-square-foot room is constructed of adobe and is depicted on the 1930 Sanborn Fire Insurance map, the first map to cover the area, as a small garage (Fig. 5). Its exterior features a doorway with an older four-light over two-panel wood door (Photo 11), which is visible in one of the pre-renovation photos when the space was still used as a kitchen (Photo 12). Adjacent to the east is a set of non-original wood casement windows with single lights. The room has clay tile flooring (Photo 13); its viga ceiling has plaster coving between the beams, which was likely added during renovation (Photo 14).

Photo 14: Room 2. Interior, ceiling.

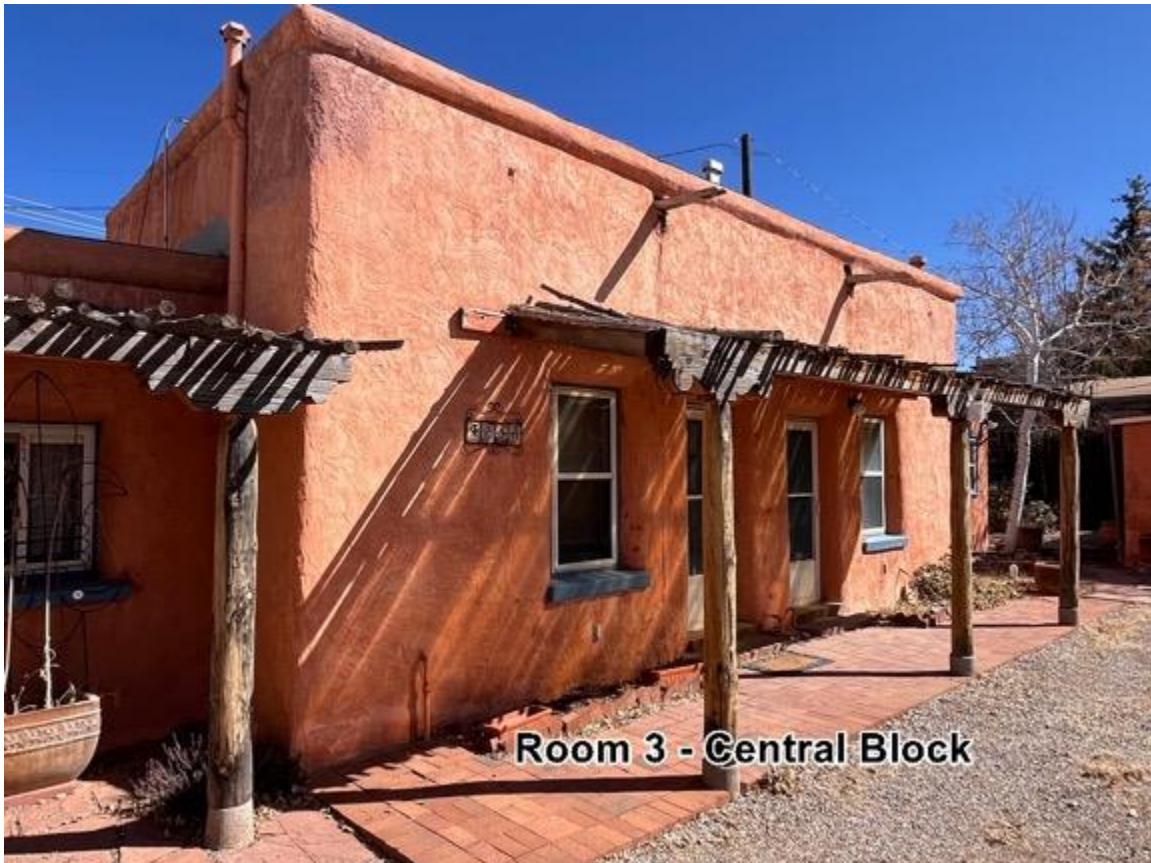
Projecting out approximately 4' from the kitchen, the central block is the building's oldest and most significant piece (Photo 15). It presents a strong example of late 19th and early 20th-century vernacular construction with its tall profile, adjacent doors, and what may be brick coping under built-up stucco. Its construction is of traditional adobe brick covered with multiple layers of stucco, suggesting an older vintage (Photo 16).

Photo 15: Room 3 (Central Block). Camera facing northeast.

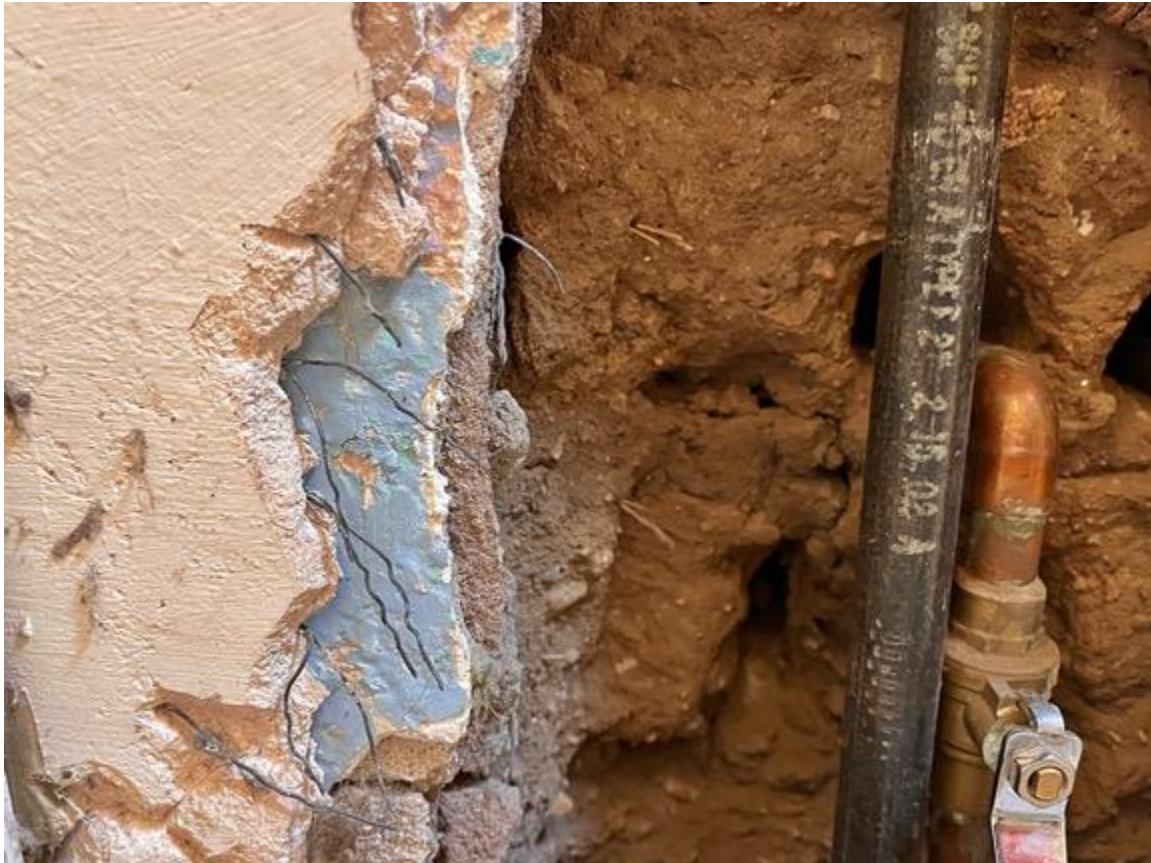
Photo 16: Exterior exposure of Room 3 at east wall, showing multiple layers of stucco and plaster.

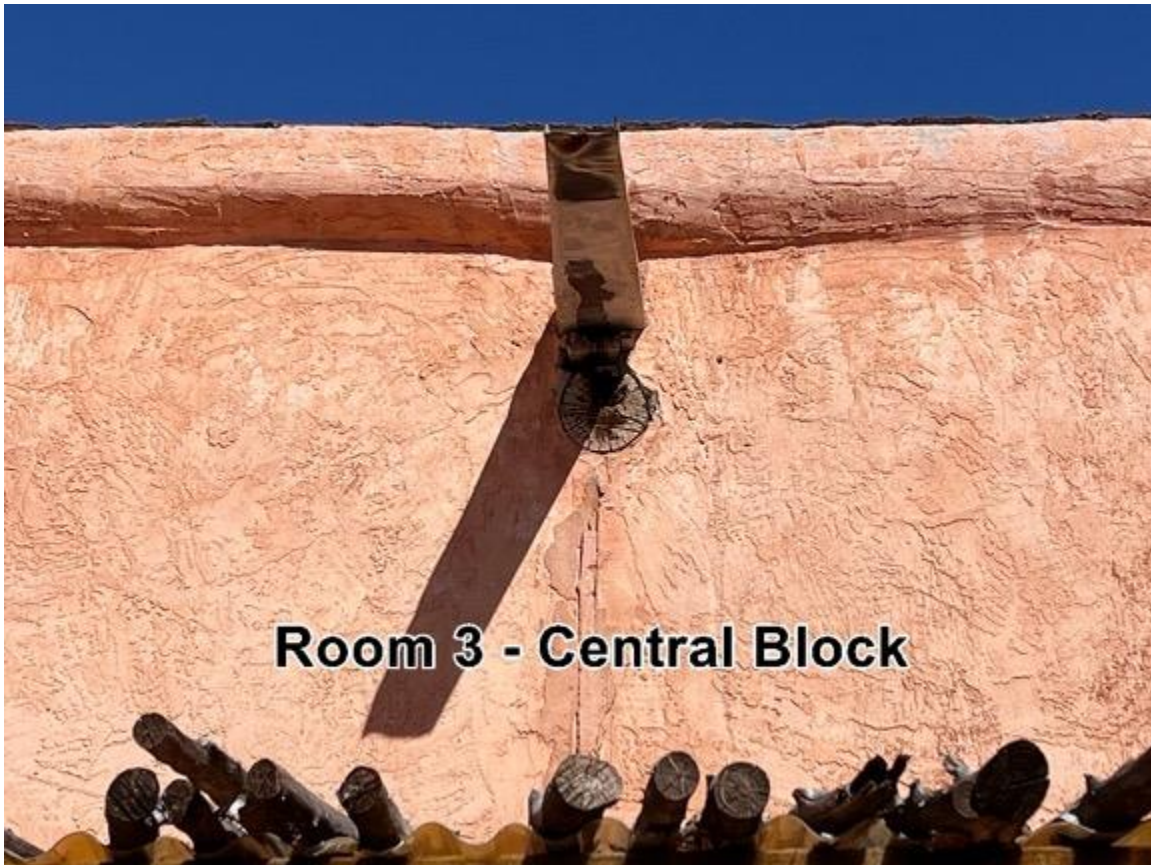
Photo 16: Room 3. Tin or galvanized metal *canale*.

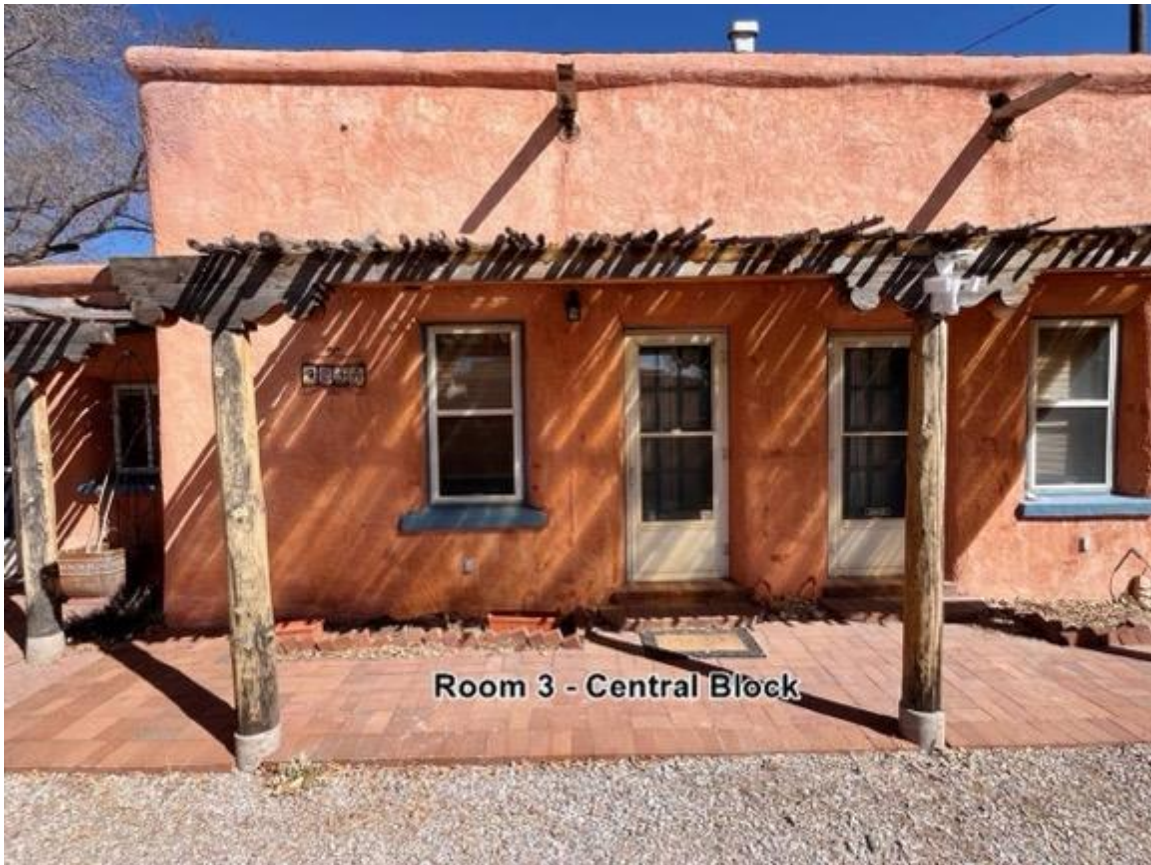
The façade features a pattern of alternating window and door openings, possibly reflecting its design as two separate dwellings (Photo 17). The doors installed during the renovation are 15-light units (Photo 18), while the windows are 1/1 replacement wood sash. The window openings have heavy lug sills, each having a depth of 7 1/2 inches. Photographs taken during the renovation show that entries originally had glass and wood panel doors. The 9 1/2" deep jambs suggest that the door openings may date from the historic period.

Photo 17: Room 3. Fenestration pattern. Camera facing north.

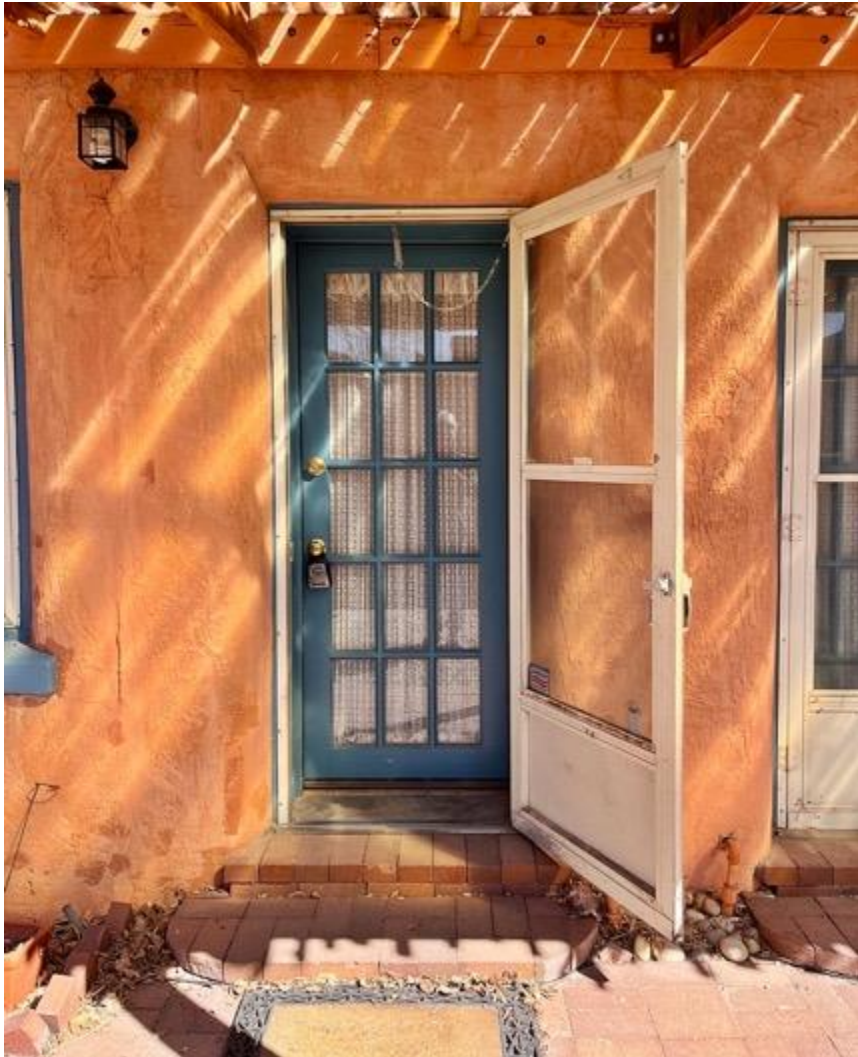
Photo 18: Room 3. West door. Camera facing north.

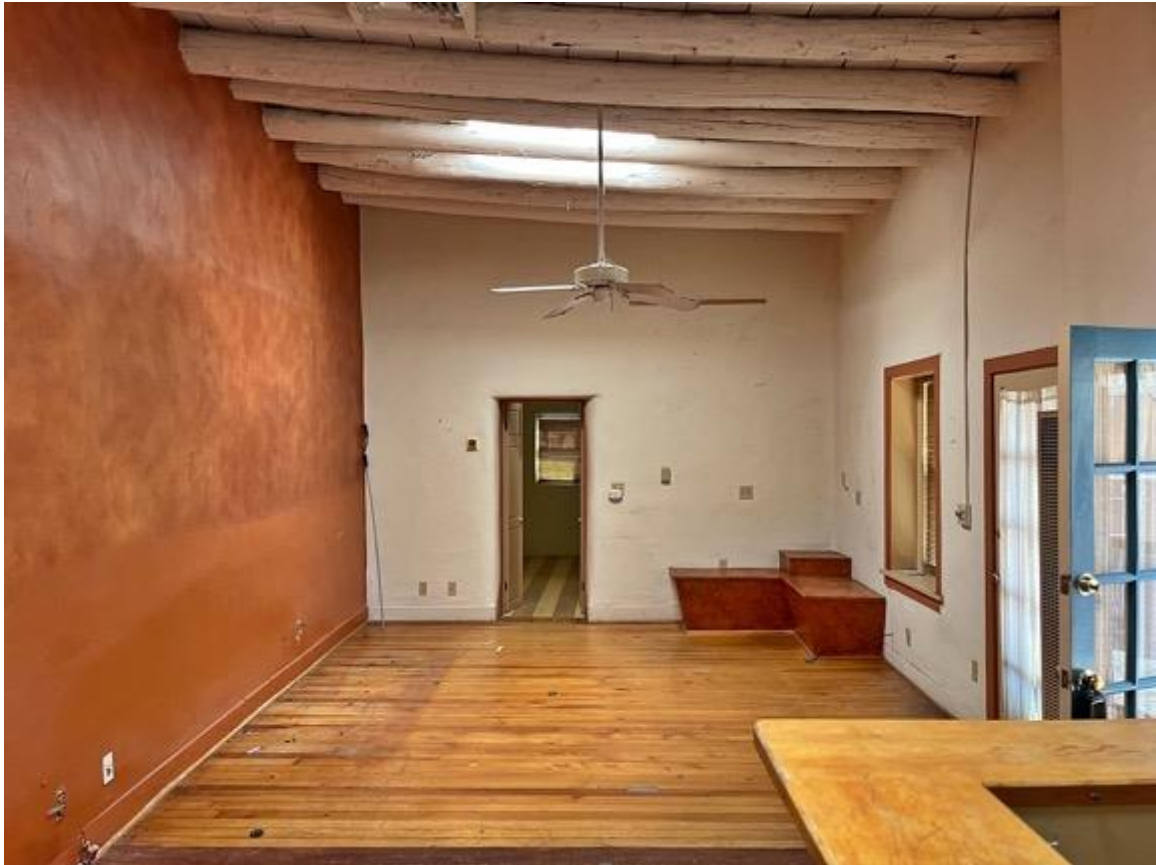
The interior, measuring 104 square feet, features an informal kitchen nook in the southwest corner created during the renovation (Photo 19). Historically consisting of

Photo 19: Room 3. Interior. Camera facing east.

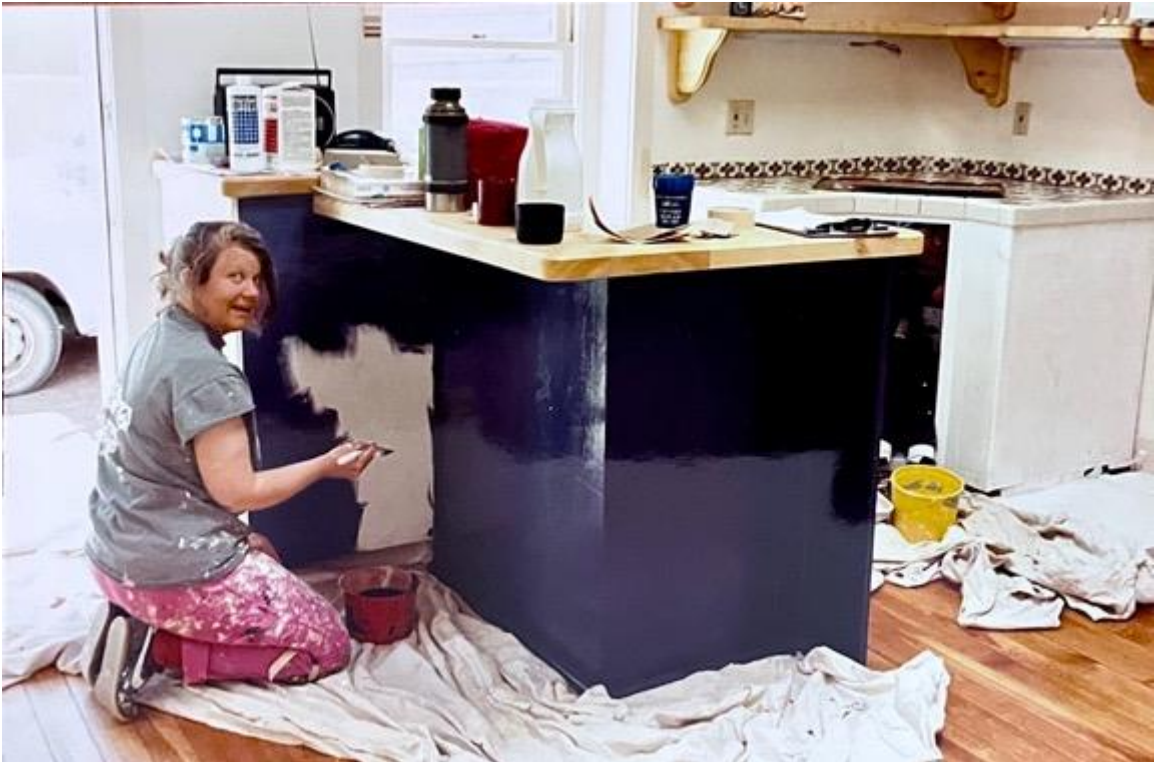
two rooms, the central block’s interior was opened during the renovation to create a combined kitchen and living area (Photo 20).

Photo 20: Room 3. Installation of kitchen at southwest corner. Camera facing southwest. Courtesy of Heidi Cost.

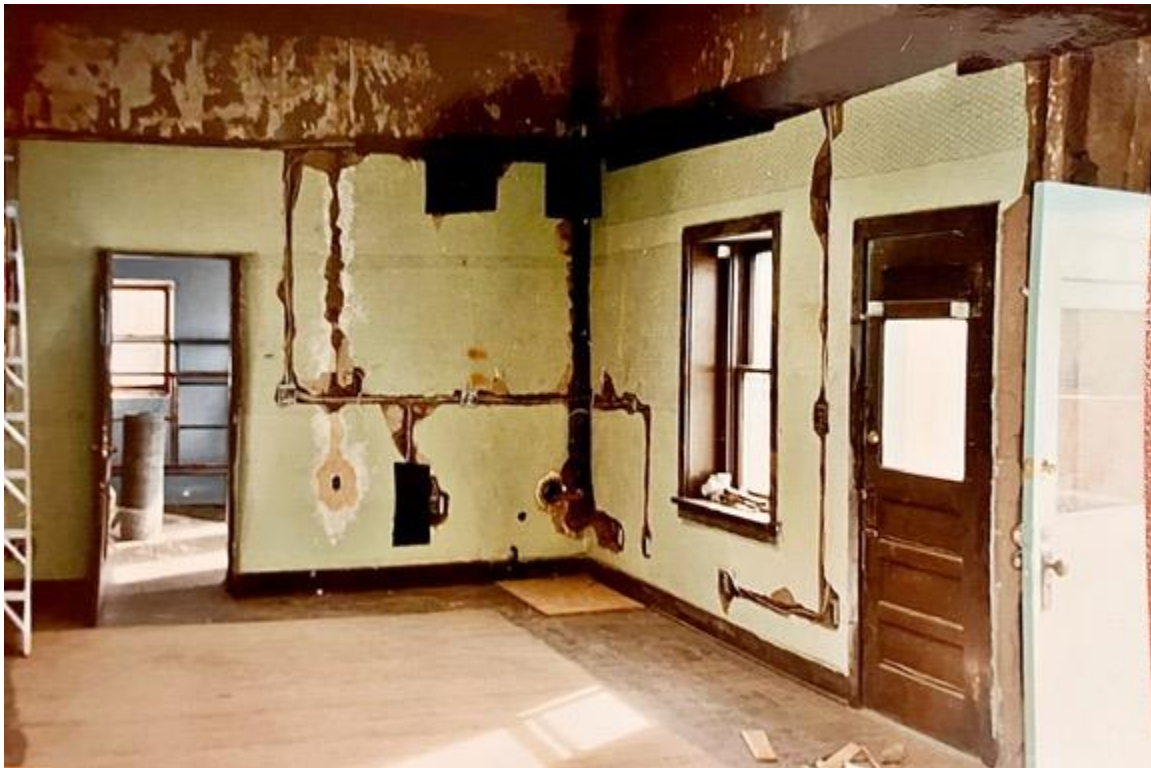
Photographs from this period show Rosina's old house undergoing significant renovations. The ceiling of the central room was removed, exposing the vigas, and the adobe walls were cut to accommodate new electrical conduit. A room that had previously served as the kitchen was converted into a bedroom. Older doors and windows were replaced with new ones, and a rustic ramada was installed across the façade of the main block.

Photo 21: Room 3. 1990s renovation photograph. Camera facing southeast. Note conduit cuts in the adobe walls, removal of ceiling, and older window and door. Courtesy of Heidi Cost.

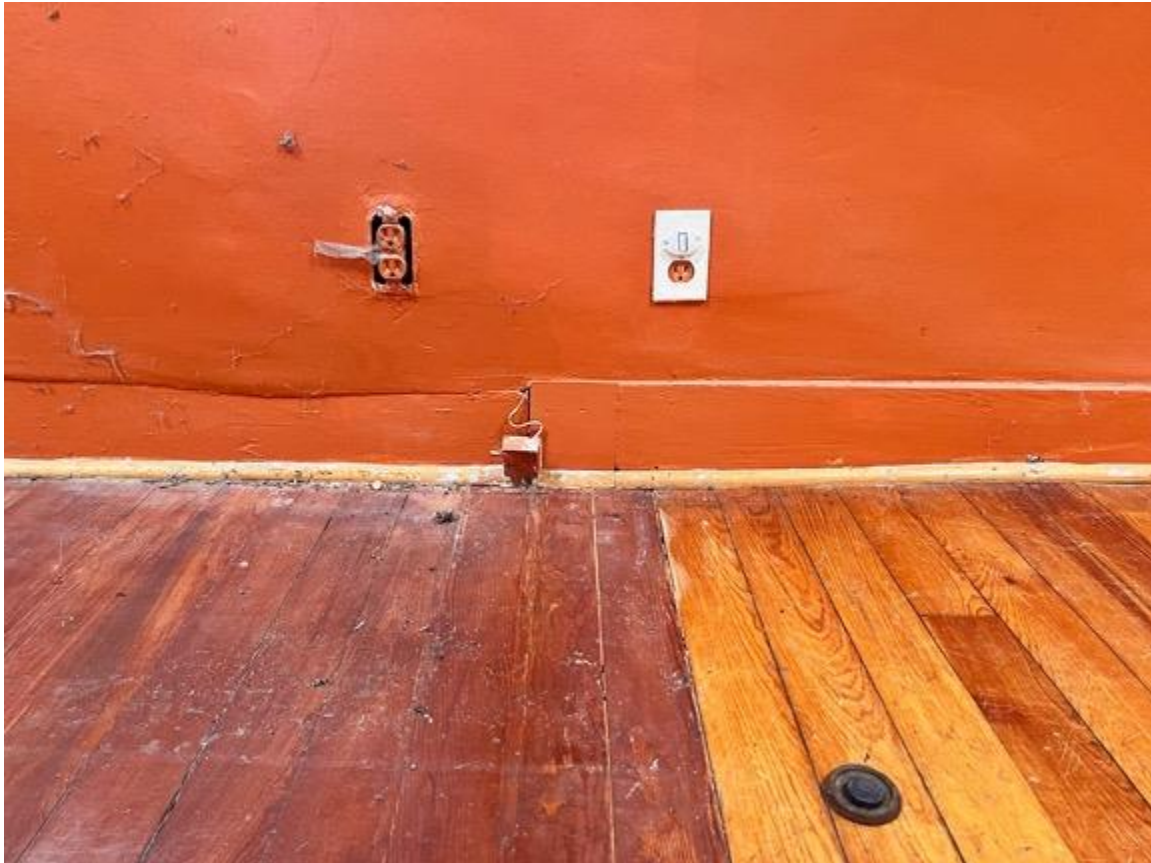
Photo 23: Room 3. Interior, change of floor coloring and shoe molding.

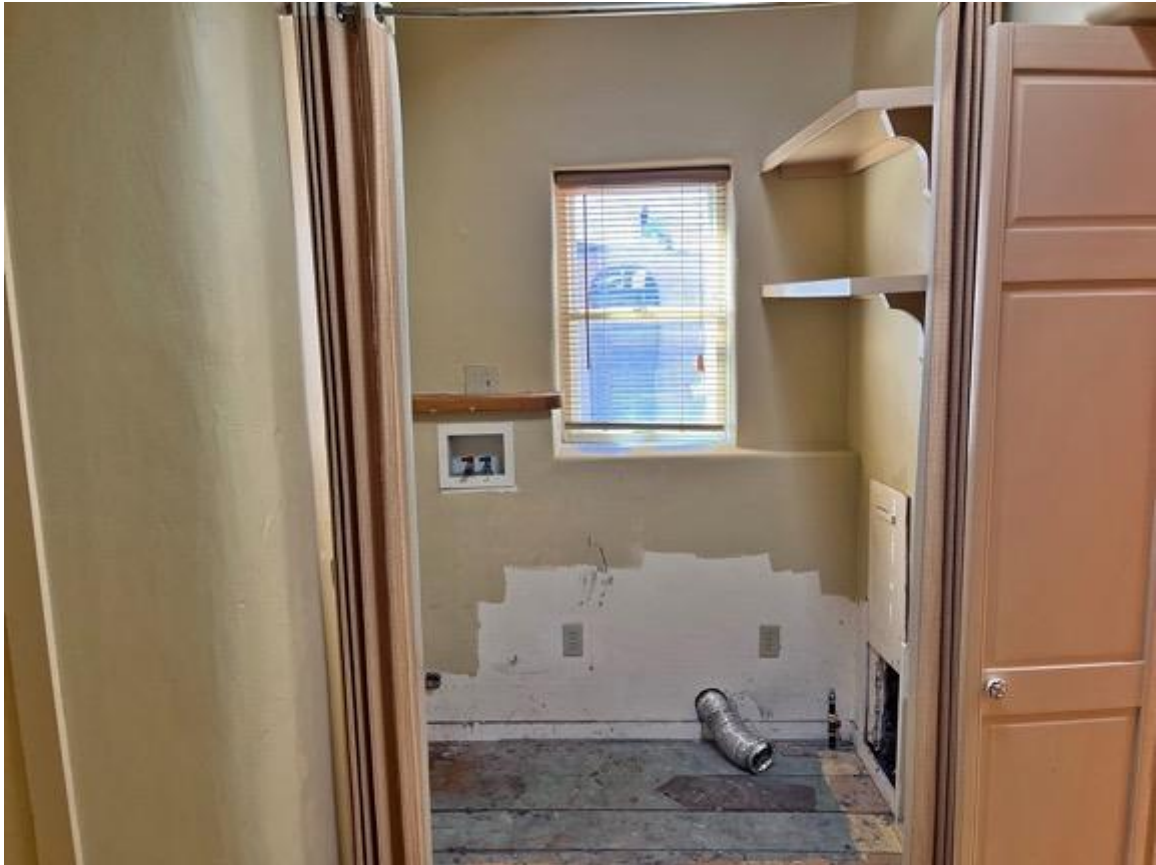
Photo 27: Room 4. Interior, frame bathroom enclosure. Camera facing south.

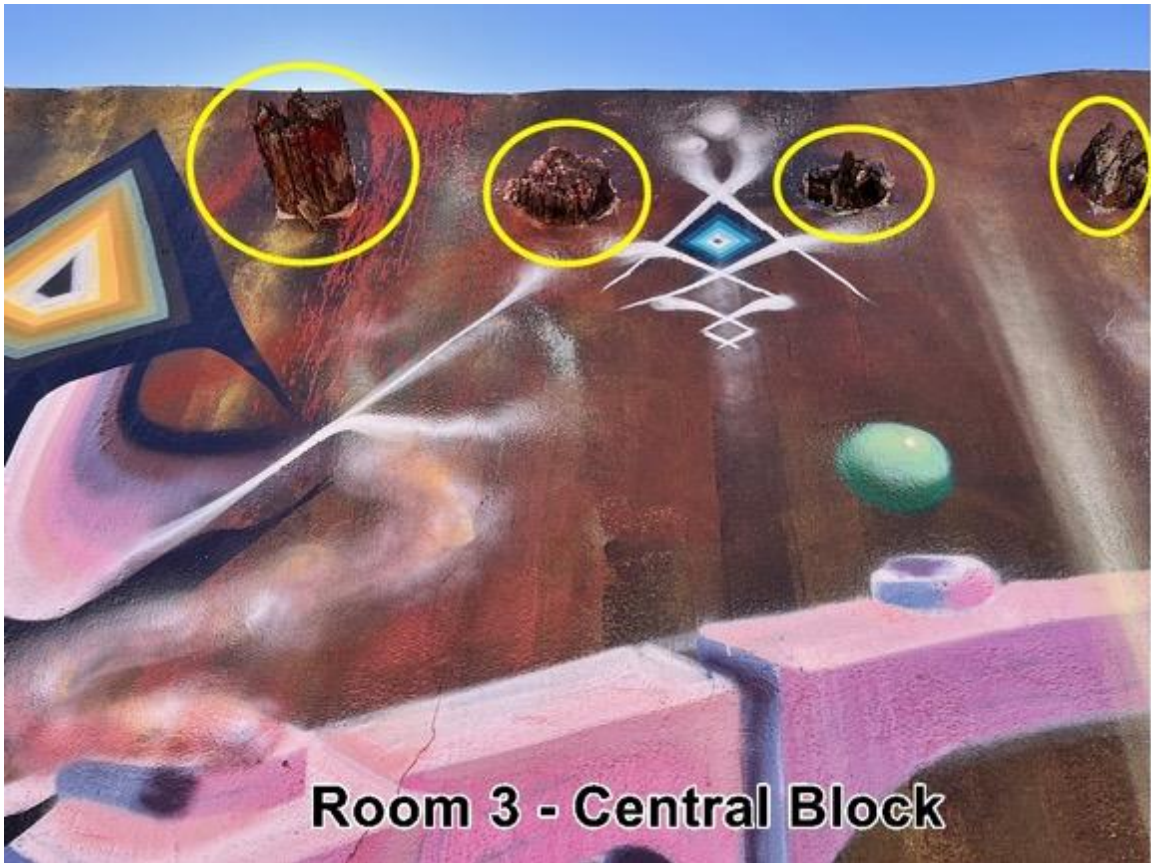
Photo 29: Room 3. North elevation, viga ends highlighted.
