NEW MEXICO HISTORIC BUILDING INVENTORY - SANTA FE RESURVEY 1991

| ADDRESS: 433 Calle la Paz Camino del Monte Sol National Historic District | | ID NUMBER: 051600051 |

SURVEYED 9/91 BY DB

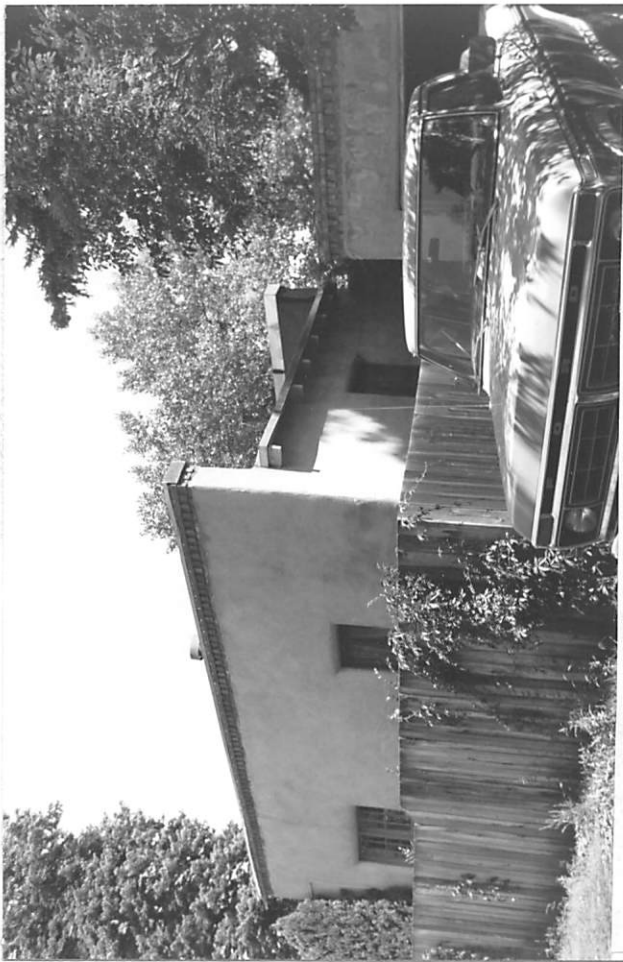
#16 from southwest

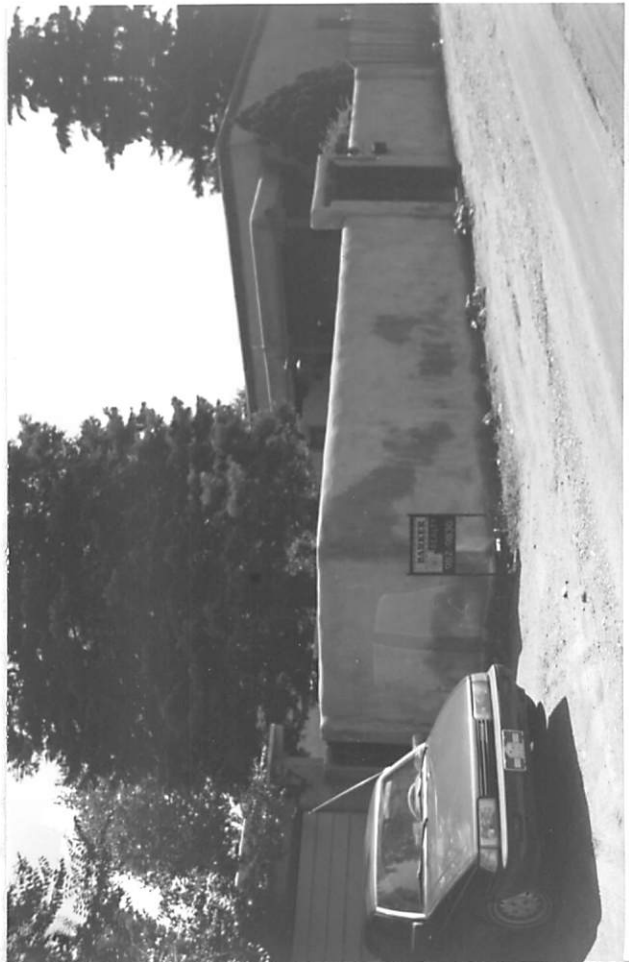
#17 streetscape from NW

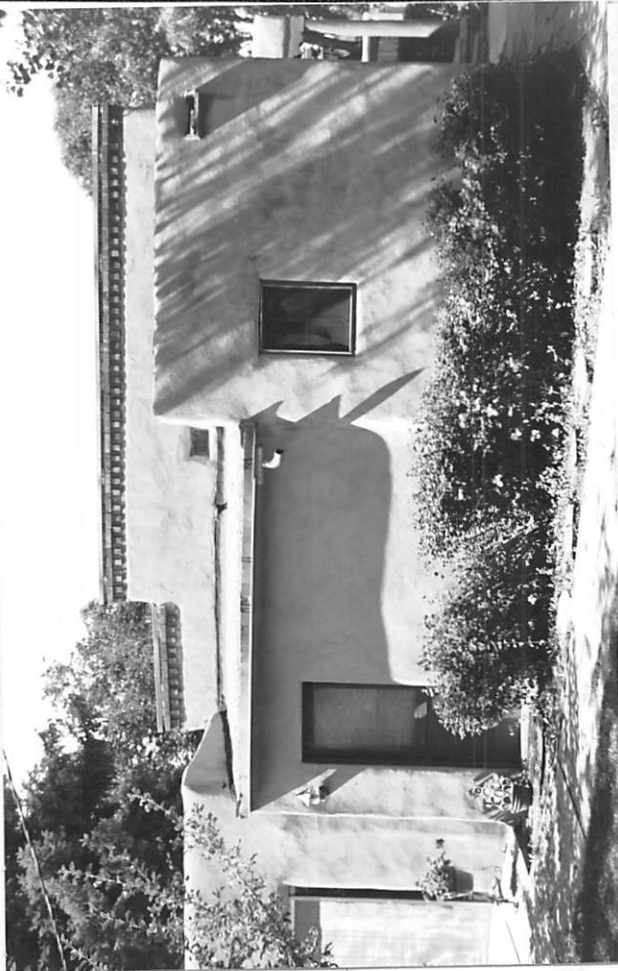
#11 east elevation

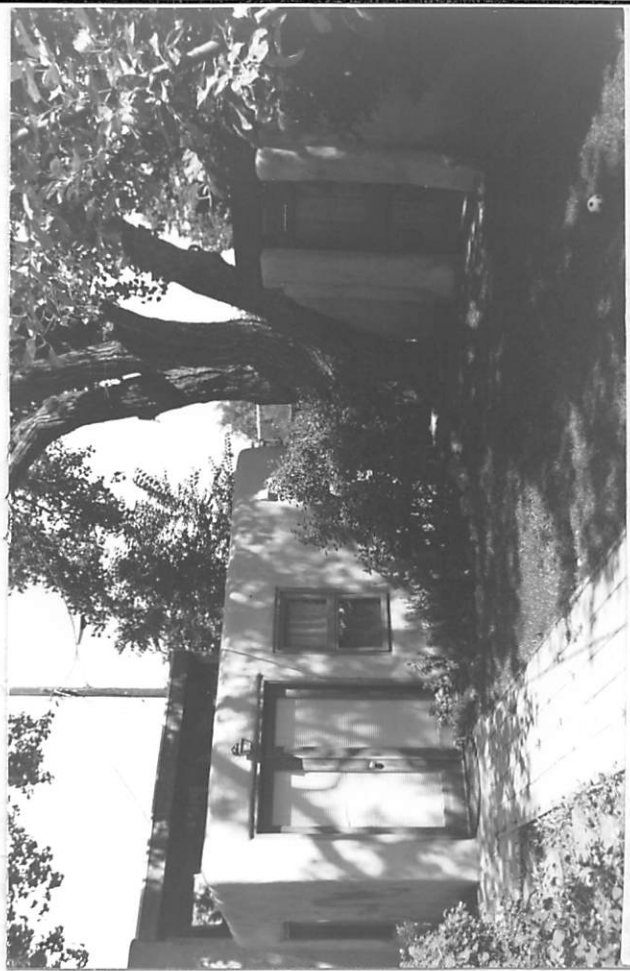
#14 south, guest house

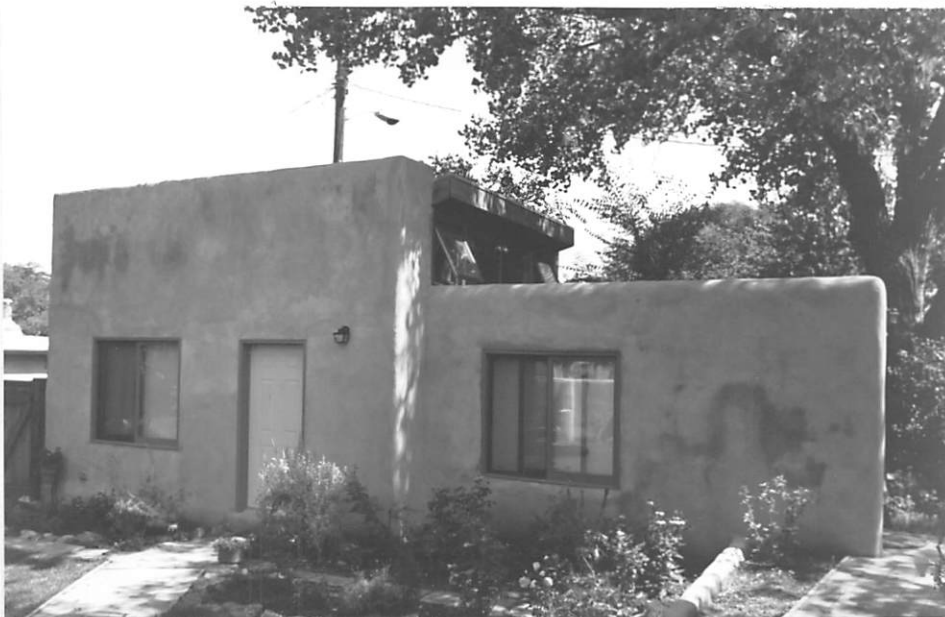
#13 guest house, west

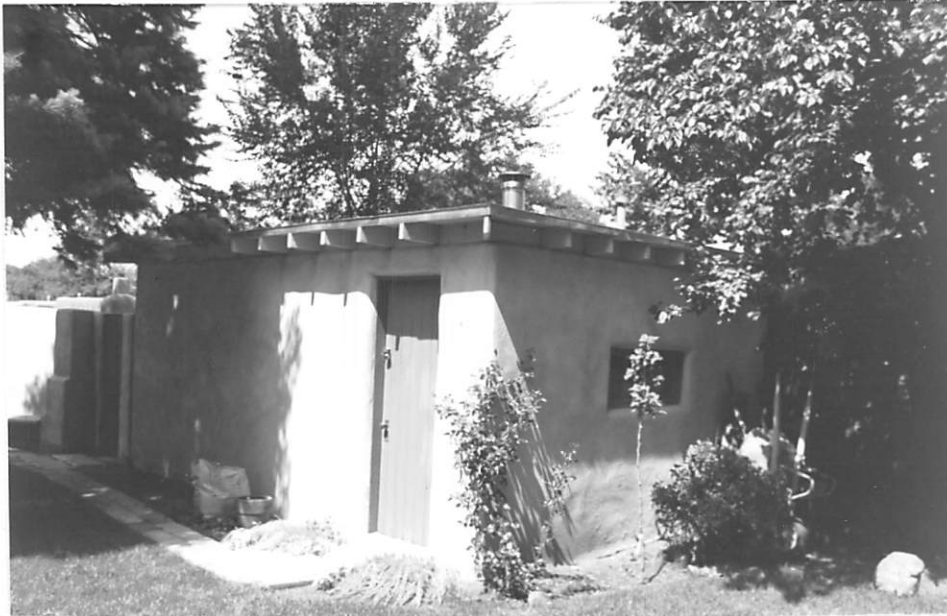
#15 garage from southeast
