RPA & Associates, LLC.

HISTORIC ASSESSMENT
NO. 050625-HA

JOB	DATE
433 CALLE LA PAZ – MAIN HOUSE, SANTA FE, NM 87505	06/05/2025

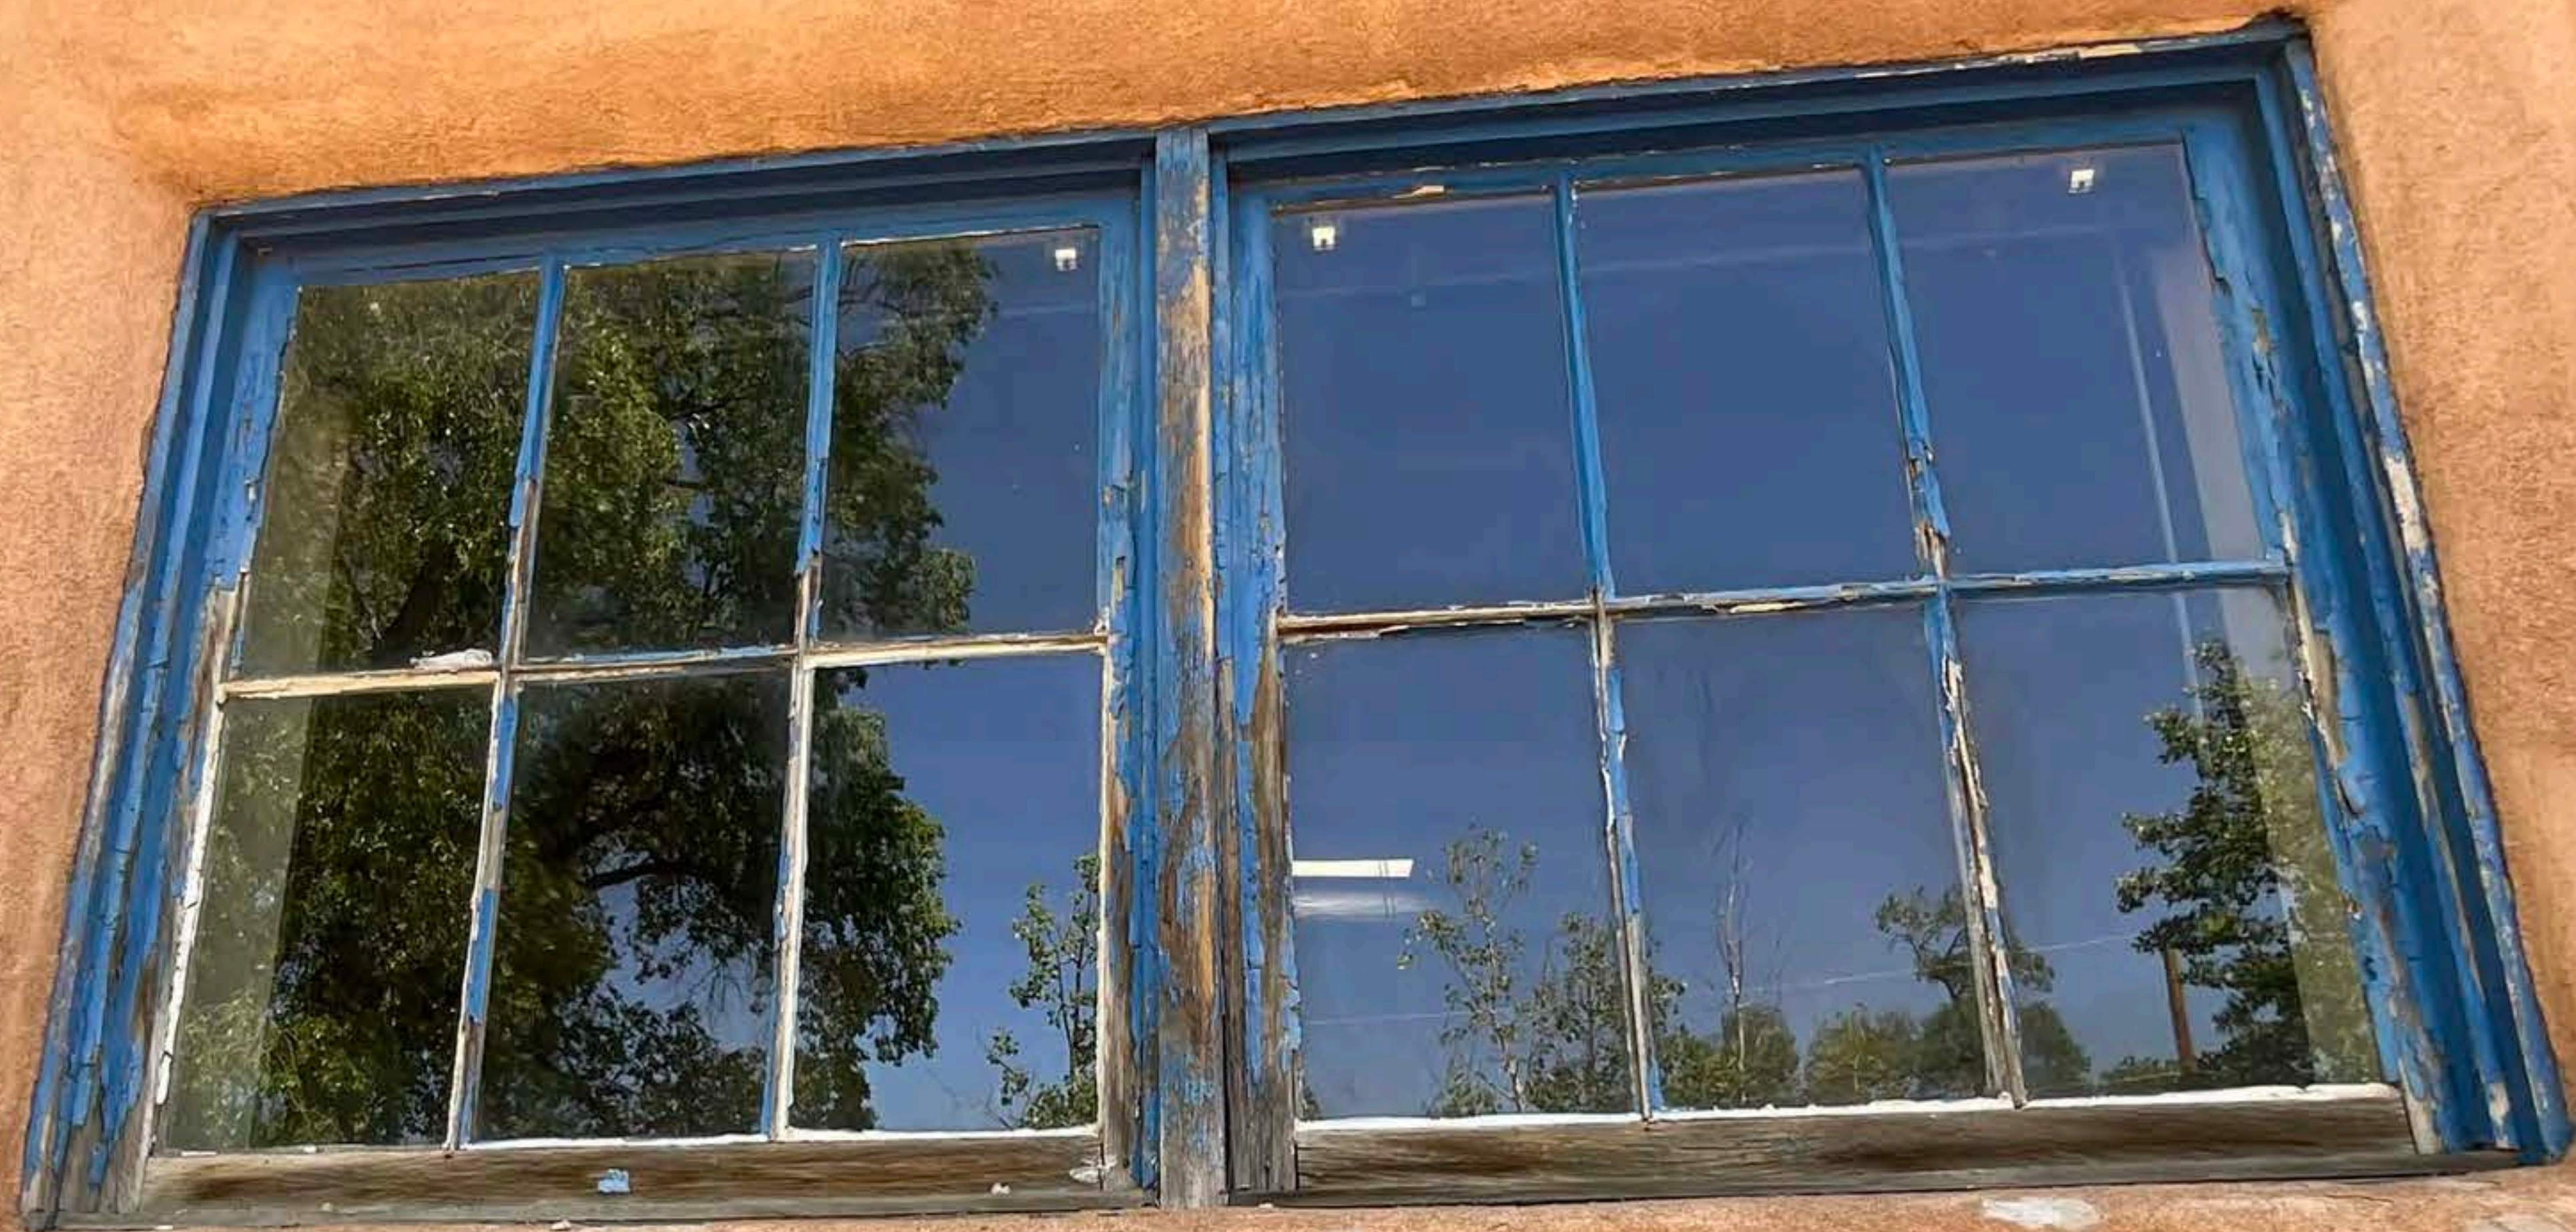
Main House
Window
MH-A

Windows and doors A, C, D, E, DR #1, F and I are non-historic.

If the windows and doors are replaced must be matched to historic requirements and "like and kind" to the existing openings.

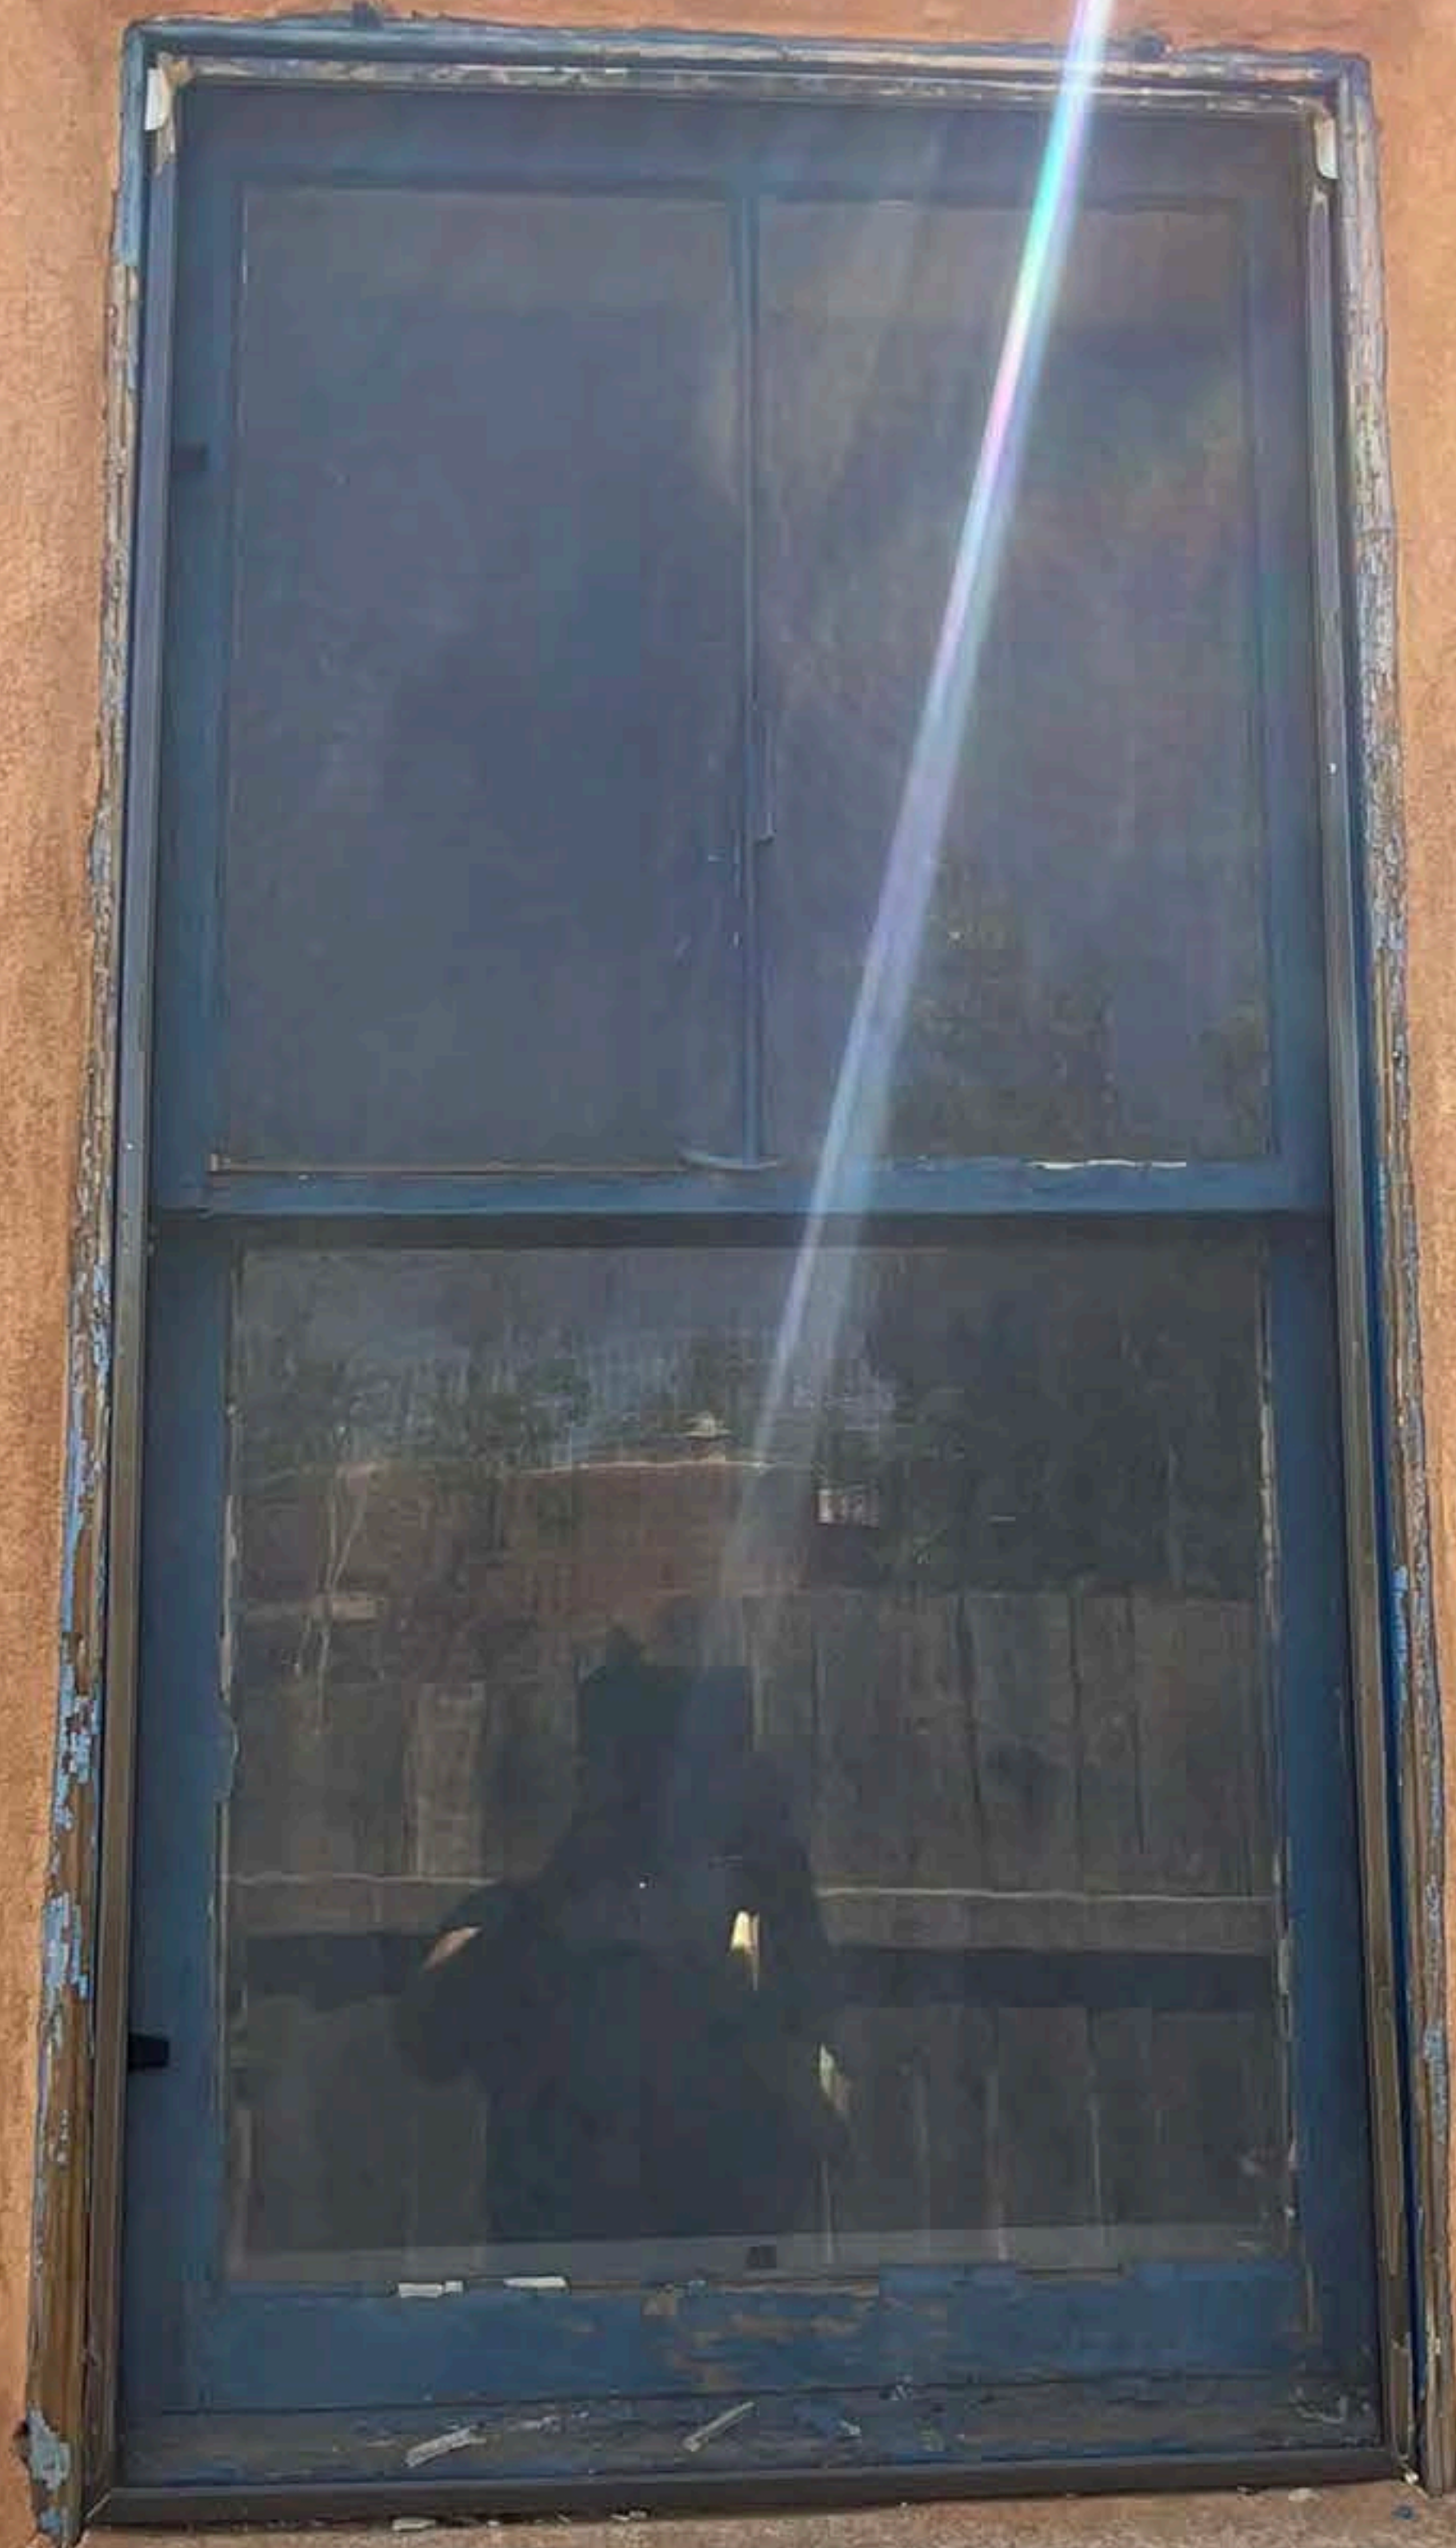
Main House
Window
MH-B

Windows B & H and J are historic however there are signs of water penetration underneath the sills of the water causing structural integrity damage to the adobe. The windows would need to be removed to properly flash the openings to stop the water penetration. The window jambs are the buck in the openings. Removal of the window would destroy the jamb and cause the historic window to be non-reusable and non-restorable.

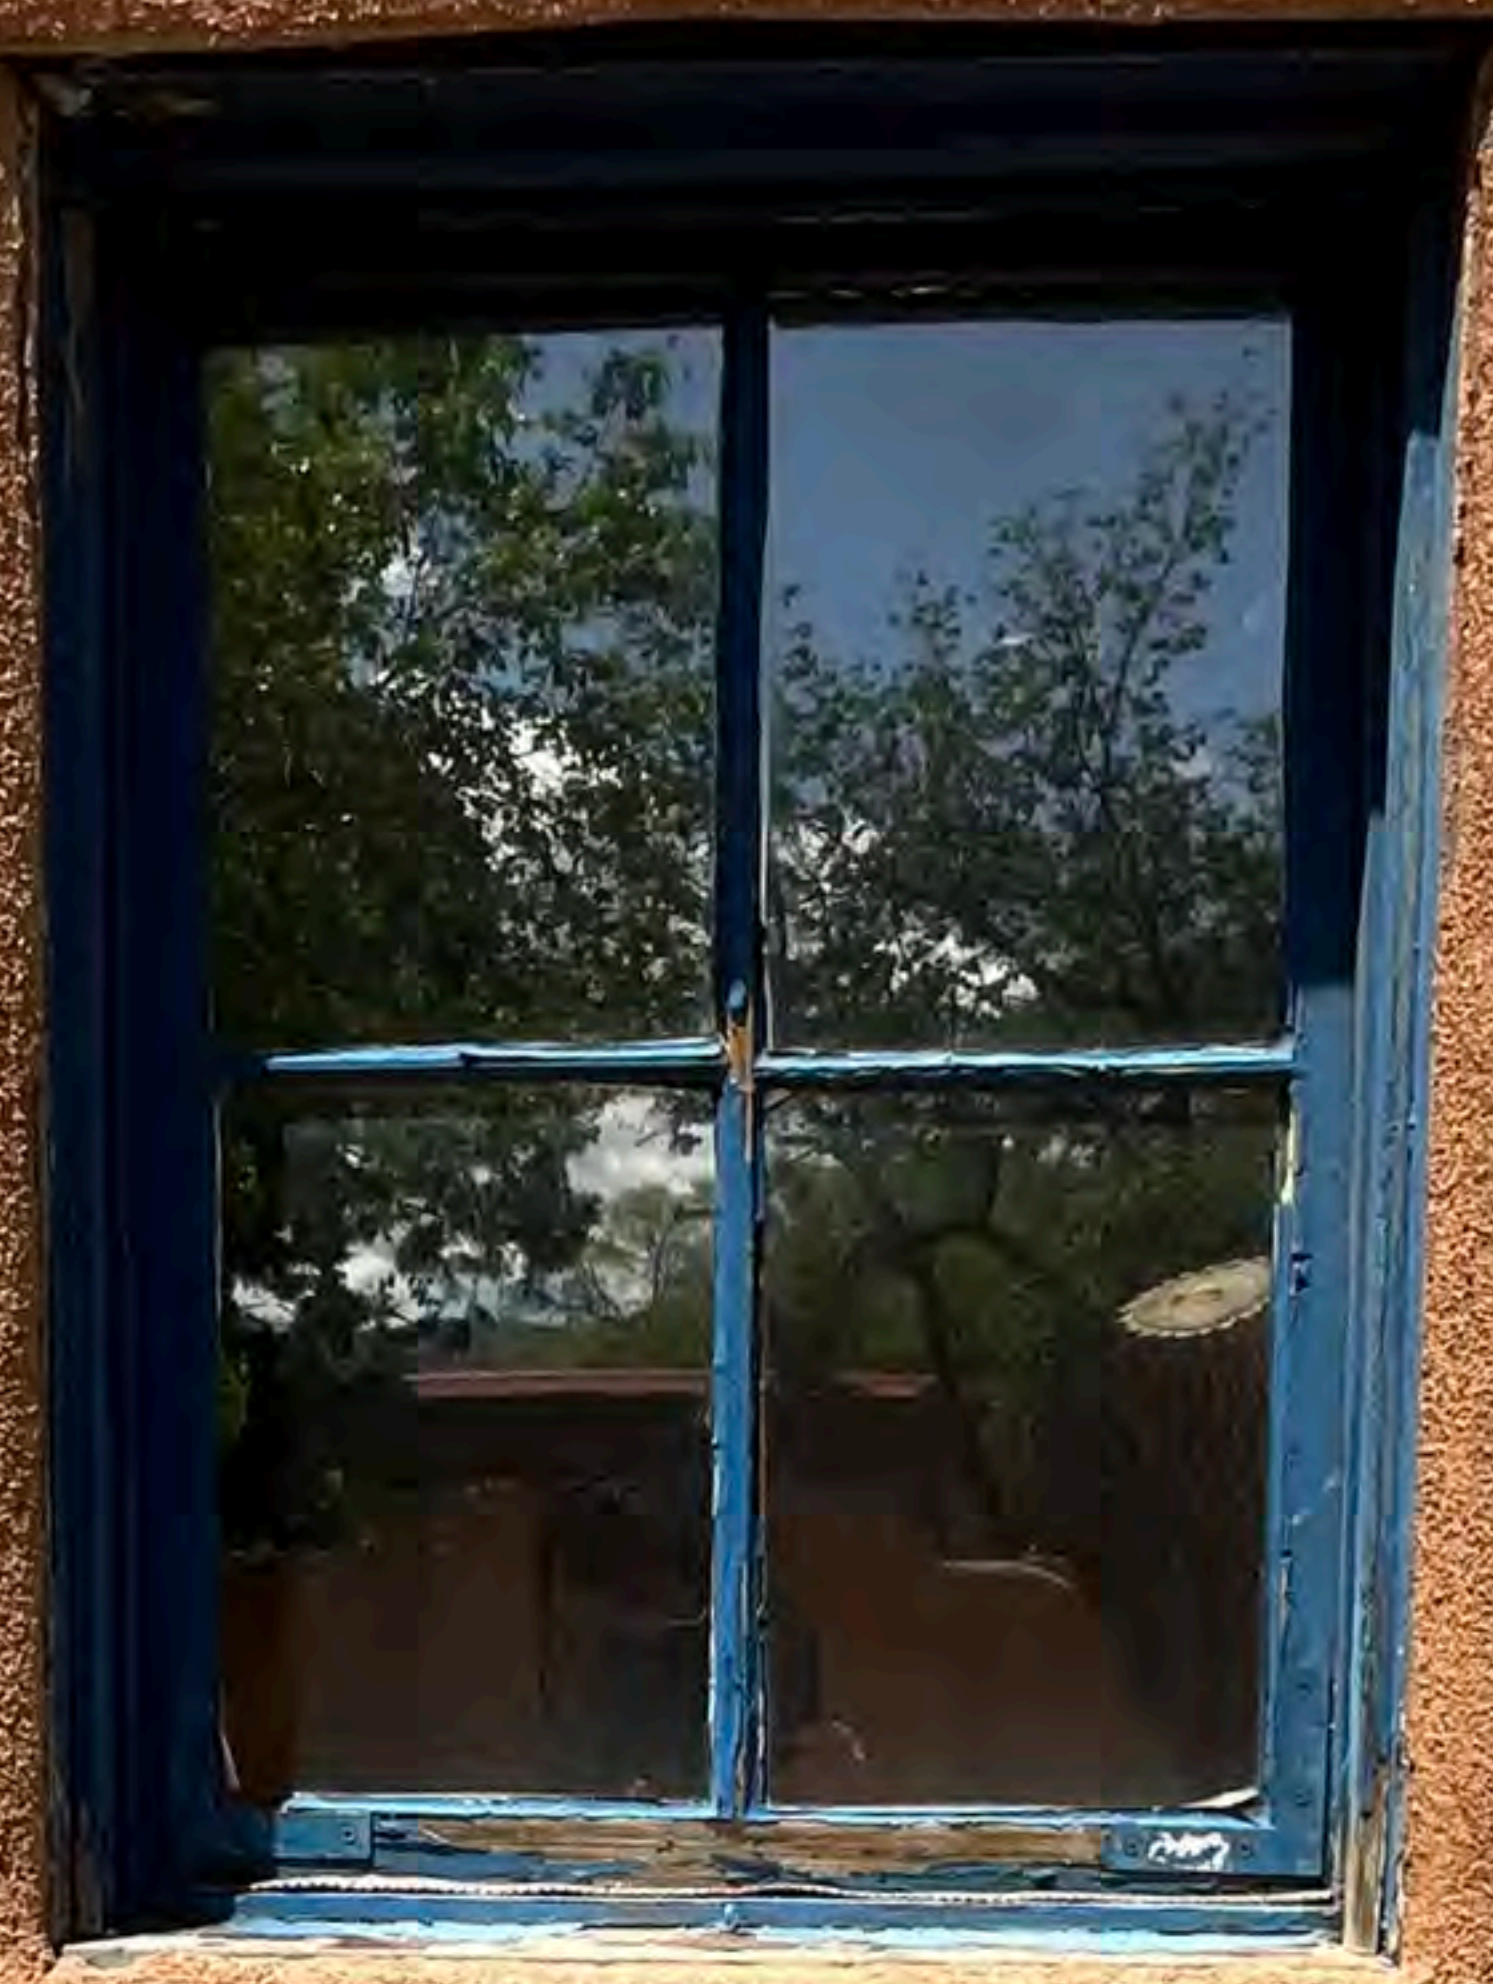
Main House
Window
MH-G

Window G is historic however rotted beyond 40% and non-restorable.

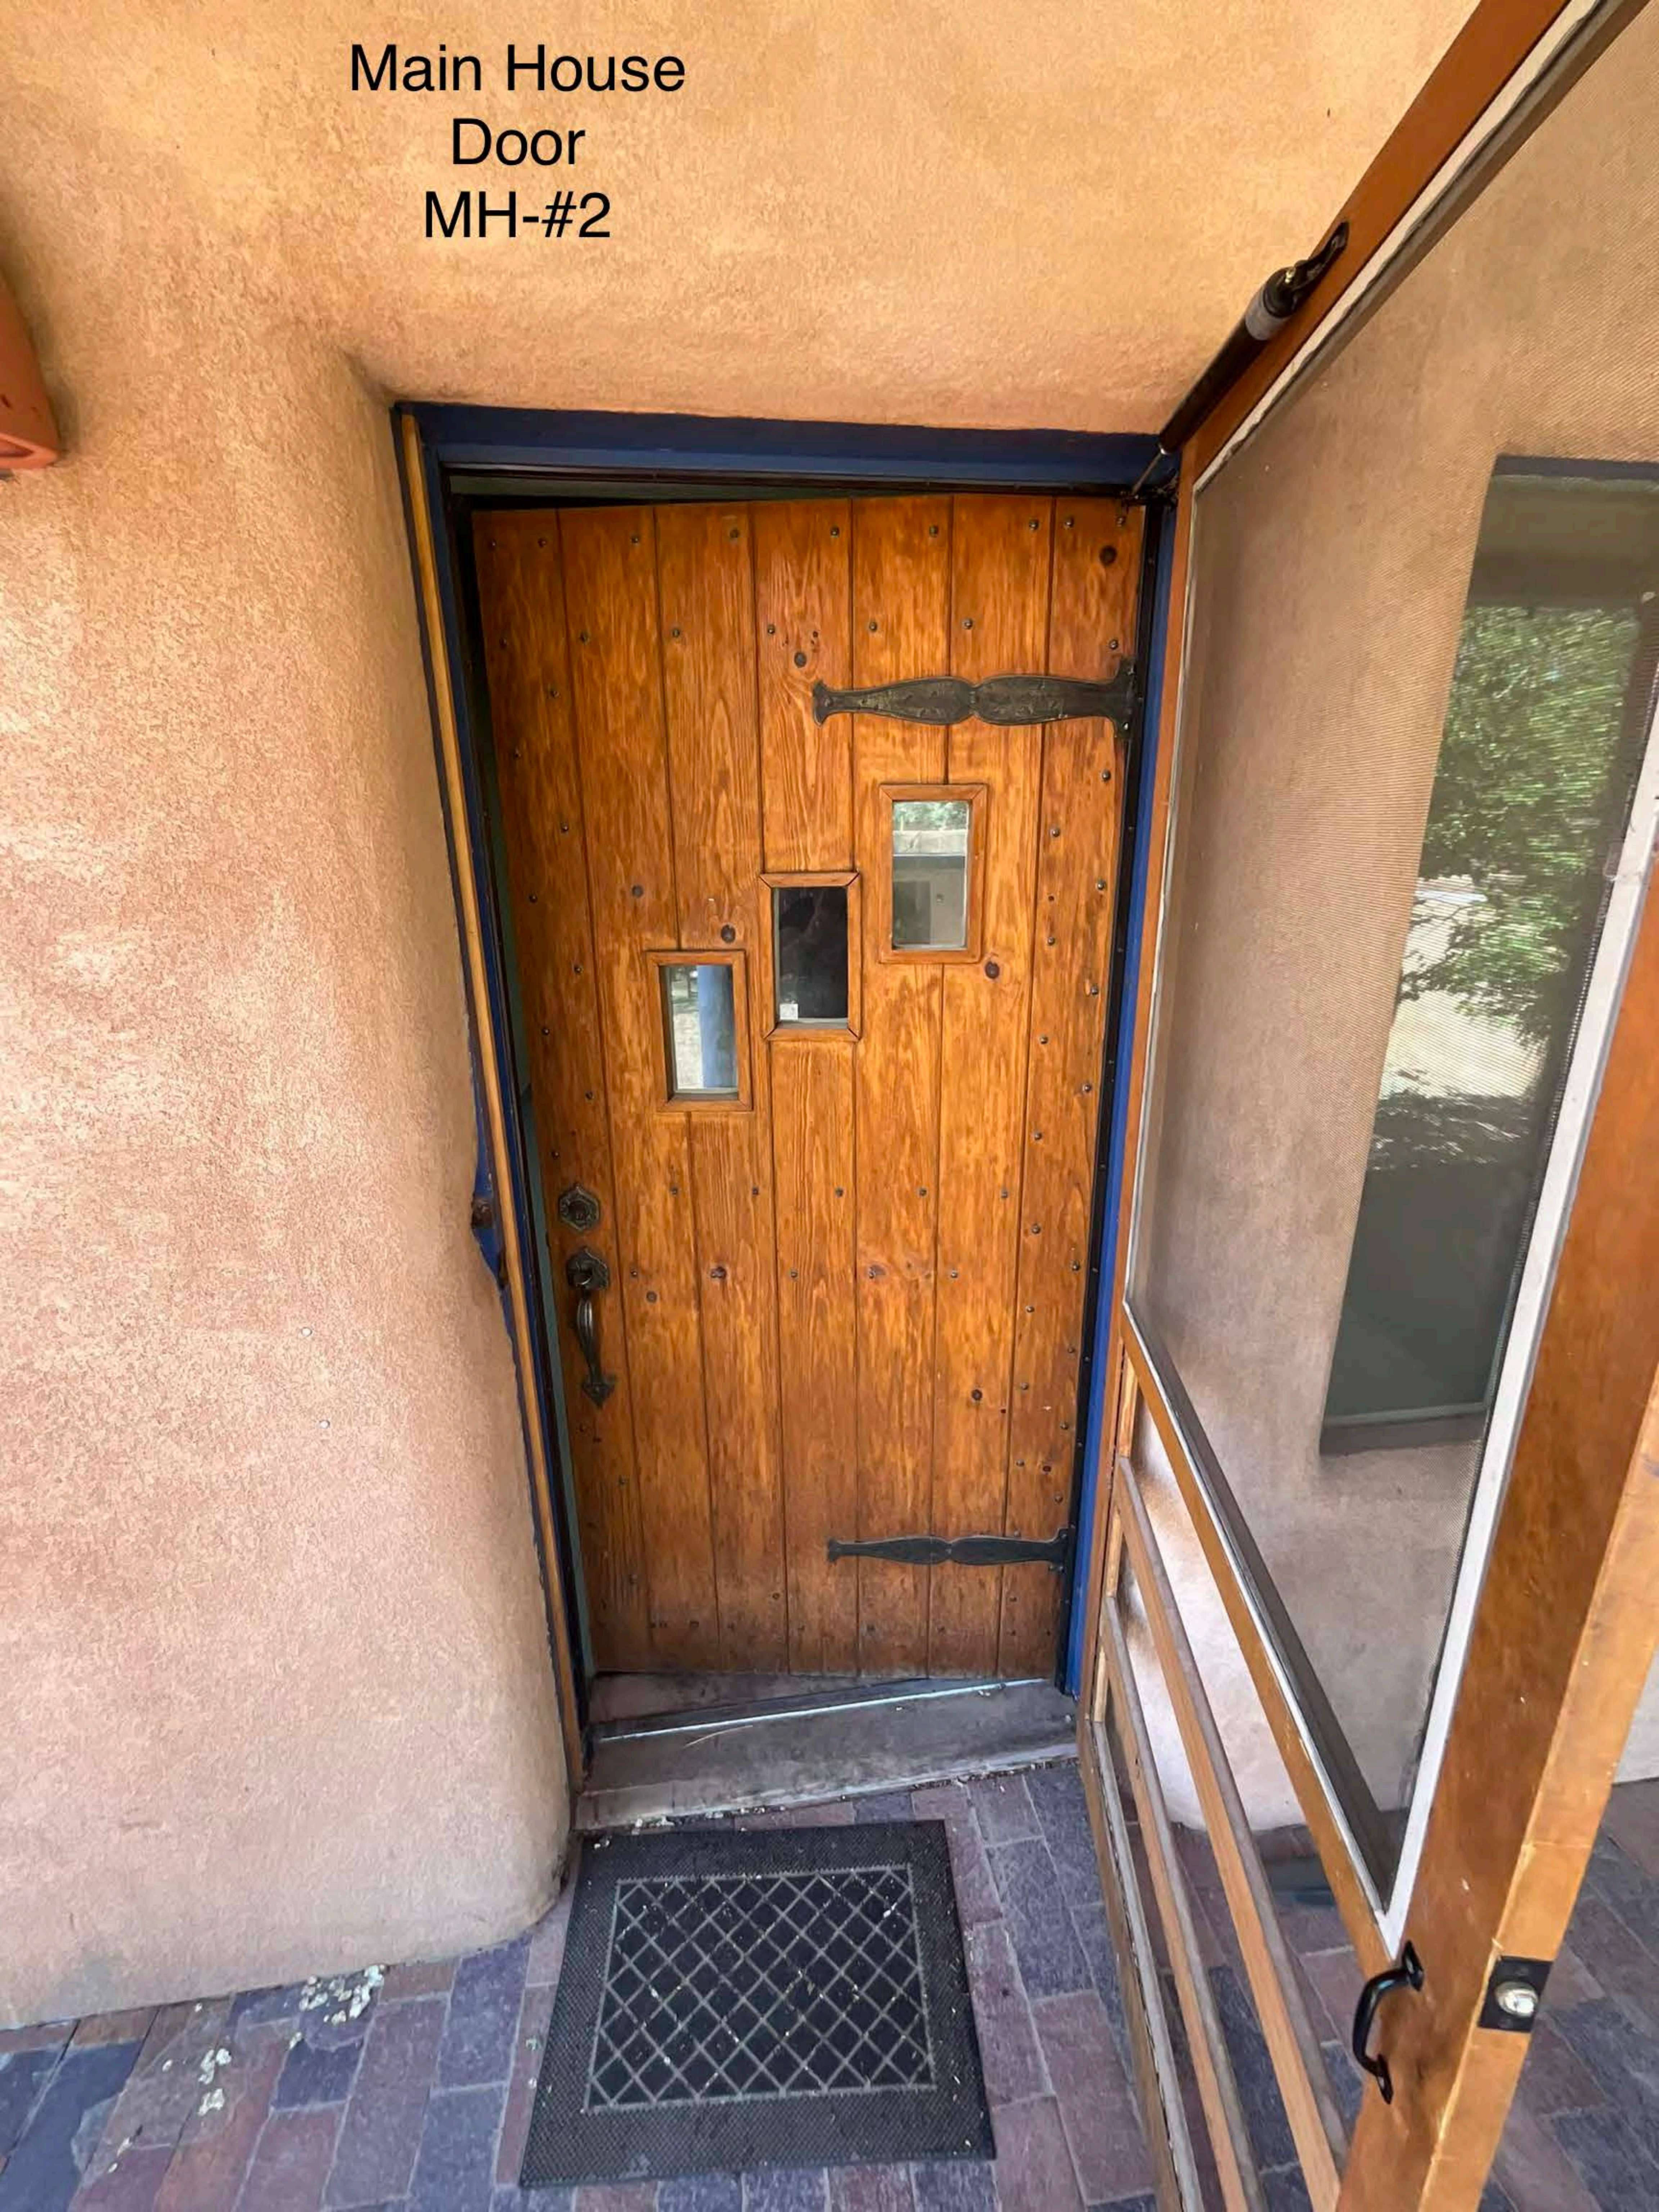
Main House
Window
MH-I

MH-I	14 x 51 FXD STOPPED WITH INSULATED GLASS	S	NON-HISTORIC – INSULATED GLASS WITH 1994 QUARTER ROUND STOP 1994
MH-J	29 x 48 DOUBLE HUNG 2W1H/1-LT	F	HISTORIC
