NEW MEXICO HISTORIC BUILDING INVENTORY - SANTA FE RESURVEY 1995

IDENTIFICATION	ADDRESS: <u>836 Don Cubero</u>		ID NUMBER: <u>0516 00604</u>
			BUILDING NAME:
	UTM REFERENCE EASTING NORTHING	LEGAL DESCRIPTION:	SANTA FE ID NUMBER: <u>H1683</u>
	ZONE <u>12 13</u>	TNSP <u>17</u> <u>N</u> S RANGE <u>9</u> <u>E</u> W SEC <u>26</u> <u>NE</u> 1/4 <u>SE</u> 1/4	
BUILDING DATA	FIELD MAP <u>Santa Fe Historic Structures Survey, 1983-85/1992</u>		
	DATE OF CONSTRUCTION: ____ ESTIMATE <u>1928</u> ^{by} ACTUAL		
	SOURCE(S) <u>city directory</u> <u>1930 Sanborn</u>		
	ARCHITECTURAL STYLE: <u>Vernacular</u>		
USE:			
HISTORIC: <u>residential</u>			
OTHER _____			
PRESENT: <u>residential</u>			
OTHER _____			
SURROUNDINGS: <u>residential</u>			
RELATIONSHIP TO HISTORIC SURROUNDINGS: <input checked="" type="checkbox"/> SIMILAR _____ NOT SIMILAR			
ASSOCIATED BUILDINGS ON SITE: <input checked="" type="checkbox"/> YES _____ NO			
WHAT TYPE? <u>garage</u>			
IF INVENTORIED, LIST ID NUMBER(S) _____

836 Don Cubero

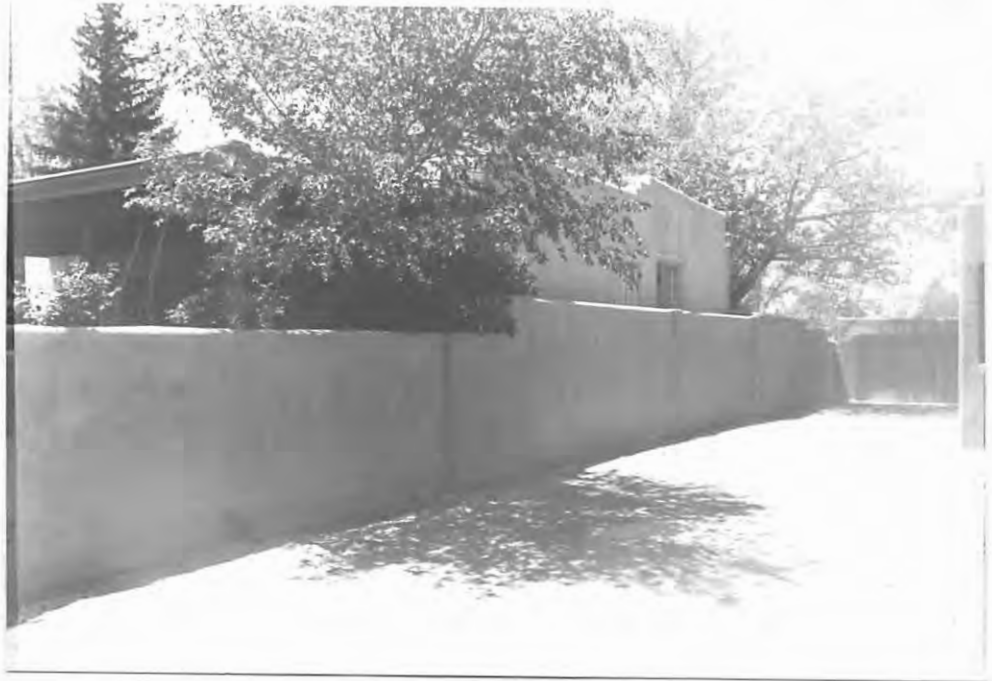
#7 north elevation

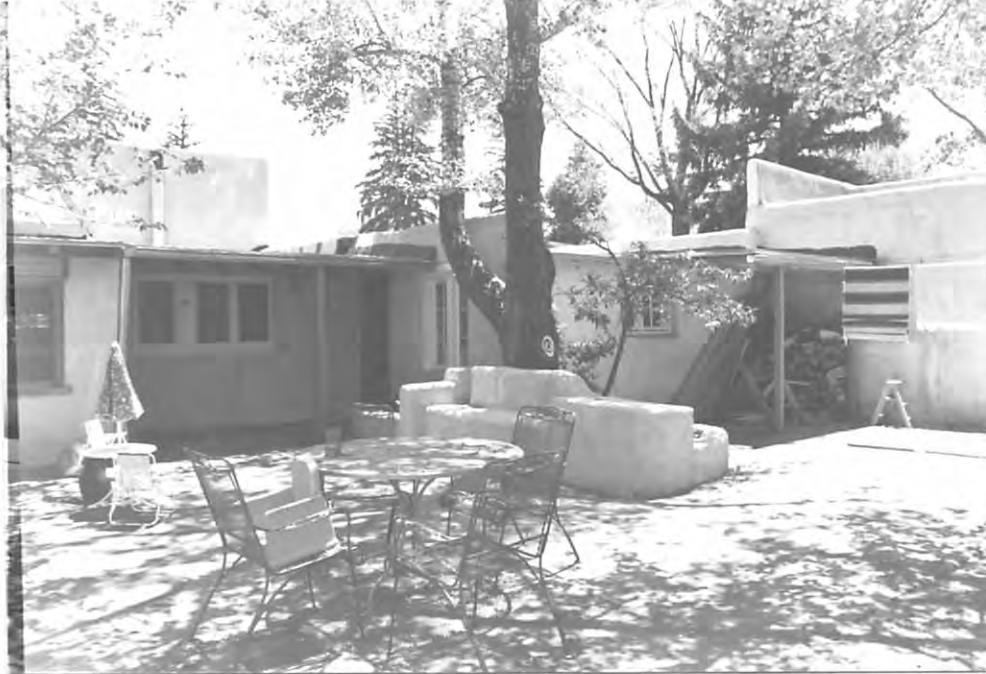
#2 from NW, garage at right

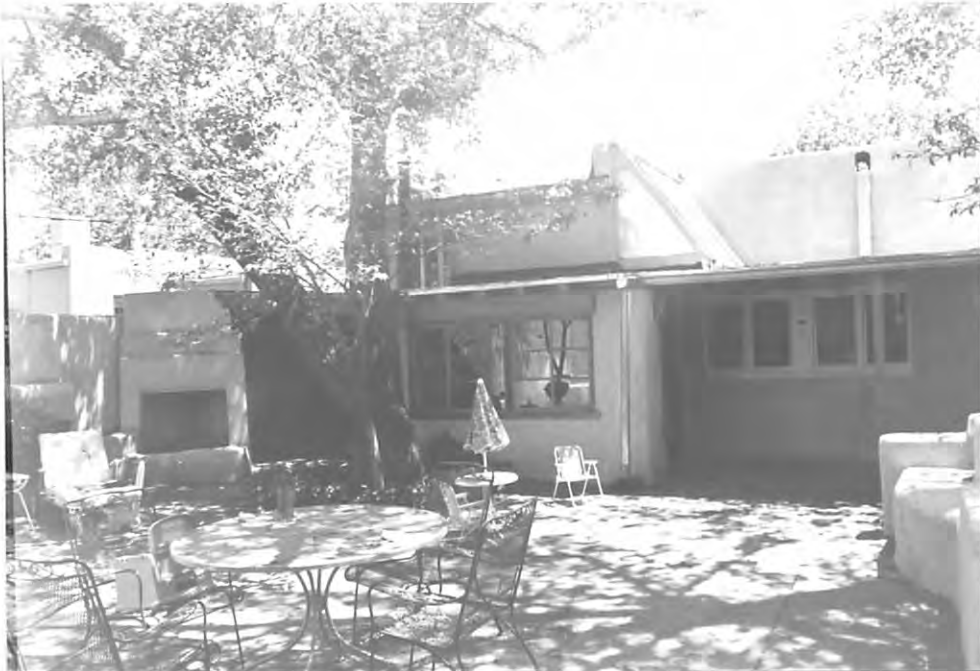
COMMENTS Addition on W - 1 1/2 story (site slopes down) with solar clerestory over casements on S, steel casements in west wall, aluminum slider W, upper story. Owner reports door moved

#0 west elevation

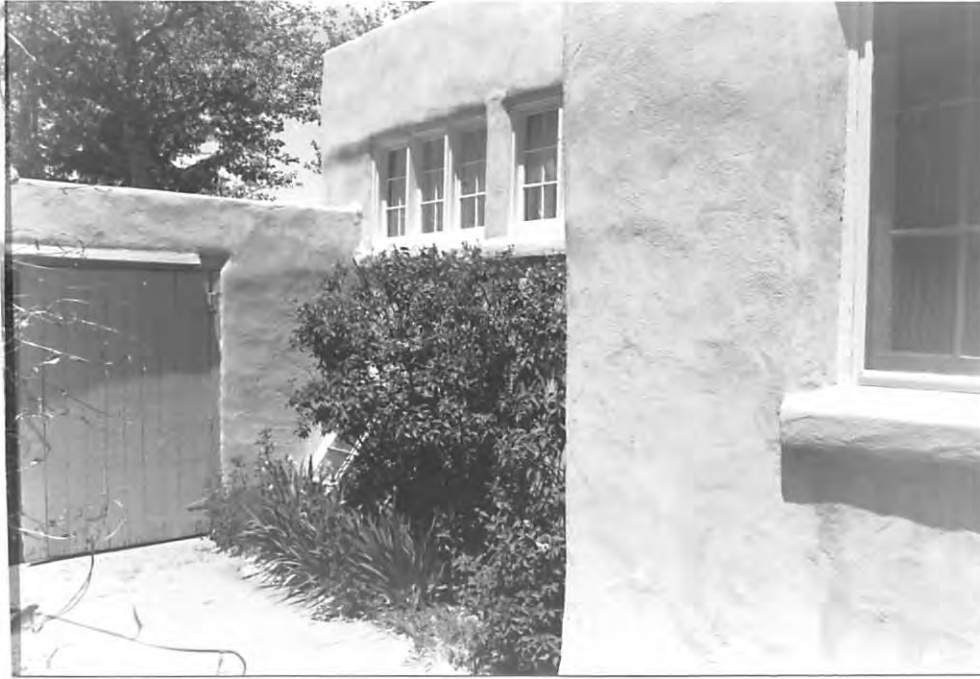
#5 south center

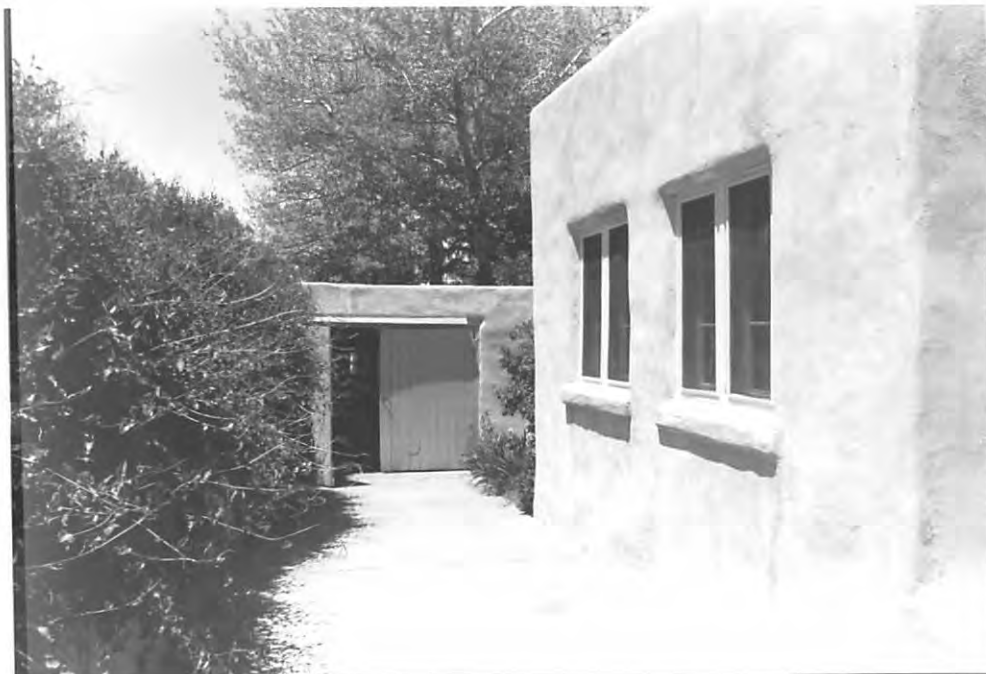
#4 garage, east
