**MEMORANDUM**

**RE:** 515 Paseo de Peralta**Date:** June 30, 2025**TO:** Amanda RomeroHistoric Senior Planner  
Land Use Department  
City of Santa Fe**Subject:** HDRB Status Review – 515 Paseo de Peralta**Attachments:**

# Historic Cultural Properties Inventory (HCPI) Base Form (FORM 1)

Date	Issue
MAY, 6th 2025	
Drawn by	Checked by
JUS	JUS
File	Plot Date
515 PdPeralta_A100 Plans 250331.vwx	
Set	Schematic Design Set
Sheet Title	EXISTING FLOOR PLAN w/ STRUCTURAL DEFICIENCIES
<b>S001</b>	
Sheet	of

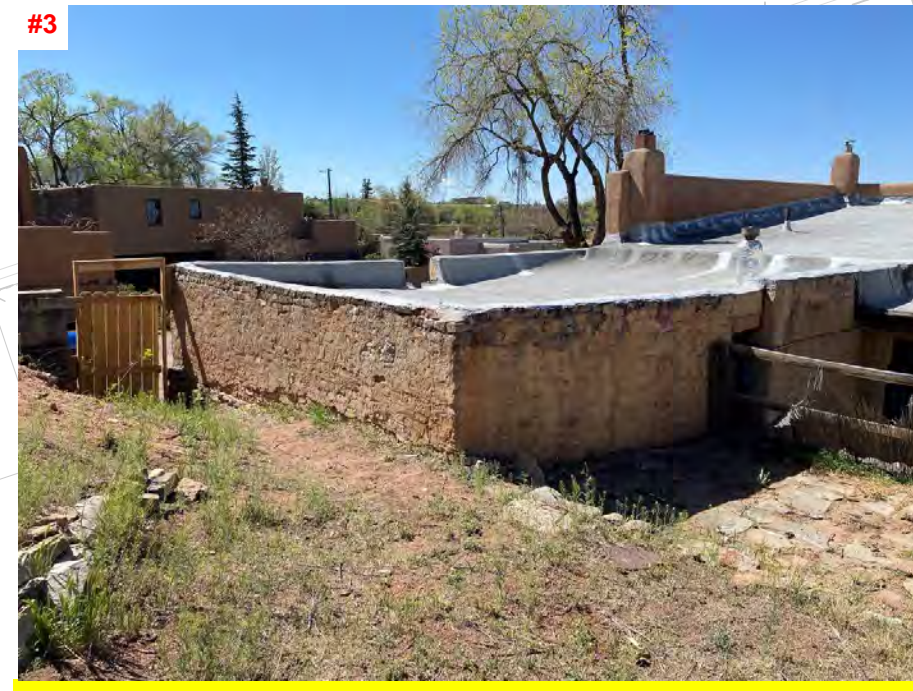
- The garage walls are dependent on an assortment of unreinforced brick, stone and clay-block (pentile) masonry walls. The northwest and northeast walls are retaining up to 6 feet of soil. A waterproofing and drainage system was not observed and could lead to hydrostatic pressure building up behind the retaining portion. Moisture intrusion has caused some debonding of the masonry and deterioration of the wall itself. This condition can potentially cause a hazard and could be susceptible to collapse under extreme loading scenarios. The unreinforced wall cannot properly resist lateral earth pressures and cannot sufficiently transfer loading.

#3 RUBBLE RETAINING WALL, WATERPROOFING NOT PRESENT AND DETERIORATION PRESENTS ON EXTERIOR. THE WALL IS ALSO CONSTRUCTED WITH NON-STANDARD MASONRY MATERIAL AND PRACTICES

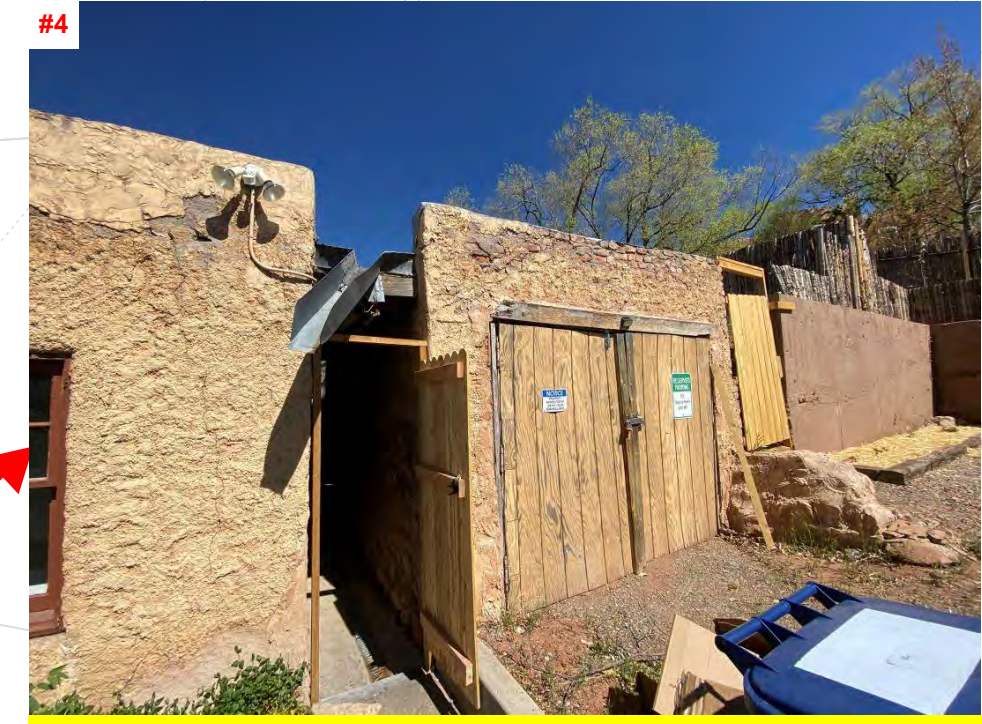
- The far north-east unreinforced stone masonry retaining site wall is dependent on an assortment of various sized stones with mortar joints. The northeast wall is integrated into the existing garage wall and is retaining up to 5 feet of soil. A waterproofing and drainage system was not observed and could lead to hydrostatic pressure building up behind the retaining wall. This condition can potentially cause rotational movement and sliding under typical loading scenarios. The unreinforced wall cannot properly resist lateral earth pressures and cannot sufficiently retain the earth behind the wall.

#4 MORTAR JOINTS ON RUBBLE MASONRY WALL HAVE DE-BONDED AND HAVE COMPROMISED THE WALLS STRUCTURAL INTEGRITY.

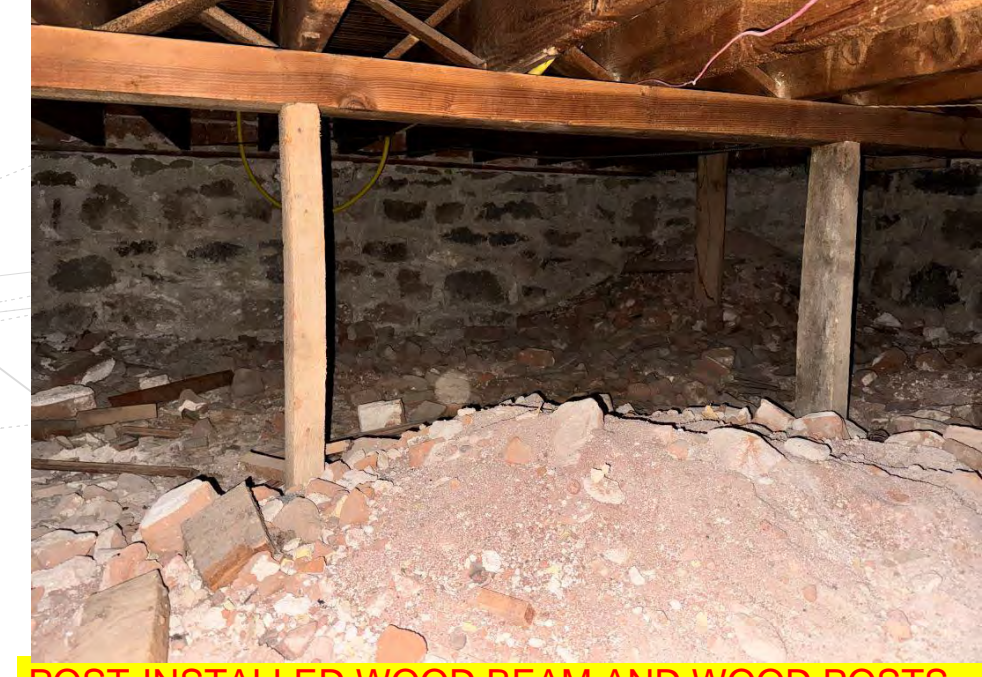
- Wood timber posts were installed in an apparent attempt to control floor joist deflections and correct floor framing alterations. The timber supports are at random locations throughout the residence. This condition will need to be corrected with a new wood post and wood beam system with concrete spot footings at the new posts.

#7 POST-INSTALLED WOOD BEAM AND WOOD POSTS FOUNDED ON SOIL OR TIMBER PLANKS INSTALLED THROUGHOUT FOOTPRINT OF ORIGINAL STRUCTURE

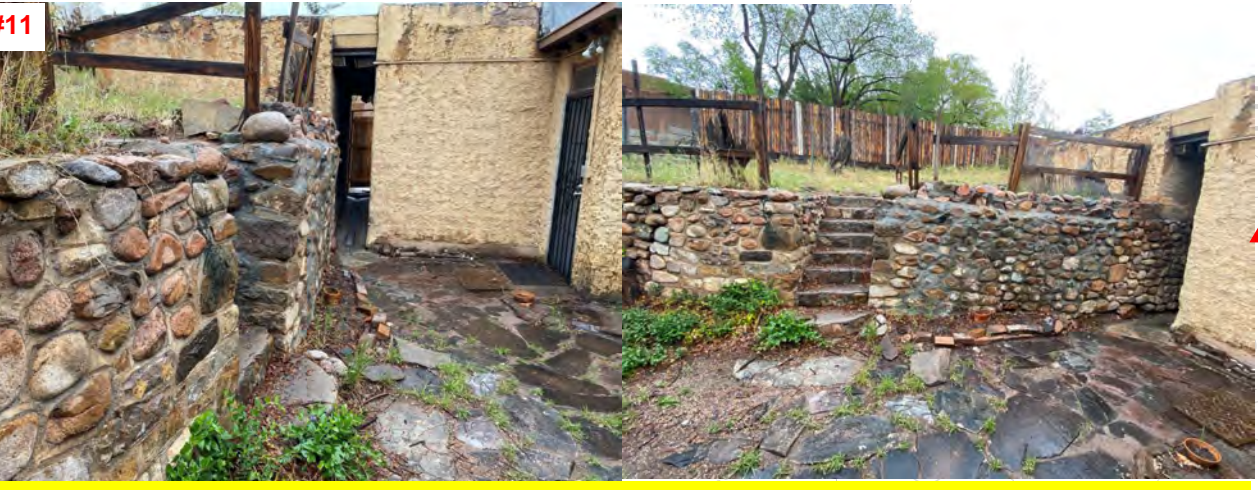
- The southwest corner of the residence exhibited a large crack propagating from the exterior facade to the interior plaster finish. Upon further investigation it was noted that water intrusion had occurred and compromised the masonry and mortar joints in this area. The damaged portion of the wall should be reconstructed with standard masonry techniques to reestablish structural integrity.

#11 CRACK EXTENDS THROUGH ENTIRE WALL SECTION, MASONRY COURSES HAVE DE-BONDED AND THE STRUCTURAL INTEGRITY OF THE WALL HAS BEEN COMPROMISED

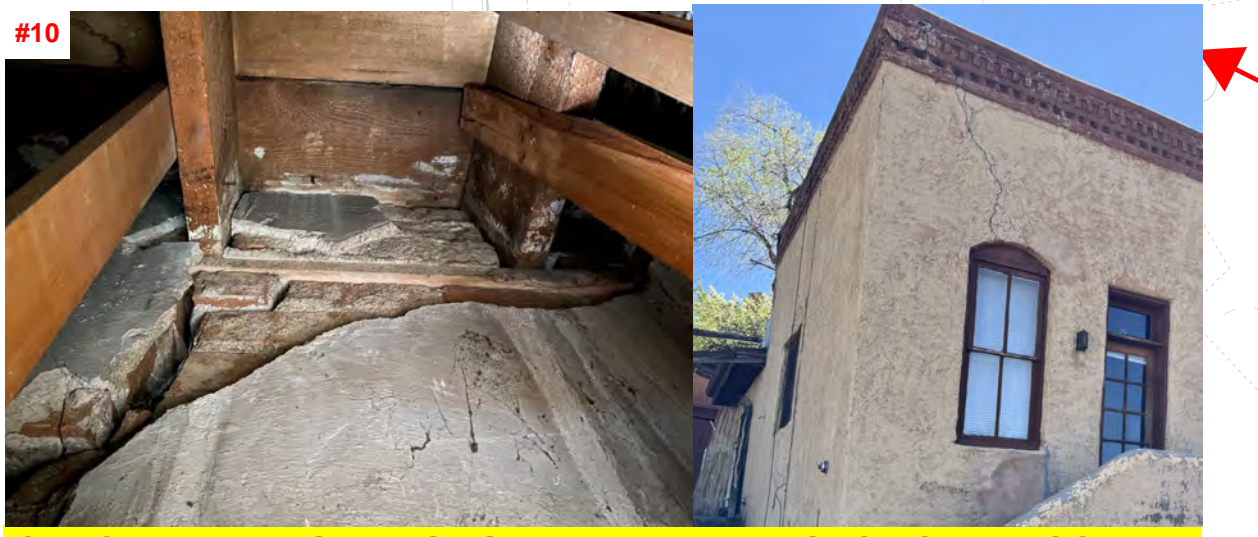
#10 CRACK EXTENDS THROUGH ENTIRE WALL SECTION, MASONRY COURSES HAVE DE-BONDED AND THE STRUCTURAL INTEGRITY OF THE WALL HAS BEEN COMPROMISED

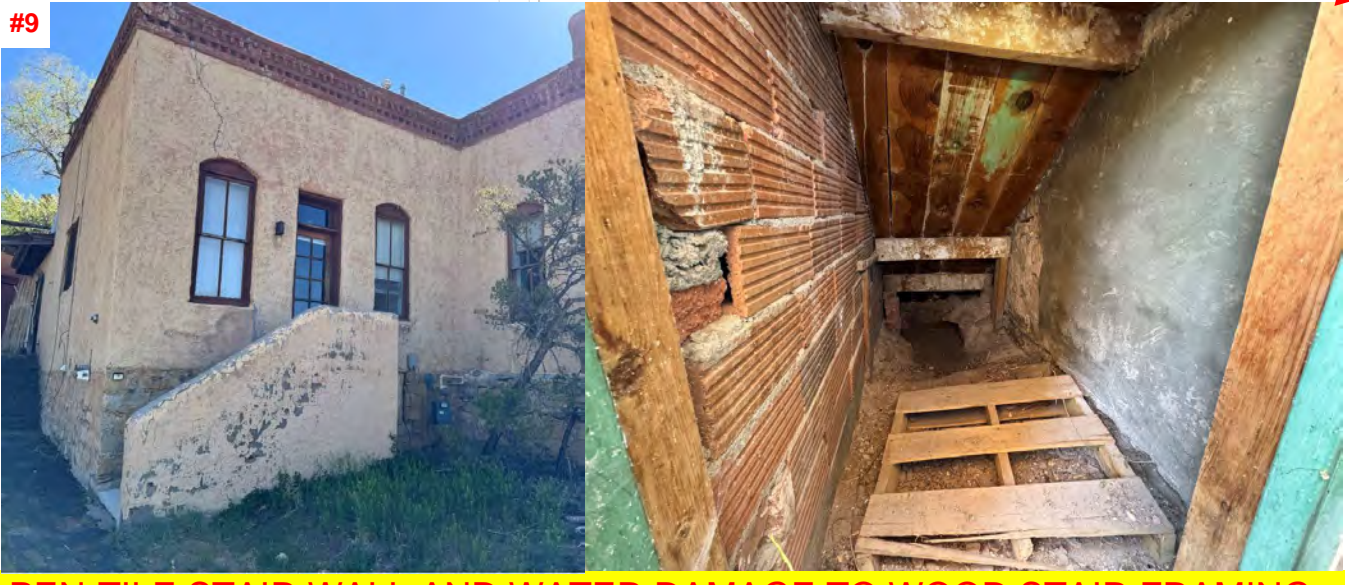
#9 PEN-TILE STAIR WALL AND WATER DAMAGE TO WOOD STAIR FRAMING, FUNGAL DECAY OF WOOD HAS BEGUN AND HAS COMPROMISED THE STRUCTURAL SECTION

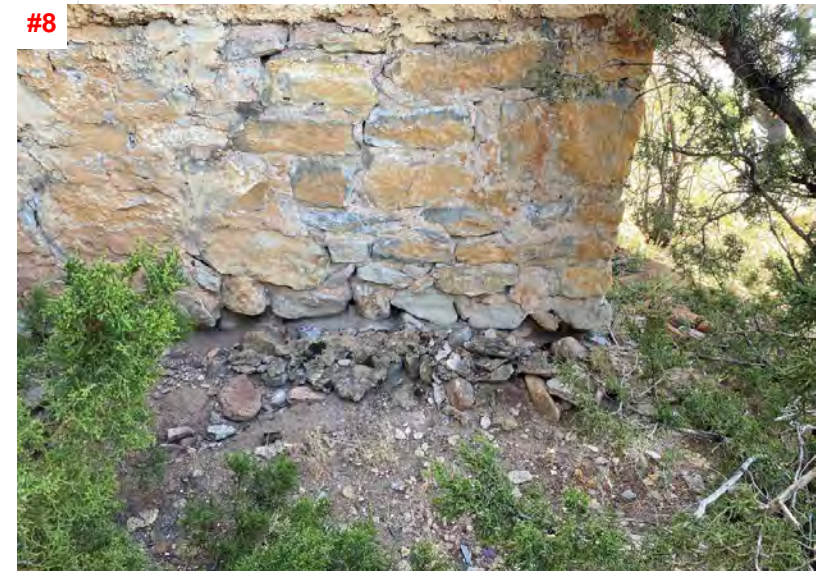
- Tunneling through stone masonry stem walls to accommodate HVAC & plumbing chases were noted to occur in numerous locations throughout the main residence. This alteration will need to be corrected as it has caused localized failures of the wood bearing plates for the floor system.

#8 DAMAGE TO RUBBLE FOUNDATION STEM WALL

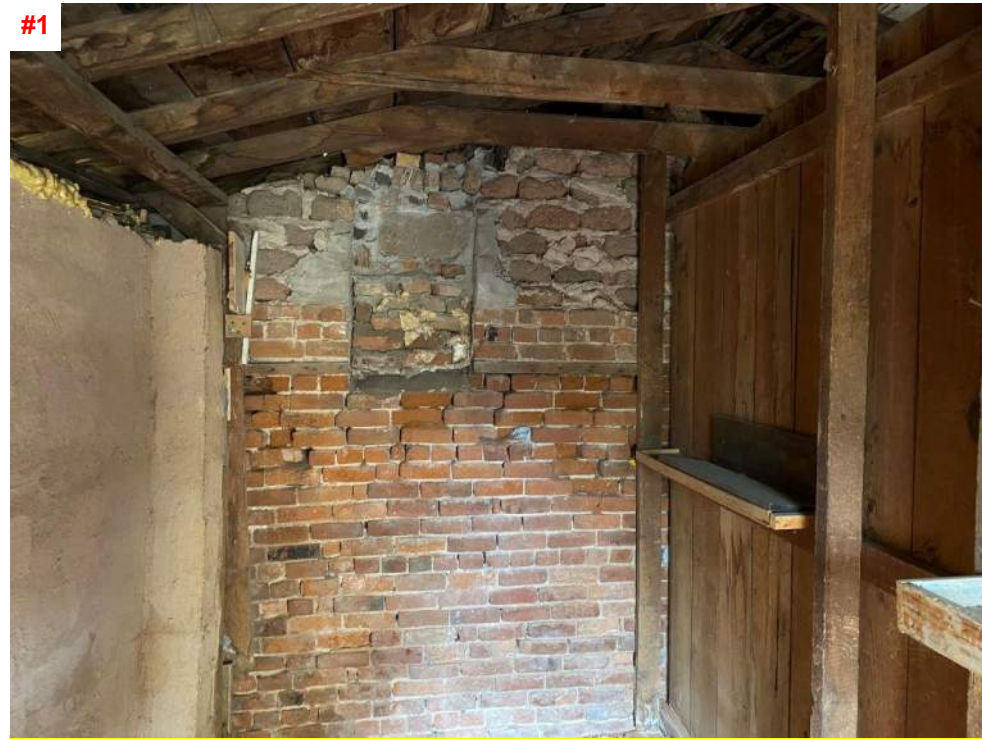
#1 RUBBLE RETAINING WALL, WATERPROOFING NOT PRESENT AND DETERIORATION PRESENTS ON EXTERIOR & INTERIOR FACES.

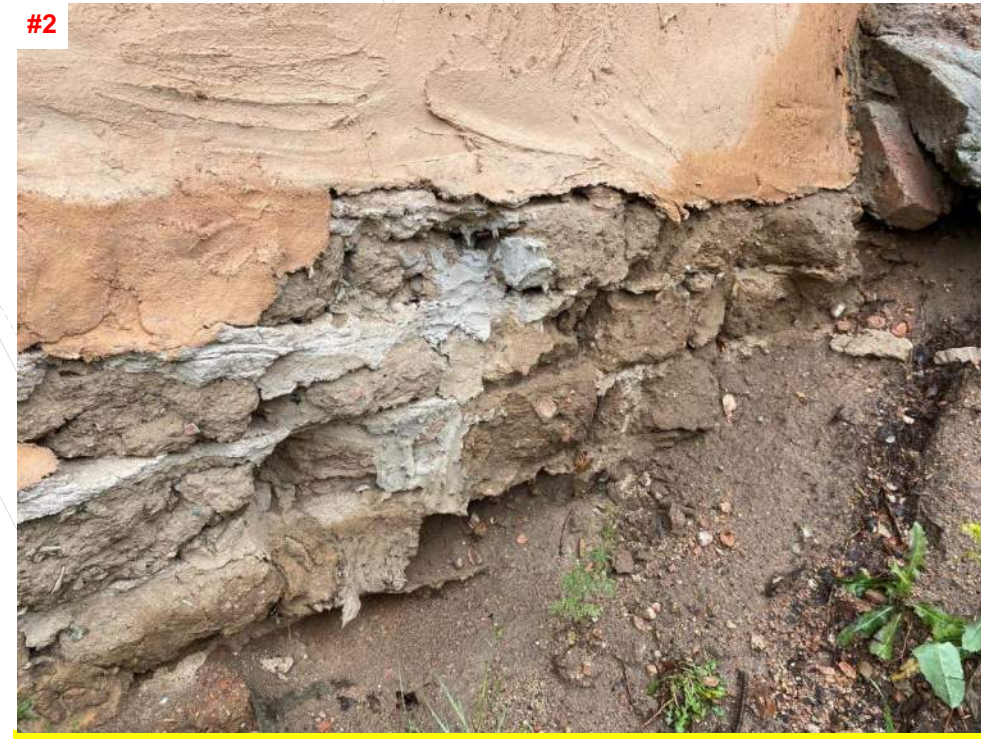
#2 A PORTION OF THE SHED WALLS ARE CONSTRUCTED WITH ADOBE. SIGNIFICANT DETERIORATION OF THE ADOBE BLOCK FROM MOISTURE INTRUSION WAS OBSERVED, AND NO FOUNDATION WAS DETECTED.

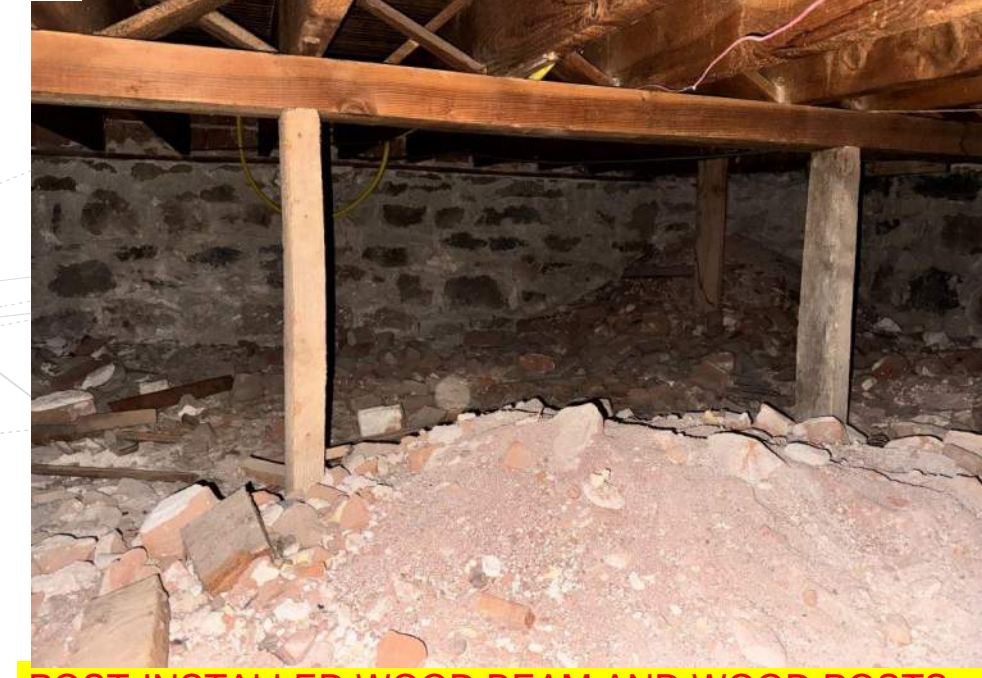
#7 POST-INSTALLED WOOD BEAM AND WOOD POSTS FOUNDED ON SOIL OR TIMBER PLANKS INSTALLED THROUGHOUT FOOTPRINT OF ORIGINAL STRUCTURE

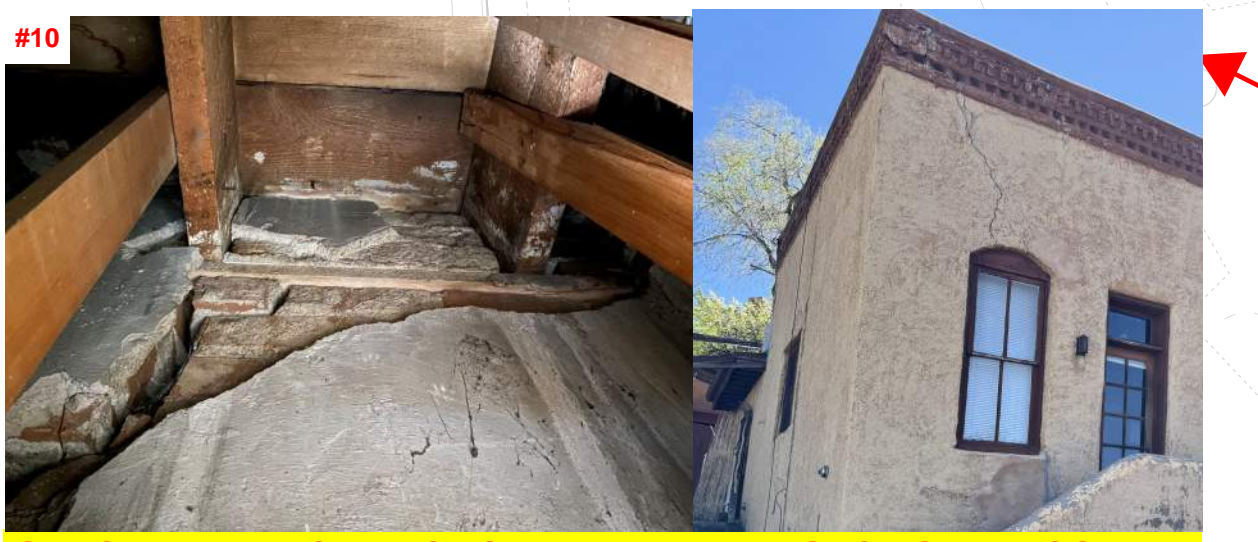
#10 CRACK EXTENDS THROUGH ENTIRE WALL SECTION, MASONRY COURSES HAVE DE-BONDED AND THE STRUCTURAL INTEGRITY OF THE WALL HAS BEEN COMPROMISED

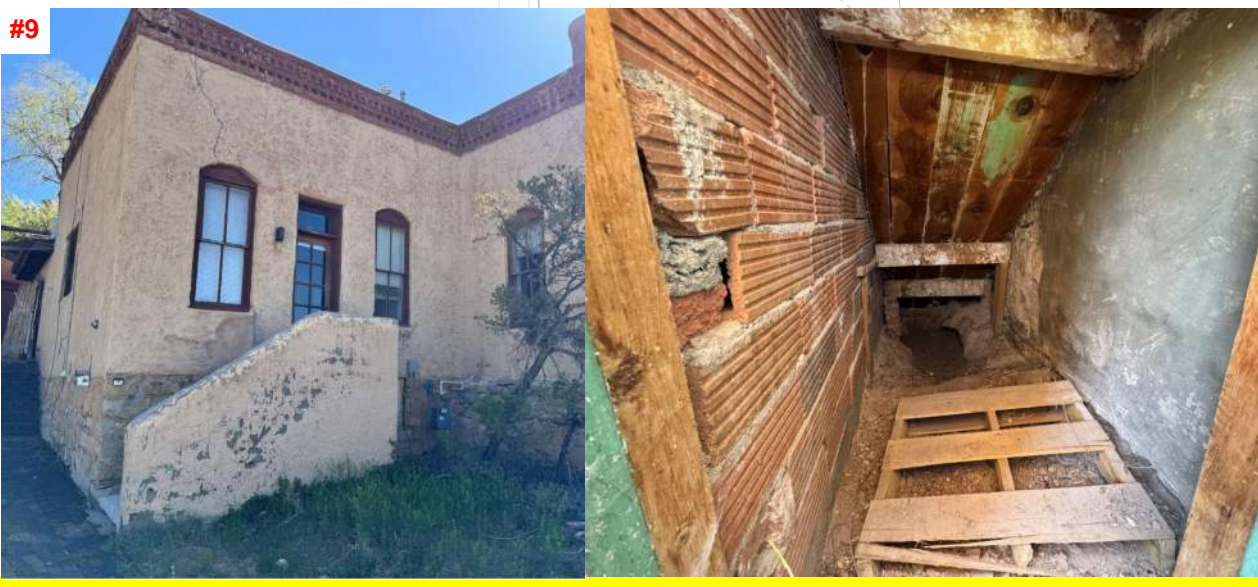
#9 PEN-TILE STAIR WALL AND WATER DAMAGE TO WOOD STAIR FRAMING, FUNGAL DECAY OF WOOD HAS BEGUN AND HAS COMPROMISED THE STRUCTURAL SECTION

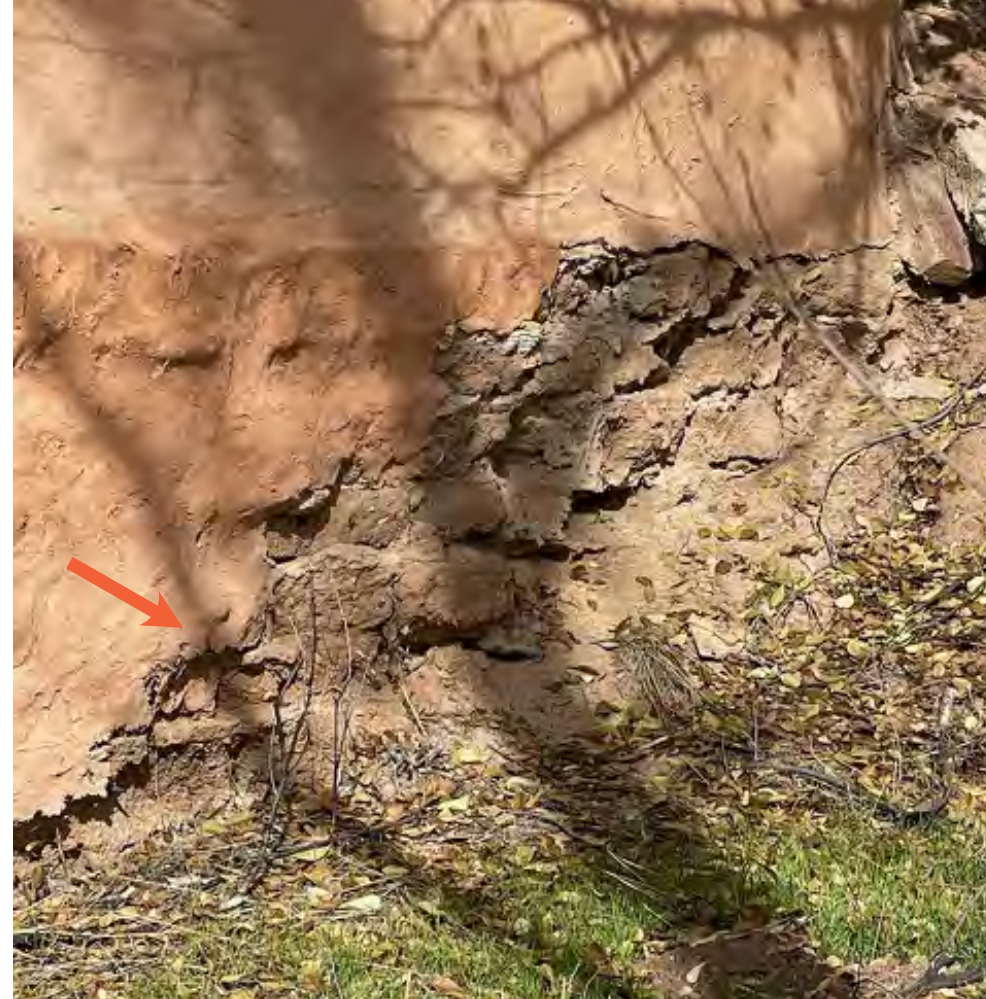
ADOBE BRICK DETERIORATING, NO FOUNDATIONS  
(STRUCTURAL CONCERN)

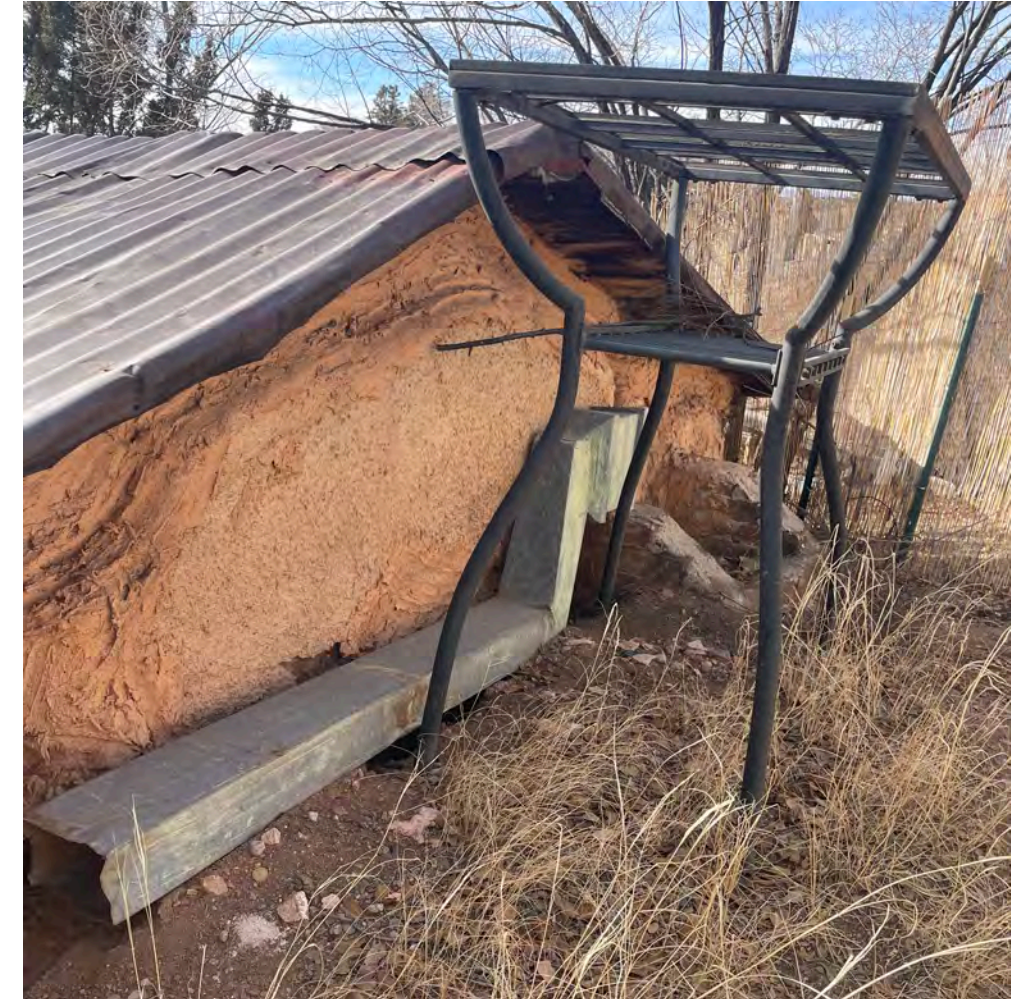
NORTH WALL IS ACTING AS A RETAINING WALL  
(STRUCTURAL CONCERN)

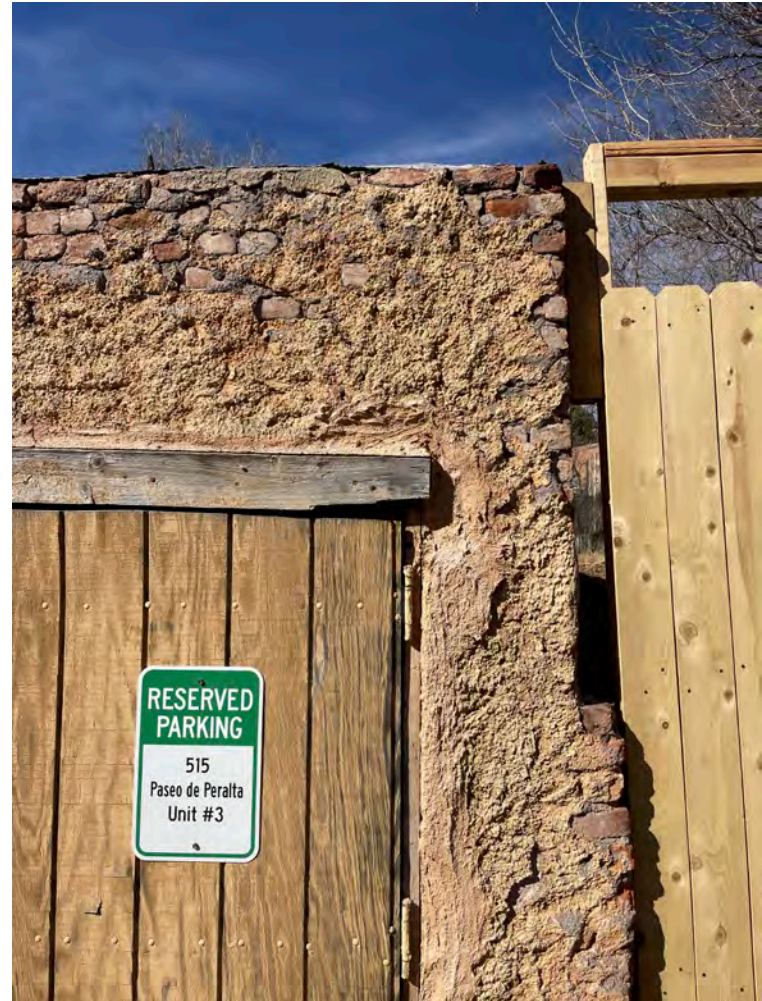
**DETERIORATING BRICK**

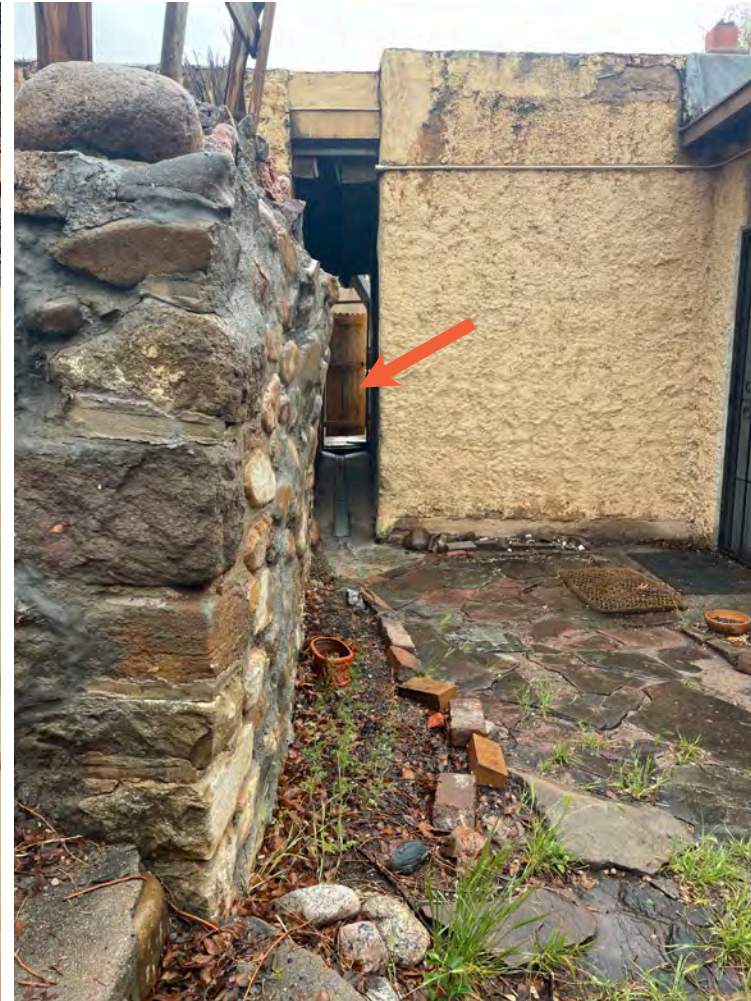
**STONE RETAINING WALL  
(STRUCTURAL CONCERN)**

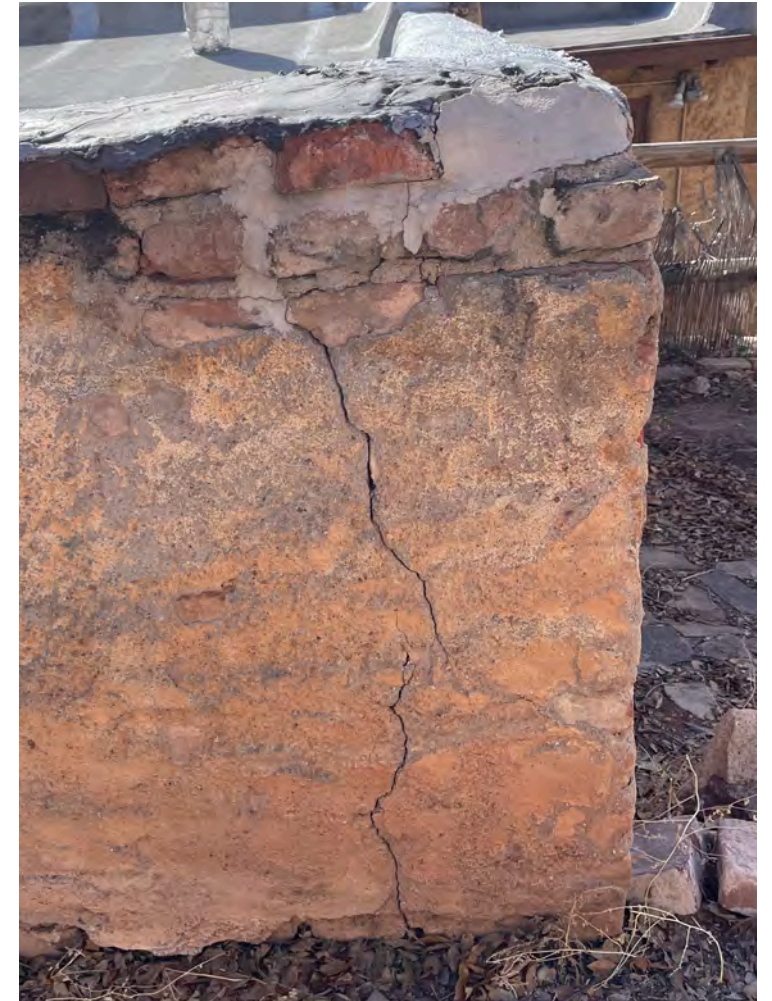
**NO FOUNDATION,  
RETAINING AT LEAST 6' OF SOIL  
(STRUCTURAL CONCERN)**
