NEW MEXICO HISTORIC BUILDING INVENTORY - SANTA FE RESURVEY 1996

IDENTIFICATION	ADDRESS: <u>515 Paseo de Peralta</u> <u>(previously 133 Hillside)</u>	OLD ID NUMBER: <u>051610566</u>	
	UTM REFERENCE EASTING NORTHING ZONE <u>12 13</u>	LEGAL DESCRIPTION: TNSP <u>17</u> (N) S RANGE <u>9</u> (E) W SEC <u>24</u> NE 1/4 SW 1/4	BUILDING NAME:
	FIELD MAP <u>Santa Fe</u> Historic Status Map 1996	SANTA FE ID NUMBER: <u>H 30040</u>	
BUILDING DATA	DATE OF CONSTRUCTION: by _____ ESTIMATE <u>1890</u> ACTUAL _____ SOURCE(S) <u>owners</u>

ID NUMBER: 051610566

SANTA FE ID NUMBER: H30040

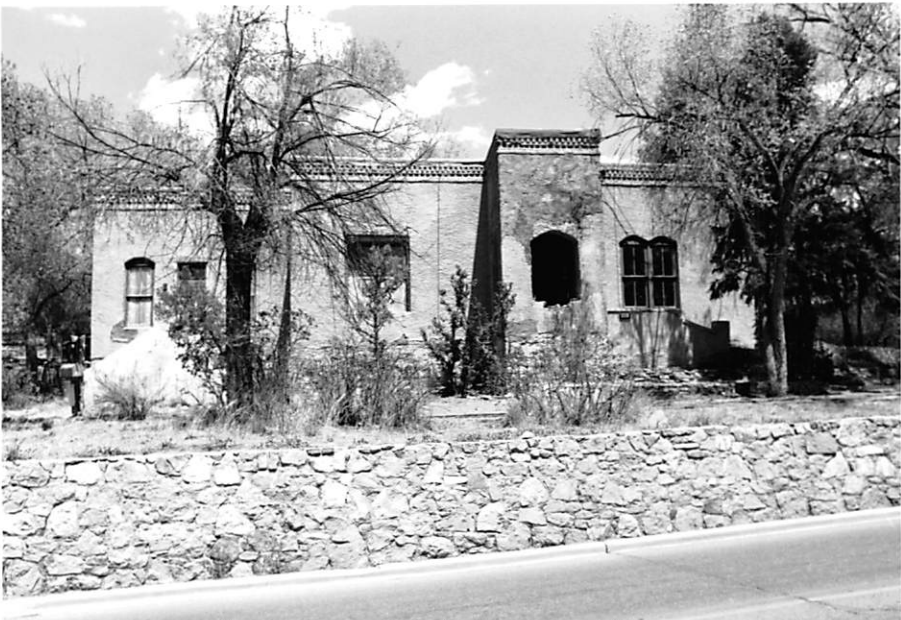
ARCHITECTURAL FEATURES: STYLE, MATERIALS, AND CONDITION	ROOFS & DRAINS	Shed with brick coping, stabilized with concrete & asphalt along top row; flat w/ asphalt roofing	
	BUILDING WALLS	tan textured stucco over double brick	
	FOUNDATIONS	stone (visible under porch)	APPROX. HEIGHT (FT.) 20
	DOORS	S - wood with double arched light N - wood panel w/ 4 lights, wood panel w/ 2 lights, wood panel w/ single light - all w/ old wood screens	
	WINDOWS	paired and single 2/2 wood DHWs in double or single segmental openings, old glass (windows at S center in flat openings); 6/6 wood DHWs on NE	
	PORCHES OR PORTALES	center S - projecting "tower" with arched openings, stuccoed brick banister, approached by curving steps on E; concrete stoop SE w/ steps; brick steps NE corner	
	ARCHITECTURAL DETAILS	string course on parapet, windows in segmental recesses, brick evident under stucco - stucco has deteriorated & is patched on porch.

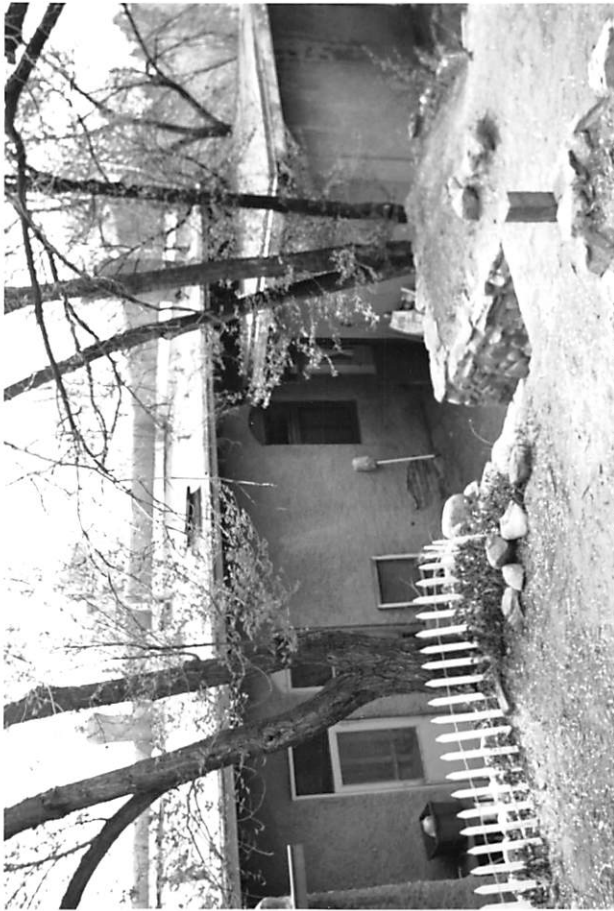
#30 north elevation, W end

FENCES/WALLS	stone wall all along property, S on street (no side-walks) with stone steps	
	SITE FEATURES	stone retaining walls at street and at intervals up the slope; large concrete retaining wall on N	
	OTHER/ COMMENTS	In 1940s, porch was partially demolished and west stairs removed. Addition on NW 1940s with clearly different windows (3 light awning). Shed at NW very old, exposed adobe w/ metal roof.
