Project description . . : REPAIR/RESTORATION OF BUILDING EXTERIOR
 Project number . . . : 95- 10100091
 Case Number : H-95-91
 Project type : HISTORIC DESIGN REVIEW BOARD
 Application date . . : 06/19/95

PROJECT LOCATION(S) : 515 Paseo De Peralta

CASE #H-95-91 ADDRESS 515 PASEO DE PERALTA

This proposal is for the repair and restoration of the exterior stucco, exterior wood surfaces, and structural integrity of the front porch on significant historic building #533, located at 515 Paseo de Peralta (Ex. A).

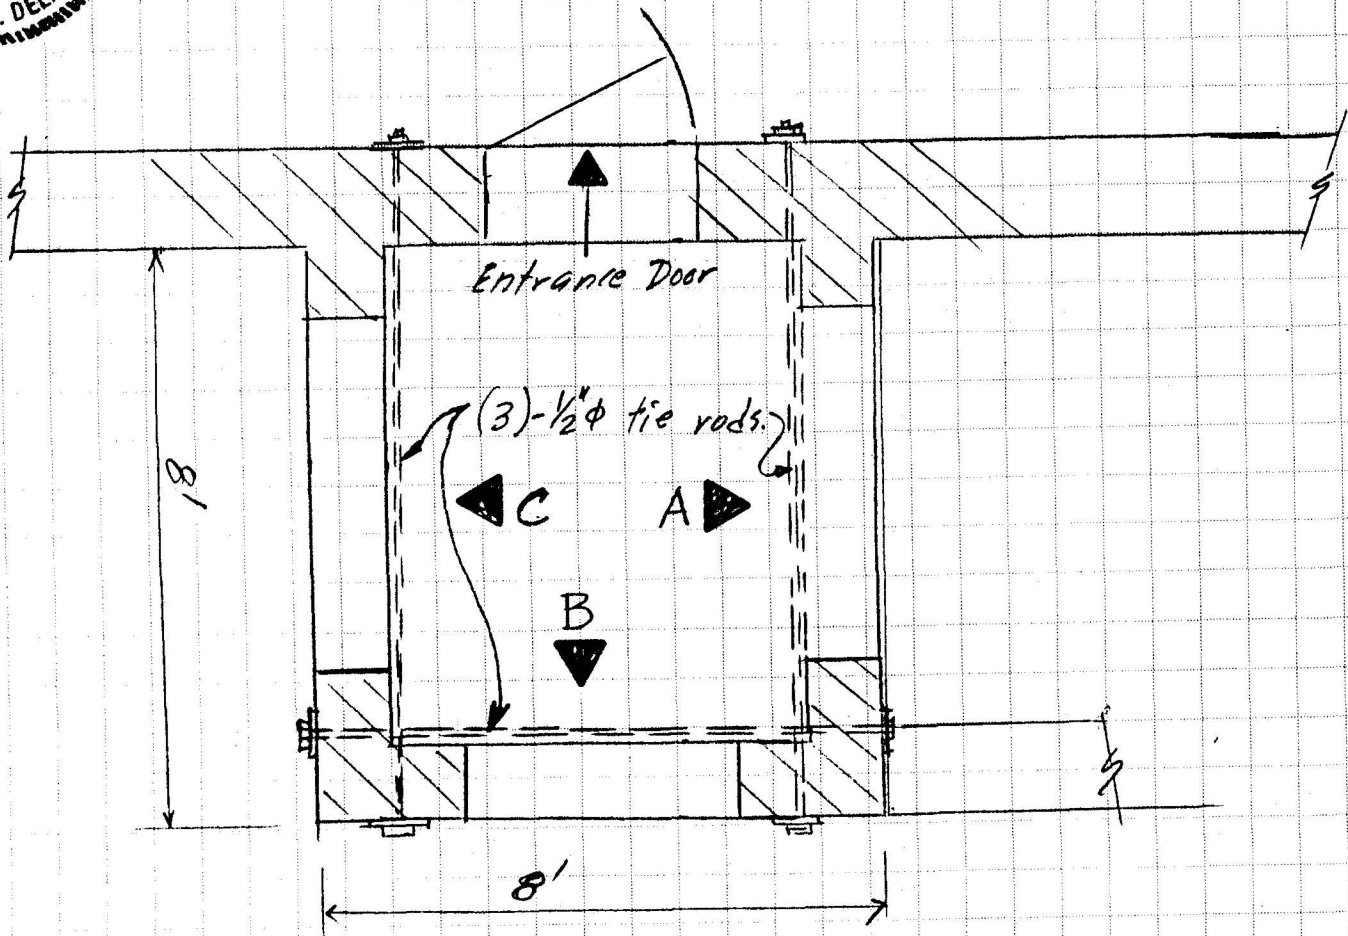
PLAN
 $\frac{3}{8}'' = 1'-0'' (\pm)$

I am attaching two 8 1/2 by 11 drawing sheets to indicate the repairs and strengthening required for the front entry porch. The south and west sides have suffered serious deterioration, with cracking and some of the brick masonry having fallen. With the tie rods added and filling and patching of the walls, I feel that the walls will be adequate and safe.

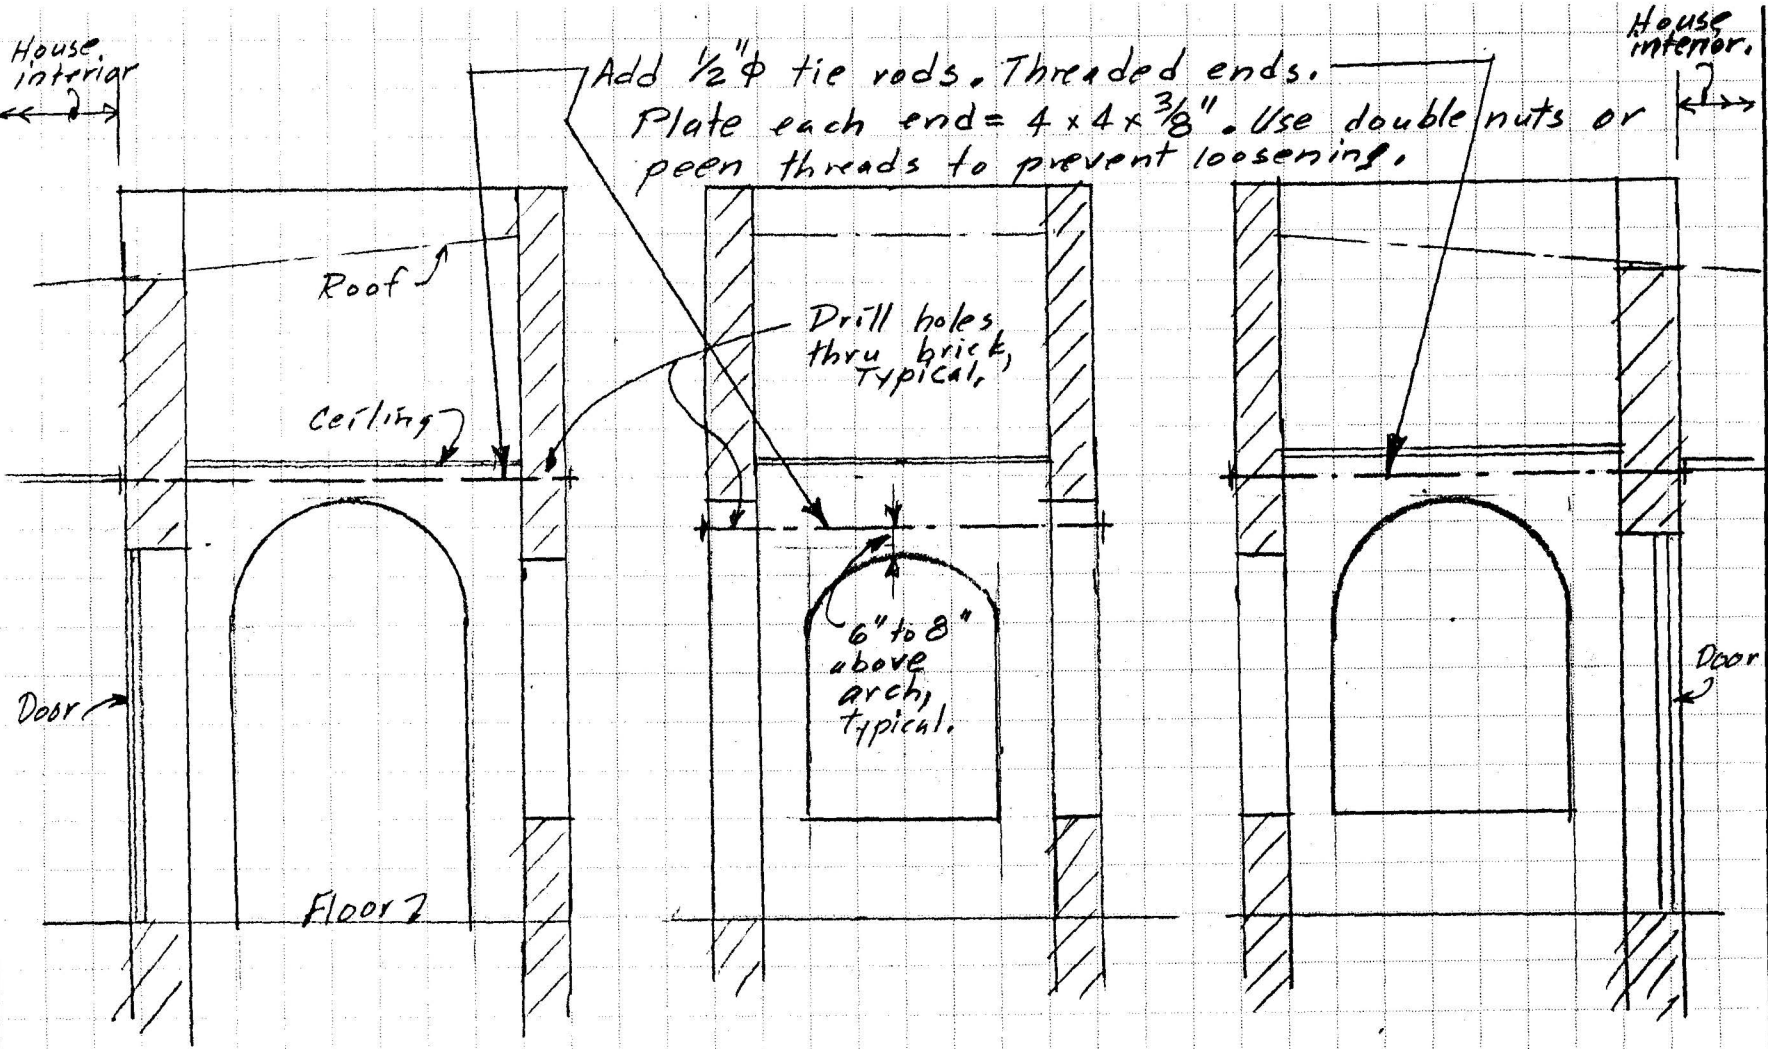
ELEV. A
Looking East

ELEV. B
Looking South

ELEV. C
Looking West

1. Drill & install tie rods. Snug up on nuts.
2. Fill & patch all cracks & holes in walls of entry.
3. Re-tighten and set nuts just before new stucco is applied.
