RPA & ASSOCIATES, LLC | WINDOW & DOOR CONDITION AND INTEGRITY CODES

NEW ADDITIONS, ALTERATIONS, AND YARDWALLS AT

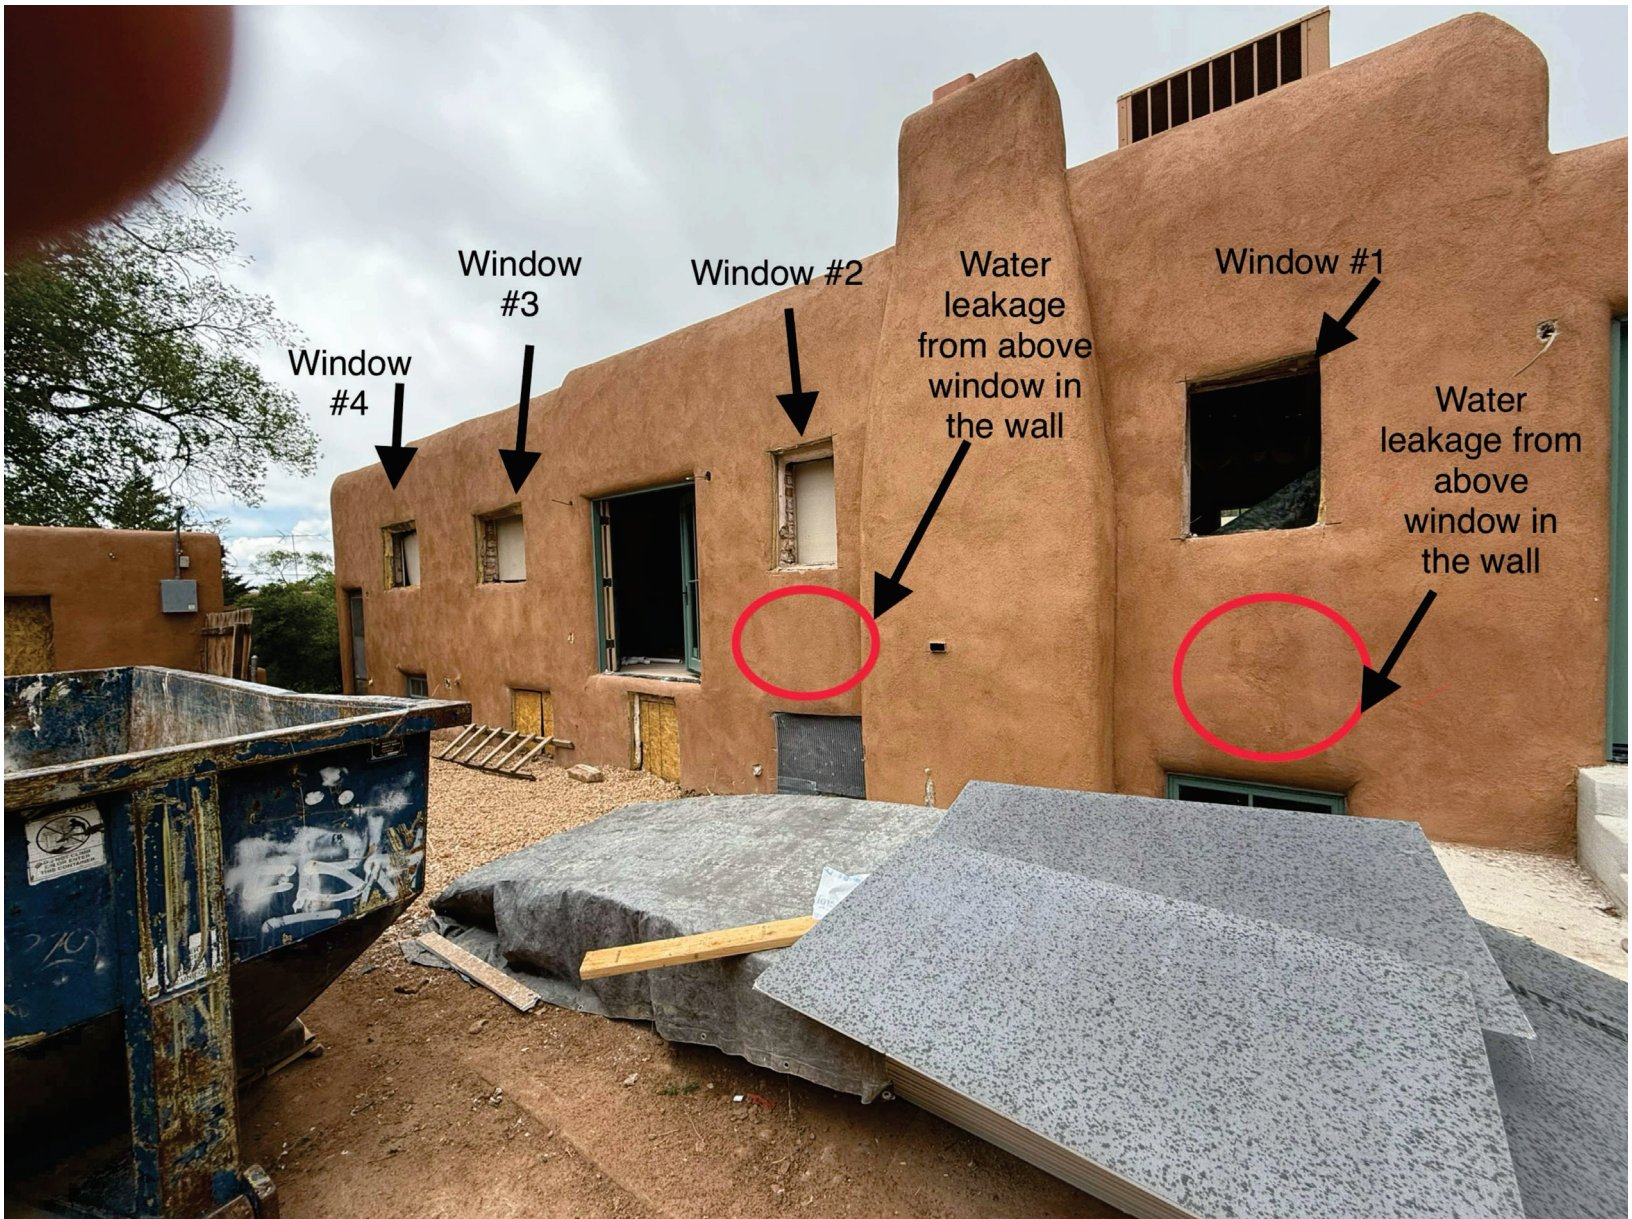
South
Elevation
Window
#4

The openings show spray foam insulation around the windows that resulted in moisture damage and the moisture damage is a contributing factor to the window deterioration. Due to the damage from moisture seeping into the interior, the interior plaster has been compromised. Water stains can be seen on the stucco.

Water leakage from above window in the wall

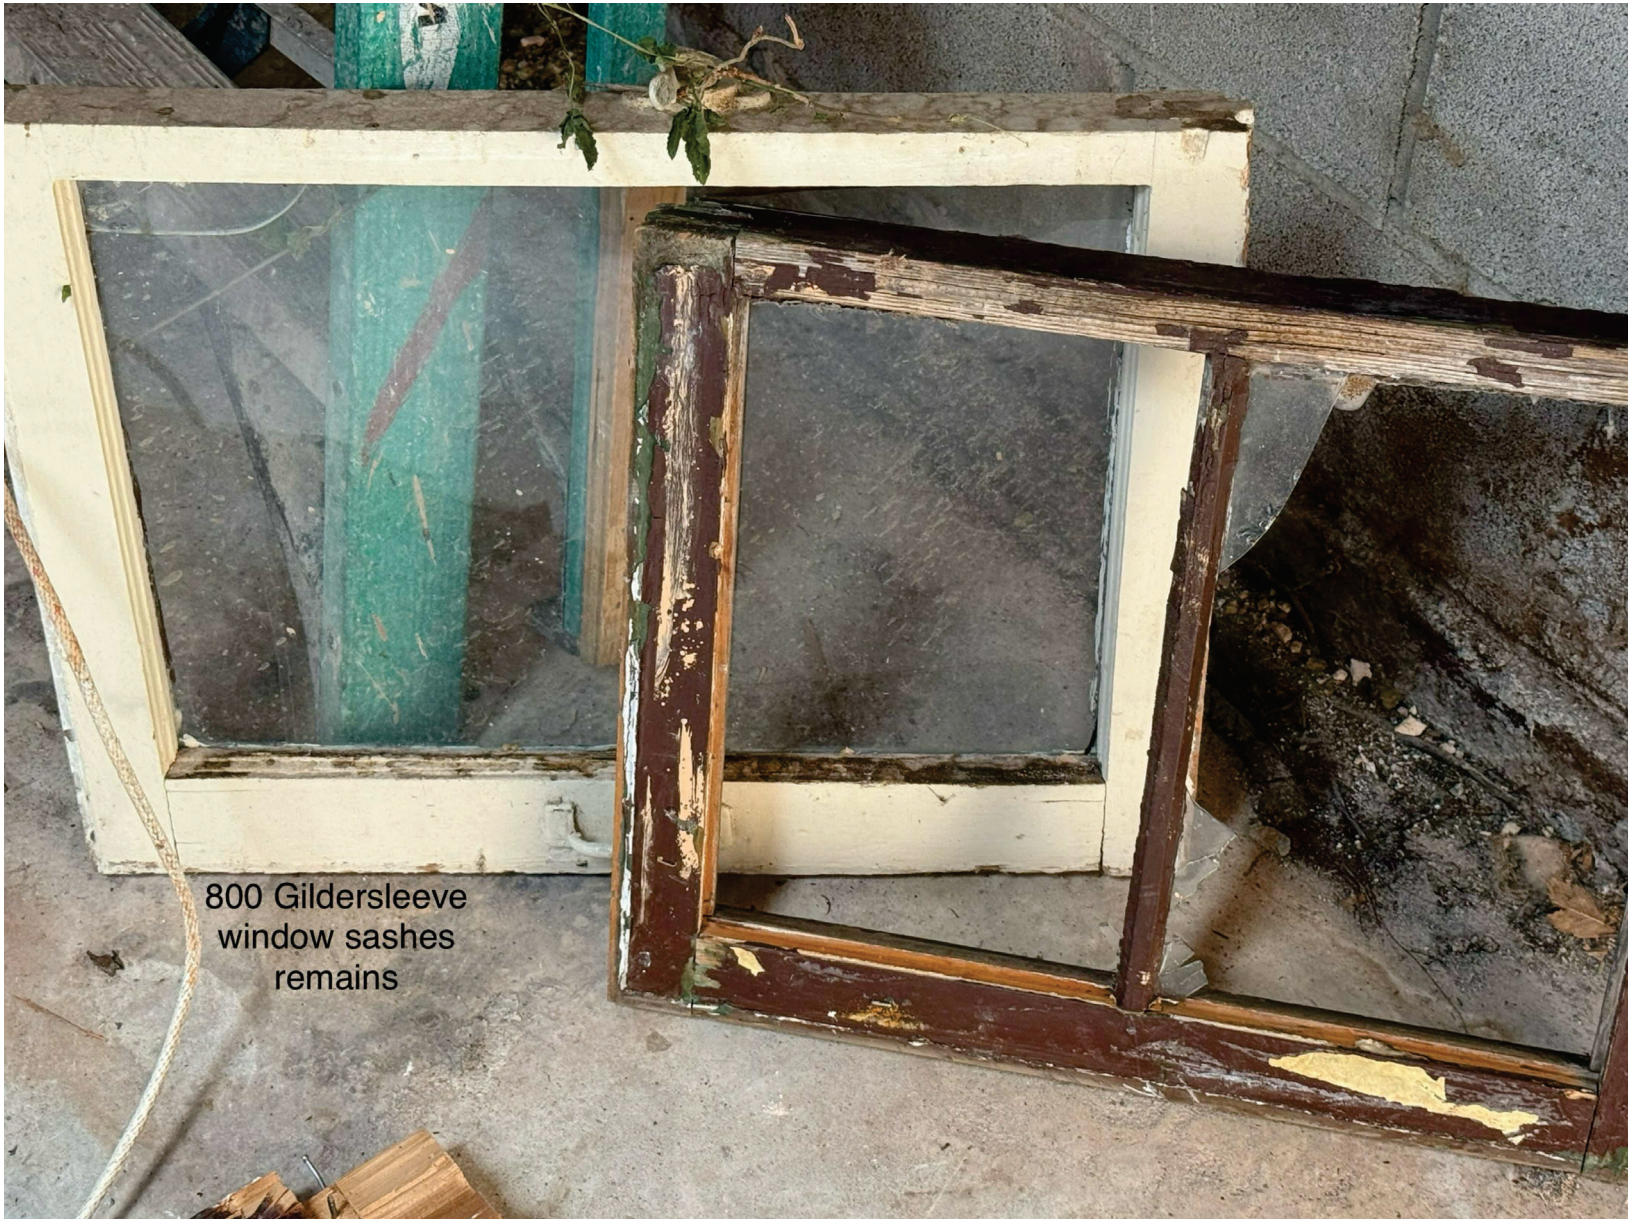
Attached to my report are pictures of 4 sashes and 1 head jamb that were saved. These 4 sashes and head jamb have more than 40% rot and most of the glazing either cracked or missing.

800 Gildersleeve
window sashes
remains

At this point with the 4 windows being removed and only a few pieces left, my suggestion is to replace the windows in like and kind to the windows that have been previously replaced in the other areas, to follow the historic requirements.

Clad/wood simulated divided light, color to match the replaced windows. Sizes to match the windows that were removed.

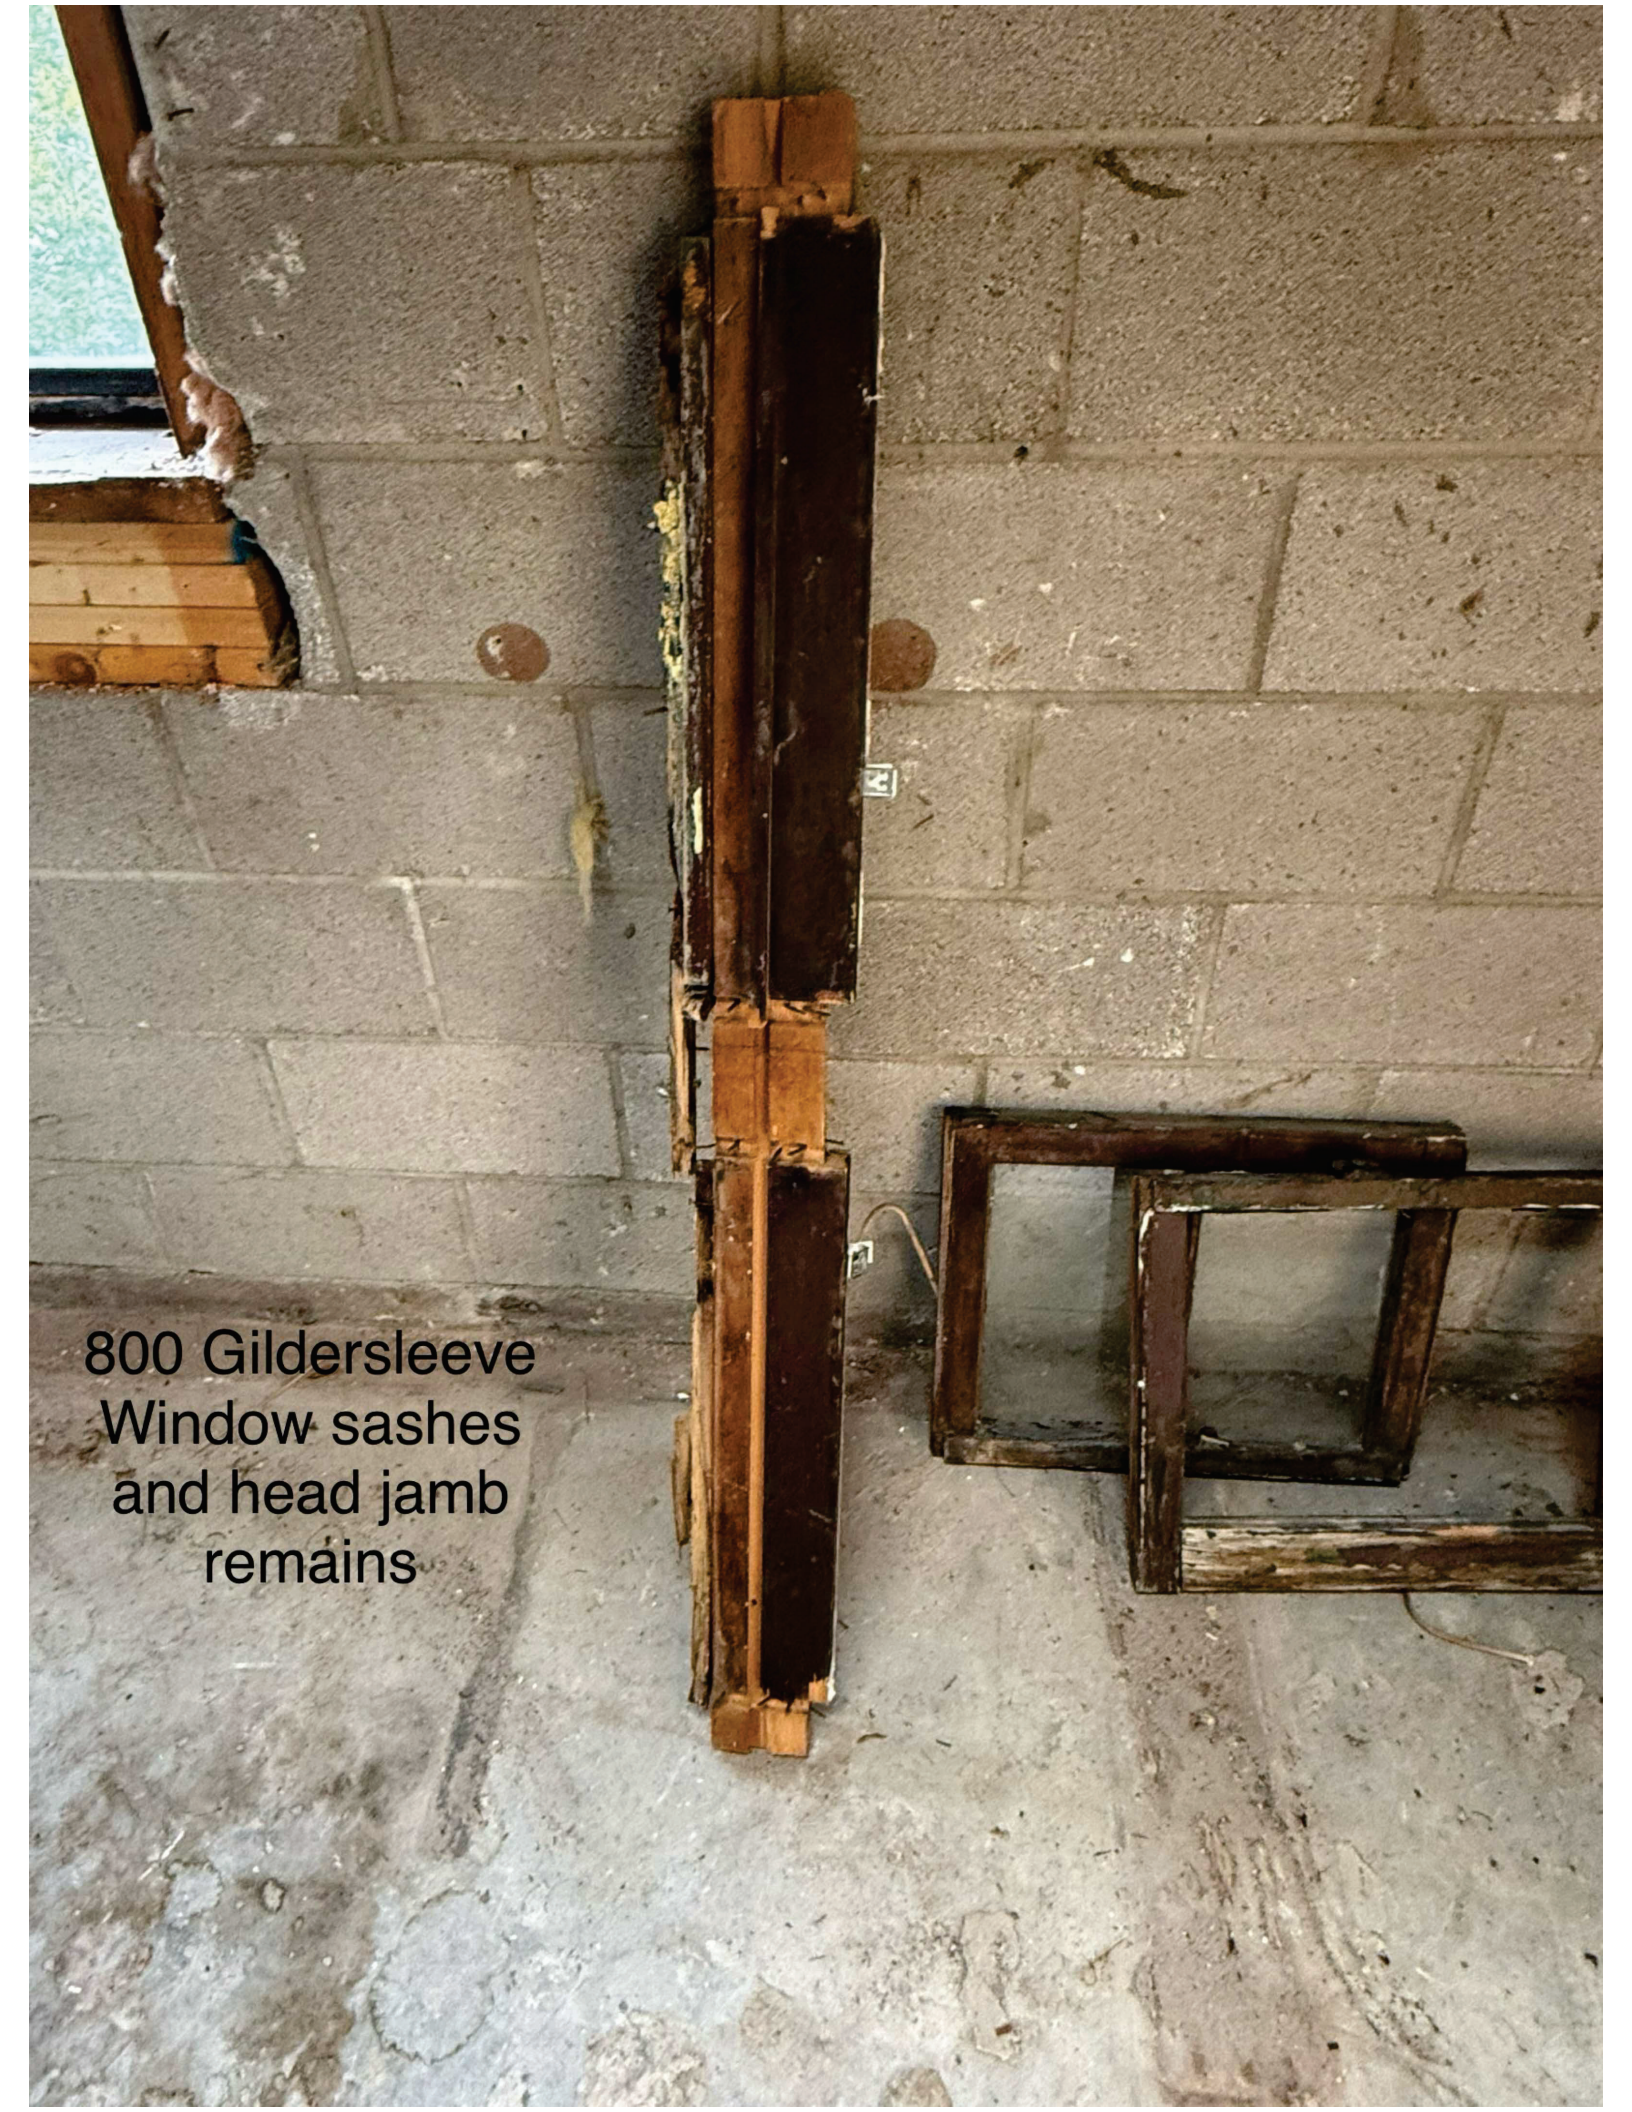
800 Gildersleeve
Window sashes
and head jamb
remains
