Luchini Trujillo Structural Engineers, Inc.

May 20, 2025

Re: Residence @ 515 Paseo Del Peralta, Santa Fe, New Mexico 87505

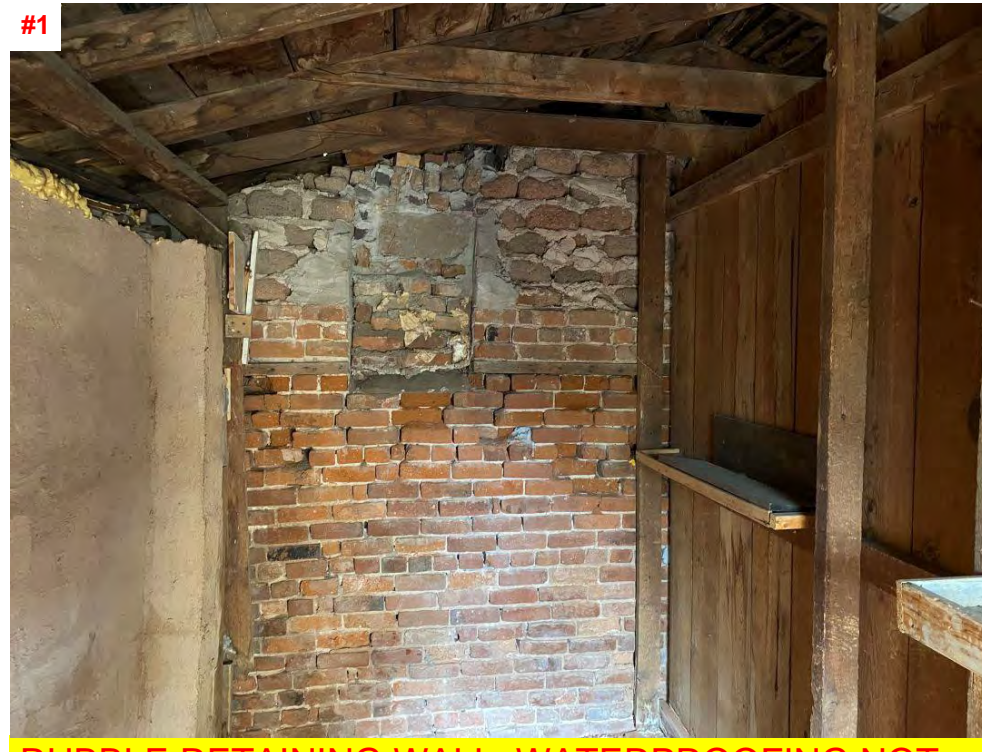
- The garage walls are dependent on an assortment of unreinforced brick, stone and clay-block (pentile) masonry walls. The northwest and northeast walls are retaining up to 6 feet of soil. A waterproofing and drainage system was not observed and could lead to hydrostatic pressure building up behind the retaining portion. Moisture intrusion has caused some debonding of the masonry and deterioration of the wall itself. This condition can potentially cause a hazard and could be susceptible to collapse under extreme loading scenarios. The unreinforced wall cannot properly resist lateral earth pressures and cannot sufficiently transfer loading.

#1 RUBBLE RETAINING WALL, WATERPROOFING NOT PRESENT AND DETERIORATION PRESENTS ON EXTERIOR & INTERIOR FACES.

Based on the deterioration of the rubble masonry and adobe retaining walls in the garage and shed respectively, the ability to correct the structural issues with the structures retaining walls would not be possible. The existing walls are unreinforced adobe, & stone/rubble masonry: these types of walls are not permitted for retaining conditions.

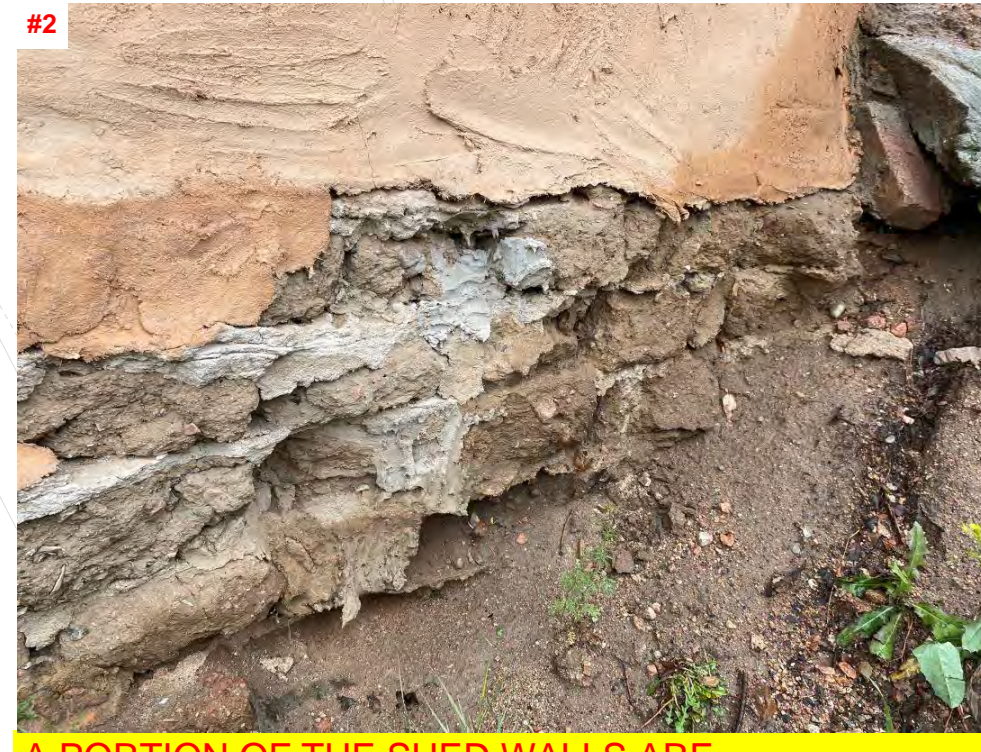
- The shed walls are dependent on unreinforced adobe and random masonry walls. The transition from adobe & masonry walls to concrete stem wall/footing was not observed. The northwest and northeast walls are retaining anywhere from 1 to 6 feet of soil. Moisture intrusion has caused some debonding of the adobe blocks and deterioration of the block itself. This condition can cause a potential hazard and is susceptible to movement and overturning during extreme loading conditions. The unreinforced wall cannot properly resist lateral earth pressures and cannot sufficiently transfer loading.

#2 A PORTION OF THE SHED WALLS ARE CONSTRUCTED WITH ABODE. SIGNIFICANT DETERIORATION OF THE ADOBE BLOCK FROM MOISTURE INTRUSION WAS OBSERVED

It is my opinion that an effort to restore or repair the shed and garage auxiliary structures is not feasible. Replacement of all retaining and vertical load bearing walls, and the installation of a foundation system would require so much removal of the existing structure that the undertaking can no longer be considered a restoration, but a replacement. That is, no portions of the existing shed and existing garage structure can remain in place if this building is to meet building code requirements.

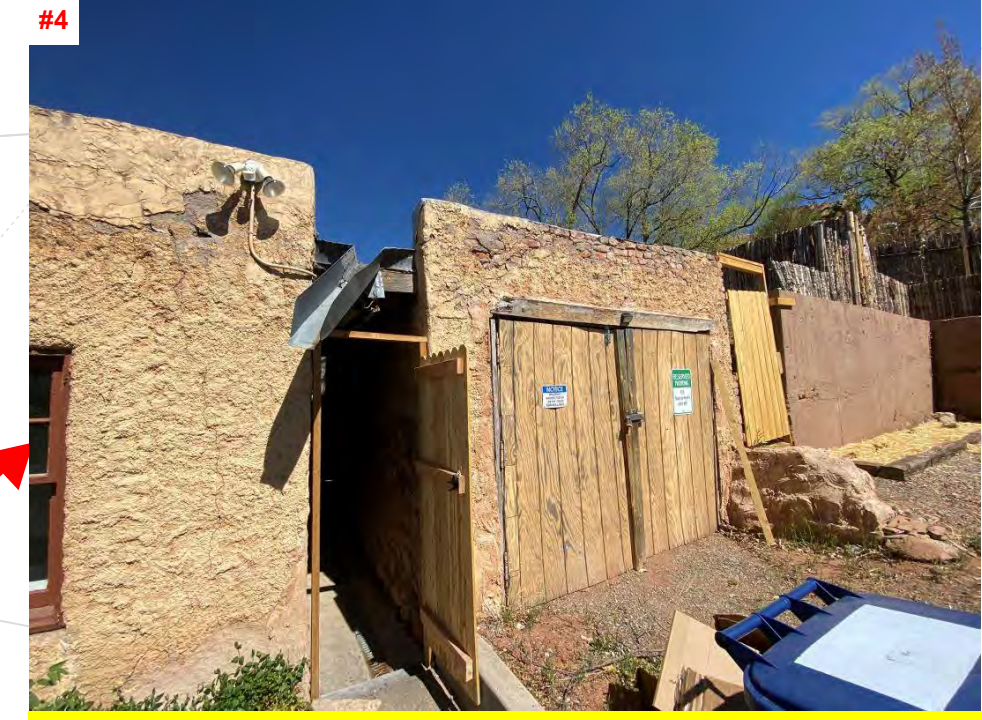
#4 MORTAR JOINTS ON RUBBLE MASONRY WALL HAVE DE-BONDED AND HAVE COMPROMISED THE WALLS STRUCTURAL INTEGRITY.

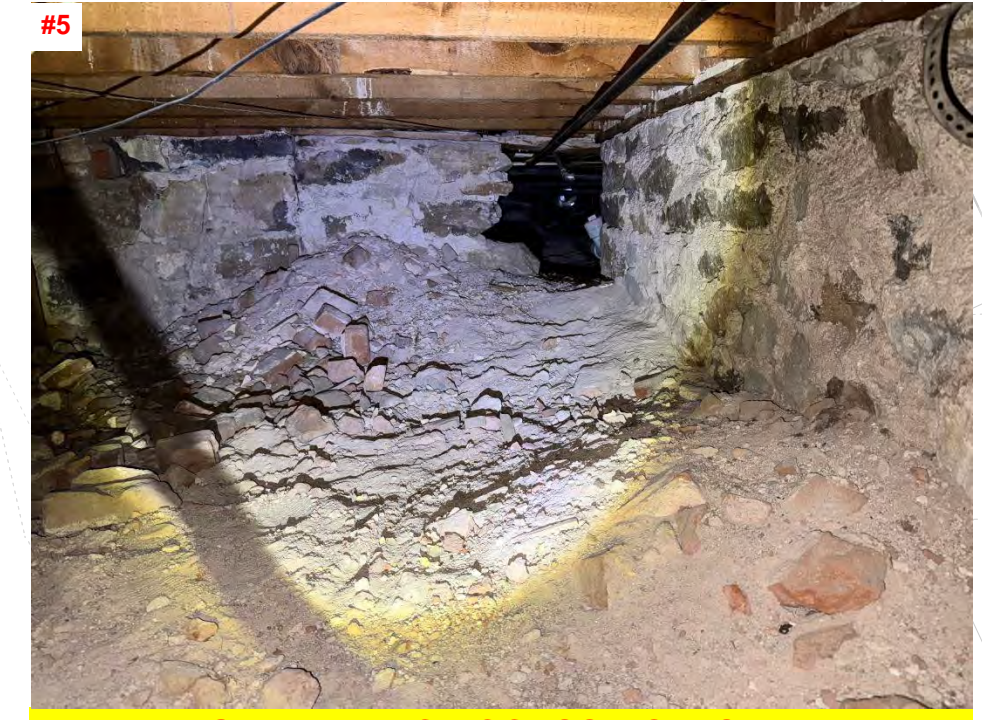
- Tunneling through stone masonry stem walls to accommodate HVAC & plumbing chases were noted to occur in numerous locations throughout the main residence. This alteration will need to be corrected as it has caused localized failures of the wood bearing plates for the floor system.

#5 PLUMBING AND HVAC ACCESS HOLES HAVE BEEN TUNNELED THROUGH THE STONE RUBBLE STEM WALL

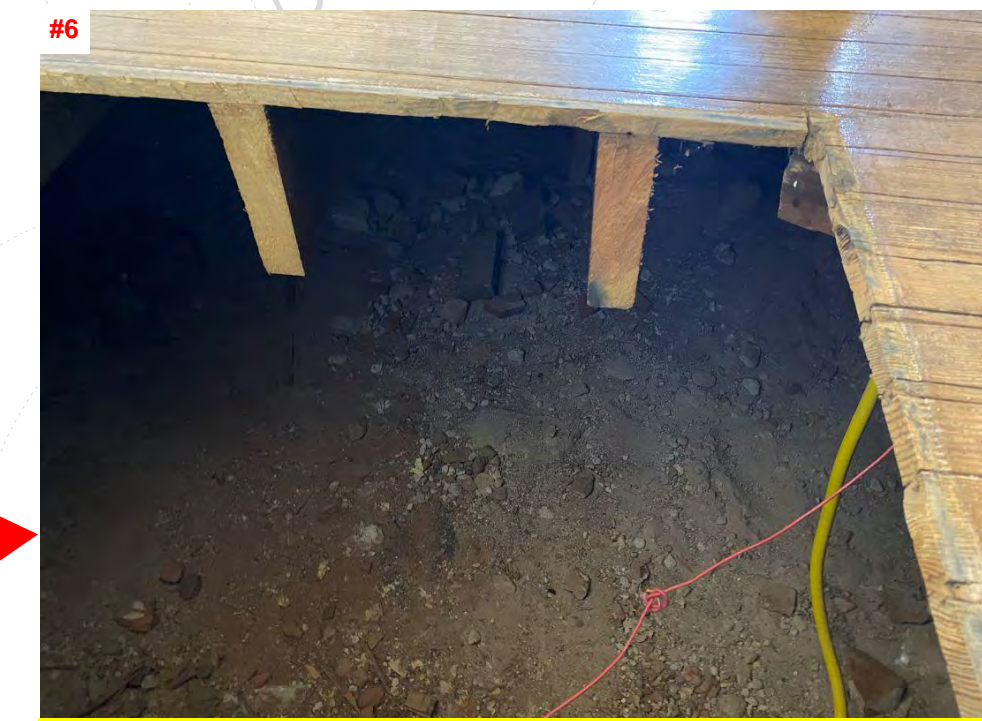
- Floor joists that have been cut to accommodate out of service floor heaters were noted to occur in two locations in the main structure. The alterations should be corrected with adequately sized floor joist girders and headers.

#6 2x8 FLOOR JOISTS CUT AT OUT-OF-SERVICE GAS FLOOR HEATERS

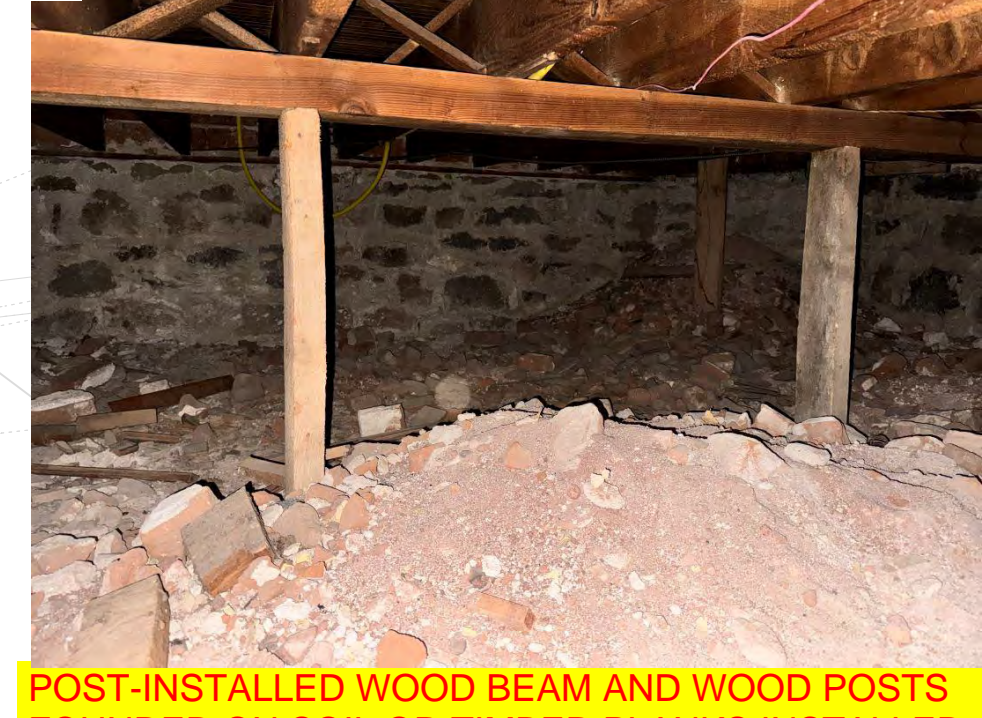
- Wood timber posts were installed in an apparent attempt to control floor joist deflections and correct floor framing alterations. The timber supports are at random locations throughout the residence. This condition will need to be corrected with a new wood post and wood beam system with concrete spot footings at the new posts.

#7 POST-INSTALLED WOOD BEAM AND WOOD POSTS FOUNDED ON SOIL OR TIMBER PLANKS INSTALLED THROUGHOUT FOOTPRINT OF ORIGINAL STRUCTURE

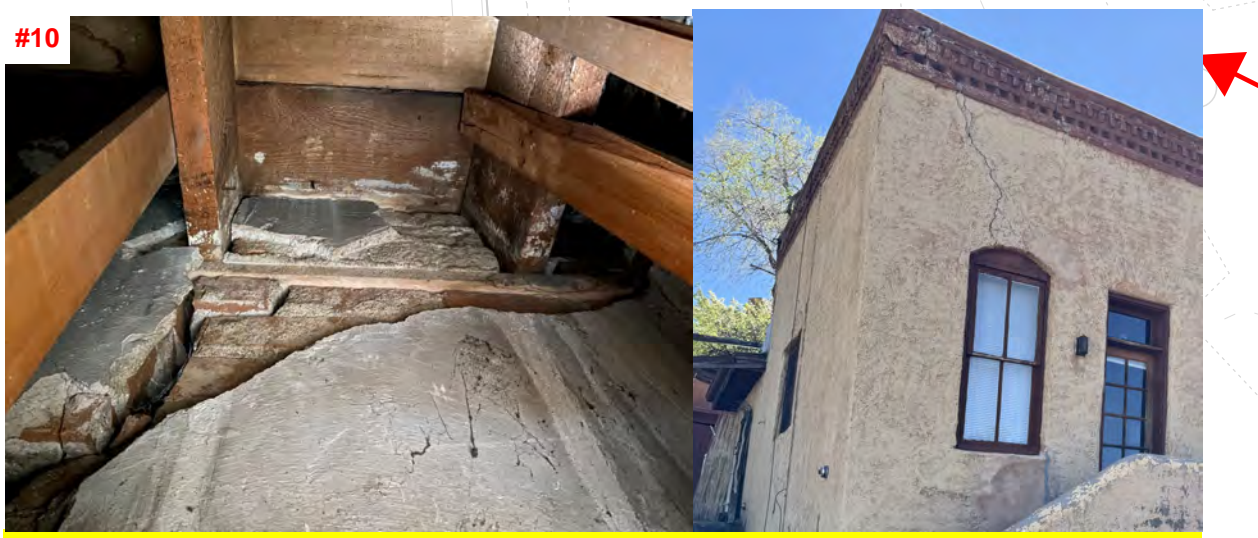
- The southwest corner of the residence exhibited a large crack propagating from the exterior facade to the interior plaster finish. Upon further investigation it was noted that water intrusion had occurred and compromised the masonry and mortar joints in this area. The damaged portion of the wall should be reconstructed with standard masonry techniques to reestablish structural integrity.

#10 CRACK EXTENDS THROUGH ENTIRE WALL SECTION, MASONRY COURSES HAVE DE-BONDED AND THE STRUCTURAL INTEGRITY OF THE WALL HAS BEEN COMPROMISED

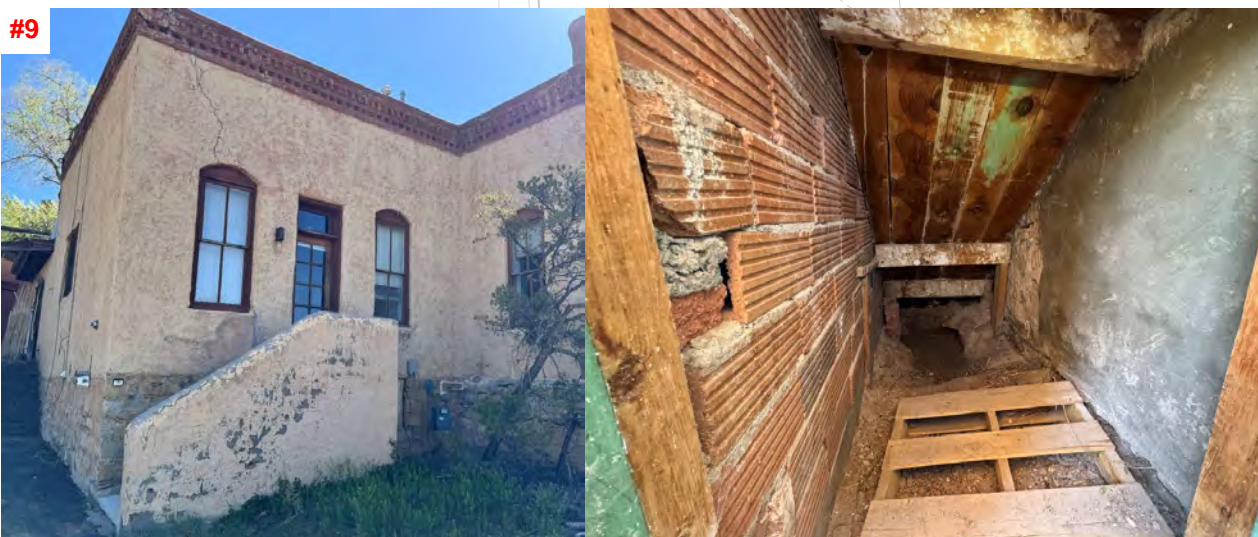
#9 PEN-TILE STAIR WALL AND WATER DAMAGE TO WOOD STAIR FRAMING, FUNGAL DECAY OF WOOD HAS BEGUN AND HAS COMPROMISED THE STRUCTURAL SECTION

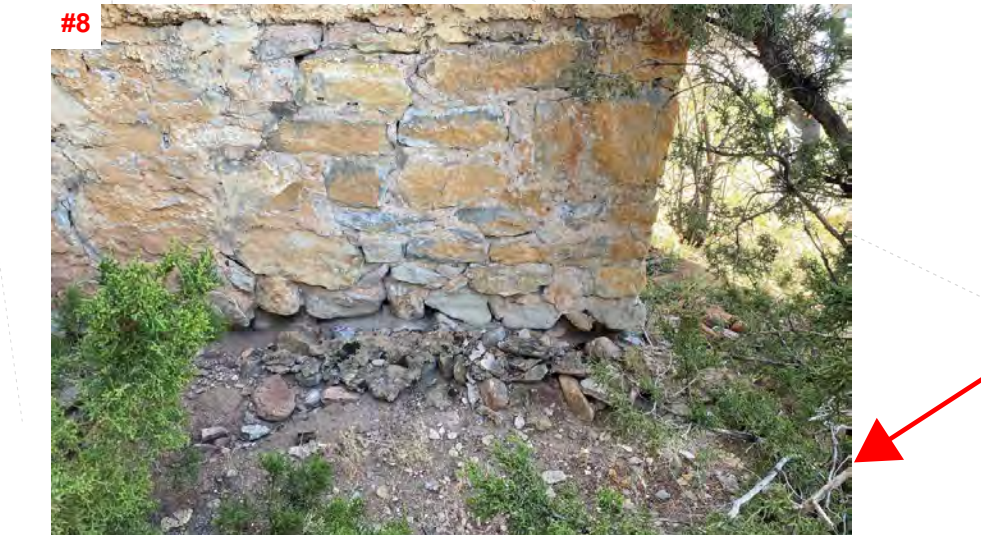
#8 DAMAGE TO RUBBLE FOUNDATION STEM WALL

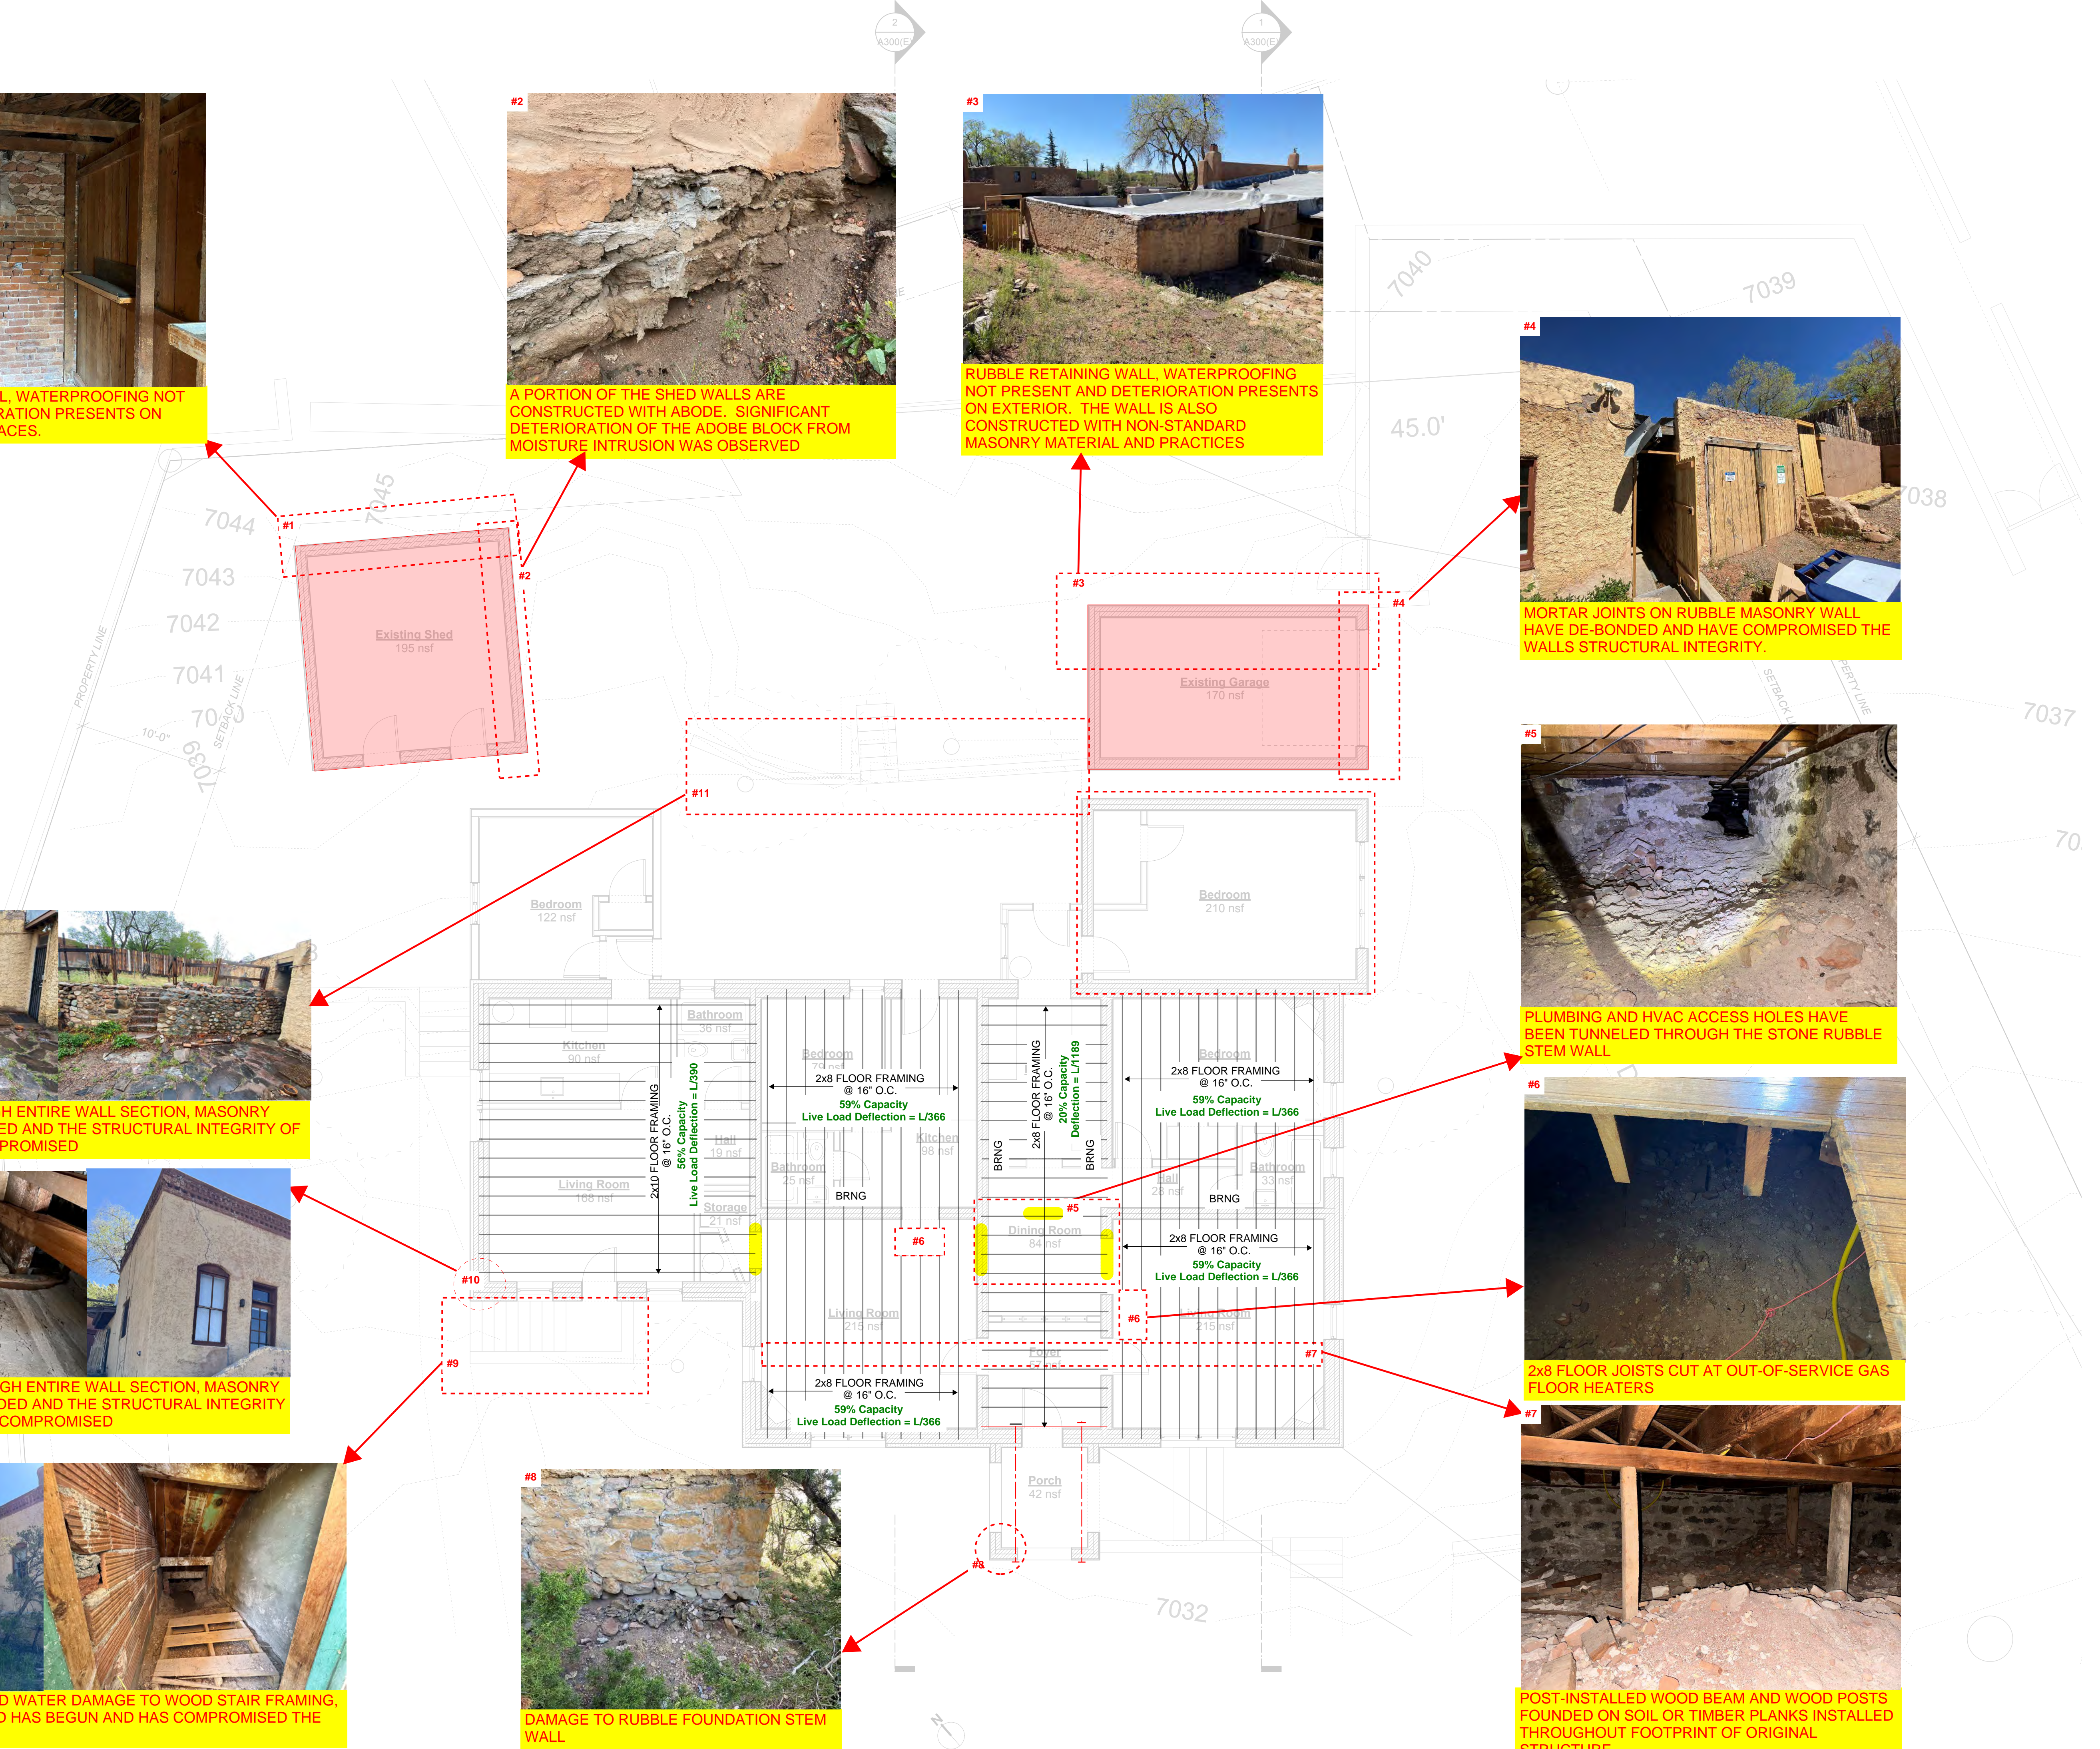
S001

File: 515 PdPeralta_A100 Plans 250331.vwx
 Set: Schematic Design Set
 Sheet Title: EXISTING FLOOR PLAN w/ STRUCTURAL DEFICIENCIES
