RPA & Associates

JOB	DATE
Unit 126 CAMINO SANTIAGO, SANTA FE, NM 87501	12/15/2023

RPA & ASSOCIATES | WINDOW & DOOR CONDITION AND INTEGRITY CODES

Unit 126 and Unit 128
Camino Santiago
Santa Fe , NM. 87501

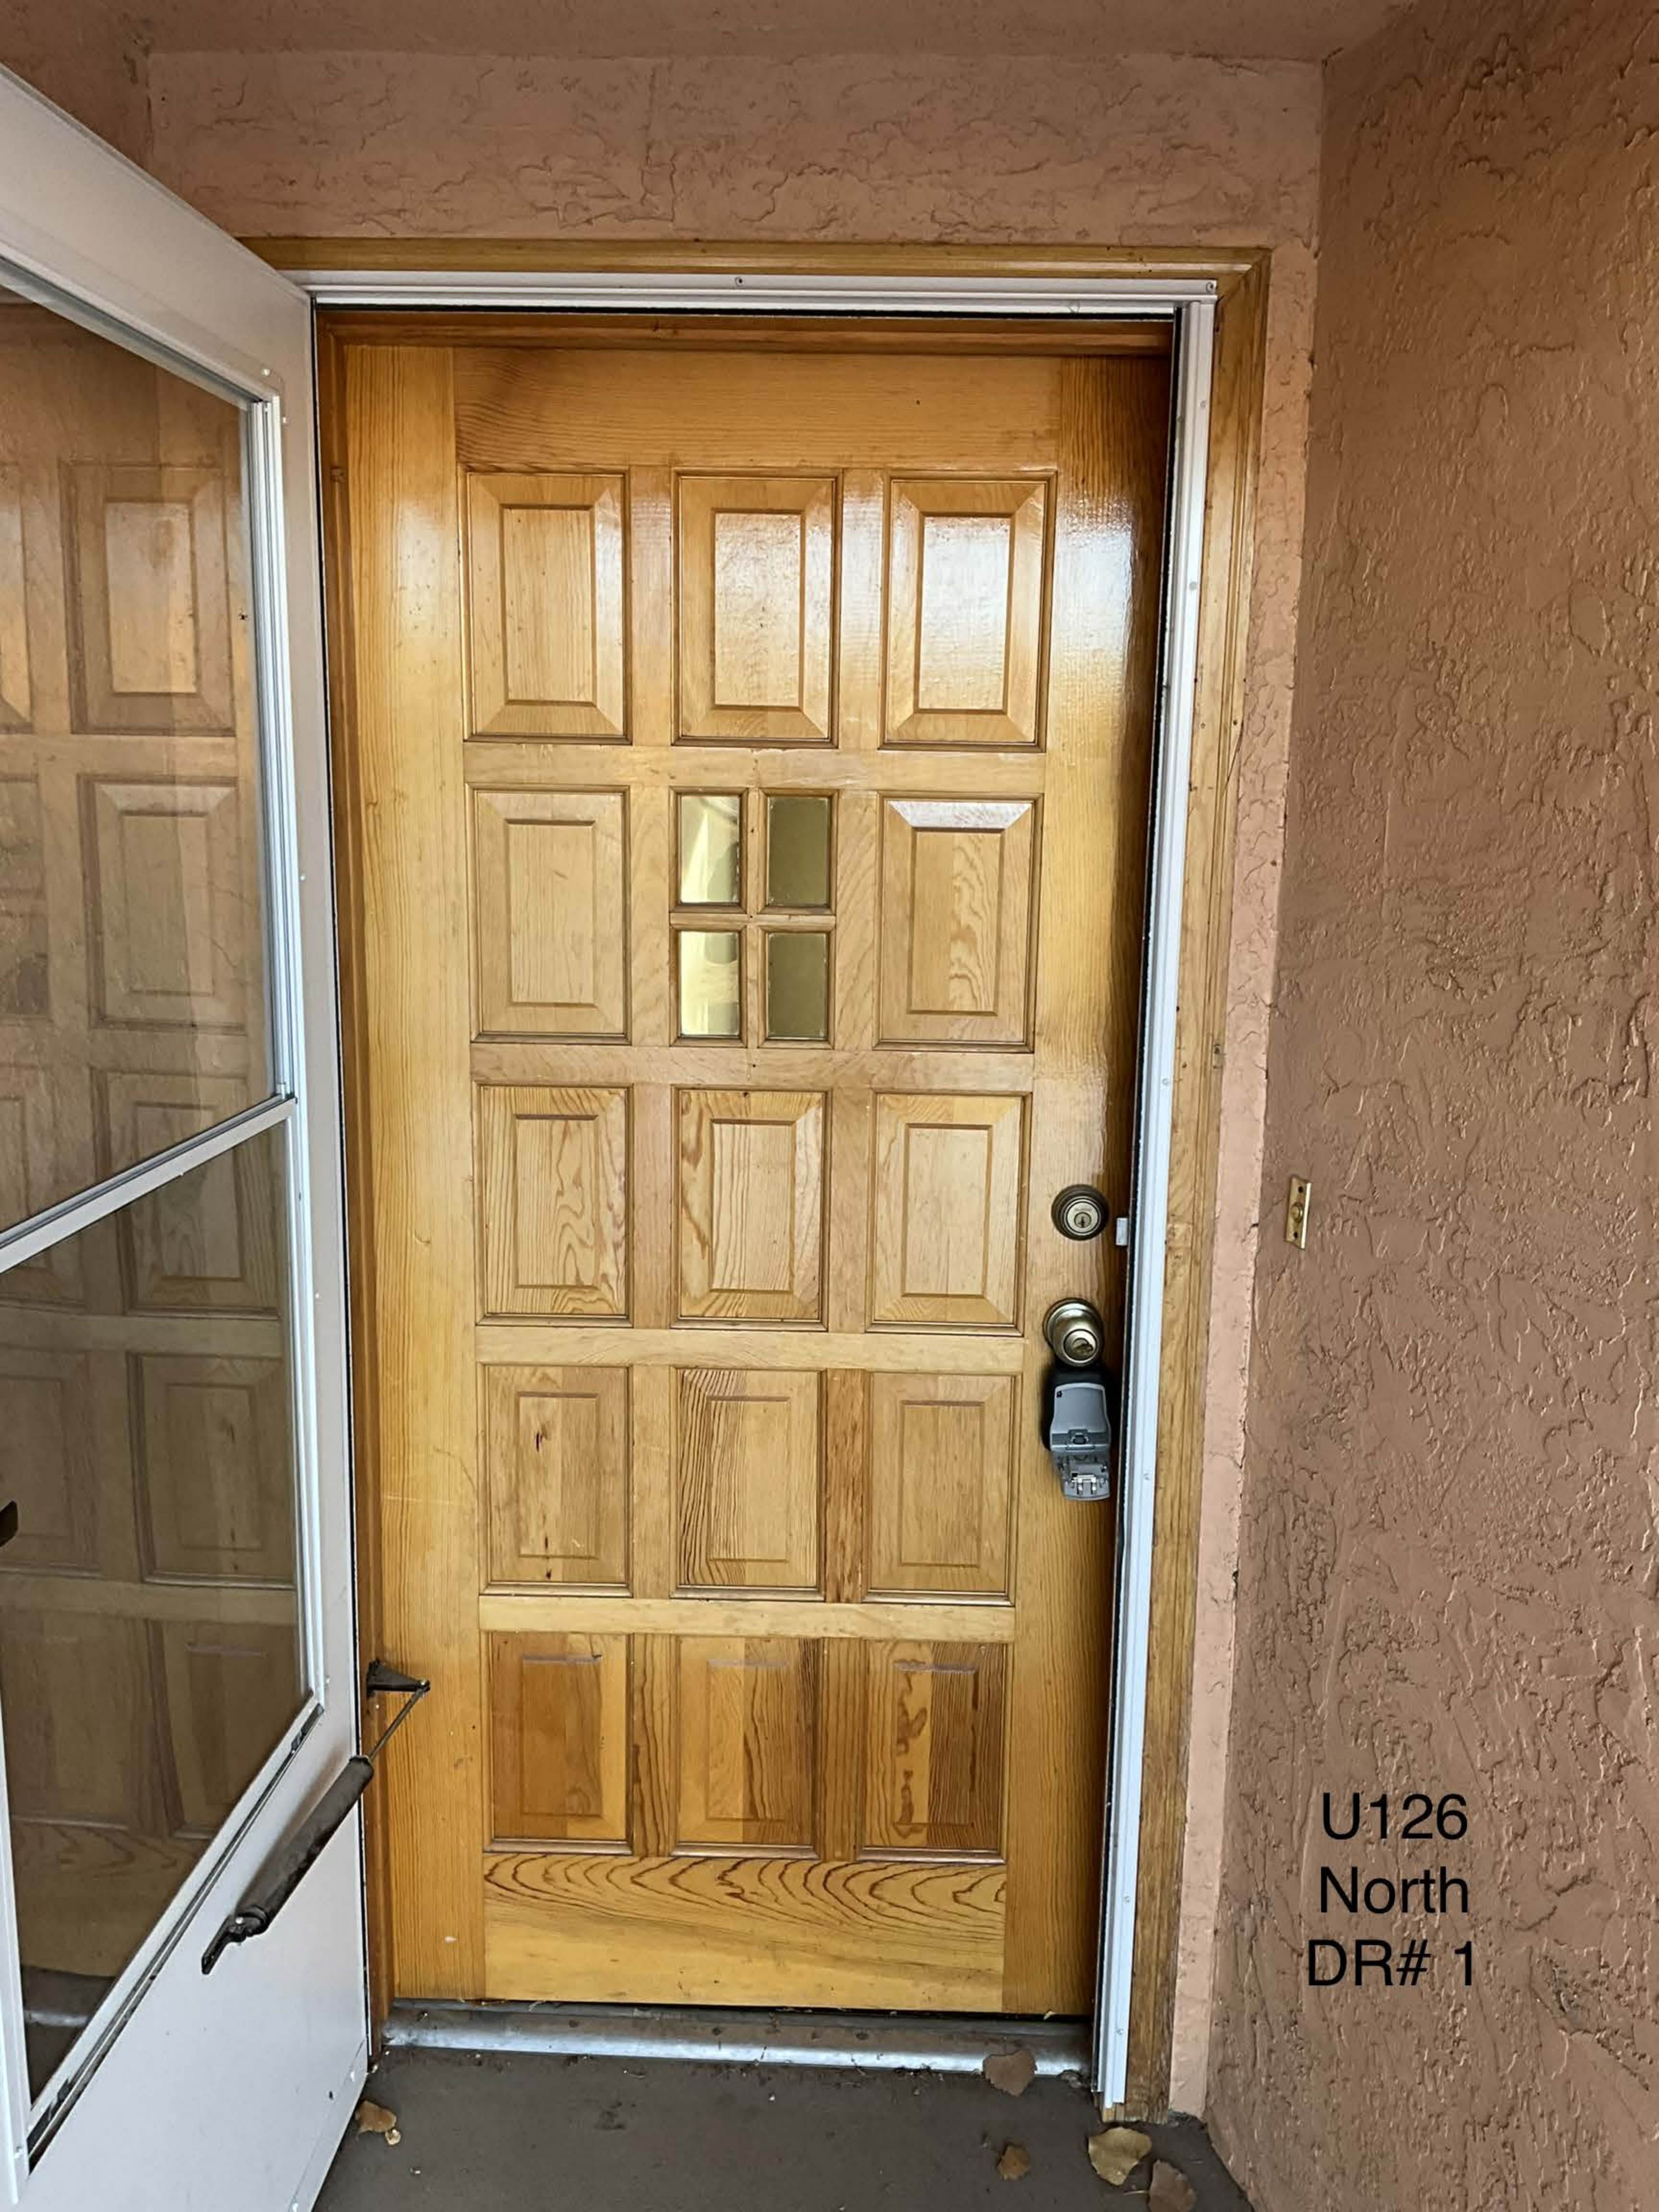
U126
North
DR# 1

LABEL	WINDOW & DOOR DESCRIPTION	CONDITION & INTERGRITY CODE	HISTORIC/NON-HISTORIC - AGE
DR #1	36 x 80 LH INSWING 15-PANEL/W 1-PANEL 4-LT	S	NON-HISTORIC – 2000 SIMPSON DOOR
A	20 x 38 L STEEL CASEMENT 90° BAY 20 x 38 R STEEL 1W3H	S	HISTORIC
B	38 x 38 LR STEEL CASEMENT 1W3H	S	HISTORIC
DR #2	36 x 80 LH OUTSWING 15-PANEL/W 1-PANEL 4-LT	S	NON-HISTORIC – 2000 SIMPSON DOOR
DR #3	36 x 80 RH OUTSWING 15-PANEL/W 1-PANEL 4-LT	S	NON-HISTORIC – 2000 SIMPSON DOOR
C	38 x 38 LR STEEL CASEMENT 1W3H	S	HISTORIC
D	20 x 38 L STEEL CASEMENT 90° BAY 20 x 38 R STEEL 1W3H	S	HISTORIC
DR #4	36 x 80 RH INSWING 15-PANEL/W 1-PANEL 4-LT	S	NON-HISTORIC – 2000 SIMPSON DOOR
DR #5	72 x 80 SCD OX WHITE VINYL 1-LT	F	NON-HISTORIC – 2000 JELD-WEN DOOR VINYL
E	54 x 51 LSR STEEL CASEMENT 1W4H	S	HISTORIC
F	54 x 51 LSR STEEL CASEMENT 1W4H	S	HISTORIC
DR #6	72 x 80 OX WHITE VINYL 1-LT	F	NON-HISTORIC – 2000 JELD-WEN DOOR VINYL

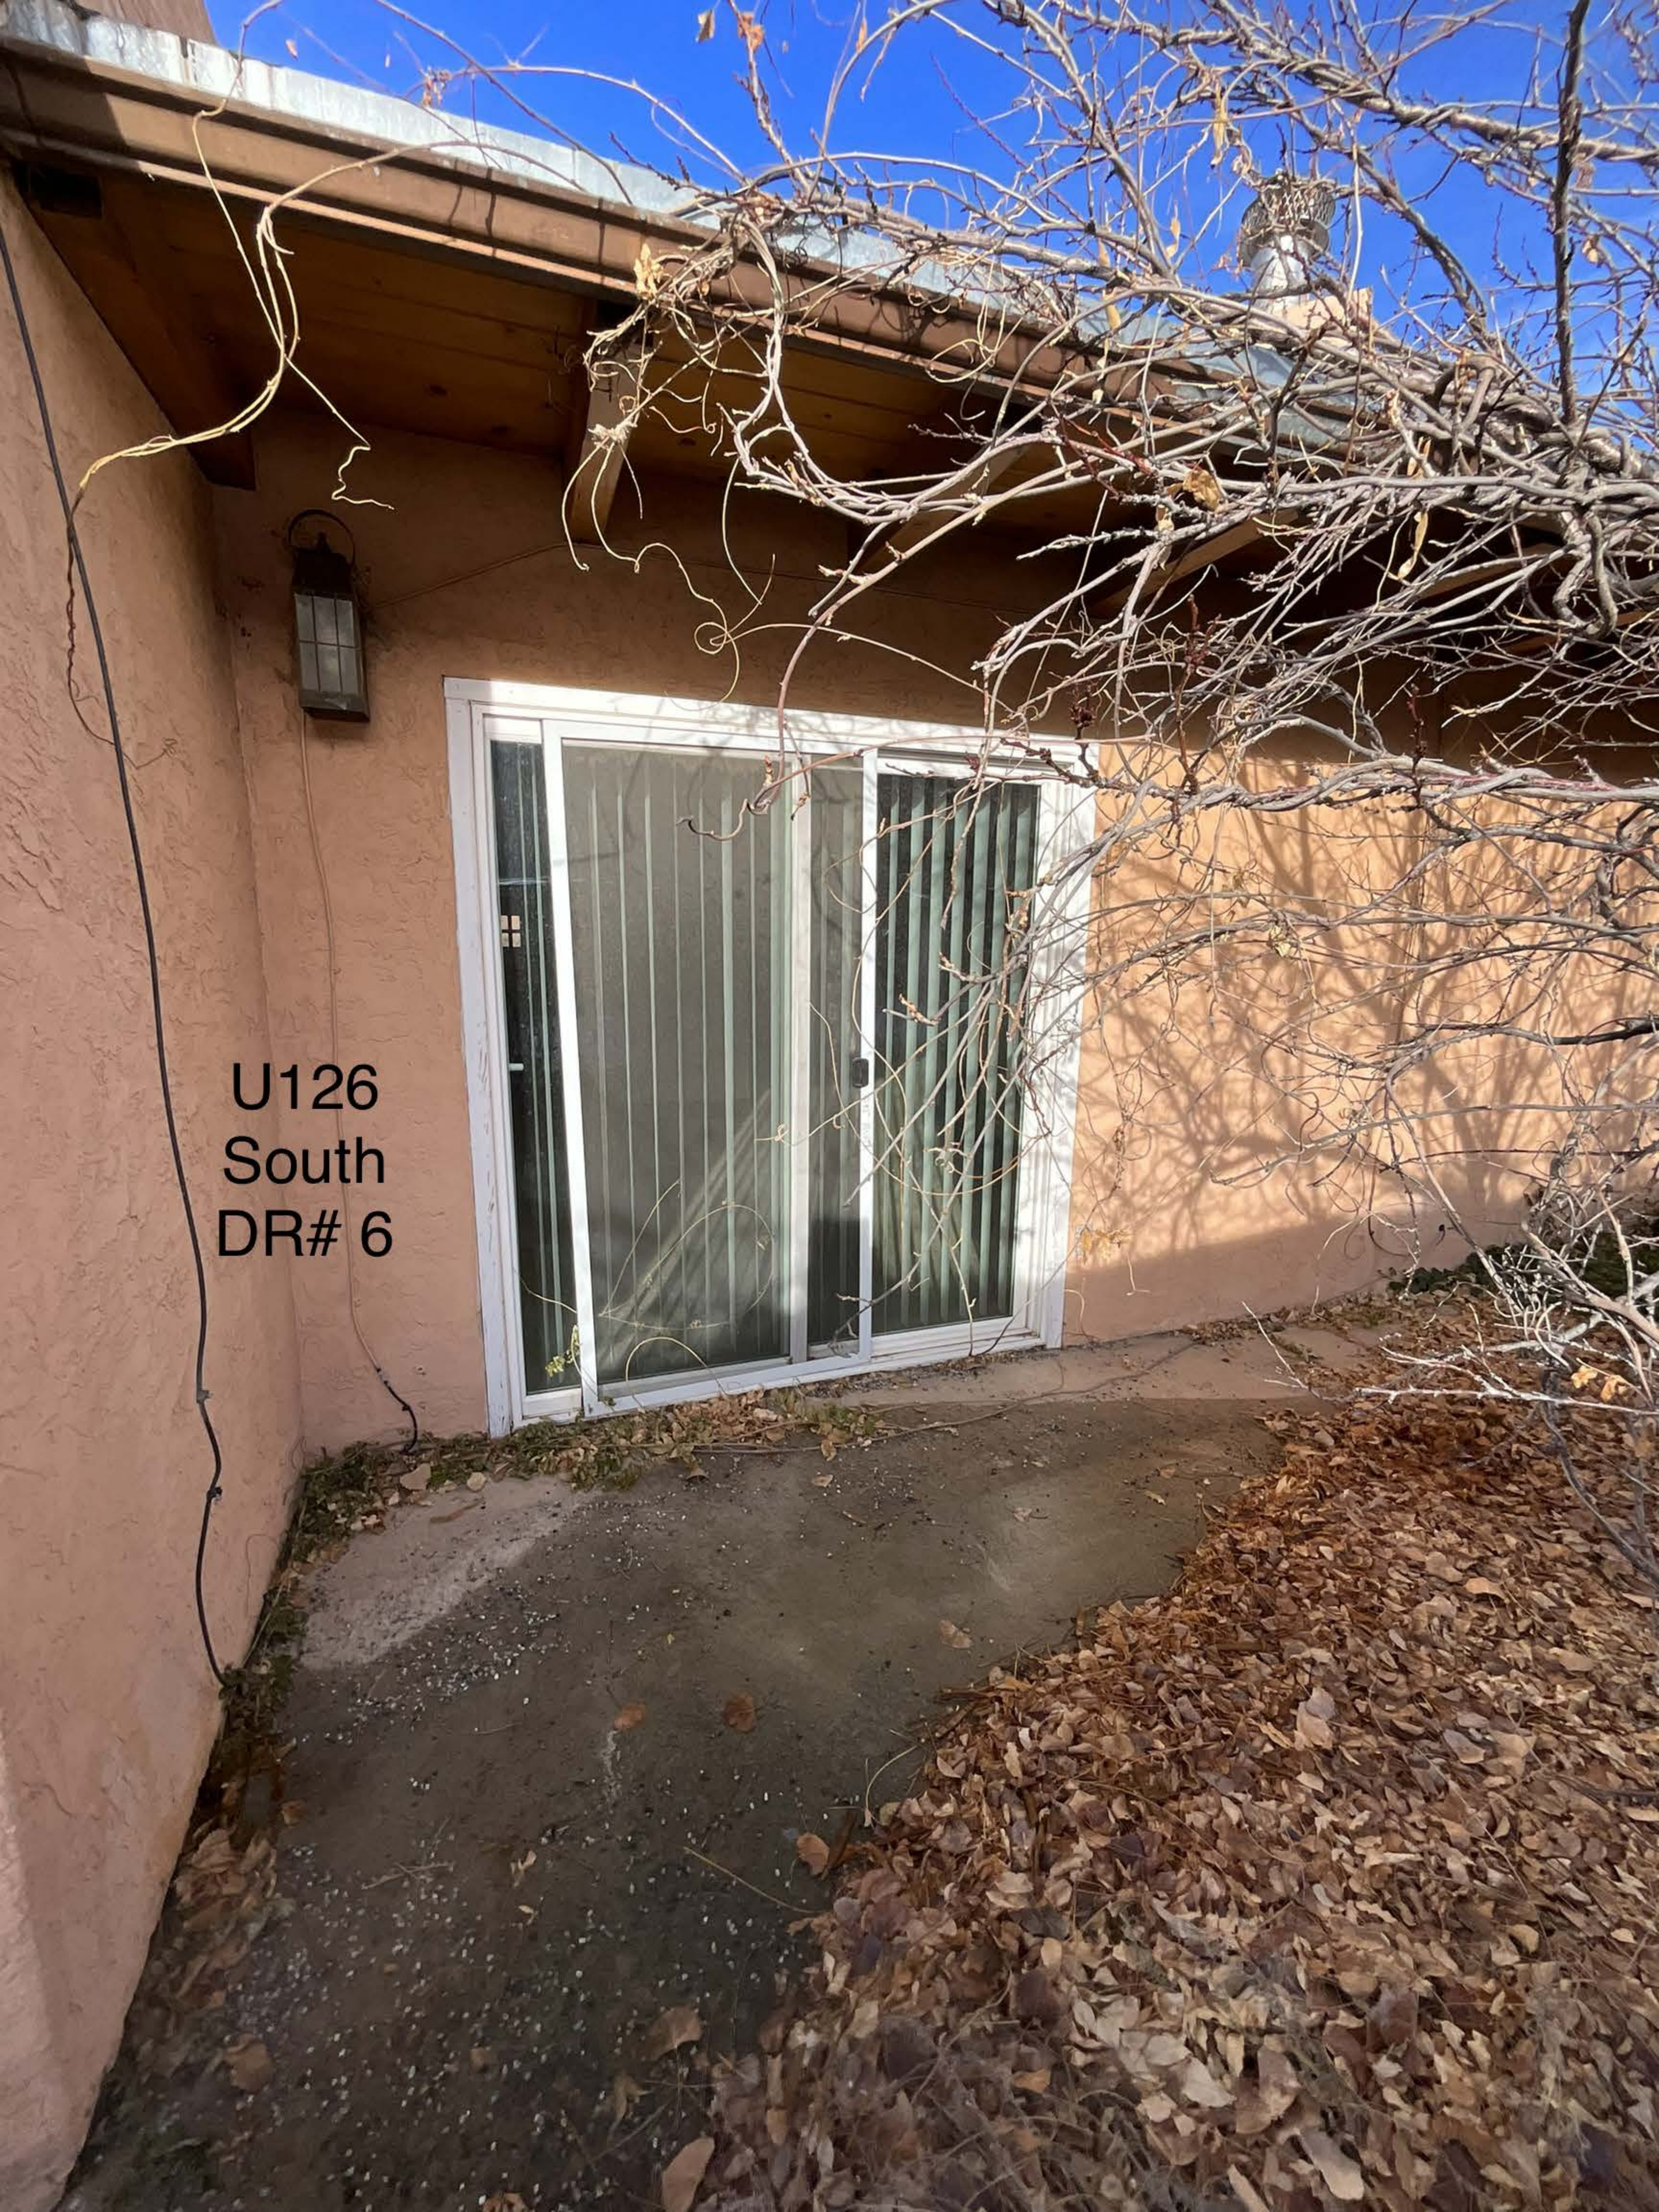
U126
South
F

Windows A, B, C, D, E & F are historic windows. The steel casements are single glazed. There is not enough shelf area in the steel casements to insert insulated glass into the frames. The single pane and steel casement windows have had a considerable amount of condensation and over time this has caused damage to the wall and interior plaster. Using storm windows with the steel casements of this style, will not work because the fact is, the steel will condensate and allow the conduction of heat and cold.

The best option for the structure would be to replace the units with a window in like and kind, with dual pane glass to cut down the condensation and preserve the structure.

Typical water
damage stain
from
condensation
On interior
plaster
