NEW MEXICO HISTORIC BUILDING INVENTORY - SANTA FE RESURVEY 1993

IDENTIFICATION	ADDRESS: <u>121 E. Santa Fe</u>	ID NUMBER: <u>051600030</u>
	BUILDING NAME:	
	UTM REFERENCE EASTING NORTHING ZONE <u>12 13</u>	LEGAL DESCRIPTION: TNSP <u>17</u> (N) S RANGE <u>9</u> (E) W SEC <u>25</u> NW 1/4 NE 1/4
FIELD MAP <u>Santa Fe Historic Structures Survey, 1983-85/1992</u>

NEW MEXICO HISTORIC BUILDING INVENTORY - SANTA FE RESURVEY 1993 (concluded)

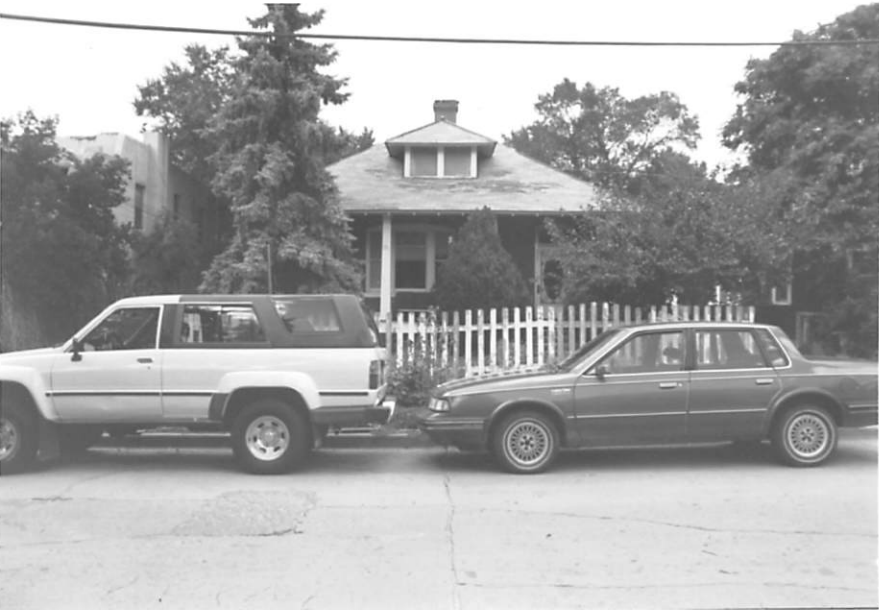
DATE OF CONSTRUCTION: ____ ESTIMATE <sup>by</sup> <u>1912</u> ACTUAL		
SOURCE(S) <u>King's map - Salmon Addn. 12-13</u>		
ARCHITECTURAL STYLE: <u>Hipped Box / NM Ver.</u>	PHOTO	#15 south elevation
USE: HISTORIC: <u>residential</u> OTHER _____ PRESENT: <u>residential</u> OTHER _____		
SURROUNDINGS: <u>residential</u>		
RELATIONSHIP TO HISTORIC SURROUNDINGS: <input checked="" type="checkbox"/> SIMILAR <input type="checkbox"/> NOT SIMILAR		
ASSOCIATED BUILDINGS ON SITE: <input checked="" type="checkbox"/> YES <input type="checkbox"/> NO WHAT TYPE? <u>garage</u> IF INVENTORIED, LIST ID NUMBER(S) _____	SITE PLAN

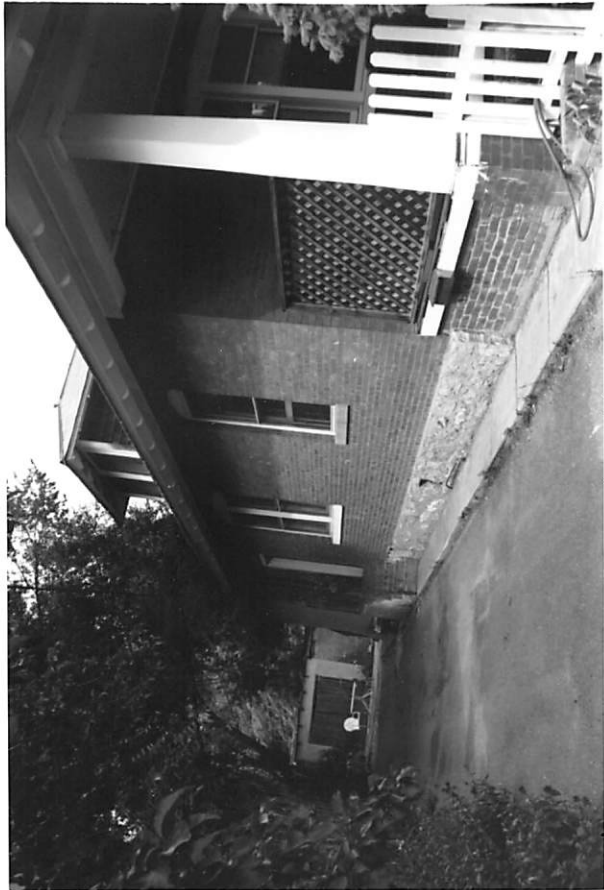
#14

west elevation, S end

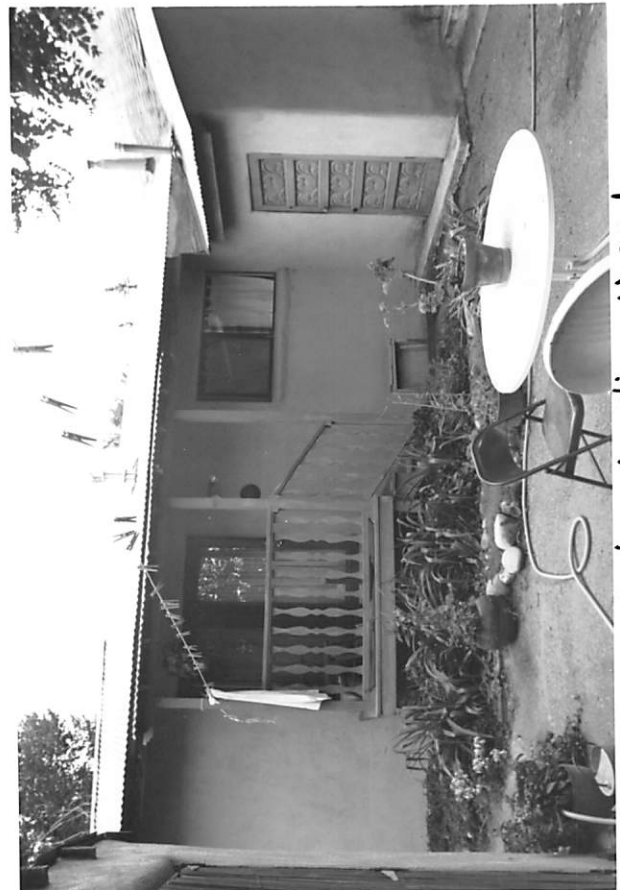
#17

west elevation, N end

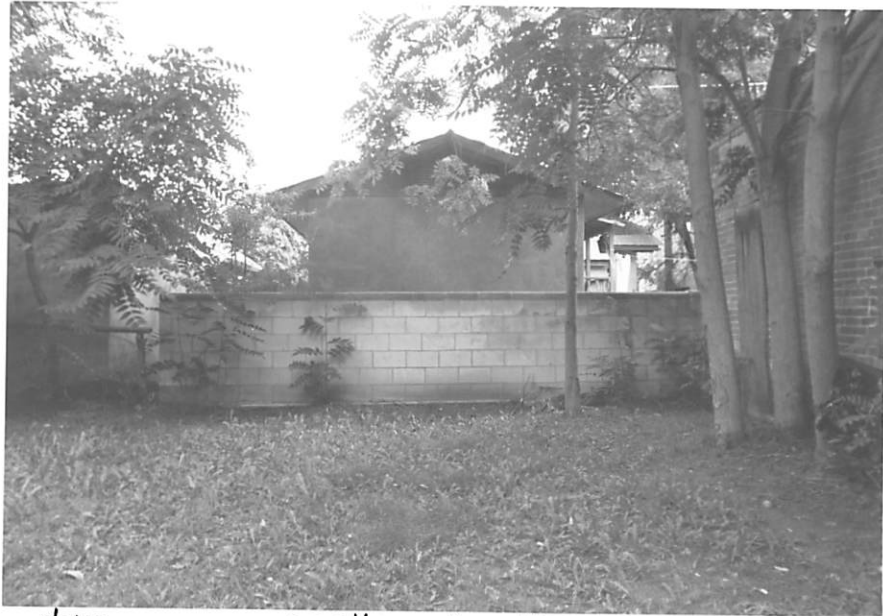
#18 north elevation

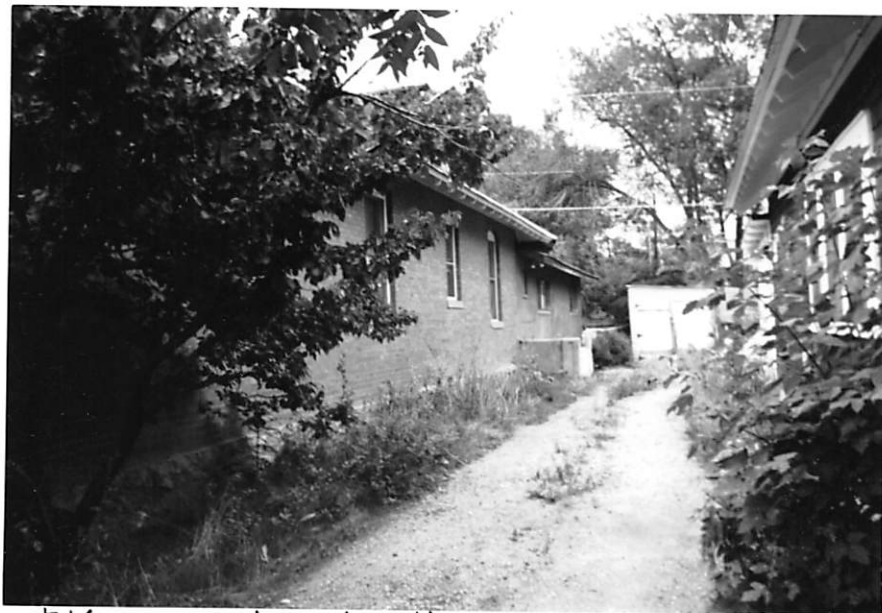
#16 east elevation
