# Historic Cultural Properties Inventory (HCPI) Base Form (FORM 1)

Date of Form: August 8, 2025 – Revised

<b>6. Date of Survey:</b> July 27, 2025	
<b>7. Previous Survey Date(s):</b> <input checked="" type="checkbox"/> Yes: December 12, 1985, Michael Belshaw <input type="checkbox"/> No:	
<b>8. Name of Project:</b> HDRB Status Evaluation	
<b>9. Lat/Long:</b> 35.6806349,-105.9331281	
<b>10. Photo Information:</b> Giulia Caporuscio, photographer.      Photo 1: View of east elevation, facing northwest.

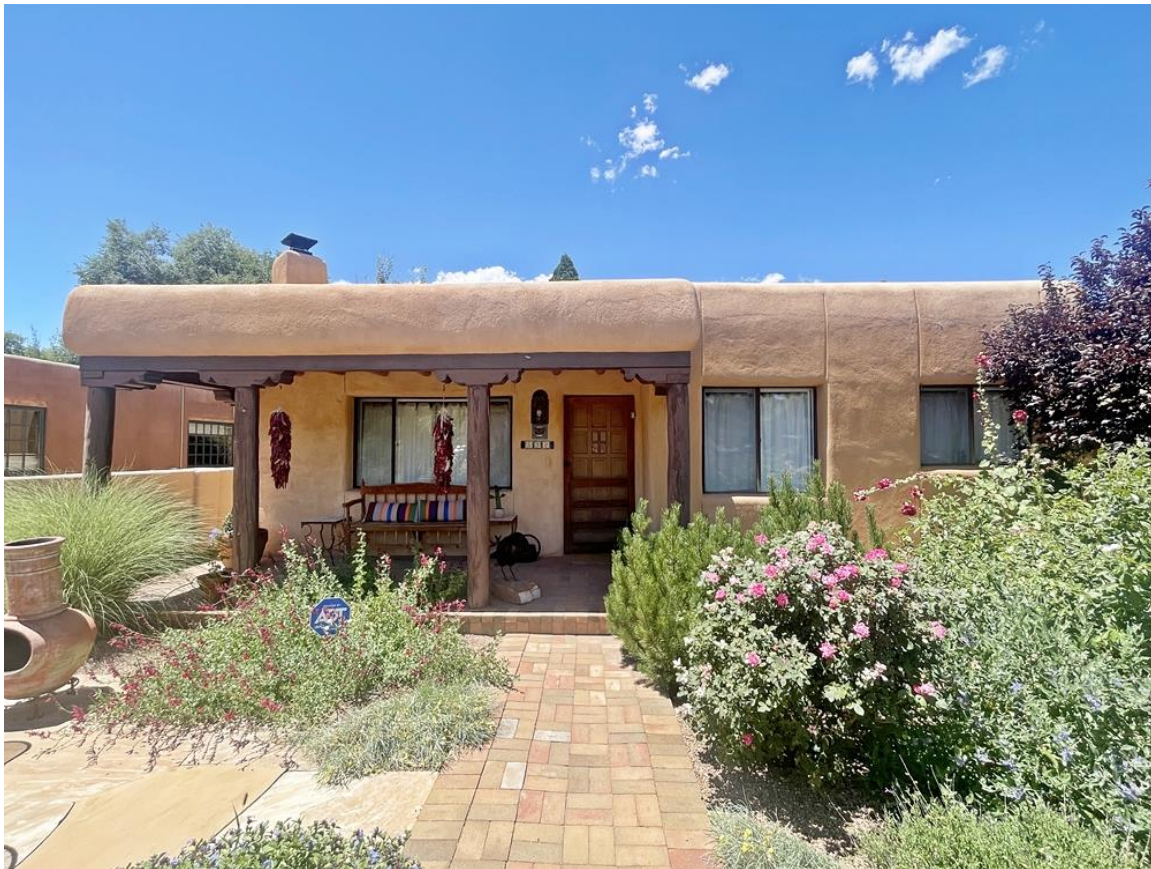
The front façade, which faces Calle Corvo, presents a Spanish Pueblo Revival vocabulary, although several elements were introduced in recent years. At the south end is a generously sized *portal* (Photo 2). This flat-roofed structure with a stuccoed parapet is supported by round wood posts topped with double *zapatas* (corbels).

**Photo 2: East (front) façade. Camera facing west.**

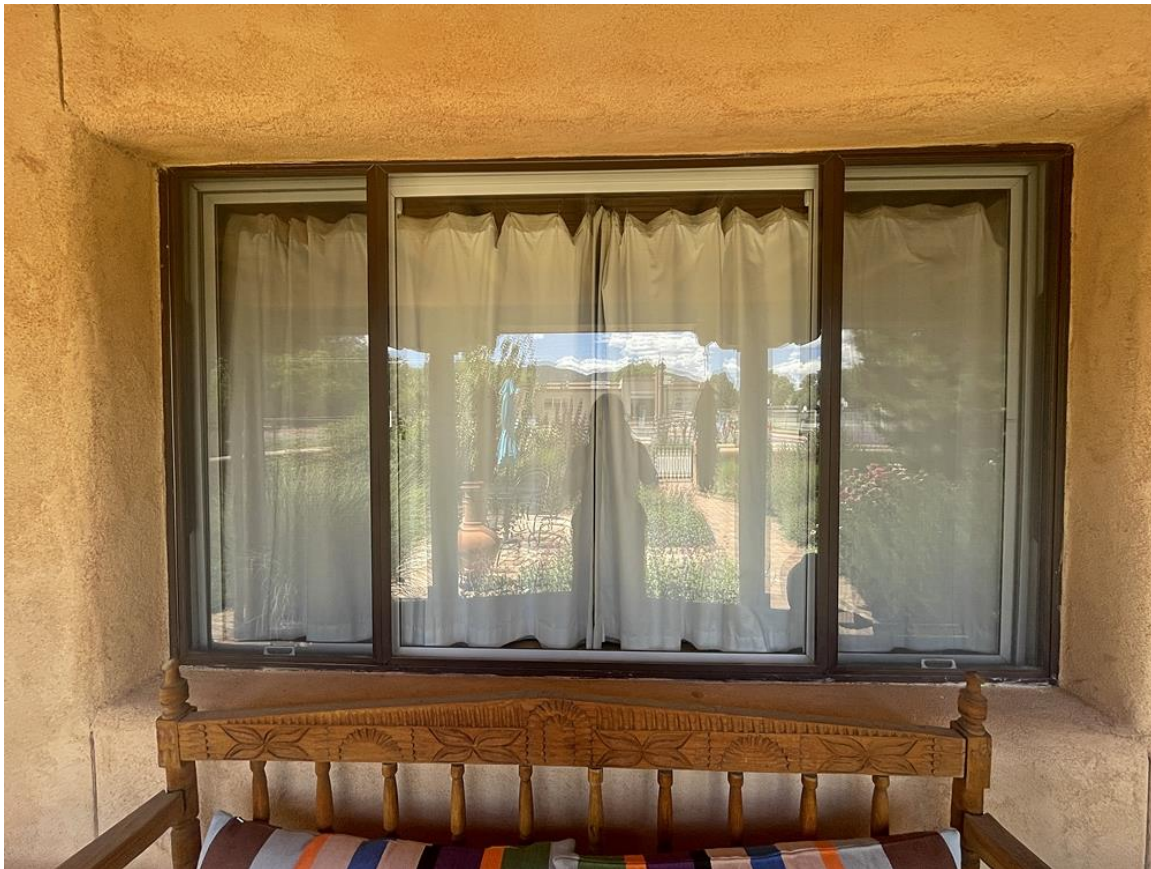
Centered within the portal is an aluminum combination window composed of a fixed central panel flanked by sliding sashes (Photo 3). Like most windows on the house, it is covered by a metal storm unit. The portal floor is now finished in brick and square concrete pavers, replacing the original poured concrete surface. The main entry door is sheltered beneath the portal; it is a wood unit with an 18-panel design and a small glazed vision light (Photo 4).

**Photo 3: East (front) façade. Replaced window at portal. Camera facing west.**

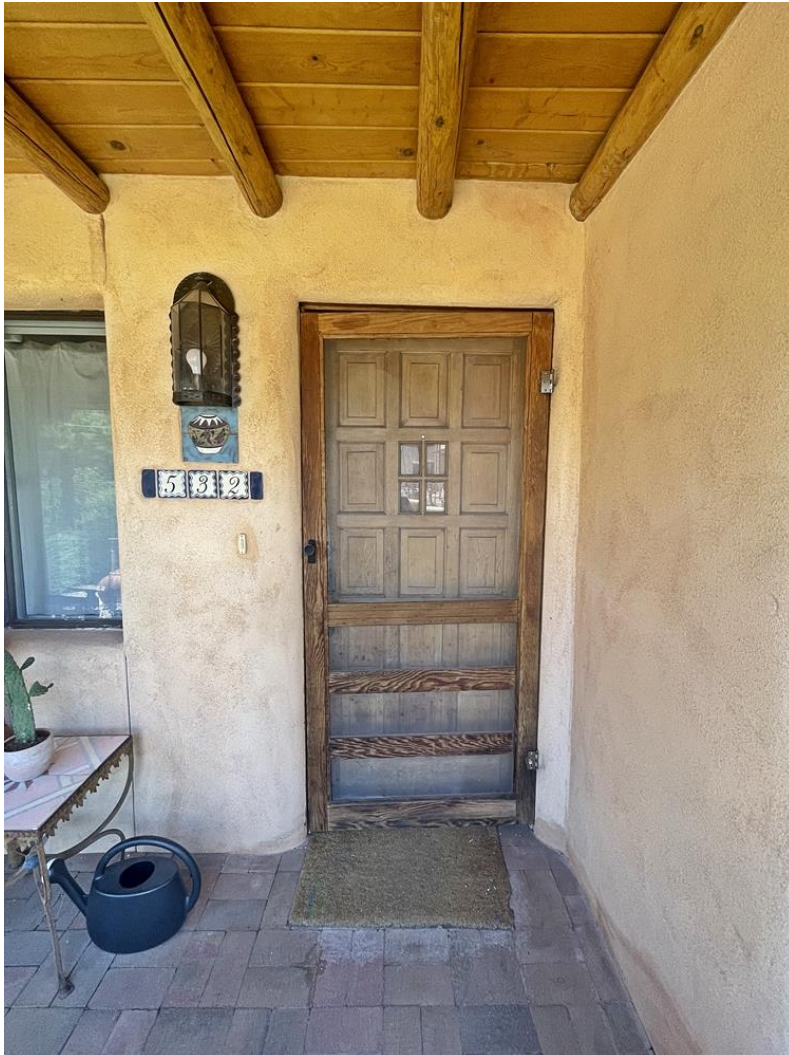
**Photo 4: East (front) façade. Front entry door. Camera facing west.**

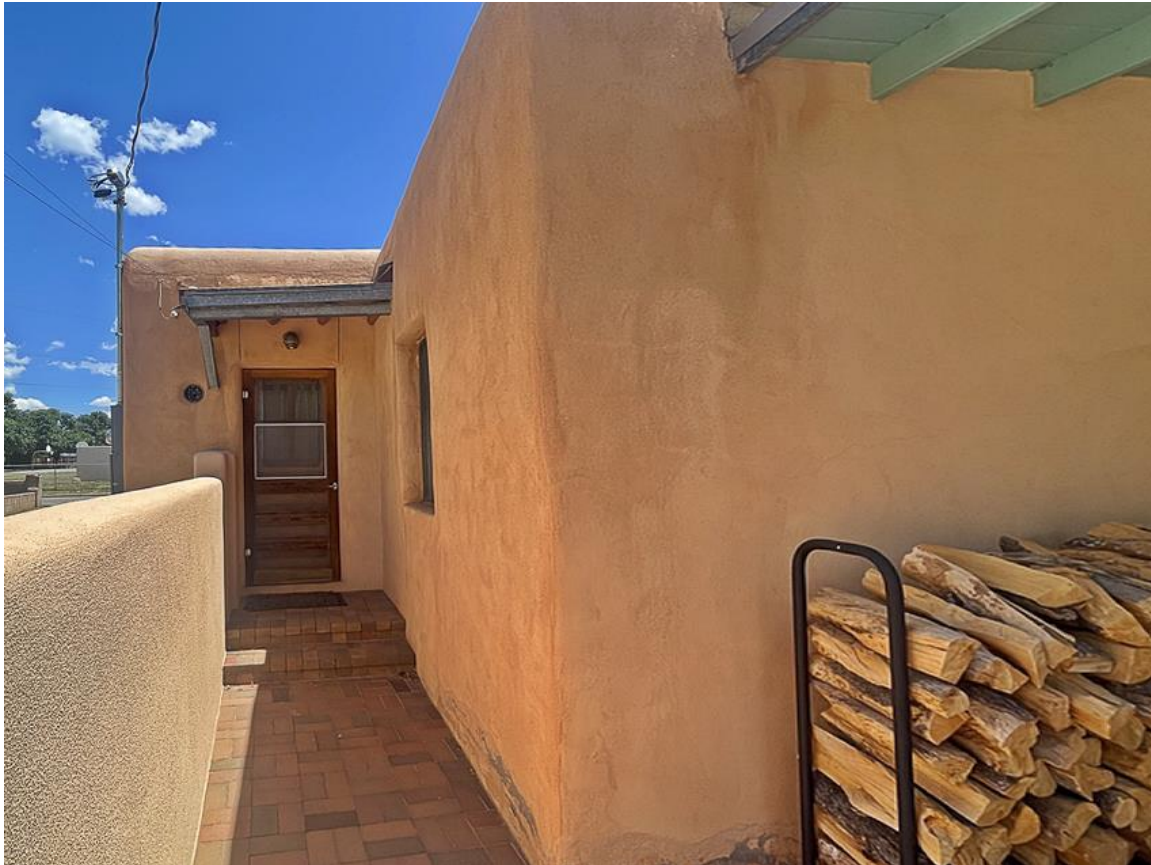
It is sheltered by a shallow shed-roof canopy made of corrugated metal, supported by peeled-log vigas. A galvanized steel brace—likely a later addition—anchors the canopy to the wall, marking it as an aftermarket intervention not original to the building. The canopy does not appear in the 1958 aerial photograph (Fig. 4).

**Photo 8: West elevation. Laundry room. Camera facing east.**

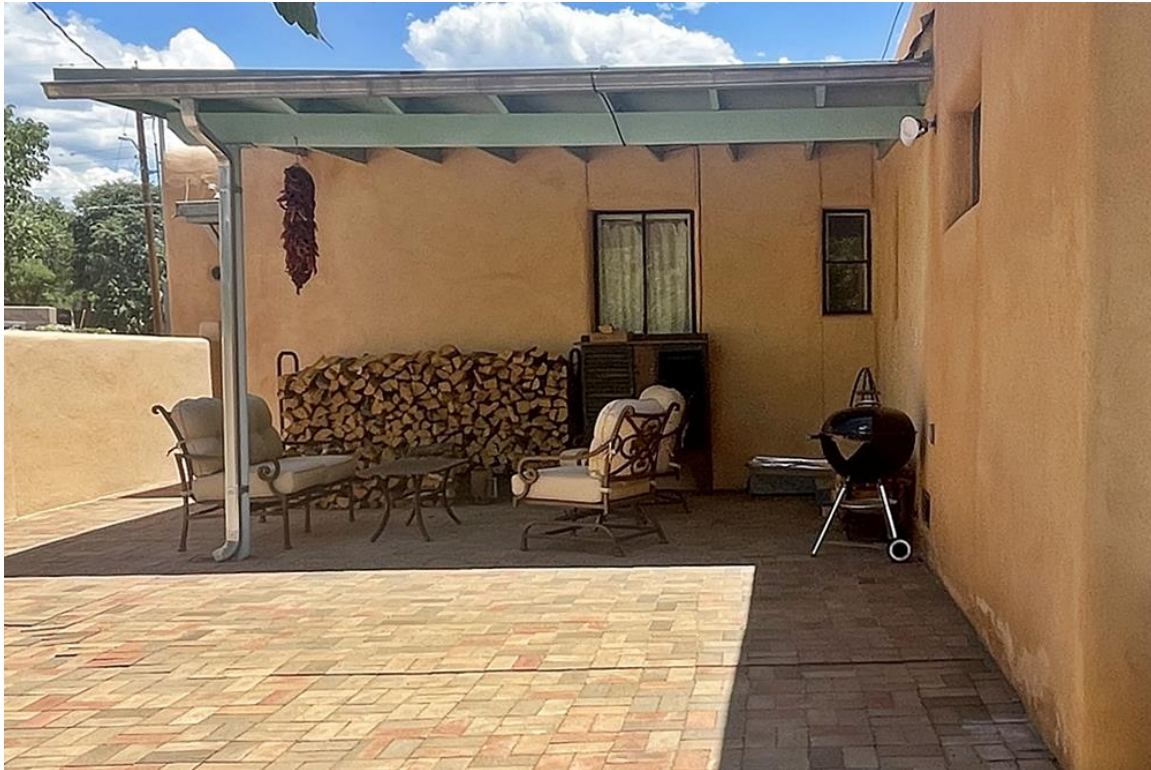
Turning the corner, the west elevation of the original house comes into view. This section includes a sheltered rear porch added after 1958, as well as window openings serving the bedroom and bathroom (Photo 10).

**Photo 10: West elevation. Original section. Camera facing east.**

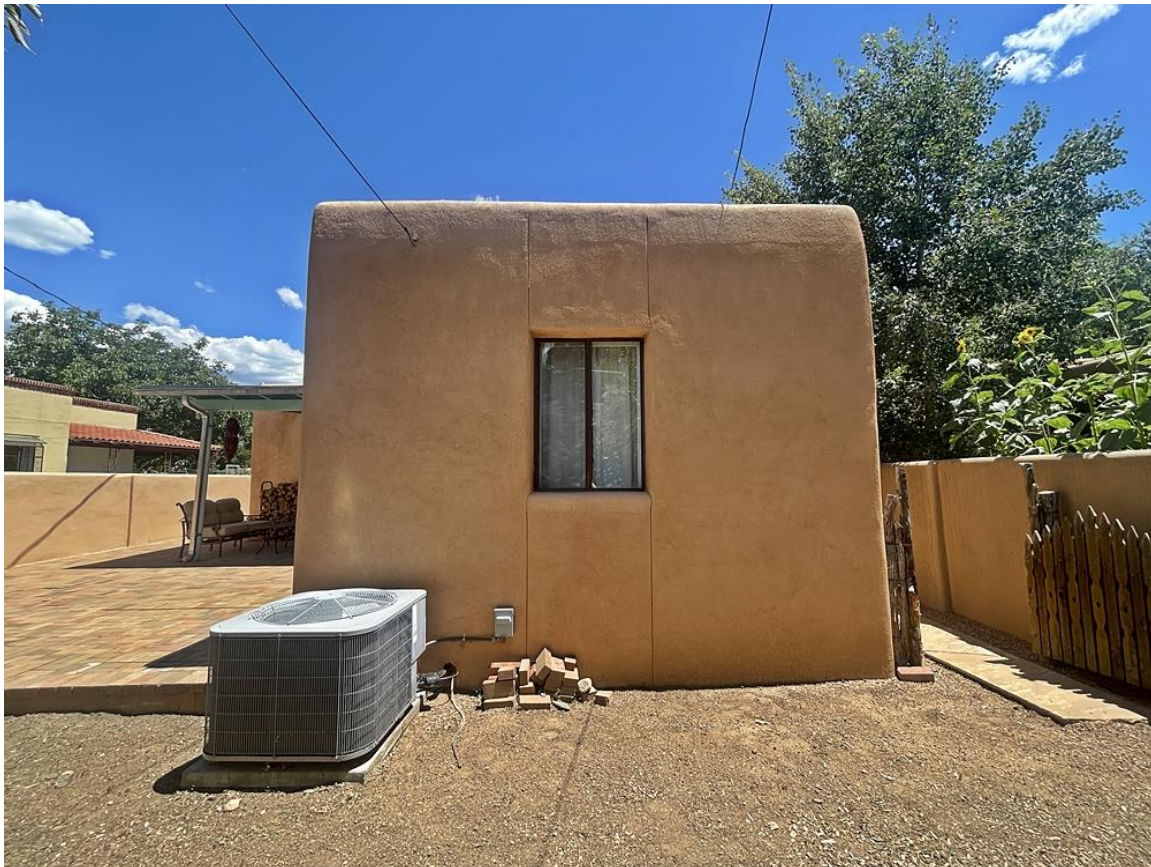
Beyond this is a primary bedroom addition, constructed—based on aerial photographs—between 1958 and 1966 (Figs. 4 & 5). This rectangular volume projects approximately 13 feet and features privacy-oriented fenestration: high-set horizontal windows and a vertical aluminum sliding unit placed in the short west-facing wall (Photo 11).

**Photo 11: West elevation. Primary bedroom addition. Camera facing east.**

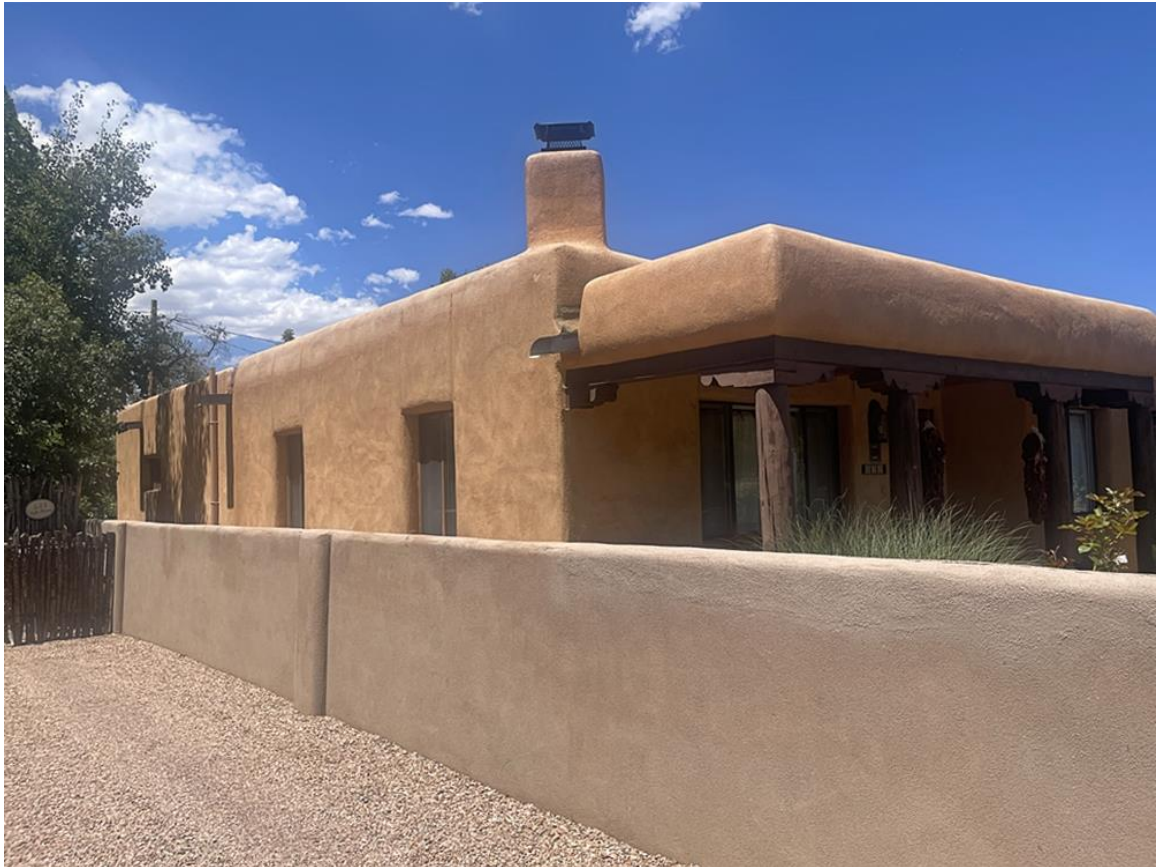
The south elevation sits close to the property line (Photo 12). It includes the south wall of the primary bedroom addition, which is marked by a single high-set privacy window (Photo 13). The remainder of the elevation belongs to the original volume and is fenestrated with two vertical openings, each fitted with sliding aluminum units (Photo 14).

**Photo 12: South elevation and property wall. Camera facing northeast.**

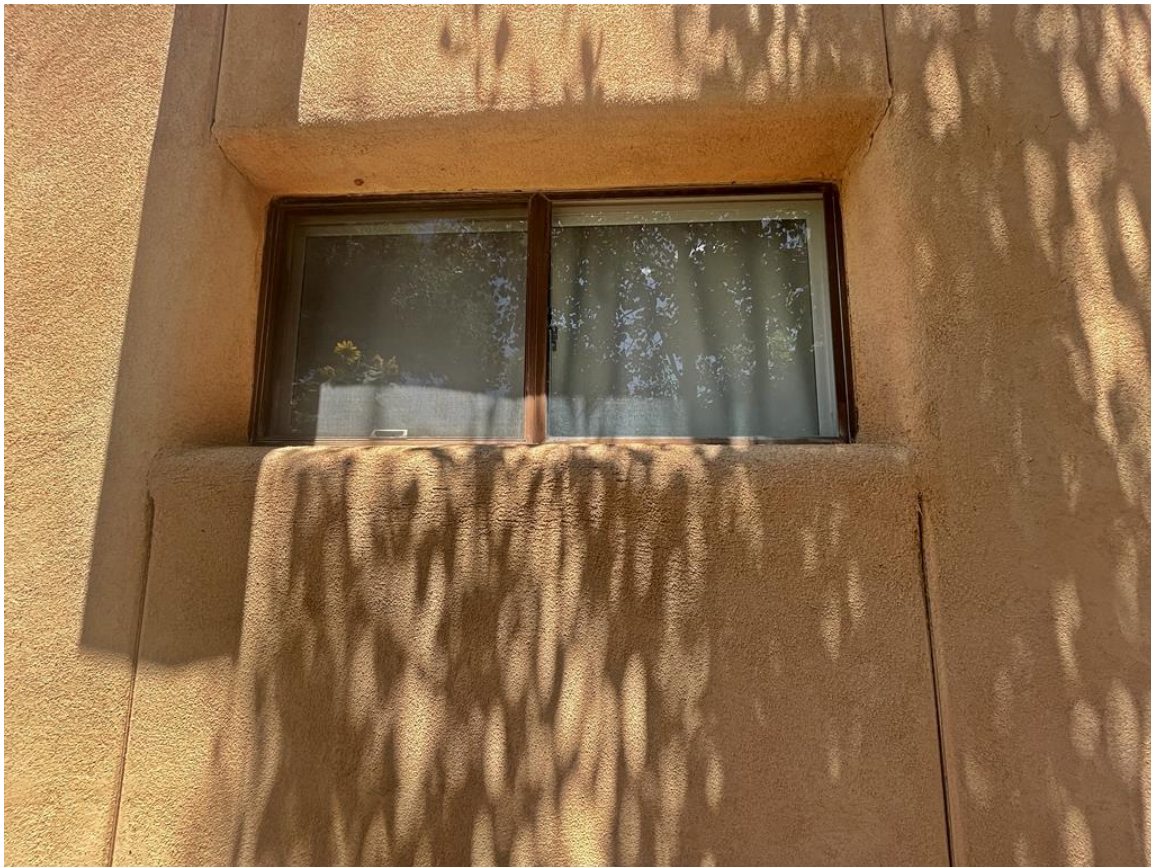
**Photo 13: South elevation. Privacy window at primary bedroom addition. Camera facing north.**

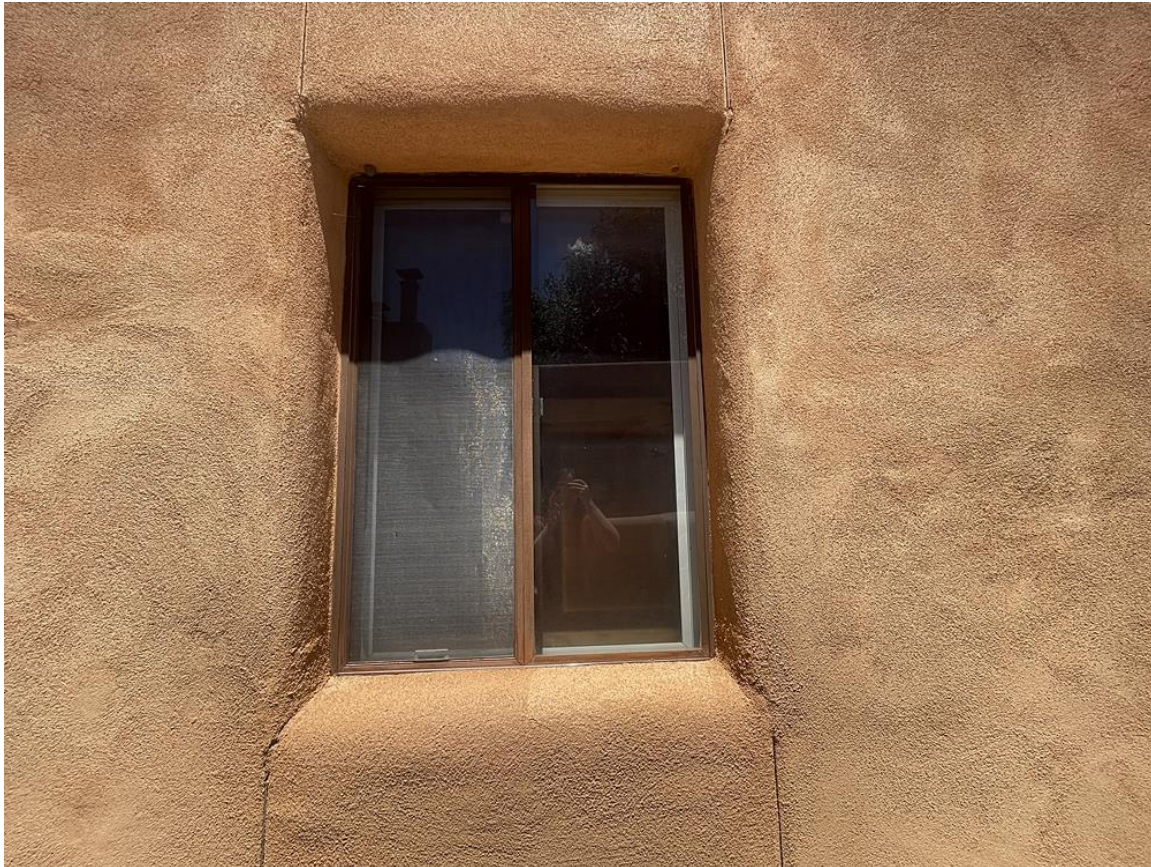
**Photo 14: South elevation. Original section. Window detail. Camera facing north.**

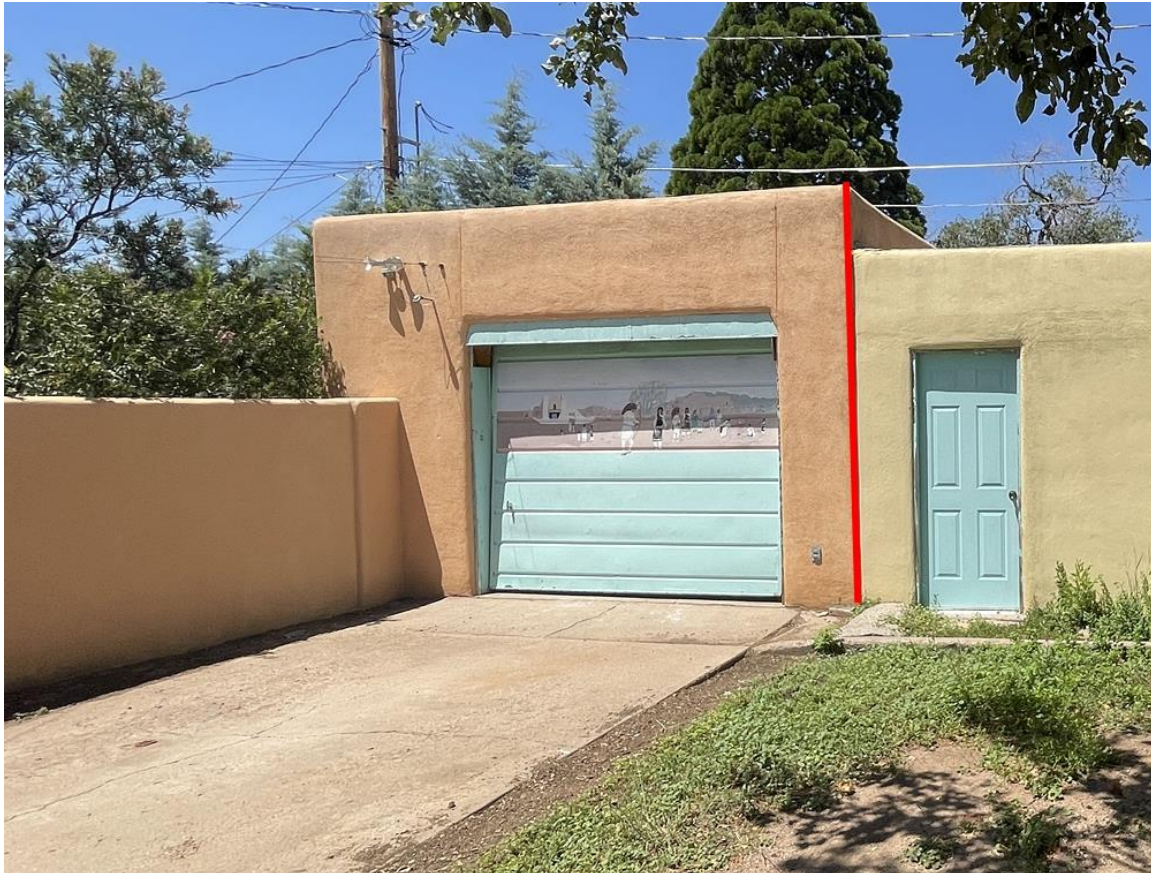
Tucked into the northwest corner of the lot, at the end of the driveway, is a one-bay garage (Photo 15). The roughly 392-square-foot structure is constructed of stuccoed concrete masonry units (CMU) and was likely built contemporaneously with the house. Its north wall shares a zero-lot-line condition with an adjoining garage—now used for storage—on the neighboring property.

The subject garage features a metal tilt-up door painted with a decorative scene of an Indian Pueblo. The south elevation includes a single 12-light steel industrial window. No other fenestration is present.

**Photo 15: Garage (left of red line). Camera facing southwest.**
