# RPA & Associates, LLC.

JOB	DATE
527 AGUA FRIA, SANTA FE, NM 87501	8/15/2025

Renovation of an Existing Residential Structure

527 Agua Fria Street, Santa Fe NM 87501

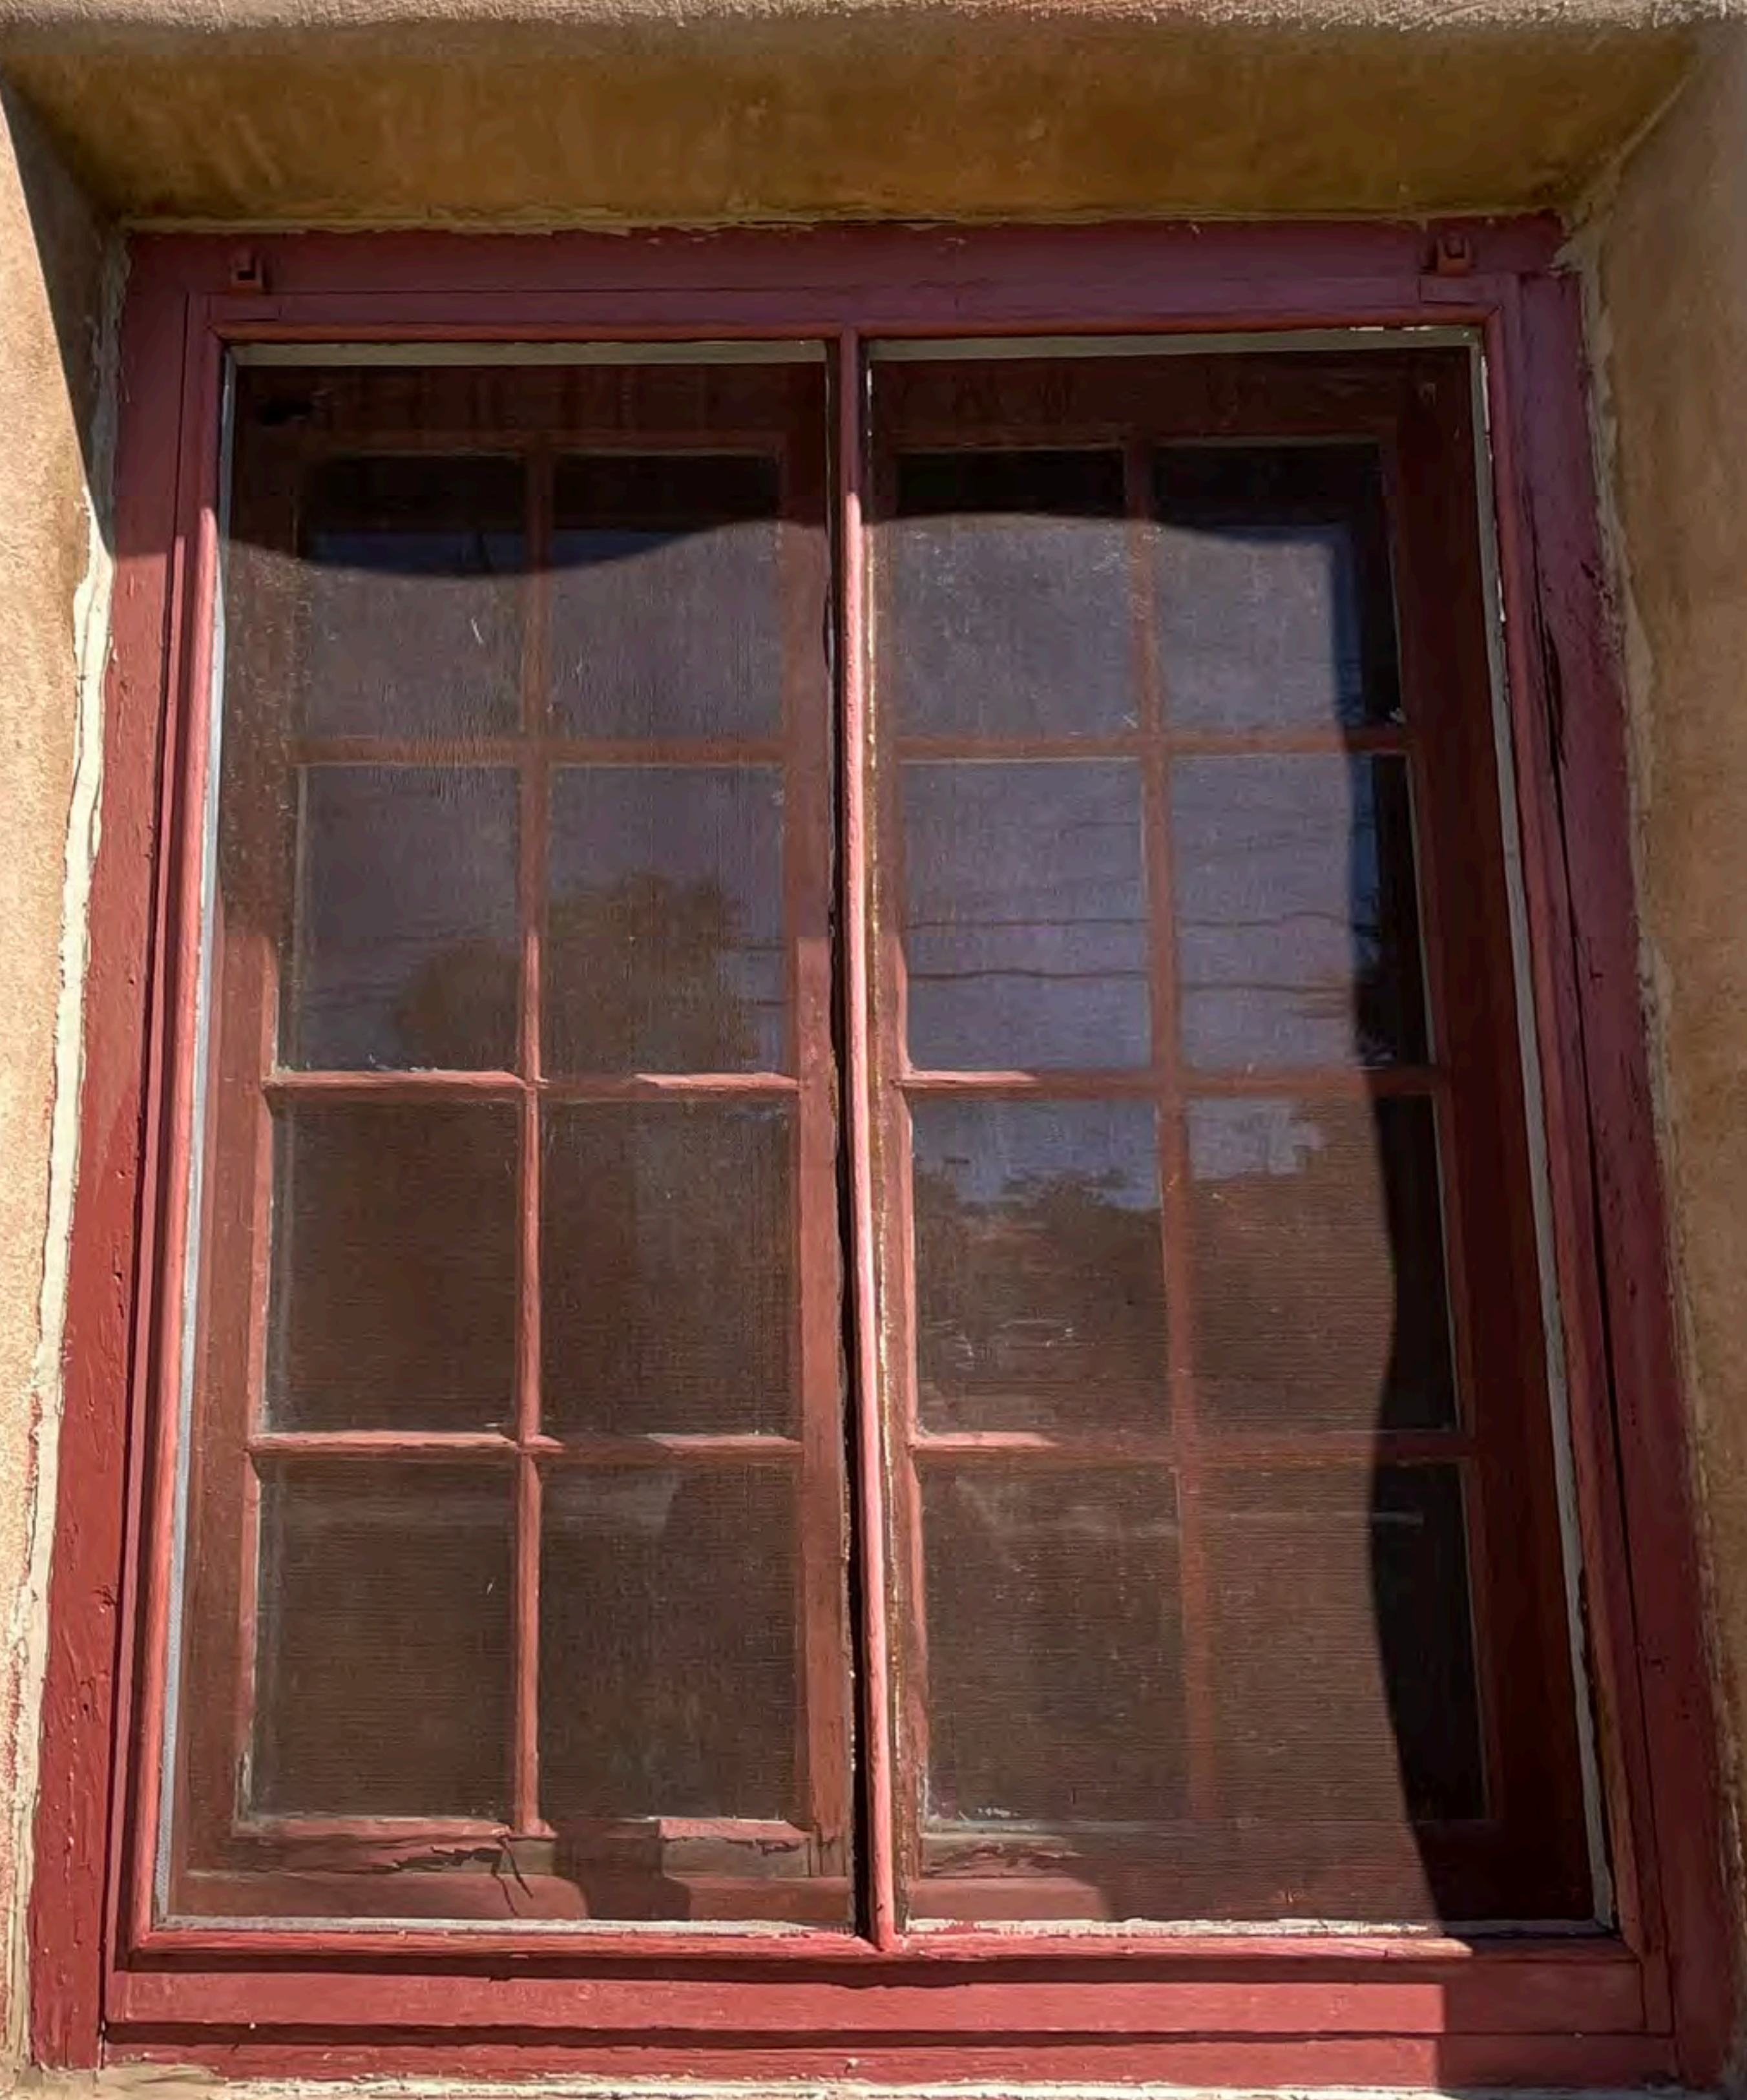
South Elevation  
Window  
F

Windows F, G, H, I and J are historic and restorable.

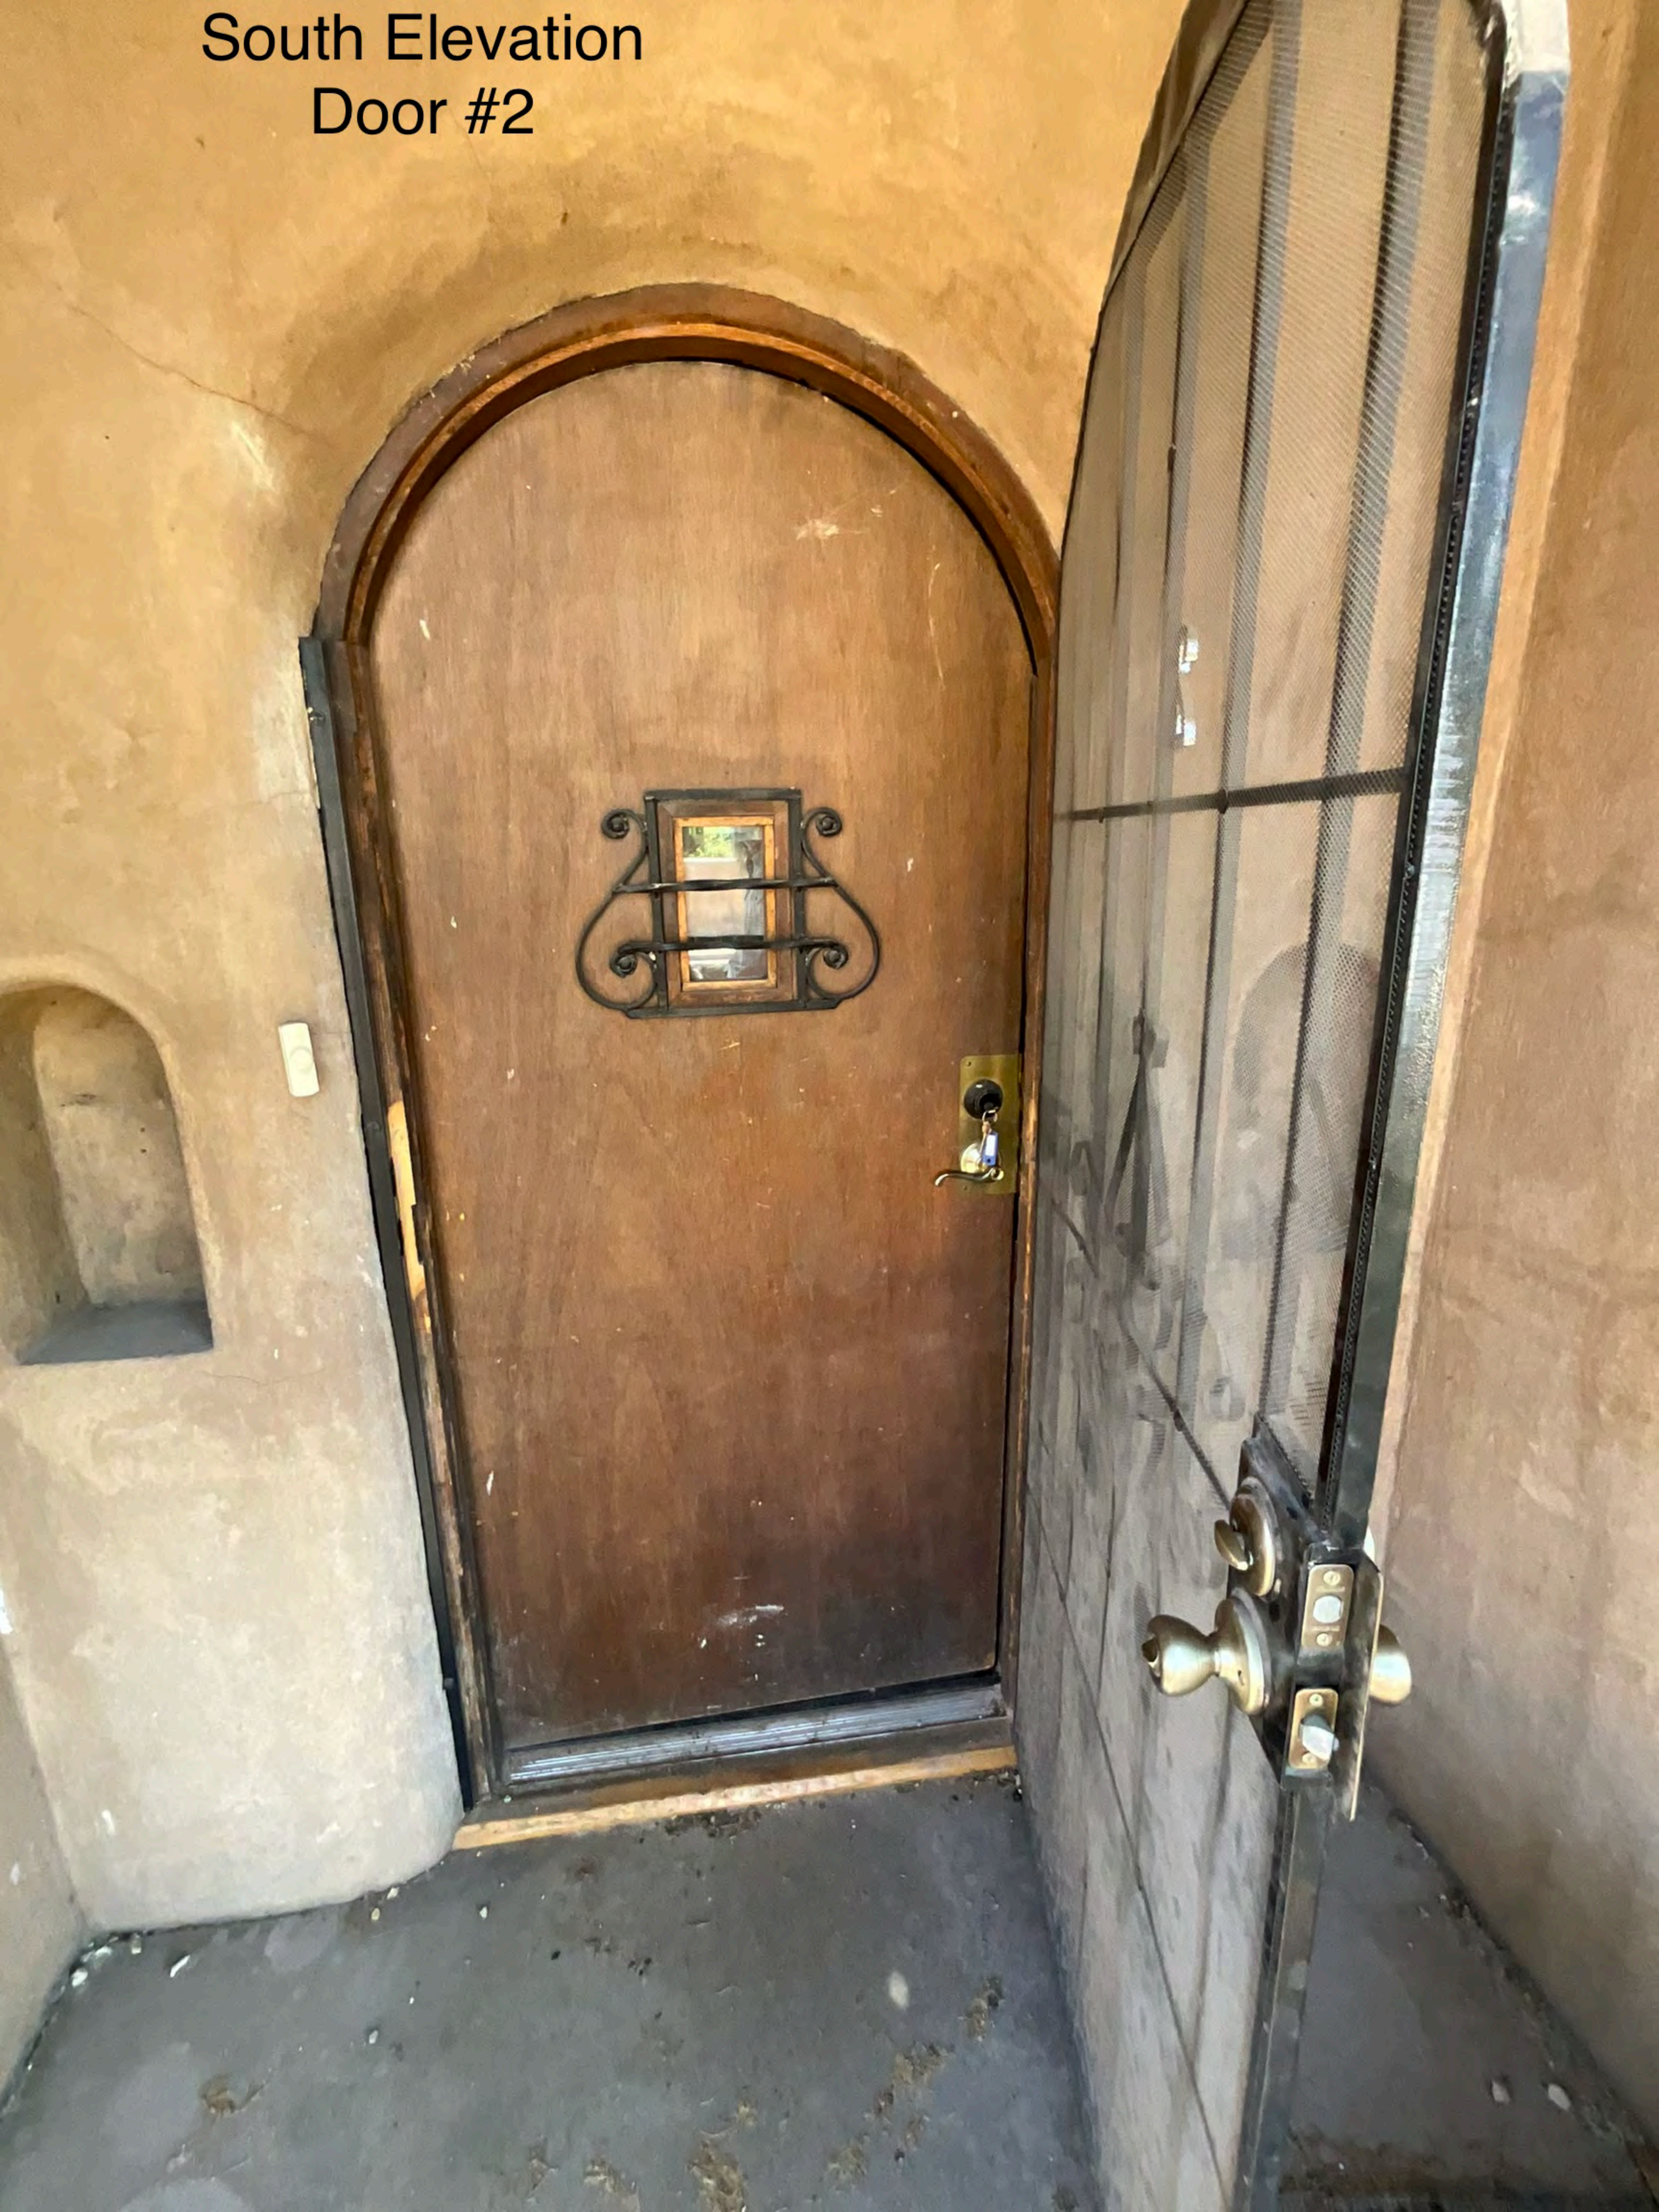
South Elevation  
Door #2

DR #2	36 x 81 LH ARCH TOP W/1-PEEP GLASS 1 ¾ SC BIRCH	S	NON-HISTORIC – 1 ¾ SC BIRCH CUT OUT AND ARCHED VENEERED (1990)
I	23 x 55 RH INSWING CASEMENT 2W4H ALL WOOD	F	HISTORIC – RESTORABLE, THE SCREENS ARE NOT RESTORABLE
DR #3	36 x 82 ½ RH 3W5H ALL WOOD GLASS DOOR W/15" BOTTOM RAIL	S	NON-HISTORIC – SIMPSON DOOR (1995)

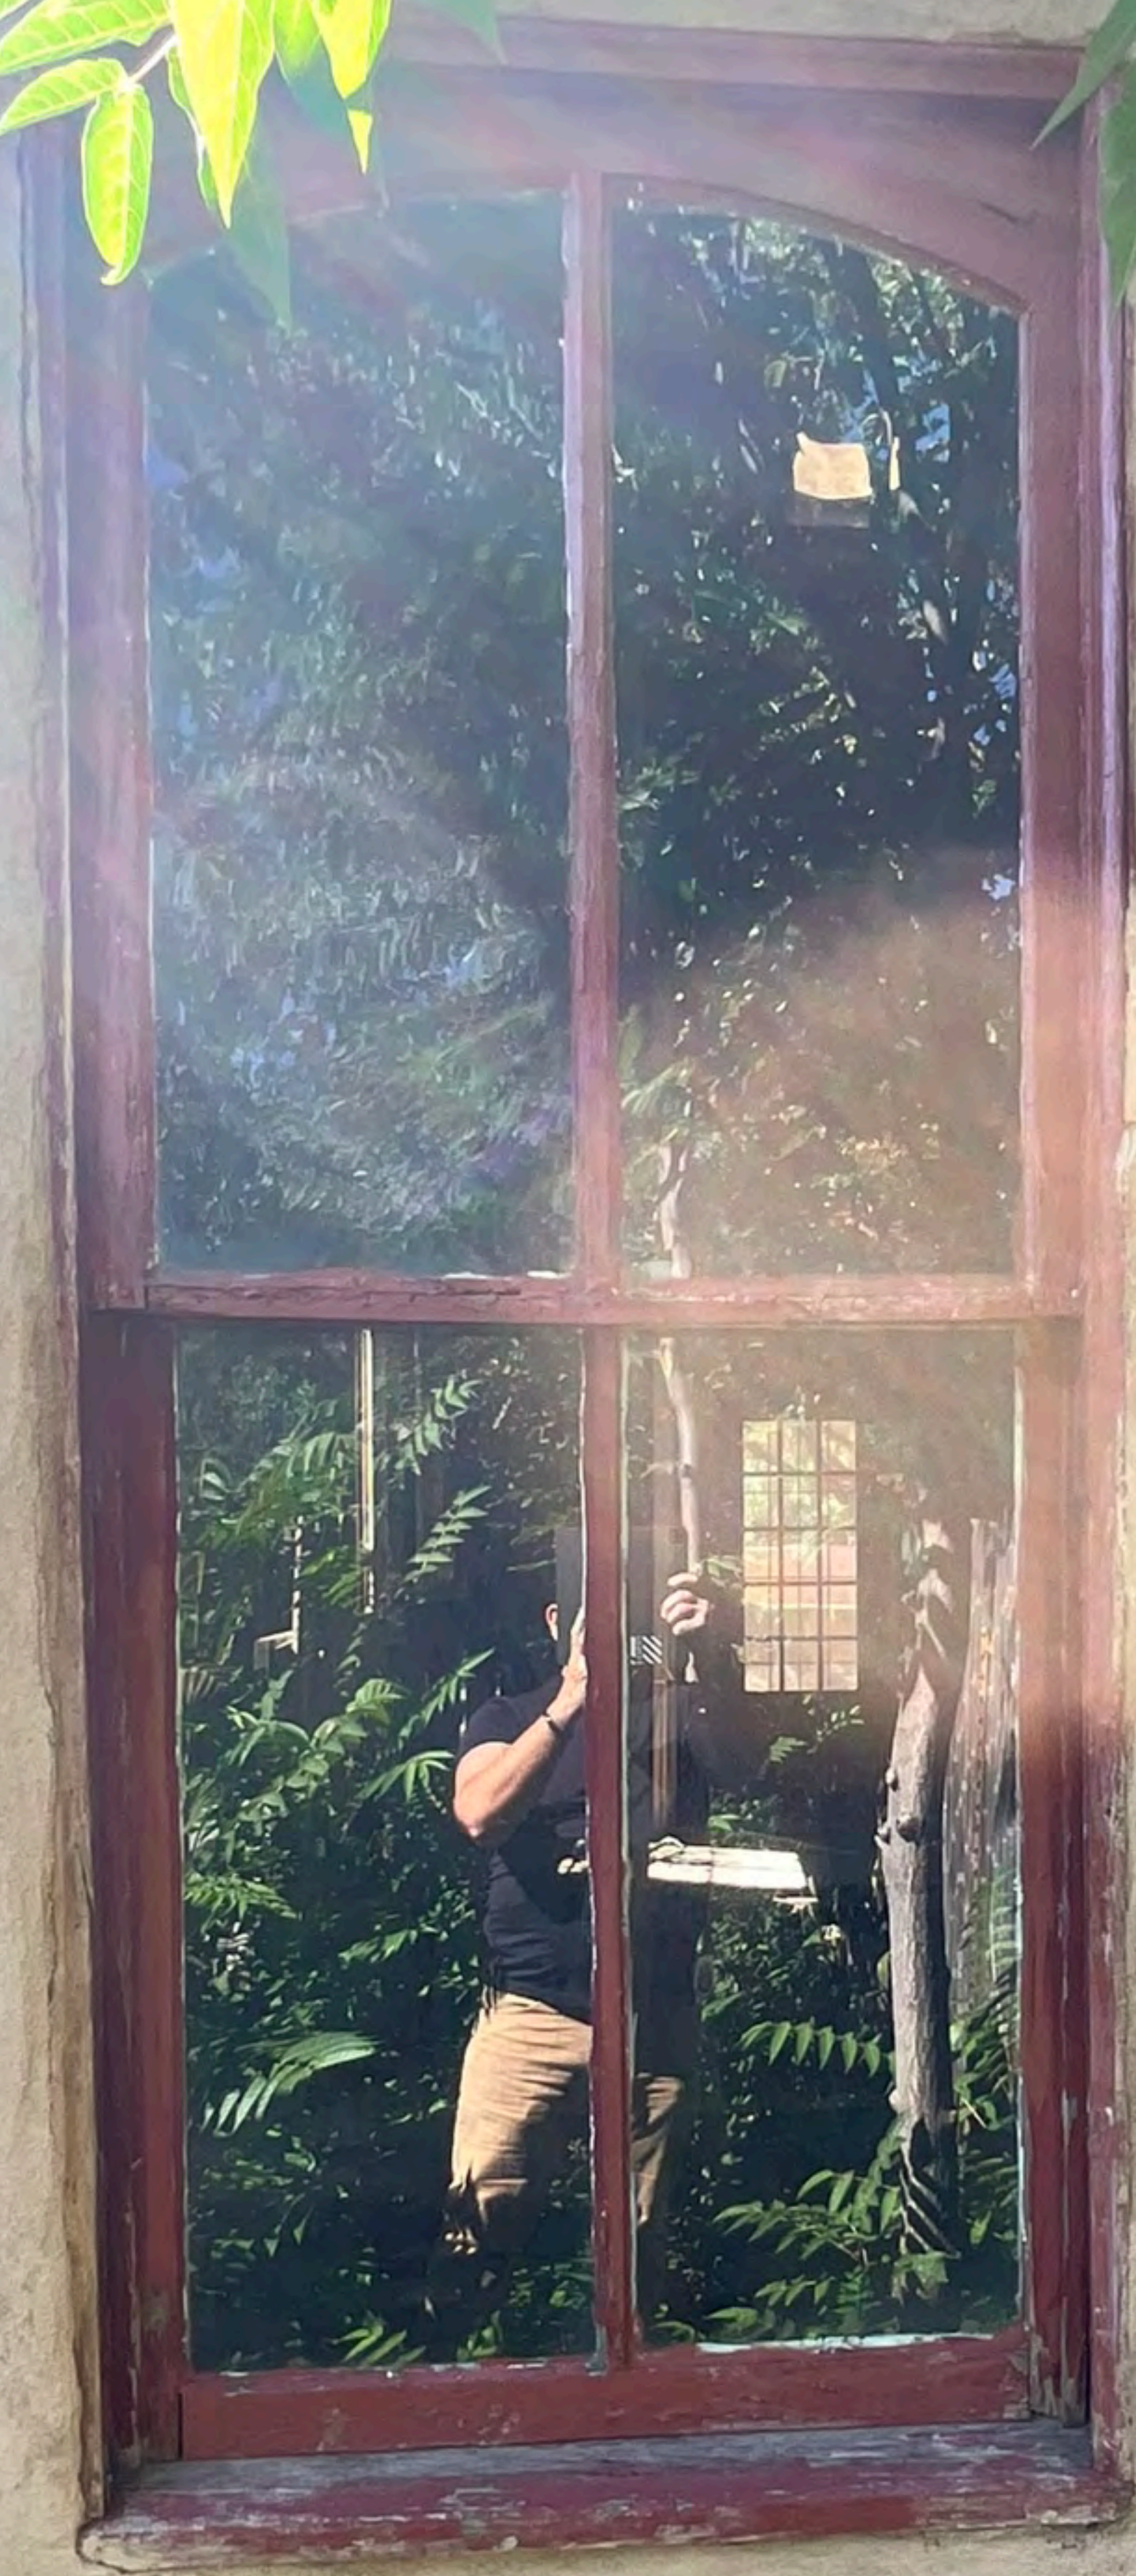
North  
Elevation  
Window  
N

Window N is historic however not part of the original house.

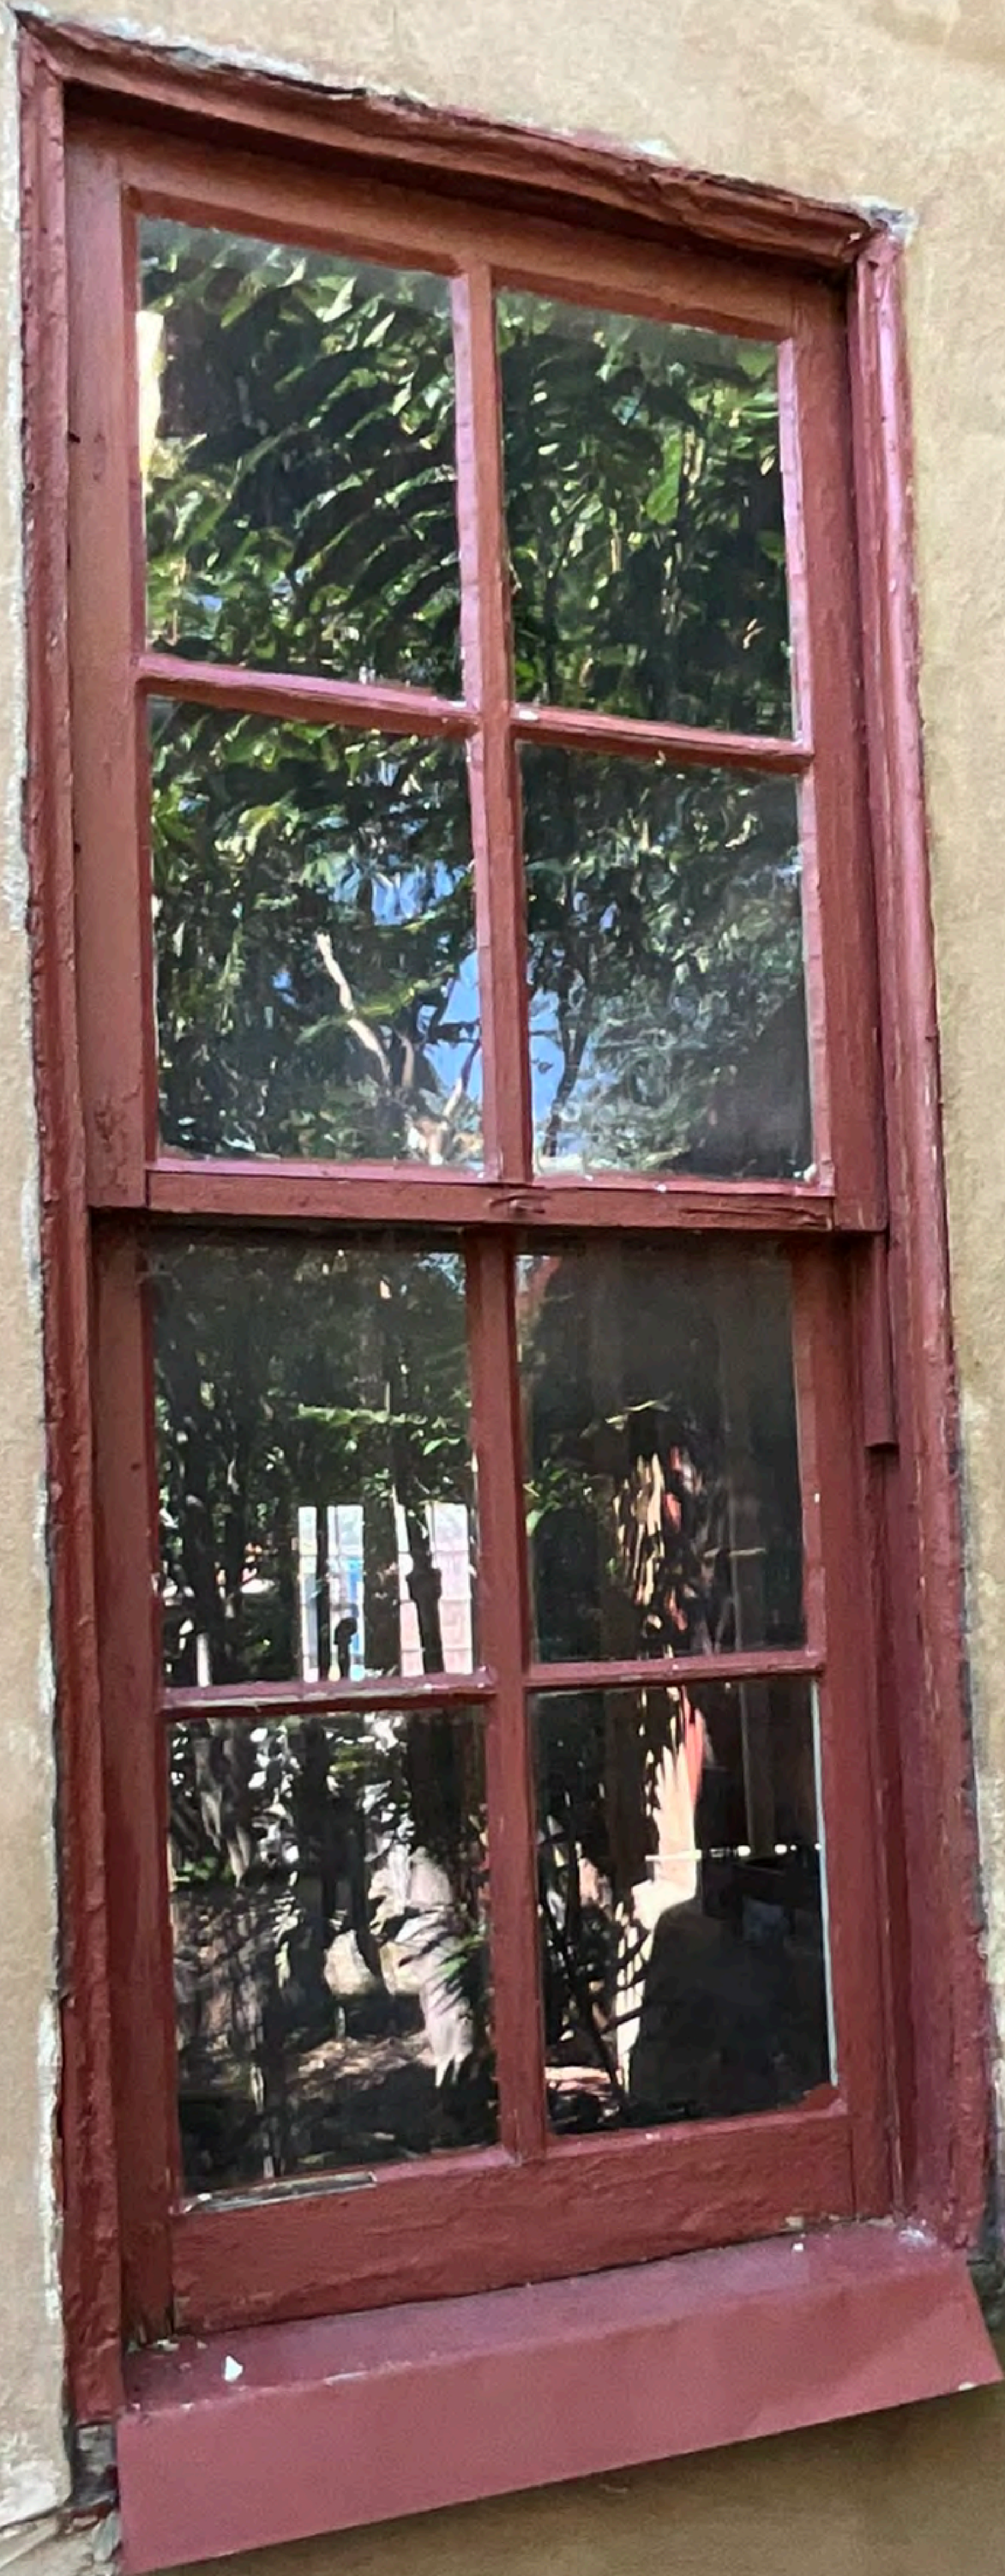
North  
Elevation  
Window  
O

Window O is historic however unrestorable.

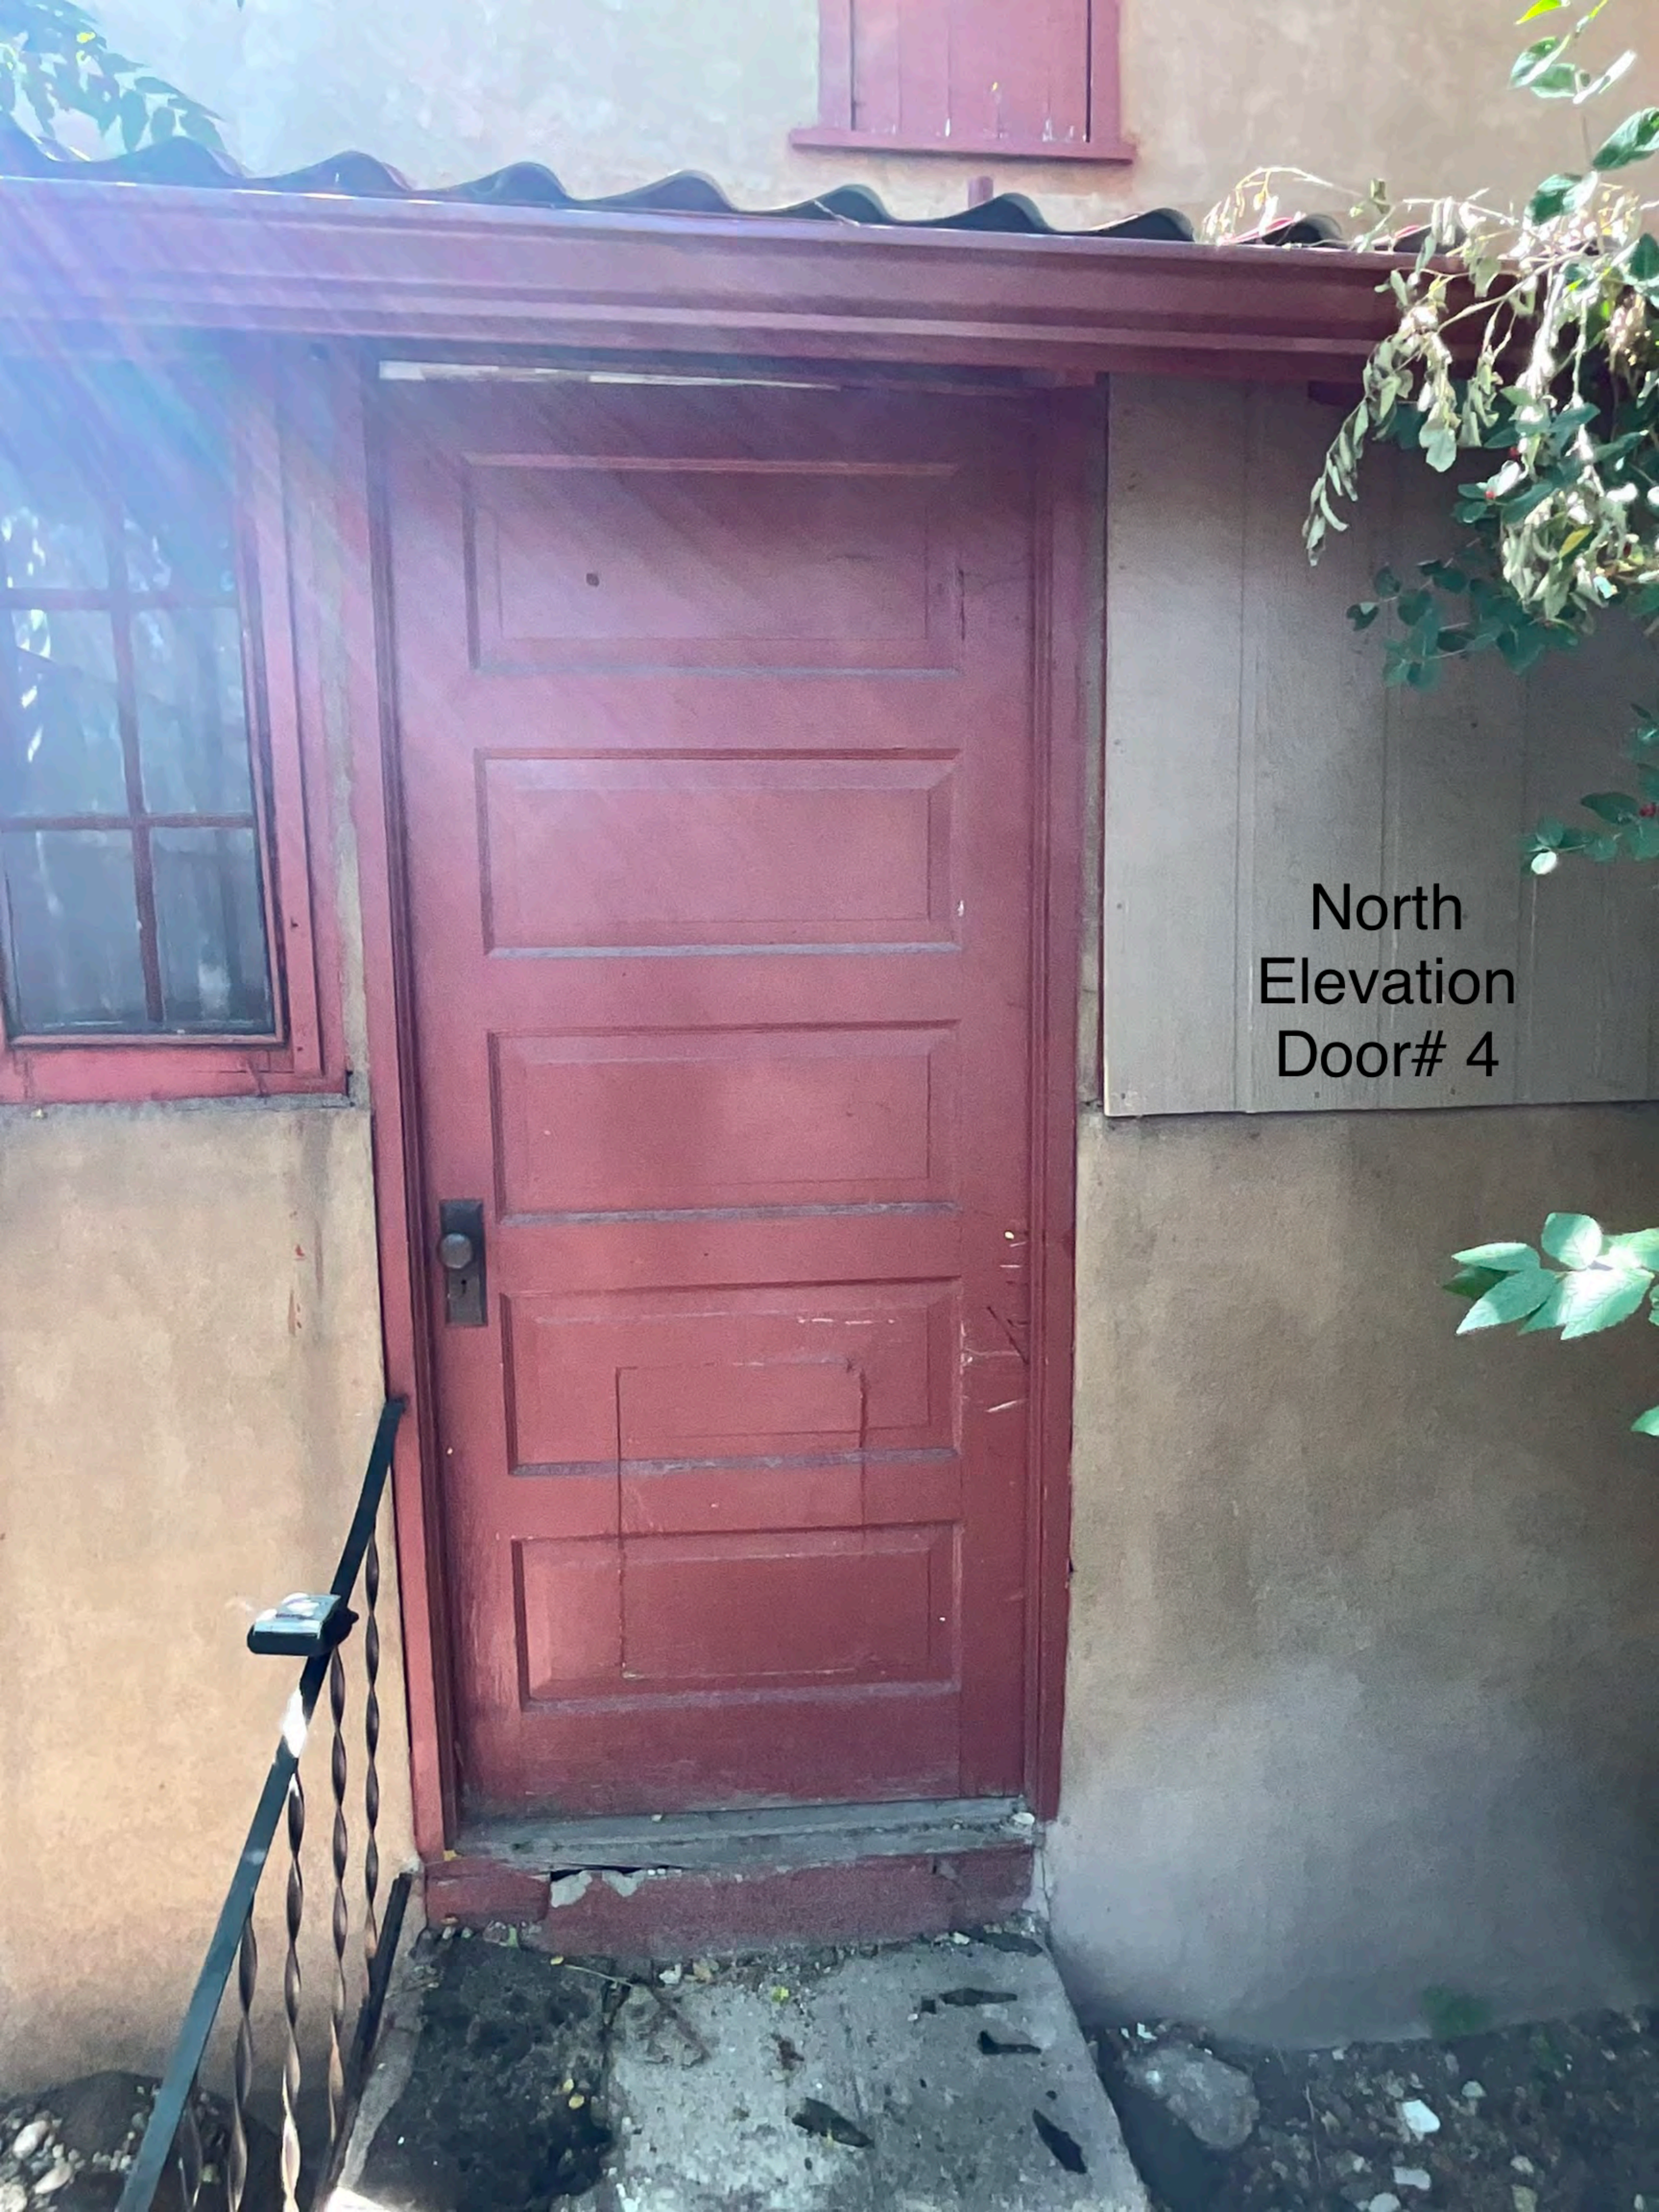
North  
Elevation  
Window  
Q

Q	15 x 36 L INSWING CASEMENT ALL WOOD 2W3H	F	NON-HISTORIC – BARN SASH (1996)
DR #4	36 x 80 RH INSWING DOOR 5-HORIZONTAL PANELS ALL WOOD	U	HISTORIC – HOWEVER NOT PART OF THE ORIGINAL HOUSE. ALL DOORS ARE 2-PANEL CUT, ONE CROSS RAIL CUT, RESULTING IN WEAK STRUCTURAL INTEGRITY

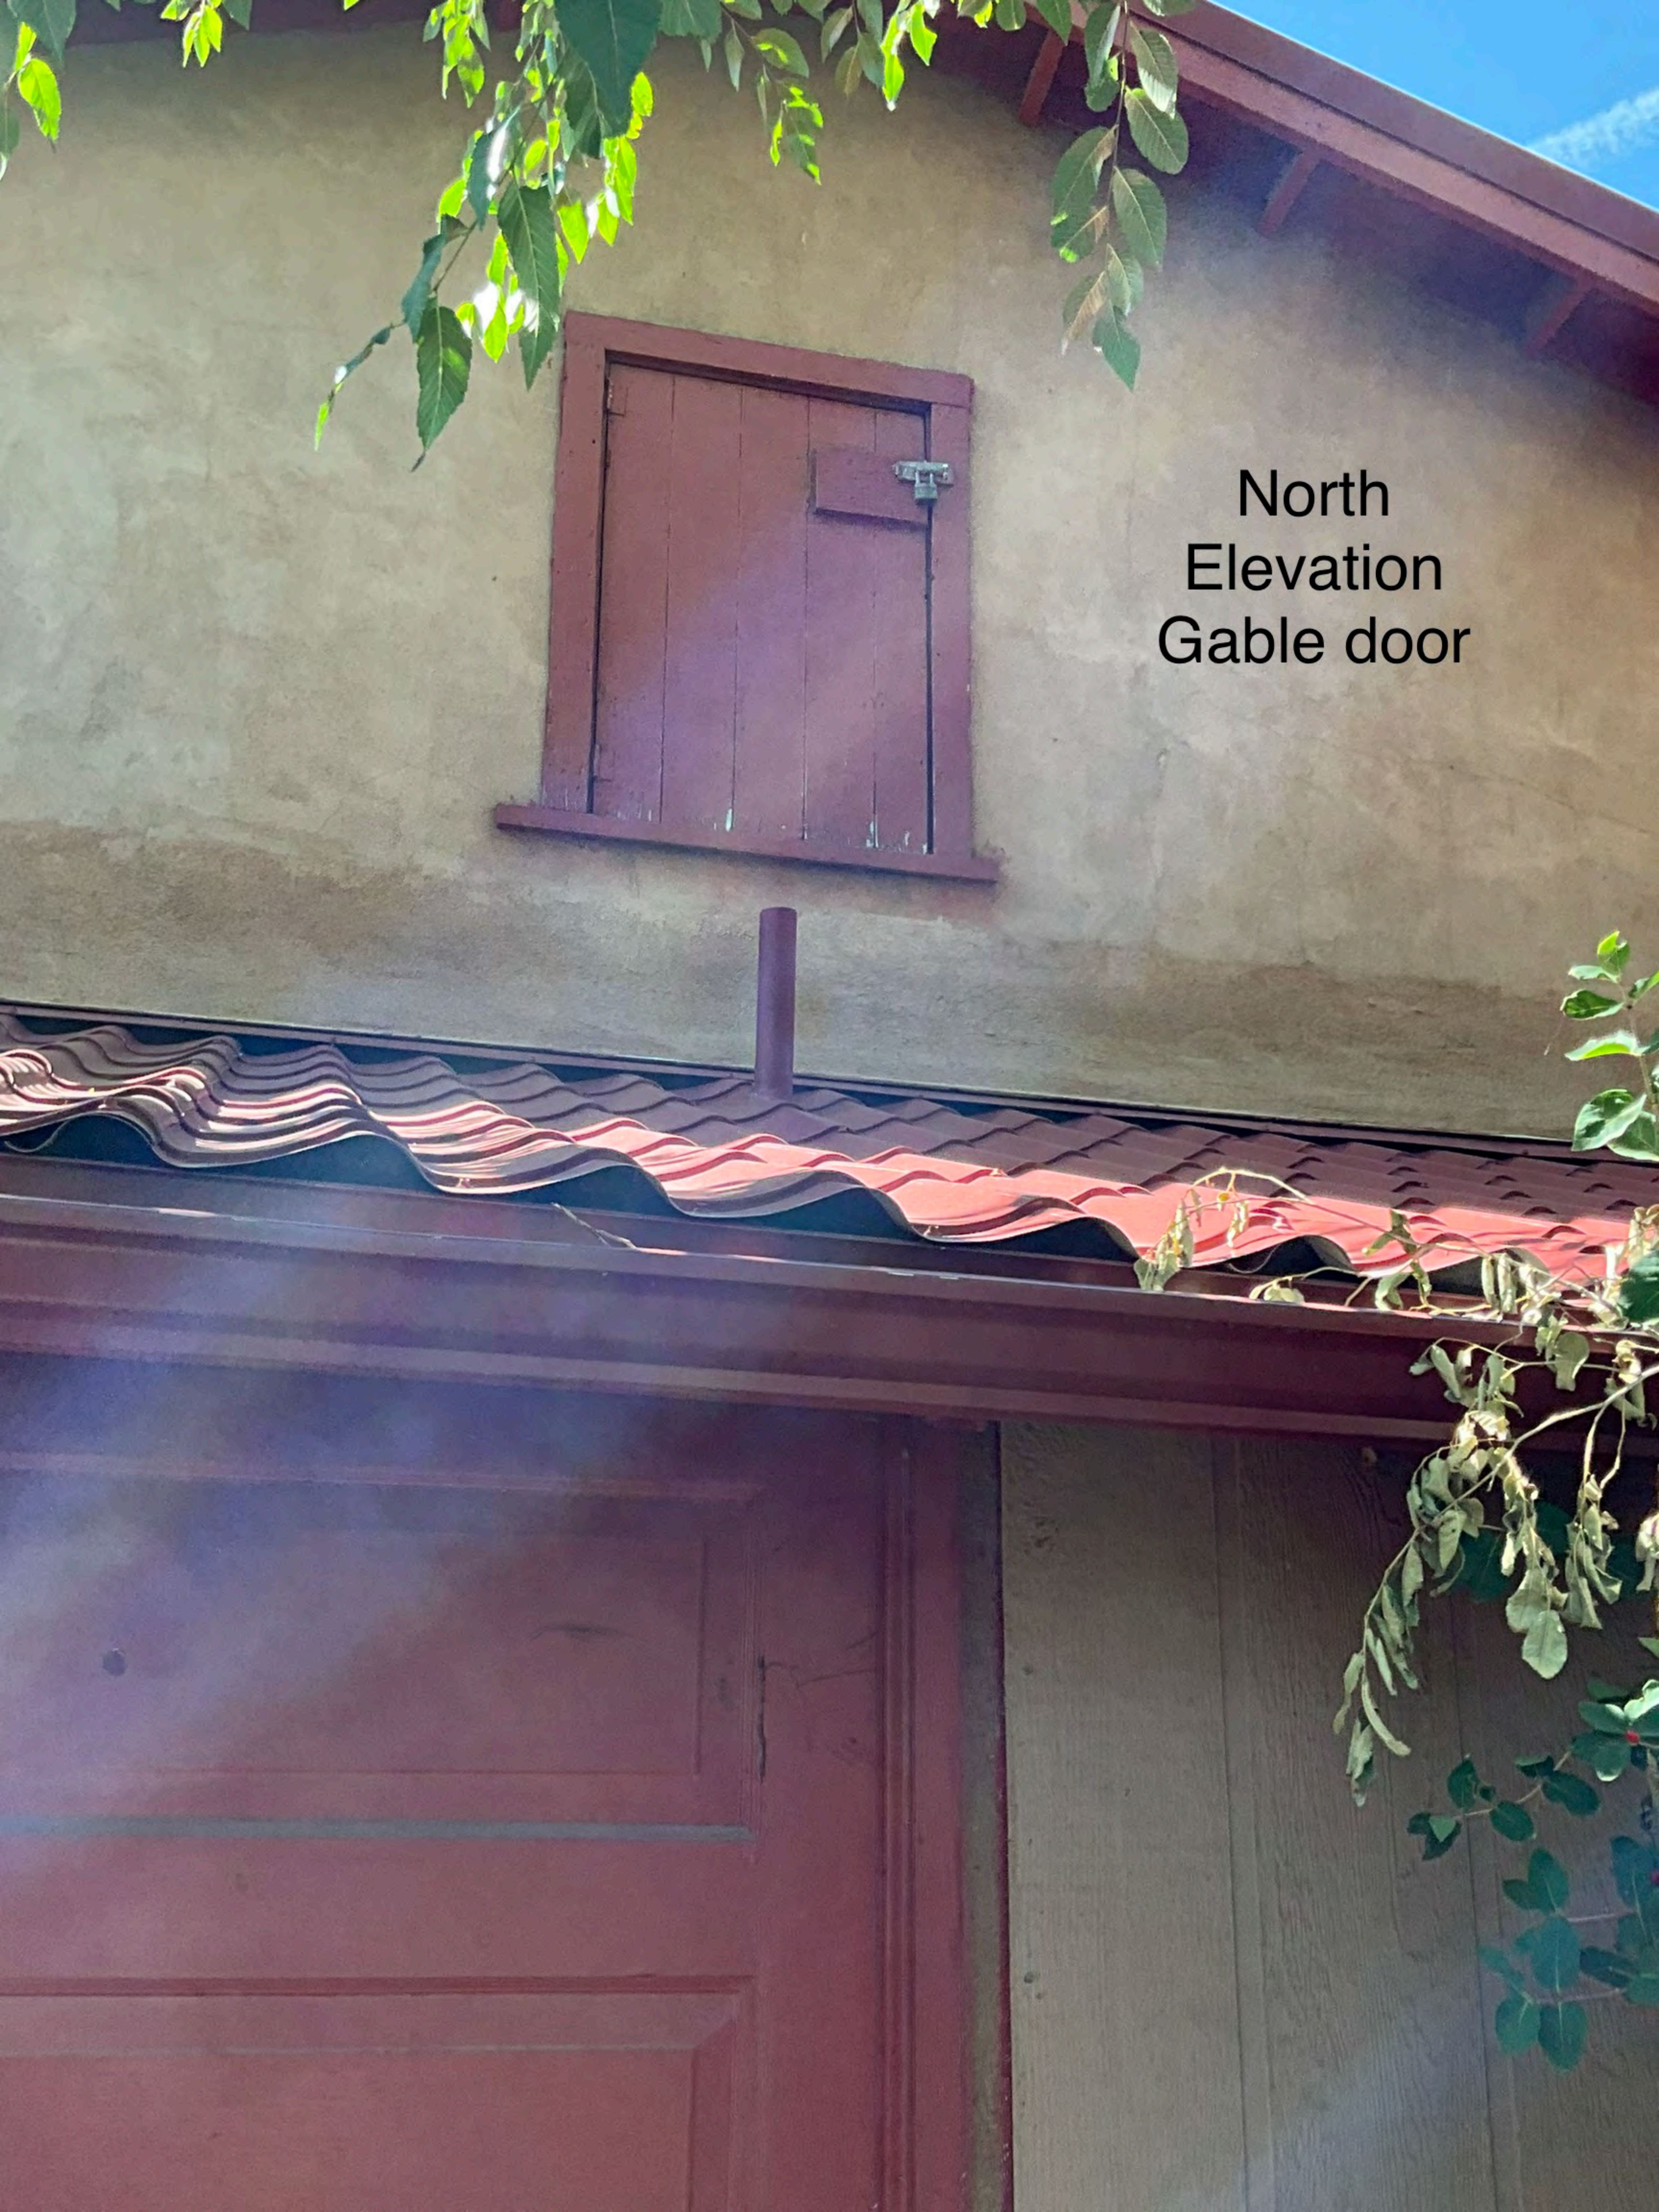
North  
Elevation  
Door# 4

Door #4 is historic however not of the original house. The unit has cut stiles and rails. The unit is lacking in structural integrity.
