# RPA & Associates, LLC.

JOB	DATE
527 AGUA FRIA, SANTA FE, NM 87501	8/15/2025

Renovation of an Existing Residential Structure

527 Agua Fria Street, Santa Fe NM 87501

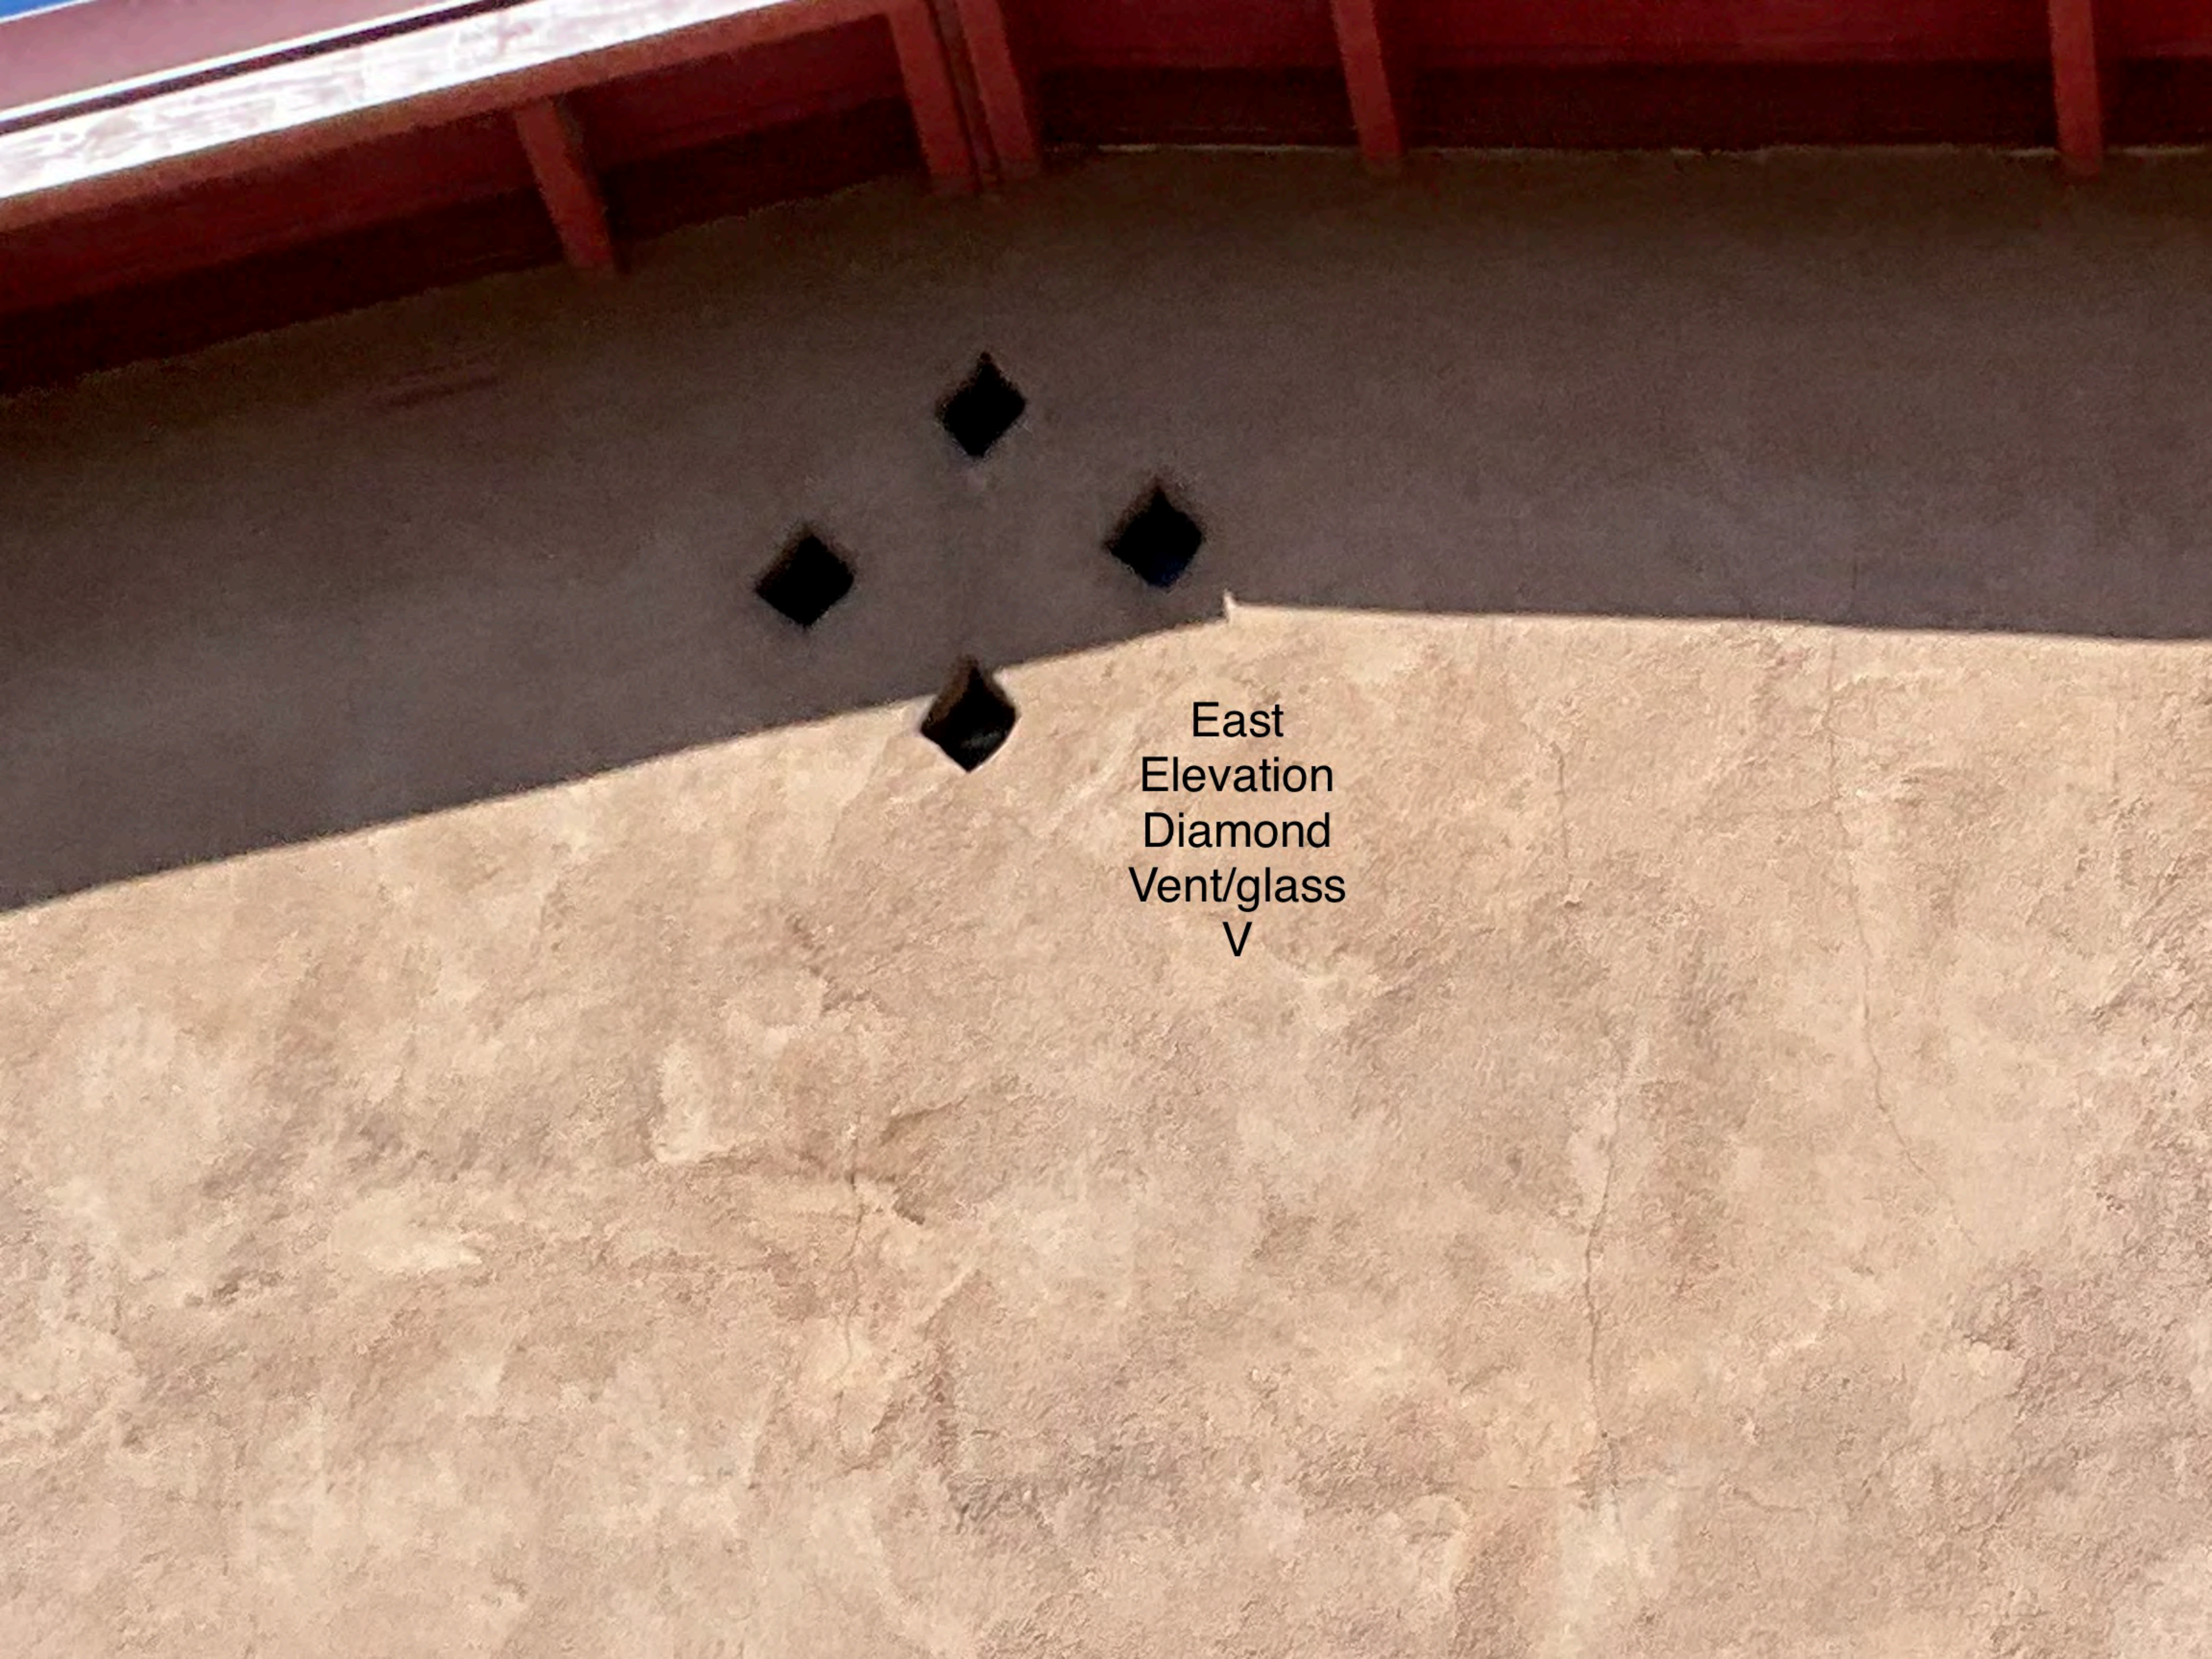
East  
Elevation  
Diamond  
Vent/glass  
V

East and south gable vents should be vents however have glass on the inside and not venting to facilitate with attic air flow.

LABEL	WINDOW & DOOR DESCRIPTION	CONDITION & INTEGRITY CODE	HISTORIC/NON-HISTORIC – AGE
GABLE VENTS			
<u>EAST</u>			
V	4 – DIAMOND GLASS	F	HISTORIC – THERE IS A PLATE GLASS ON THE BACK SIDE OF CUT HOLES INTO THE STUCCO (NOT VENTS, HOWEVER THERE SHOULD BE VENTS FOR VENTING THE ATTIC)
<u>SOUTH</u>			
W	4 – DIAMOND GLASS		HISTORIC – THERE IS A PLATE GLASS ON THE BACK SIDE OF CUT HOLES INTO THE STUCCO (NOT VENTS, HOWEVER THERE SHOULD BE VENTS FOR VENTING THE ATTIC)
