# RPA & Associates, LLC.

JOB	DATE
815 DUNLAP STREET, SANTA FE, NM 87501	08/18/2025

## RPA & ASSOCIATES, LLC | WINDOW & DOOR CONDITION AND INTEGRITY CODES

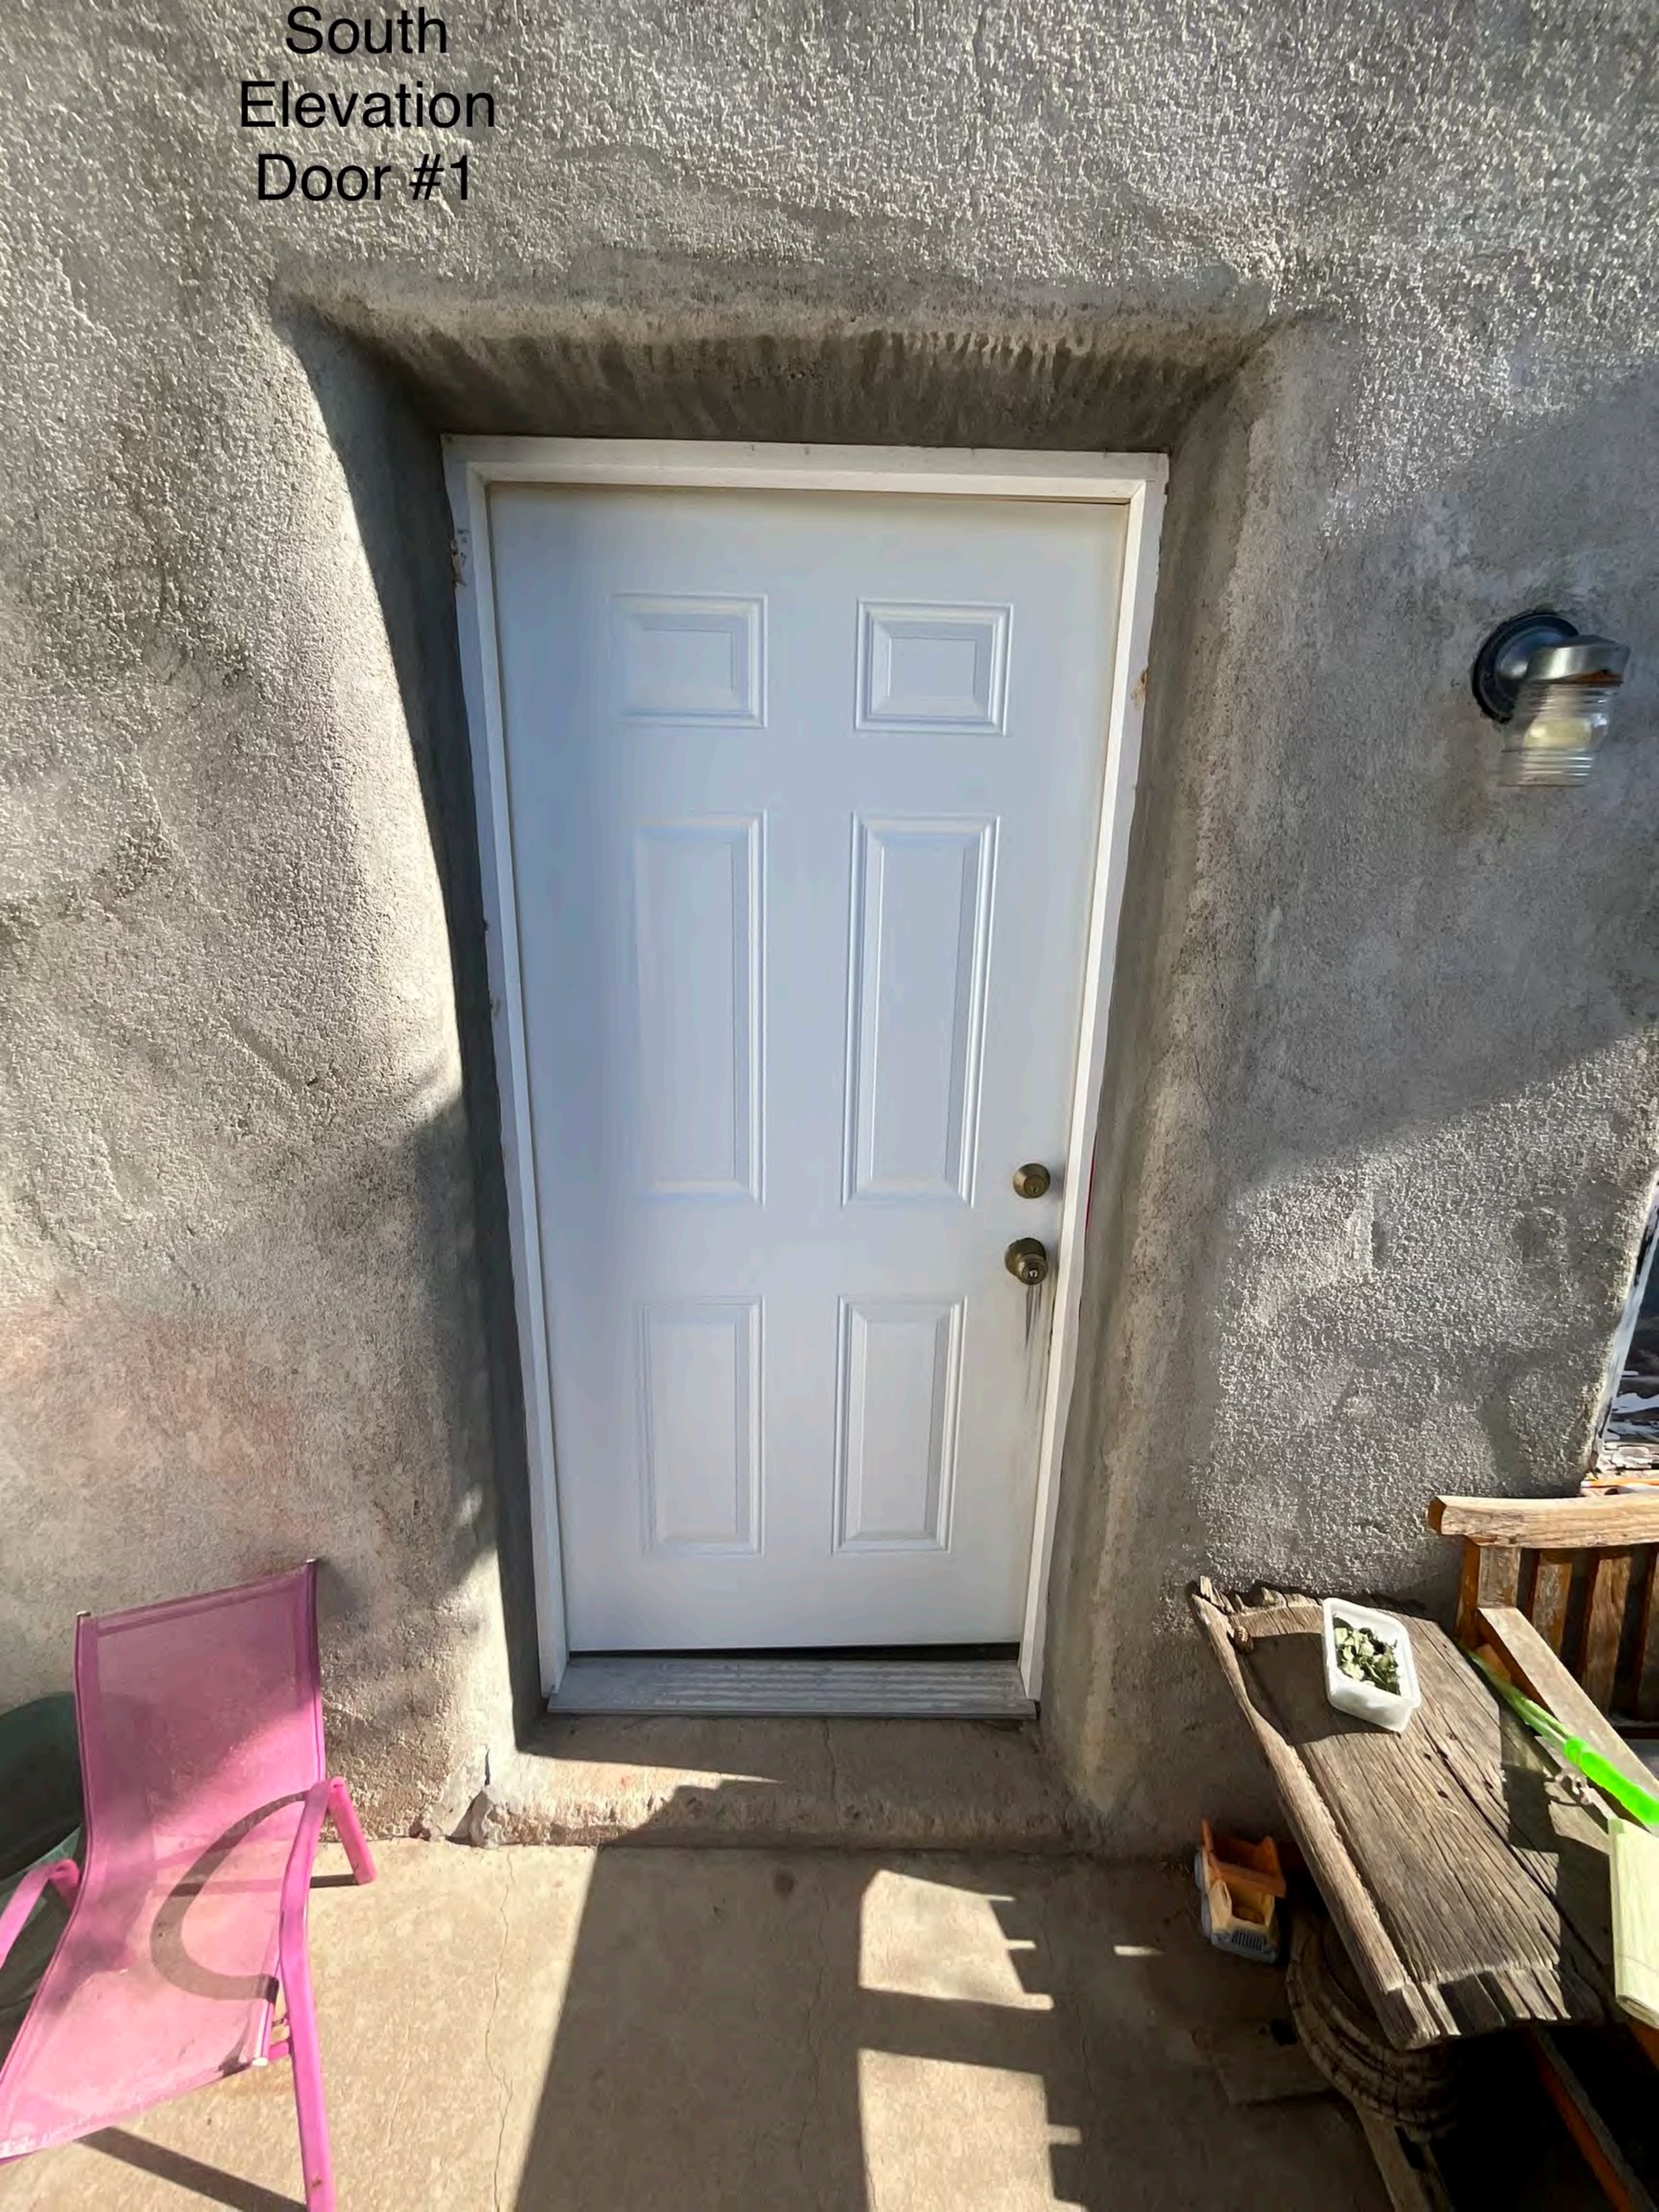
South  
Elevation  
Door #1

Doors #1 and #2 are non-historic.

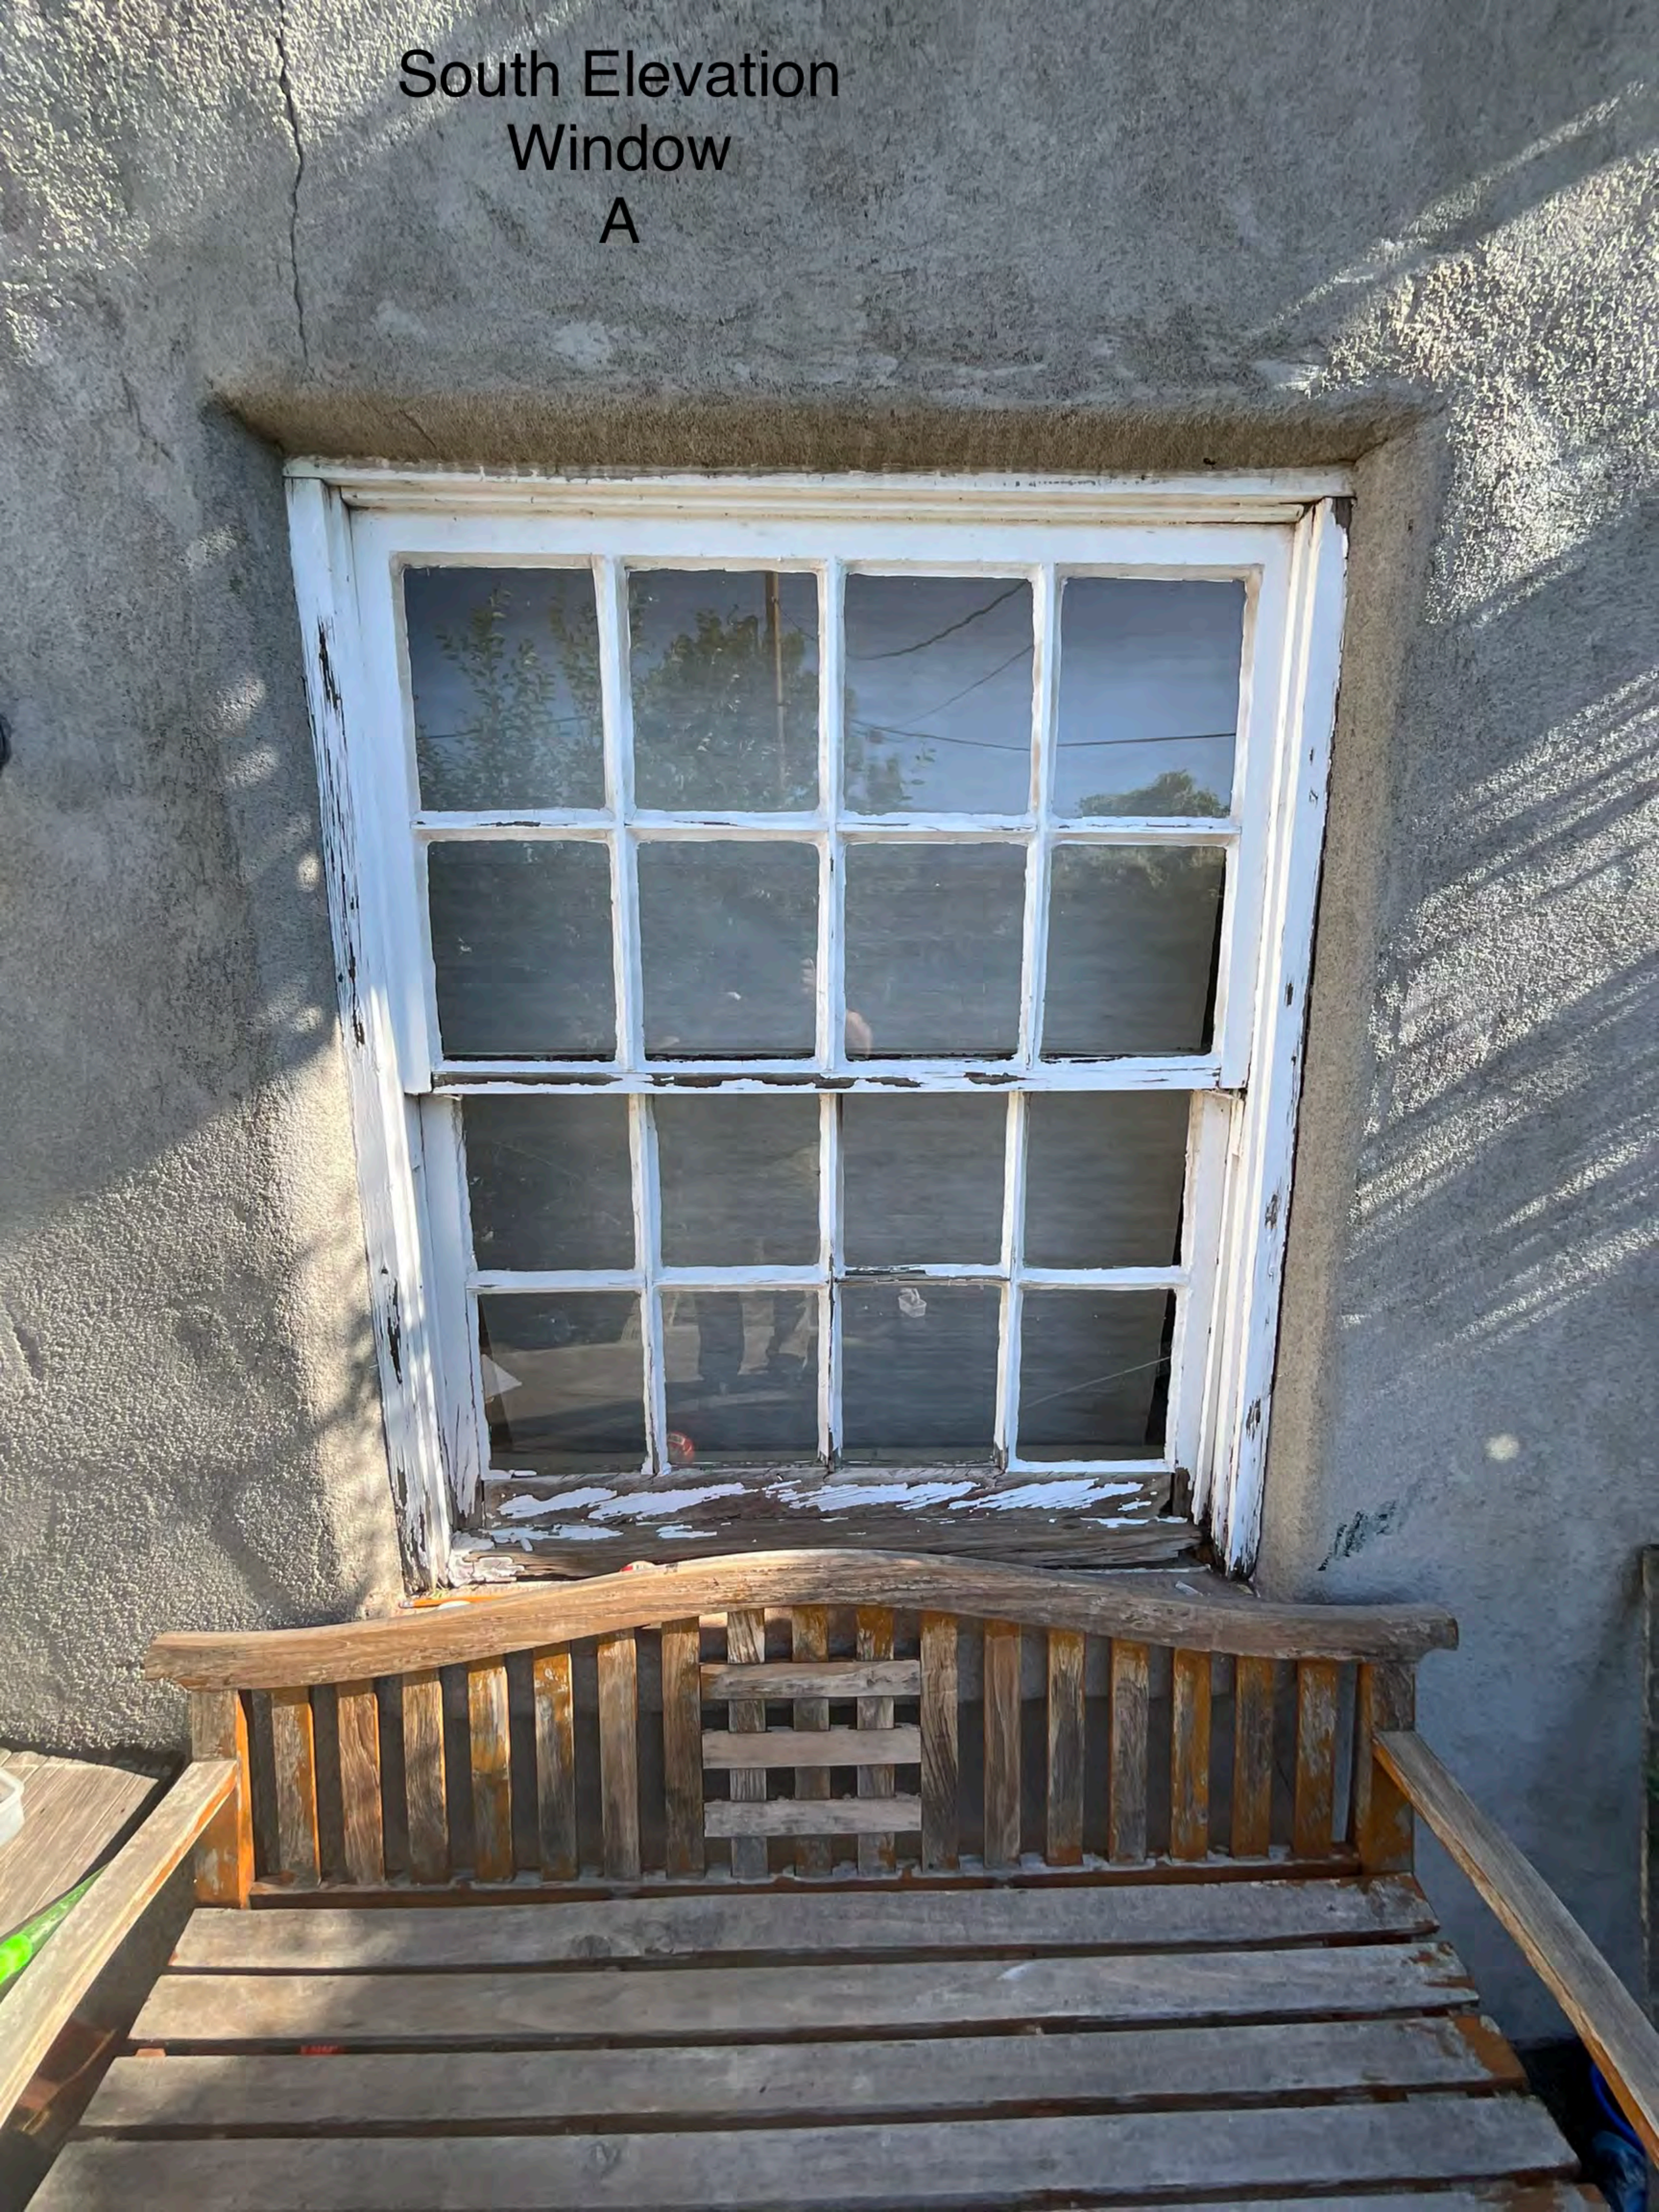
South Elevation  
Window  
A

Windows A, B, D, E, F, H, I, J and L are historic however unrestorable.

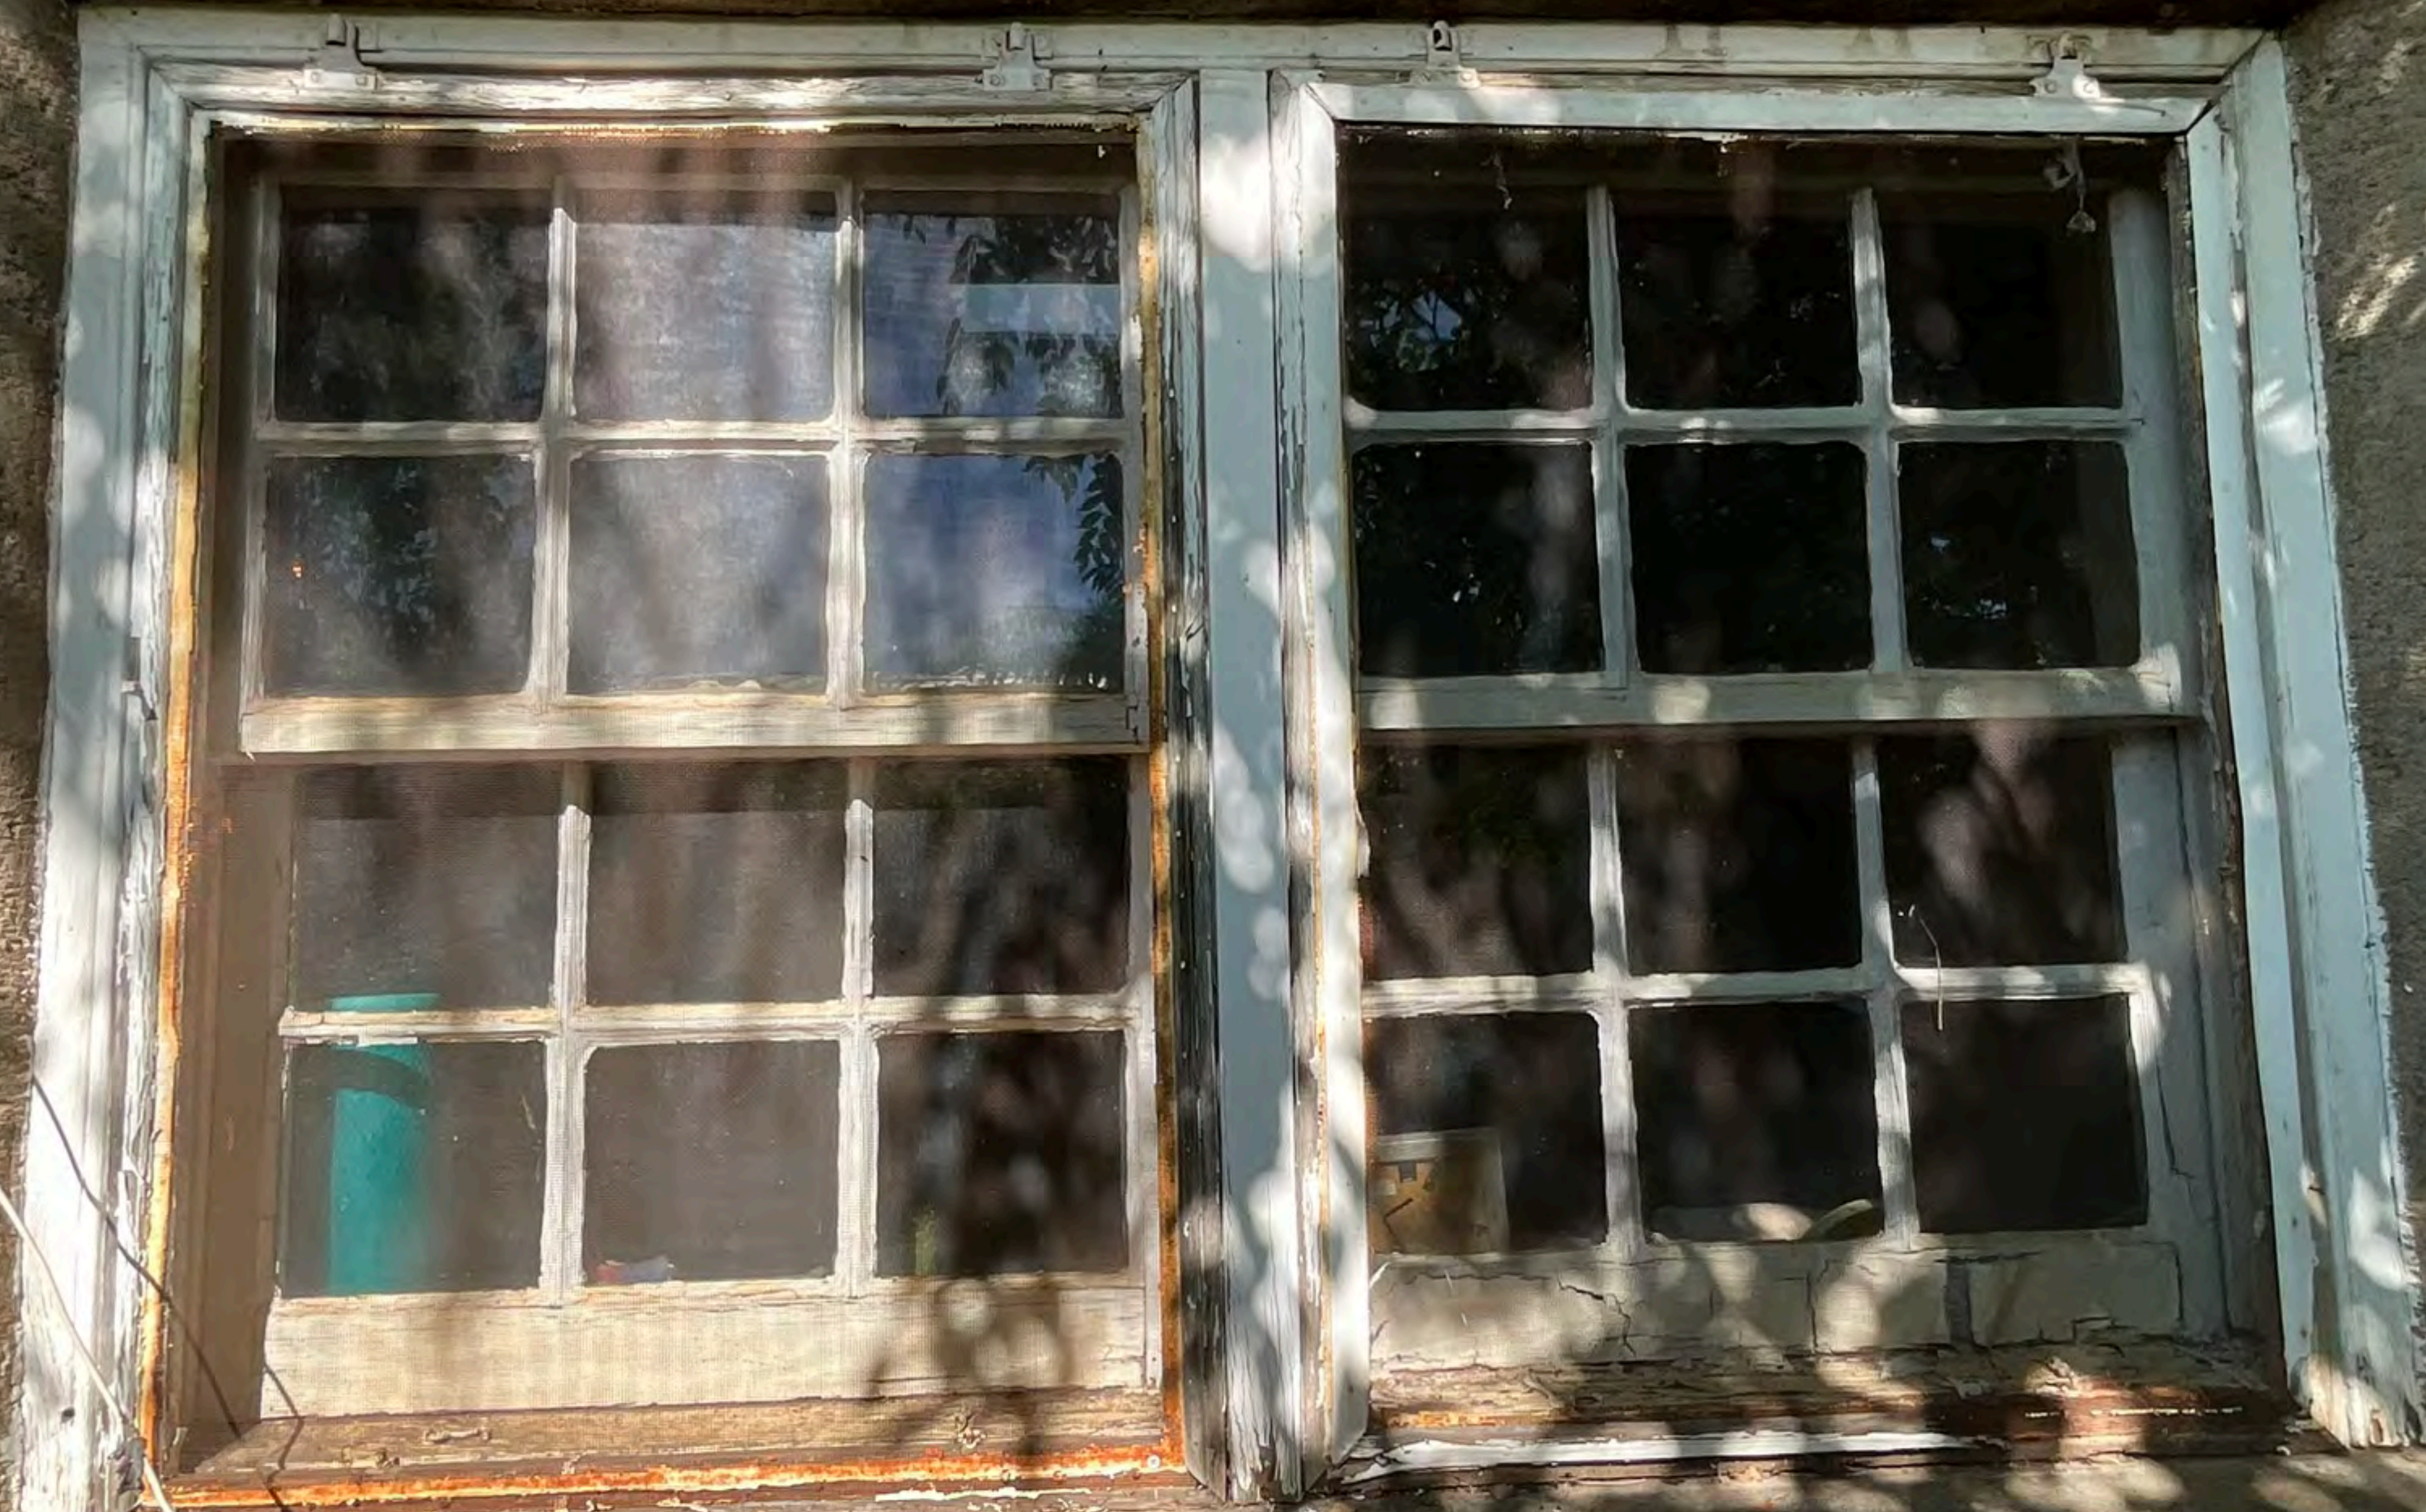
Last  
Elevation  
Window  
C

Windows C is historic and restorable.

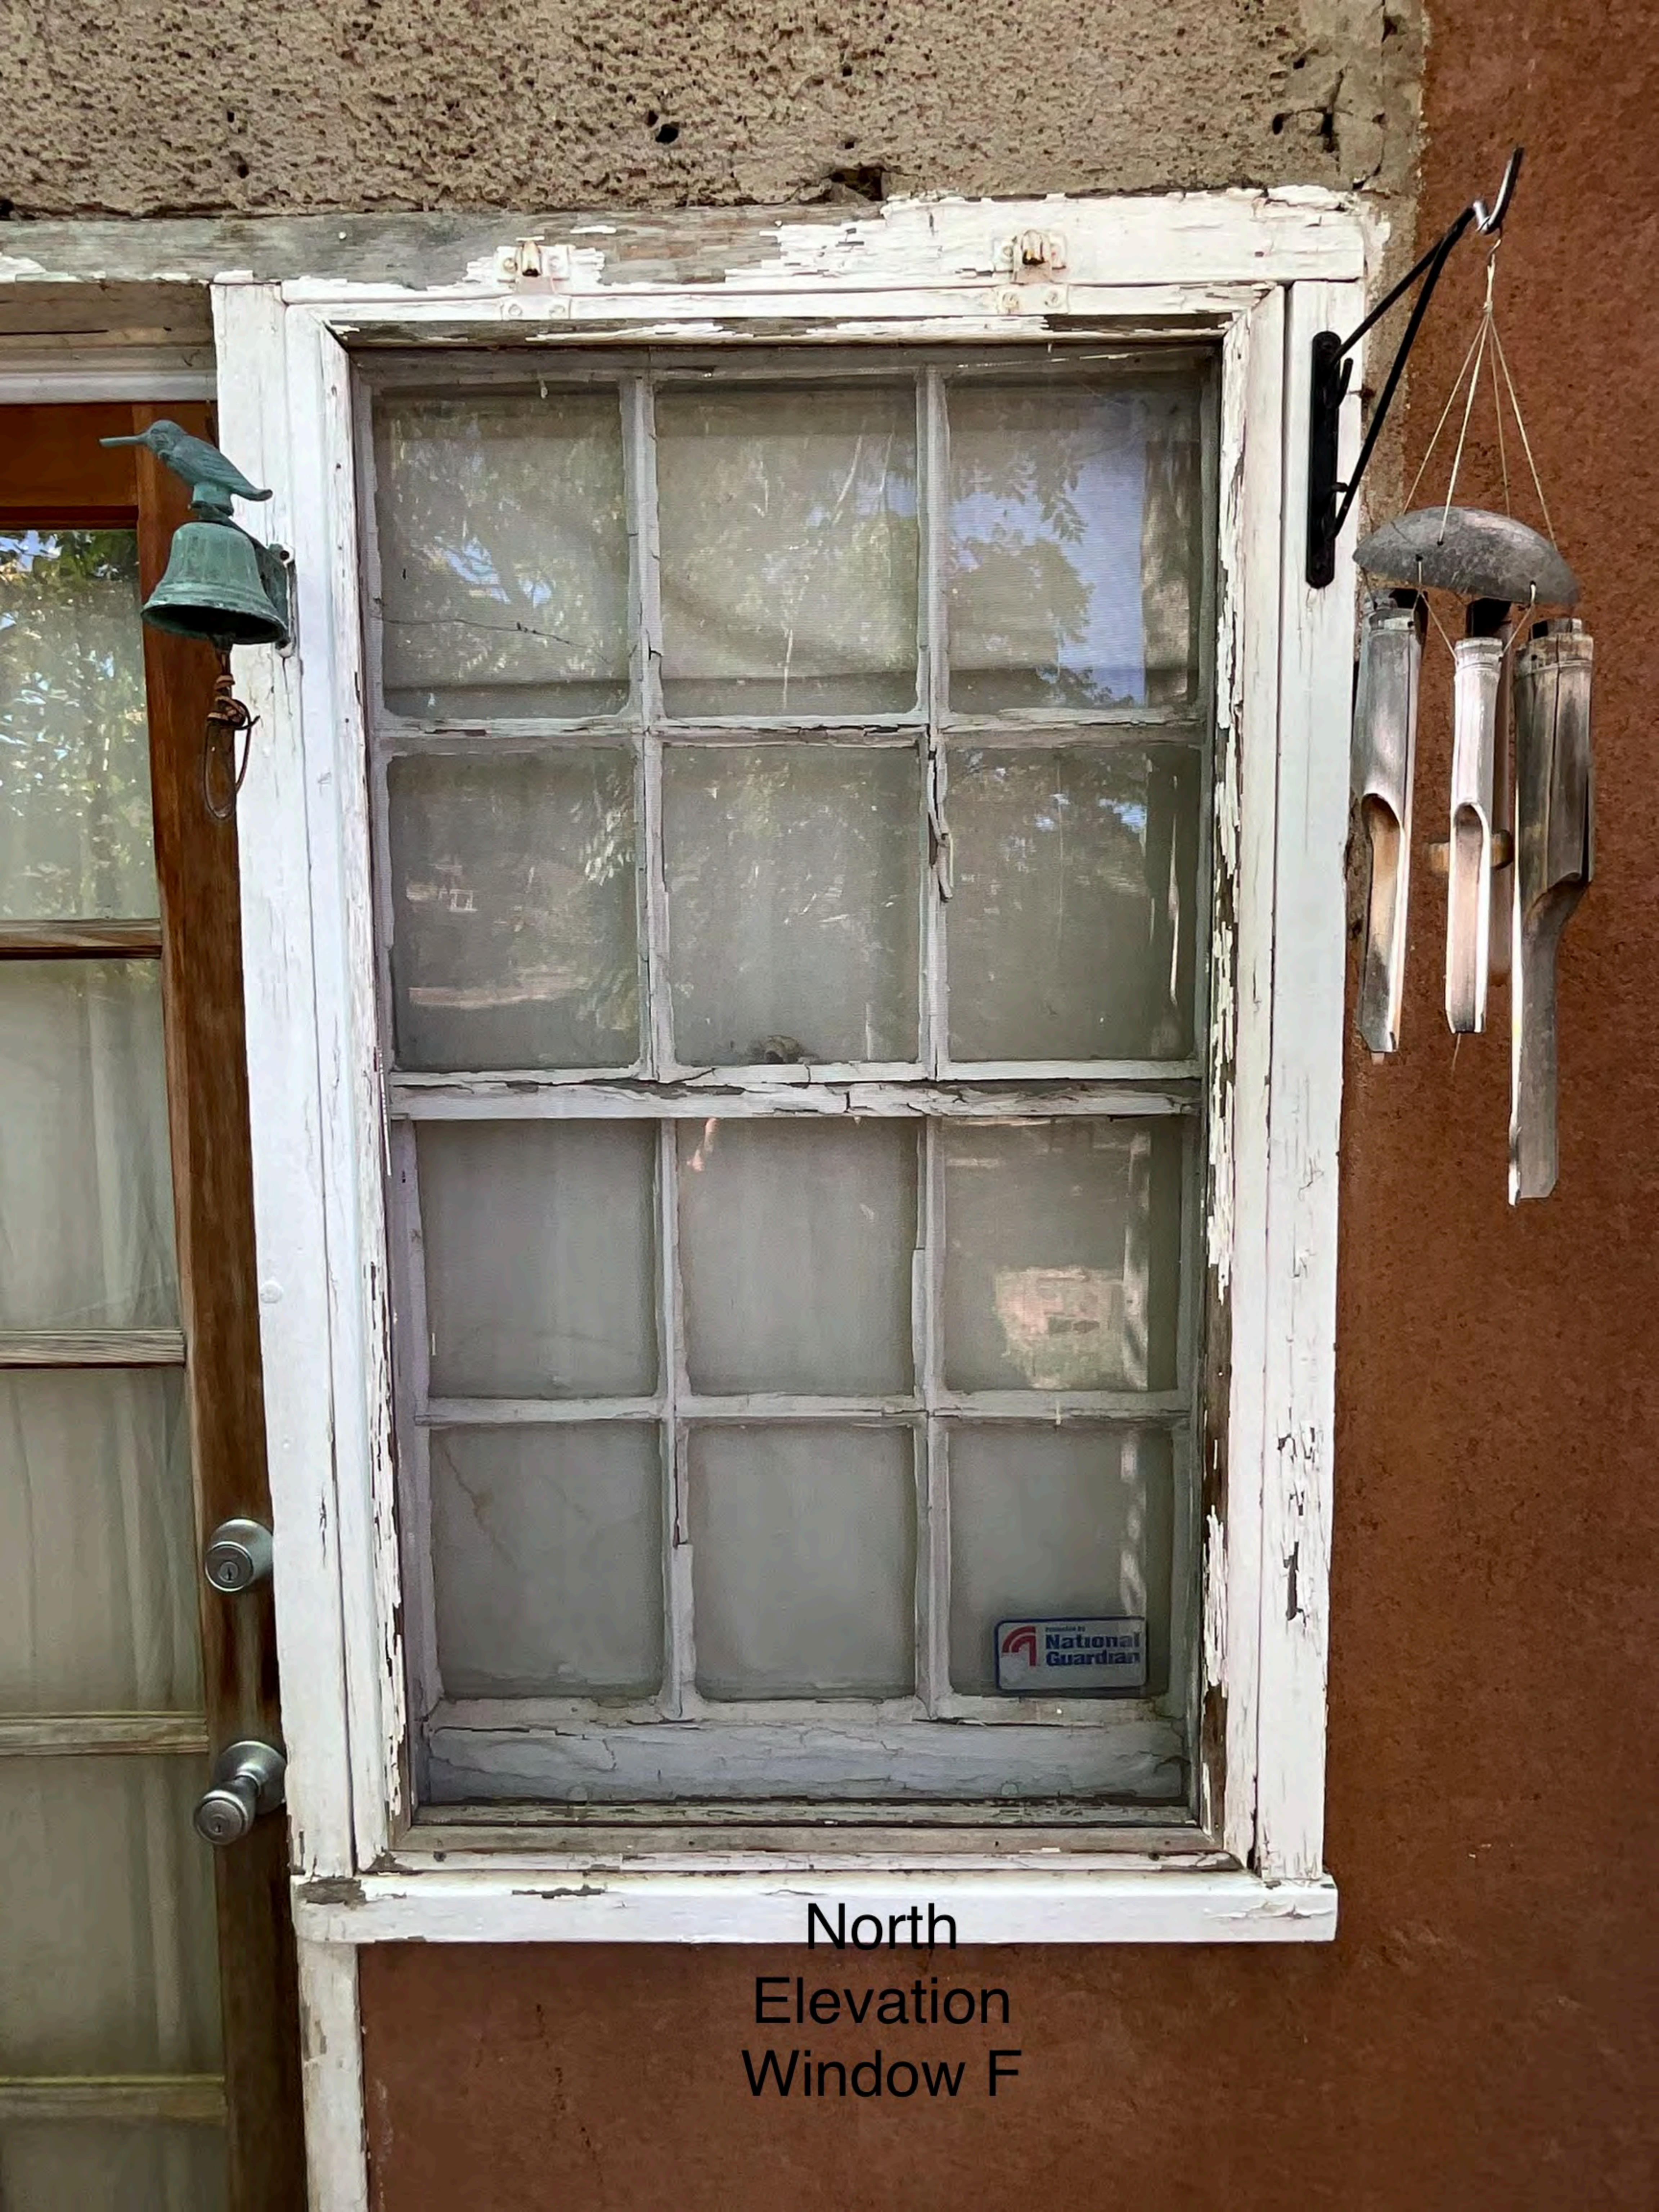
North  
Elevation  
Window F

F	28 x 46 DOUBLE HUNG 3W2H/3W2H	U	HISTORIC - SASHES AND FRAME ROTTED BEYOND 30-40%, EVIDENCE OF MOISTURE LEAKING INTO THE WALL
G	54 x 52 LSR 3W1H W/TRANSOM STEEL CASEMENT	F	NON-HISTORIC - THE WOOD JAMB IS THE SAME AS THE DOUBLE HUNGS. THE STEEL CASEMENT WAS PLACED IN THE JAMB.

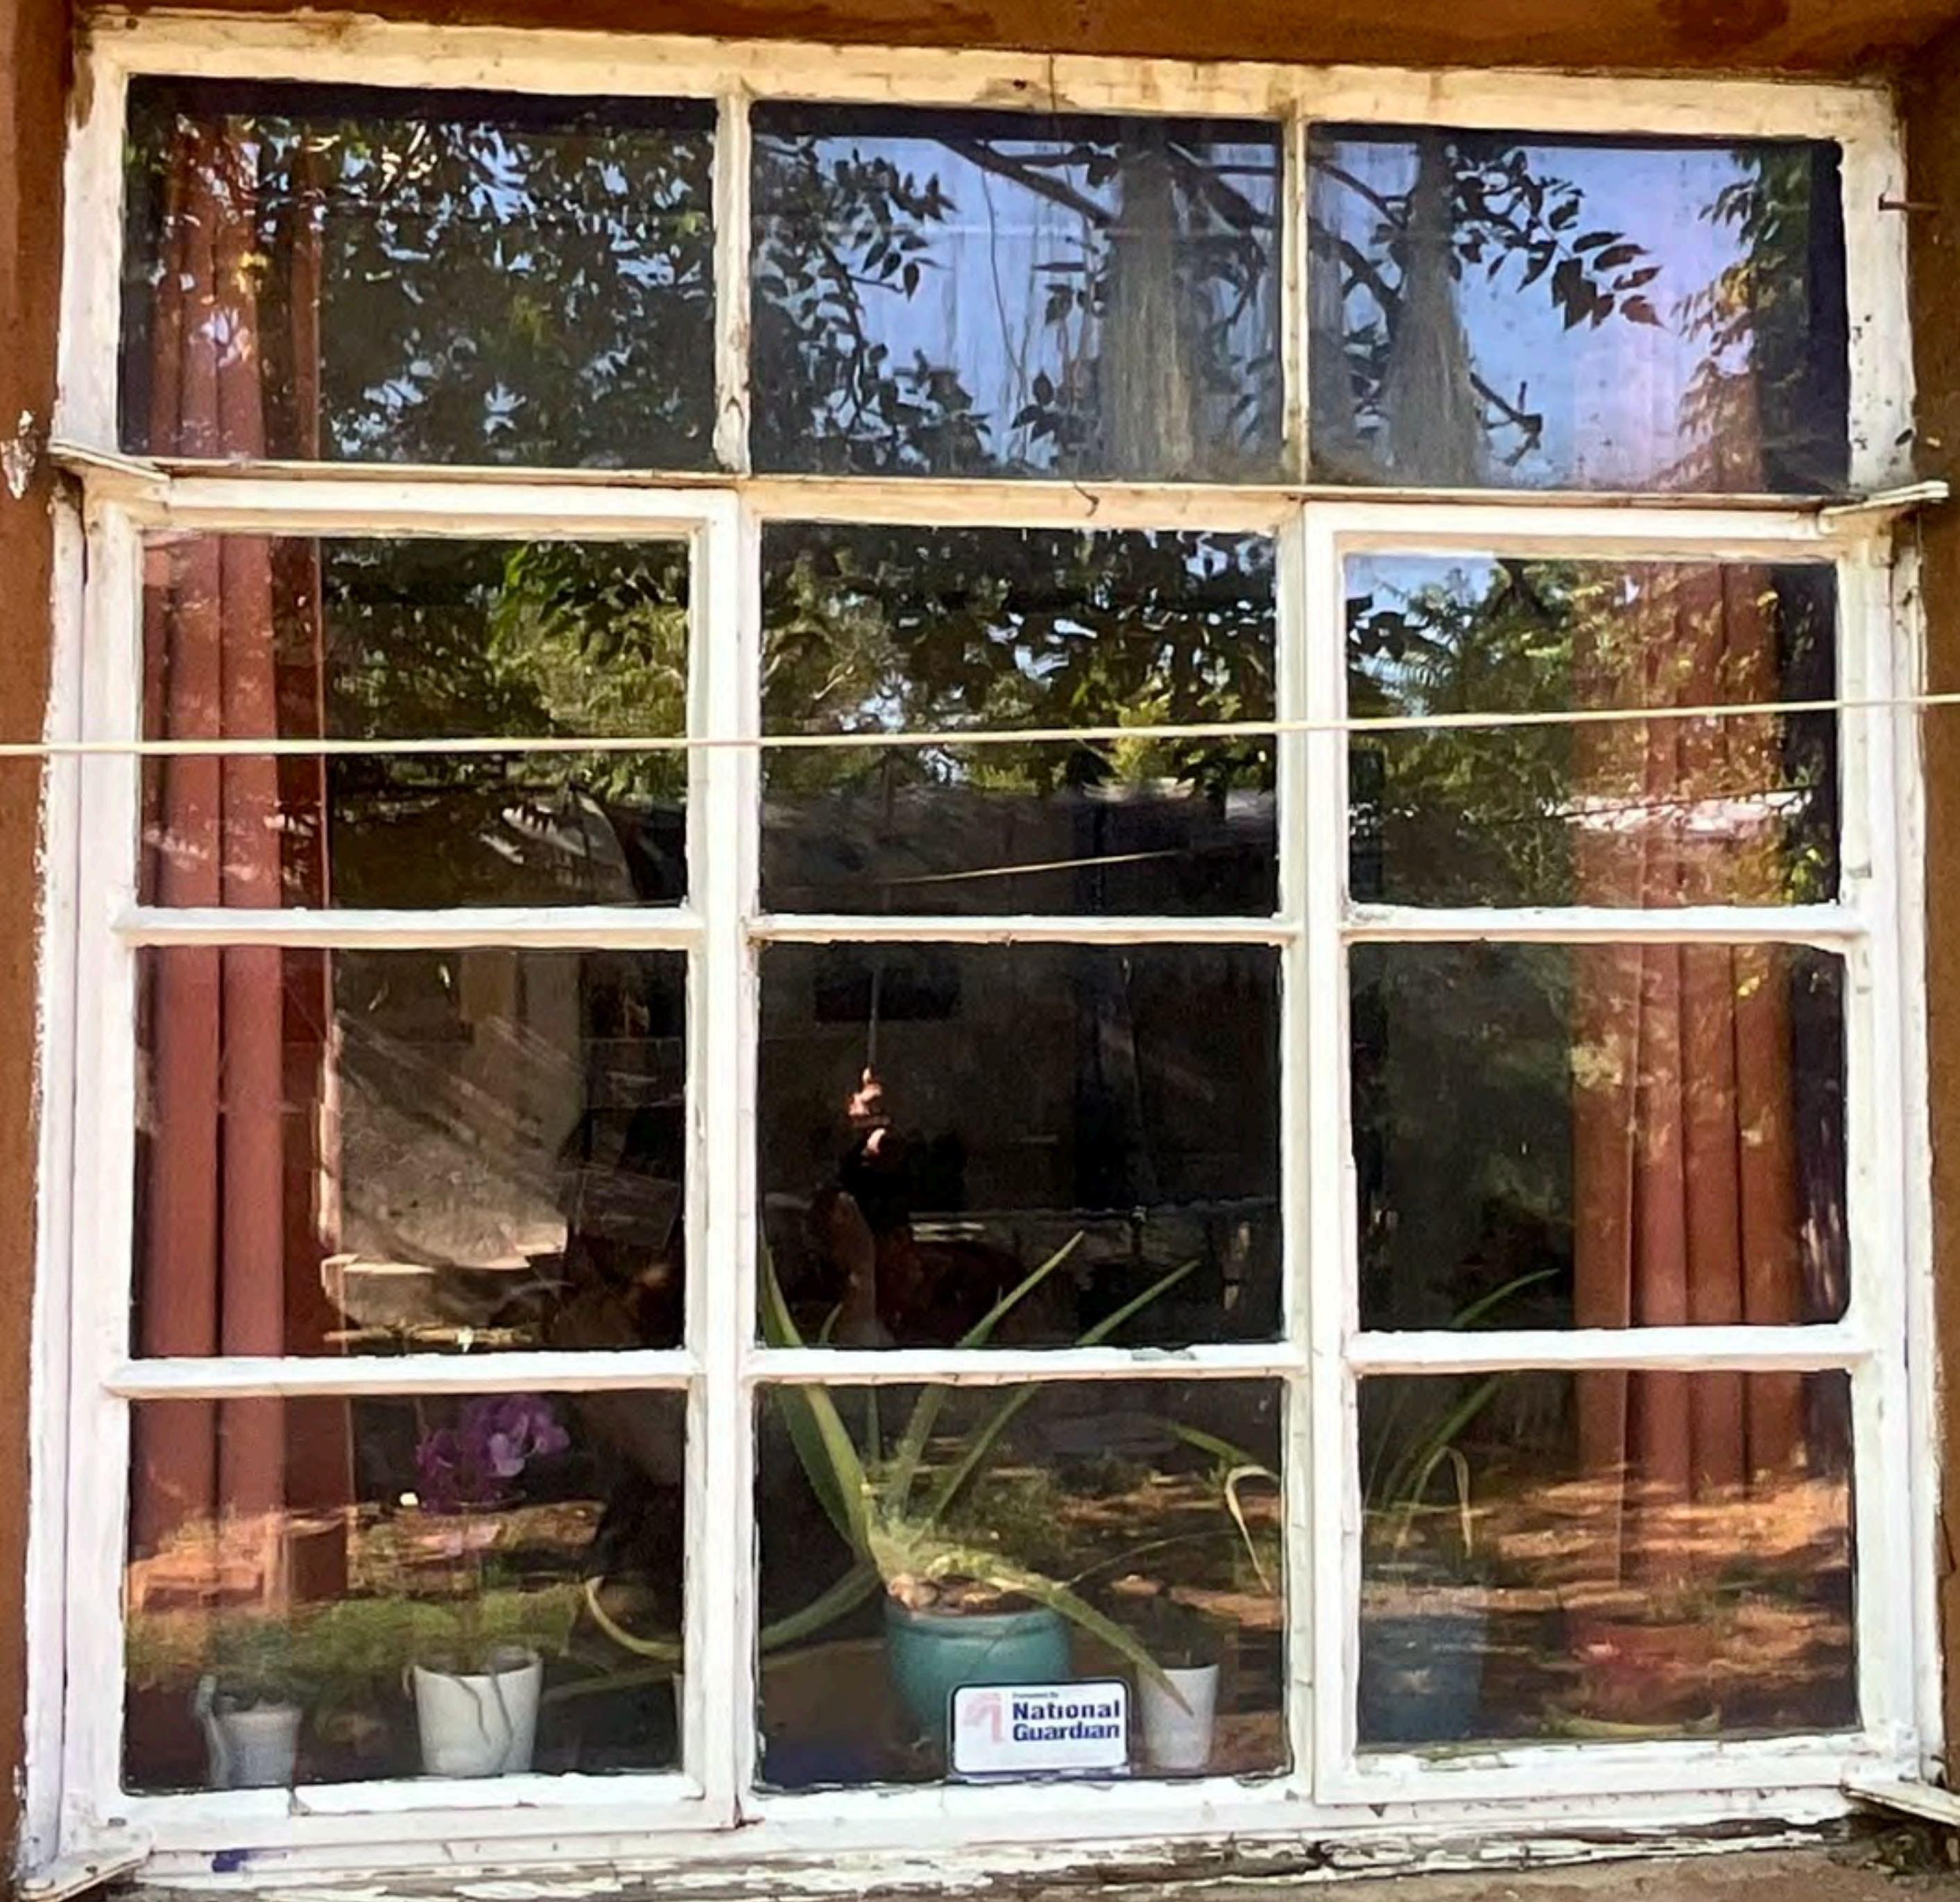
North  
Elevation  
Window  
G

Windows G and K are non-historic.

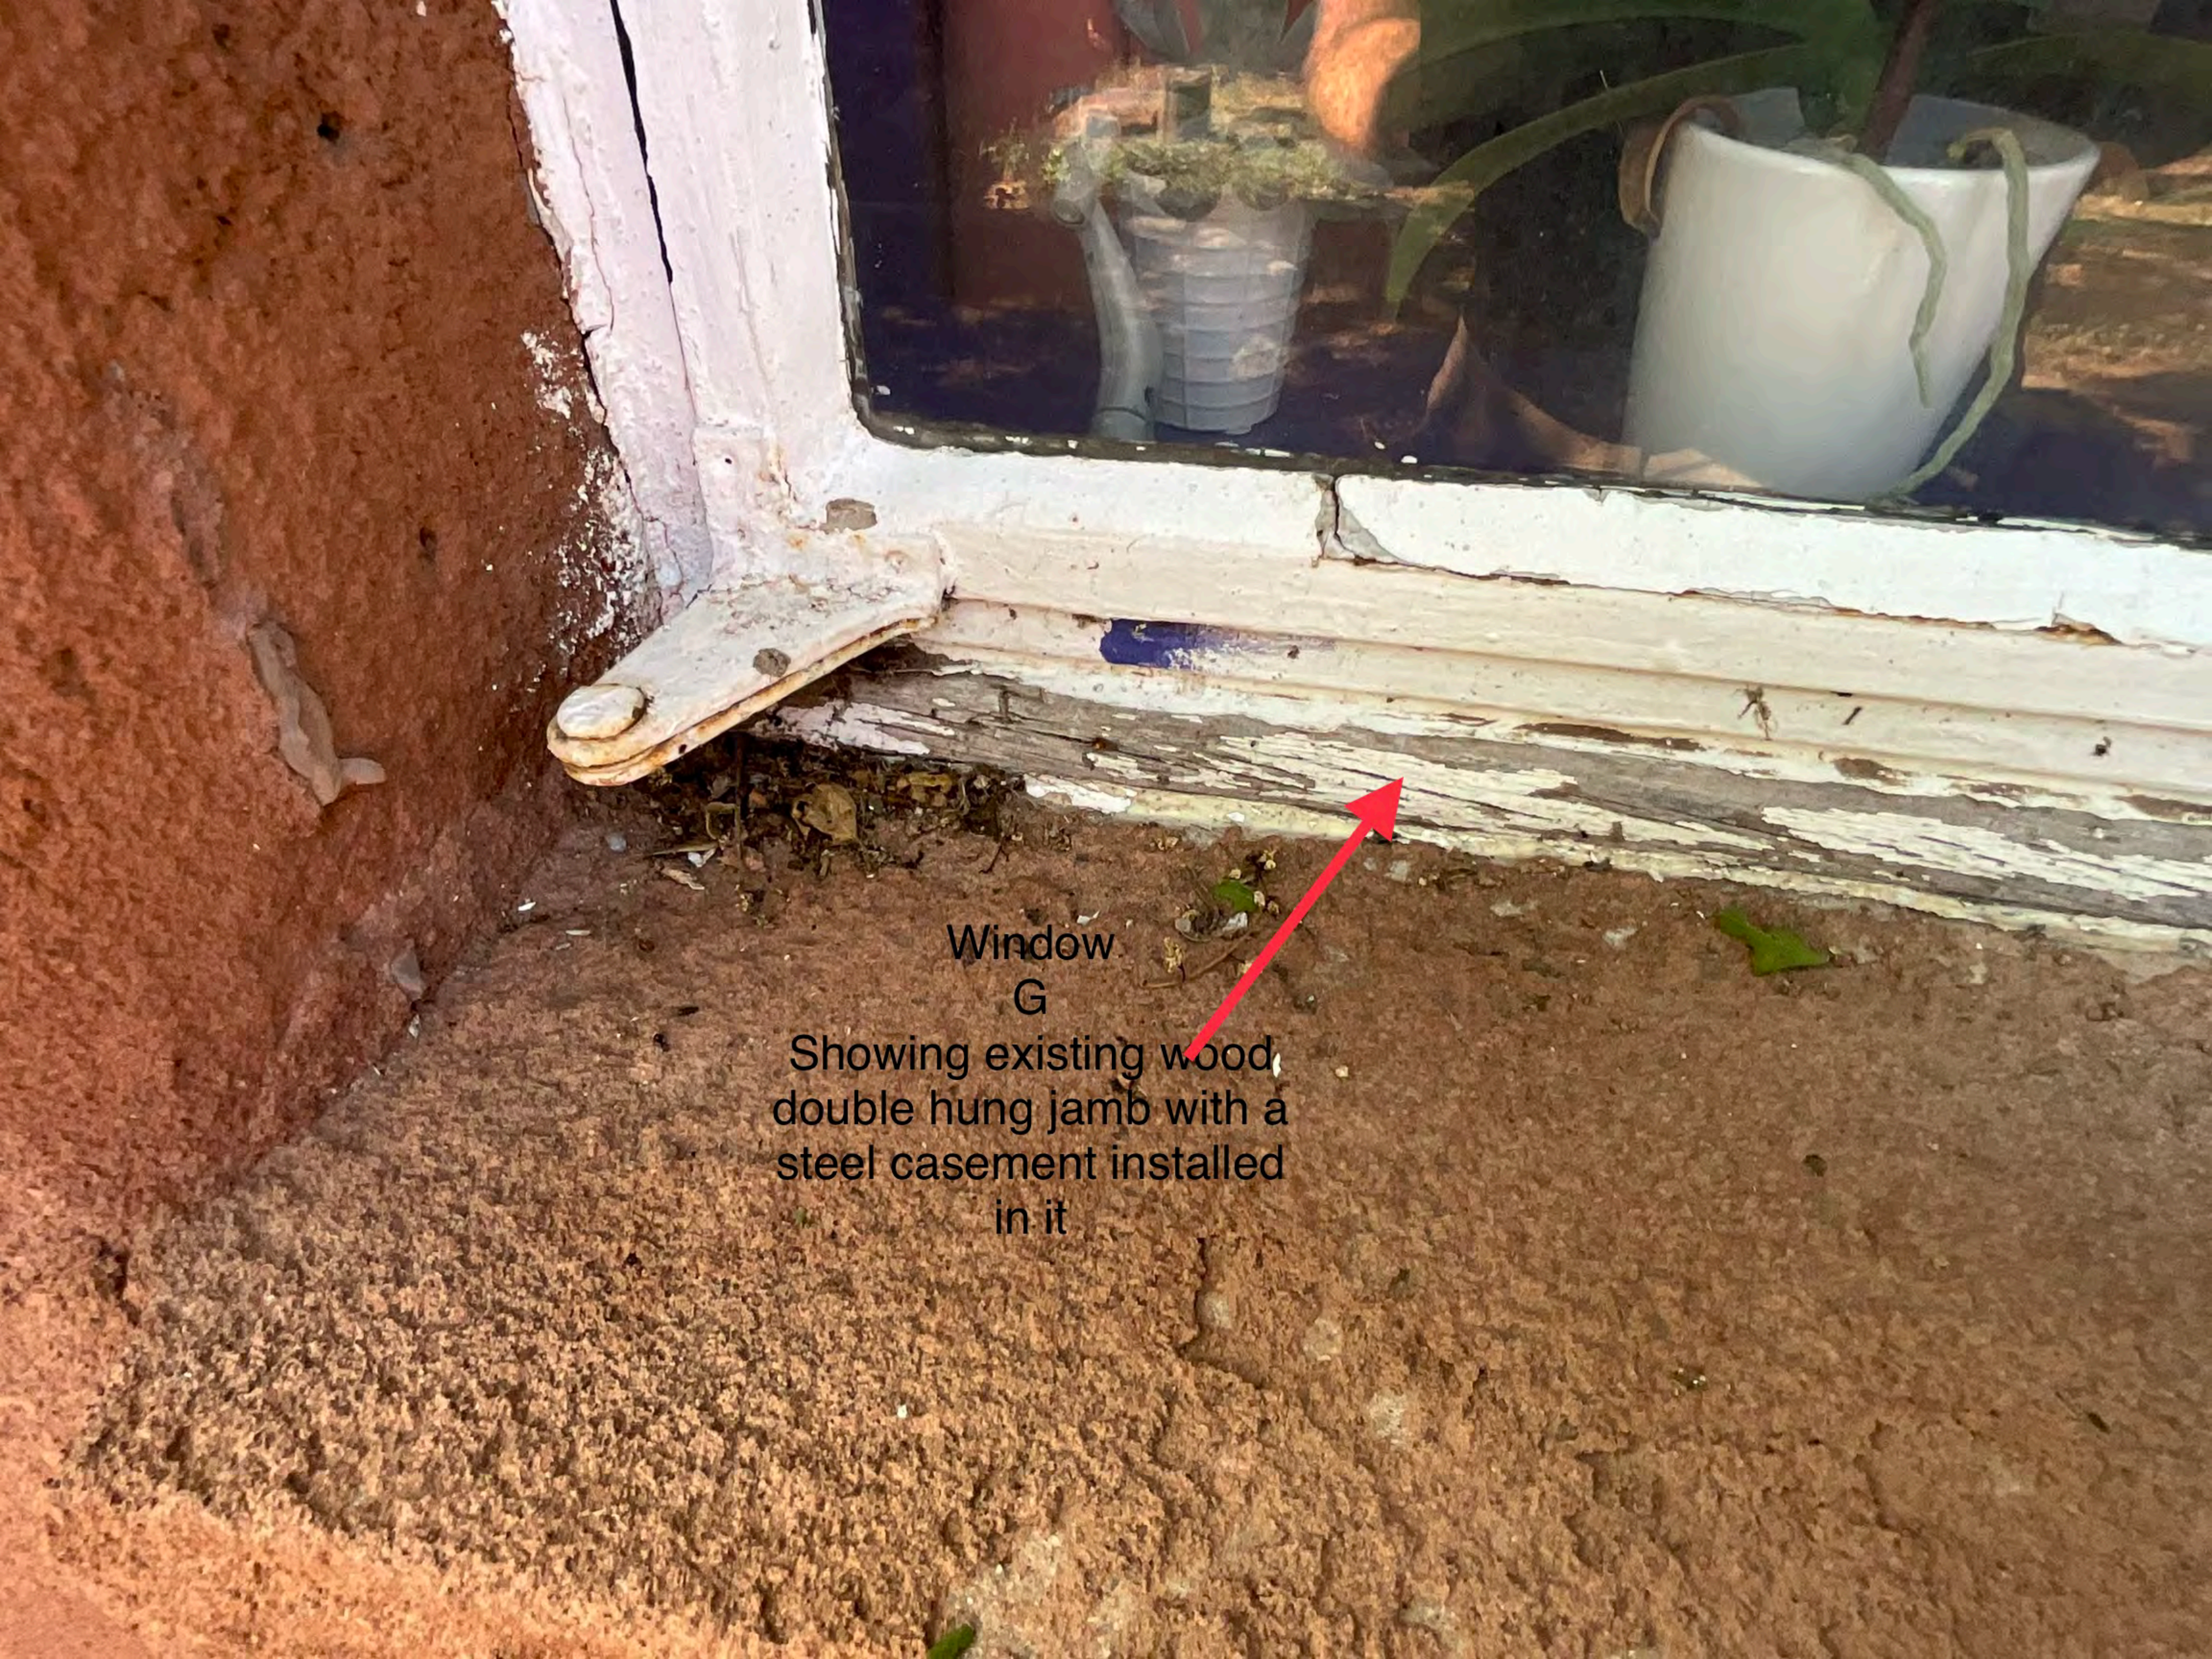
Window  
G

Showing existing wood  
double hung jamb with a  
steel casement installed  
in it
