# RPA & Associates, LLC.

JOB	DATE
815 DUNLAP STREET, SANTA FE, NM 87501	08/18/2025

## RPA & ASSOCIATES, LLC | WINDOW & DOOR CONDITION AND INTEGRITY CODES

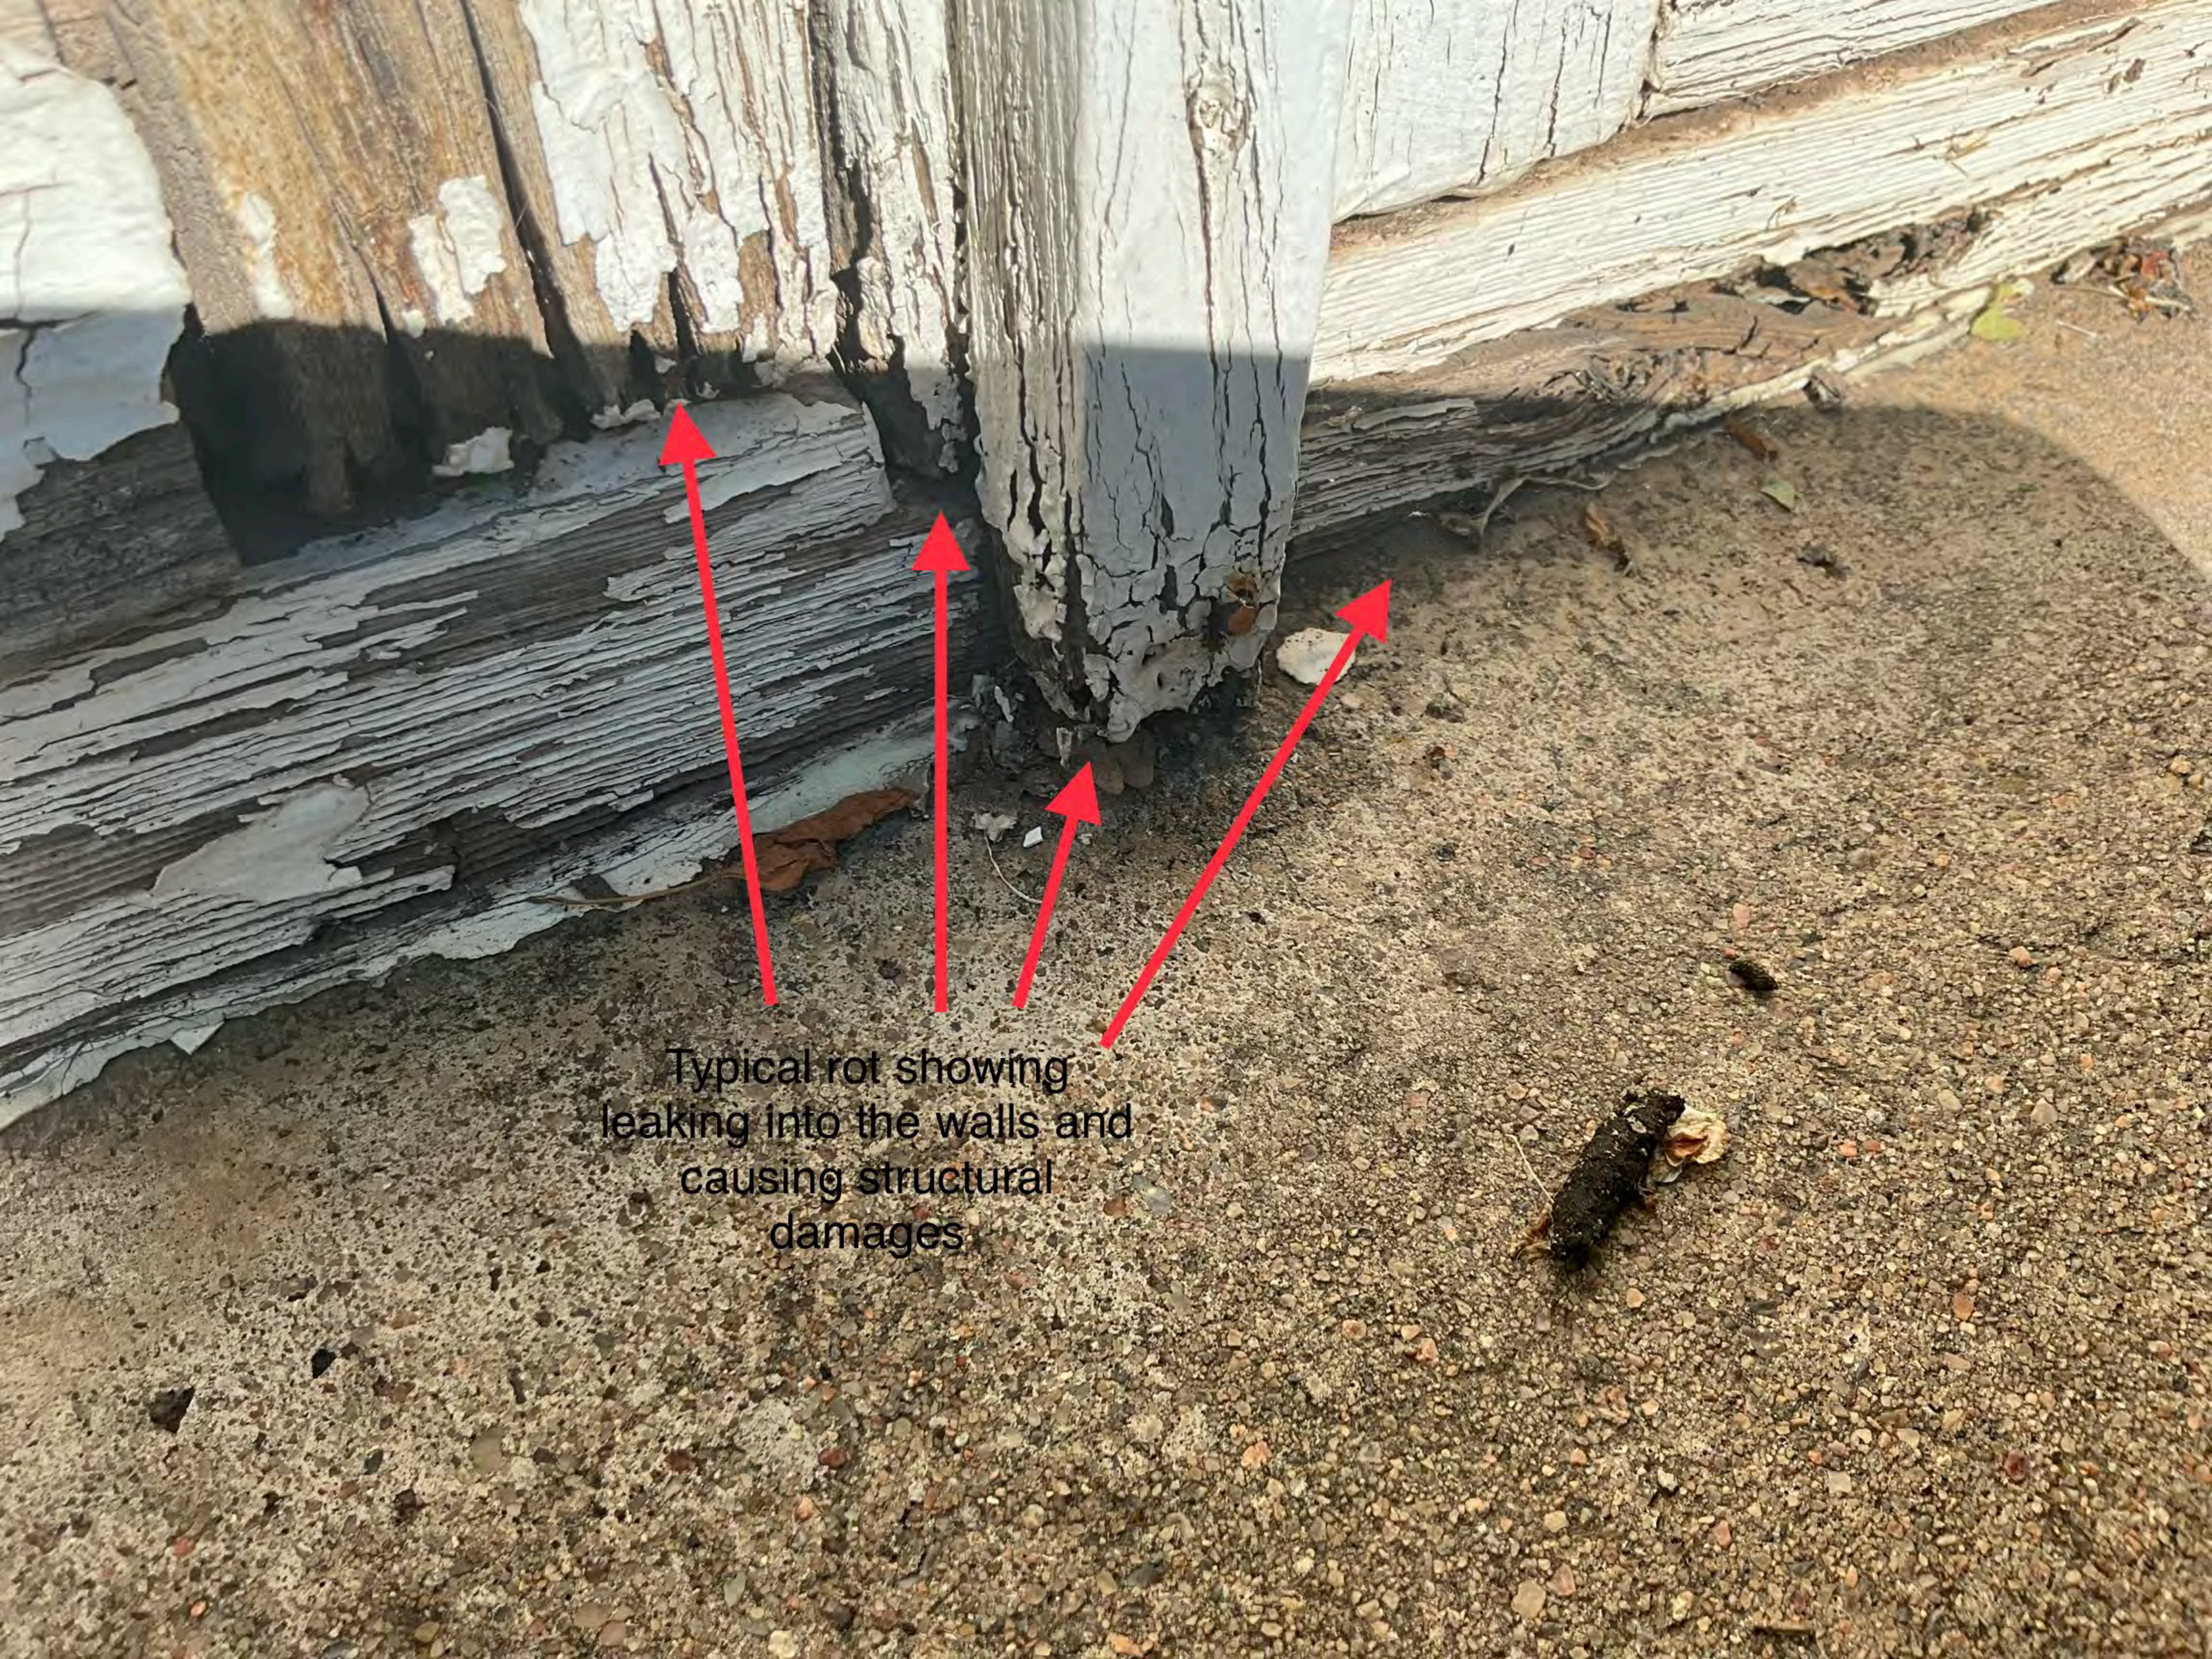
Typical rot showing  
leaking into the walls and  
causing structural  
damages

Concrete sills only on  
some of the windows  
Would have been  
added later original  
windows only had  
wood sills

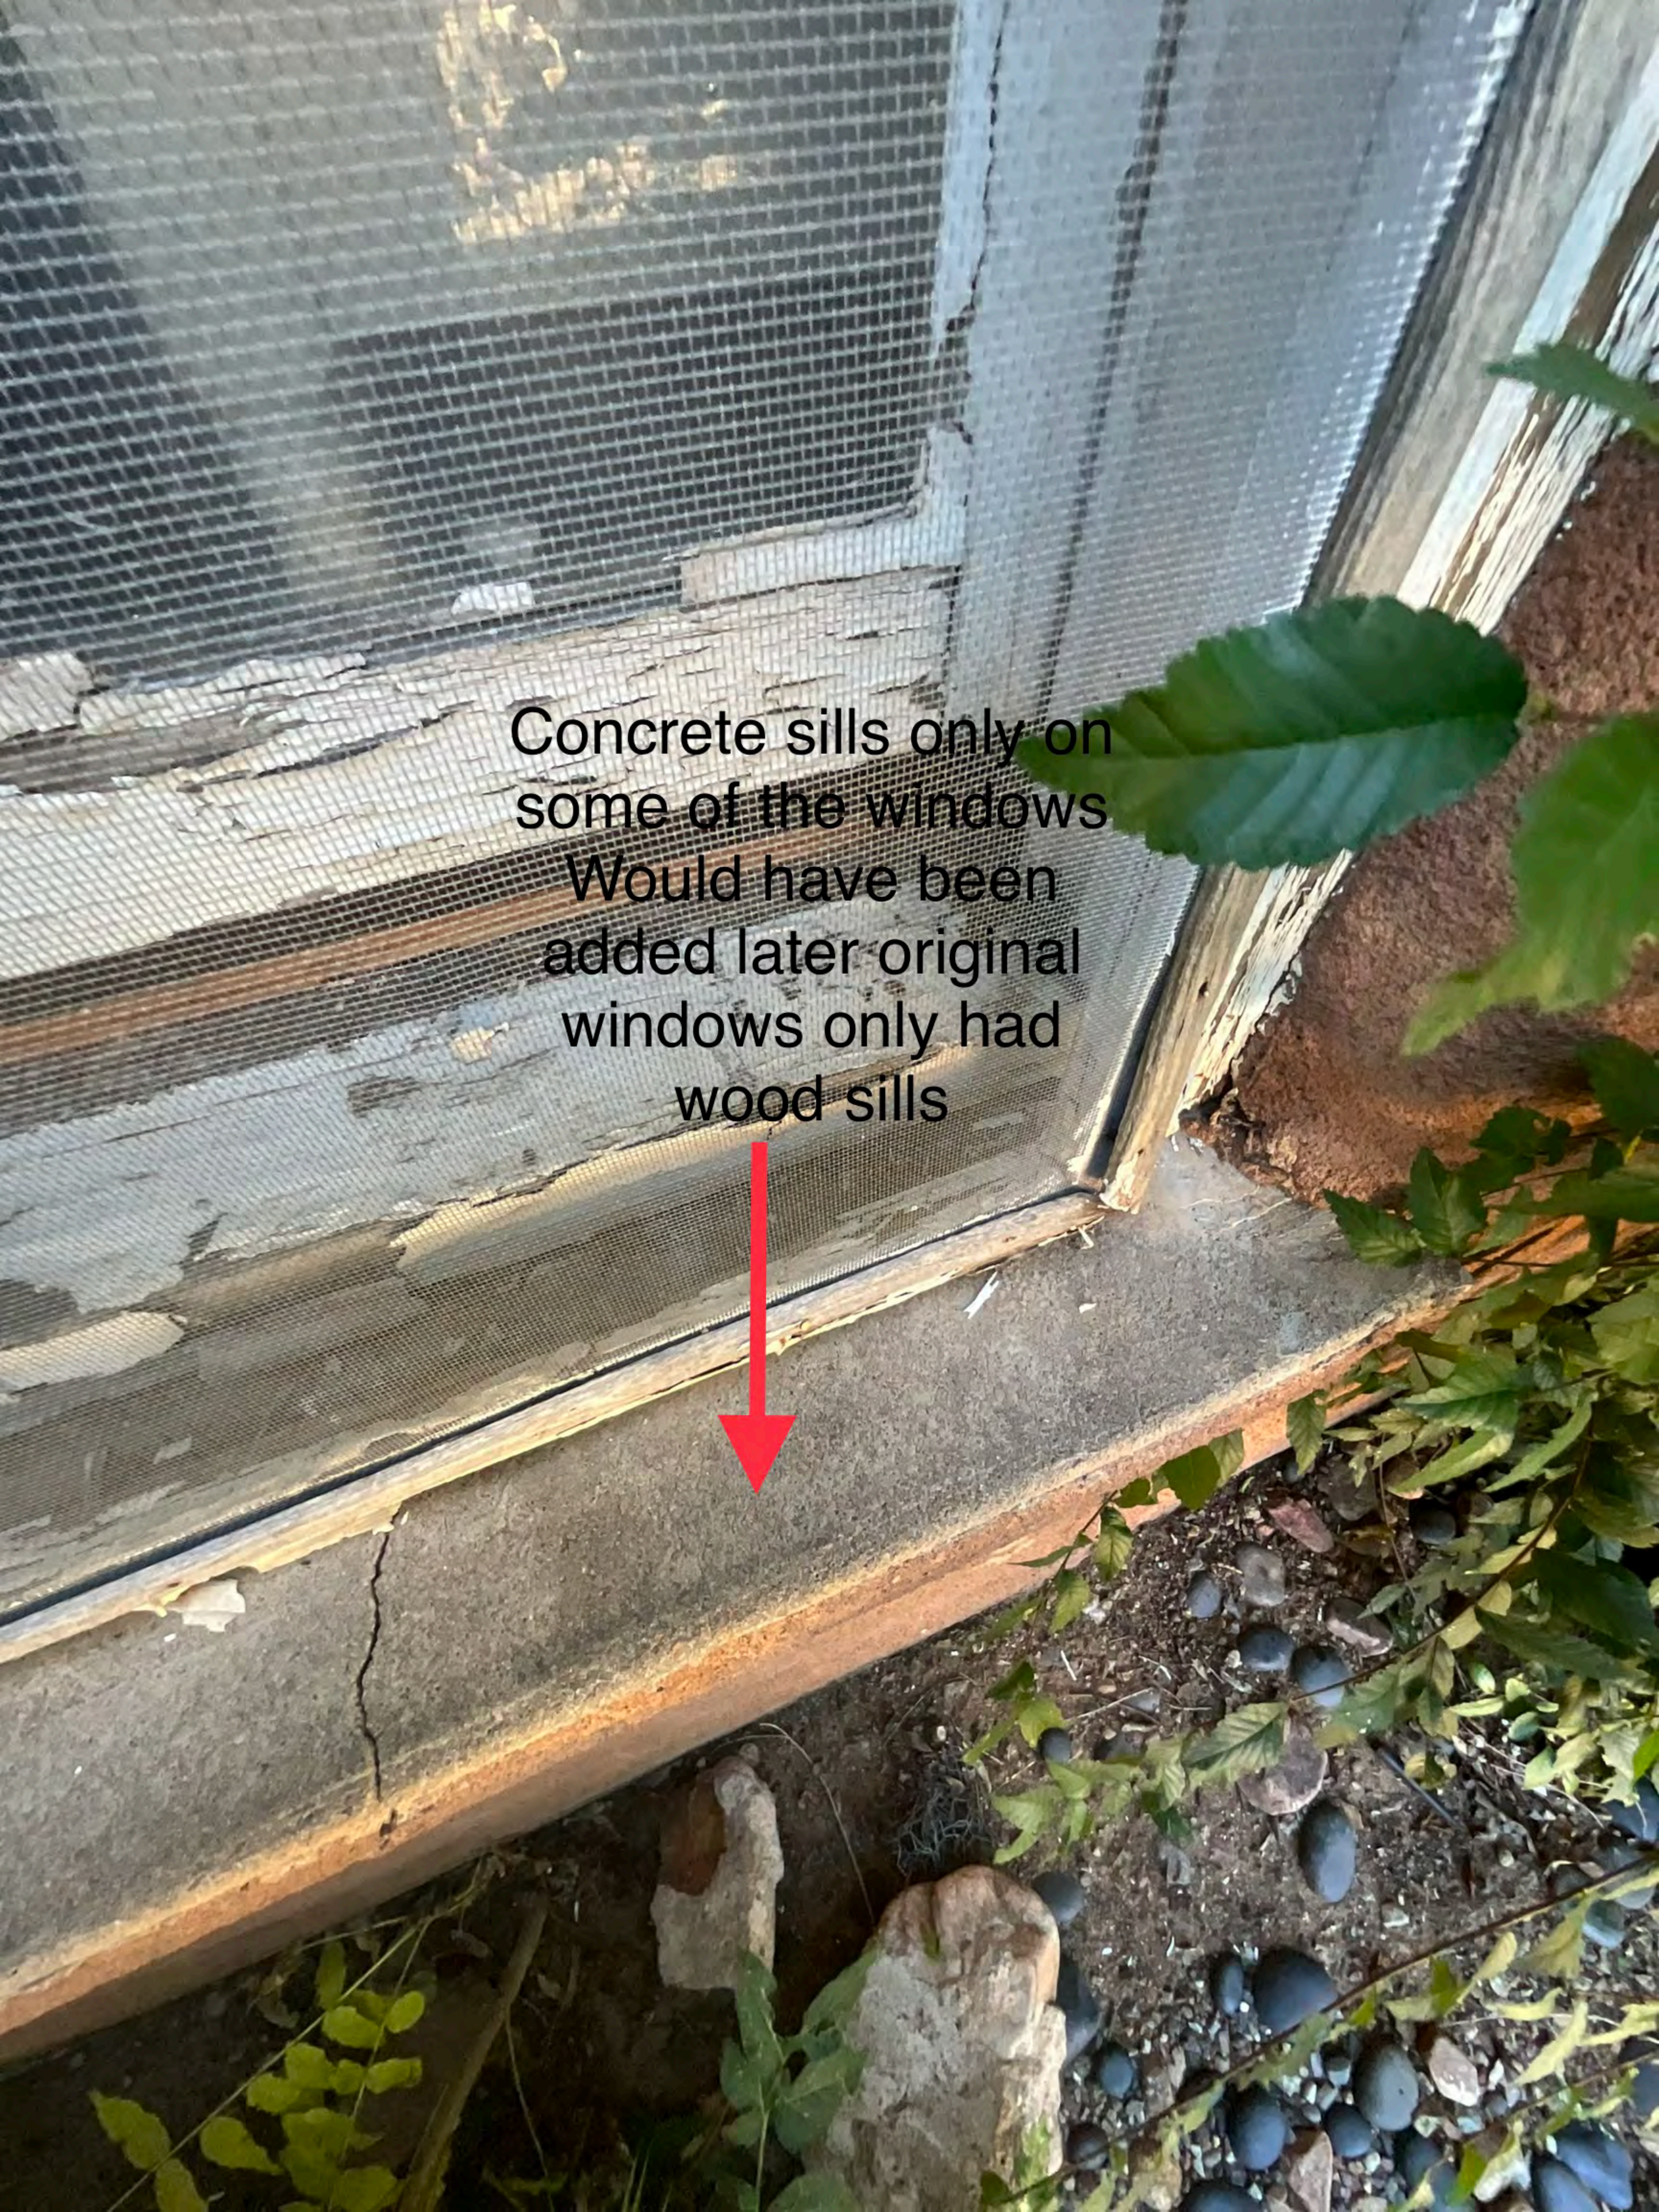
Typical rot at sill, btw  
rails and side stiles  
and exterior casings

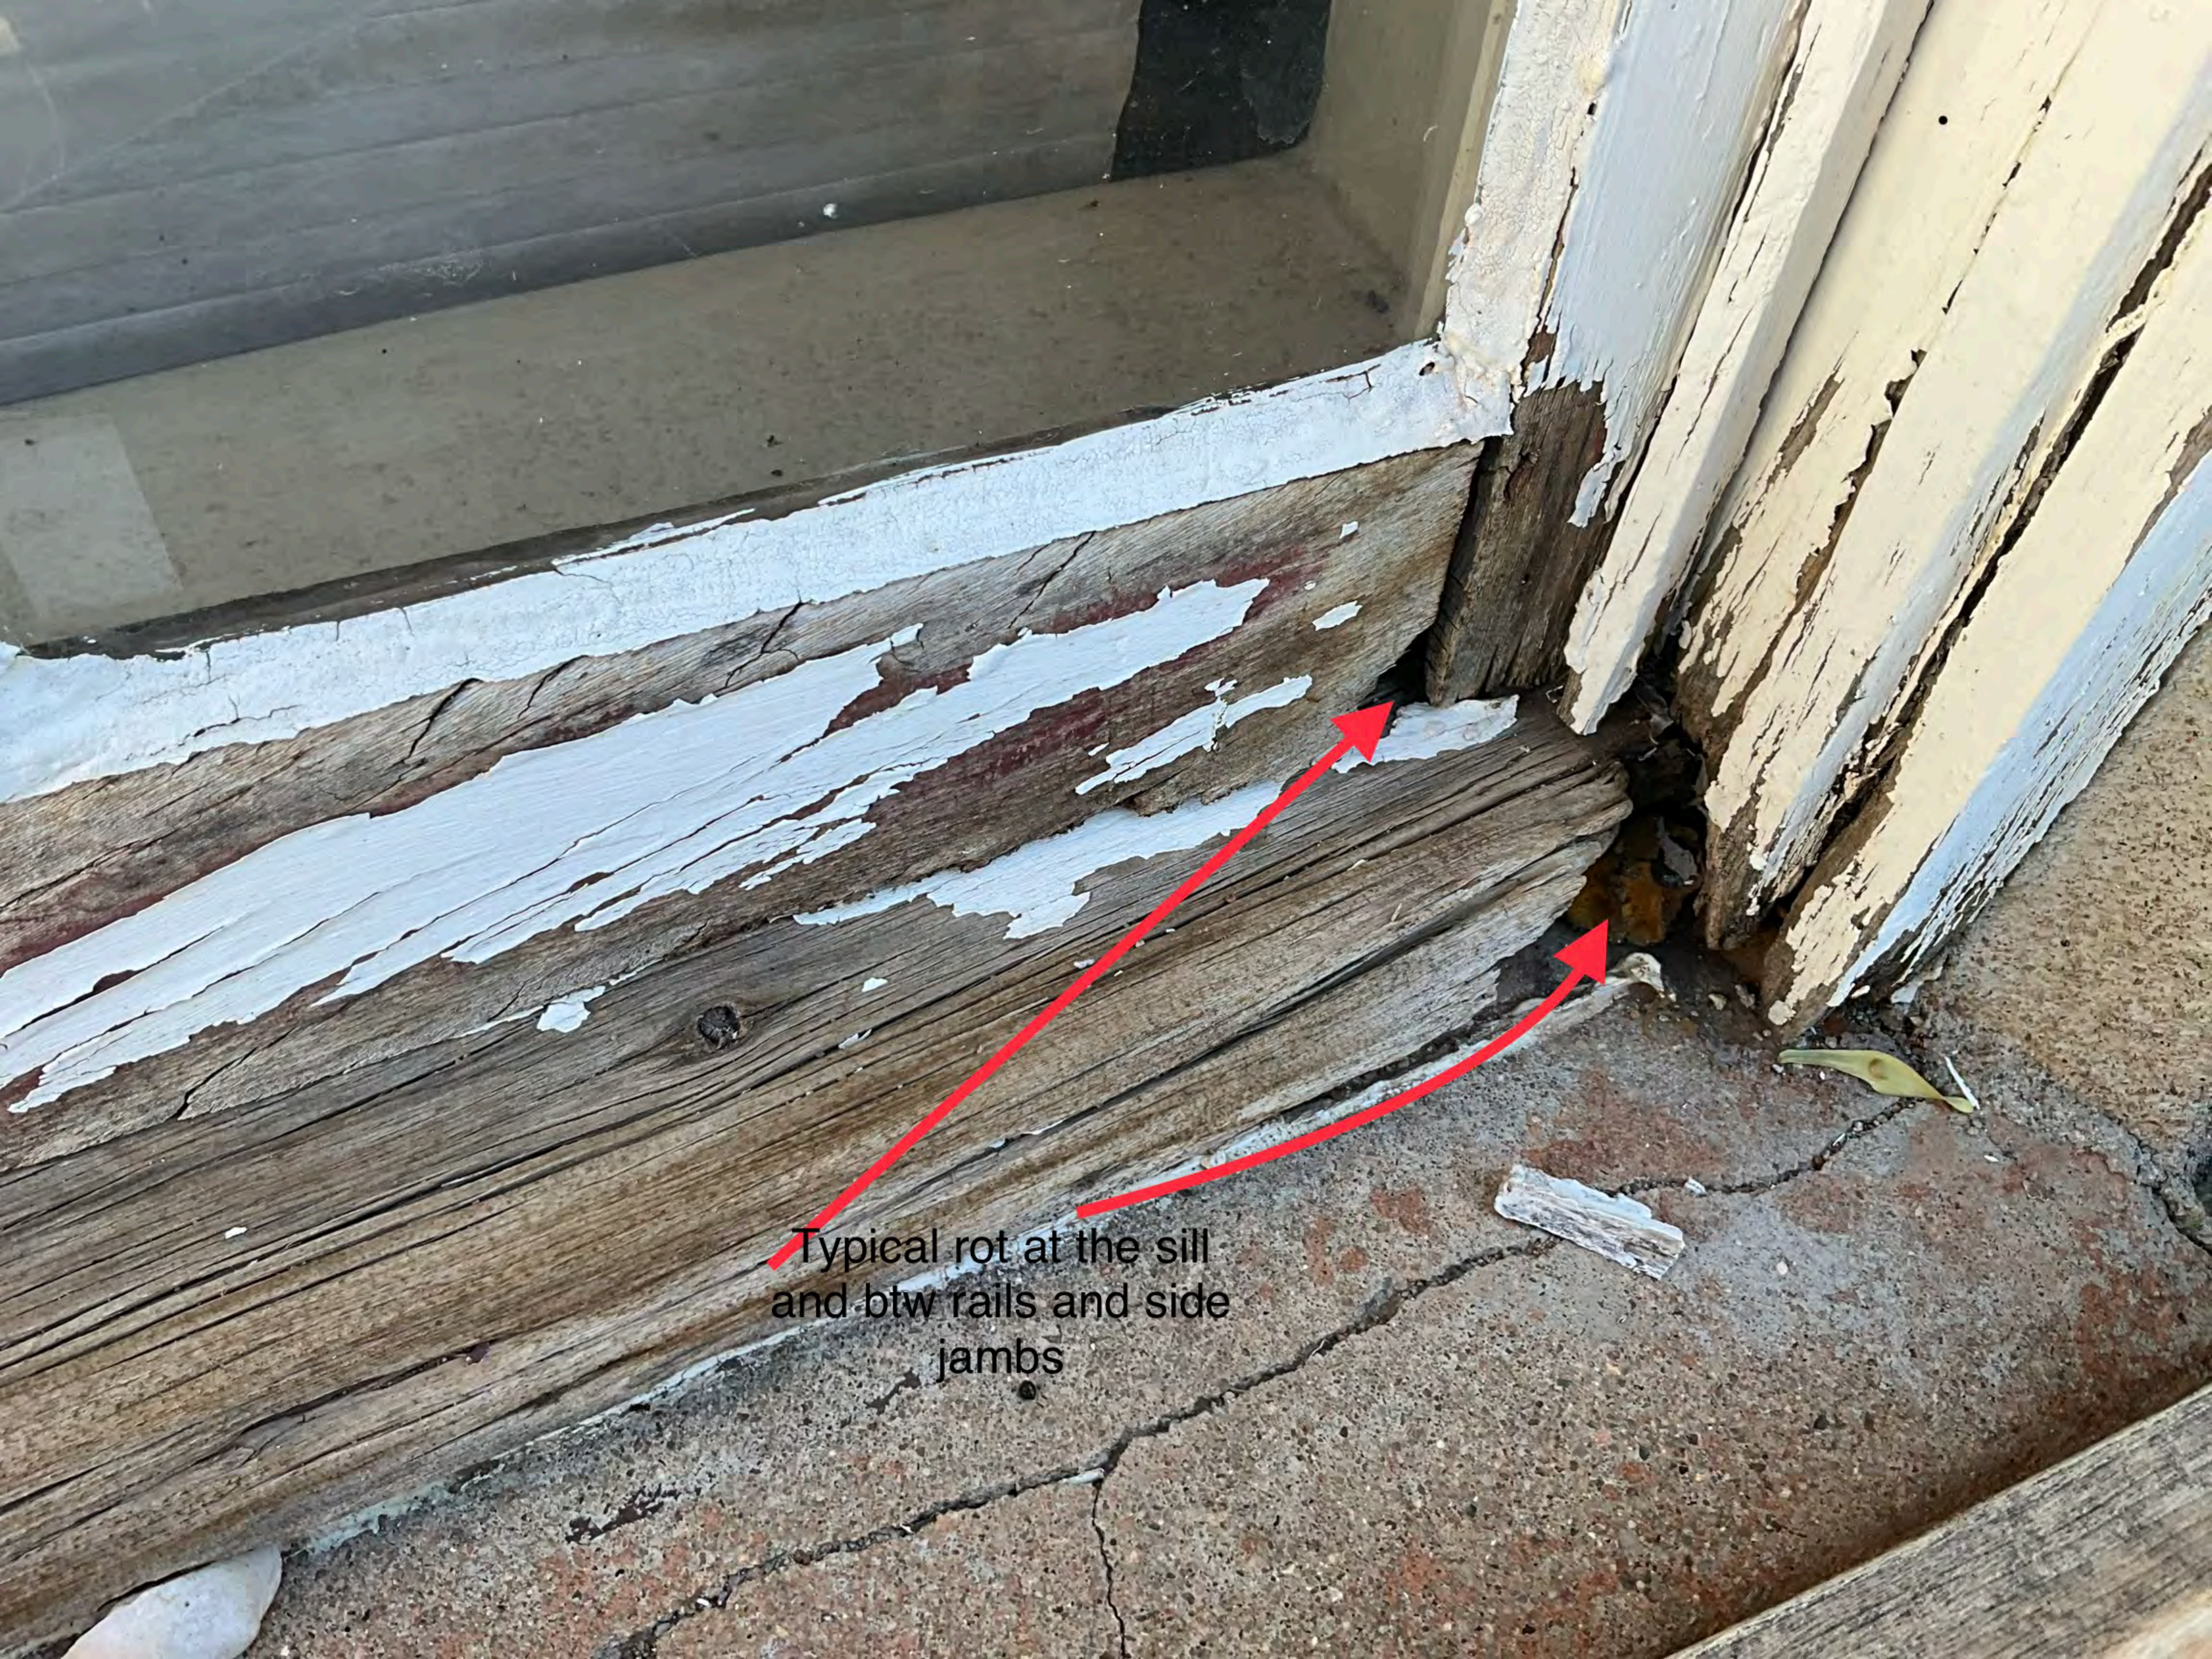
Typical rot at the sill  
and btw rails and side  
jambs
