RPA & Associates, LLC.

JOB	DATE
826 Camino del Poniente, Santa Fe, NM 87505	01/20/2024

RPA & ASSOCIATES, LLC. | WINDOW & DOOR CONDITION AND INTEGRITY CODES

RPA & ASSOCIATES, LLC. | 826 CAMINO DEL PONIENTE, SANTA FE, NM 87505

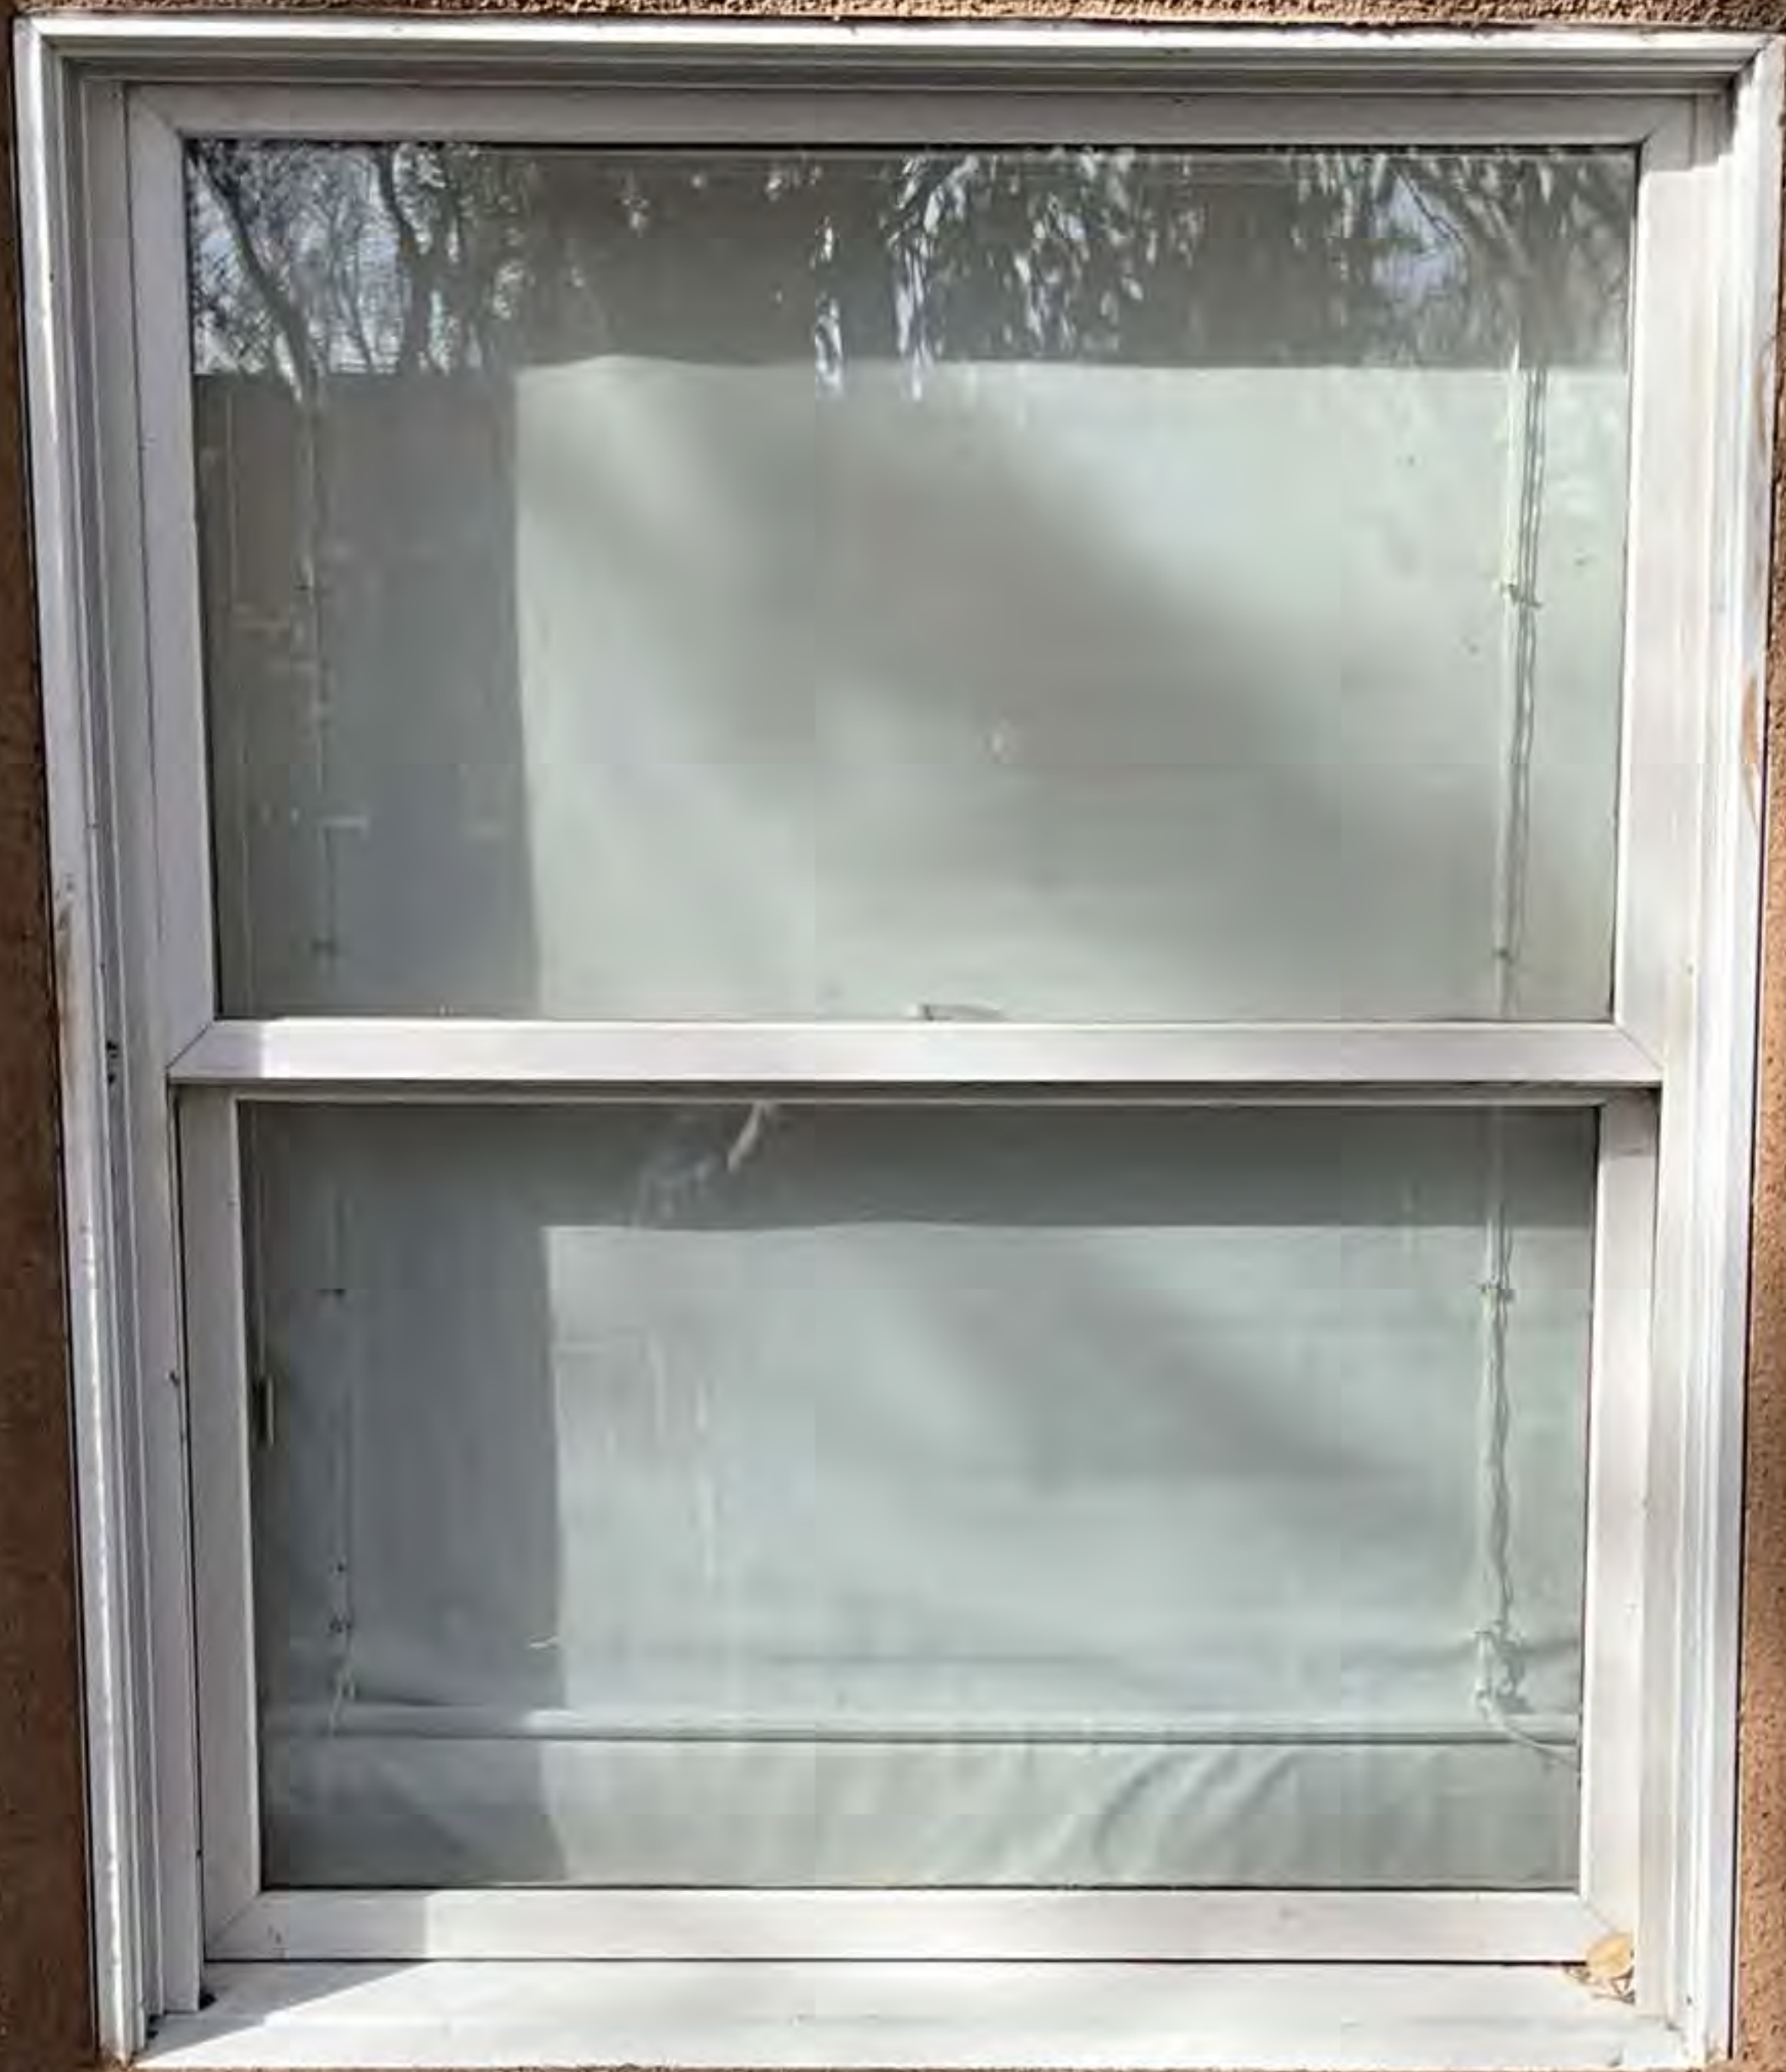
East
Window
A

Windows A, B, C, D, & E are non-historic. The windows are from a Jeld-Wen 2002 series.

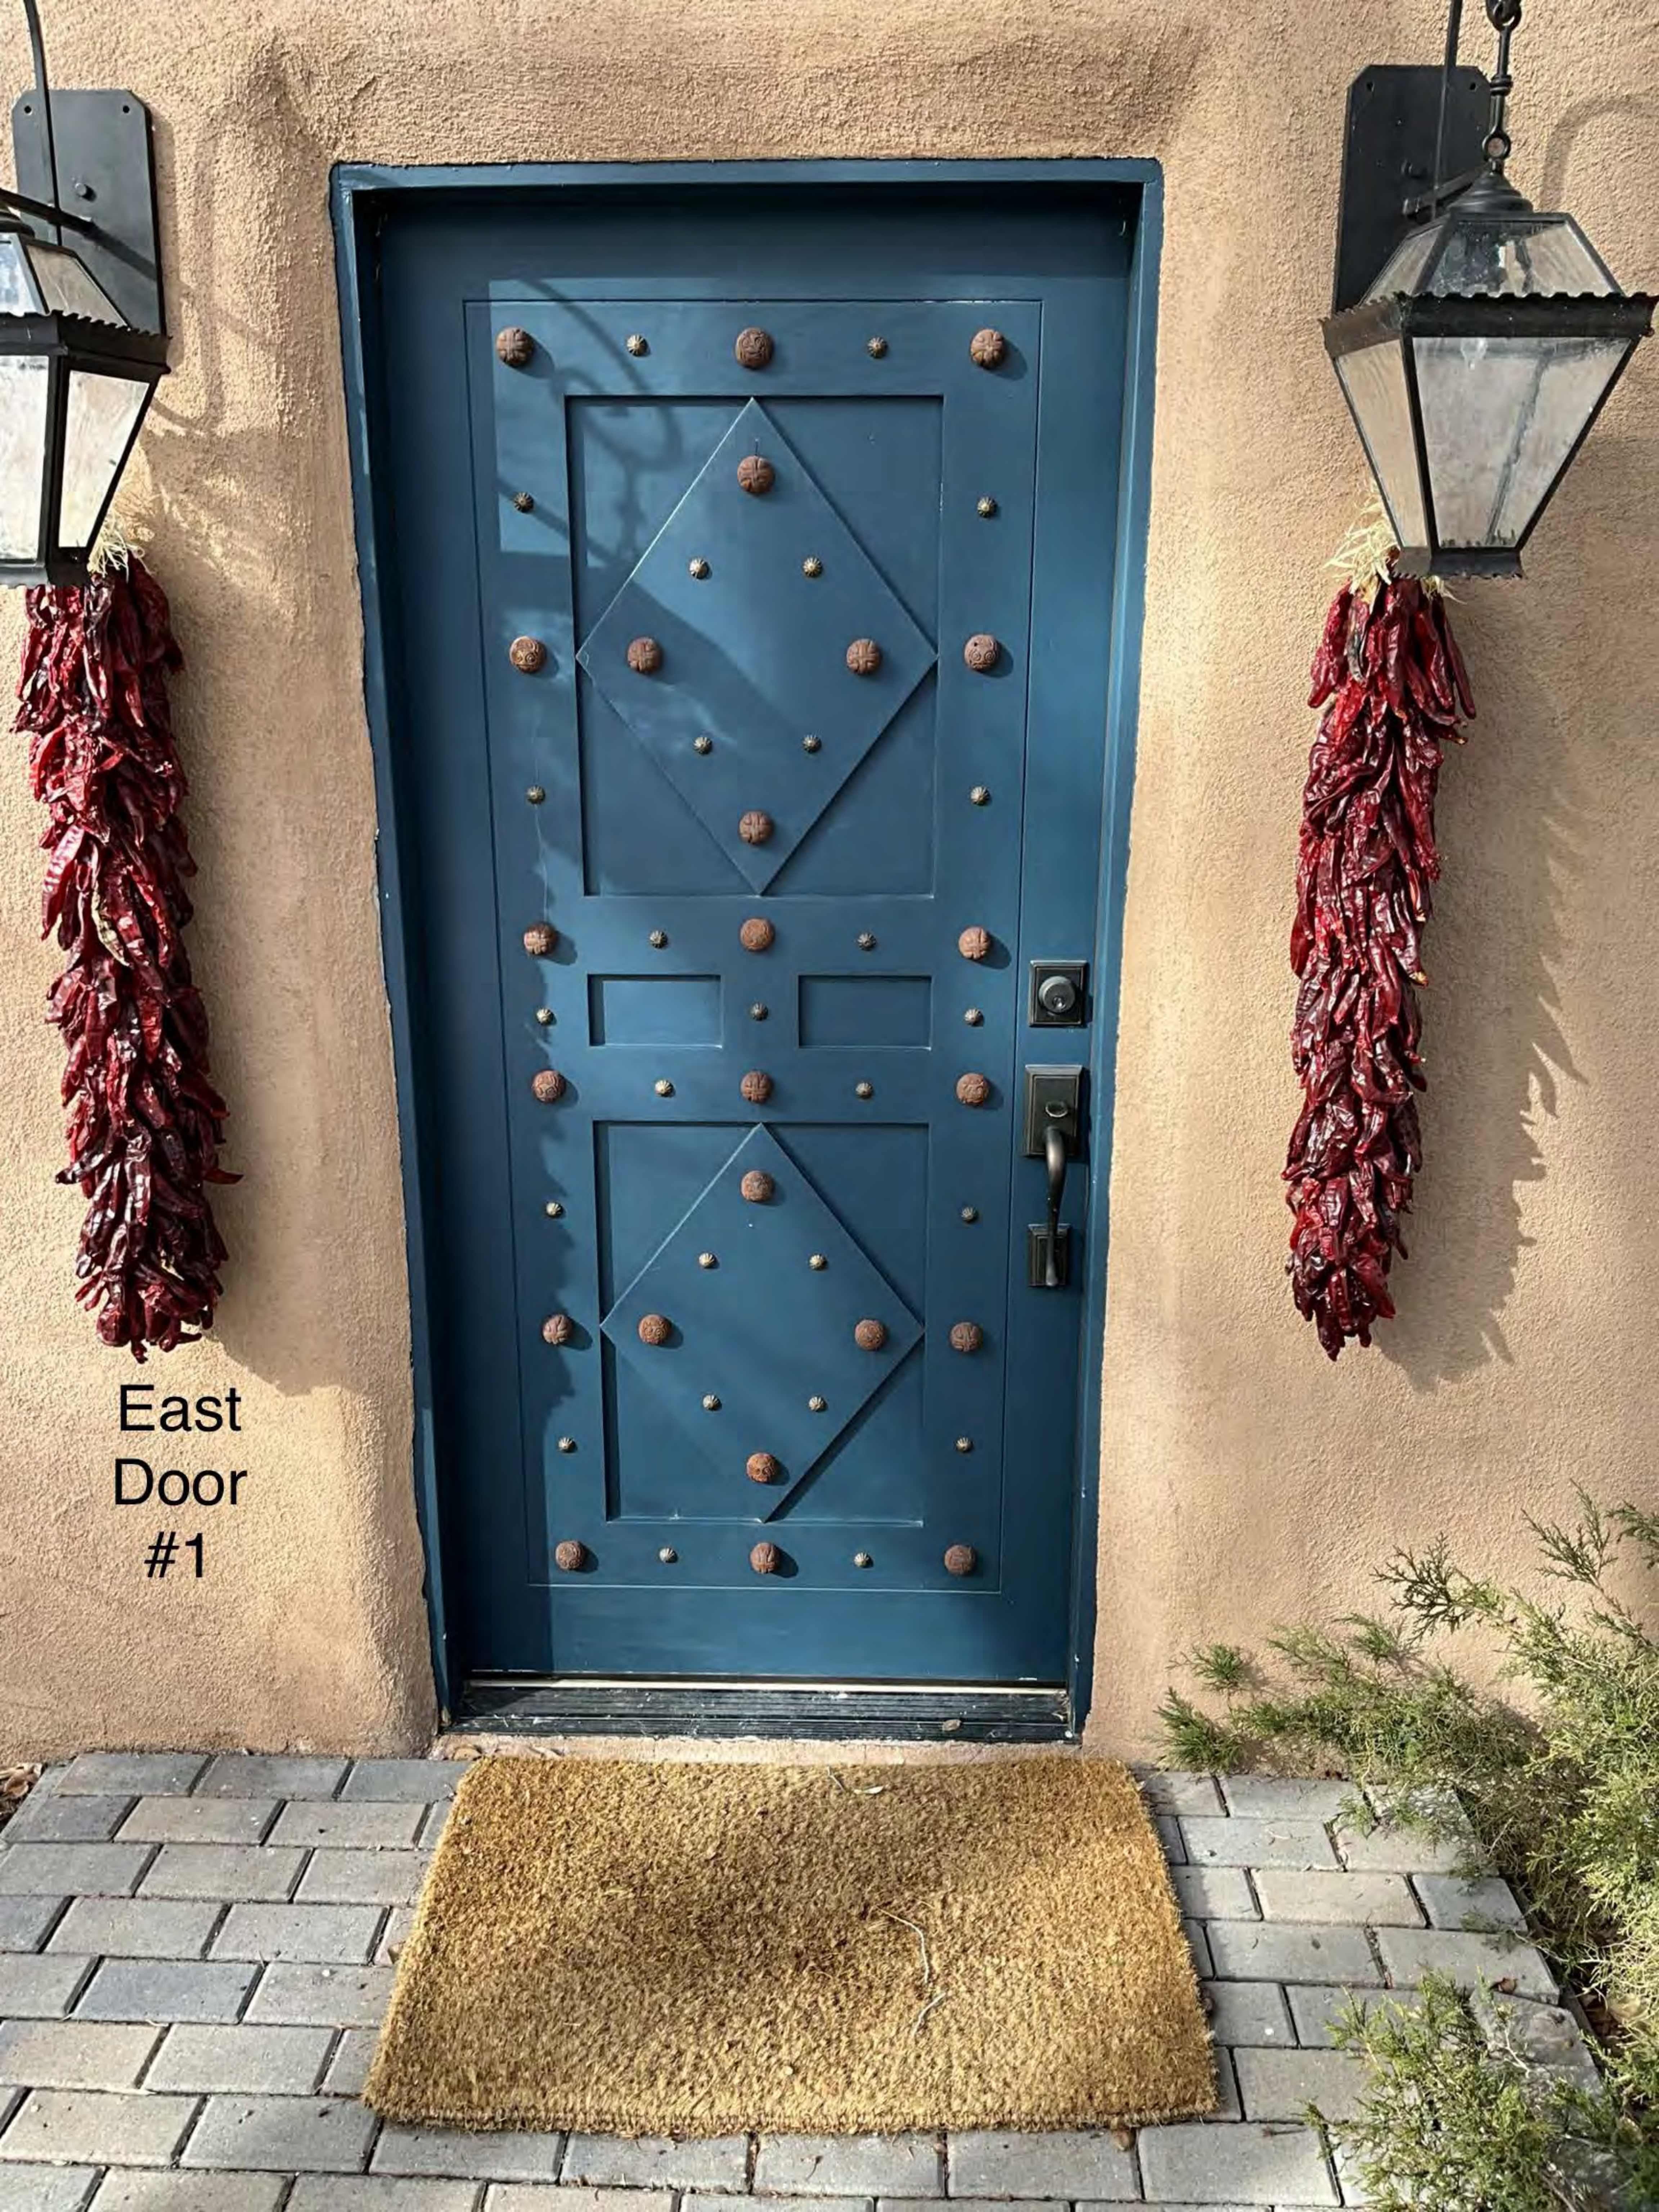
East
Door
#1

Doors 1, 2, 3, 4, & 5 are non-historic. The doors are from the 2000's (-/+), shop made, Therma-Tru and Simpson.

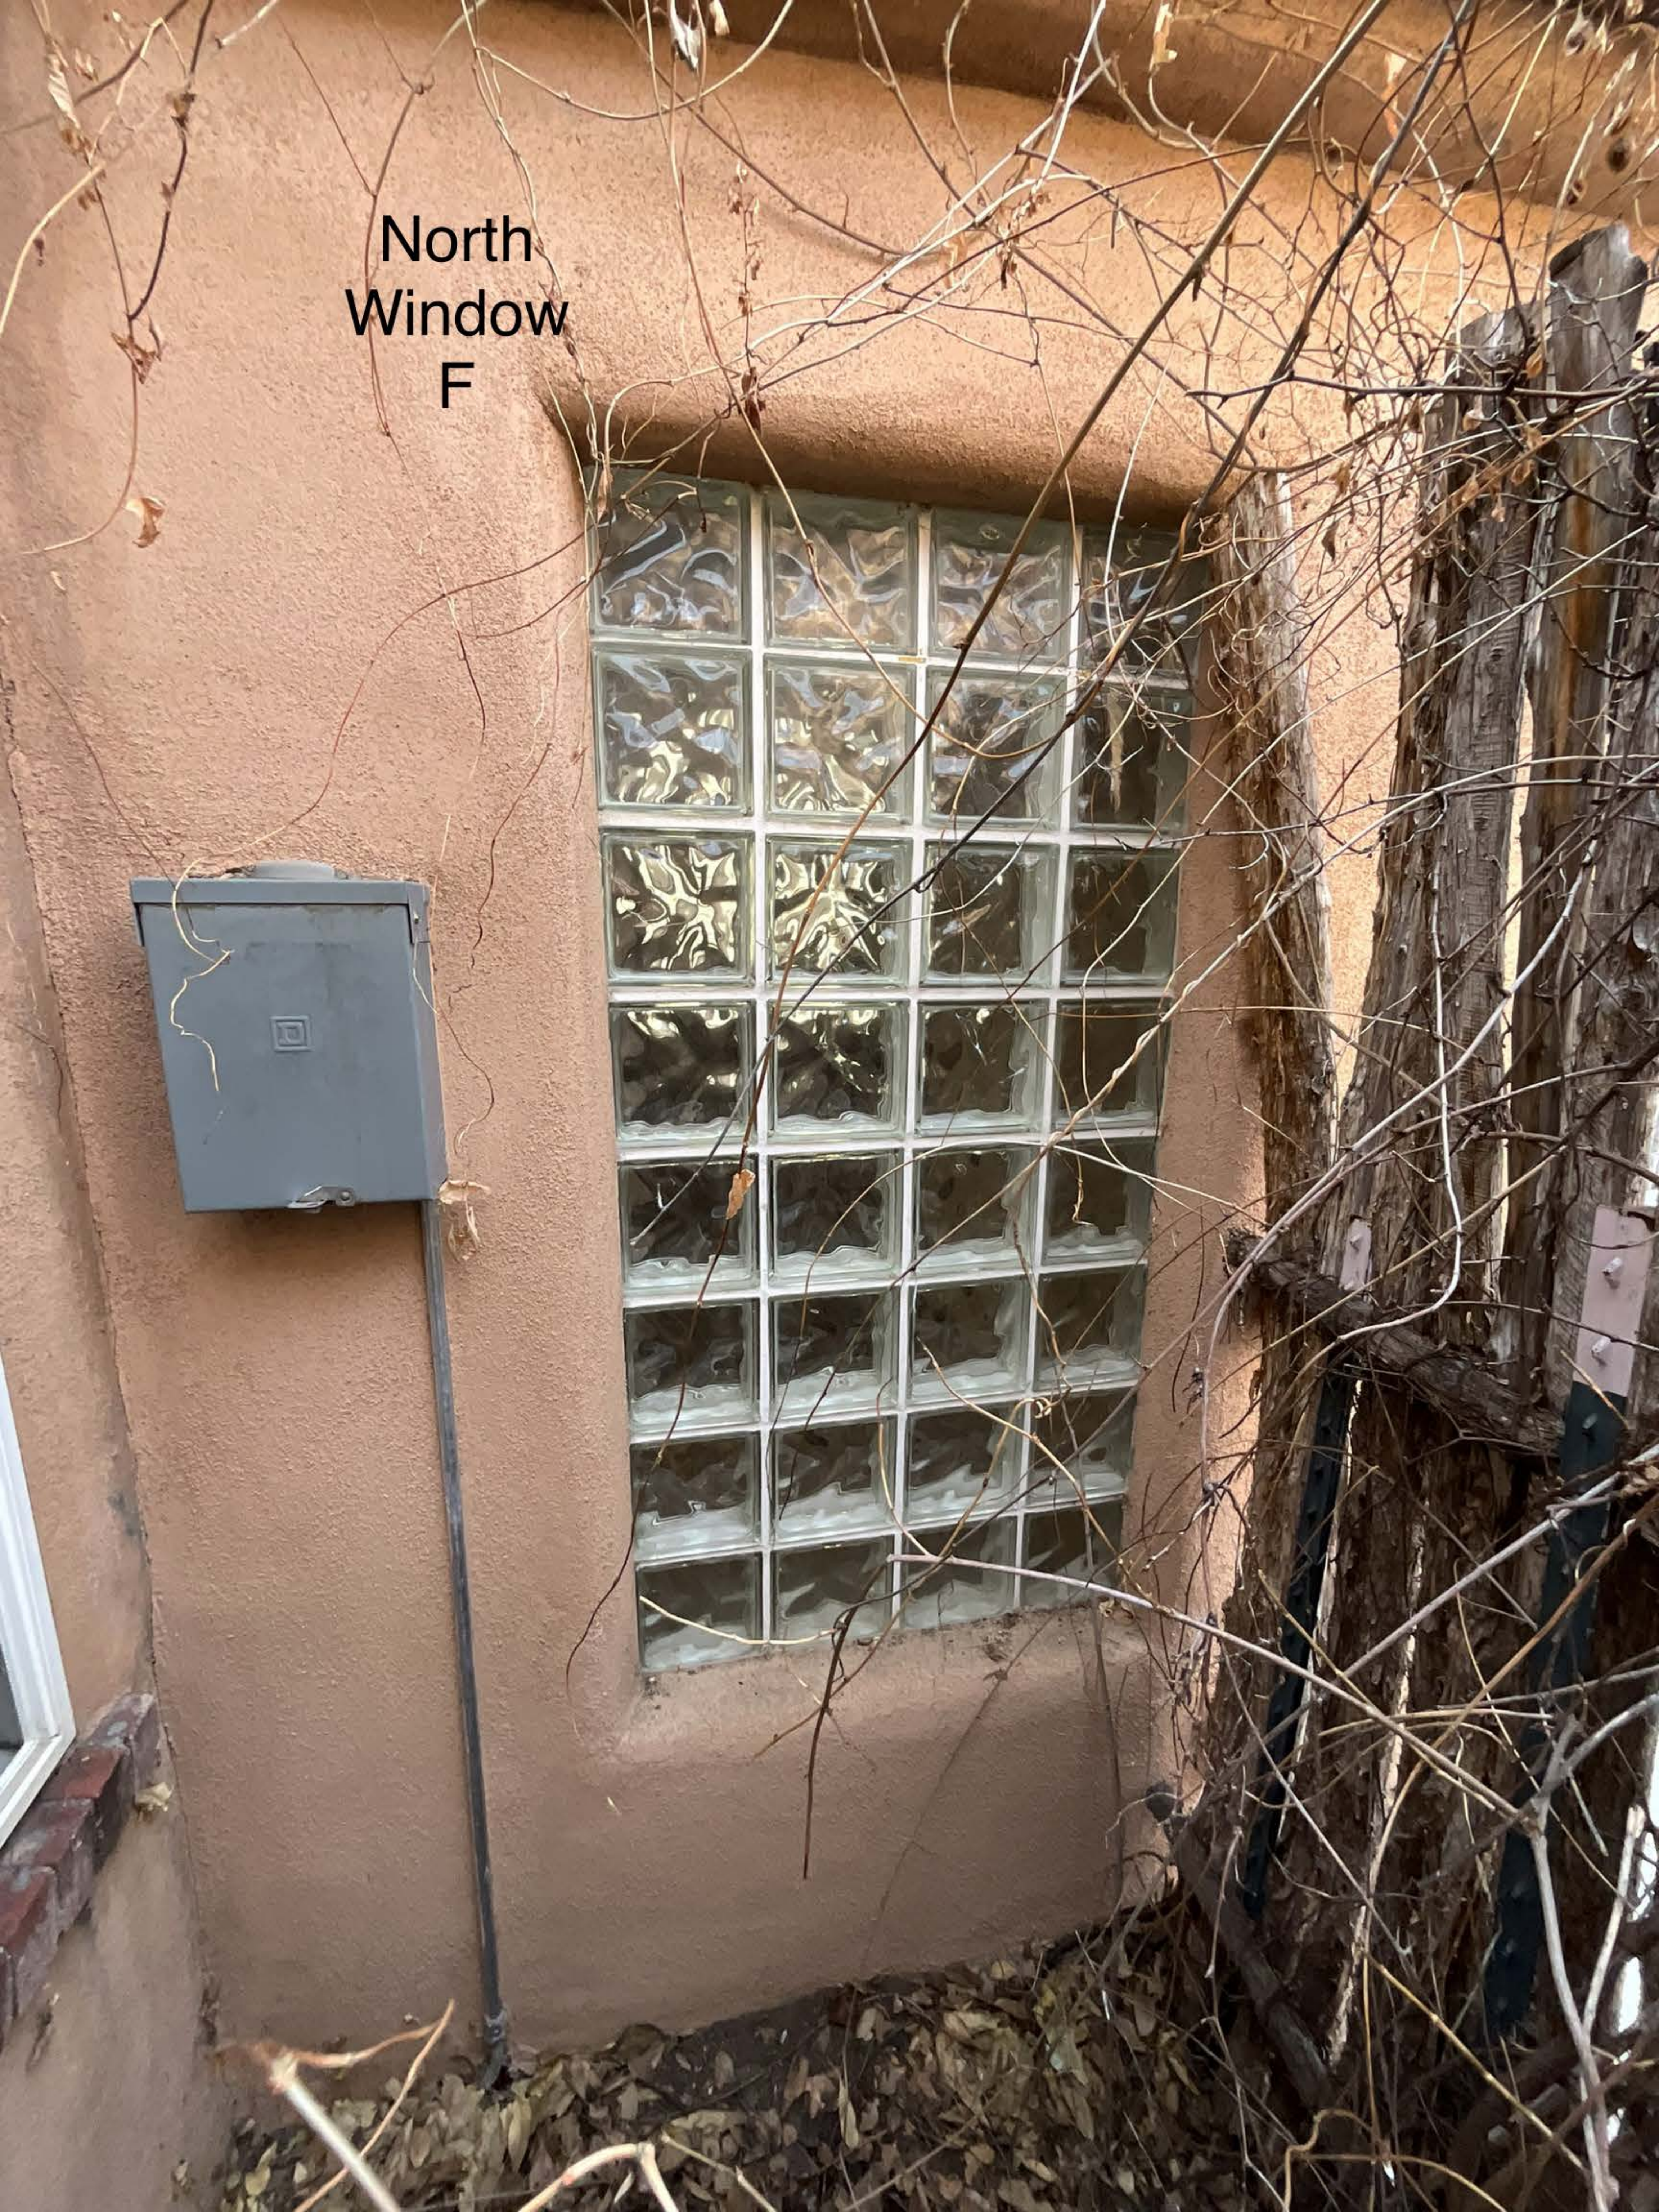
West
Window
G

Window G, H, I, J, K, & L are non-historic. The windows are from an Andersen 2003 series.
