# Historic Cultural Properties Inventory (HCPI) Base Form (FORM 1)

For HPD Office use only:		District No. _____		NRHP	SRCP	Criteria	A	B	C	D
<b>1. Name of property:</b>  Edward and Mary Vigil House Ed's Appliance Service		<b>2. Location:</b>  925 Canyon Road Downtown and Eastside Historic District - Santa Fe			<b>3. Local Reference Number:</b> Santa Fe ID: H-1117					
<b>5. Property Type:</b> <input checked="" type="checkbox"/> Buildings: 1 house, shed <input checked="" type="checkbox"/> Structures: walls <input type="checkbox"/> Site <input type="checkbox"/> Object

<b>6. Date of Survey:</b> September 8, 2025										
<b>7. Previous Survey Date(s):</b> <input checked="" type="checkbox"/> Yes: November 7, 1984, Michael Belshaw <input type="checkbox"/> No:										
<b>8. Name of Project:</b> HDRB Status Evaluation										
<b>9. Lat/Long:</b> 35.6798765,-105.9246747										
<b>10. Photo Information:</b> Giulia Caporuscio, photographer. Photo 1: View of south elevation from Canyon Road. Camera facing north.

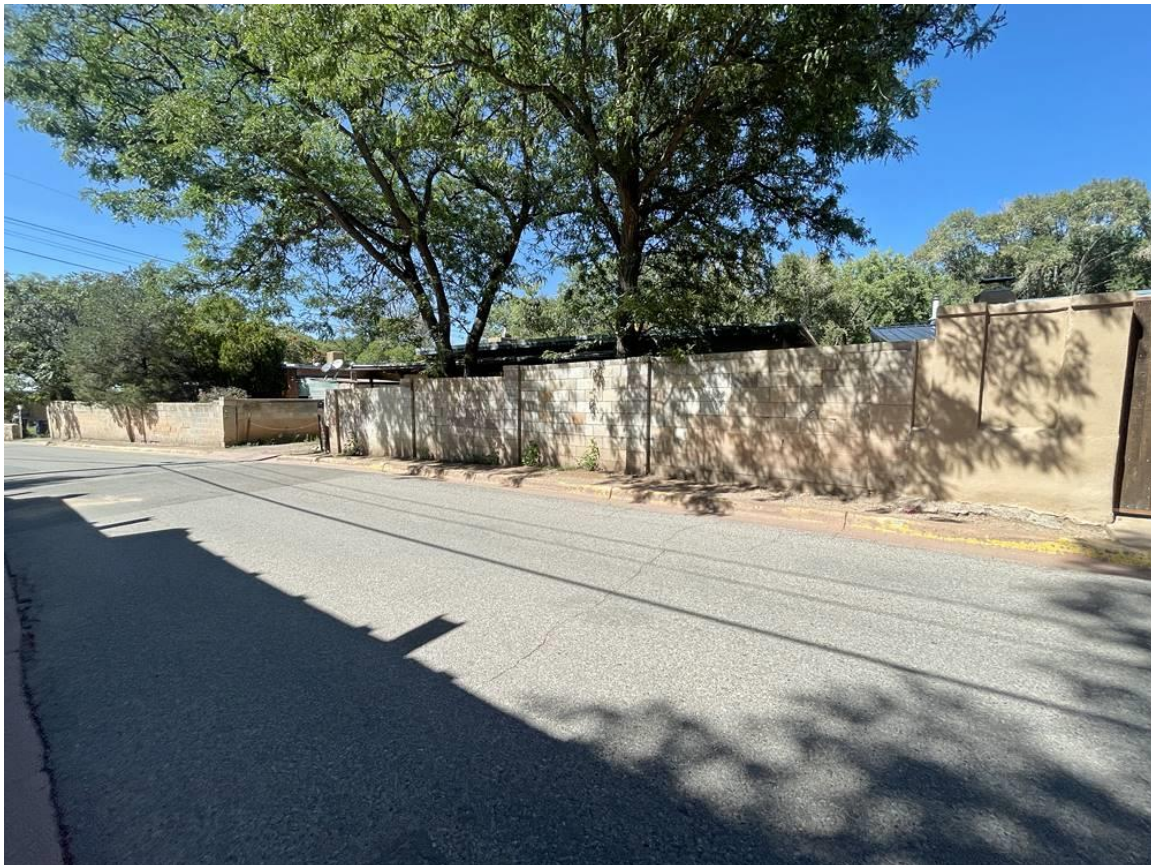
**Photo 2: Canyon Road and street walls. Camera facing northwest.**

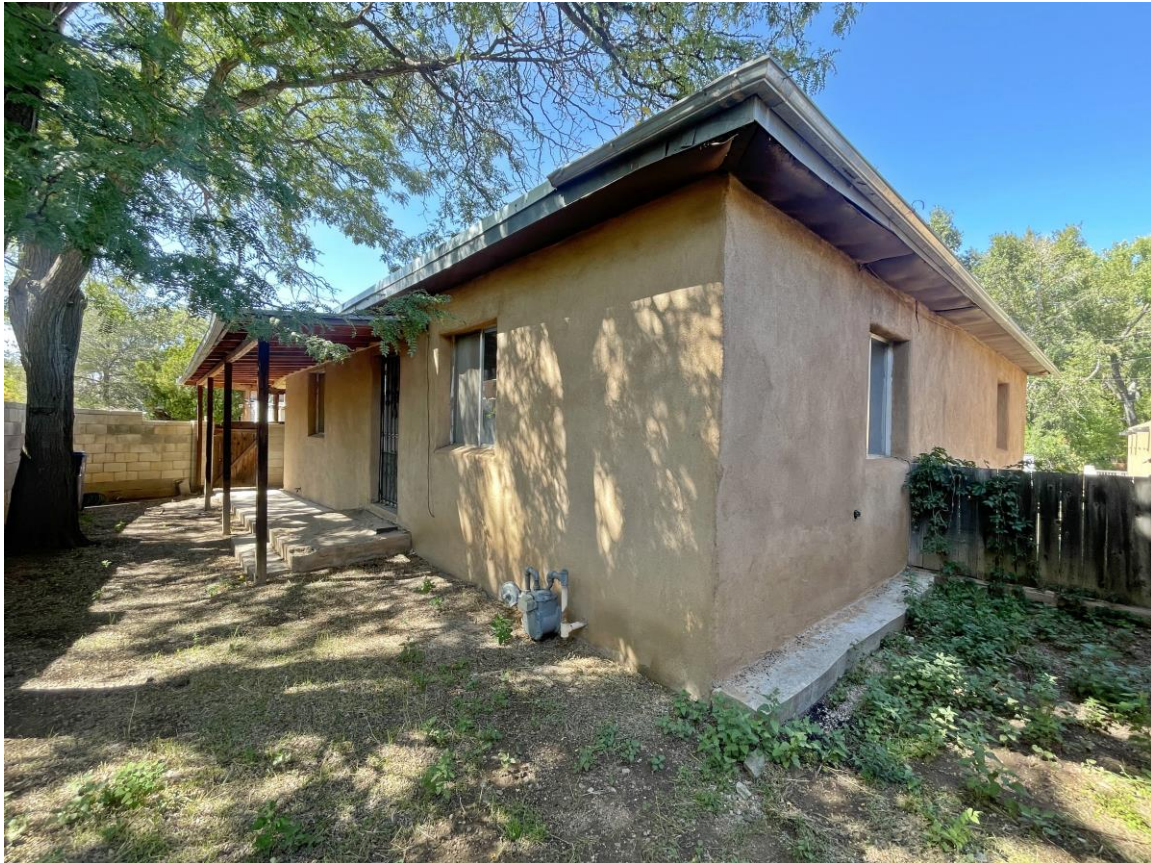
The front of the house, largely concealed behind the wall, presents a plain midcentury façade (Photo 3). The 1950s core consists of a centered entry flanked by single windows (Photo 4). The entry retains a 15-panel wood door characteristic of the period, now obscured by a decorative security grille. The flanking windows are aluminum sliding units with small sash handles. The sharp-edged reveals suggest CMU construction. A flat roof edged with a seamed metal fascia provides a modest midcentury detail. This simple expression has been compromised by a later non-historic porch, built with exposed plywood decking. Measuring 100 inches in depth, the shed-roofed porch is placed just above the fenestration line, causing a visual dissonance (Photo 4).

The east elevation, a secondary façade, descends with the slope, with most fenestration concentrated at the upper level (Photos 3 & 13). These openings contain aluminum sliding windows, consistent with those elsewhere on the house. At the basement level, a smaller opening is fitted with a two-light steel casement window, a departure from the otherwise uniform aluminum units.

**Photo 3: South(front) and east elevations. Camera facing northwest.**

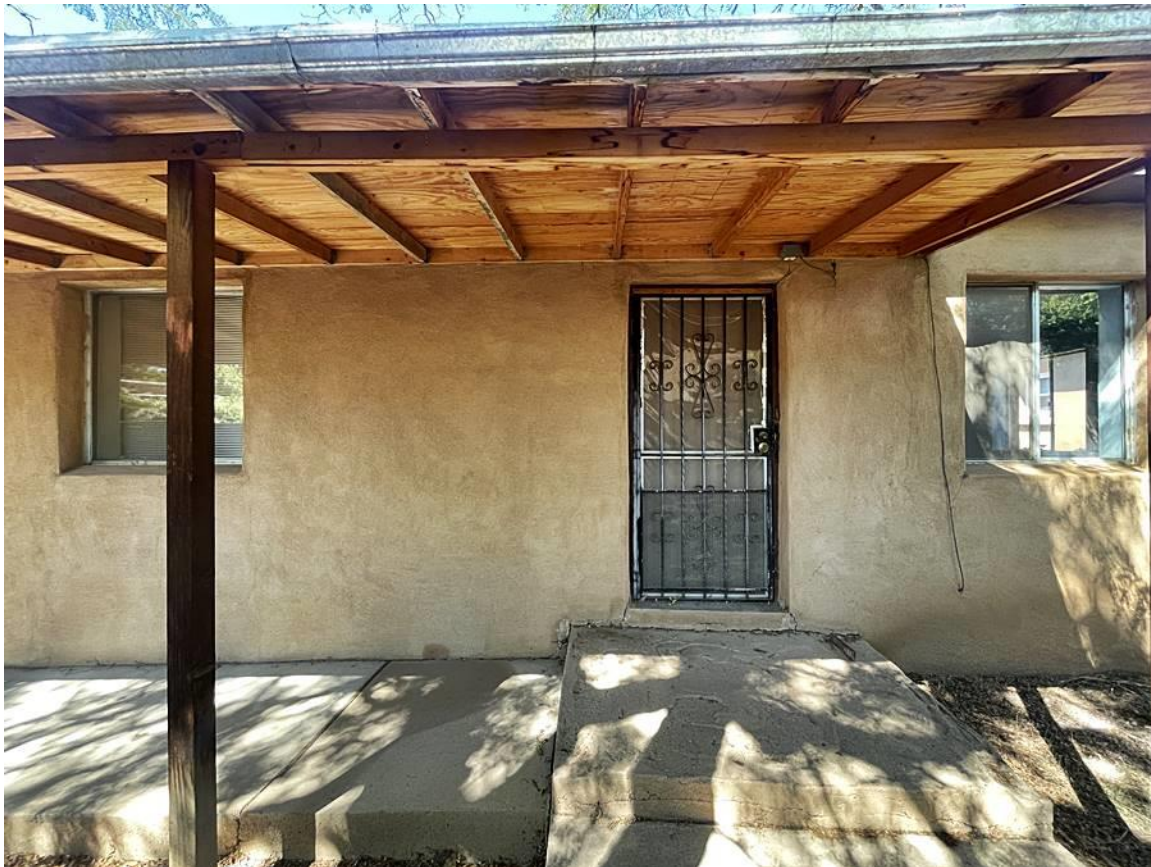
**Photo 4: South (front) elevation and porch. Camera facing north.**

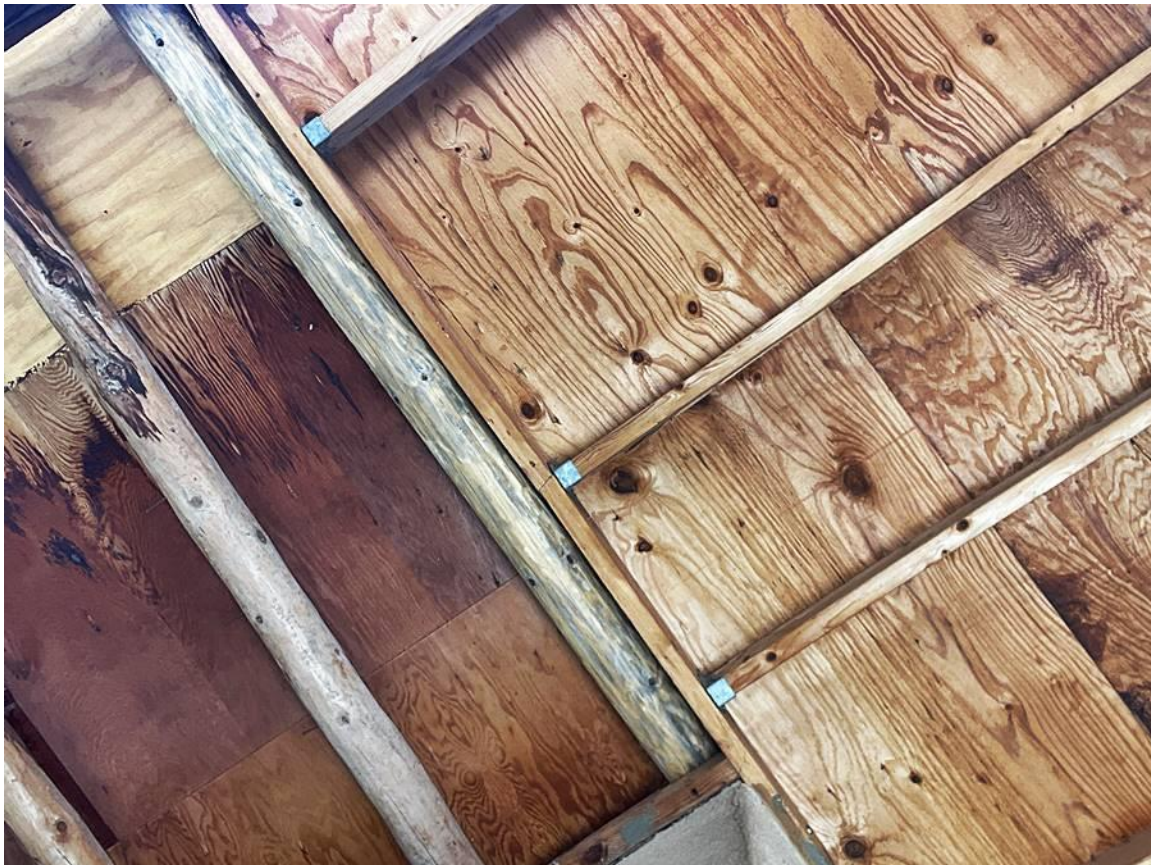
**Figure 5: Joining of two non-historic porches at southwest corner of south (front) elevation. Camera facing up.**

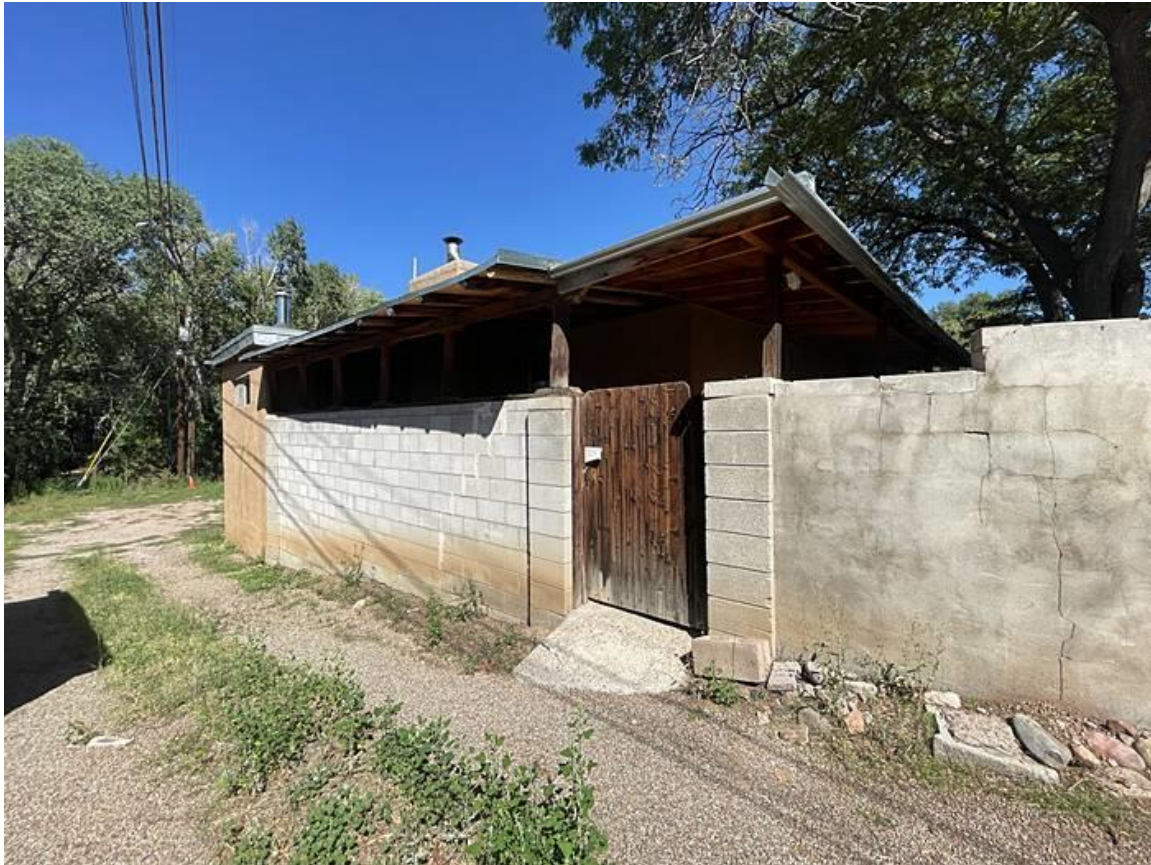
The west elevation incorporates the original 1950s core but has been substantially altered by later additions and a folk-style porch (Photo 6). The original section is distinguished by a prominent rectangular projecting chimney, flanked by small aluminum sliding windows. (On the other side of the chimney is a handsome sandstone Roman brick fireplace). In the late 1960s, a block addition was constructed at the north end, creating a two-story volume that holds a laundry room at the top level. This space

**Photo 6: West elevation. Camera facing northeast.**

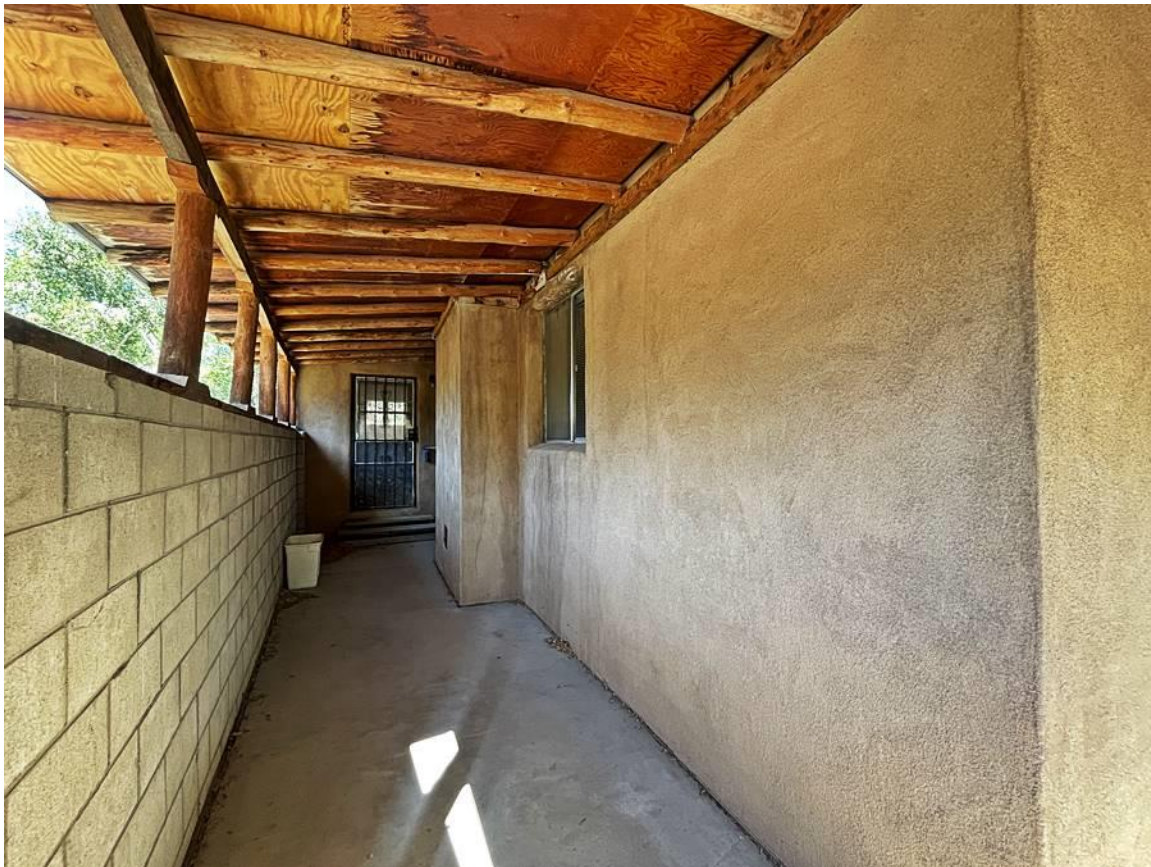
introduced a secondary entry to the façade (Photos 7 & 8). The laundry room is entered from the south through a half-light wood door. This area is shaded by the wood porch supported by improvised “Doric” columns set on a CMU wall. The remainder of the elevation is defined by the laundry room addition, marked by a single aluminum sliding window (Photo 9).

**Photo 7: West elevation and porch. Camera facing north.**

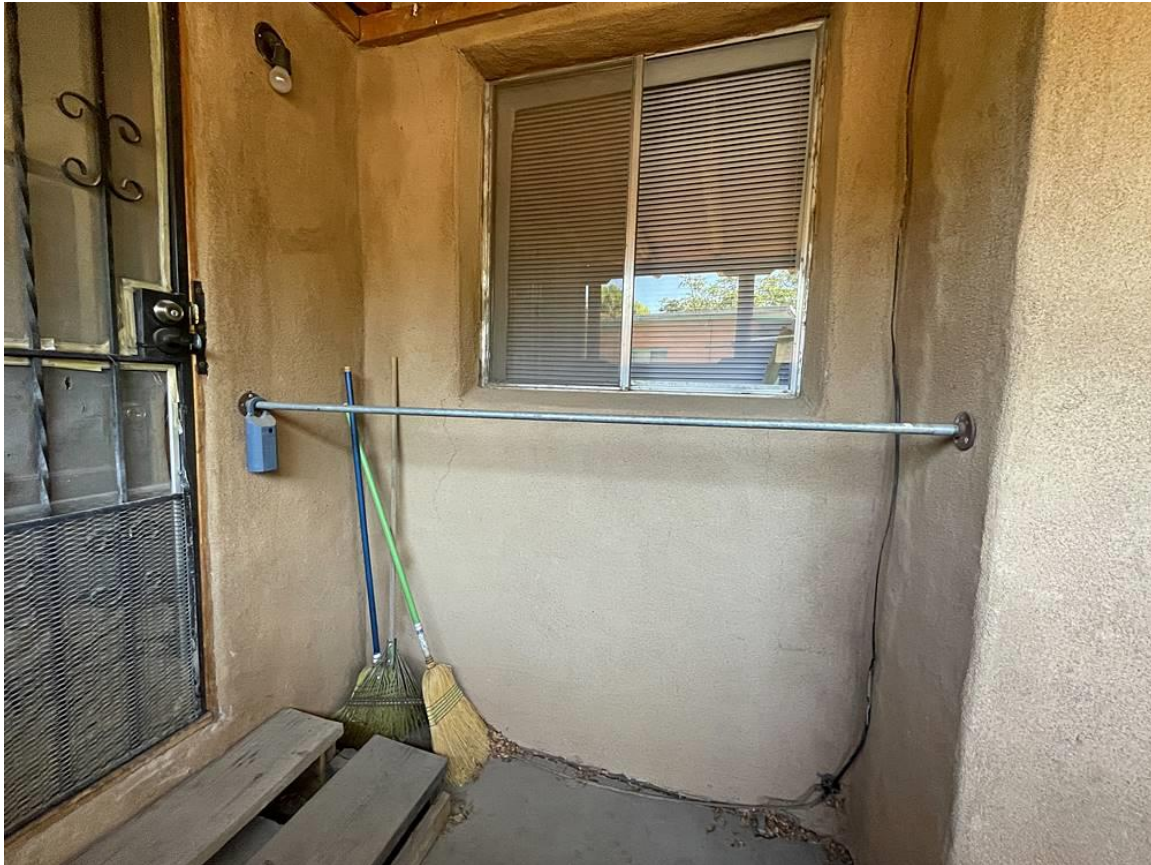
**Photo 8: West elevation. Older home and entry to laundry room addition. Camera facing northeast.**

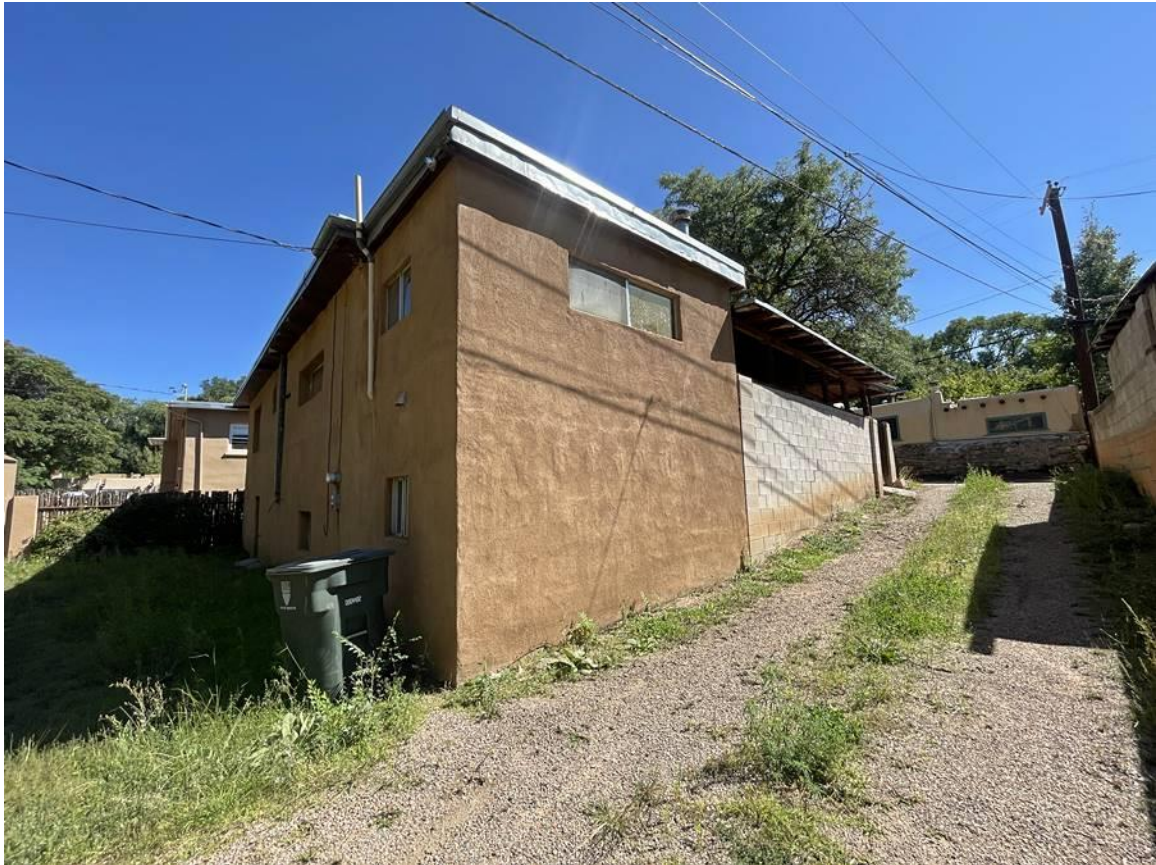
**Photo 9: North and west elevations. Laundry room addition at center. Camera facing southeast.**

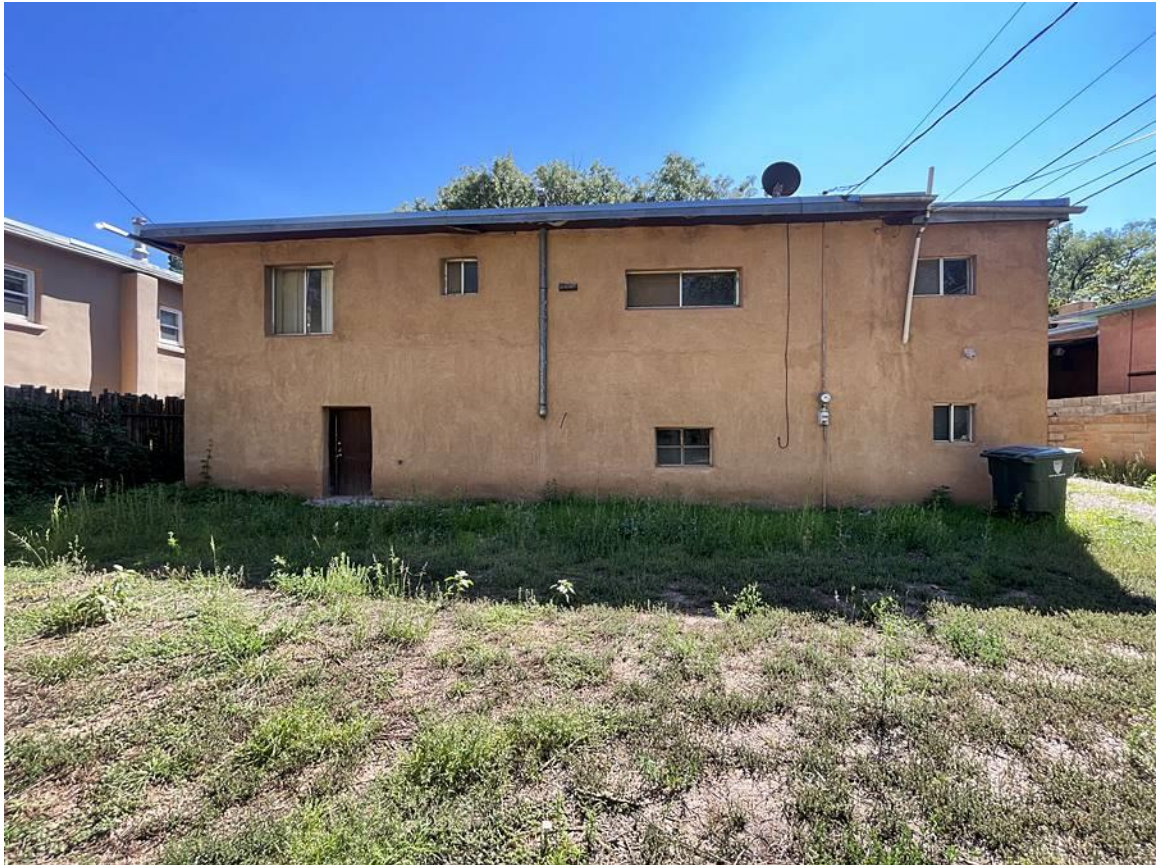
The north (rear) elevation illustrates the sequence of additions documented in aerial photographs (Photo 10). Its dominant feature is a flat-roofed, two-story rectangular volume constructed in the 1960s, designed to take advantage of the grade change at the rear of the lot. This strategy, also seen in neighboring houses, allowed expansion without extensive excavation, creating service or storage space below and habitable rooms above. (Compare this with the placement of the home holding the Santa Fe Teahouse & Bistro a few hundred feet to the west). It is fenestrated with standard aluminum sliding windows in varied sizes. At the ground floor, a small entry door once provided access to Ed’s Appliance Shop, the repair business operated by original homeowner Edward Vigil from the 1960s through the 1980s (Photo 11). The 1970s laundry room addition is visible at the northwest corner (Photo 12).

**Photo 10: North elevation. Camera facing south.**

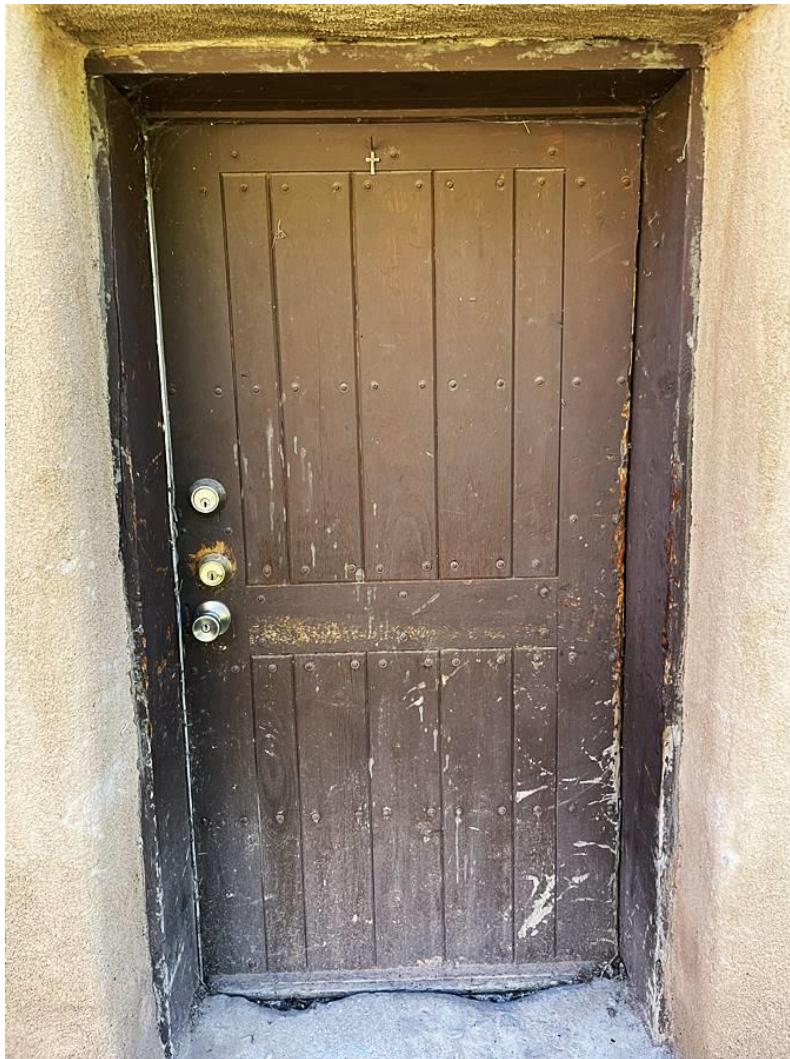
**Photo 11: North elevation. Entry door at ground level. Camera facing south.**

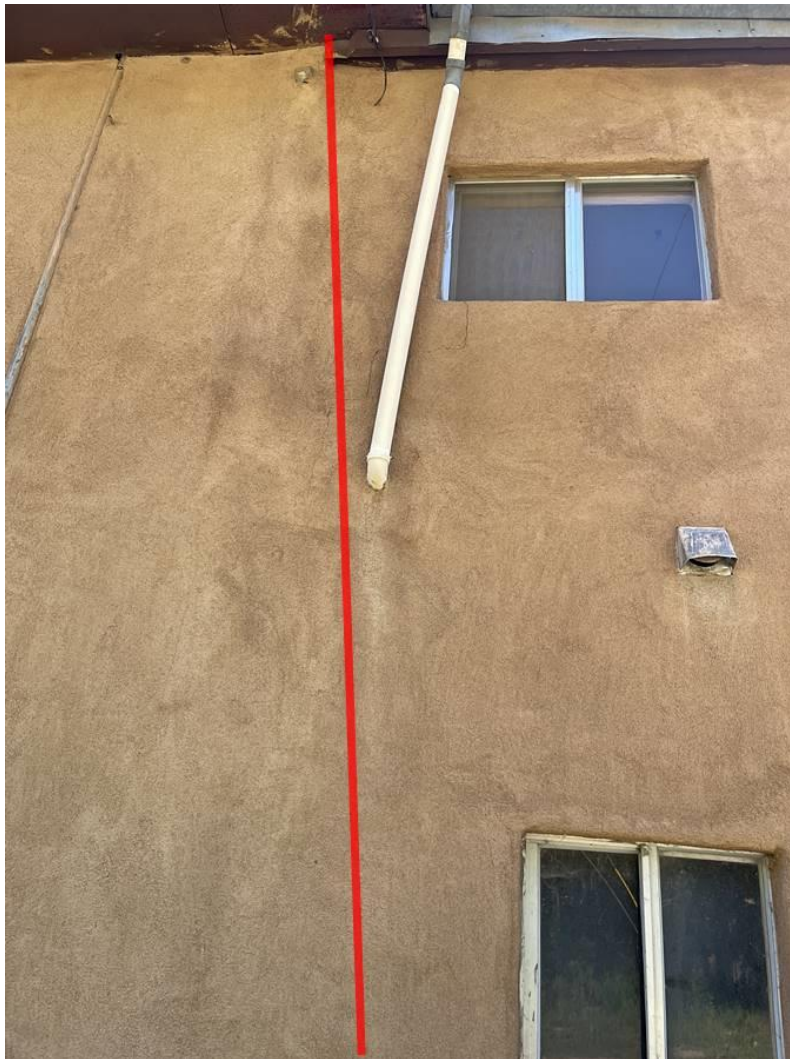
**Photo 12: North elevation. Addition at northwest corner. Camera facing up.**

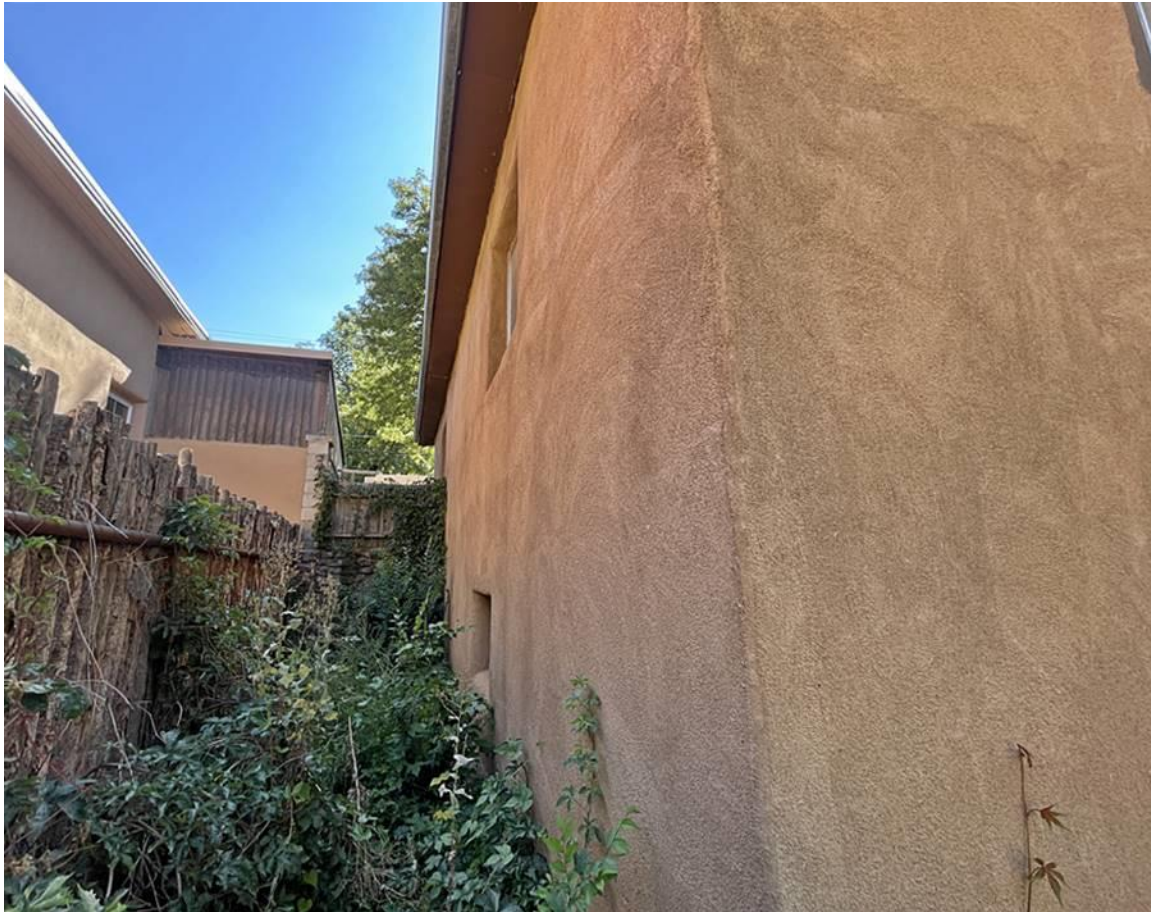
**Photo 13: East elevation. Camera facing south.**
