MEMORANDUM

RE: 515 Paseo de Peralta

Subject: HDRB Demolition Review – 515 Paseo de Peralta

File: 515 PdPeralta_A100 Plans 250331.vwx
Set: Schematic Design Set
Sheet Title: EXISTING FLOOR PLAN w/ STRUCTURAL DEFICIENCIES

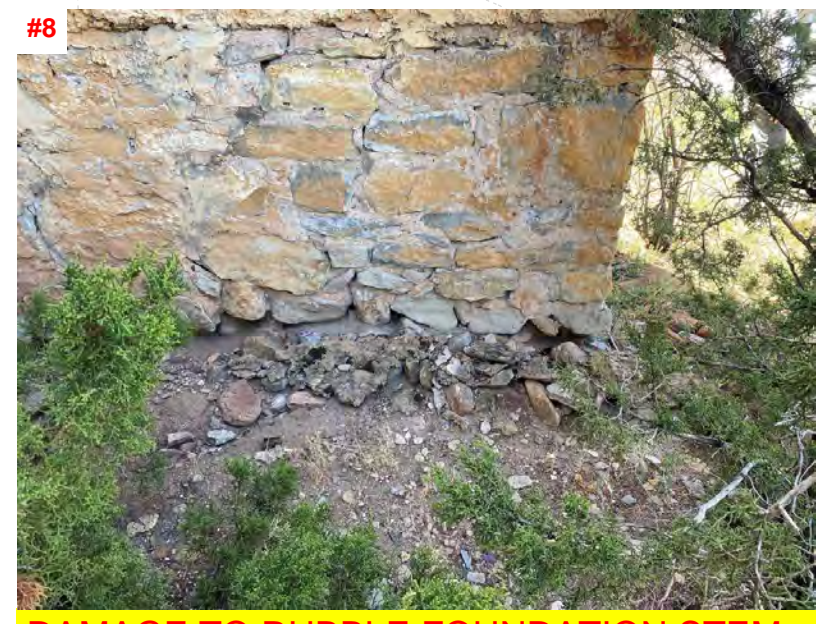
#8 DAMAGE TO RUBBLE FOUNDATION STEM WALL

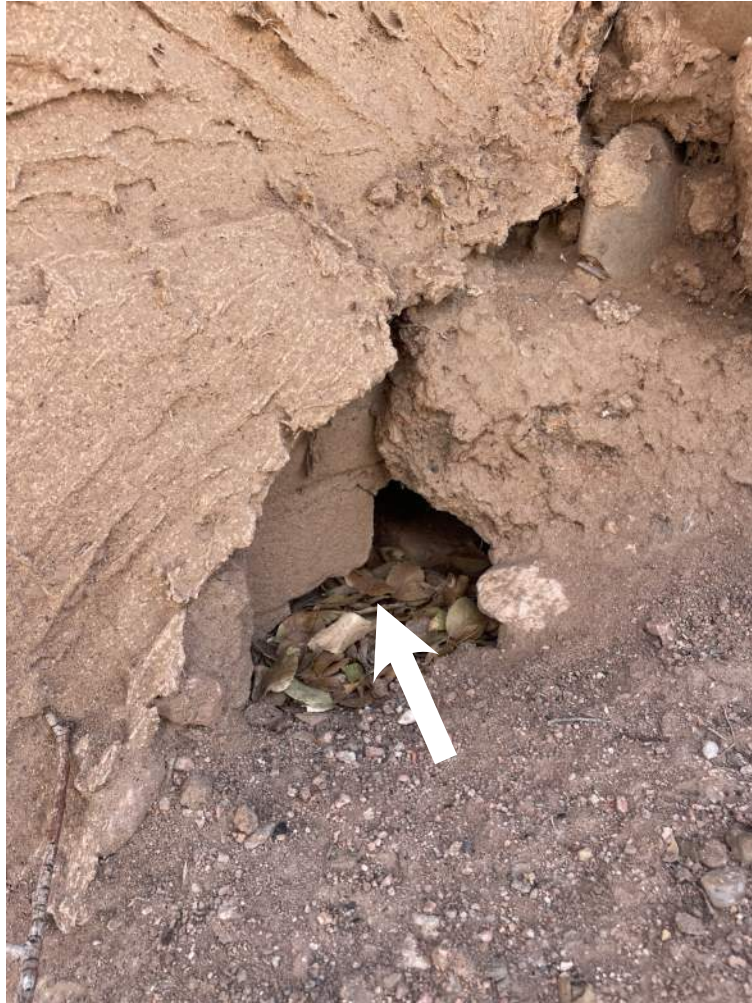
ADOBE BRICK DETERIORATING, NO FOUNDATIONS

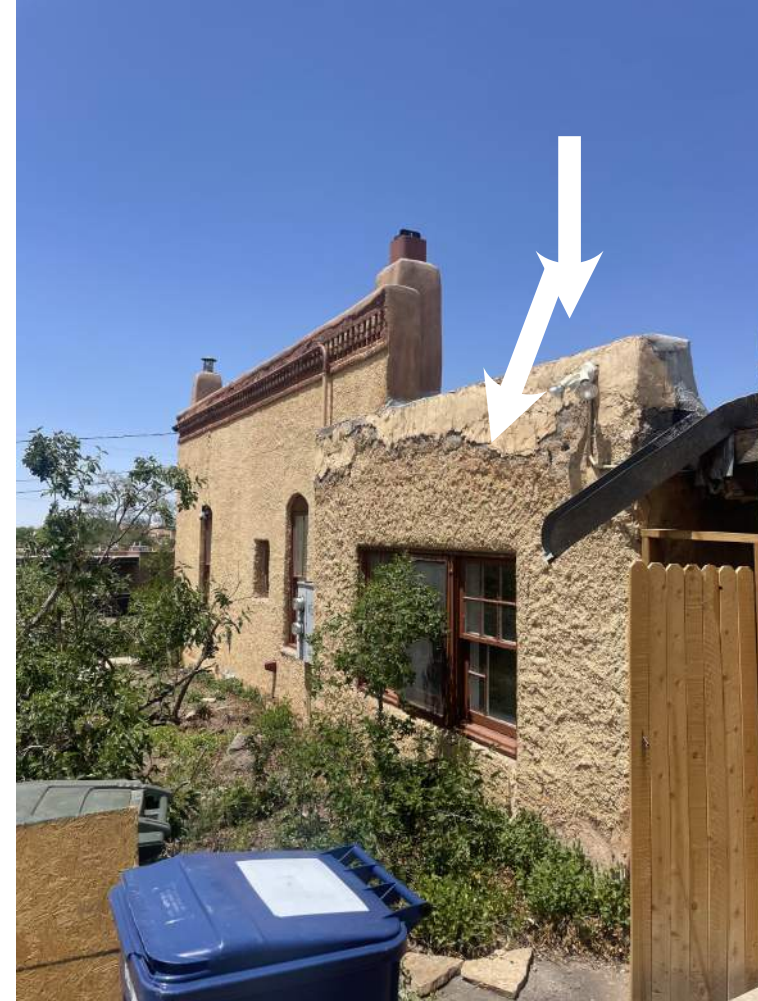
STUCCO DETERIORATION

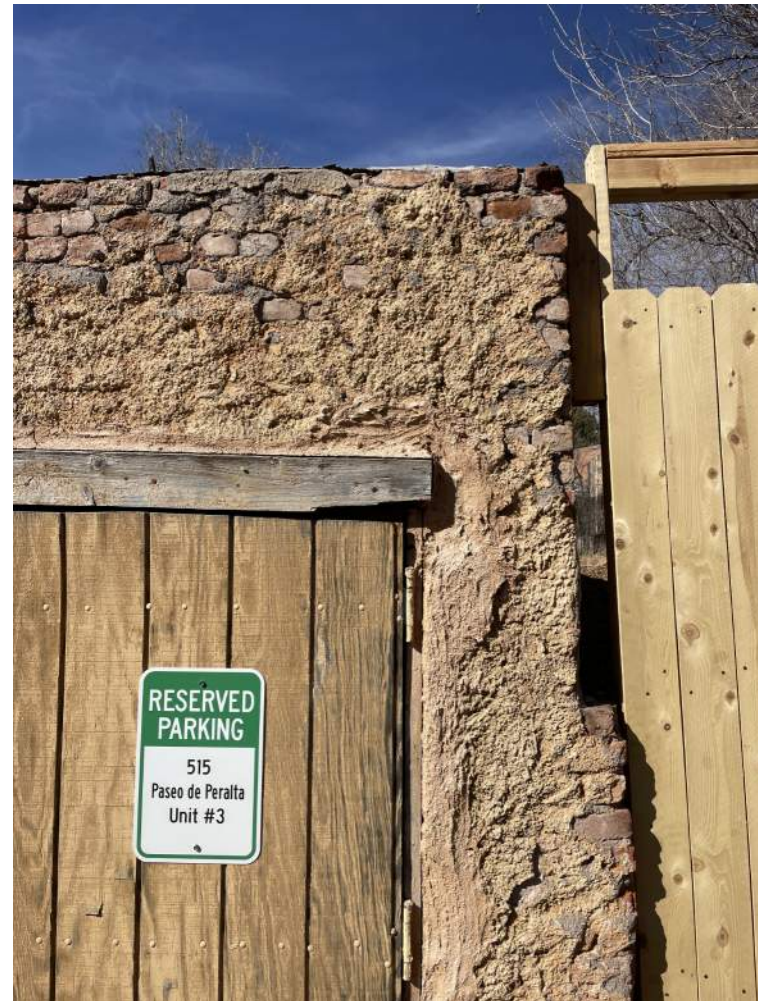
DETERIORATING BRICK

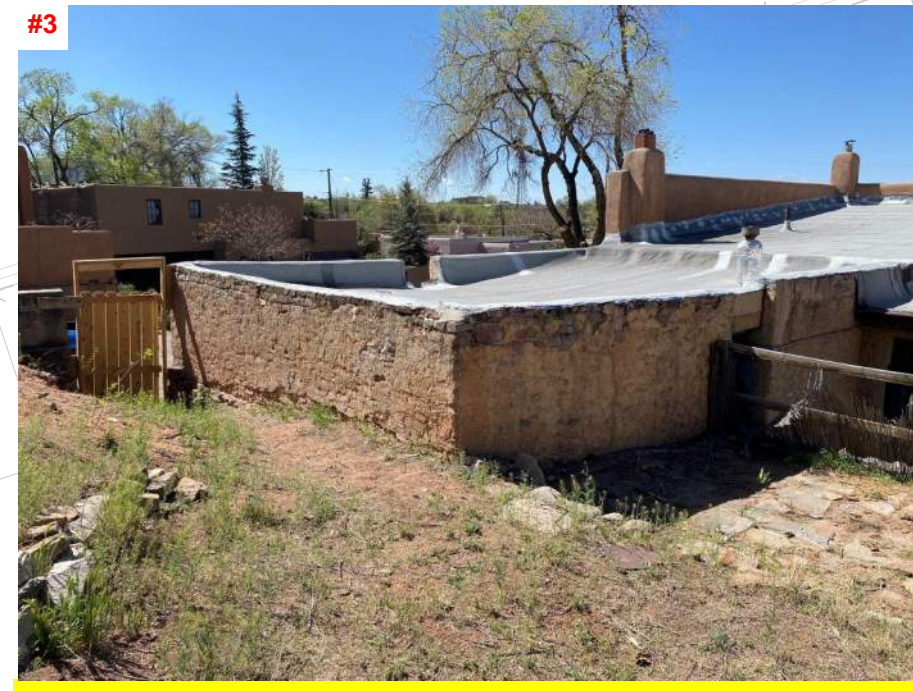
#3 RUBBLE RETAINING WALL, WATERPROOFING NOT PRESENT AND DETERIORATION PRESENTS ON EXTERIOR. THE WALL IS ALSO CONSTRUCTED WITH NON-STANDARD MASONRY MATERIAL AND PRACTICES

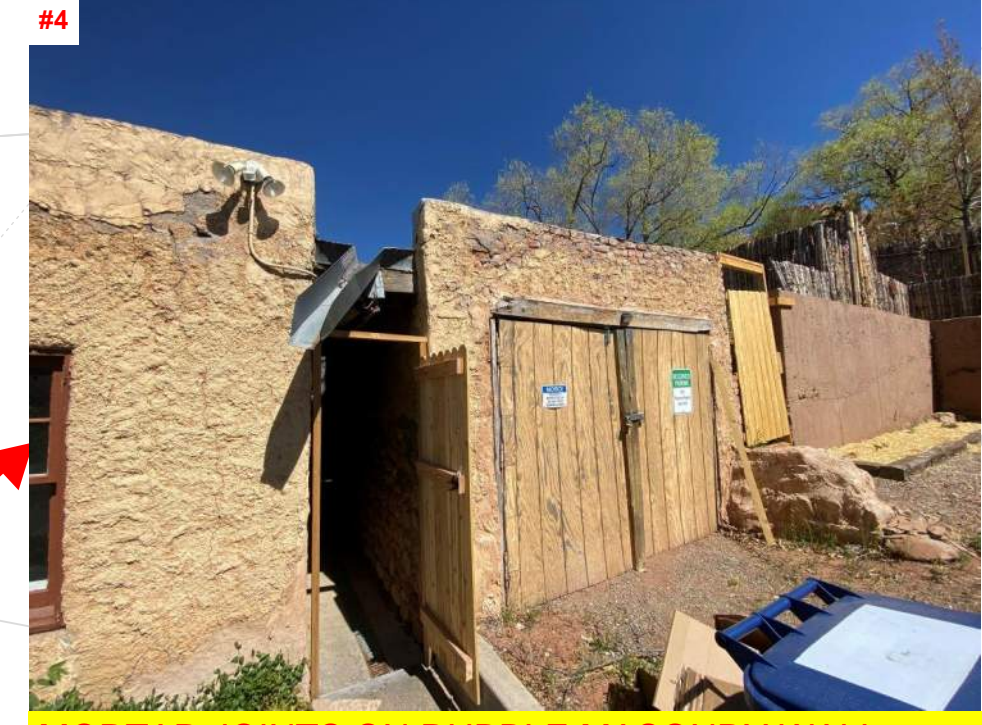
#4 MORTAR JOINTS ON RUBBLE MASONRY WALL HAVE DE-BONDED AND HAVE COMPROMISED THE WALLS STRUCTURAL INTEGRITY.

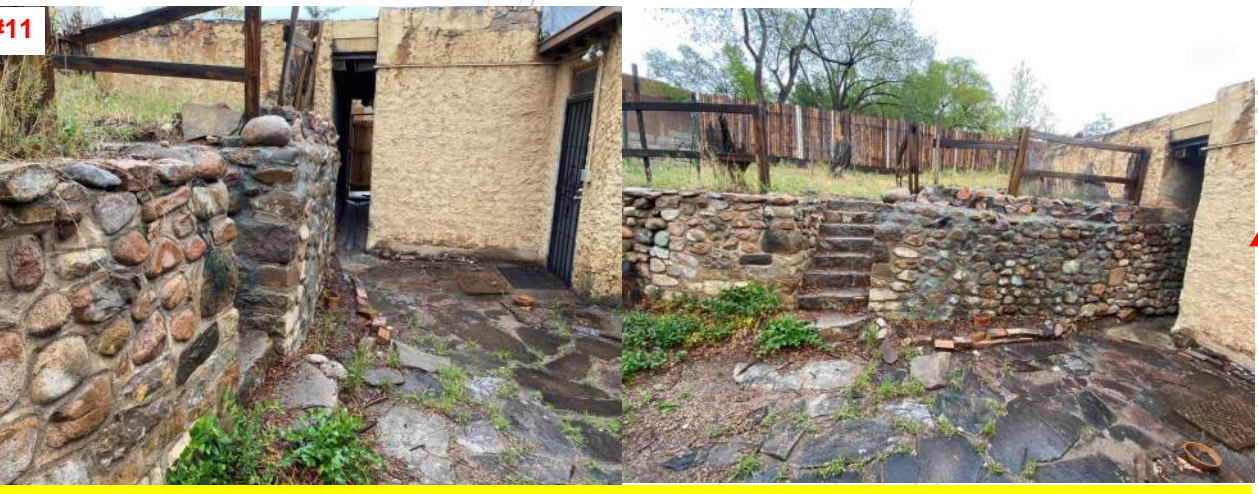
#11 CRACK EXTENDS THROUGH ENTIRE WALL SECTION, MASONRY COURSES HAVE DE-BONDED AND THE STRUCTURAL INTEGRITY OF THE WALL HAS BEEN COMPROMISED

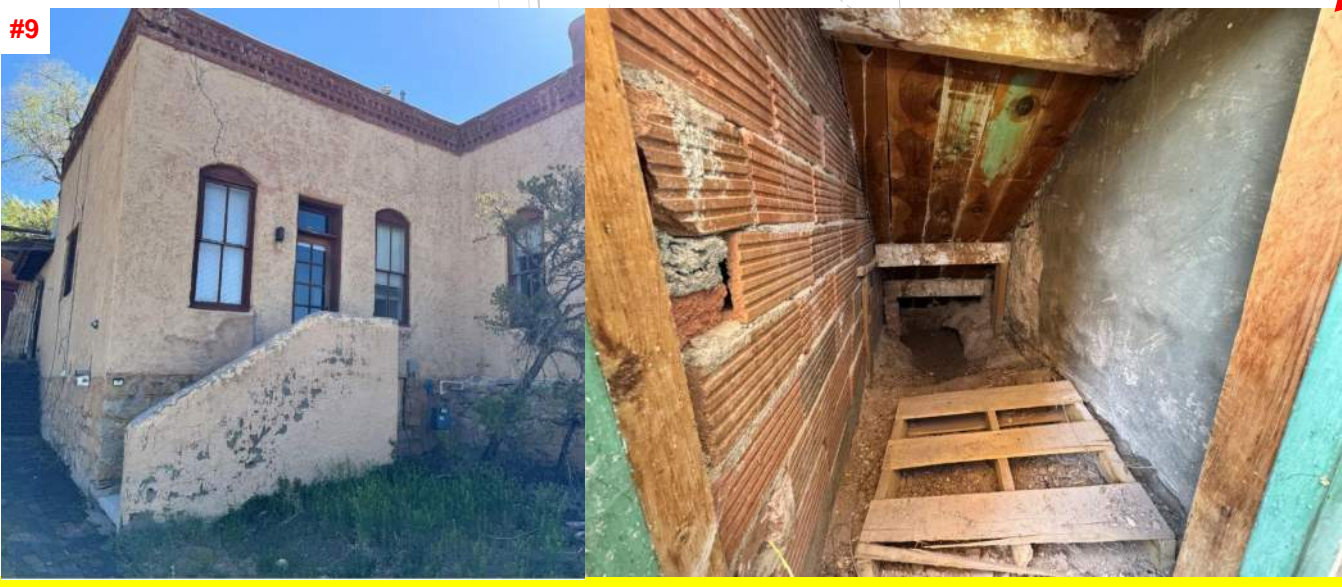
#9 PEN-TILE STAIR WALL AND WATER DAMAGE TO WOOD STAIR FRAMING, FUNGAL DECAY OF WOOD HAS BEGUN AND HAS COMPROMISED THE STRUCTURAL SECTION

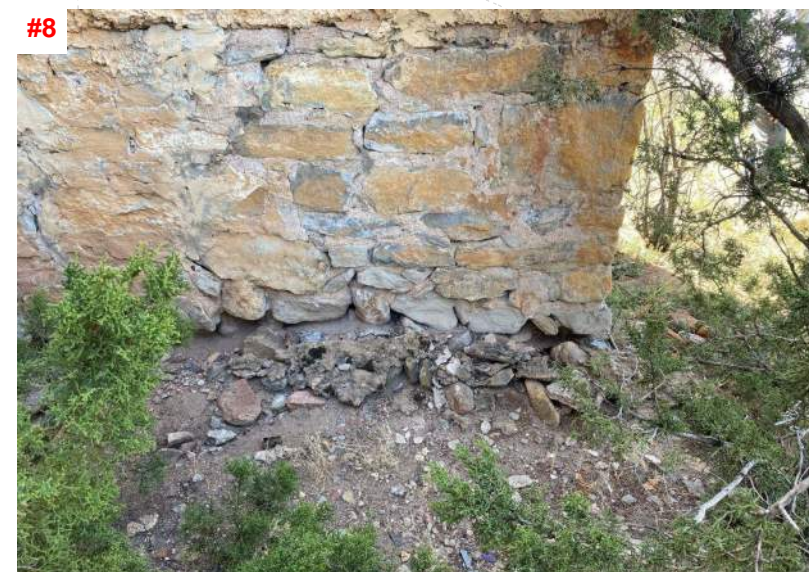
#8 DAMAGE TO RUBBLE FOUNDATION STEM WALL
