NEW MEXICO HISTORIC BUILDING INVENTORY - SANTA FE RESURVEY 1993

IDENTIFICATION	ADDRESS: <u>912 Don Gaspar</u>	ID NUMBER: <u>0516 00322</u>	
	UTM REFERENCE EASTING NORTHING ZONE <u>12 13</u>	LEGAL DESCRIPTION: TNSP <u>17</u> (N) S RANGE <u>9</u> (E) W SEC <u>25</u> NW 1/4 SE 1/4	BUILDING NAME: <u>Lynn House</u> SANTA FE ID NUMBER: <u>41842</u>
	FIELD MAP <u>Santa Fe Historic Structures Survey, 1983-85/1992</u> DATE OF CONSTRUCTION: <u>1893</u> by <u>owner</u> ESTIMATE <u>1930</u> ACTUAL SOURCE(S) <u>Sanborn map</u>

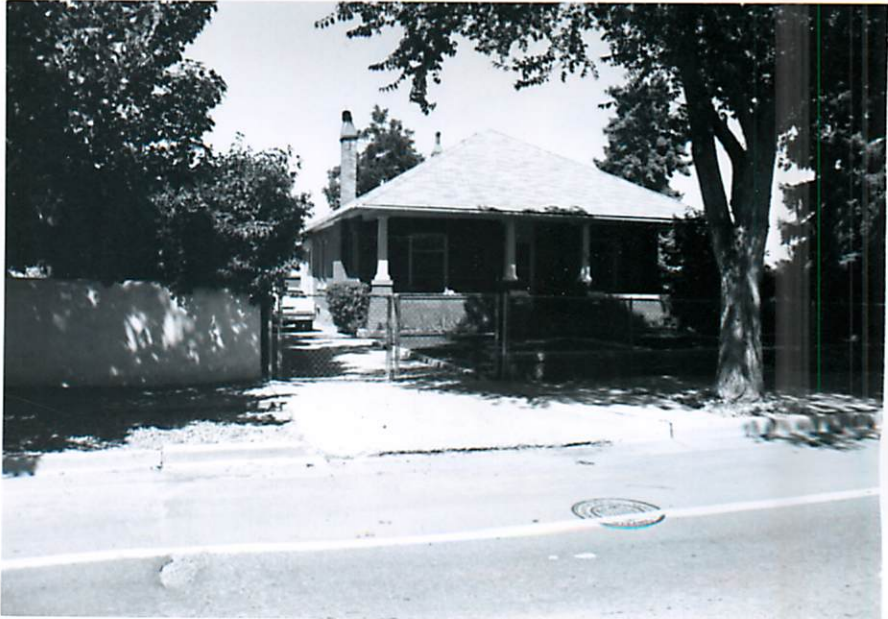
<p>#32 east elevation</p>	
ARCHITECTURAL STYLE: <u>Hipped Box</u>			
USE: HISTORIC: <u>residential</u> OTHER _____ PRESENT: <u>residential</u> OTHER _____			
SURROUNDINGS: <u>residential</u>			
BUILDING DATA	RELATIONSHIP TO HISTORIC SURROUNDINGS: <input checked="" type="checkbox"/> SIMILAR <input type="checkbox"/> NOT SIMILAR	SITE PLAN

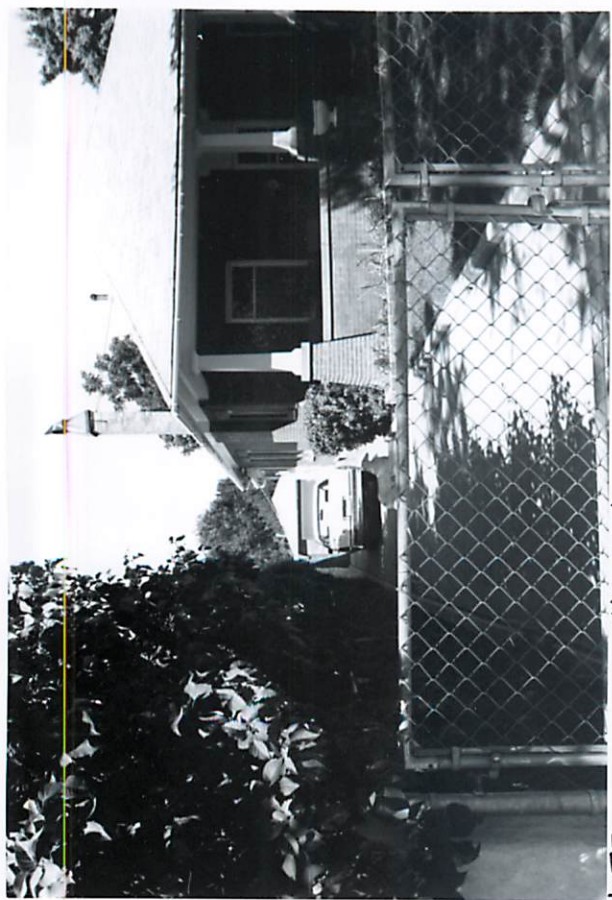
#33 southeast

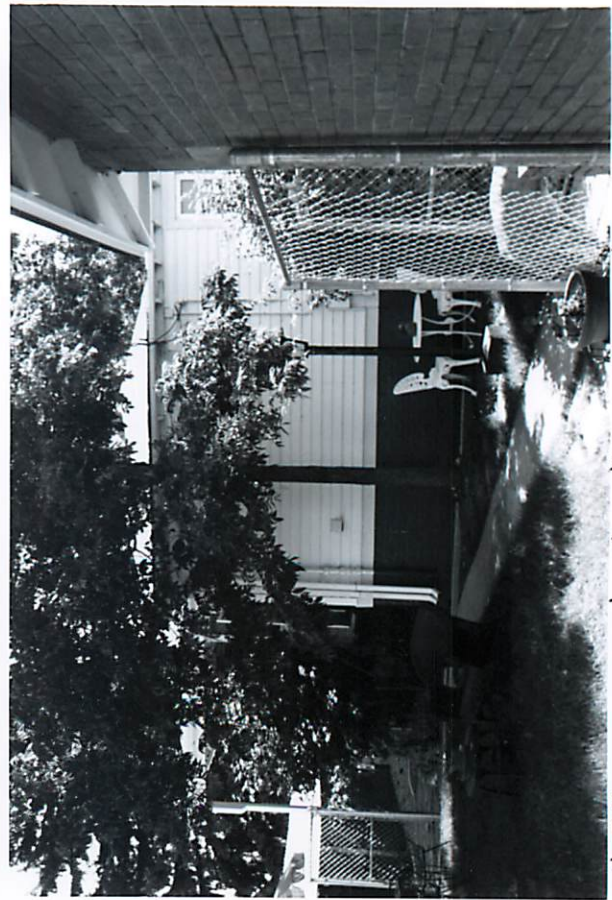
#34 west elevation, S end

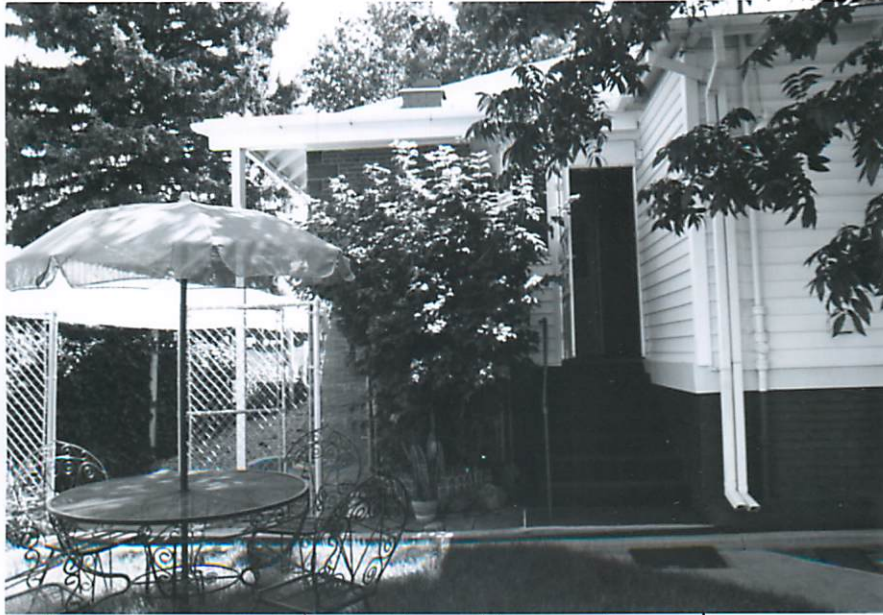
#35 west elevation, N end

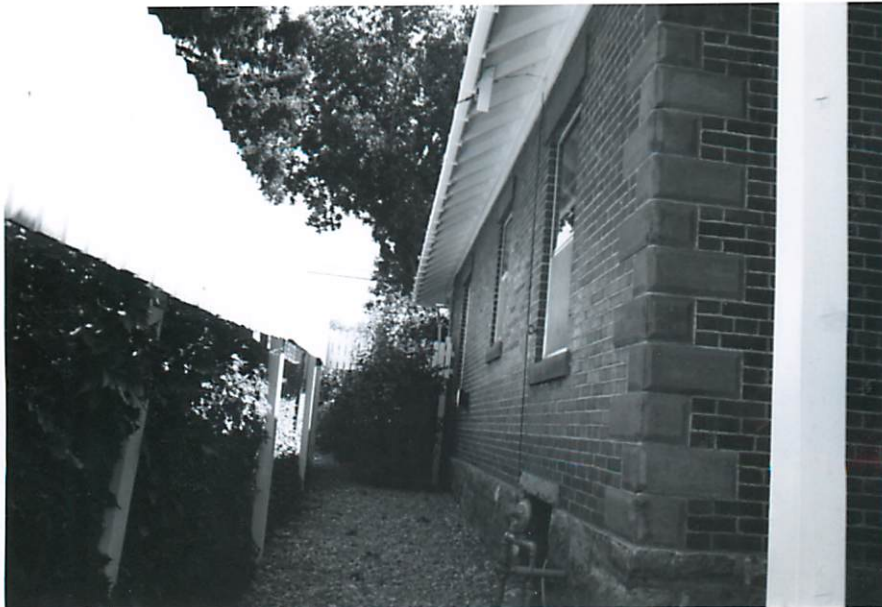
#36 north elevation
