City of Santa Fe, New Mexico

DATE: December 9, 2025
TO: Historic Districts Review Board Members
FROM: Heather Lamboy, Assistant Director, Planning & Land Use Department

2023-007595-HDRB. 402 Don Gaspar Ave. Downtown and Eastside Historic District. Contributing (office and garage buildings). Jennifer Jenkins, JenkinsGavin, Inc., agents for the State of New Mexico General Services Division, request demolition of the office building (previously a duplex) and garage. Exceptions are requested to Sections 14-5.2(M)(3)(b), Contributing, Significant and Landmark Buildings for consideration of the loss of Historic Status, and 14-5.2(M)(4) Demolition of Historic and Landmark Structures within the State Capital Outlay Projects section of the code.

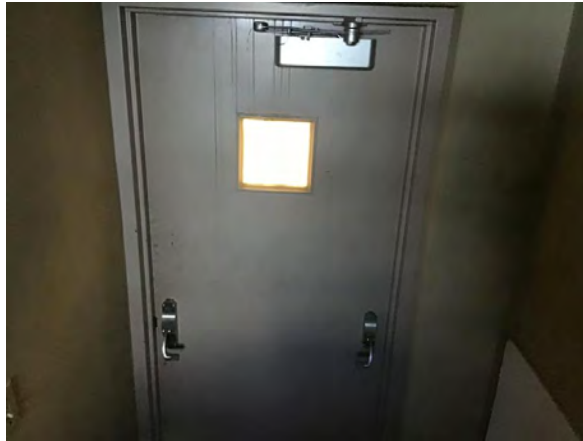
Facility: Concha Ortiz y Pino Building **IDNO:** 01-001-00018
Category: 2. **Type 1:** 05. **Type 2:** A01. **P/Class:** 1.

The crossbar is missing from the panic bar hardware in the stairwell leading to the roof access hatch.

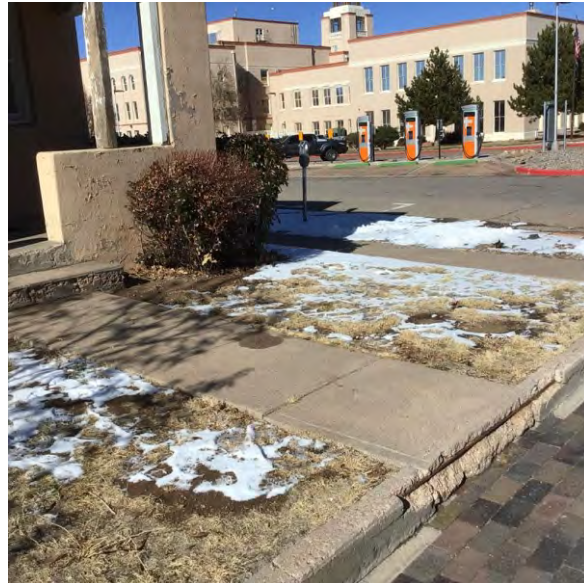
Facility: 402 Don Gaspar - Casita **IDNO:** 01-001-00019
Category: 3. **Type 1:** 06. **Type 2:** A03.1. **P/Class:** 3.

The concrete sidewalks are old, worn, weed infested, and have settled creating uneven walks that are not ADA compliant. No accessible curb cut is present. No accessible ramp leads to the building entrance.

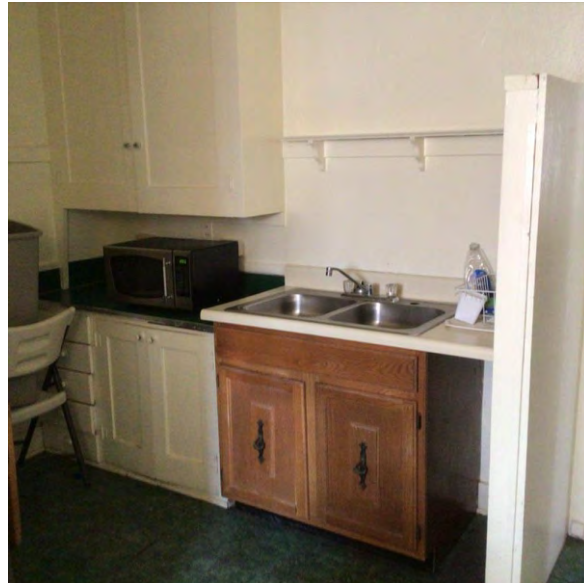
Facility: 402 Don Gaspar - Casita **IDNO:** 01-001-00019
Category: 3. **Type 1:** 05. **Type 2:** A03.3. **P/Class:** 3.

Offices and support rooms do not have ADA-required signage. A compliant drinking fountain is absent. The break room sink is not compliant. Vertical and horizontal grab bars are missing in the restrooms. The restroom sinks have uninsulated pipes. Several doors have knob-style hardware. The stairs and handrails in both basement stairways are not compliant. All doors within the Casita are 2'-8" or 2'-6" wide and are not ADA compliant.

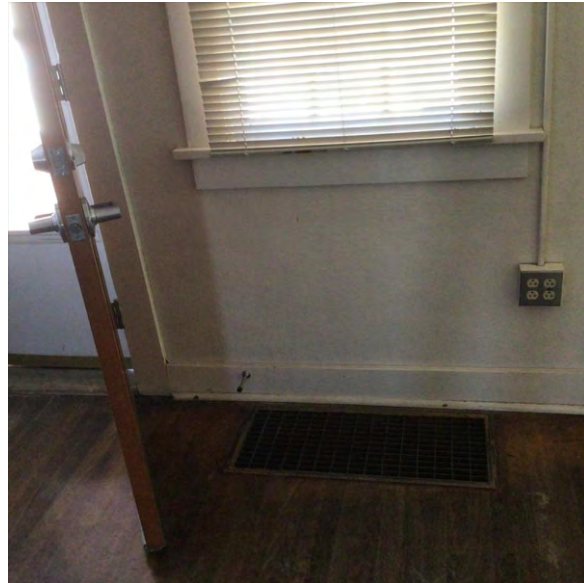
Facility: 402 Don Gaspar - Casita **IDNO:** 01-001-00019
Category: 4. **Type 1:** 05. **Type 2:** E01. **P/Class:** 3.

The wood flooring is worn. The VCT in the break room is dated and delaminating. Interior paint is scuffed and peeling. The lighting quality is poor. Blinds are in poor condition.

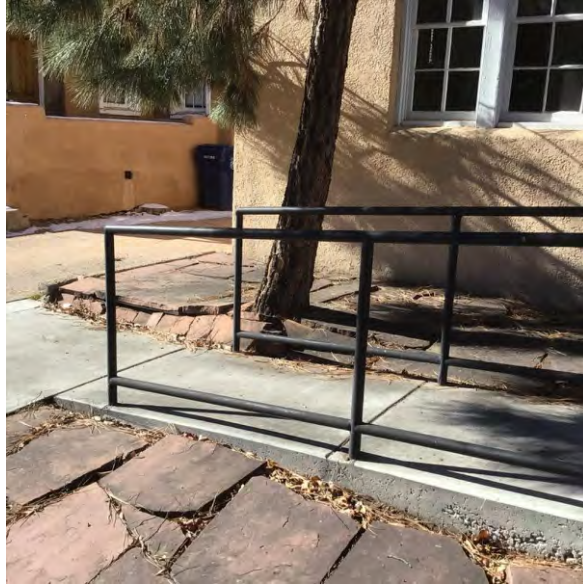
Facility: 406 Don Gaspar - Casita **IDNO:** 01-001-00020
Category: 3. **Type 1:** 06. **Type 2:** A03.1. **P/Class:** 3.

The sidewalks are old, worn, weed-infested, and have settled, creating uneven walks that are not ADA compliant. The ramp at the building entrance is noncompliant. The ramp does not provide a 5'x5' turnaround space, and the handrails are noncompliant.

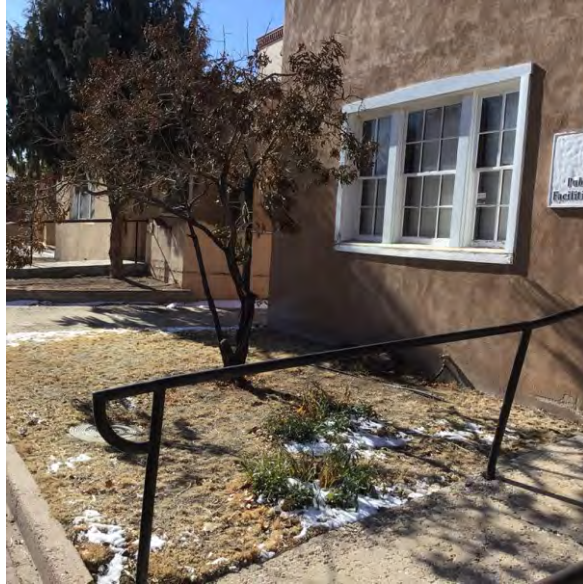
Facility: 410 Don Gaspar - Casita **IDNO:** 01-001-00014
Category: 4. **Type 1:** 06. **Type 2:** B03. **P/Class:** 3.

The sidewalks are old, worn, weed infested, and have settled creating uneven walks that are not ADA compliant. The accessible ramp does not have edge protection.

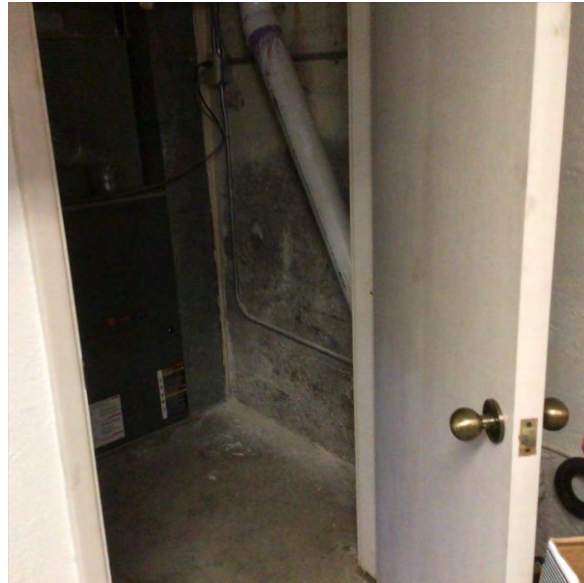
Facility: 410 Don Gaspar - Casita **IDNO:** 01-001-00014
Category: 2. **Type 1:** 13. **Type 2:** A02. **P/Class:** 2.

Because the building is 90 years old, hazardous materials may be present.

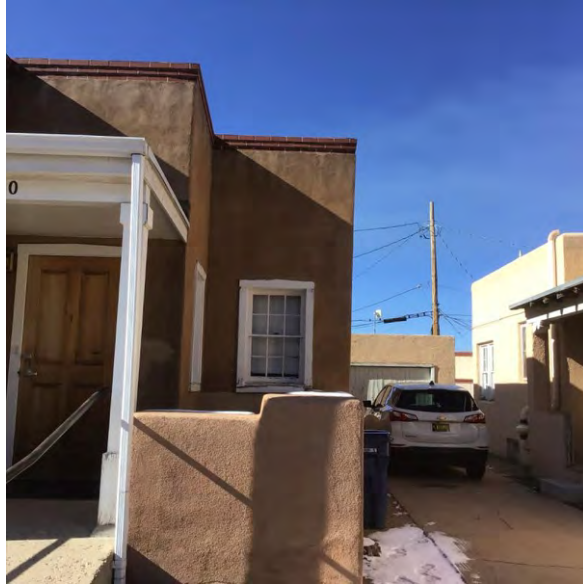
Facility: 410 Garage **IDNO:** 01-001-00007
Category: 4. **Type 1:** 05. **Type 2:** C02. **P/Class:** 3.

The garage door and the stucco on the garage are in poor condition. The concrete driveway is in poor condition.
