Long-range Strategic Space Master Plan

For Owned Buildings in the Santa Fe Area

Appendix B.3:

Facilities Condition Assessment Summary

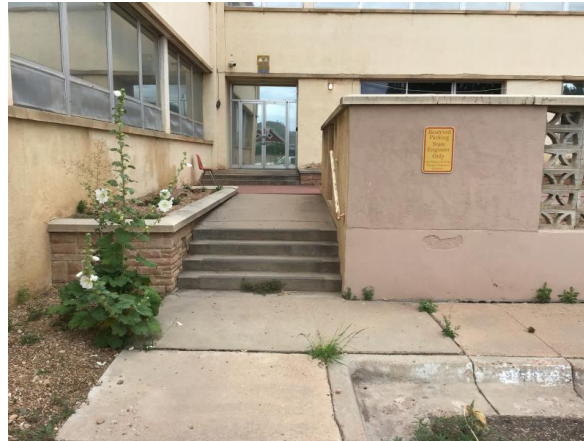
Project 01-001-00018.2001 · ADA Compliance - Site Improvements

Some of the sidewalks around the site are in poor condition. The walkways on the southeast and northeast are pitted and cracked concrete with uneven surfaces and lifted edges. Stairs connecting the west courtyard to the west parking lot do not have ADA-compliant stairs or an access ramp. The stairs exiting on the west are not ADA compliant. The ADA parking stall striping is faded, and none of the access aisles at the ADA parking area have compliant access to a sidewalk. The railing at the south entrance is not compliant.

Replace damaged concrete sidewalks. Install ADA-compliant stairs and a ramp in the courtyard. Install a handrail and replace the open treads at the west building exit. Install handrail extensions and edge protection at the south entrance. Provide compliant access to the sidewalk from access aisles and re-stripe accessible stalls.

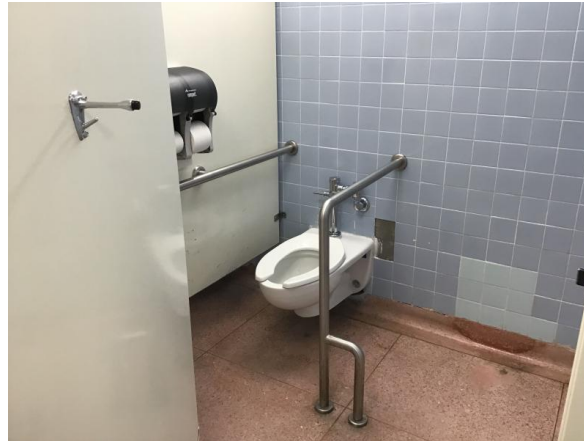
Project 01-001-00018.2002 · ADA Compliance - Restroom Renovations

The building has no ADA-compliant, multi-stall restrooms. A single-stall restroom in the basement is the only ADA-compliant restroom in the building. The restroom doors on the second floor are too narrow to be compliant. The wall and floor finishes in all multi-stall restrooms are in poor condition with cracked and missing tiles, the terrazzo flooring is in fair condition with some unsightly patched areas. The ceramic tile walls still have visible holes from previous mounting locations of the restroom accessories. The tile counter tops have cracked or missing tiles, the lavatories have compliant faucet hardware but lack water waste line pipe insulation. The partition walls in the restrooms are in poor condition with oxidation at mounting locations and gouges on the surfaces. The restroom stalls have grab bars installed; however, the grab bars are not ADA compliant and lack vertical grab bars. The restrooms also lack the proper clear floor space to accommodate an ADA compliant stall. To achieve proper clear floor space the restrooms will require reconfiguration.

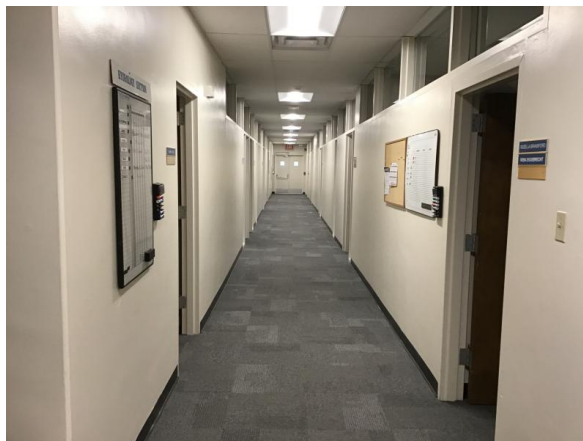
Project 01-001-00018.2003 · ADA Compliance - Tactile and Braille Signage

The buildings lacks ADA-compliant tactile and Braille signage.

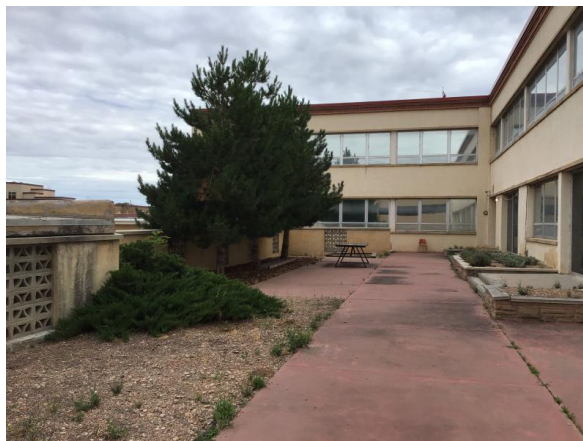
Project 01-001-00018.2004 · Site Improvements - Landscape

A landscaped and paved courtyard along the east side of the building is in poor condition.

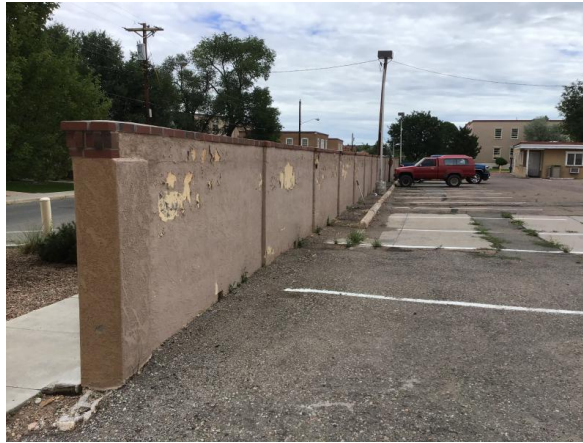
Project 01-001-00018.2005 · Site Improvements - Stucco Wall

The site has a concrete masonry unit (CMU) wall with stucco finish along Galisteo Street. The wall is structurally sound. However, the stucco finish is sun bleached, cracking, and peeling.

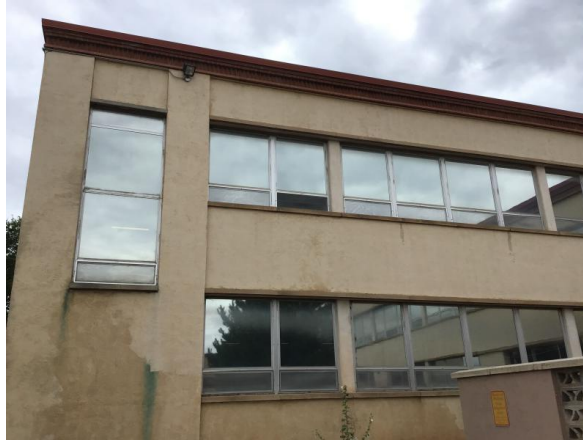
Project 01-001-00018.2006 · Exterior Improvements

The exterior walls are masonry with a stucco finish. The stucco is sun bleached with spalling around windows and at the base of the building. Paint covers several areas due to graffiti. The exterior doors and windows have aluminum frames and single glazing. The windows have fixed panes with a small screened operable window below. The windows are not energy efficient.

Replace all single-pane glass windows, and doors with thermally-broken doors and windows, with insulated glass units. Repair the stucco and color coat the building.

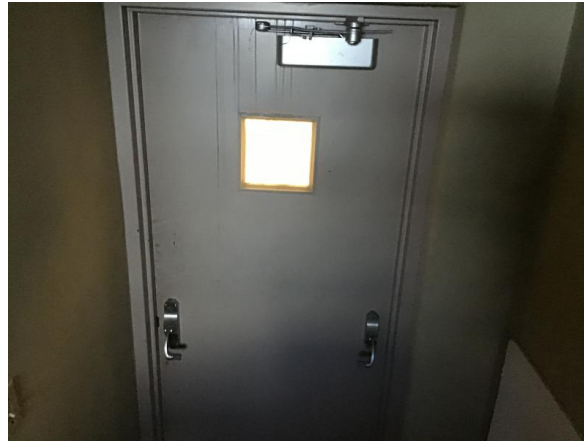
Project 01-001-00018.2007 · Interior Improvements - Door Hardware

The crossbar is missing from the panic bar hardware in the stairwell leading to the roof access hatch.

Replace panic bar hardware.

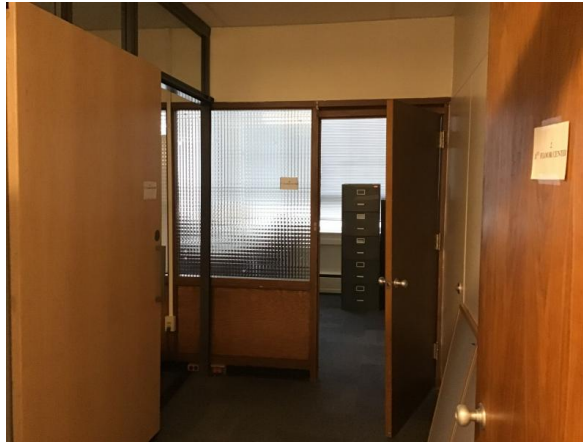
Project 01-001-00018.2008 · Interior Renovation

The building has a combination of traditional and open office spaces. Many of the first-floor offices are small and awkward due to the subdivision of larger areas into smaller individual offices. Various wall systems and finish materials create an incongruous hodgepodge of office spaces. The second floor is more cohesive regarding materials and finishes, but offices are small and cramped. Office furniture impedes clear pathways. The basement finishes are old and past their usable life span. The rooms in the basement are randomly furnished and finished.

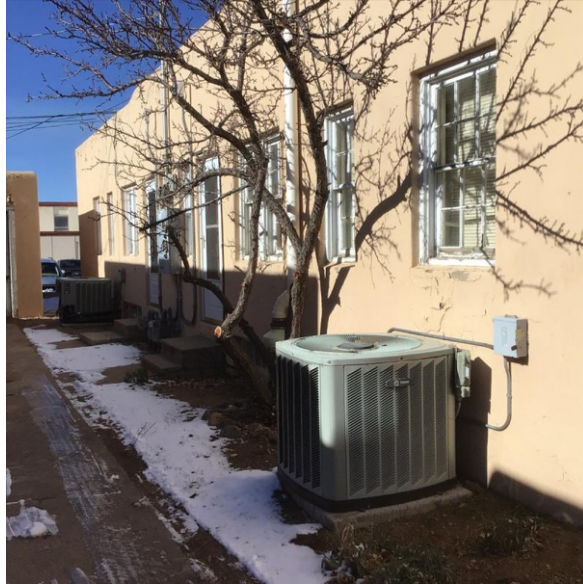
Project 01-001-00019.2001 · Landscaping Upgrades

The landscaping is neglected. Trees and bushes are not pruned.

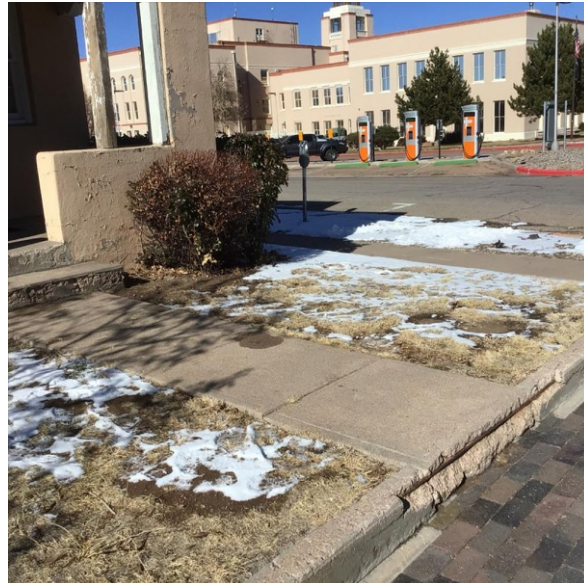
Project 01-001-00019.2002 · ADA Compliance: Site Improvements

The concrete sidewalks are old, worn, weed infested, and have settled creating uneven walks that are not ADA compliant. No accessible curb cut is present. No accessible ramp leads to the building entrance.

Replace old sidewalks. Install a curb cut ramp. Install an accessible ramp leading to the building entrance.

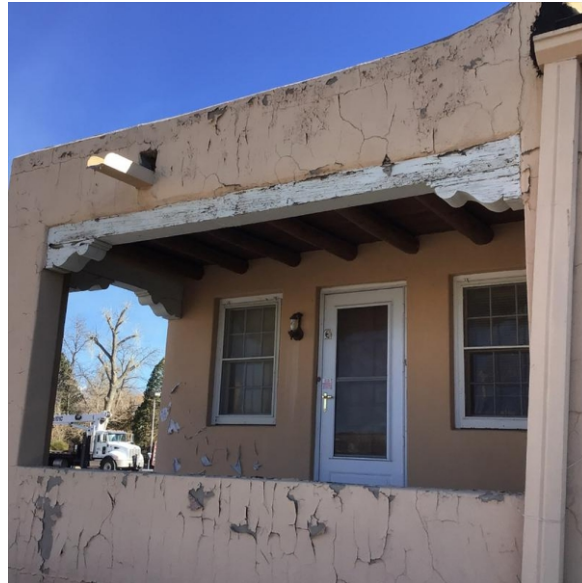
Project 01-001-00019.2003 · Exterior Building Improvements

Stucco and paint are cracking and peeling. The building's windows are single pane, broken, and painted shut. The exterior doors are in disrepair. Exterior lighting is inadequate. A building sign is absent.

Replace windows with double-paned insulated glass. Replace exterior doors. Re-stucco the building. Replace rotted vigas, latillas, corbels, lintels, and miscellaneous woodwork at portals in the front and back of the Casita. Install exterior lighting and building sign.

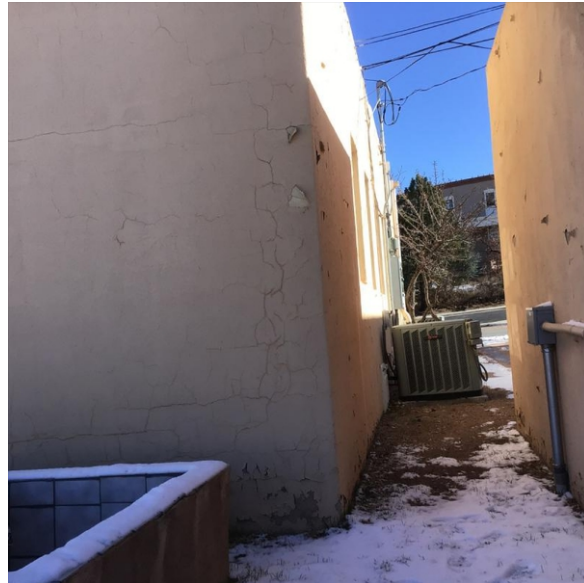
Project 01-001-00019.2004 · Security Upgrades

The building has no security alarm or surveillance system.

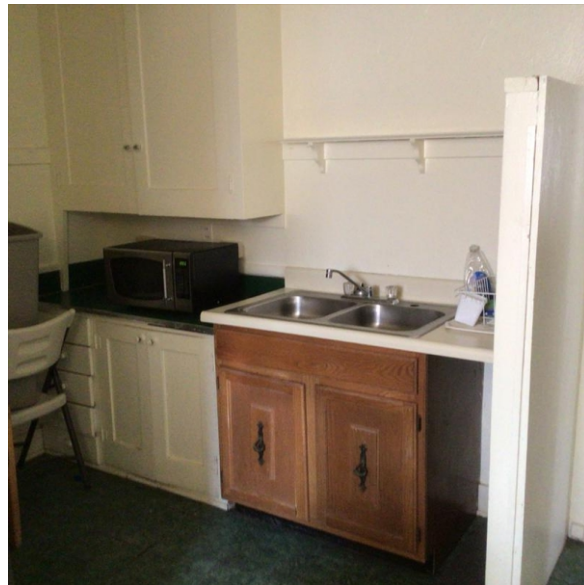
Project 01-001-00019.2005 · ADA Compliance: Interior

Offices and support rooms do not have ADA-required signage. A compliant drinking fountain is absent. The break room sink is not compliant. Vertical and horizontal grab bars are missing in the restrooms. The restroom sinks have uninsulated pipes. Several doors have knob-style hardware. The stairs and handrails in both basement stairways are not compliant. All doors within the Casita are 2'-8" or 2'-6" wide and are not ADA compliant.

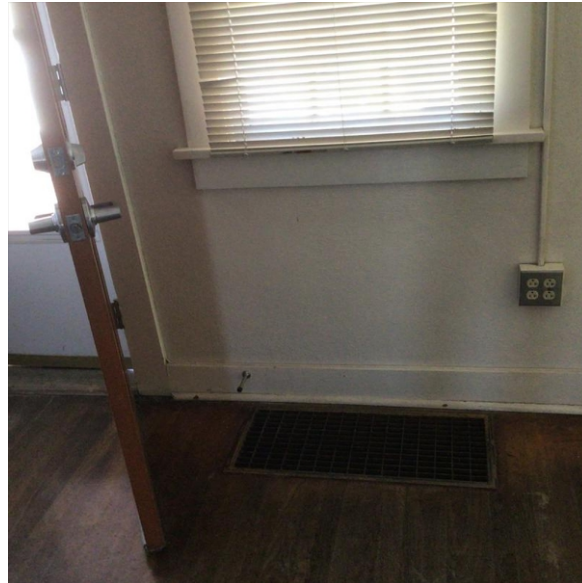
Project 01-001-00019.2006 · Interior Refurbishment

The wood flooring is worn. The VCT in the break room is dated and delaminating. Interior paint is scuffed and peeling. The lighting quality is poor. Blinds are in poor condition.

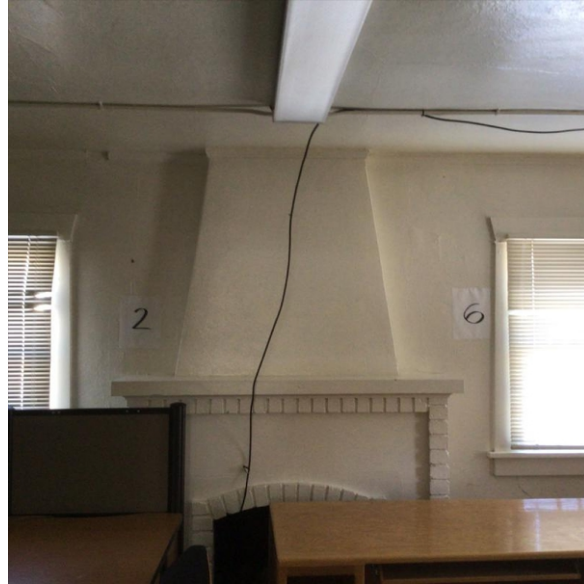
Project 01-001-00019.2007 · Hazardous Materials

Because the building is 90 years old, hazardous materials may be present.

Commission a hazardous materials study.

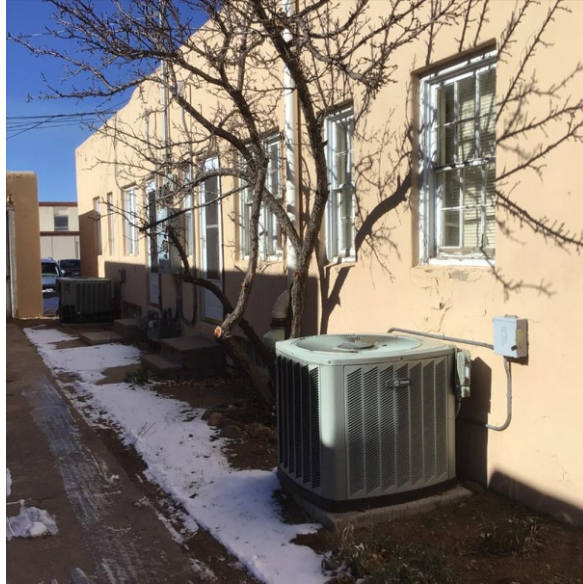
Project 01-001-00020.2001 · Landscaping Upgrades

The landscaping and flagstone are neglected. Trees and bushes are not pruned.

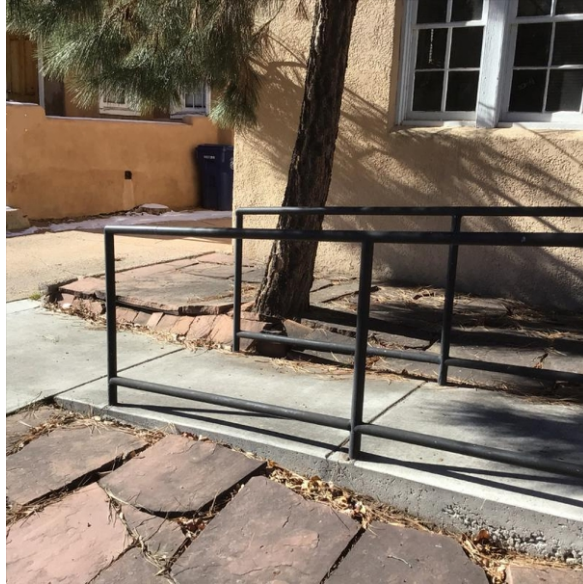
Project 01-001-00020.2002 · ADA Compliance: Site Work

The sidewalks are old, worn, weed-infested, and have settled, creating uneven walks that are not ADA compliant. The ramp at the building entrance is noncompliant. The ramp does not provide a 5'x5' turnaround space, and the handrails are noncompliant.

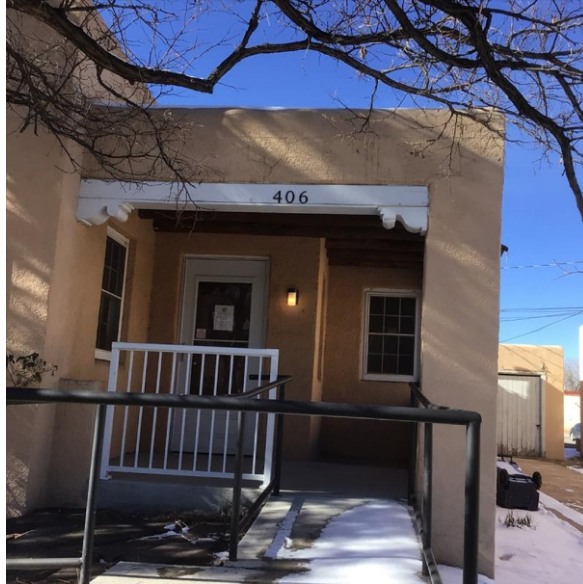
Project 01-001-00020.2003 · Exterior Building Improvements

Stucco and paint are cracking. The building's windows are single pane, broken, and painted shut. The exterior doors are in disrepair.

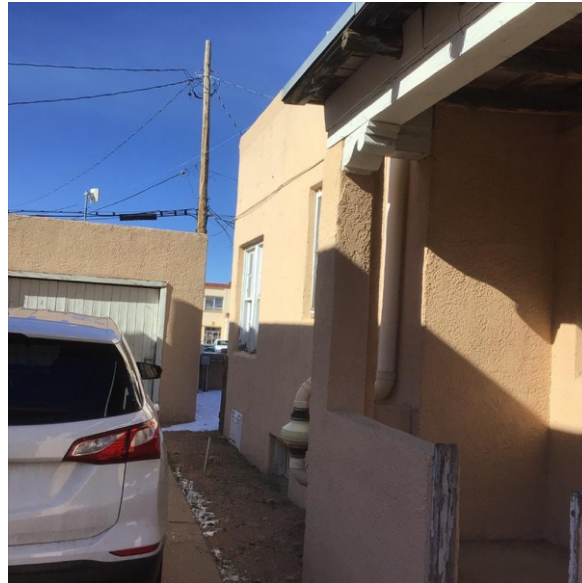
Project 01-001-00020.2004 · Security Upgrades

There is no security alarm or cameras in the building.

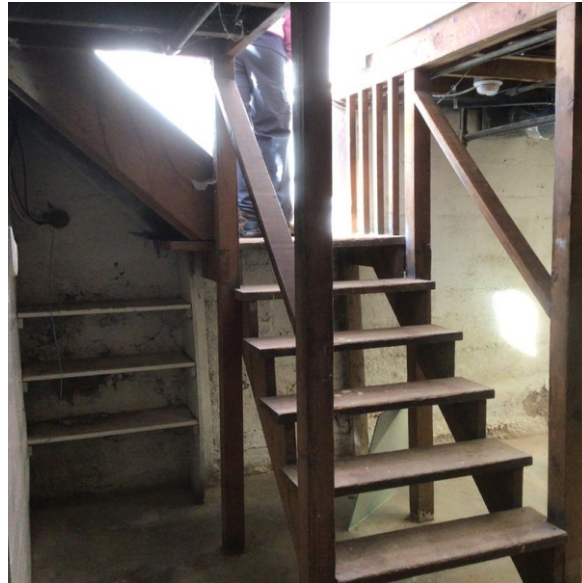
Project 01-001-00020.2005 · ADA Compliance: Interior

Offices and support rooms do not have ADA required signage. A compliant drinking fountain is absent. The break room and restroom sinks are not compliant. Vertical and horizontal bars are missing in the restroom. Stairs and handrails in the basement stairway are not compliant. All doors within the Casita are 2'-8" wide and are not ADA compliant. Knob-style hardware hangs on all doors.

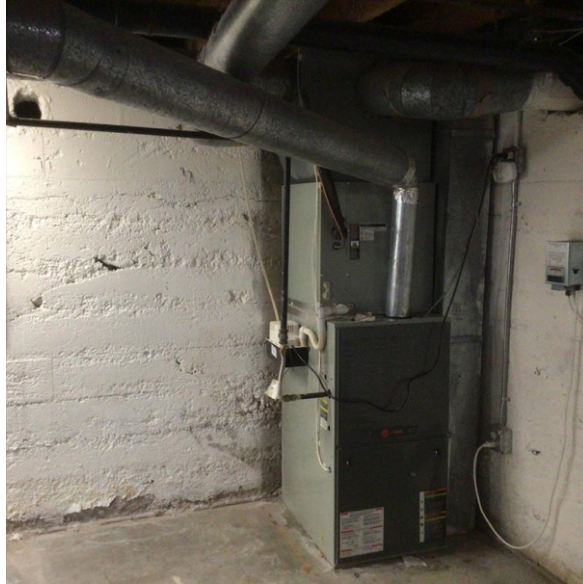
Project 01-001-00020.2006 · Hazardous Materials Study

Because the building is 90 years old, hazardous materials may be present.

Commission a hazardous materials study.

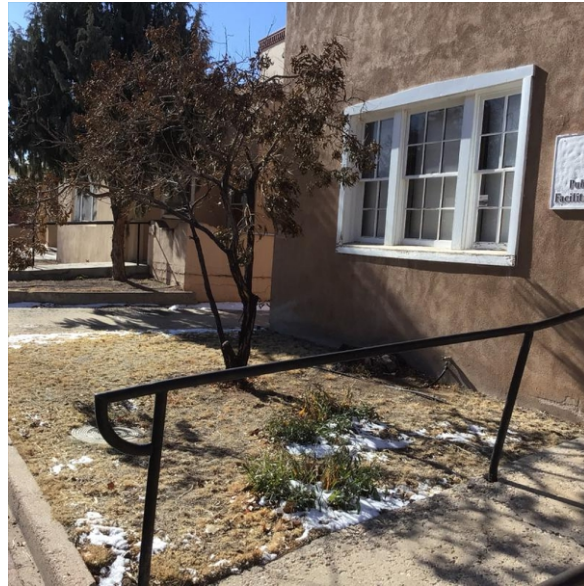
Project 01-001-00014.2002 · ADA Compliance: Site Work

The sidewalks are old, worn, weed infested, and have settled creating uneven walks that are not ADA compliant. The accessible ramp does not have edge protection.

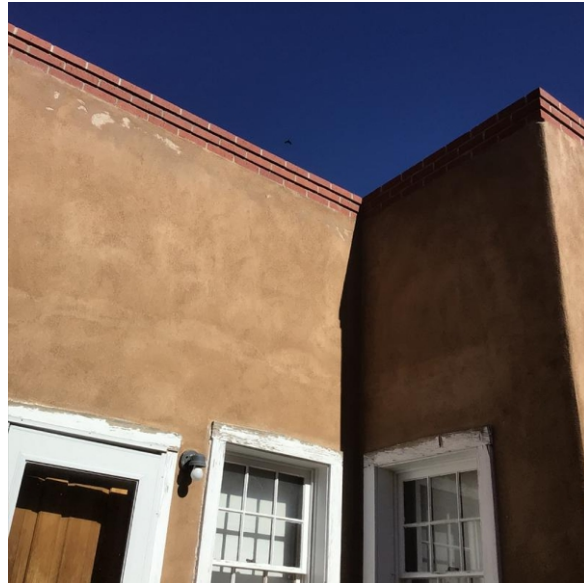
Project 01-001-00014.2003 · Exterior Building Improvements

The windows are single pane, broken, and painted shut. The stucco and paint are cracking and peeling. The building lacks exterior wall-mounted light fixtures.

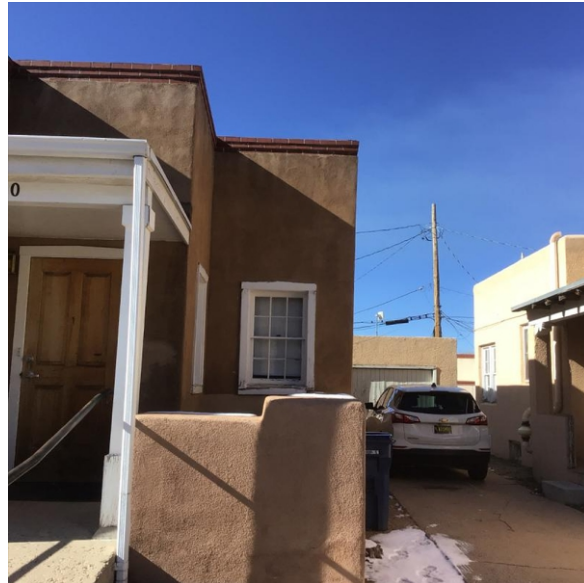
Project 01-001-00014.2004 · Security Upgrades

The building has no security alarm or surveillance system.

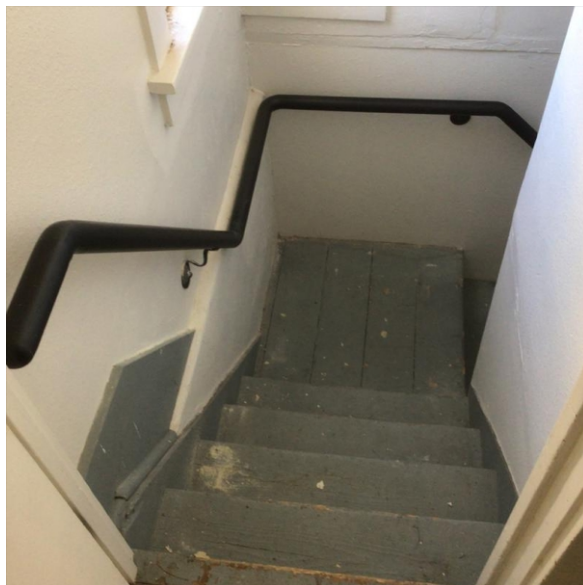
Project 01-001-00014.2005 · ADA Compliance: Interior

Offices and support rooms do not have ADA-required signage. A compliant drinking fountain is absent. The break room sink is not compliant. Vertical and horizontal bars are missing in the restroom. Insulation is missing from the restroom sink. Stairs and handrails leading to the basement are not compliant. All doors within the Casita are 2'-8" or 2'-6" wide and are not ADA compliant.

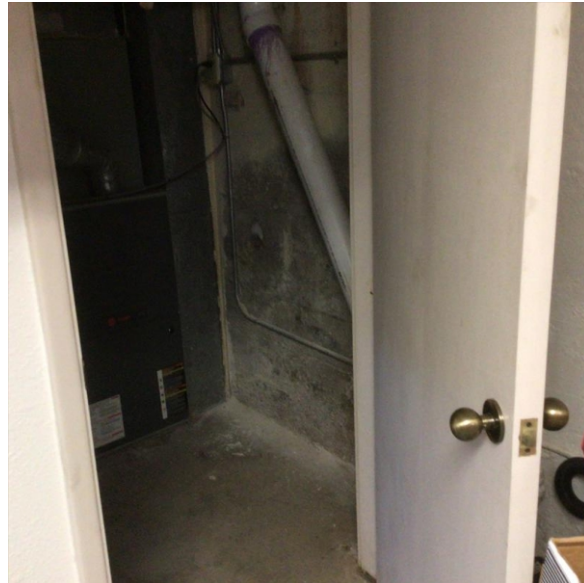
Project 01-001-00014.2006 · Hazardous Materials Study

Because the building is 90 years old, hazardous materials may be present.

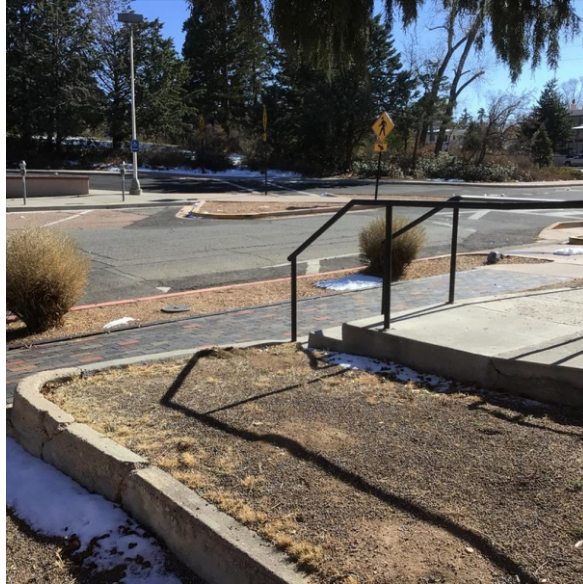
The sidewalks are old, worn, weed-infested, and have settled, creating uneven walks that are not ADA compliant. The ramp at the building entrance is noncompliant. The ramp does not provide a 5' x 5' turn around space in two locations, handrails are noncompliant, and edge protection is absent.

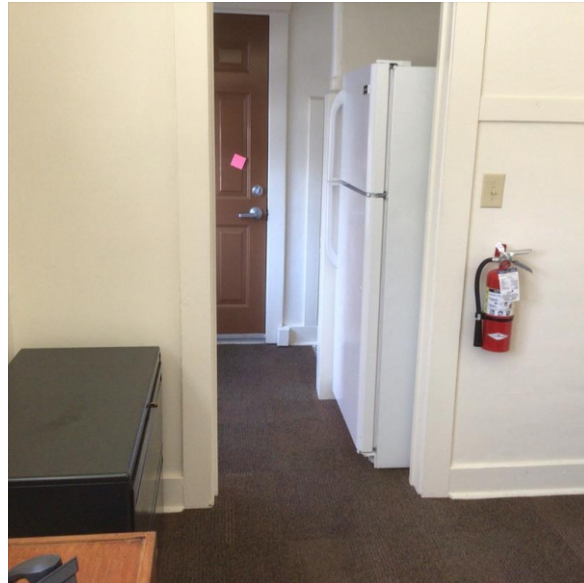
Because the building is 90 years old, hazardous materials may be present. Commission a hazardous materials study.
