# City of Santa Fe, New Mexico

# memo

**2023-007597-HDRB. 410 Don Gaspar Ave.** Downtown and Eastside Historic District. Contributing (office and garage buildings). Jennifer Jenkins, JenkinsGavin, Inc., agents for the State of New Mexico General Services Division, request demolition of the of the office building (previously a residence) and garage. Exceptions are requested to Sections 14-5.2(M)(3)(b), Contributing, Significant and Landmark Buildings for consideration of the loss of Historic Status, and 14-5.2(M)(4) Demolition of Historic and Landmark Structures within the State Capital Outlay Projects section of the code.

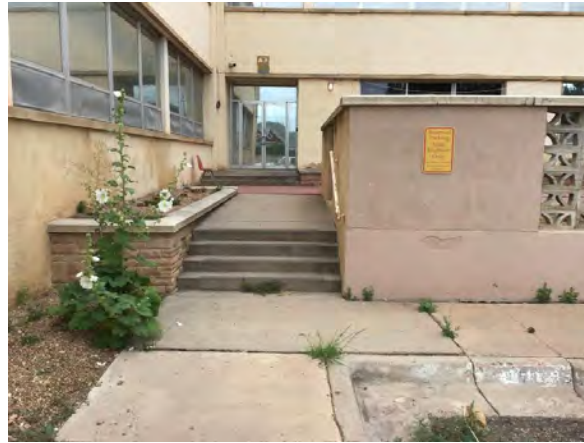
**Facility:** Concha Ortiz y Pino Building    **IDNO:** 01-001-00018  
**Category:** 3.    **Type 1:** 06.    **Type 2:** A03.1.    **P/Class:** 2.

Some of the sidewalks around the site are in poor condition. The walkways on the southeast and northeast are pitted and cracked concrete with uneven surfaces and lifted edges. Stairs connecting the west courtyard to the west parking lot do not have ADA-compliant stairs or an access ramp. The stairs exiting on the west are not ADA compliant. The ADA parking stall striping is faded, and none of the access aisles at the ADA parking area have compliant access to a sidewalk. The railing at the south entrance is not compliant.

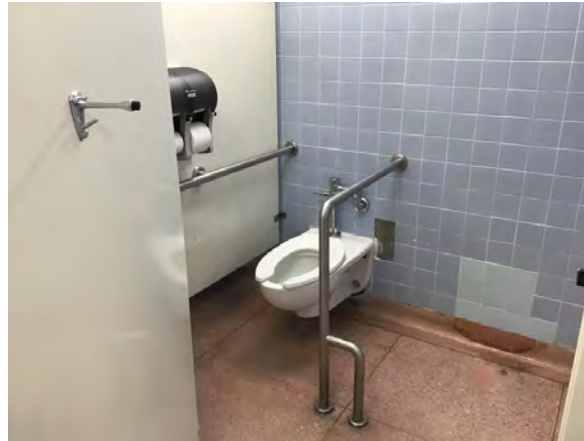
**Facility:** Concha Ortiz y Pino Building    **IDNO:** 01-001-00018  
**Category:** 3.    **Type 1:** 04.    **Type 2:** A03.2.    **P/Class:** 2.

The building has no ADA-compliant, multi-stall restrooms. A single-stall restroom in the basement is the only ADA-compliant restroom in the building. The restroom doors on the second floor are too narrow to be compliant. The wall and floor finishes in all multi-stall restrooms are in poor condition with cracked and missing tiles, the terrazzo flooring is in fair condition with some unsightly patched areas. The ceramic tile walls still have visible holes from previous mounting locations of the restroom accessories. The tile counter tops have cracked or missing tiles, the lavatories have compliant faucet hardware but lack water waste line pipe insulation. The partition walls in the restrooms are in poor condition with oxidation at mounting locations and gouges on the surfaces. The restroom stalls have grab bars installed; however, the grab bars are not ADA compliant and lack vertical grab bars. The restrooms also lack the proper clear floor space to accommodate an ADA compliant stall. To achieve proper clear floor space the restrooms will require reconfiguration.

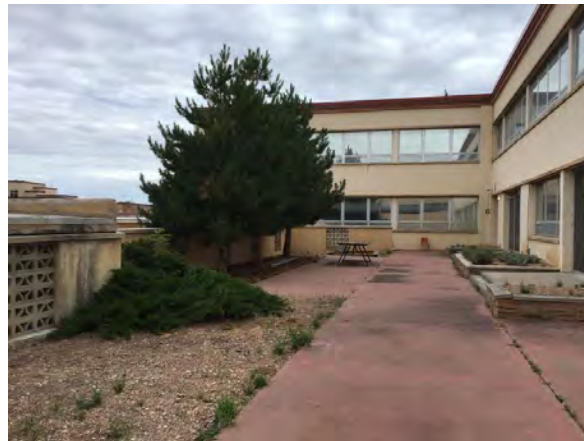
**Facility:** Concha Ortiz y Pino Building **IDNO:** 01-001-00018  
**Category:** 4. **Type 1:** 06. **Type 2:** B02. **P/Class:** 3.

A landscaped and paved courtyard along the east side of the building is in poor condition.

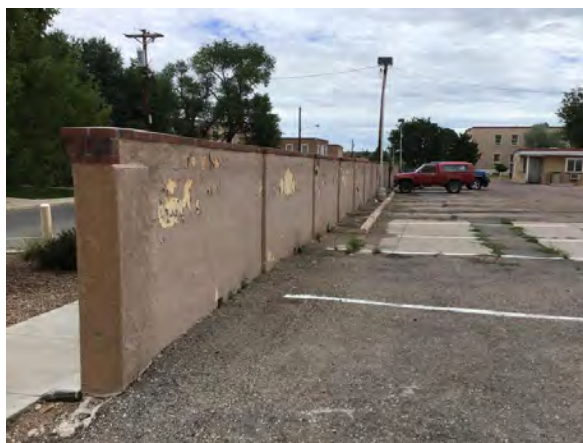
**Category:** 4. **Type 1:** 06. **Type 2:** B04. **P/Class:** 3.

The site has a concrete masonry unit (CMU) wall with stucco finish along Galisteo Street. The wall is structurally sound. However, the stucco finish is sun bleached, cracking, and peeling.

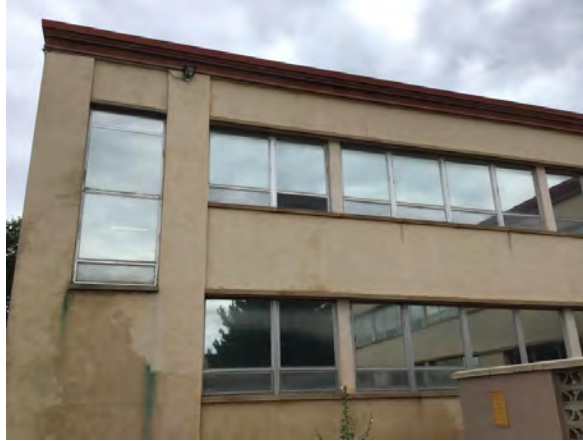
**Facility:** Concha Ortiz y Pino Building    **IDNO:** 01-001-00018  
**Category:** 10.   **Type 1:** 05.   **Type 2:** C01.   **P/Class:** 3.

The exterior walls are masonry with a stucco finish. The stucco is sun bleached with spalling around windows and at the base of the building. Paint covers several areas due to graffiti. The exterior doors and windows have aluminum frames and single glazing. The windows have fixed panes with a small screened operable window below. The windows are not energy efficient.

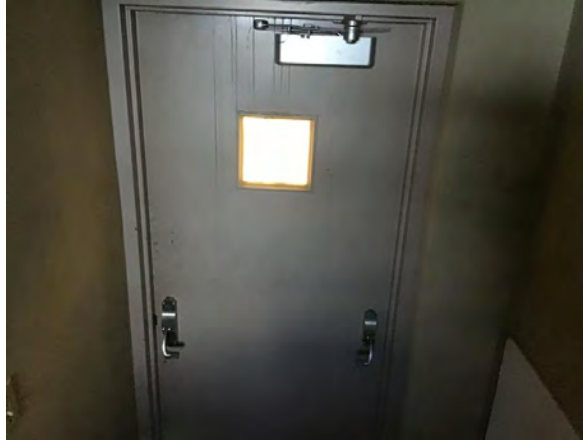
**Facility:** Concha Ortiz y Pino Building **IDNO:** 01-001-00018  
**Category:** 2. **Type 1:** 05. **Type 2:** A01. **P/Class:** 1.

The crossbar is missing from the panic bar hardware in the stairwell leading to the roof access hatch.

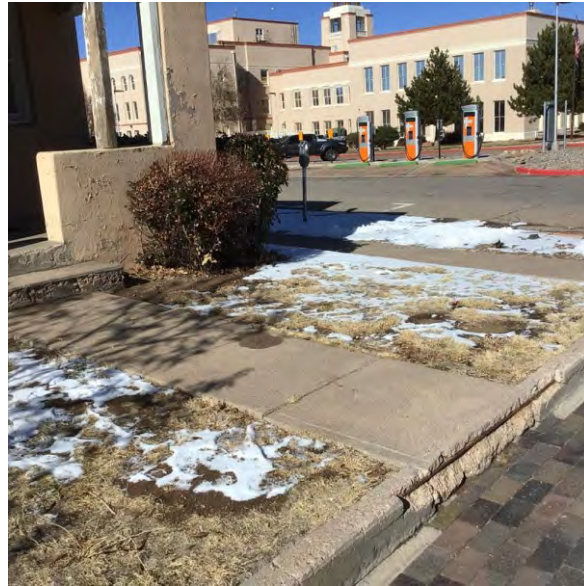
Facility: 402 Don Gaspar - Casita IDNO: 01-001-00019  
 Category: 3. Type 1: 06. Type 2: A03.1. P/Class: 3.

The concrete sidewalks are old, worn, weed infested, and have settled creating uneven walks that are not ADA compliant. No accessible curb cut is present. No accessible ramp leads to the building entrance.

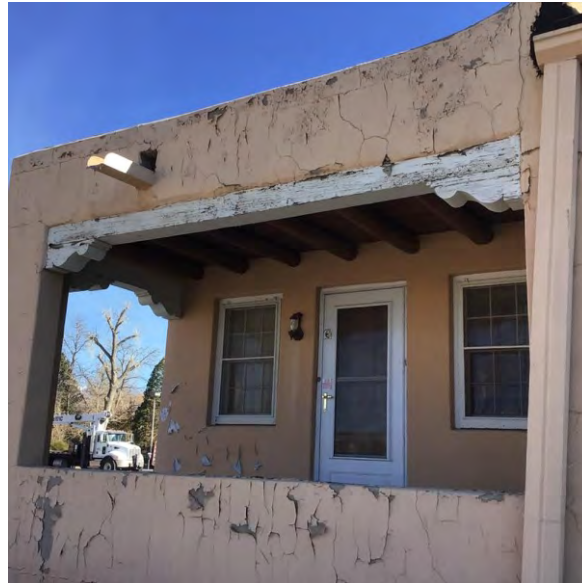
**Facility:** 402 Don Gaspar - Casita      **IDNO:** 01-001-00019  
**Category:** 4. **Type 1:** 05. **Type 2:** C03. **P/Class:** 3.

Stucco and paint are cracking and peeling. The building's windows are single pane, broken, and painted shut. The exterior doors are in disrepair. Exterior lighting is inadequate. A building sign is absent.

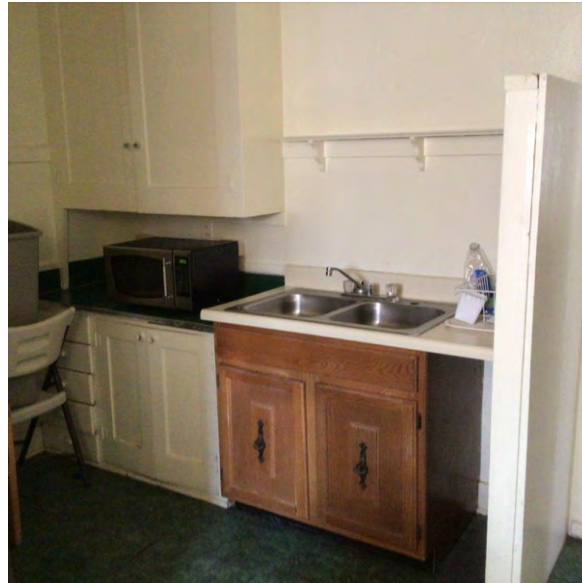
**Facility:** 402 Don Gaspar - Casita      **IDNO:** 01-001-00019  
**Category:** 3. **Type 1:** 05. **Type 2:** A03.3. **P/Class:** 3.

Offices and support rooms do not have ADA-required signage. A compliant drinking fountain is absent. The break room sink is not compliant. Vertical and horizontal grab bars are missing in the restrooms. The restroom sinks have uninsulated pipes. Several doors have knob-style hardware. The stairs and handrails in both basement stairways are not compliant. All doors within the Casita are 2'-8" or 2'-6" wide and are not ADA compliant.

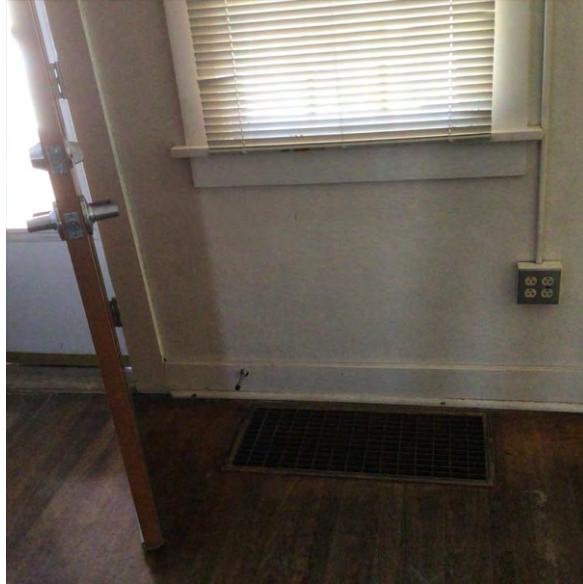
**Facility:** 402 Don Gaspar - Casita      **IDNO:** 01-001-00019  
**Category:** 4. **Type 1:** 05. **Type 2:** E01. **P/Class:** 3.

The wood flooring is worn. The VCT in the break room is dated and delaminating. Interior paint is scuffed and peeling. The lighting quality is poor. Blinds are in poor condition.

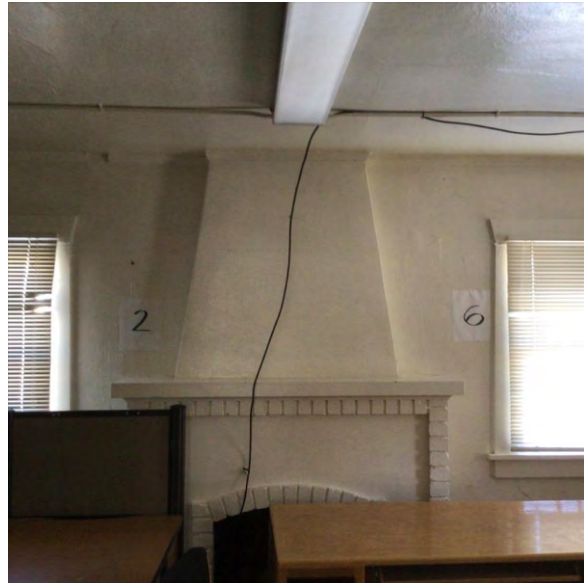
**Facility:** 402 Don Gaspar - Casita      **IDNO:** 01-001-00019  
**Category:** 4. **Type 1:** 13. **Type 2:** A02. **P/Class:** 2.

Because the building is 90 years old, hazardous materials may be present.

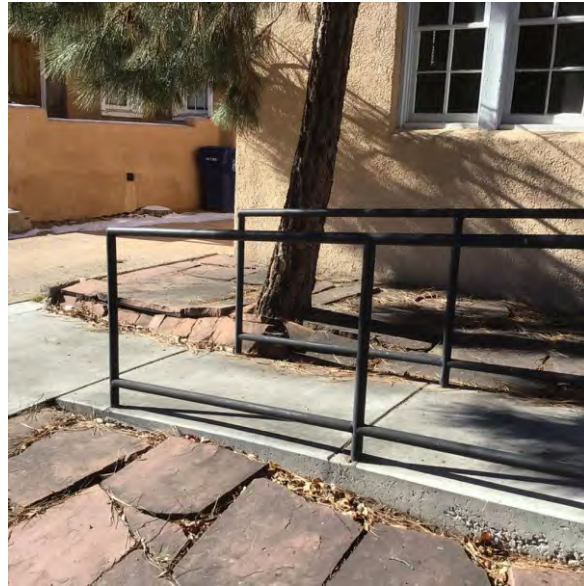
**Facility:** 406 Don Gaspar - Casita      **IDNO:** 01-001-00020  
**Category:** 3. **Type 1:** 06. **Type 2:** A03.1. **P/Class:** 3.

The sidewalks are old, worn, weed-infested, and have settled, creating uneven walks that are not ADA compliant. The ramp at the building entrance is noncompliant. The ramp does not provide a 5'x5' turnaround space, and the handrails are noncompliant.

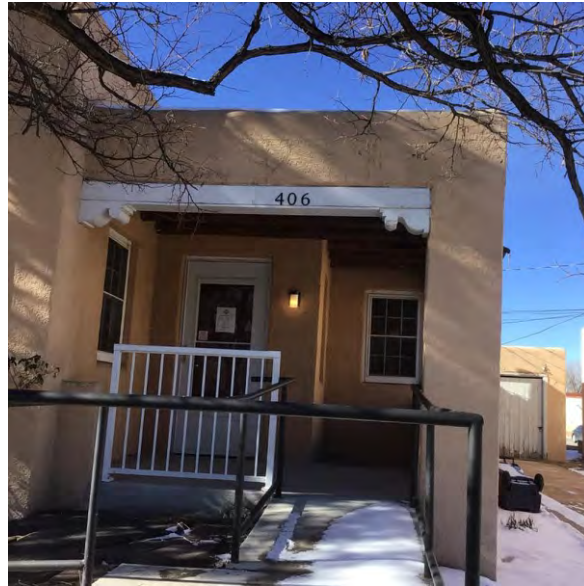
**Facility:** 406 Don Gaspar - Casita      **IDNO:** 01-001-00020  
**Category:** 4. **Type 1:** 05. **Type 2:** C03. **P/Class:** 3.

Stucco and paint are cracking. The building's windows are single pane, broken, and painted shut. The exterior doors are in disrepair.

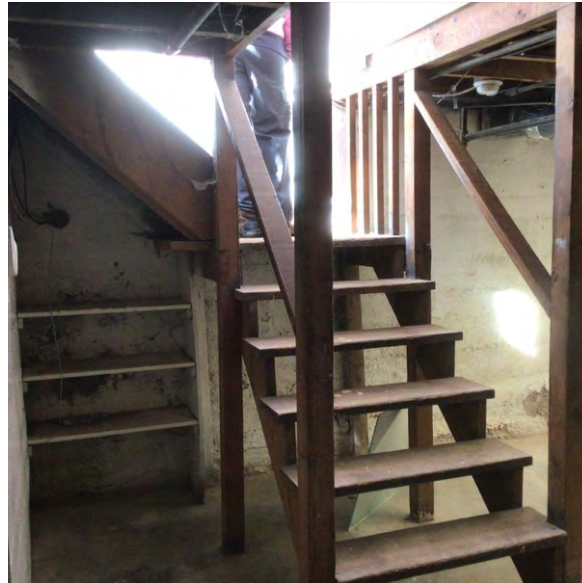
**Facility:** 406 Don Gaspar - Casita      **IDNO:** 01-001-00020  
**Category:** 3. **Type 1:** 05. **Type 2:** A03.3. **P/Class:** 3.

Offices and support rooms do not have ADA required signage. A compliant drinking fountain is absent. The break room and restroom sinks are not compliant. Vertical and horizontal bars are missing in the restroom. Stairs and handrails in the basement stairway are not compliant. All doors within the Casita are 2'-8" wide and are not ADA compliant. Knob-style hardware hangs on all doors.

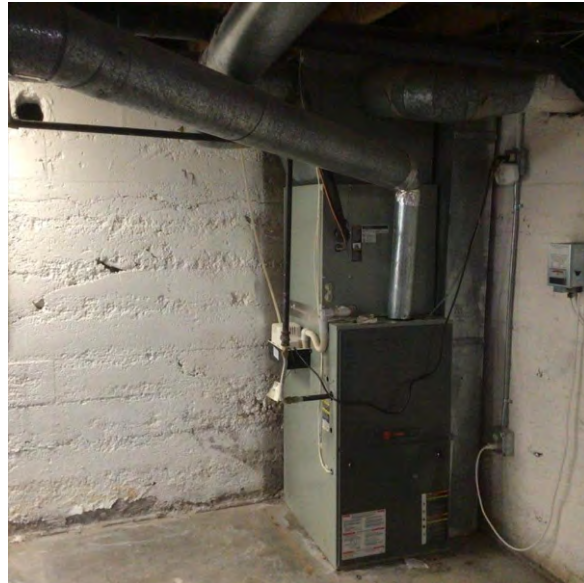
**Facility:** 406 Don Gaspar - Casita      **IDNO:** 01-001-00020  
**Category:** 2. **Type 1:** 13. **Type 2:** A02. **P/Class:** 2.

Because the building is 90 years old, hazardous materials may be present.

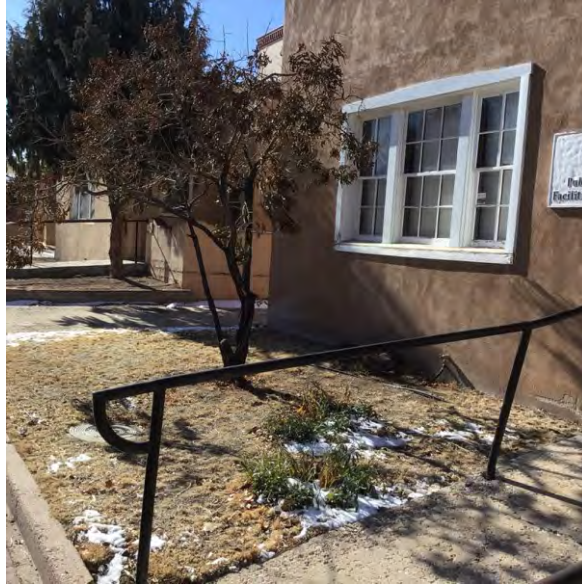
**Facility:** 410 Don Gaspar - Casita      **IDNO:** 01-001-00014  
**Category:** 4. **Type 1:** 06. **Type 2:** B03. **P/Class:** 3.

The sidewalks are old, worn, weed infested, and have settled creating uneven walks that are not ADA compliant. The accessible ramp does not have edge protection.

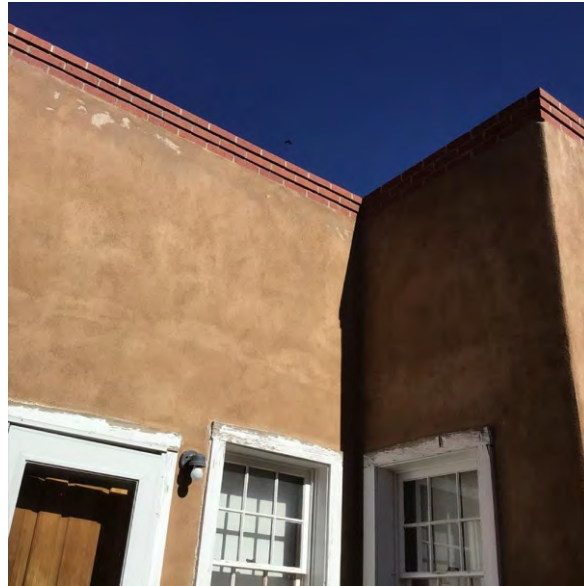
**Facility:** 410 Don Gaspar - Casita      **IDNO:** 01-001-00014  
**Category:** 4. **Type 1:** 05. **Type 2:** C03. **P/Class:** 3.

The windows are single pane, broken, and painted shut. The stucco and paint are cracking and peeling. The building lacks exterior wall-mounted light fixtures.
