RPA & Associates, LLC.

JOB	DATE
119 CAMINO SANTIAGO, SANTA FE, NM 87501	08/11/2025

RPA & ASSOCIATES, LLC | WINDOW & DOOR CONDITION AND INTEGRITY CODES

RPA & ASSOCIATES, LLC | 119 CAMINO SANTIAGO, SANTA FE, NM 87501

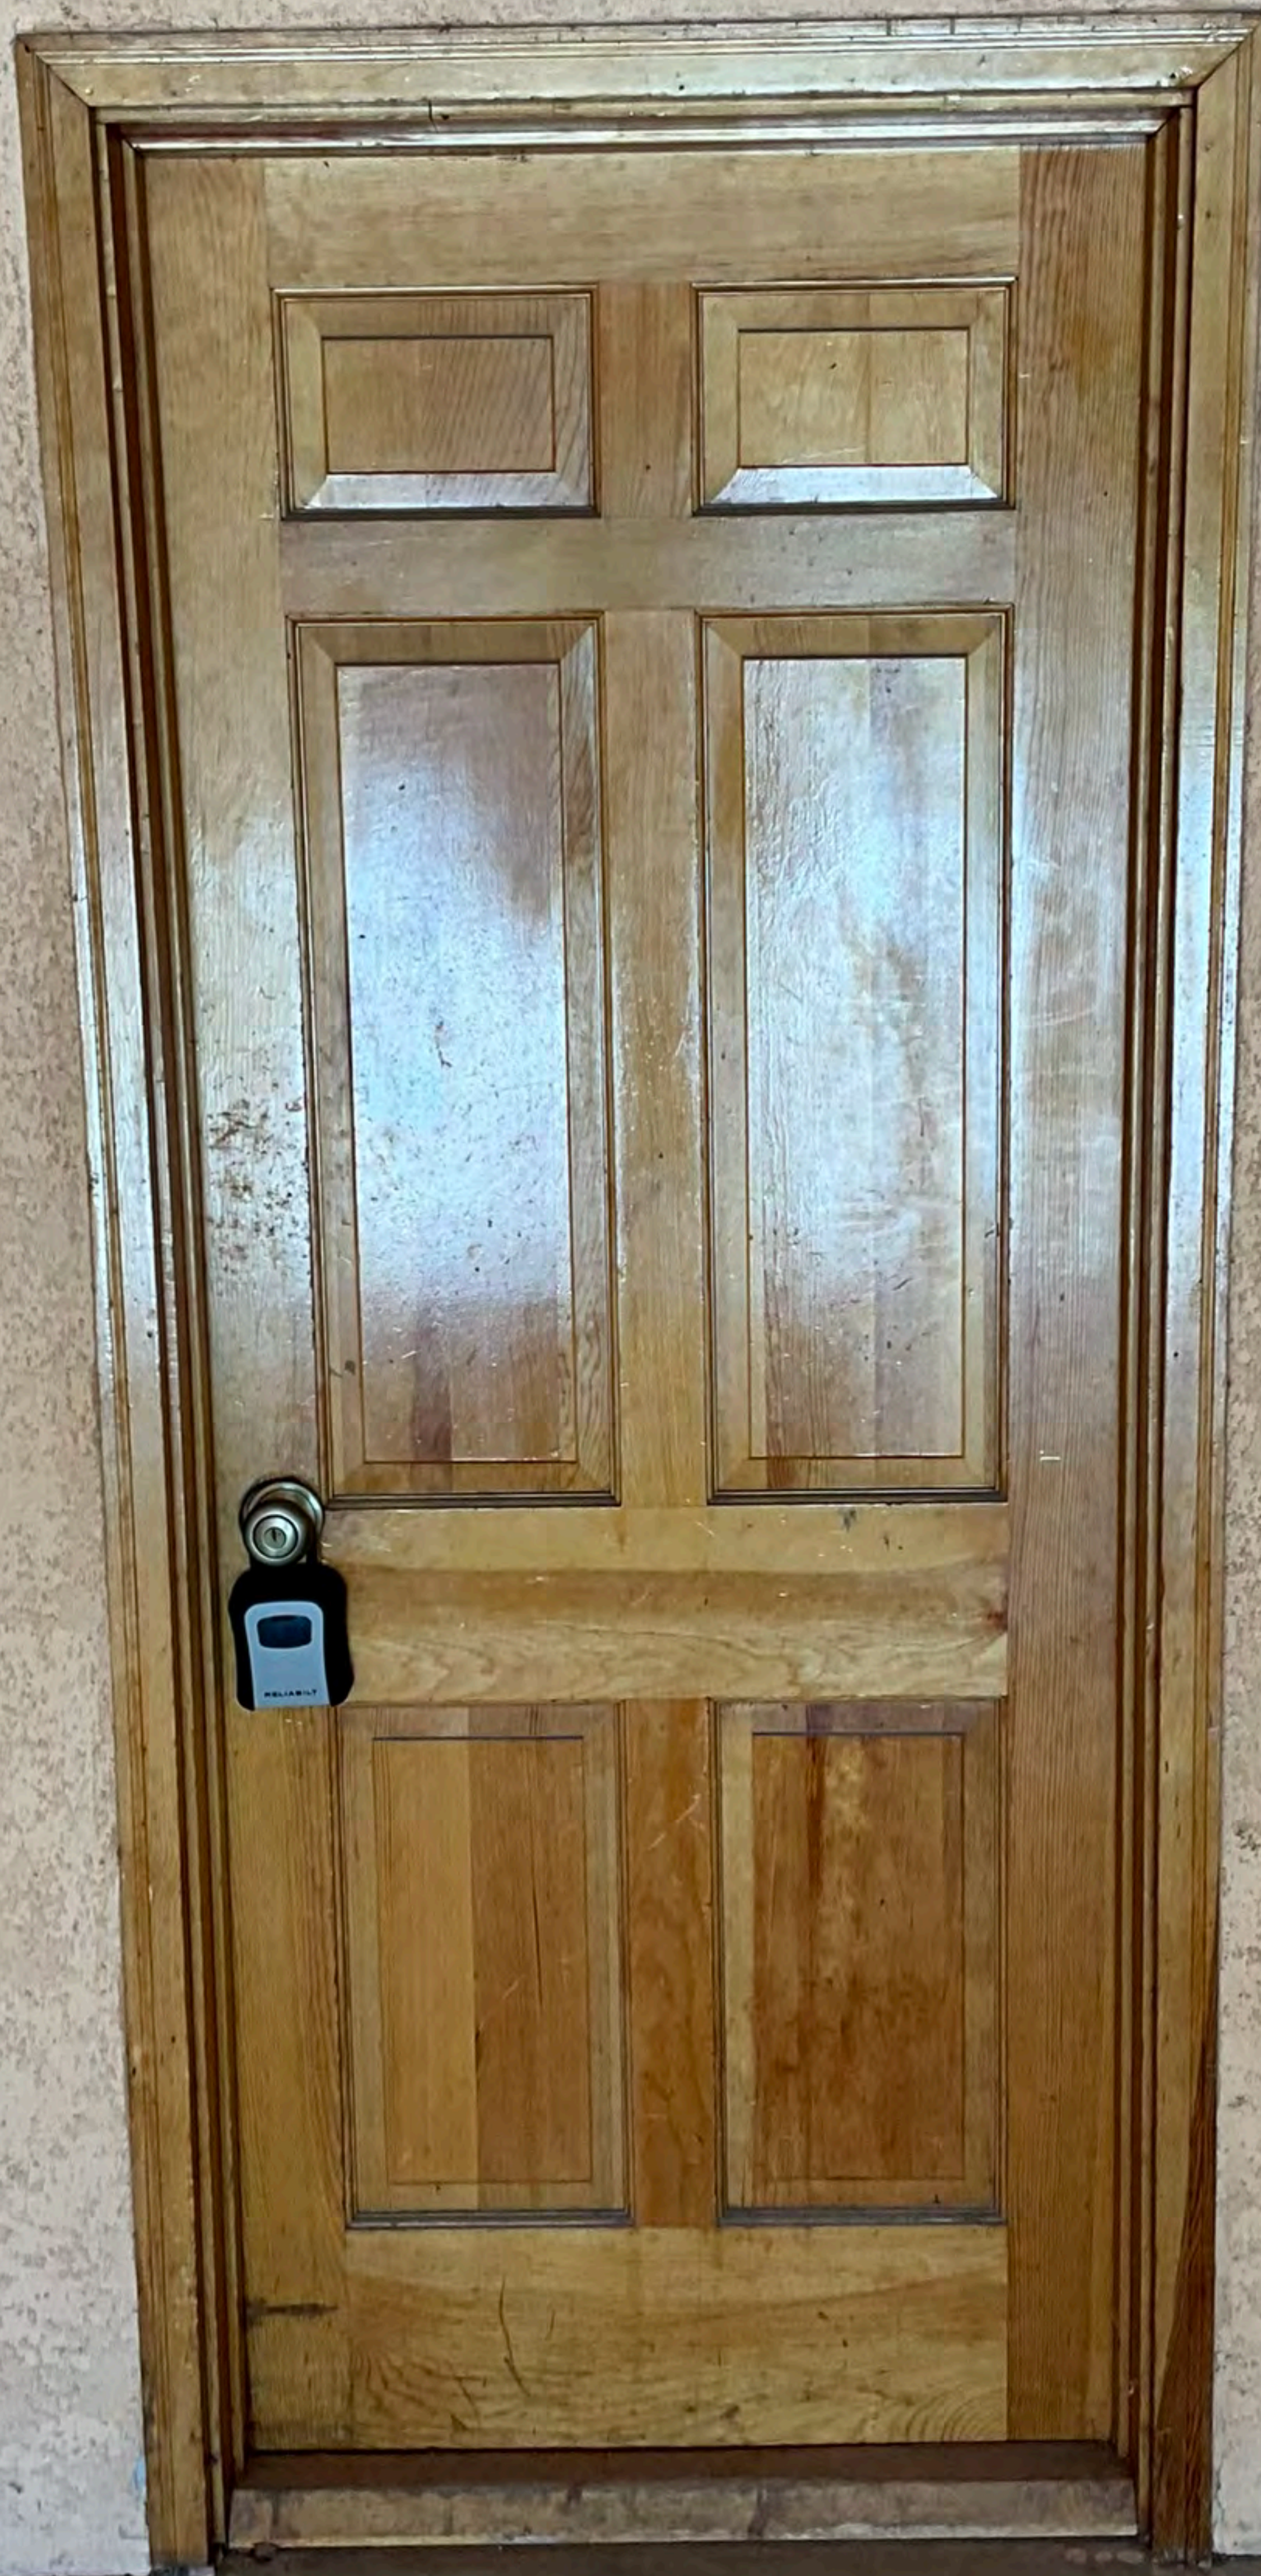
East Elevation
Door #1

Doors #1, #2, #3, #4 and #5 are non-historic however replaceable.

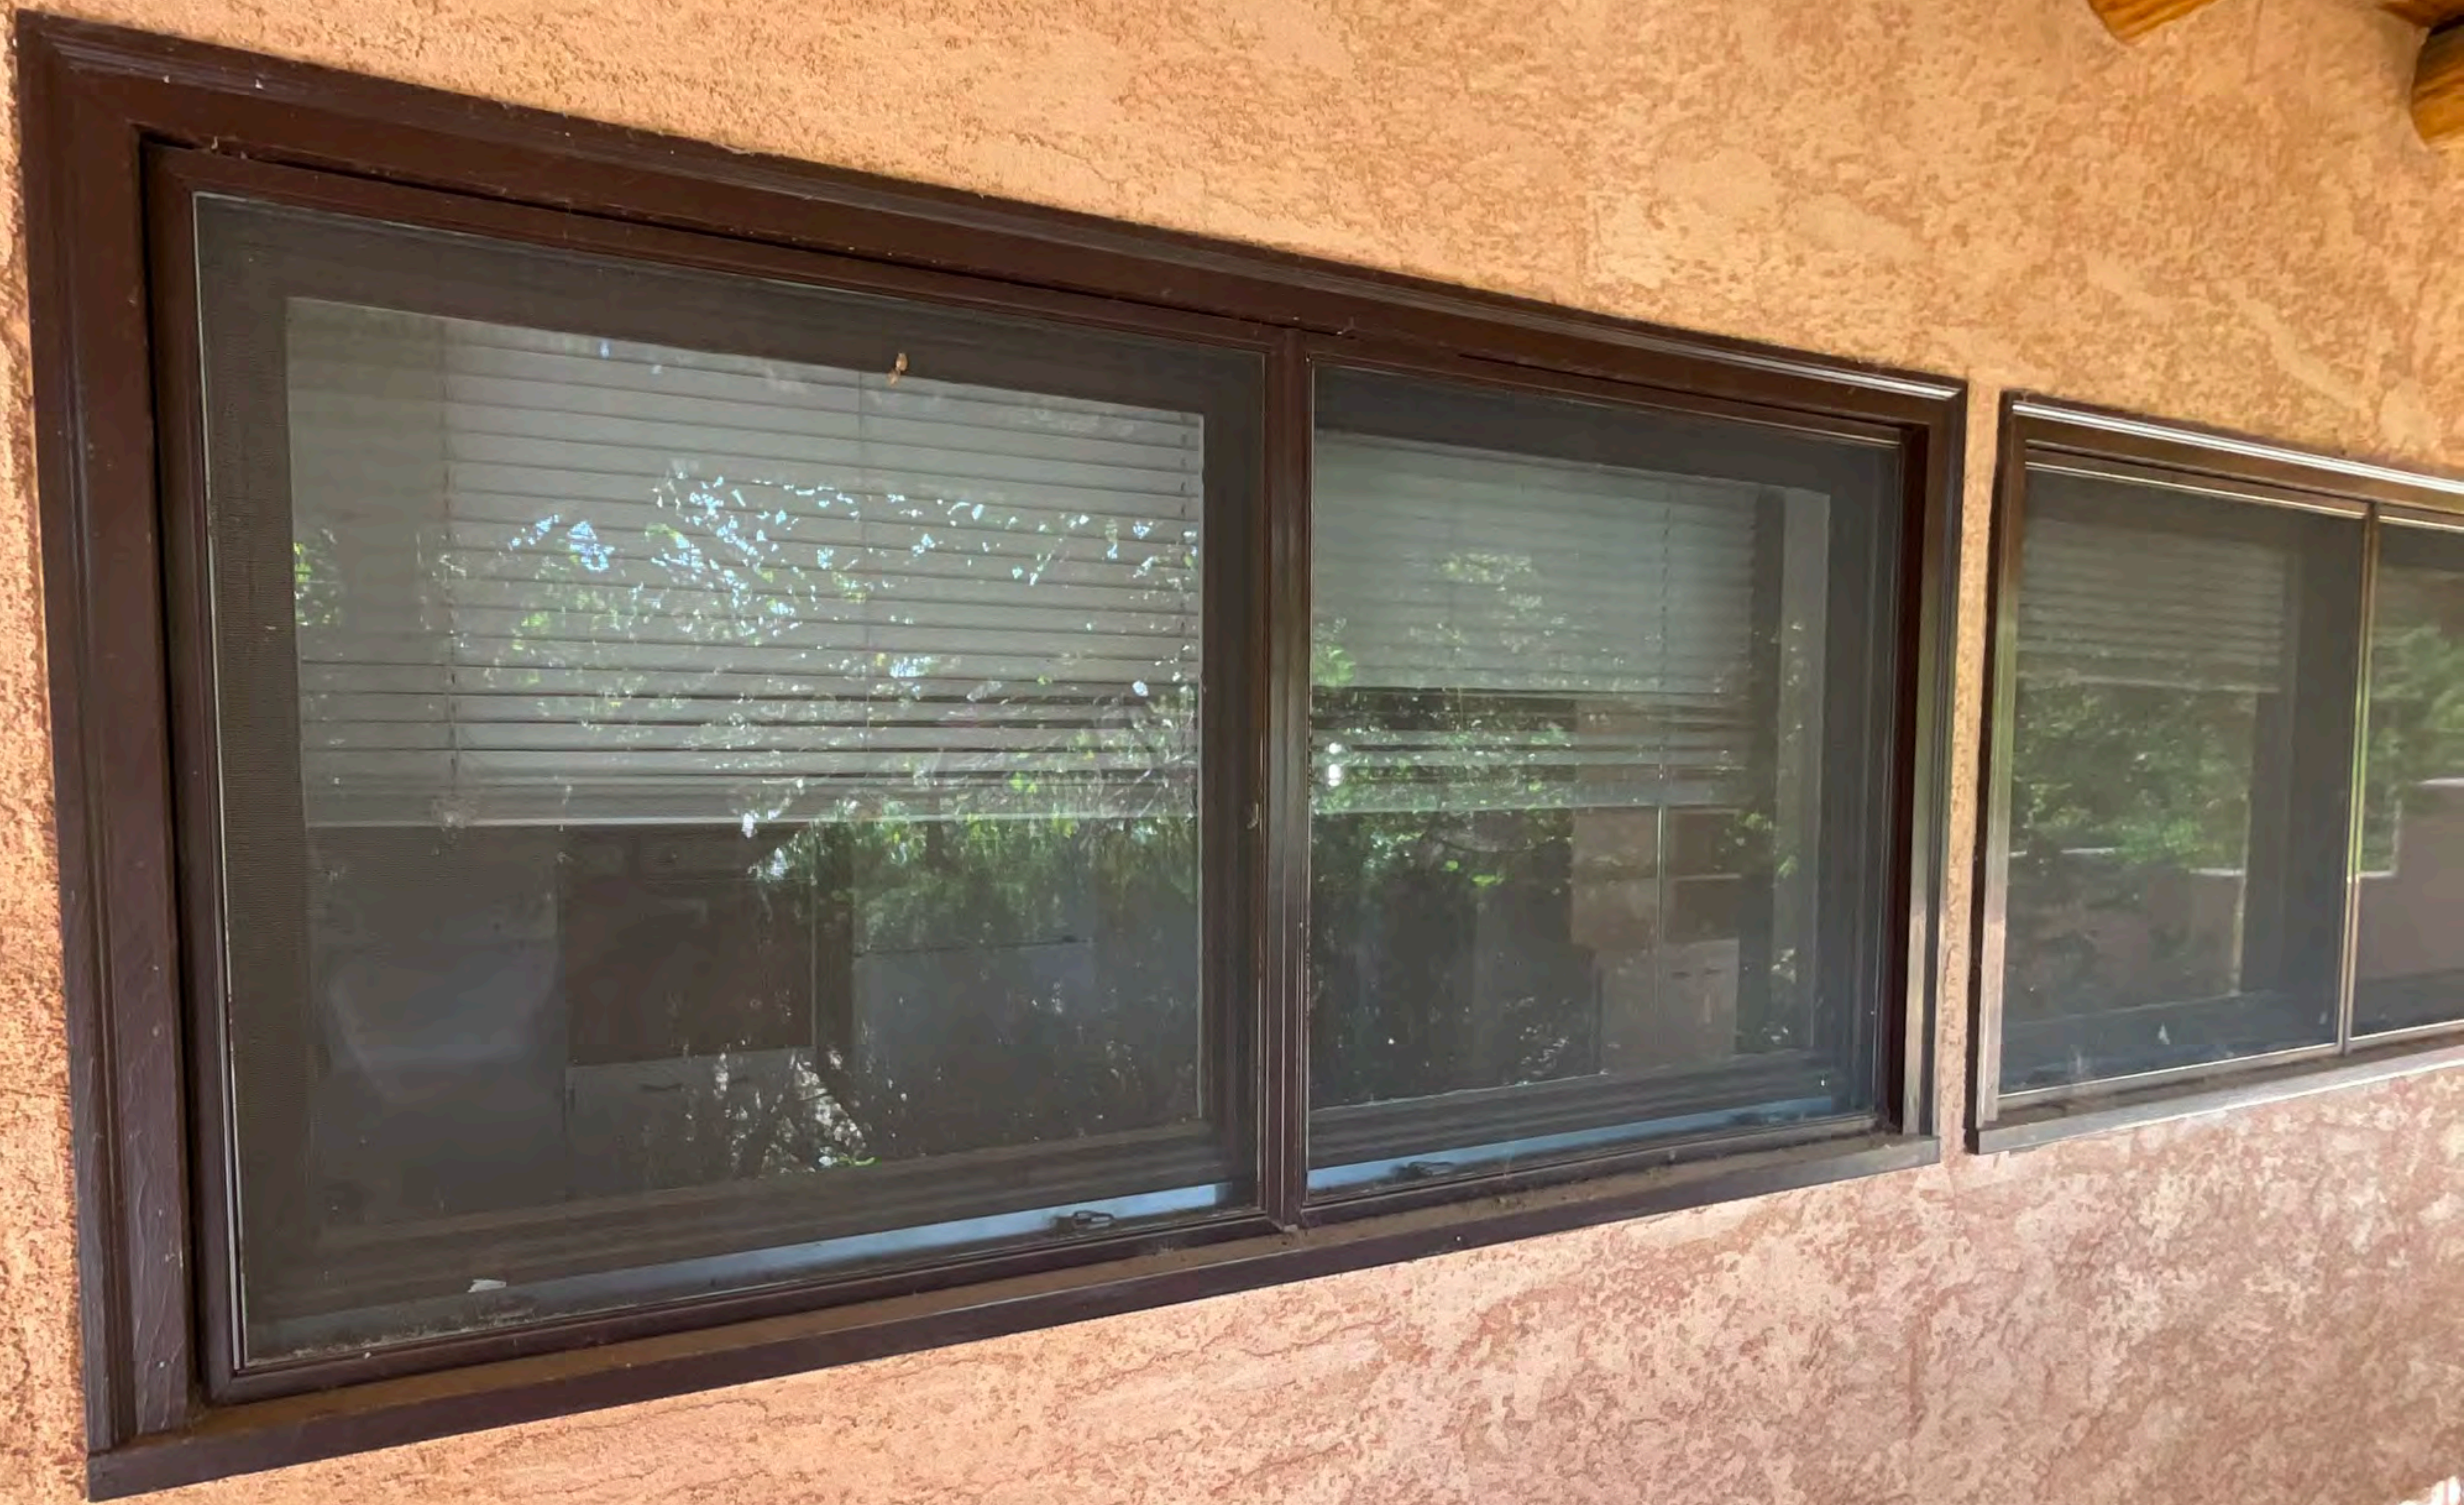
East Elevation
Window A

Windows A, B, C, E, F are historic. The units are Andersen 1964 however the tracks and the special locks are not manufactured anymore. The units would need to be replaced to function.

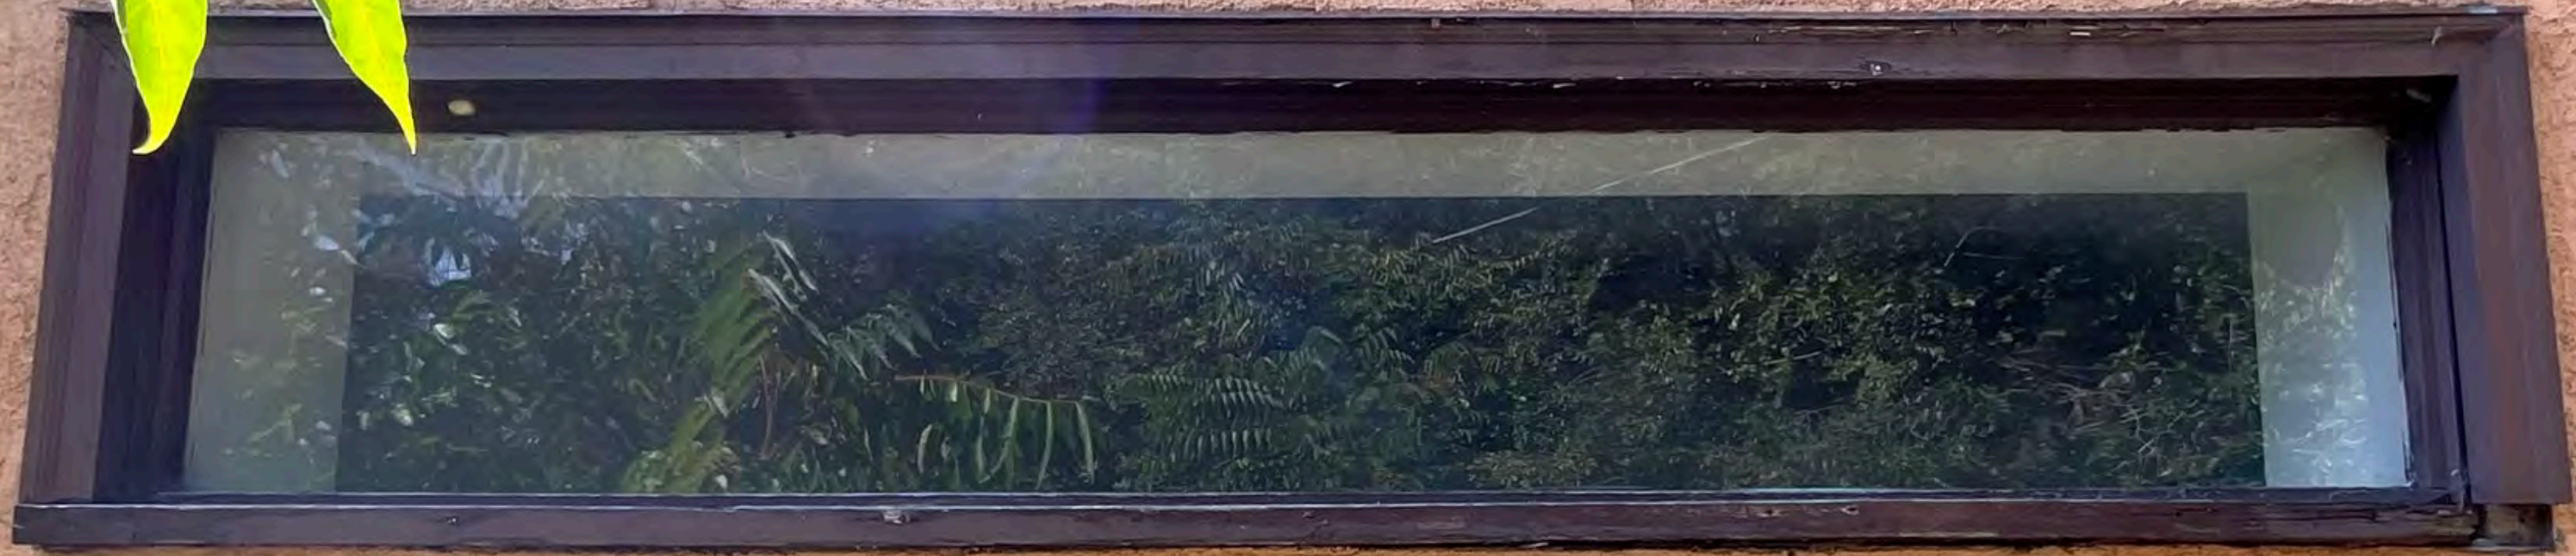
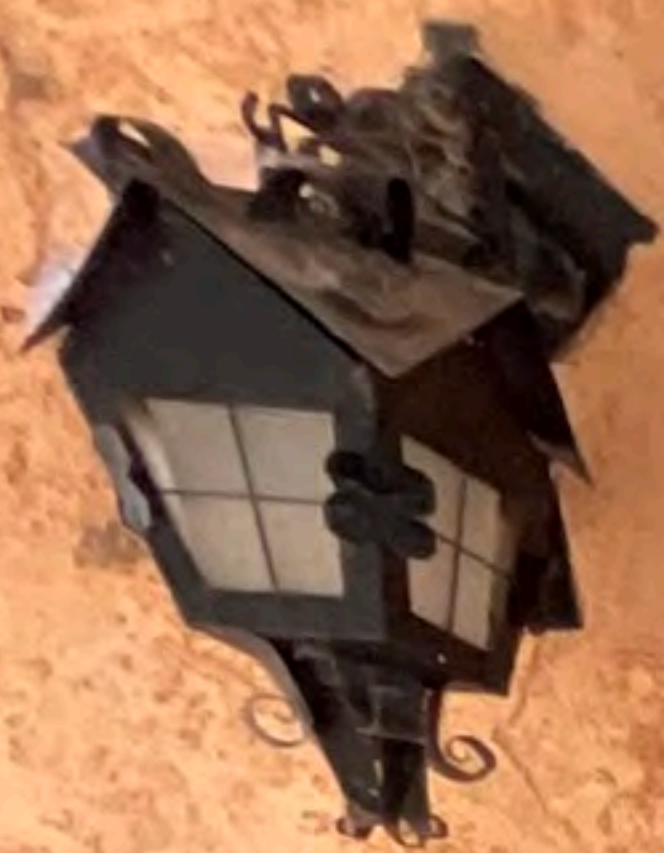
North
Elevation
Window
D

Window D is non-historic however replaceable.

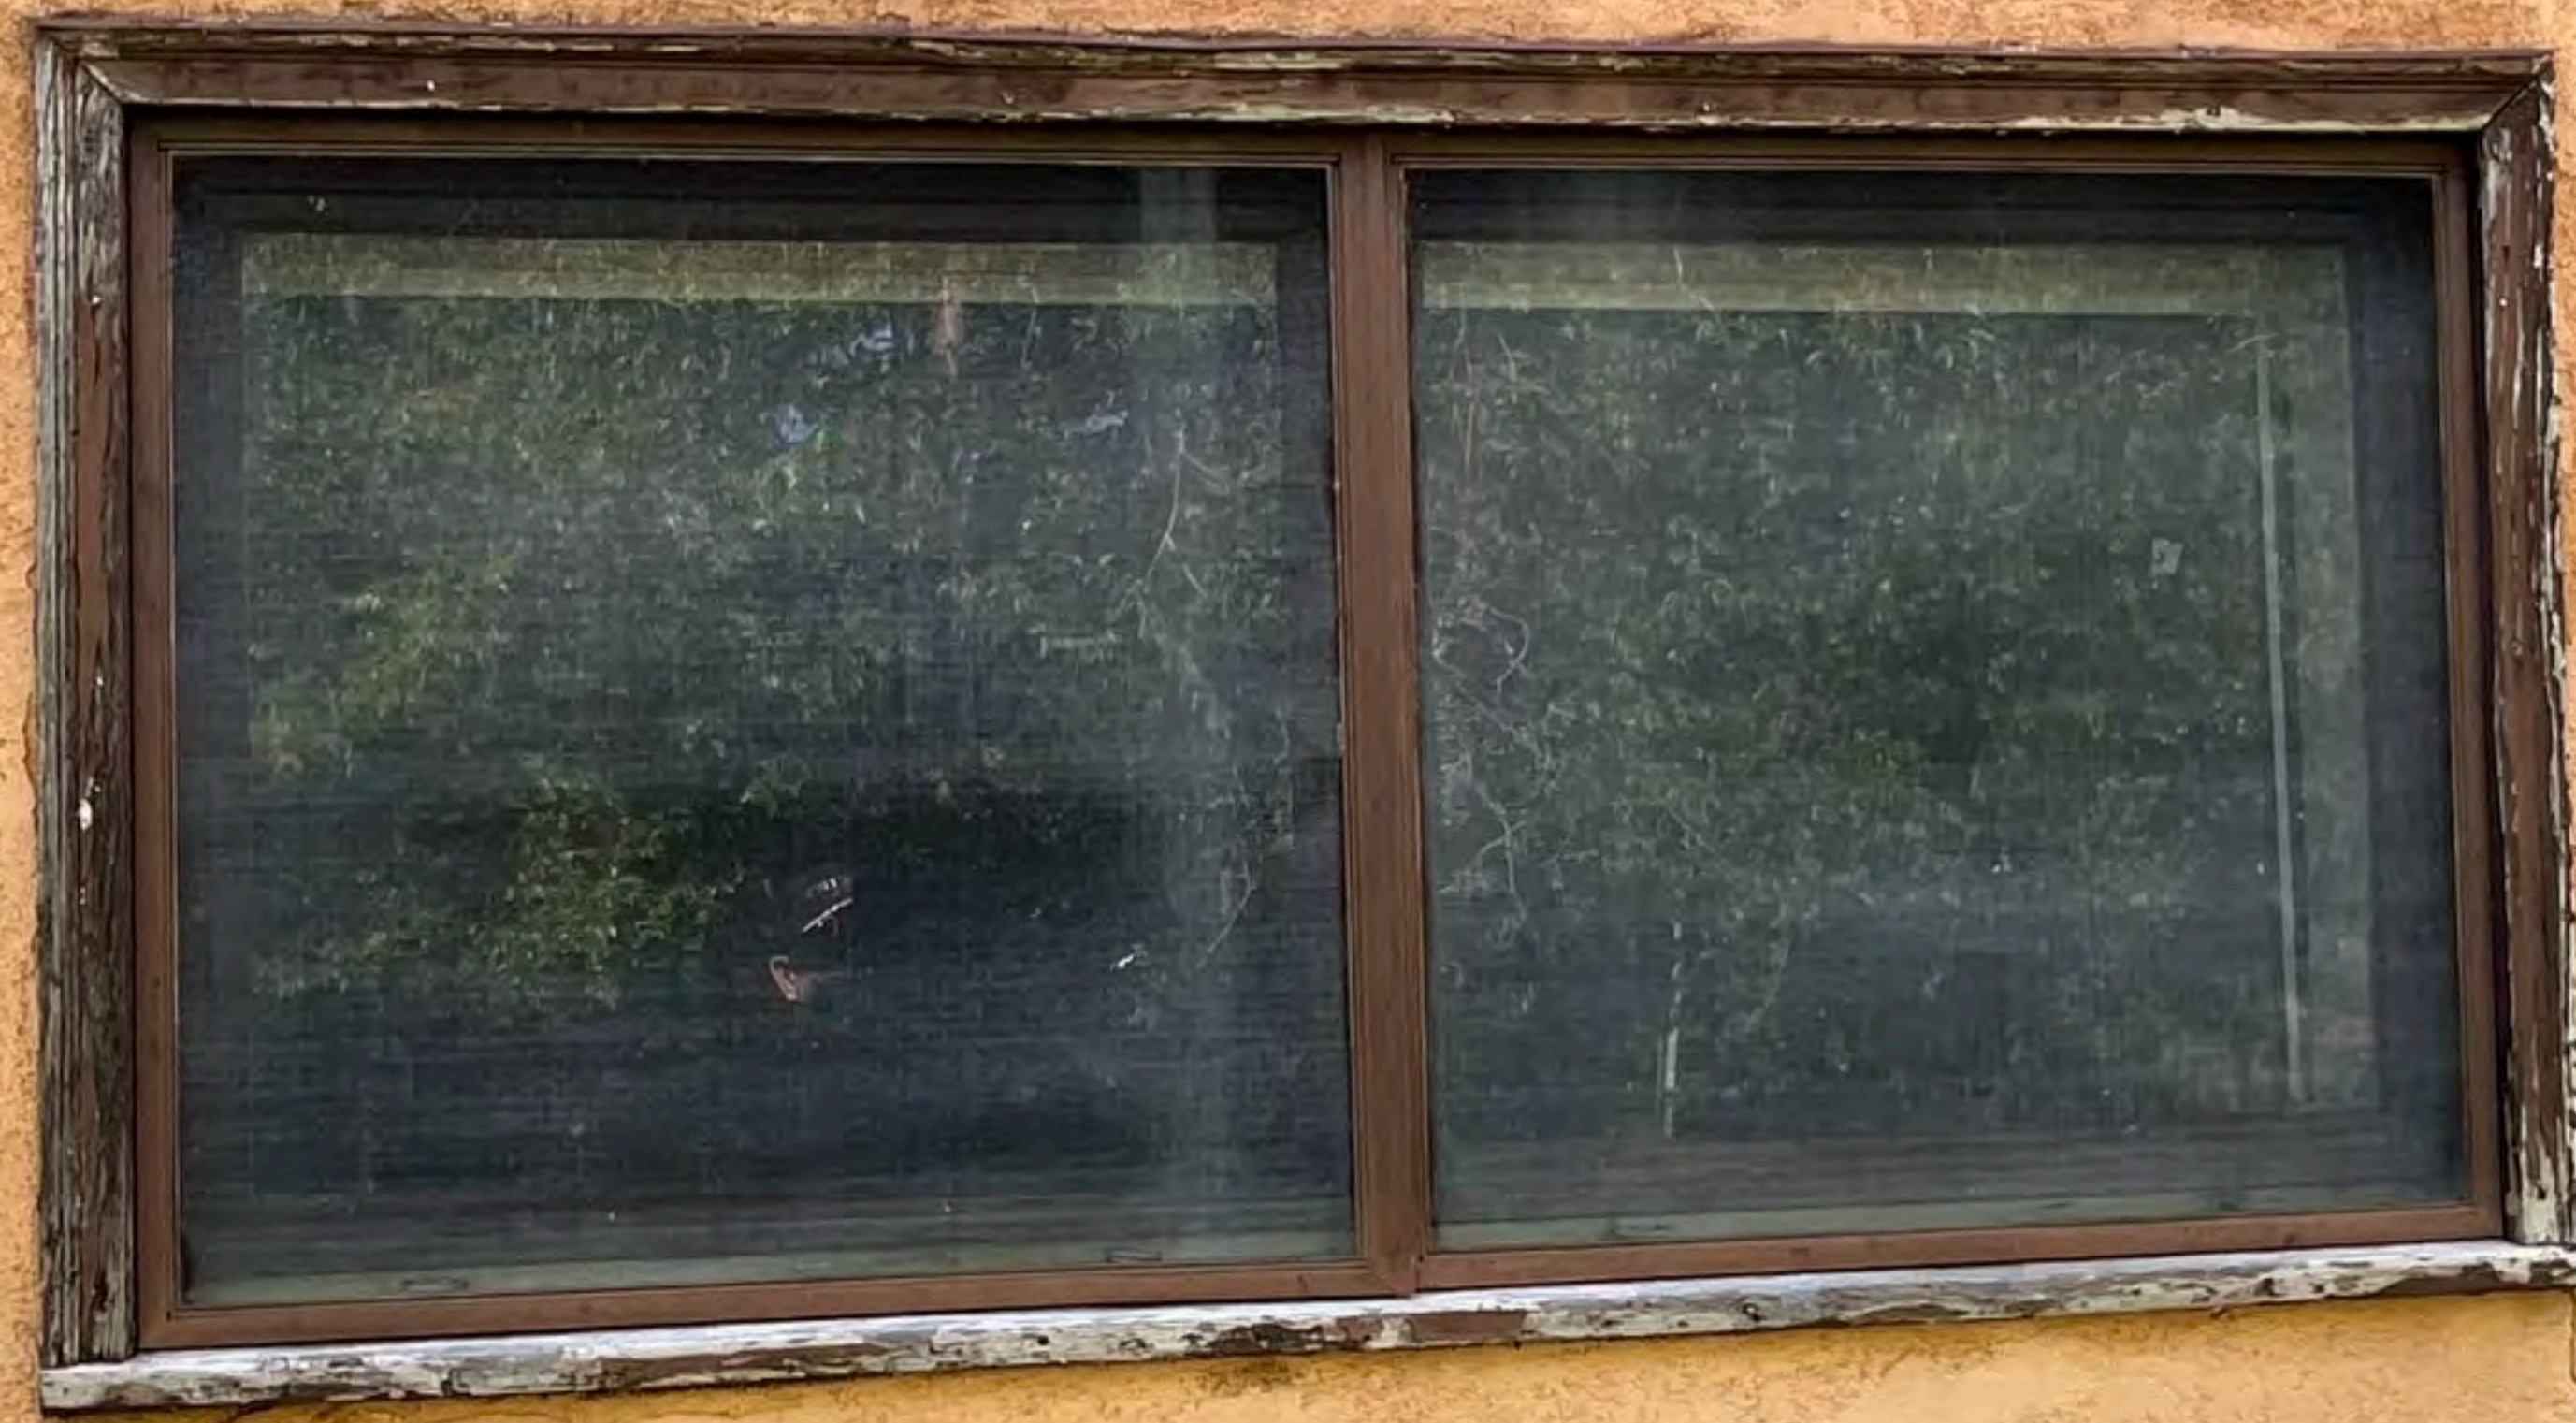
West
Elevation
Window
F

F	64 x 31 XO HORIZONTAL SLIDER 1-LT	U	HISTORIC – ANDERSEN (1964) TRACKS AND ROLLERS UNREPAIRABLE AND PARTS NO LONGER AVAILABLE

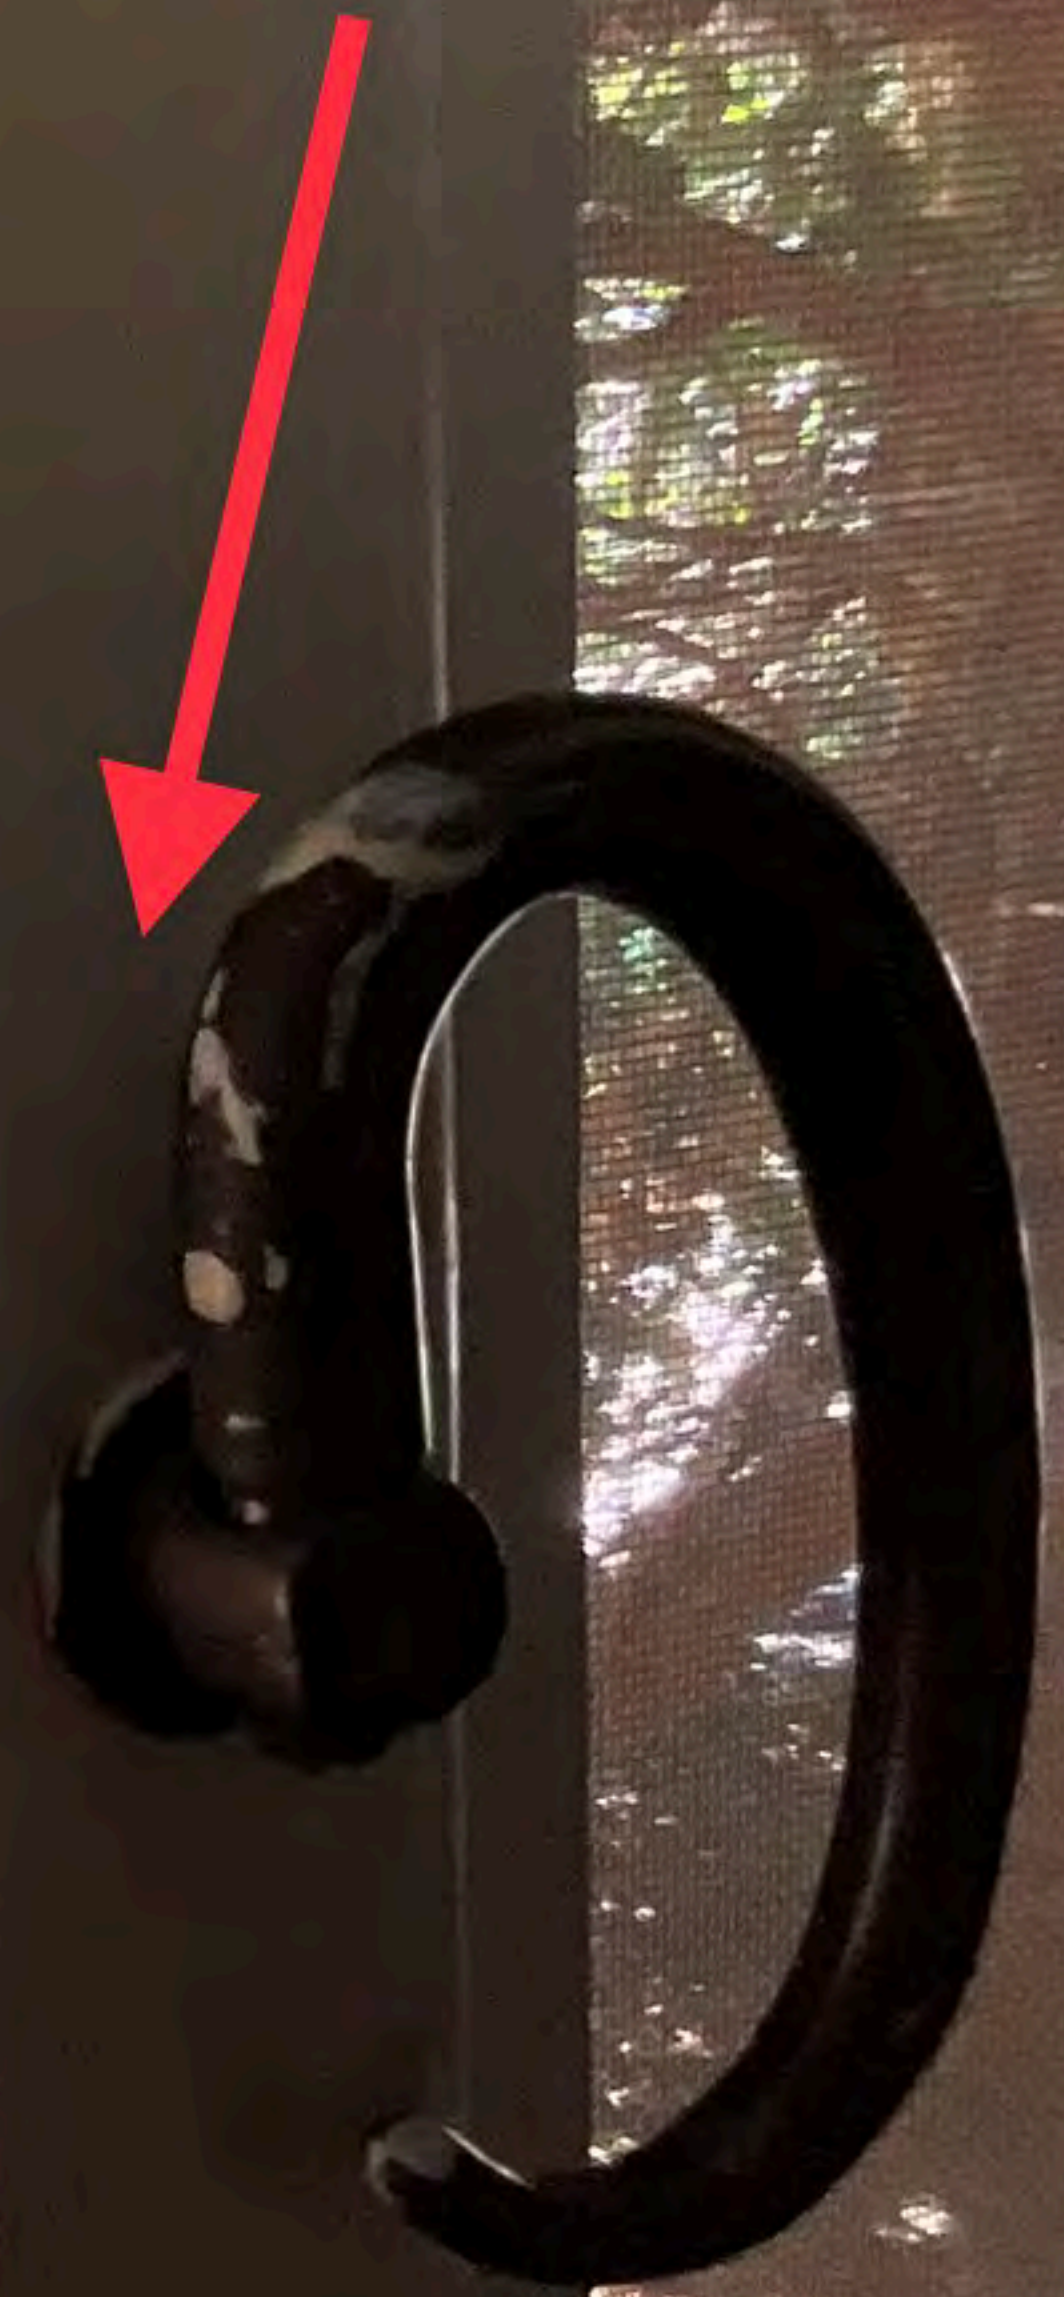
119 Camino Santiago
Typical Andersen
broken sliding
handles
Non replaceable
