RPA & Associates, LLC.

JOB	DATE
527 AGUA FRIA, SANTA FE, NM 87501	8/15/2025

Renovation of an Existing Residential Structure

527 Agua Fria Street, Santa Fe NM 87501

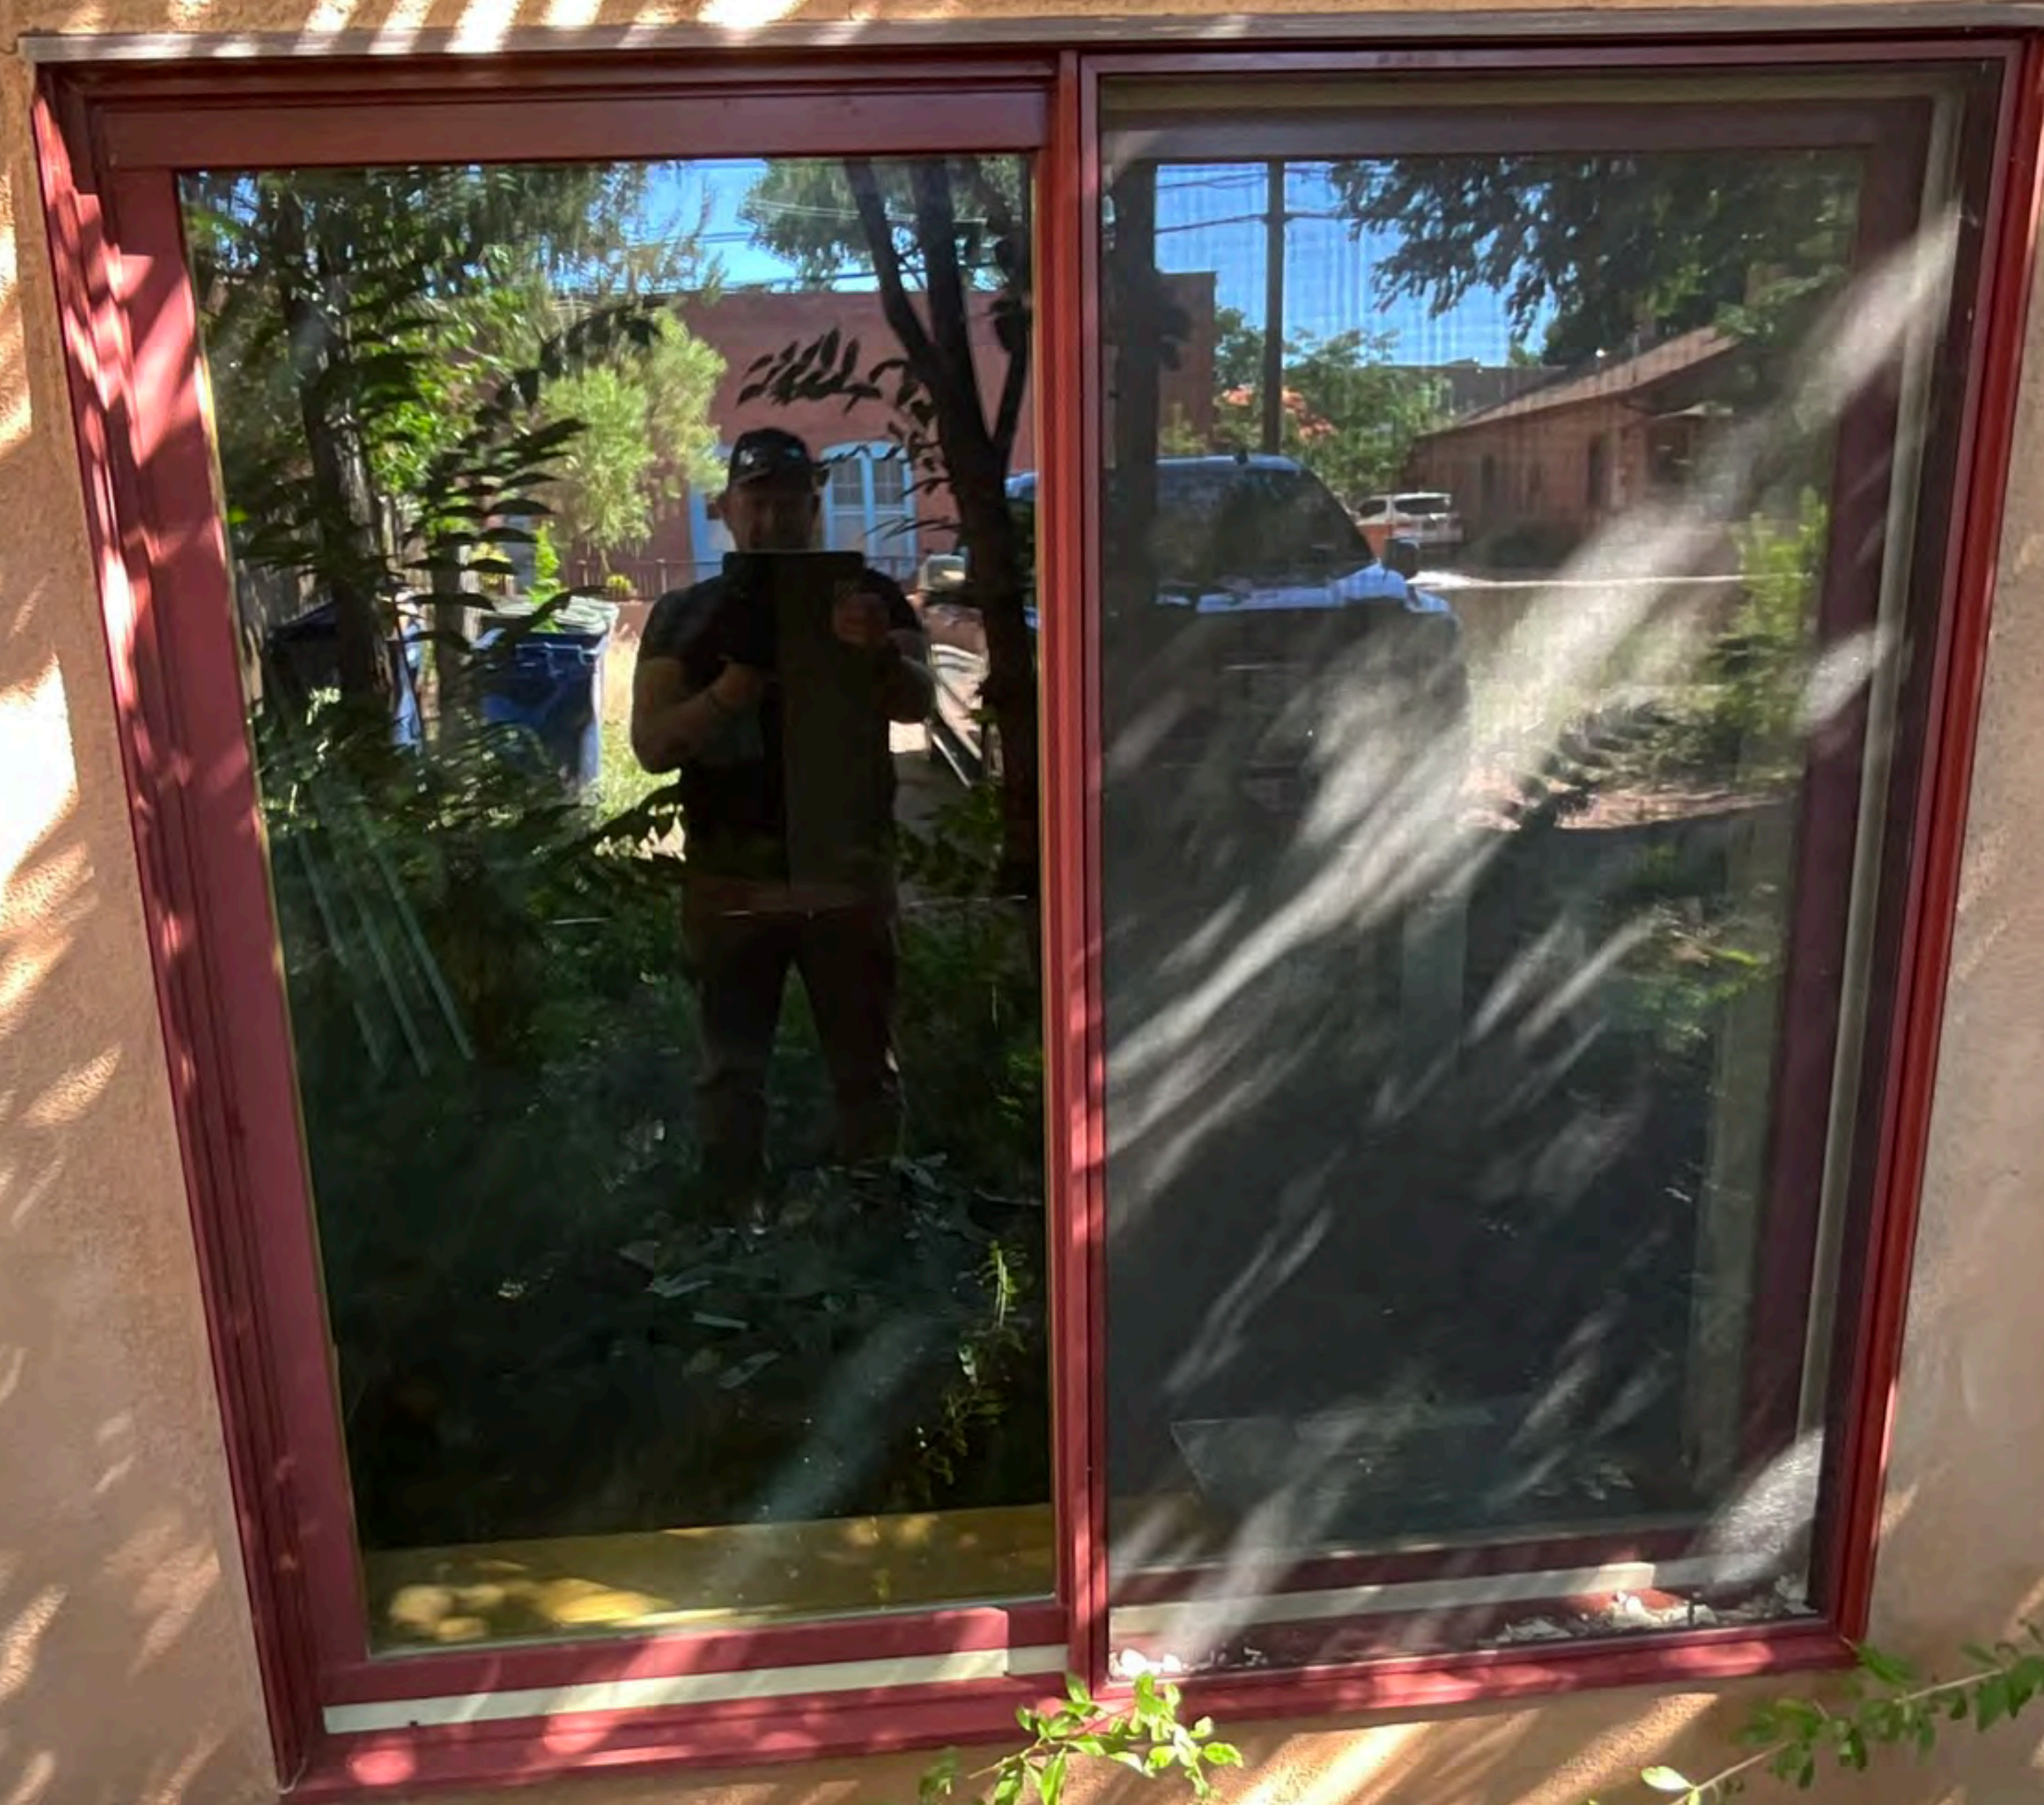
South Elevation
Window
A

Window A, B, C, D, E, K, L, M, P, Q, R, S, T, V and north gable door are non-historic.

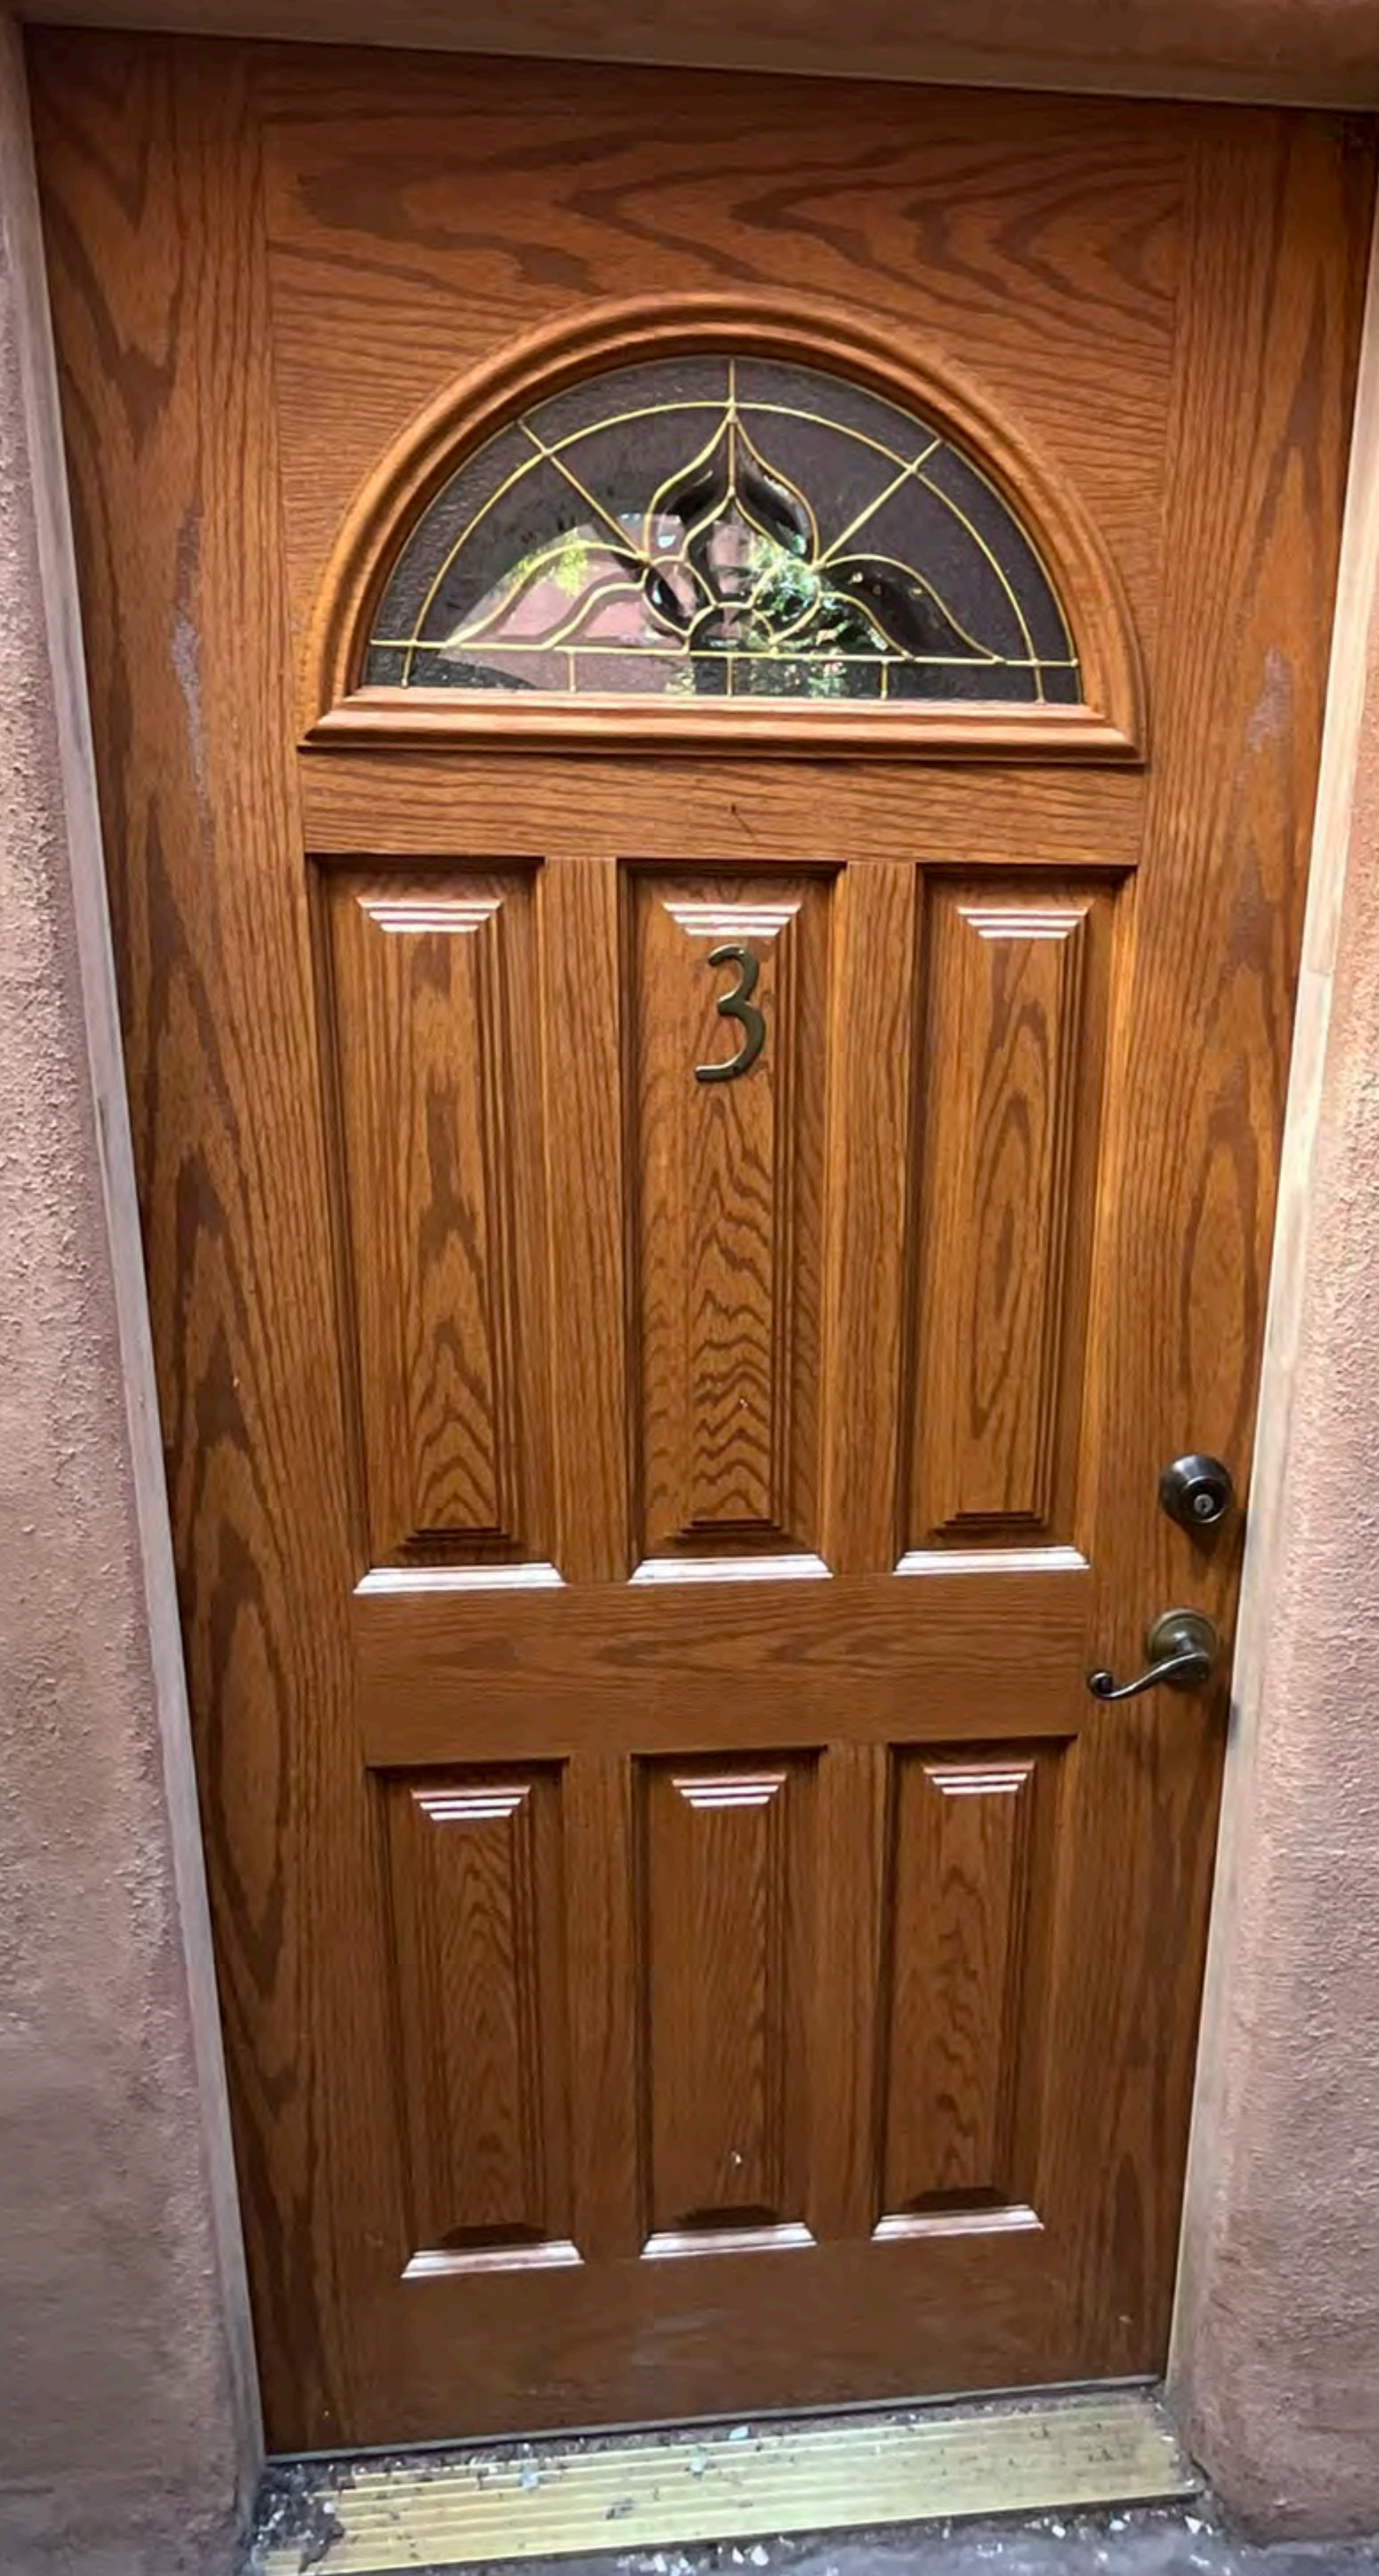
South
Elevation
Door #1

Doors #1, #2, #3, #5 and #6 are non-historic.

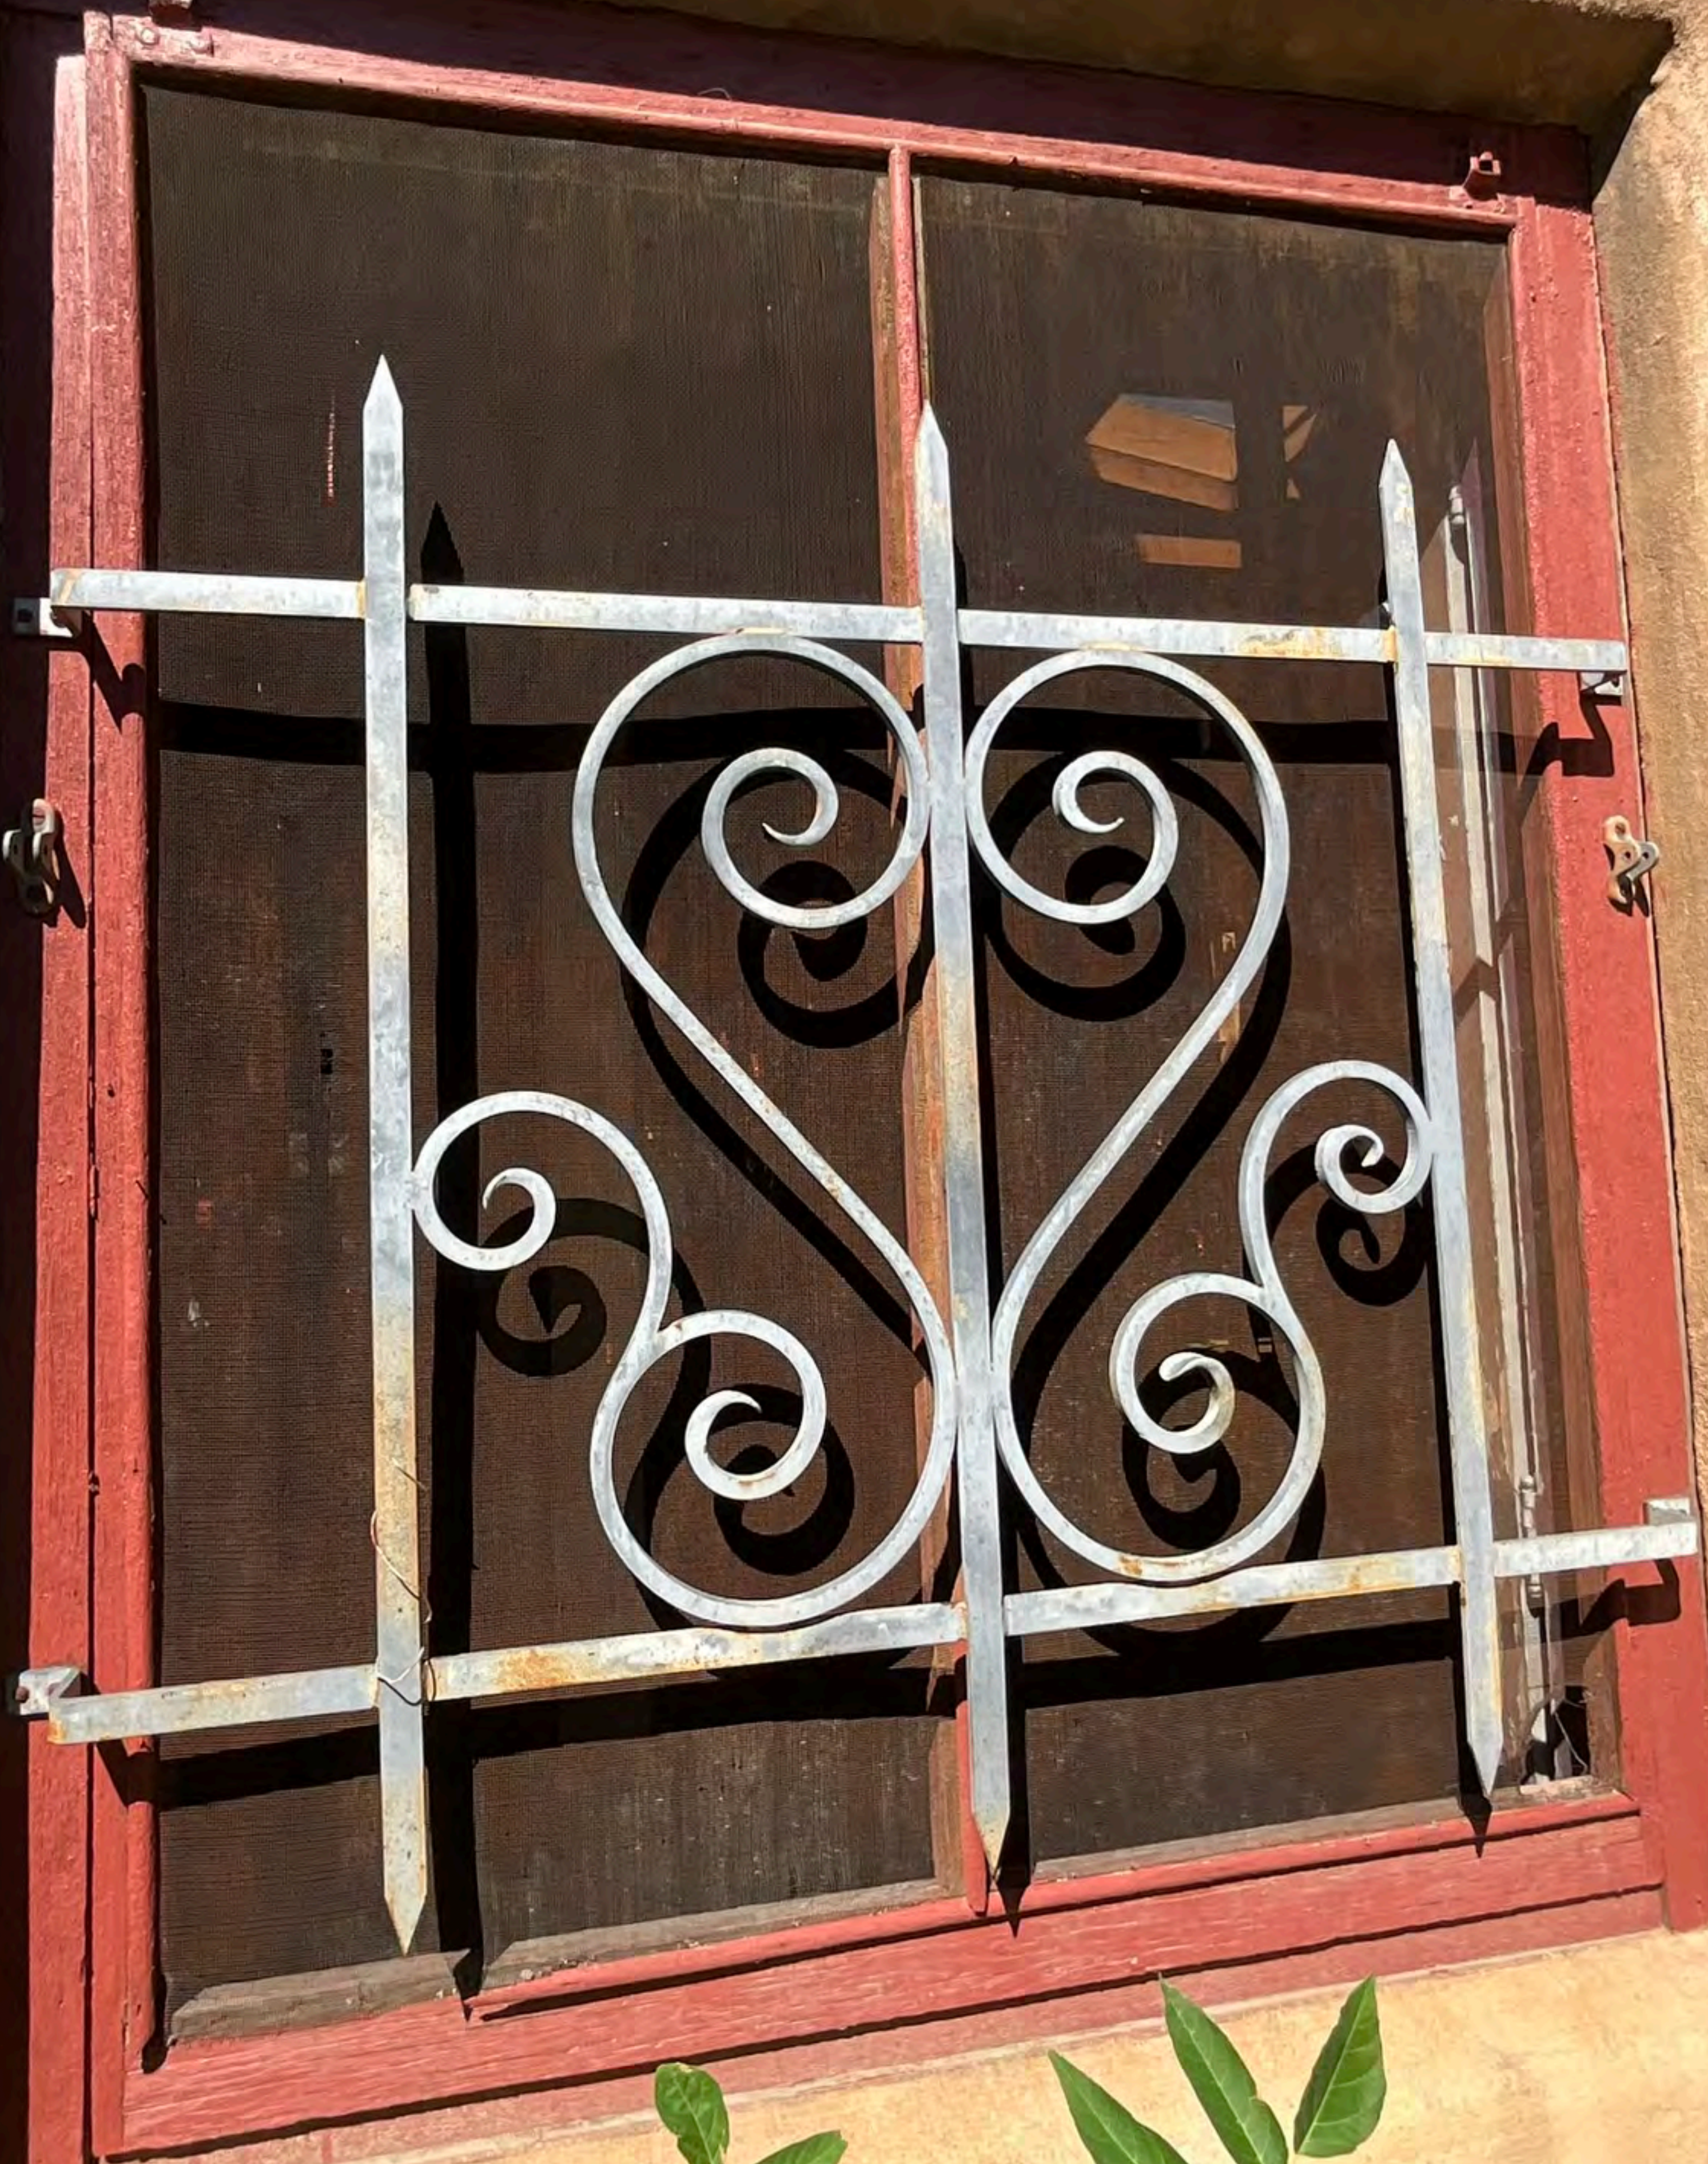
East Elevation
Window

Windows F, G, H, I and J are historic and restorable.

LABEL	WINDOW & DOOR DESCRIPTION	CONDITION & INTEGRITY CODE	HISTORIC/NON-HISTORIC – AGE
J	48 x 59 – 2 LR INSWING CASEMENT ALL WOOD 2W4H (2-24")	F	HISTORIC – RESTORABLE, THE SCREENS ARE NOT RESTORABLE NON-HISTORIC – WROUGHT IRON
K	11 x 20 FIXED 1-LT ARCHED GLASS STOPPED IN STUCCO	U	NON-HISTORIC – WROUGHT IRON
L	38 x 38 LR INSWING CASEMENT ALL WOOD 3W3H	F	NON-HISTORIC – SASH & JAMB HAVE SIGNS OF HINGES; ORIGINAL UNIT WAS A TWIN NOT A SINGLE SCREEN (NON-RESTORABLE) THE WROUGHT IRON IS ALSO NON-HISTORIC
M	24 x 24 HORIZONTAL SLIDER WHITE VINYL PAINTED RED ON THE EXTERIOR	S	NON-HISTORIC – (2001)
N	34 x 81 DOUBLE HUNG SEGMENT INSIDE RECTANGLE UPPER SASH WOOD 2W1H/2W1H	F	HISTORIC – NOT OF THE ORIGINAL HOUSE, ADDED AT A LATER DATE
O	28 x 64 DOUBLE HUNG ALL WOOD 2W2H/2W2H	U	HISTORIC – ROTTED BEYOND 30 TO 40%
P	67 x 38 – 2 LR INSWING CASEMENT ALL WOOD 3W3H (2-33 ½")	F	NON-HISTORIC – BARN SASHES CUT TO SLANT TO FOLLOW ROOF (1996)

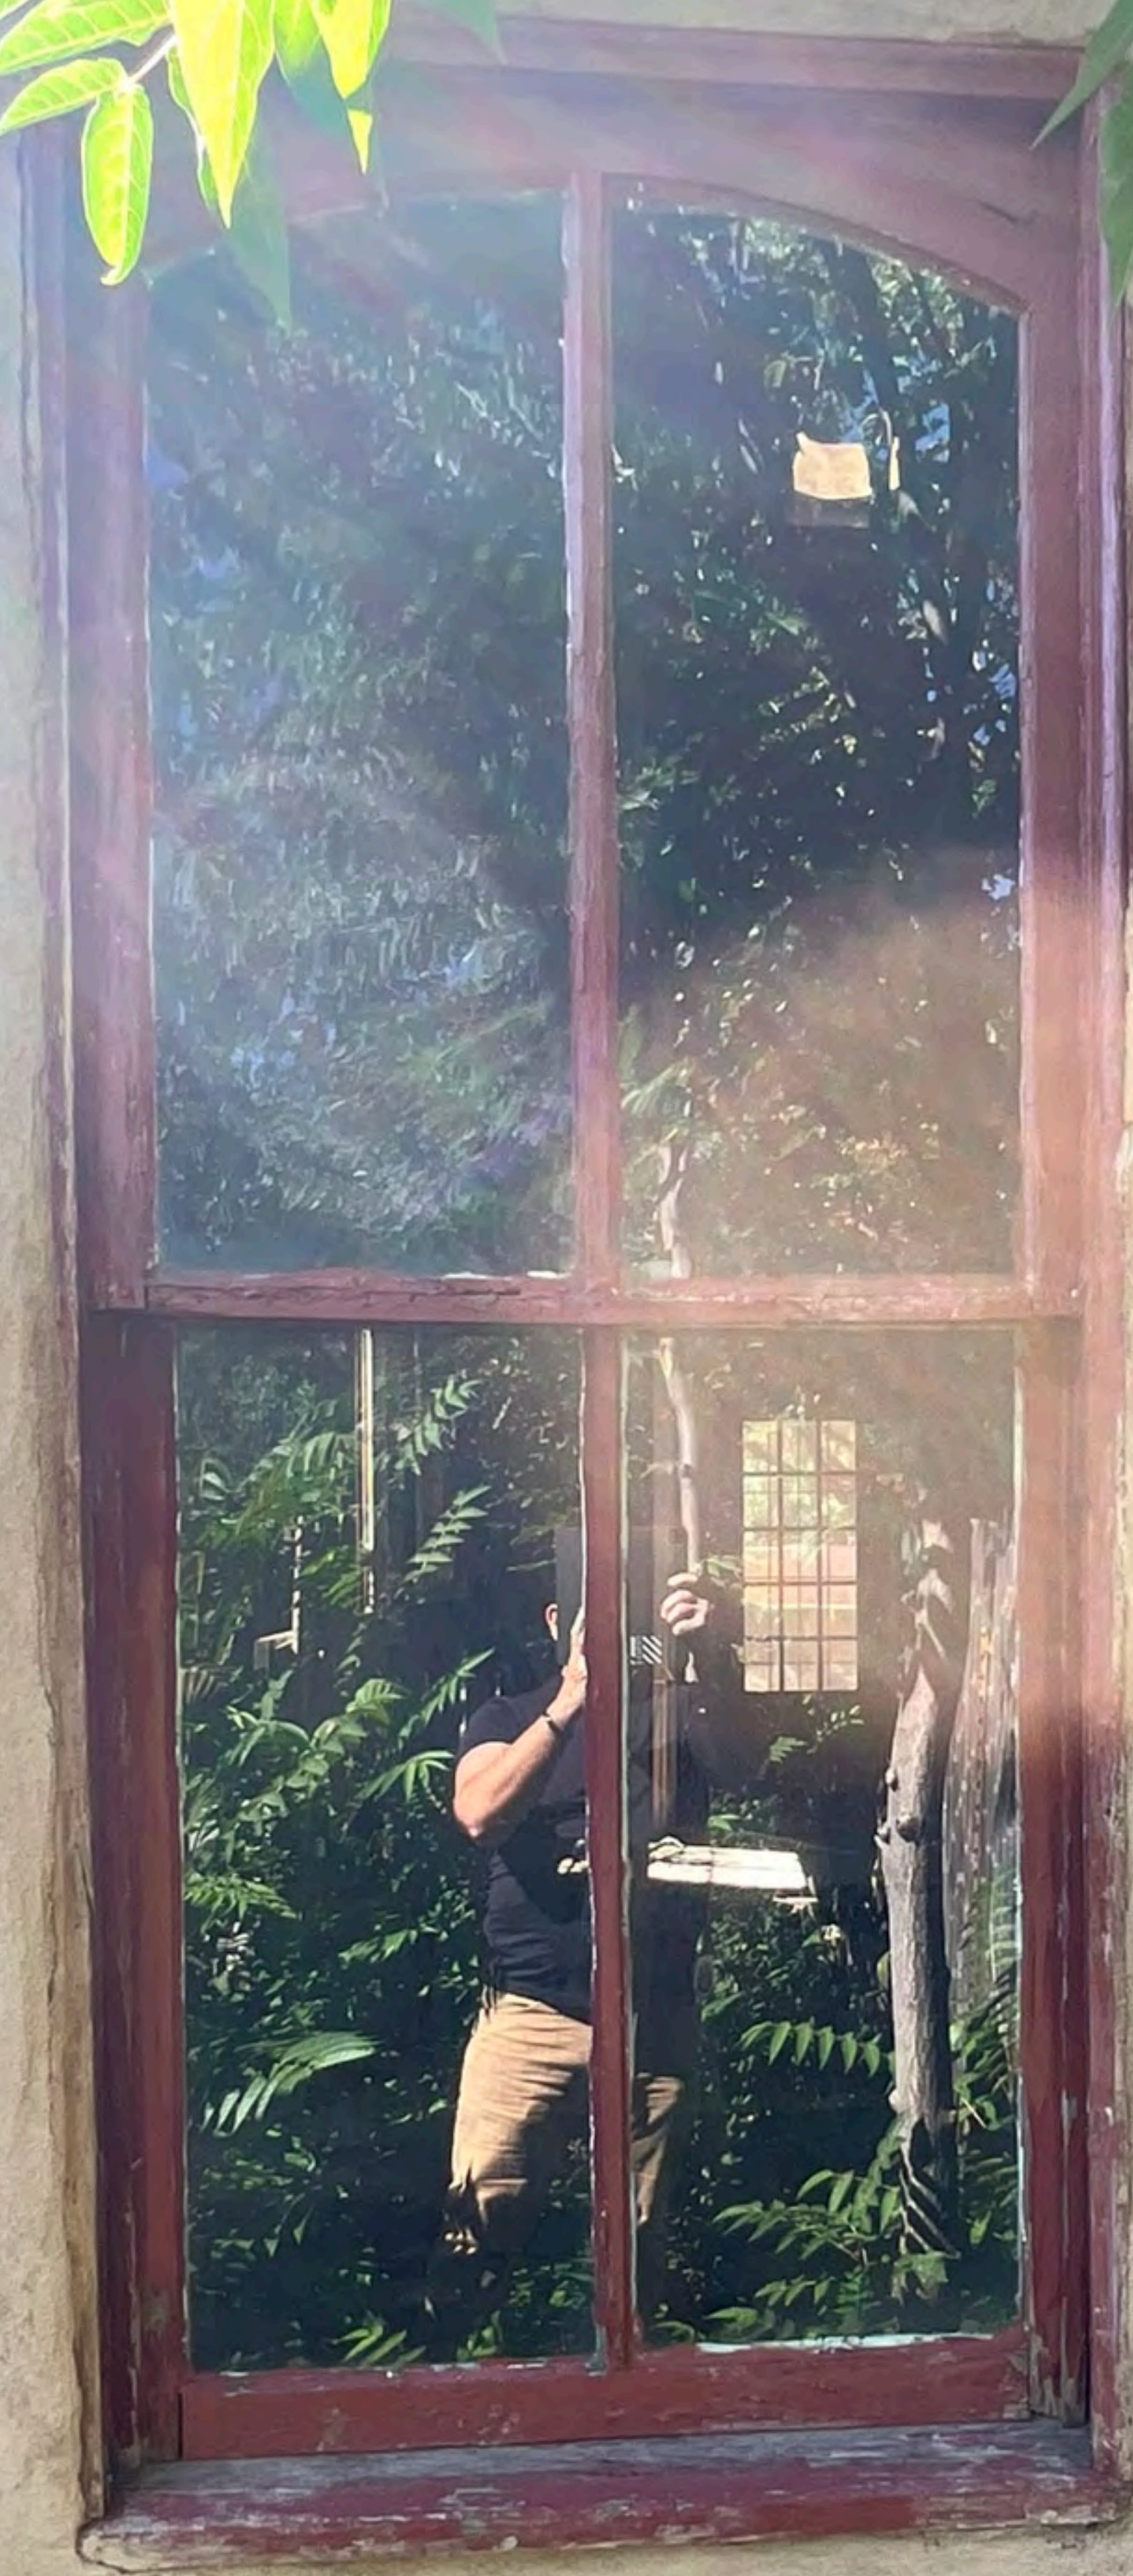
North
Elevation
Window
N

Window N is historic however not part of the original house.

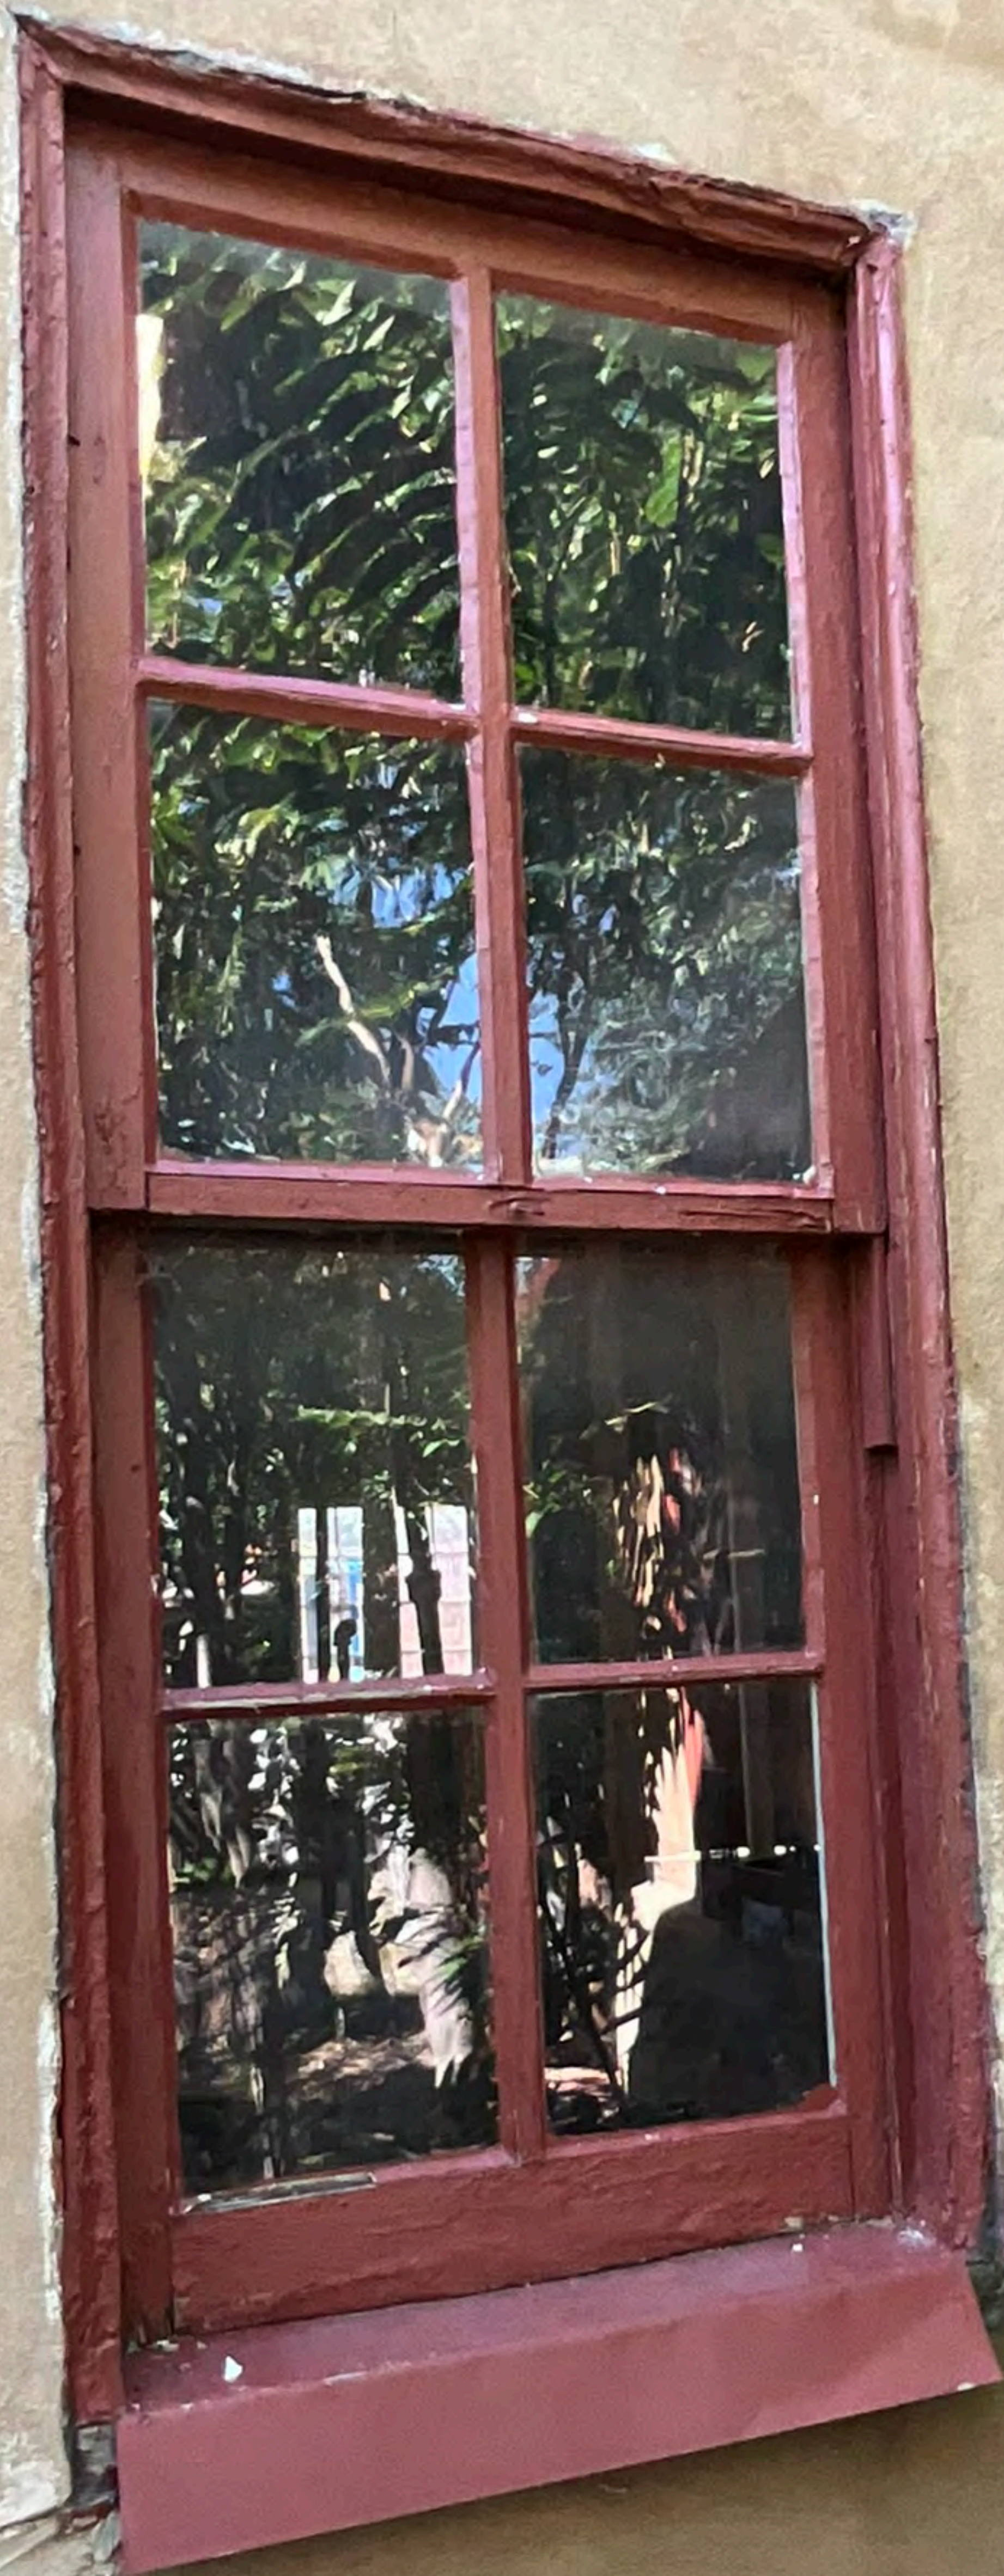
North
Elevation
Window
O

Window O is historic however unrestorable.

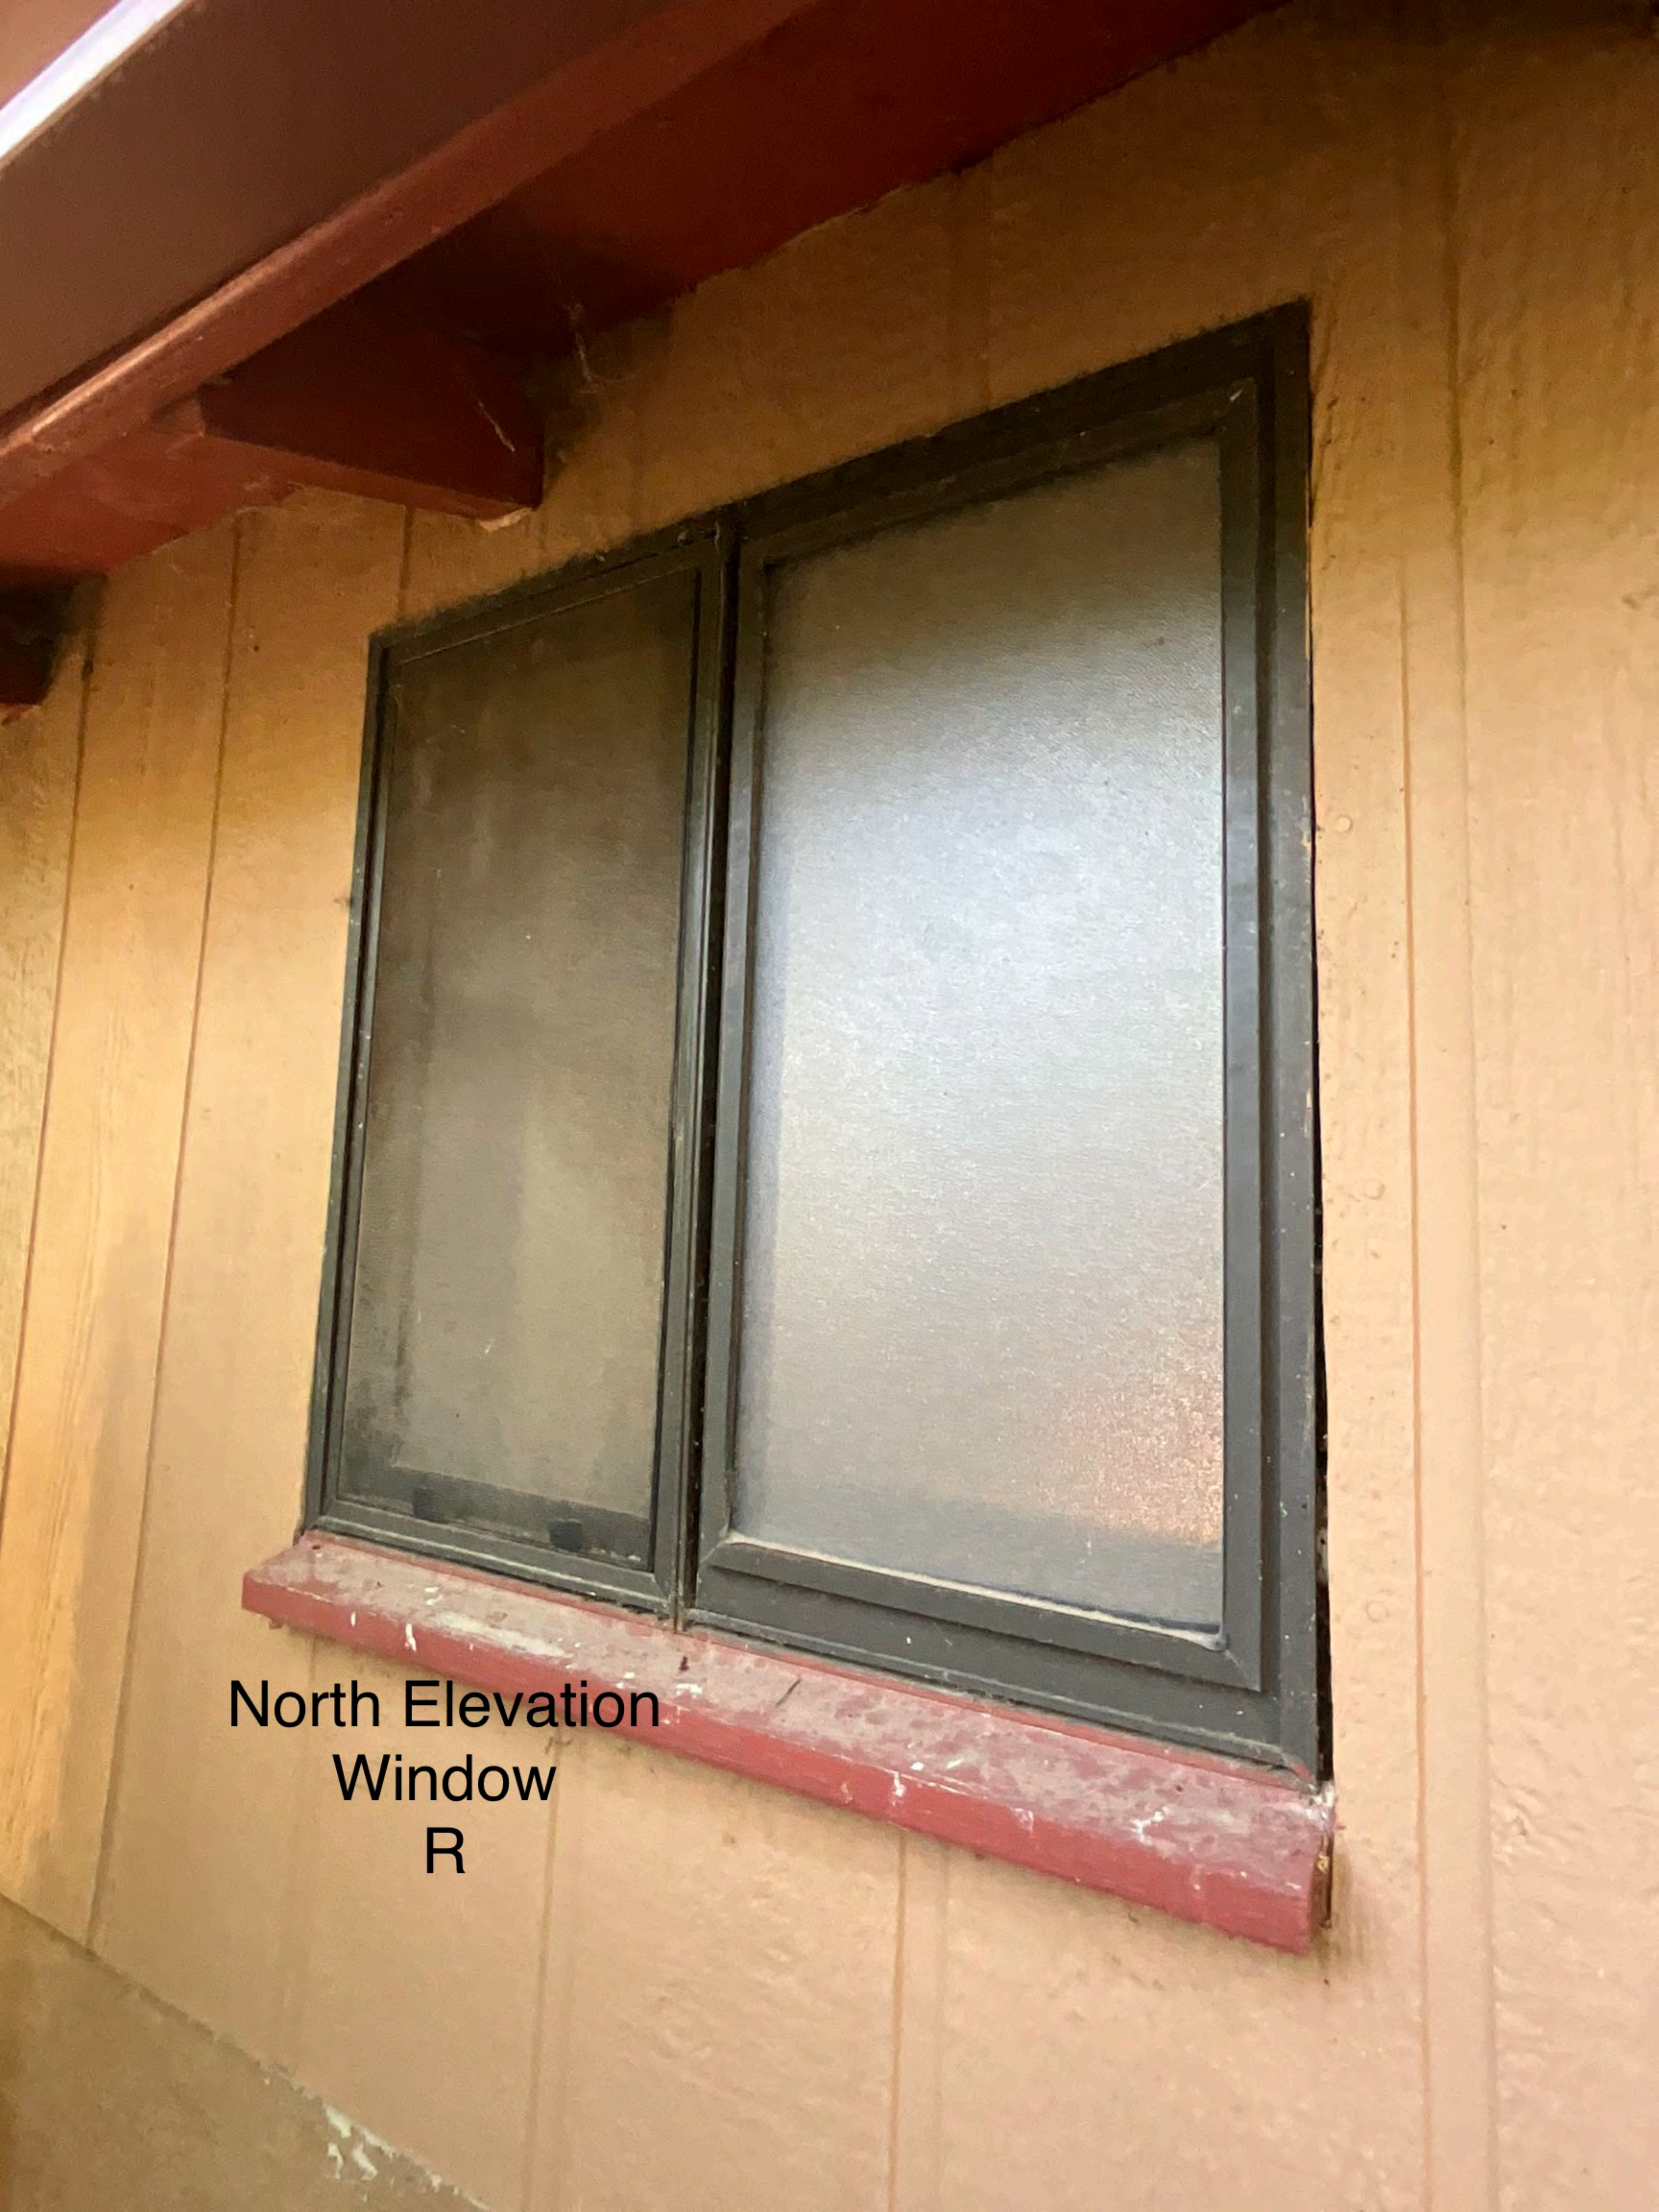
North
Elevation
Gable door

LABEL	WINDOW & DOOR DESCRIPTION	CONDITION & INTEGRITY CODE	HISTORIC/NON-HISTORIC – AGE
NORTH GABLE DOOR	32 x 44 OUTSWING PLANK DOOR	F	NON-HISTORIC – GUN NAILS USED (1989)
DR #5	30 x 80 LH INSWING DOOR 3W3H/2-PANEL	F	NON-HISTORIC – SIMPSON (1989)
R	24 x 24 HORIZONTAL SLIDER BRONZE ALL ALUMINUM INSULATED GLASS OBSCURE	S	NON-HISTORIC – ALENCO (1995)
S	36 x 36 HORIZONTAL SLIDER BRONZE ALL ALUMINUM INSULATED GLASS OBSCURE	S	NON-HISTORIC – ALENCO (1995)
T	36 x 36 HORIZONTAL SLIDER 1-LT BRONZE ALUMINUM	S	NON-HISTORIC – ALENCO (1995)
U	24 x 24 AWNING 1-LT CLAD RED/WOOD	P	NON-HISTORIC – JELD-WEN (2009)
DR #6	24 x 80 LH OUTSWING 6-PANEL WOOD DOOR	S	NON-HISTORIC – SIMPSON DOOR (2009)
DR #7	9 x 7 GARAGE DOOR	U	DOOR IS MISSING
