RPA & Associates, LLC.

JOB	DATE
527 AGUA FRIA, SANTA FE, NM 87501	8/15/2025

Renovation of an Existing Residential Structure

527 Agua Fria Street, Santa Fe NM 87501

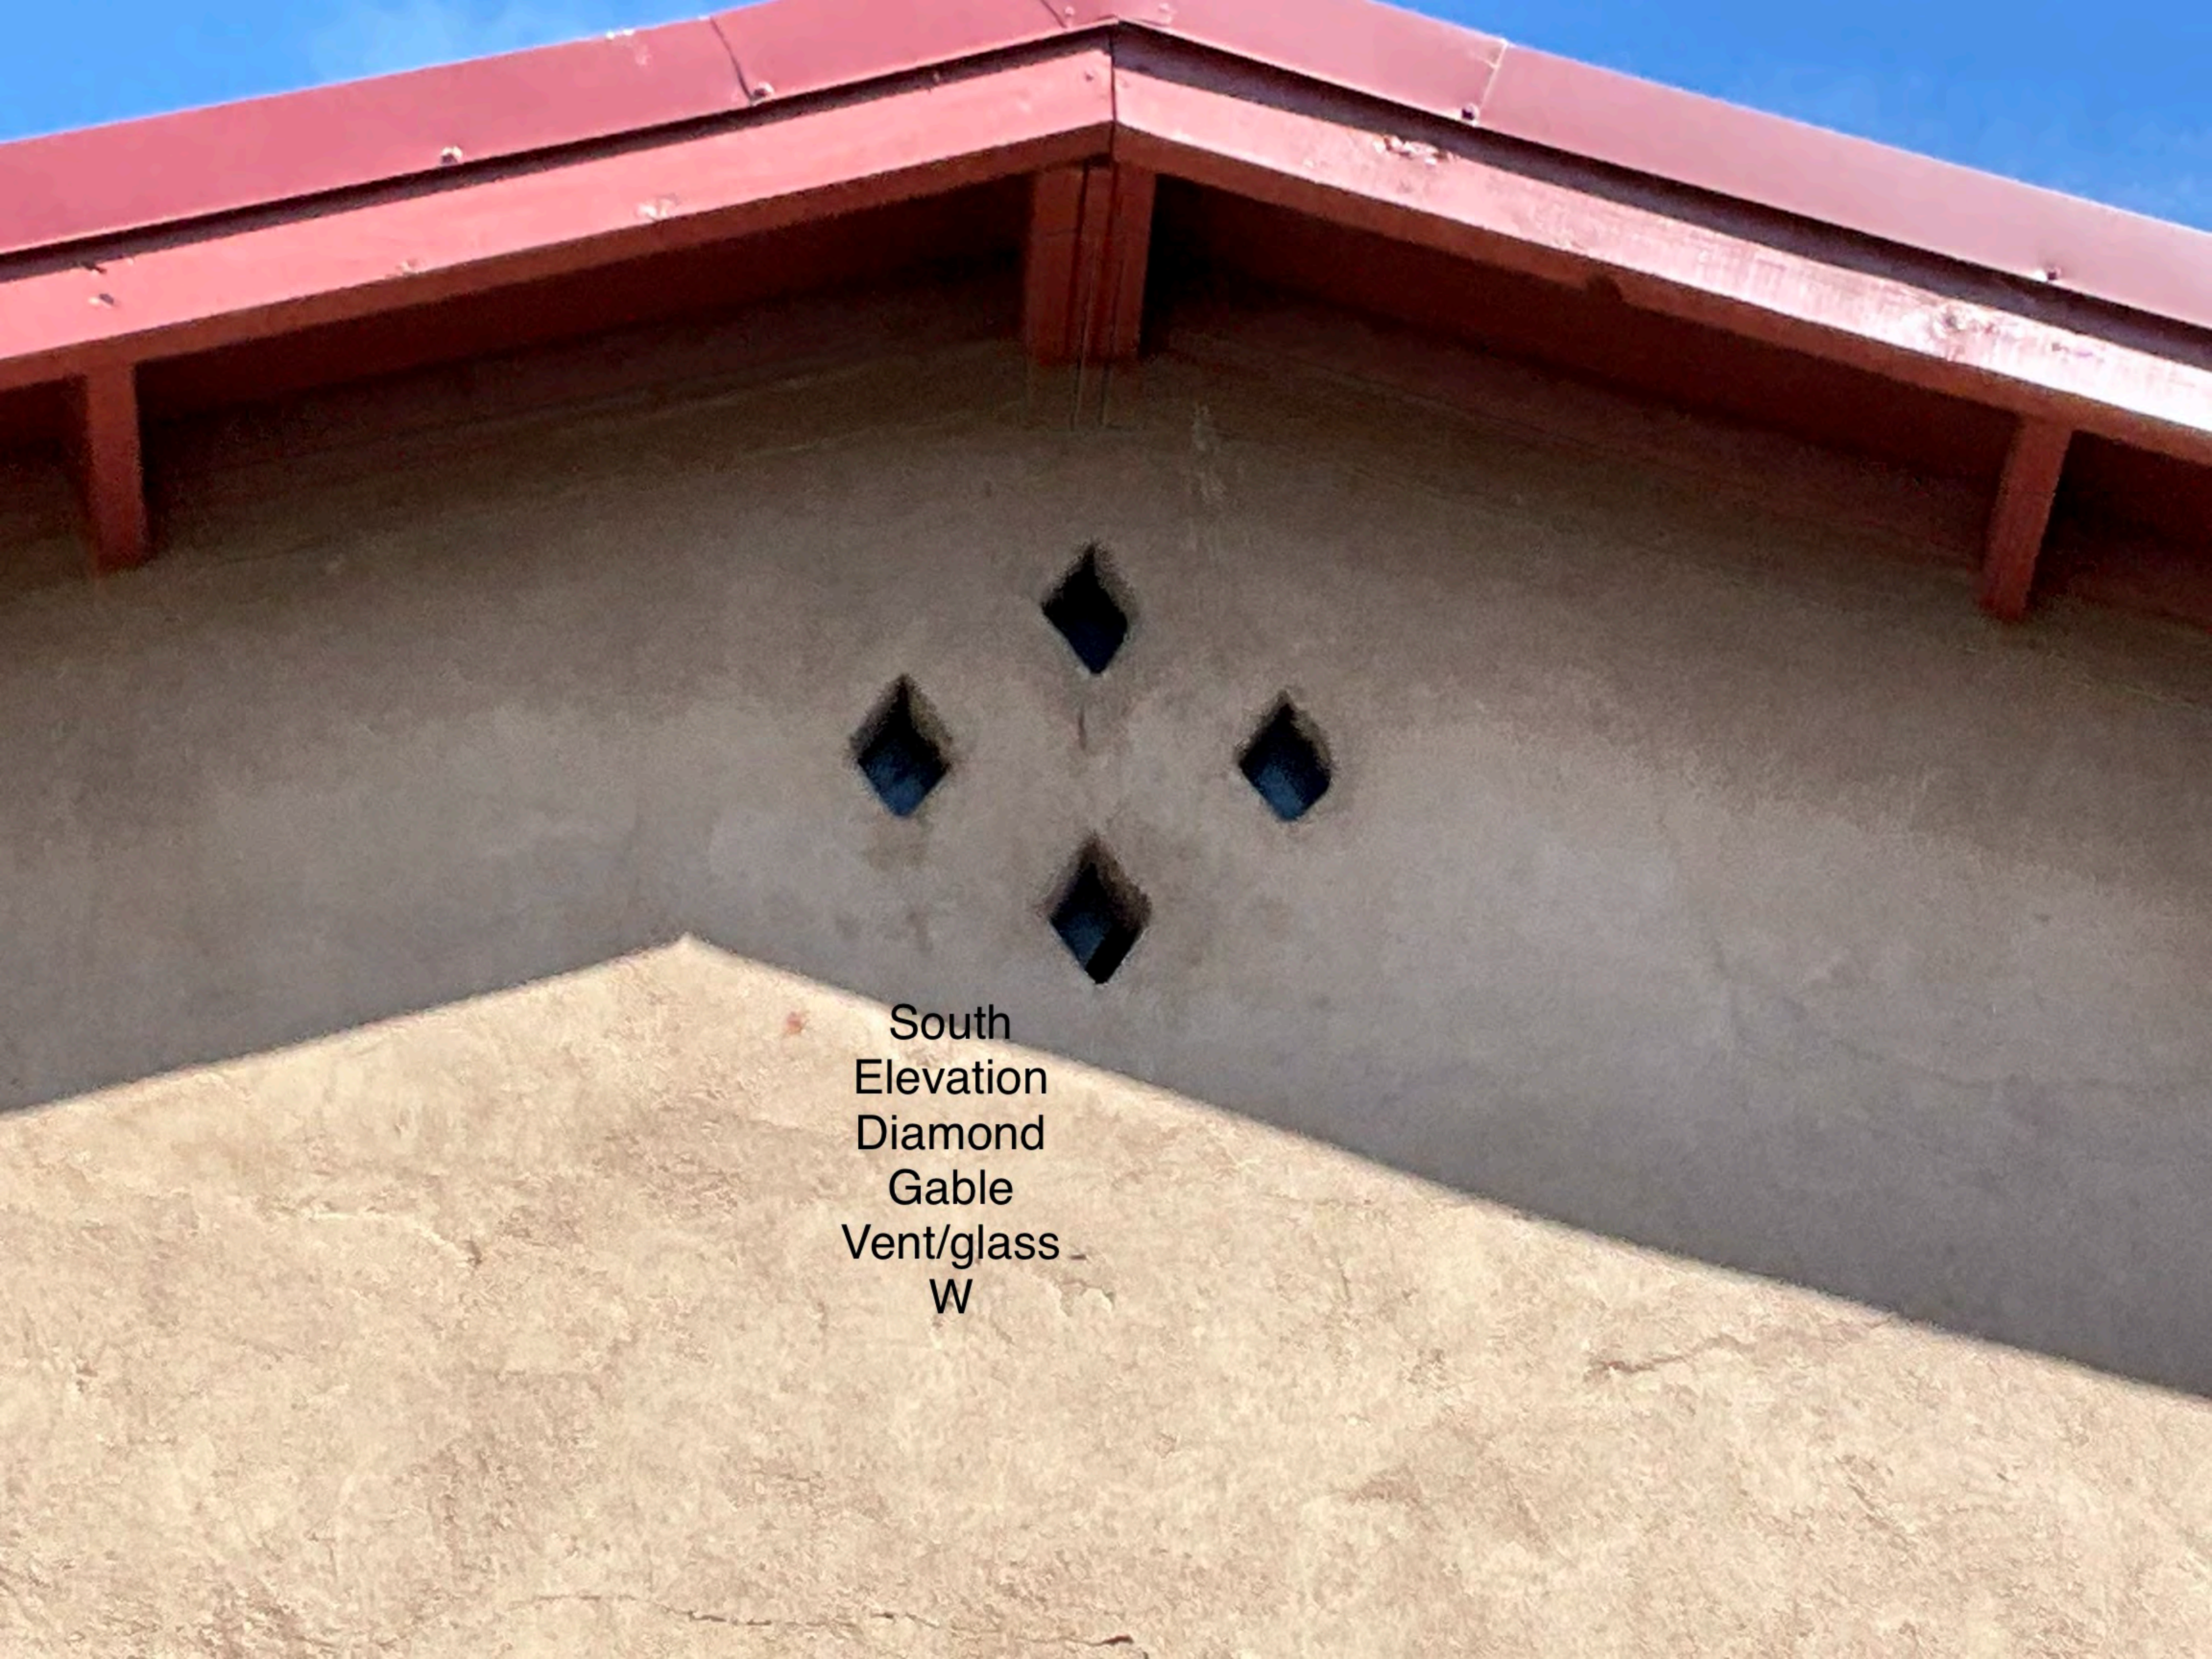
East
Elevation
Diamond
Vent/glass
V

East and south gable vents should be vents however have glass on the inside and not venting to facilitate with attic air flow.

LABEL	WINDOW & DOOR DESCRIPTION	CONDITION & INTEGRITY CODE	HISTORIC/NON-HISTORIC – AGE
GABLE VENTS			
<u>EAST</u>			
V	4 – DIAMOND GLASS	F	HISTORIC – THERE IS A PLATE GLASS ON THE BACK SIDE OF CUT HOLES INTO THE STUCCO (NOT VENTS, HOWEVER THERE SHOULD BE VENTS FOR VENTING THE ATTIC)
<u>SOUTH</u>			
W	4 – DIAMOND GLASS		HISTORIC – THERE IS A PLATE GLASS ON THE BACK SIDE OF CUT HOLES INTO THE STUCCO (NOT VENTS, HOWEVER THERE SHOULD BE VENTS FOR VENTING THE ATTIC)
