Historic Cultural Properties Inventory (HCPI) Base Form (FORM 1)

For HPD Office use only:		District No. _____		NRHP	SRCP	Criteria	A	B	C	D
1. Name of property: Catherine D. Janney/ Waldo and Ernestine Anton/ Henry and Virginia Wicks House		2. Location: 521 Calle Corvo Downtown and Eastside Historic District – Santa Fe		3. Local Reference Number: Santa Fe ID: H-632		4. County: Santa Fe Parcel # 13018752

8. Name of Project: HDRB Status Evaluation										
9. Lat/Long: 35.6819669,-105.9329764										
10. Photo Information: Giulia Caporuscio, photographer. Photo 1: View of south elevation. Facing northwest.

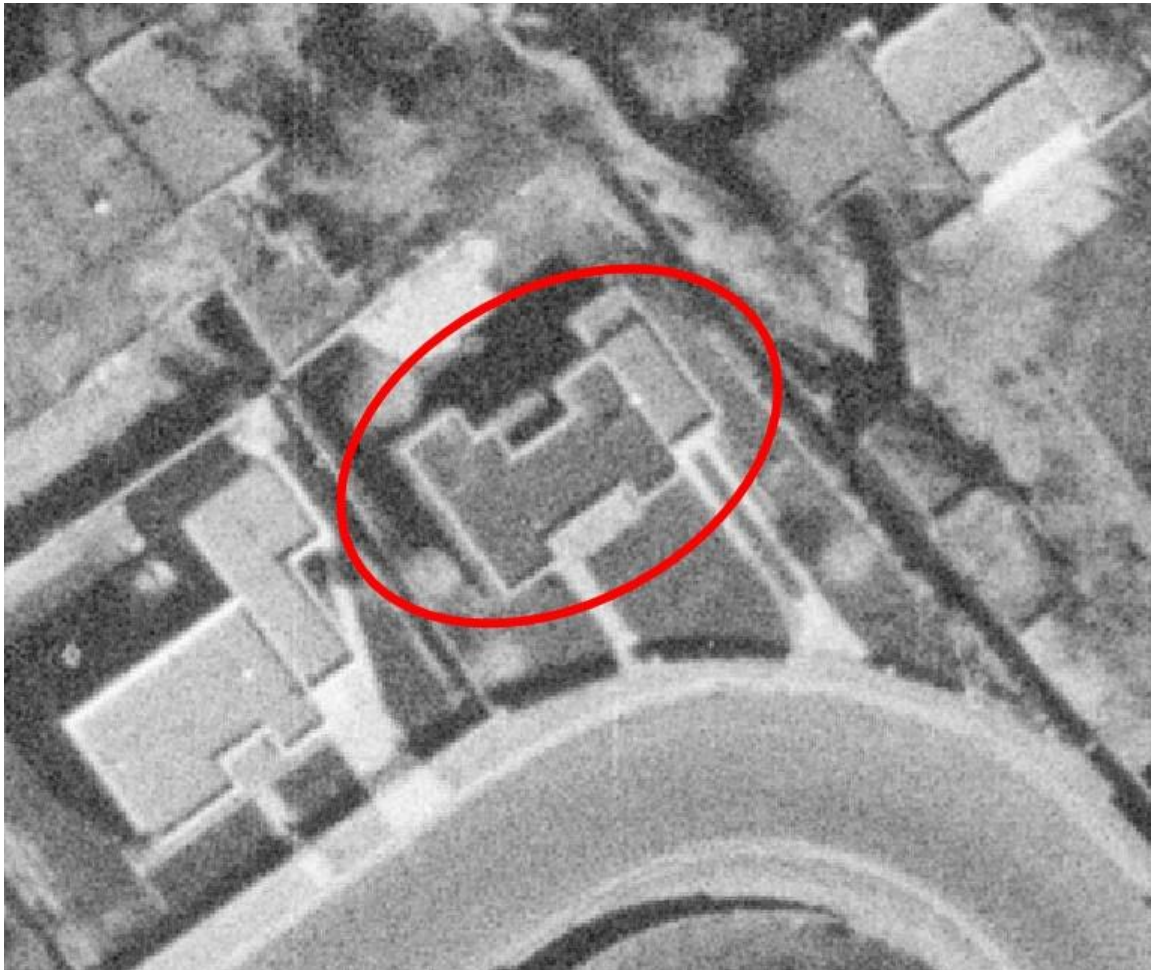
Erected in 1946–47, the house at 521 Calle Corvo has retained its massing and footprint since at least 1958, as confirmed by an aerial photograph from that year (Fig. 3). Although windows and doors have likely been replaced, the fenestration openings appear to remain in their original dimensions. The front yard wall, while compatible with the Calle Corvo streetscape, was constructed after 1984.

Figure 3: November 10, 1958, aerial photograph.
Shed is present.

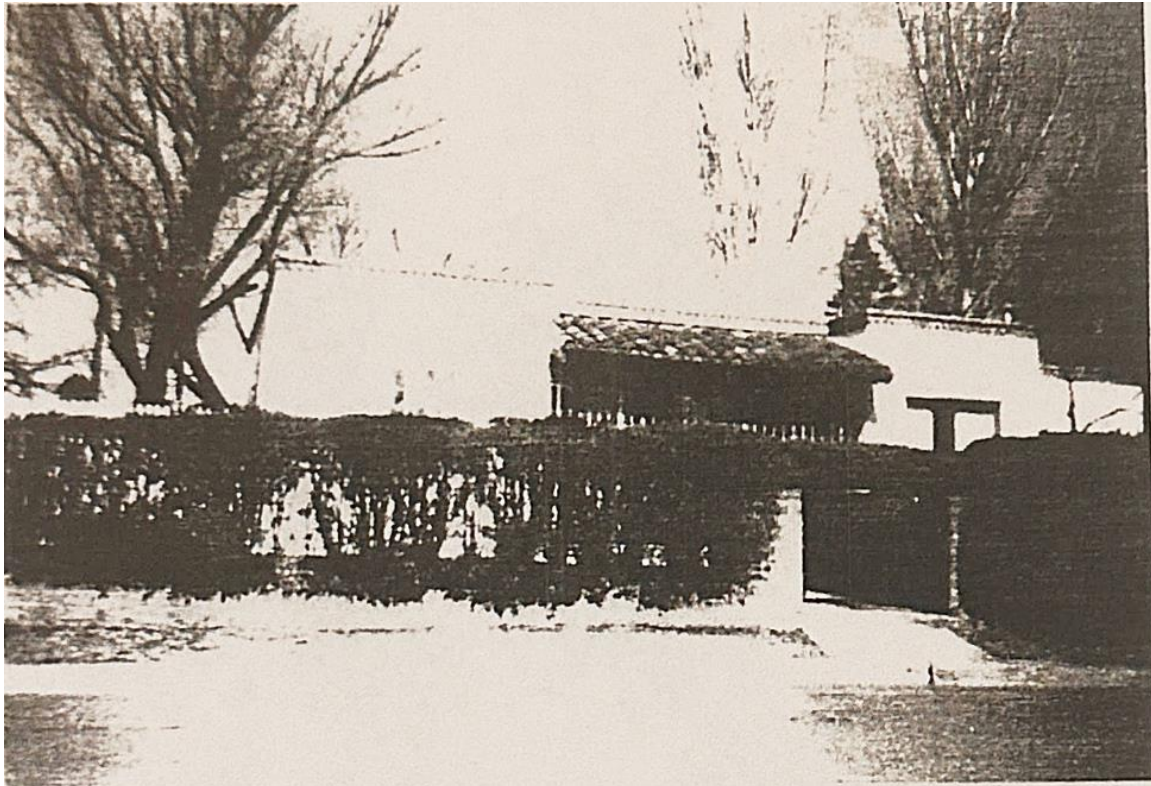
Figure 5: December 12, 1984, HBI survey photograph. Michael Belshaw. Note front yard wall.

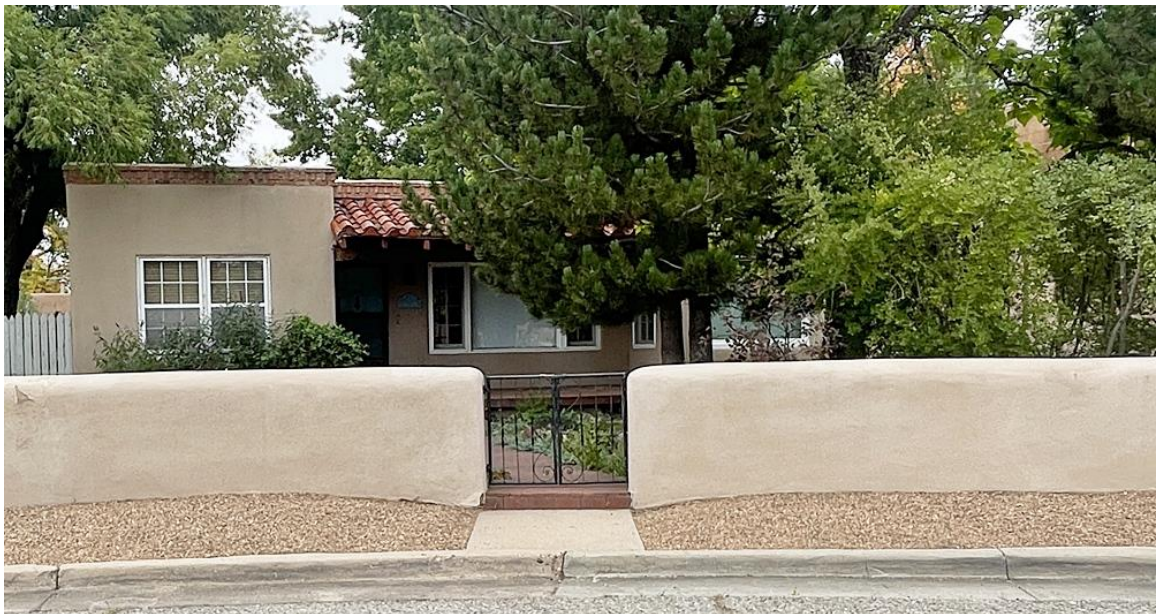
A roughly three-foot-high, two-foot-wide adobe wall extends along the front property line (Photo 2). Near the center, a steel entry gate opens onto a brick walkway leading to the main entrance. Comparison with a 1978 aerial photograph and the 1984 HBI suggests that the wall is relatively recent, replacing what had historically been a hedge (Figs. 4 & 5). The rear patio walls are also of modern construction.

Photo 2: House and setting. Camera facing northeast.

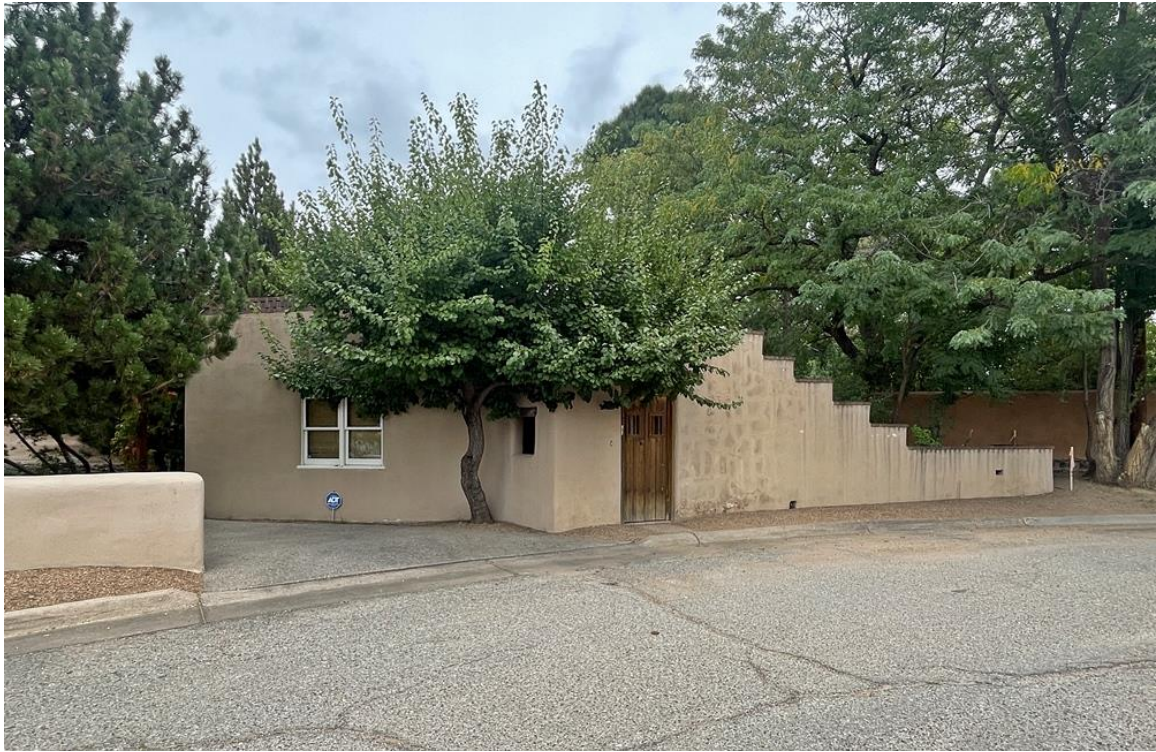
Photo 3: 521 A Calle Corvo. Newer building not included in survey. Camera facing southeast.

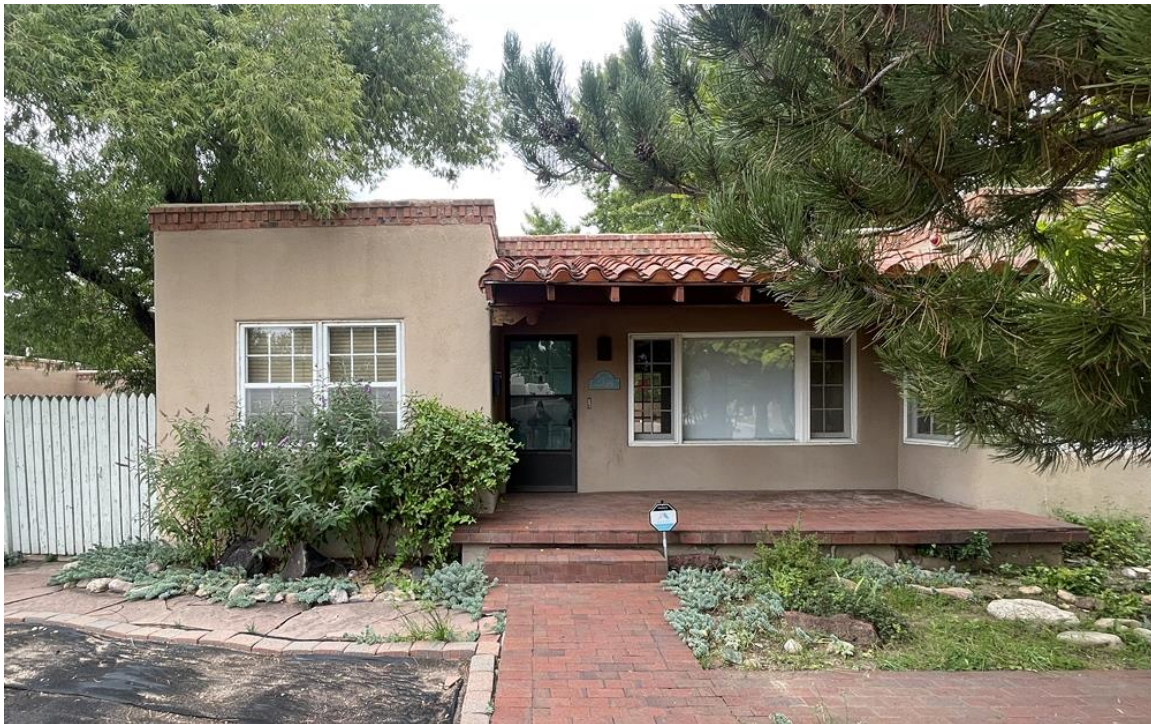
The west projection contains a sitting area with paired six-over-six double-hung sash set closely together without a mullion (Photo 4). Like many of the house’s windows, these are covered by exterior storm units. The east projection contains a modern fixed window that lights a small dining room (Photo 5). Between these two bays lies the *portal*—a four-foot-deep space with a brick floor and a shed roof tiled in clay Spanish units. The use of clay tile over entry roofs is uncommon in the subdivision and contributes to the house’s distinctive appearance.

Photo 4: South (front) façade, west and center sections. Camera facing northeast.

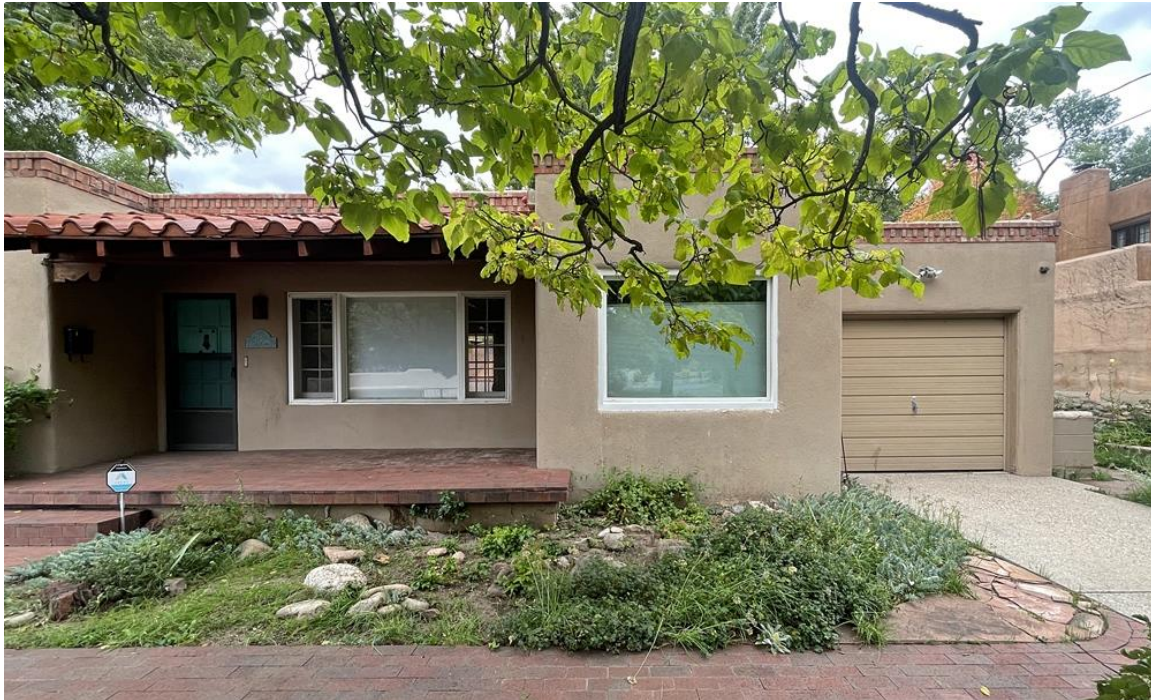
Photo 5: South (front) façade, center and east sections. Camera facing northeast.

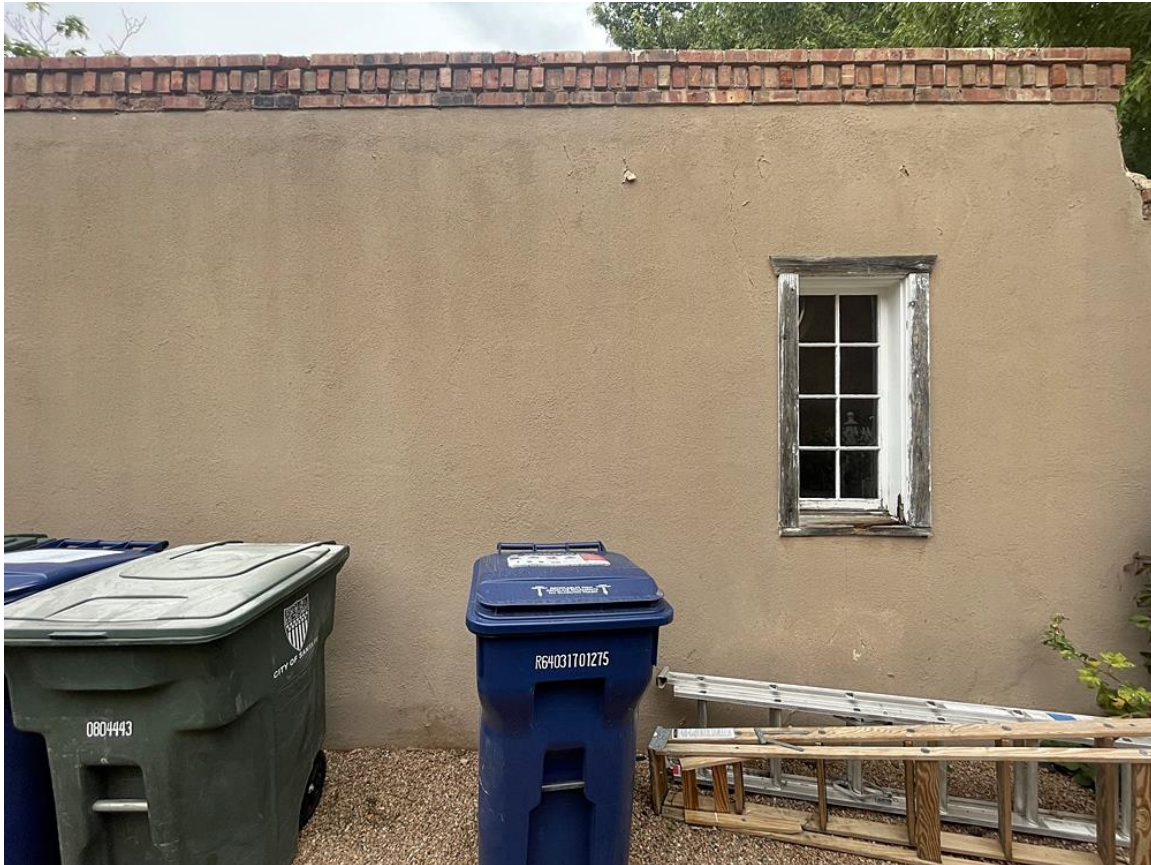
To the east of the living area, slightly recessed and of lower height, is a one-car garage (Photo 6). It is fitted with a sectional metal overhead door. The integration of an

The short east elevation faces a small side yard and contains a single eight-light wood-sash window set deeply within the adobe wall (Photo 6).

Photo 6: West elevation. Camera facing northwest.

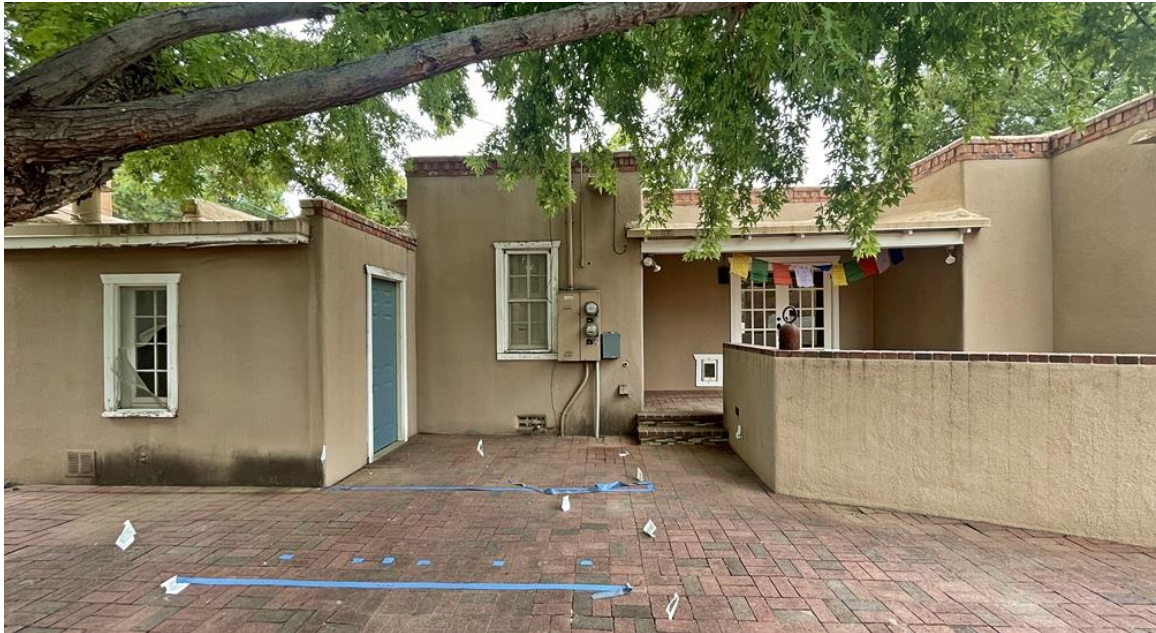
At the east end, the garage extends outward from the house and is fenestrated with an eight-light wood-sash window and a large paneled wood door painted blue (Photo 7). West of the garage is a four-over-four wood double-hung sash lighting the laundry room. The central portion of the elevation includes a small portal that shelters a pair of fifteen-light French doors opening to the living room (Photo 8). The façade terminates in a projecting bay that encloses the primary bedroom, entered from the exterior through a fifteen-light wood door.

Photo 7: North (rear) elevation, east and center sections. Camera facing southwest.

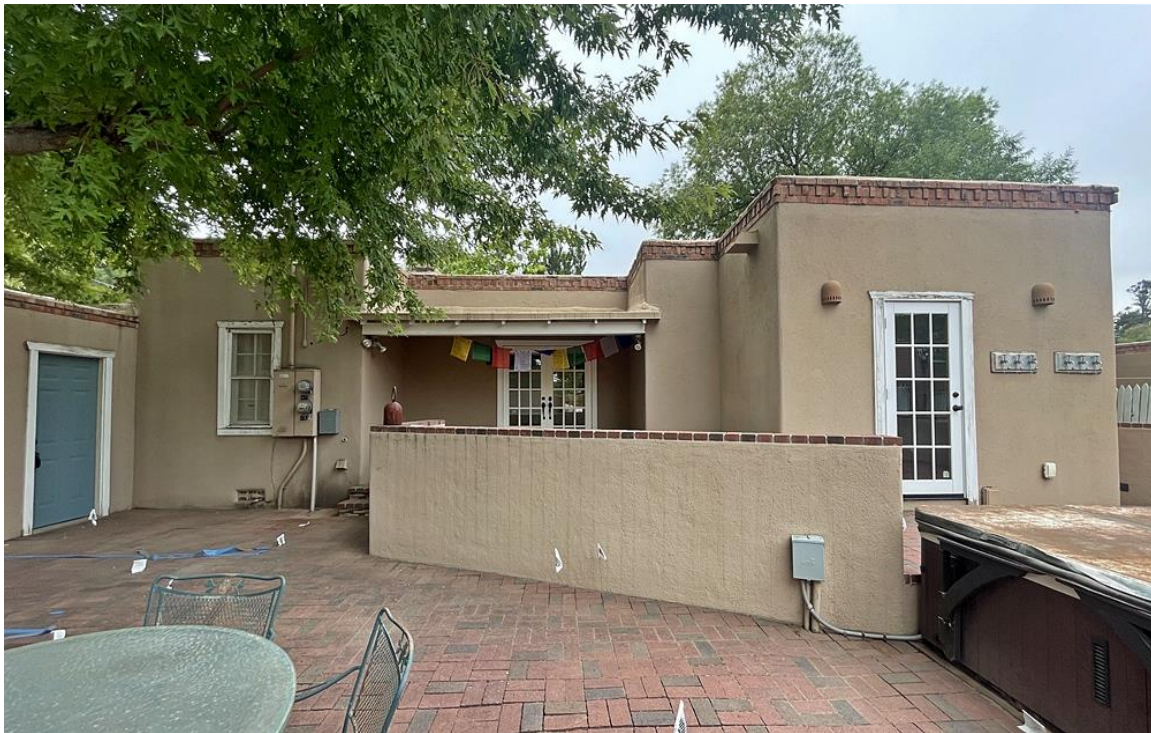
Photo 8: North (rear) elevation, center and west sections. Camera facing southwest.

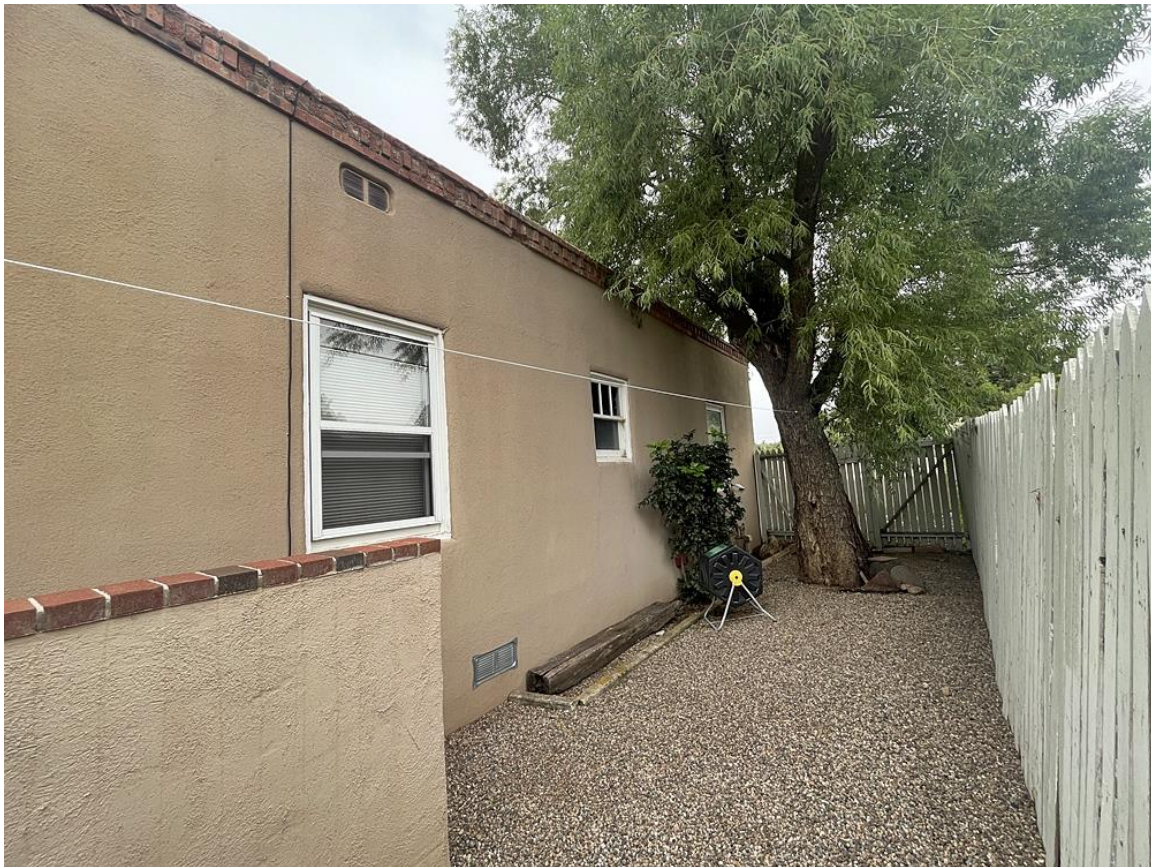
This elevation parallels a graveled side yard and contains several wood-sash windows serving the primary bedroom, bathroom, and sitting room (Photos 9 and 10).

Photo 9: West elevation. Camera facing southeast.

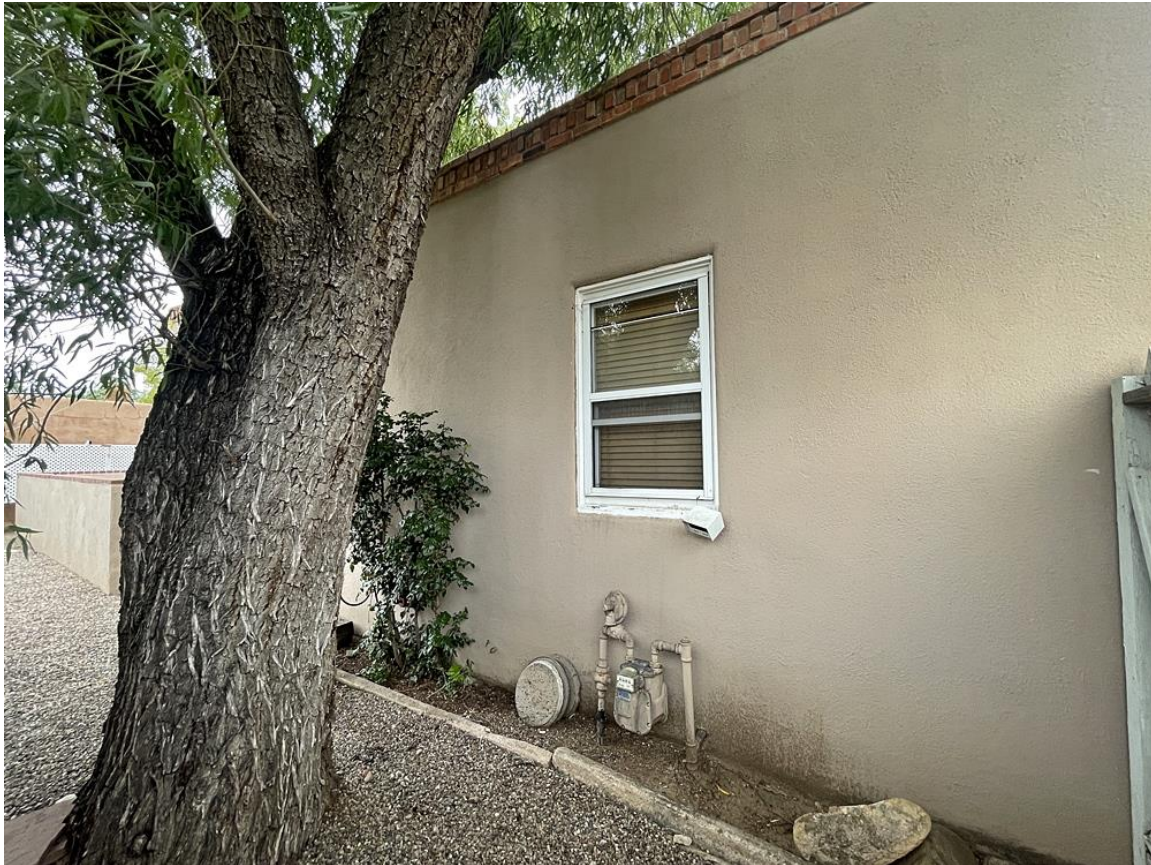
Photo 10: West elevation. Camera facing northeast.
