Status Review Request

310 Lomita St, Santa Fe, NM 87505

Historic Cultural Properties Inventory (HCPI) Base Form (FORM 1)

1. Name of property: Robert and Agnes McBride House	2. Location: 310 Lomita Street Don Gaspar Area Historic District – Santa Fe	3. Local Reference Number: Santa Fe ID: H-2551 4. County: Santa Fe Parcel # 11624320

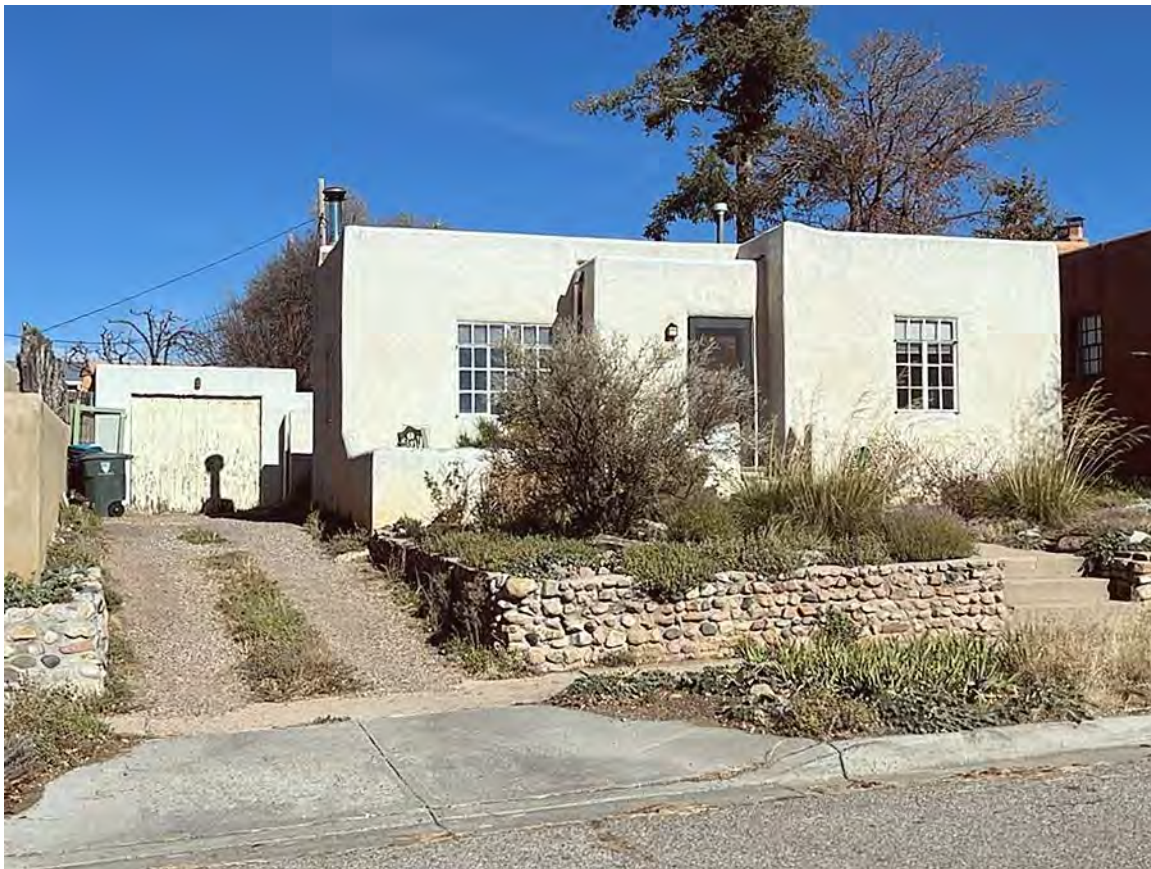
The house stands on a rectangular lot on the north side of Lomita Street, one parcel west of its intersection with Don Cubero Avenue. It is within the Linda Vista Addition, a 1940–41 subdivision of modest single-family residences set on uniform lots with consistent street setbacks. It sits above street grade, with a low arroyo-stone retaining wall defining the front terrace and a short flight of concrete steps leading to the entry (Photo 2).

Photo 2: Property setting. Camera facing northeast.

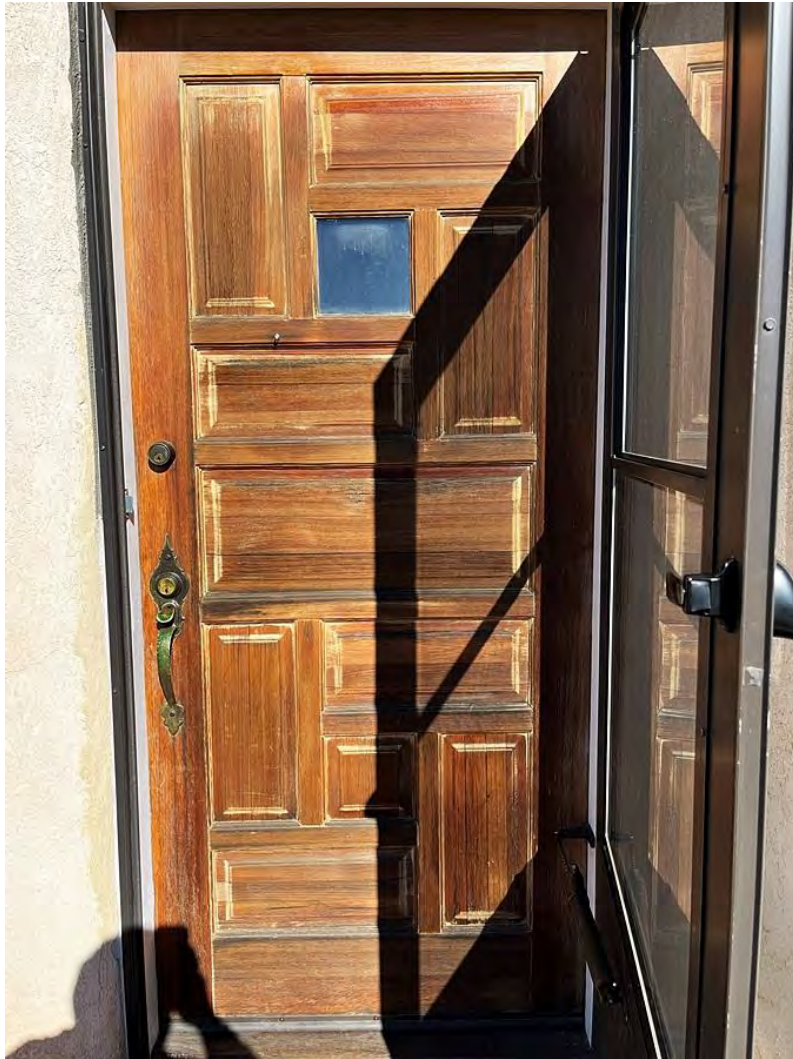
15. Modifications: <input checked="" type="checkbox"/> <input type="checkbox"/> No known modifications																																							
#1 Date: Post-1995; replacement of front and back doors; 1995 HBI form.

Projecting forward at the center (and at a lower height than the main wall), is a small volume containing the front door and entry. The original door has been replaced with a decorative panel unit (Photo 5). Stepping out farther still is a larger volume at the height of the principal roof that contains the front room. Its west parapet end rises in a slight “batwing” flare, a form that appears characteristic of Kirk’s residential work in Linda Vista. This space is lit by paired six-light casement windows topped by a fixed transom (Photo 6).

Photo 5: South (front) façade. Camera facing north.

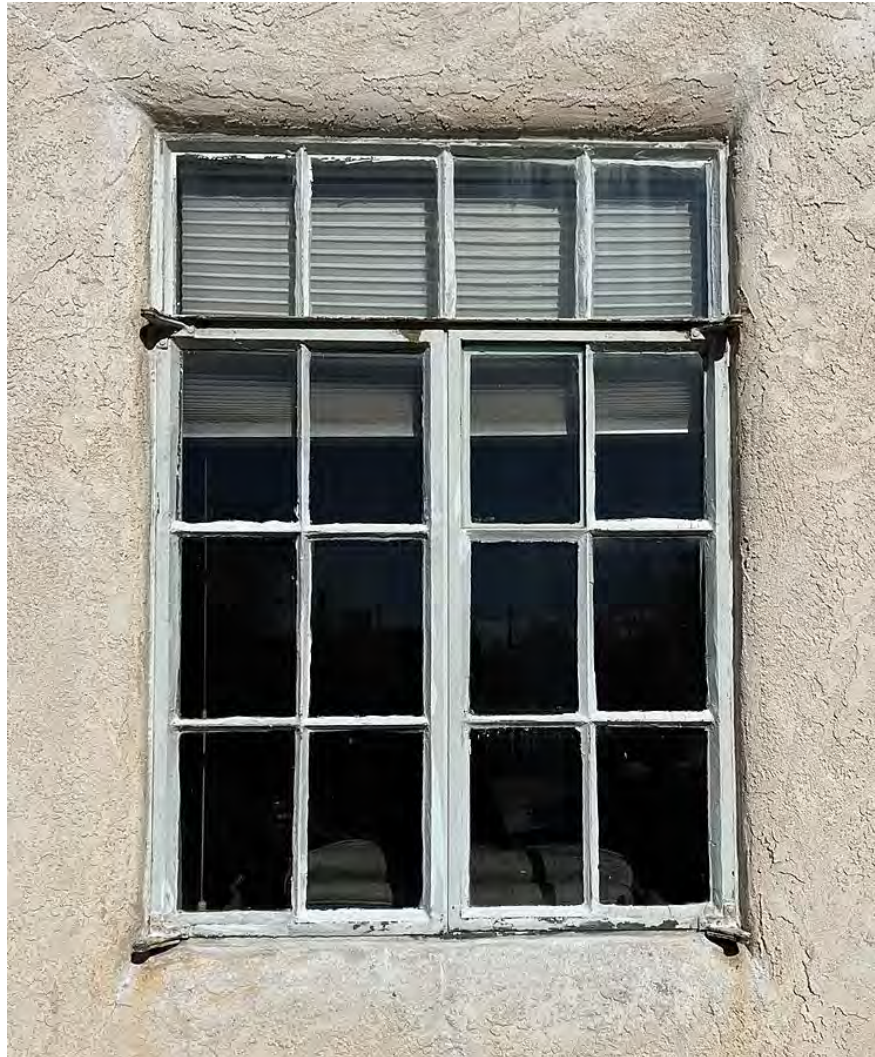
Photo 6: South (front) façade. Front bedroom window. Camera facing north.

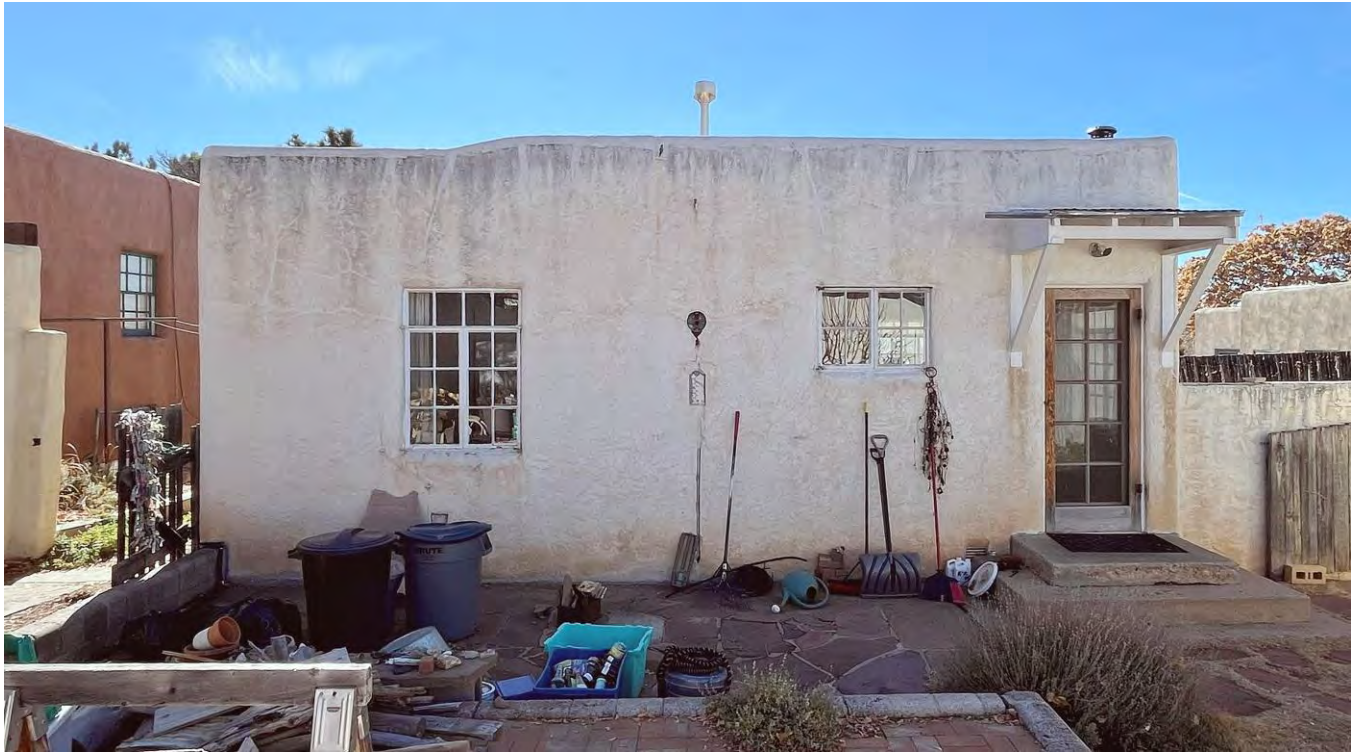
The north elevation overlooks the backyard and contains two steel casement windows of the same type and vintage as those on the south and east sides of the house (Photo 8). The larger window lights the rear bedroom, while a smaller unit illuminates the kitchen. At the northwest corner is an entry door leading directly into the kitchen. The existing ten-light wood door is a replacement and is sheltered by a non-historic wood canopy (Photo 9).

Photo 8: North elevation. Camera facing south.

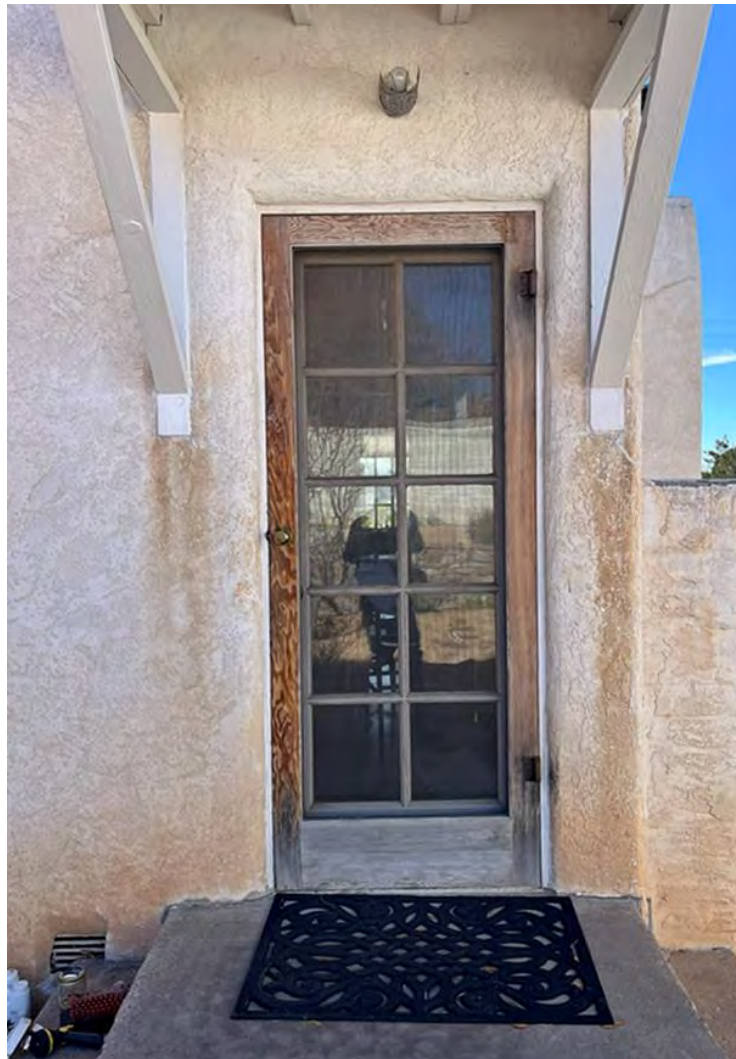
Photo 9: North elevation. Kitchen entry door. Camera facing south.

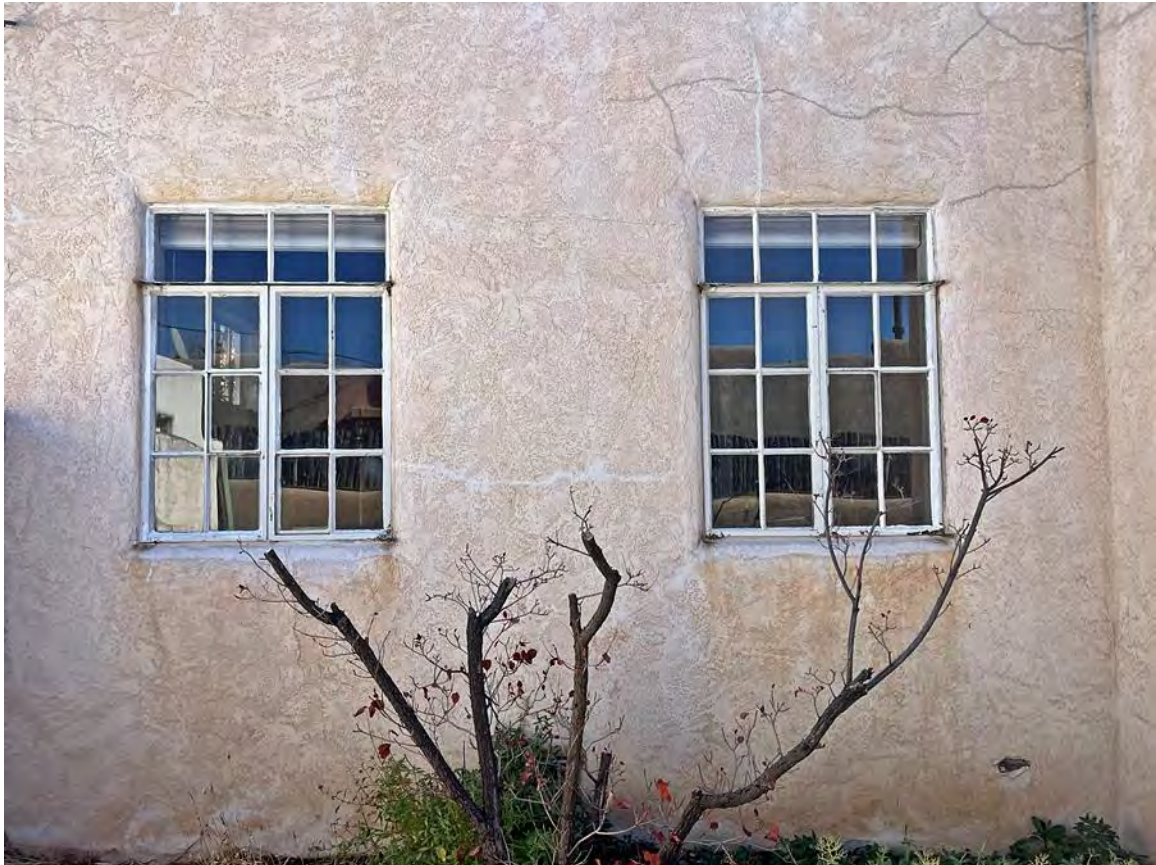
Set along the driveway, the west elevation is defined by a shallow wall recess containing paired six-light steel casement windows lighting the kitchen (Photo 10), with an additional casement serving the living room (Photo 11). A crawl-space hatch is located below the living-room window. At the northwest corner of the living room, a stuccoed

Photo 10: West elevation, north end. Camera facing east.

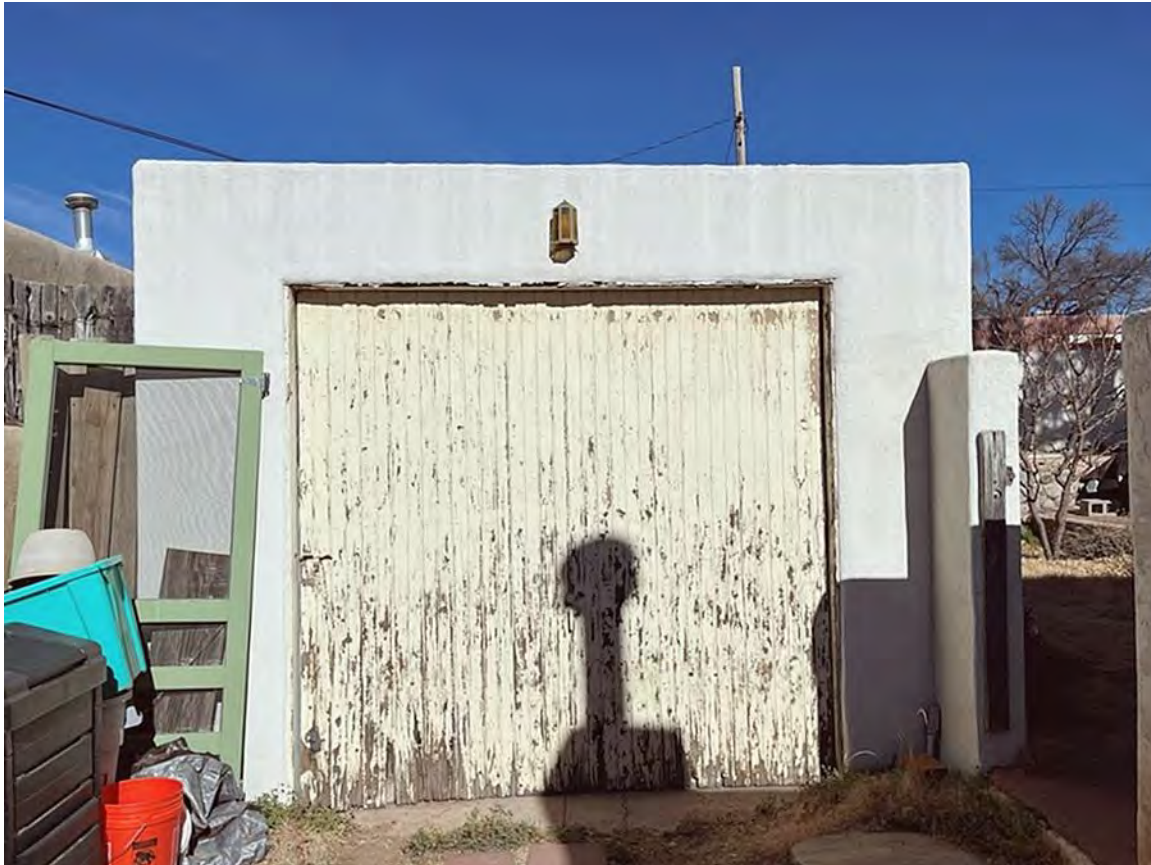
Situated at the end of the driveway is an approximately 300-square-foot, one-car garage, constructed contemporaneously with the house (Photo 12). Its roughly 95-inch-wide opening is fitted with a tongue-and-groove tilt-up door painted yellow. Centered above the opening is a small six-sided carriage light, a common sconce type found on Santa Fe houses of this vintage.

The detached one-car garage at the rear of the lot appears to date from the original construction period and retains its form, footprint, and characteristic tongue-and-groove tilt-up door. Because it continues to reflect its historic use and relationship to the house, the garage is recommended as Contributing, with the south elevation identified as its primary façade.

Photo 12: Garage. South elevation. Camera facing north.

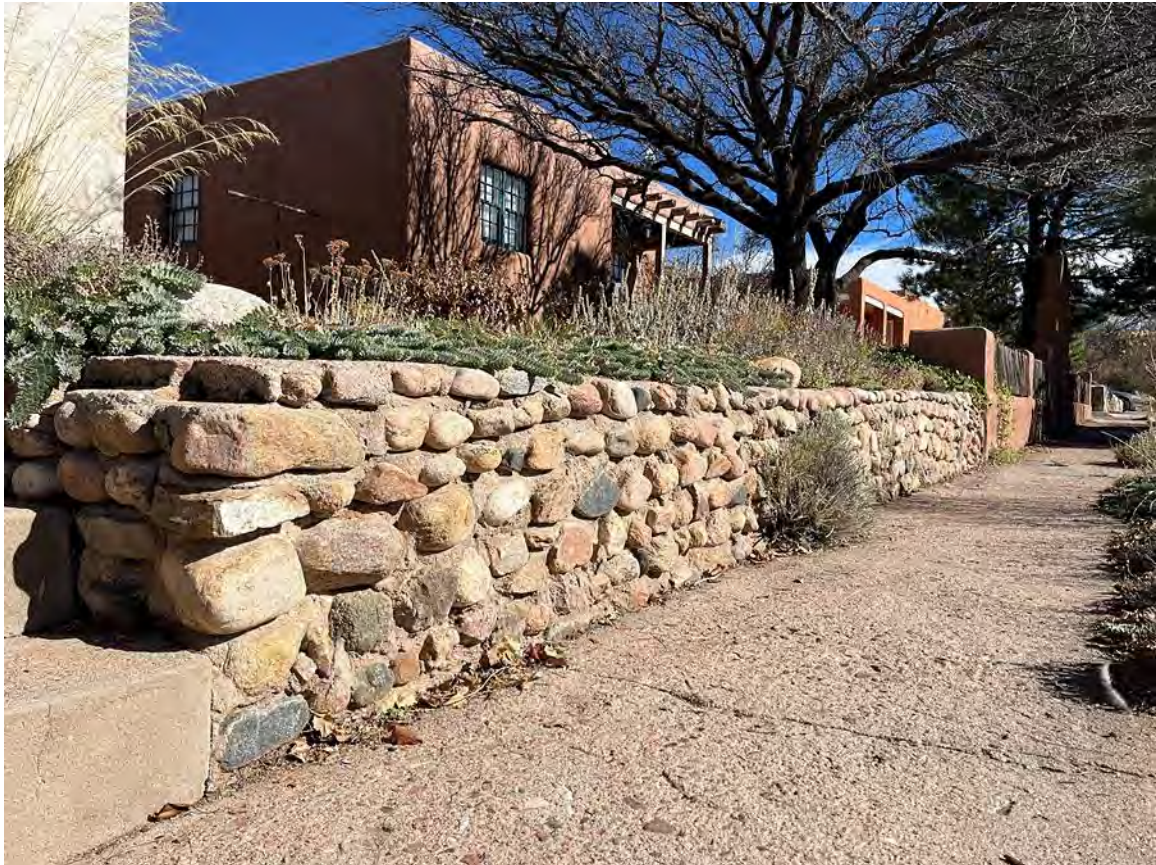
Spanning the front of the property is a knee-high stone retaining wall constructed of rounded arroyo stones that hold back the front yard terrace (Photo 13). The wall stands between 22 and 26 inches high and consists of untooled, naturally shaped stones, likely collected from a local arroyo. The stones are laid in seven regular courses set in weathered cement mortar. At the west end, the wall turns to the north, following the driveway. Near the center of the wall is a four-foot-wide opening leading to the concrete steps. The steps and adjoining concrete sidewalk were likely installed by Linda Vista’s developer, S. L. Kirk.

The arroyo-stone retaining wall spanning the front of the lot appears original to the development of the property and defines the raised terrace that visually sets the house above the street. Its material, form, and workmanship remain intact. The retaining wall is recommended as Contributing.

Photo 13: Stone retaining wall. Camera facing northeast.
