PROJECT 2025-011108-HDRB, 532 Calle Corvo, Downtown and Eastside Historic District,
DESC: Non-contributing, John Padilla, agent for Susan McShane Salomone, owner, requests status review with primary façade(s) designation if applicable.

CASE NUMBER: 2025-011108--HDRB

PROJECT TYPE: Historic Status Review

Historic Cultural Properties Inventory (HCPI) Base Form (FORM 1)

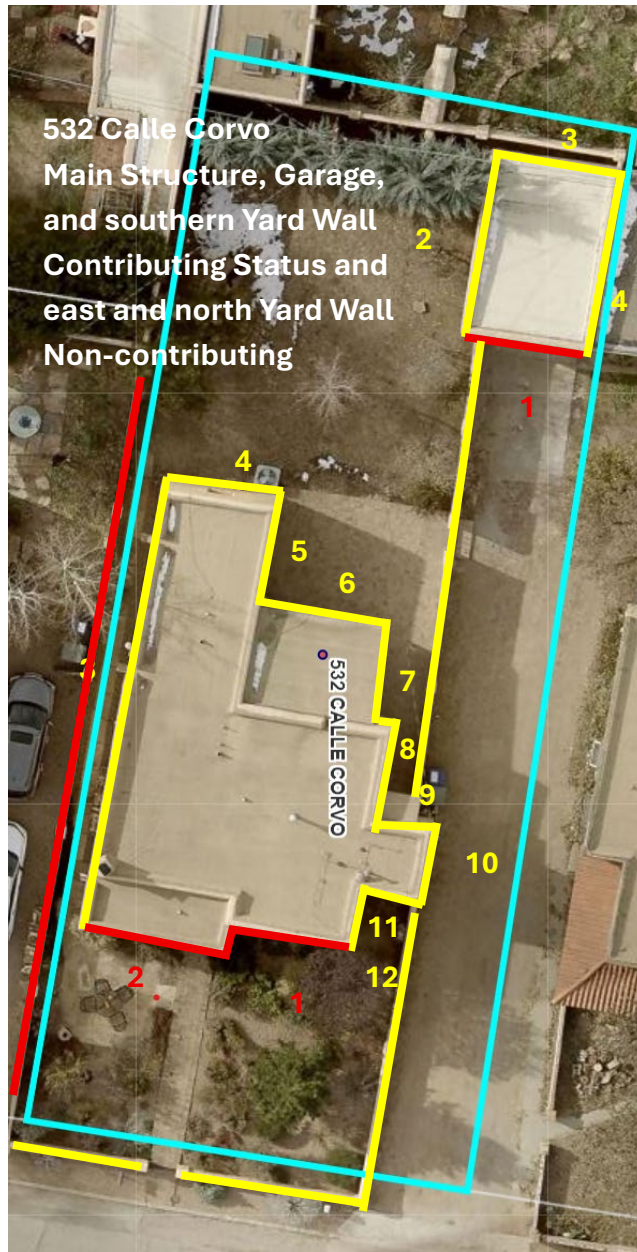
Figure 1: Façade Diagram for 532 Calle Corvo.

This is to certify that the Historic Districts Review Board (HDRB) acted on your request at their hearing on Sep 23, 2025. The decision of the Board was to adopt staff recommendations the historic status of the main residential structure, garage, and the southern yard wall be upgraded to contributing and designate the east façade's of each structure as the primary façades (numbers one and two on the façade drawing)

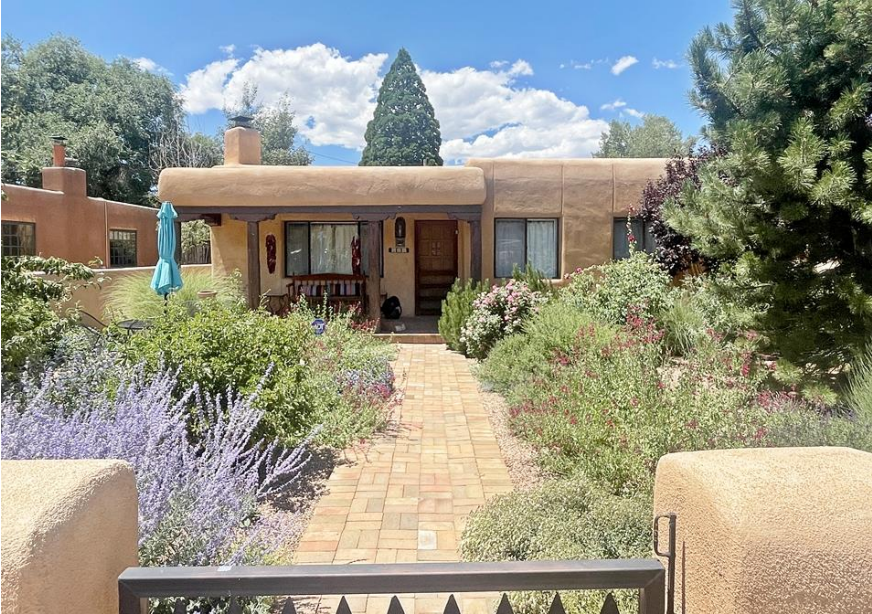
8. Name of Project: HDRB Status Evaluation		
9. Lat/Long: 35.6806349,-105.9331281		
10. Photo Information: Giulia Caporuscio, photographer. Photo 1: View of east elevation, facing northwest.

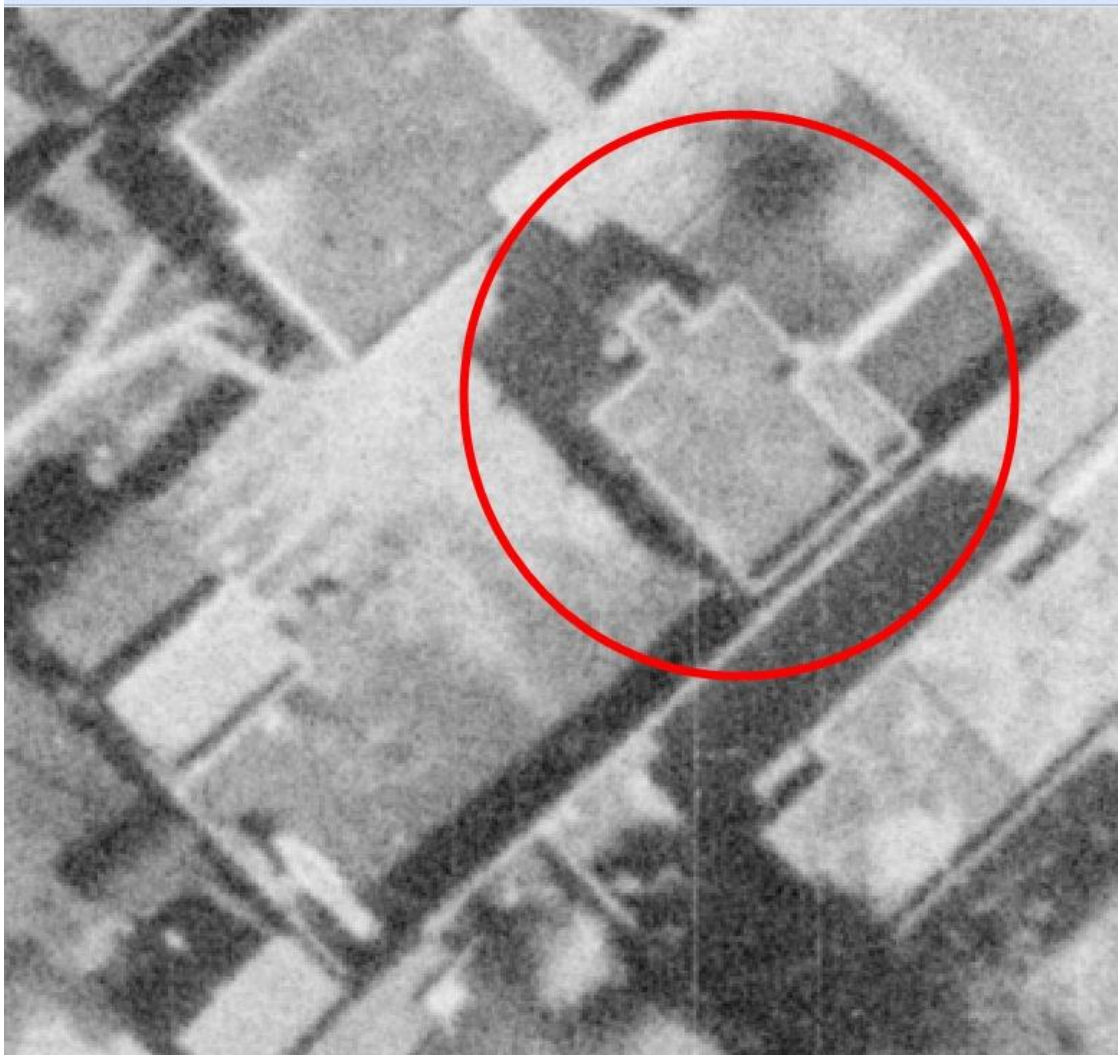
Figure 4: November 10, 1958, aerial photograph. Note original footprint of house and absence of walls except across the south property line.

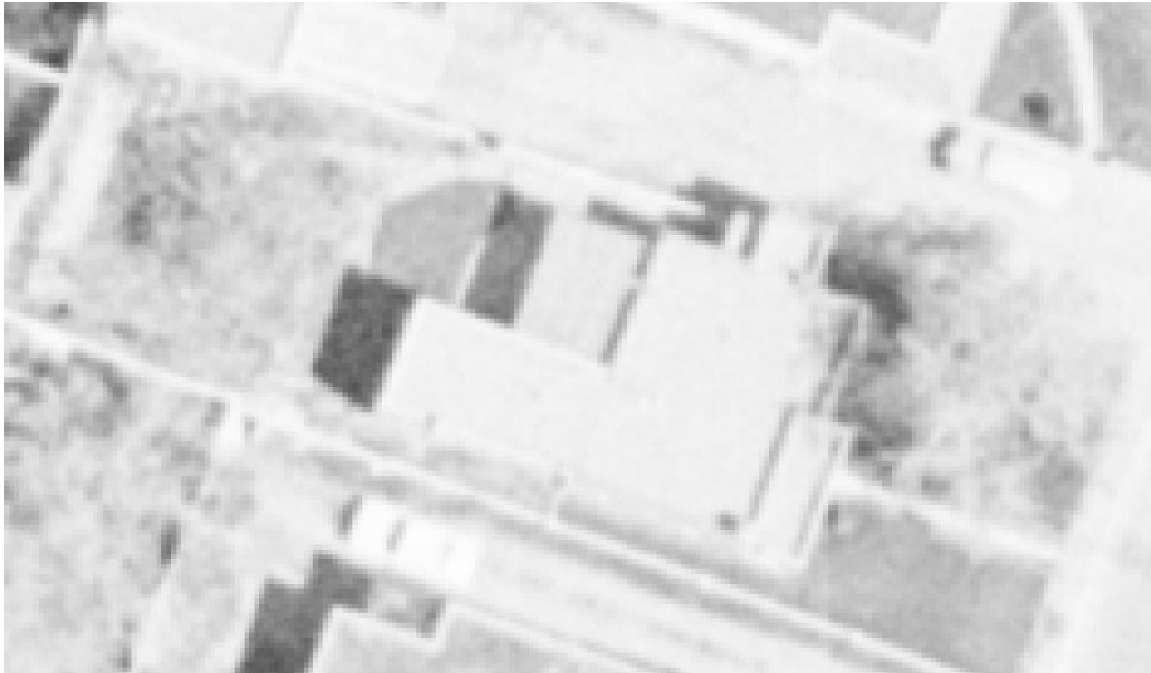
Figure 5: June 6, 1966, aerial photograph. Note presence of primary bedroom addition, roofed patio, and canopy over laundry room entry.

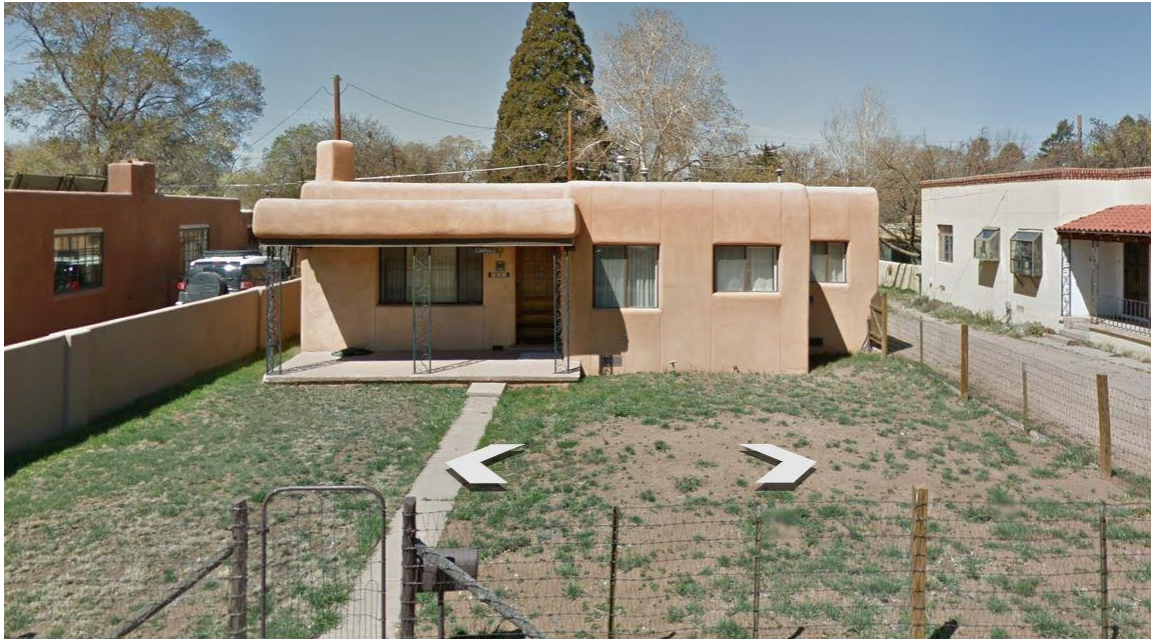
As shown in a 2014 Google Street View image (Fig. 6), the portal was previously supported by scrolled metal brackets. This prefabricated bracket type—advertised in the SANBUSCO catalog during the postwar period—was commonly used on modest Santa Fe homes for both structural and decorative effect. Identical supports remain on the adjoining house to the north.

Figure 6: April 2014 Google Street View image taken before Karen Parfitt Hughes purchased the property.
