Feasibility Study for the
Soldiers' Monument at the Santa Fe Plaza - FINAL REPORT

VOLUME I

December 5, 2025

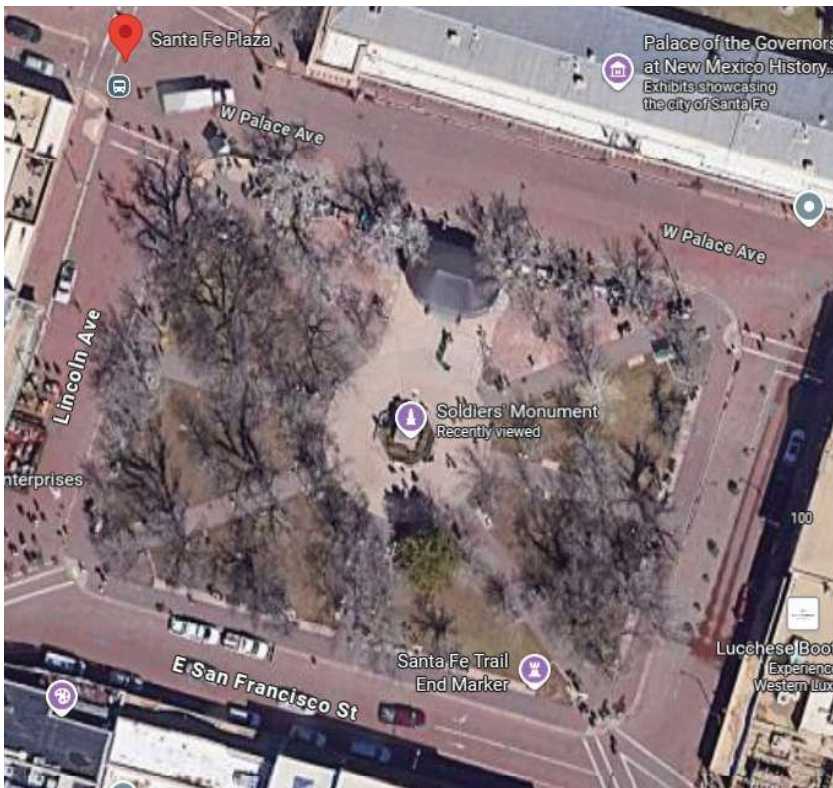
It appears that the damage done during the 2020 protest included paint and other materials that were attempted to be removed/cleaned from the monument. Areas are scratched, gouged, and scarred.

Historic mortar joints have disintegrated or have been opened up as a result of the cleaning. New darker color mortar has been installed in some areas and is still intact.

The sandstone components show signs of freeze-thaw damage where water has penetrated cracks on the surface. Some spalling has occurred and several areas are fragile to the touch.

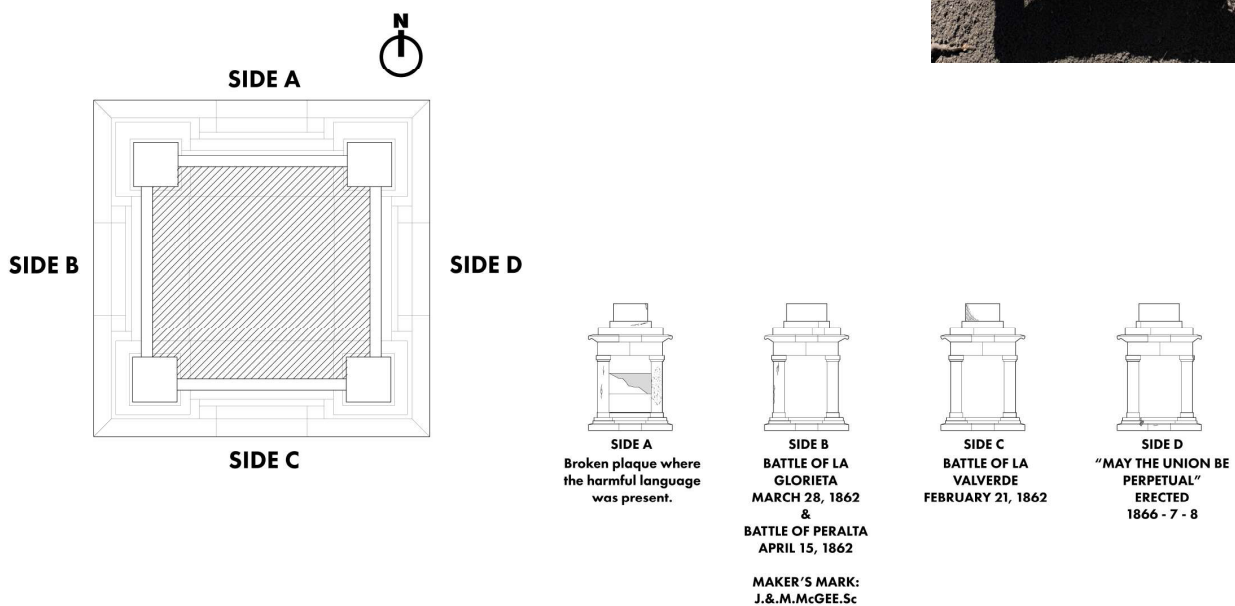
SOLDIER'S MONUMENT ELEVATIONS AS IT STAND TODAY

The monument's plinth is in fair to poor condition. The plinth appears to have a slight tilt to the southwest, but appears to be stable and unmoving. The bottom stones are slightly buried and continue below the grade at least 32". No visible sign of a footing was found when a small hole was dug to investigate it further. See structural report for more information.

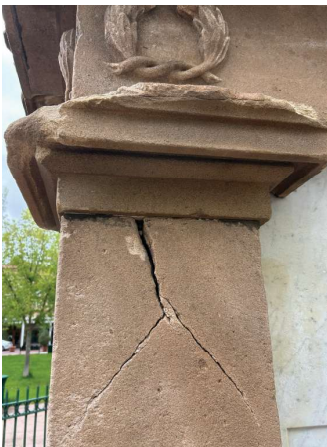
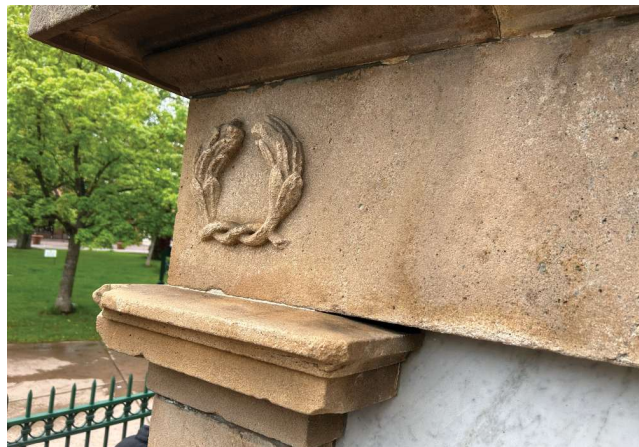
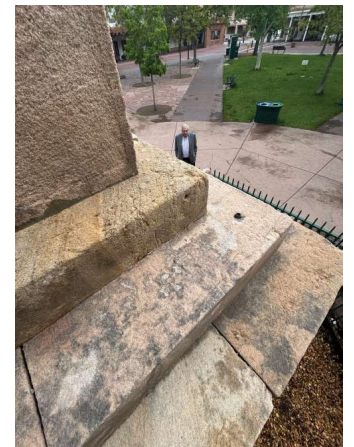
02.b.1.1 CAST STONE / SANDSTONE: It is presumed that there is a combination of historic cast stone and solid sandstone used for the monument. As each side of the monument exhibits duplicate intricate wreath designs, carving solid stone in such precise duplicity seems uncommon, but not unheard of among stone masons. The stone has weathered in time and is showing signs of moisture damage with mildew and lichen growth. This is typical of historic stone weathering.

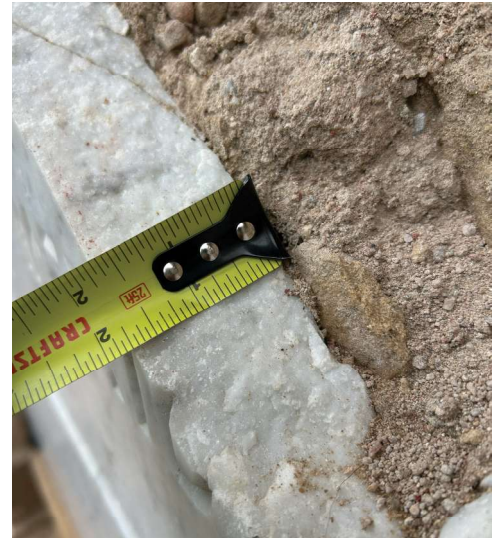
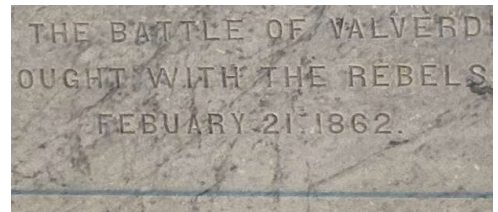
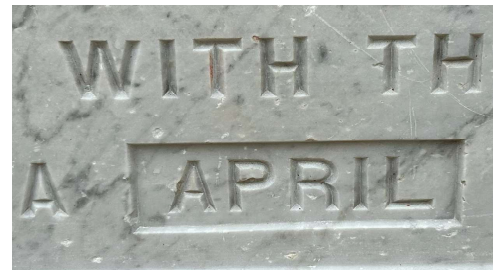
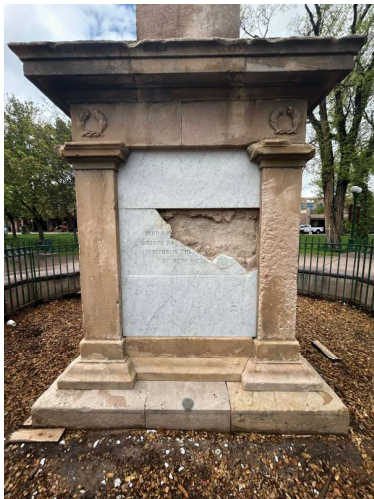
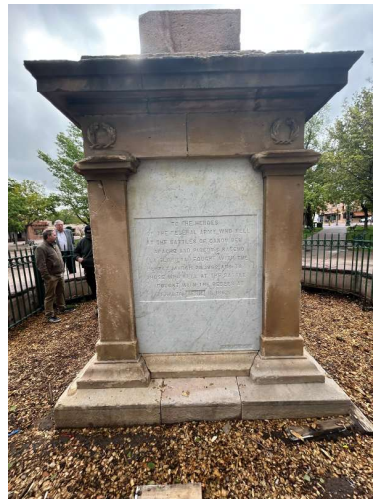
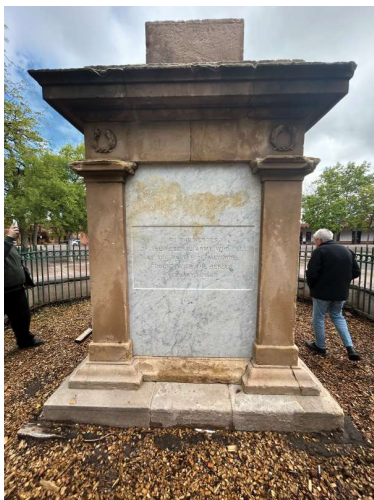
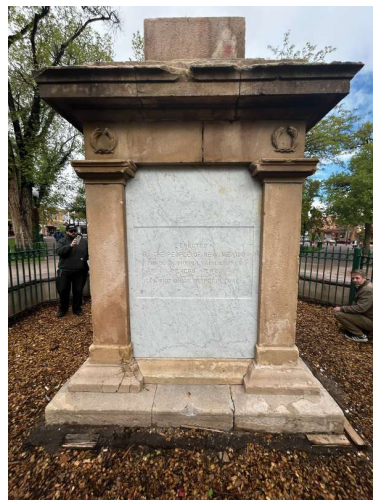
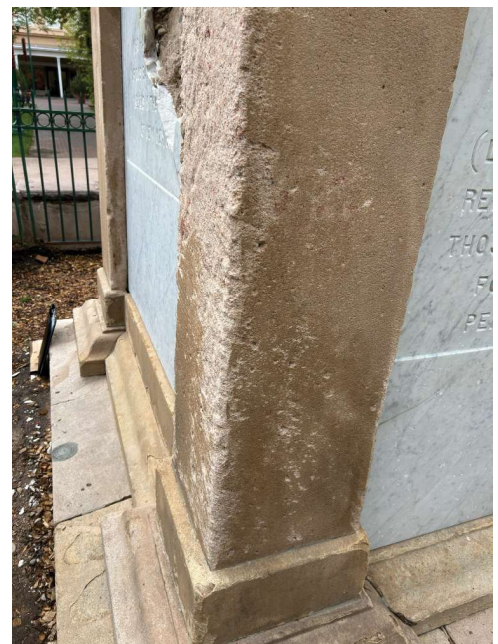
02.b.1.2 MARBLE: The marble is white, 1-3/4" or 2" thick panels installed vertically on all four sides. Inscriptions are complete with some typos or words removed, evident by the 1/4" indented inscription, highlighted in grey and others left unchecked, highlighted in yellow. They read as follows:

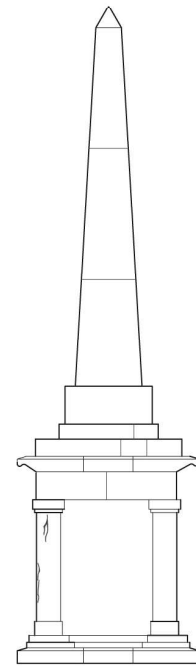
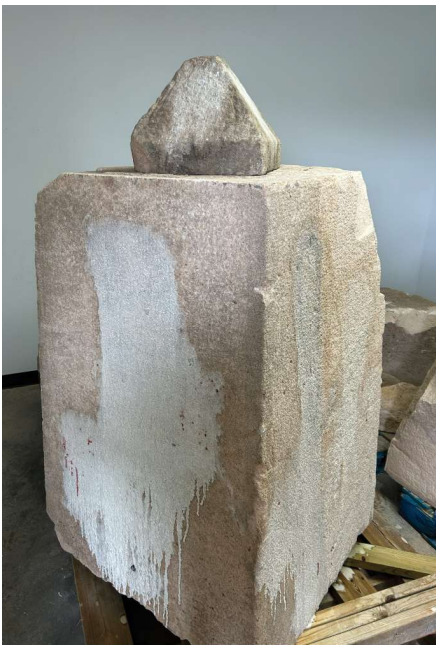
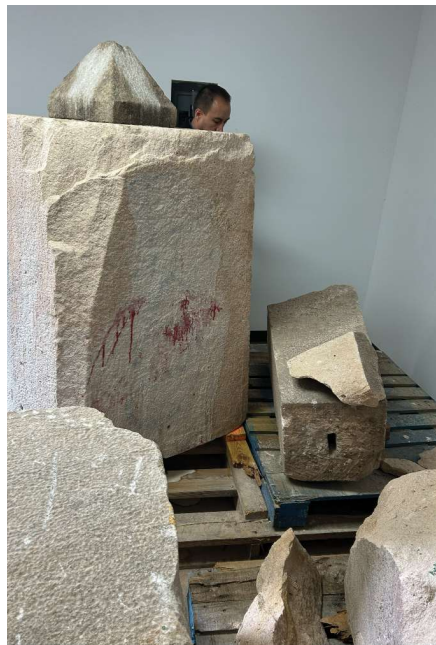
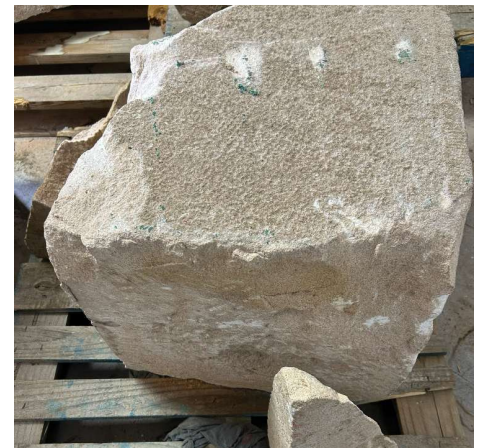
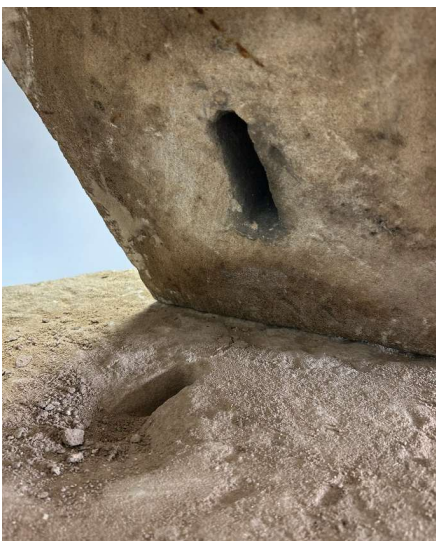
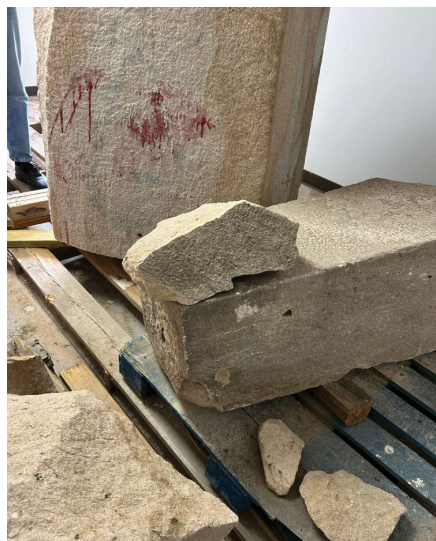
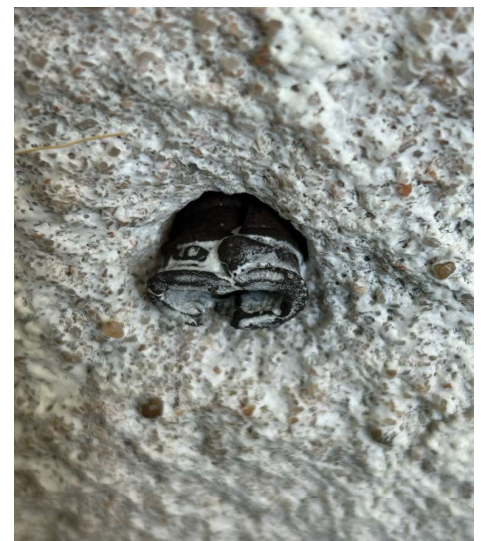
SIDE B

02.b.2.0 OBELISK: The obelisk was formed by stacking three four sided stone pieces atop the plinth with a capstone piece on top. The current remaining pieces of the obelisk are being stored in a secure location off-site on pallets. Most pieces appear to have included a slot for stacking and pinning pieces together. The recovered obelisk stone pieces have only slots. The original pins are missing. Not all of the broken obelisk pieces were recovered. Several large stones have been broken into smaller pieces. It is uncertain which pieces go together at this time. To fully assemble the obelisk will be similar to putting a three-dimensional puzzle together with missing pieces.

The largest base piece of the obelisk has the majority of graffiti and cleaning agent remaining on three of four faces. There are four holes at the base of this piece centered approximately 3" from the bottom. Some holes still contain a metal sleeve that was possibly used to lift the stone into place at installation. Now the hole is either empty or the metal sleeve has been crimped.

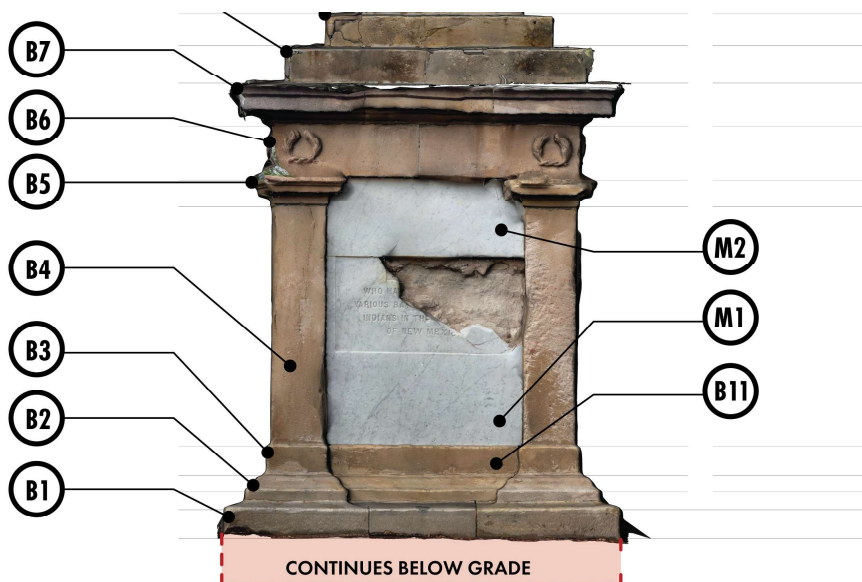
Resource Item #	Condition Indicator Assessed	Condition Status	Rationale & Key Points
B1	9 Base Stones - 7" above grade	Fair Condition	The base has 7" visible above grade, but 11" continue below grade. The top of the stone is delaminating in at the upper sloped surfaces on sides A, C, & D. Edges are chipped on all sides with a large chip on side D where the obelisk probably fell.
B2	4 Lower Column Bases	Fair to Poor Condition	The lower column base is beveled and stepped to meet the upper column base. The stone is delaminating and chipped on all sides. There is a large crack separating the base at side C and D. At side D this base has been shattered at the inner corner of the left column base. If this stone were to be moved, it would lose all integrity and would need to be replaced.
B3	4 Upper Column Bases	Fair to Poor Condition	The upper column base is a block slightly smaller than the lower base top step and larger than the column shaft above it. The stone is delaminating and chipped at the corners on all sides. At side D above the shattered base the lower inner corner of the left column base has been chipped away by some impact. It is not certain if this stone is cracked continuously through the block.

B4	4 Column Shafts	Fair to Poor Condition	The Column Shaft appears to be a solid block of stone, rectangular in shape and volume with a niche for the marble plaque to slide into place. Side A - Left Column has a vertical crack beginning at the top down two-thirds of the shaft. Right Column has been scraped heavily. Side B - Left Column has small residual scratches and pock marks. The top is cracked from possibly an impact point. Right Column has inner edges scraped. Side C - Left Column has a few chips and scrapes and a faded handprint from the painted graffiti. Right Column also has some chips and scrapes. Side D - Left and Right Columns have chips and scrapes.

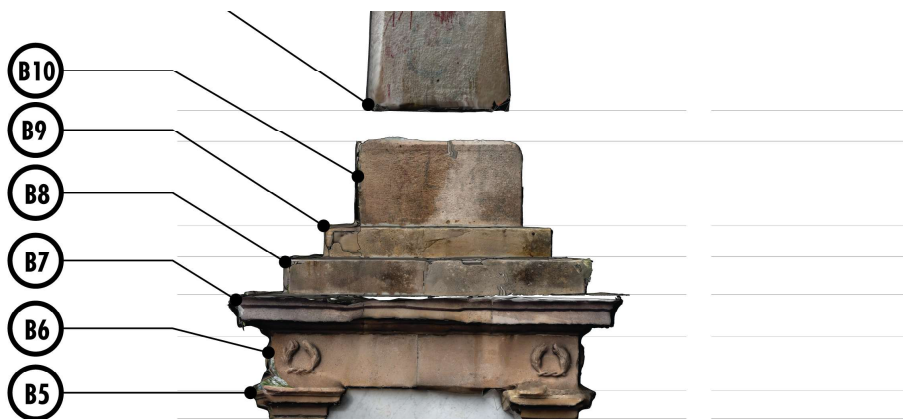
B5	4 Column Capitals	Fair to Poor Condition	The Capital appears to be a solid piece of stone with varying widths of square cap stones stacked from the column shaft, small to large with a slotted under side to allow for a drip edge. Side A - Left Capital is missing its left corner. Right Capital is missing the majority of its overhanging top layer, with considerable decay at the outer corners of the next lower overhang. Side B - Left Capital is missing the majority of its overhanging top layer, with the outer corner of the next layer chipped away. Right Capital is missing the outer corners of the top layer of the overhanging stone. Side C - Left Capital is missing the majority of its overhanging top layer, with considerable decay at the outer corners of the next lower overhang. Right Capital is missing the outer corners of the top layer of the overhanging stone and the outer corner of the next layer of stone. Side D - Left Capital is missing the inner corners of the top and second layers of stone. Right Capital is missing the inner corner of the top layer and the center of top layer is chipped. The next layer under is missing the outer corner.

B6	4 Capstones with "Open Wreaths"	Fair Condition	The Capstones include two "open wreaths" per side centered above the columns. All appear to be intact. The stones on Side A appear to have some water damage, but no delamination. On sides C & D show faded graffiti marks and slight water damage.
B7	9 Upper Cap Stones	Fair to Poor Condition	The upper cap consists of 9 stones that are almost a mirror image to the base stones but not as deep. The upper outer edge of the top is chipped on all sides. Side D has a large chip in the center where the obelisk coming down may have damaged it.
B8	Obelisk Wide Base	Fair Condition	The Obelisk Wide Base consists of 4 solid blocks of sandstone with a hole and metal sleeve at each corner when looking from the top. The top of stone shows sign of weathering with black lichen growing.
B9	Obelisk Middle Base	Fair Condition	The Obelisk Middle Base consists of 4 visible stones. At all sides, there are two holes on the vertical face at the corners with a metal sleeve inserted. Because of their regular placement it is thought that these were used to help lift the pieces in place during initial installation. Each of these stones has significant weathering and hairline cracks, some delamination, and lichen growth. Mortar between stones is missing in most areas.

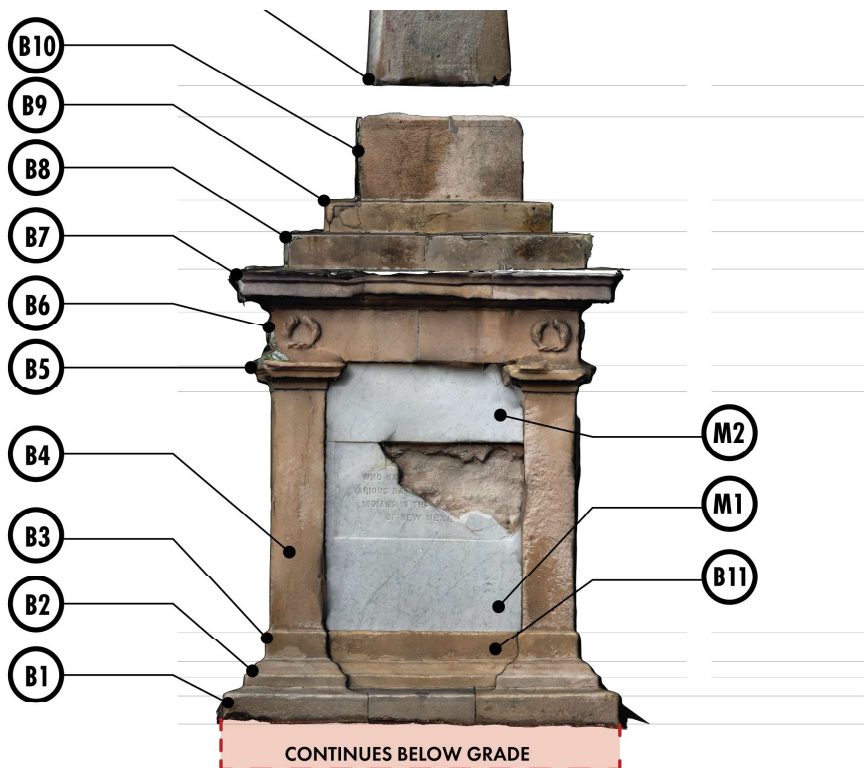
B10	Obelisk Upper Base	Fair Condition	The Obelisk Upper Base is one solid block of sandstone with a beveled top edge and a central slot on top. Side A has a chipped upper right corner with some residual paint that has left a white residue. Side B has a chipped upper left corner and chipped vertical right side; residual paint appears to have been washed off. Side C top edge is uneven and chipped left vertical side. Side D has residual red paint from graffiti. Mortar between this stone and the Obelisk Middle Base is present in two shades of gray possibly from original installation and a later repointing.
B11	Middle Plaque Base	Fair to Poor Condition	The Middle Plaque Base on Side A consists of 2 stones shaped to match the lower and upper column bases. The face and edges have some areas of delamination and small chips at the bottom edge. Side B is missing the upper plaque base and has similar delamination and small chips. Side C is missing the upper plaque base and has much more delamination and wear. Side D is missing the upper plaque base and has similar delamination as A & B with edges chipped and worn away.

M1	Bottom Marble Plaque	Poor Condition	This piece of marble has been damaged and a large triangular portion of the marble was removed. The piece missing is 1-3/4" thick.
M2	Top Marble Plaque	Good Condition	This 2" thick piece is still intact and undamaged.
M3	Marble Plaque, full height	Fair to Good Condition	Side B - appears to be intact with a brownish blotchy stain at the top. Uncertain if this can be cleaned. Side C - appears to be intact with a brownish blotchy stain at the top. Uncertain if this can be cleaned. Side D - appears to be intact with small chips around the "1866" date and near the bottom.

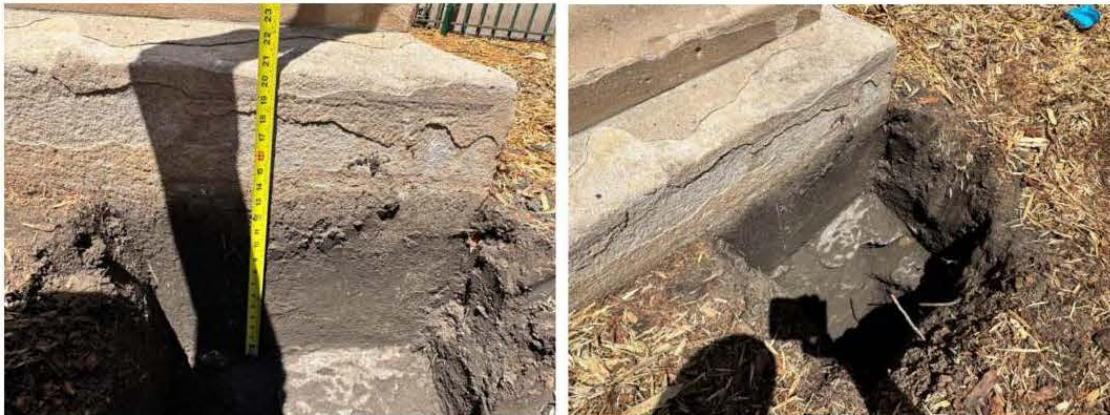
Existing Conditions - Plinth

- Monument Base
 - Composed of several sandstone block pieces; connections are unknown (dowels or keyed joints were not observed).
 - Masonry joints are in poor condition; sandstone blocks show deterioration (cracks, spalls, impact chips).
 - Joint gaps vary in width, suggesting block movement over time – could be caused by differential movement.
- Site Grading and Drainage
 - Poor grading around the monument was observed; a concrete banco and fence trap runoff, allowing water to infiltrate soils below.
 - The banco was likely installed during plaza drainage renovations, leaving the monument at the lowest elevation.
 - No drainage system exists within the banco area; soils experience wetting and drying cycles.
 - If the soils are moisture-sensitive, shrink-swell behavior may continue to damage the monument over time.

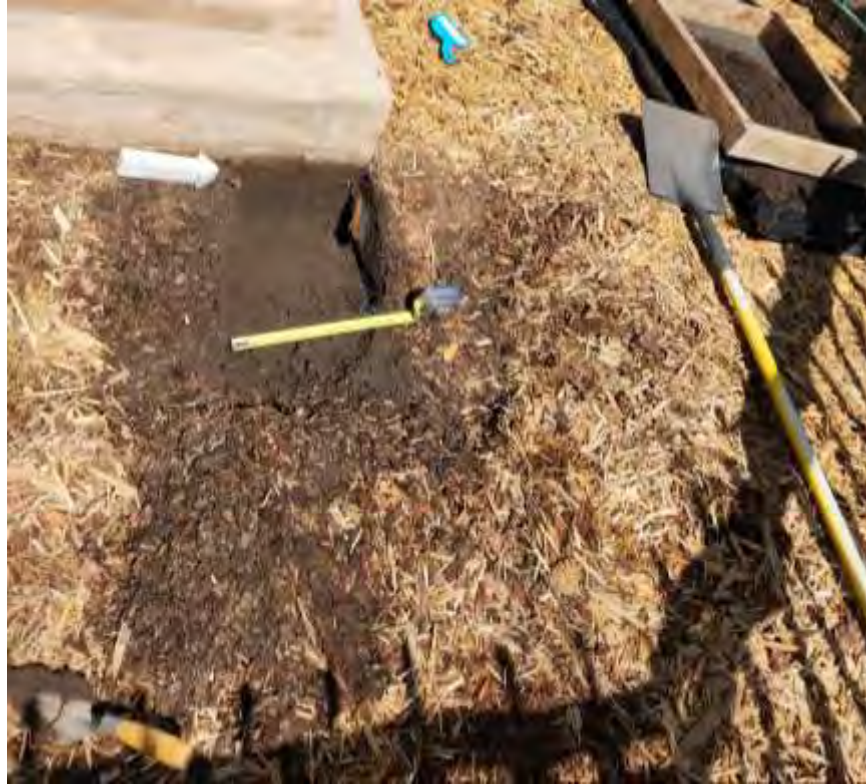
Figure 4. Levels 3 and 4 where the historic cultural materials were observed .

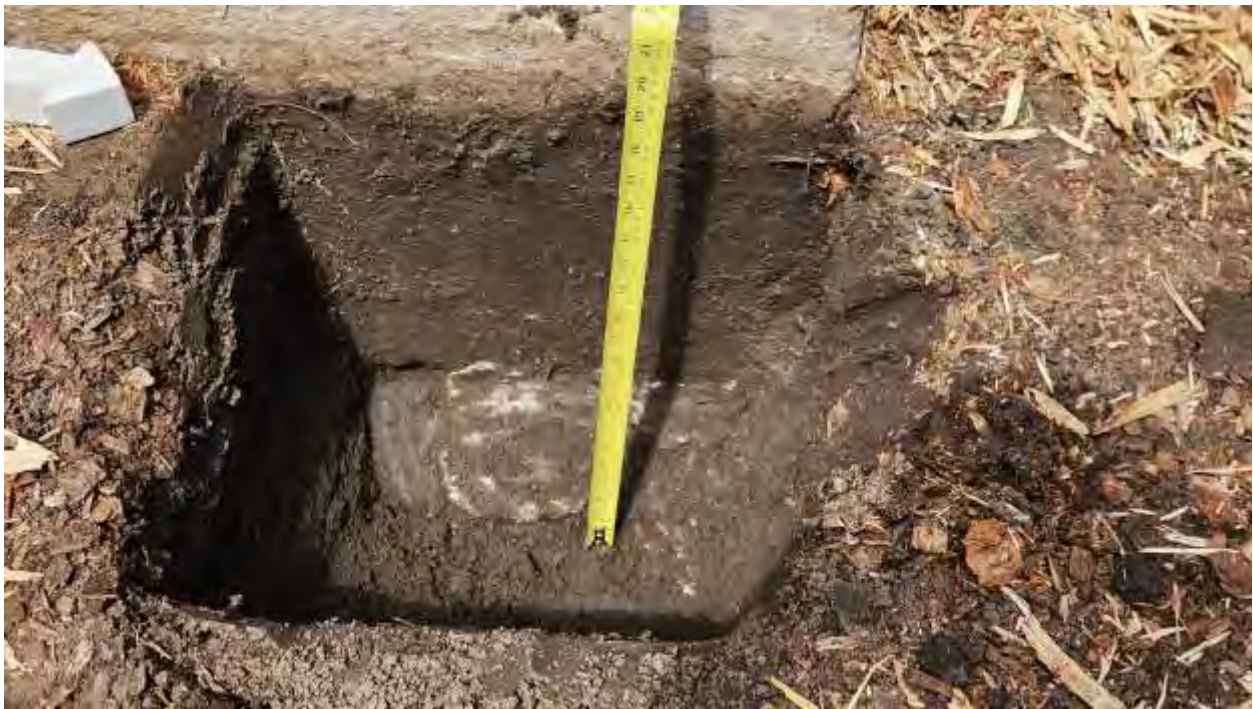
The Obelisk’s foundation comprises of granitic cobbles, boulders, and cement at a depth from 20-32 in (50-80 cm). The granitic rock does not appear to have been formed by hand tools of any kind and looks to be in its natural form. However, cement has been used to hold these materials together. No formed or manufactured rock was visible below ground surface. The depth of the foundation is unknown and may exceed the extent of what is currently known and most likely is greater than 32 in bpgs (80 cm). The overall appearance of the foundation is limited but generally appears to be intact and stable. Further investigations may be necessary to address the exact depth, integrity, and material composition (Figures 5-7).

Figure 5. Top of the granitic rock.

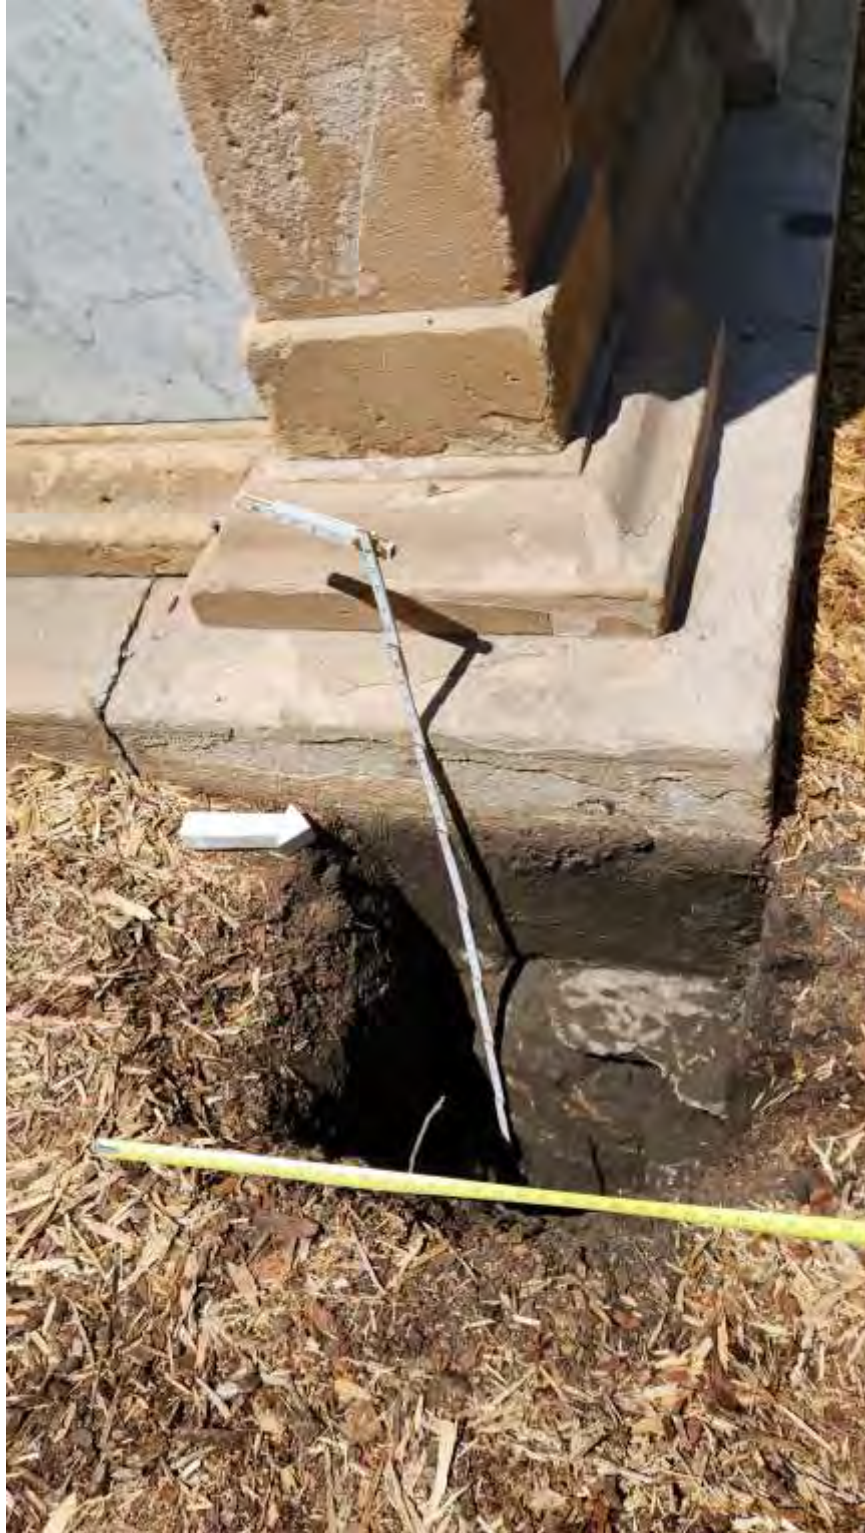
Figure 6. Bottom of excavation.

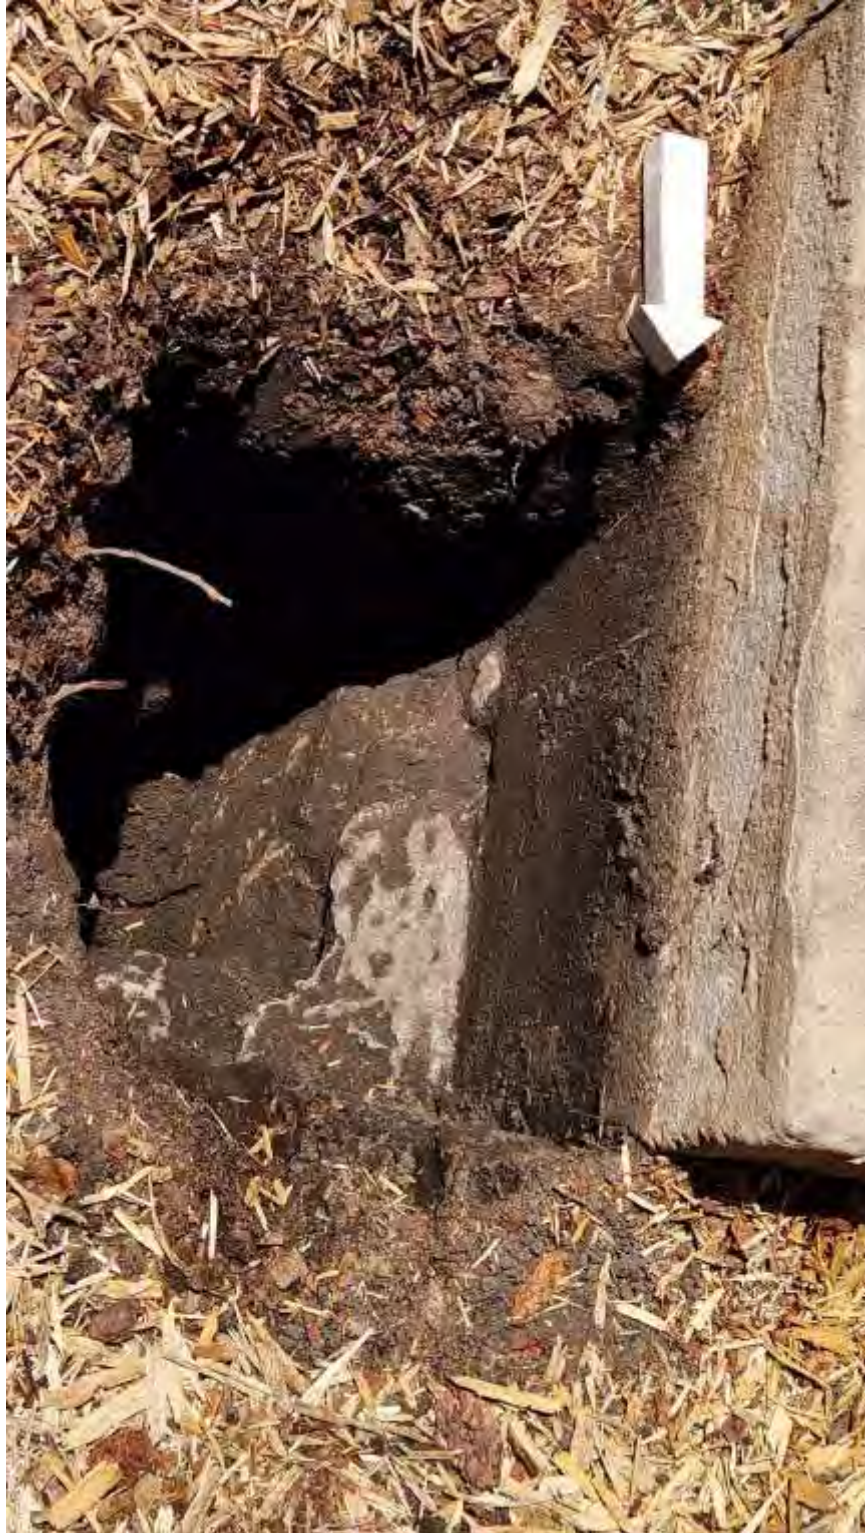
Figure 7. Plan view of the end of assessment.

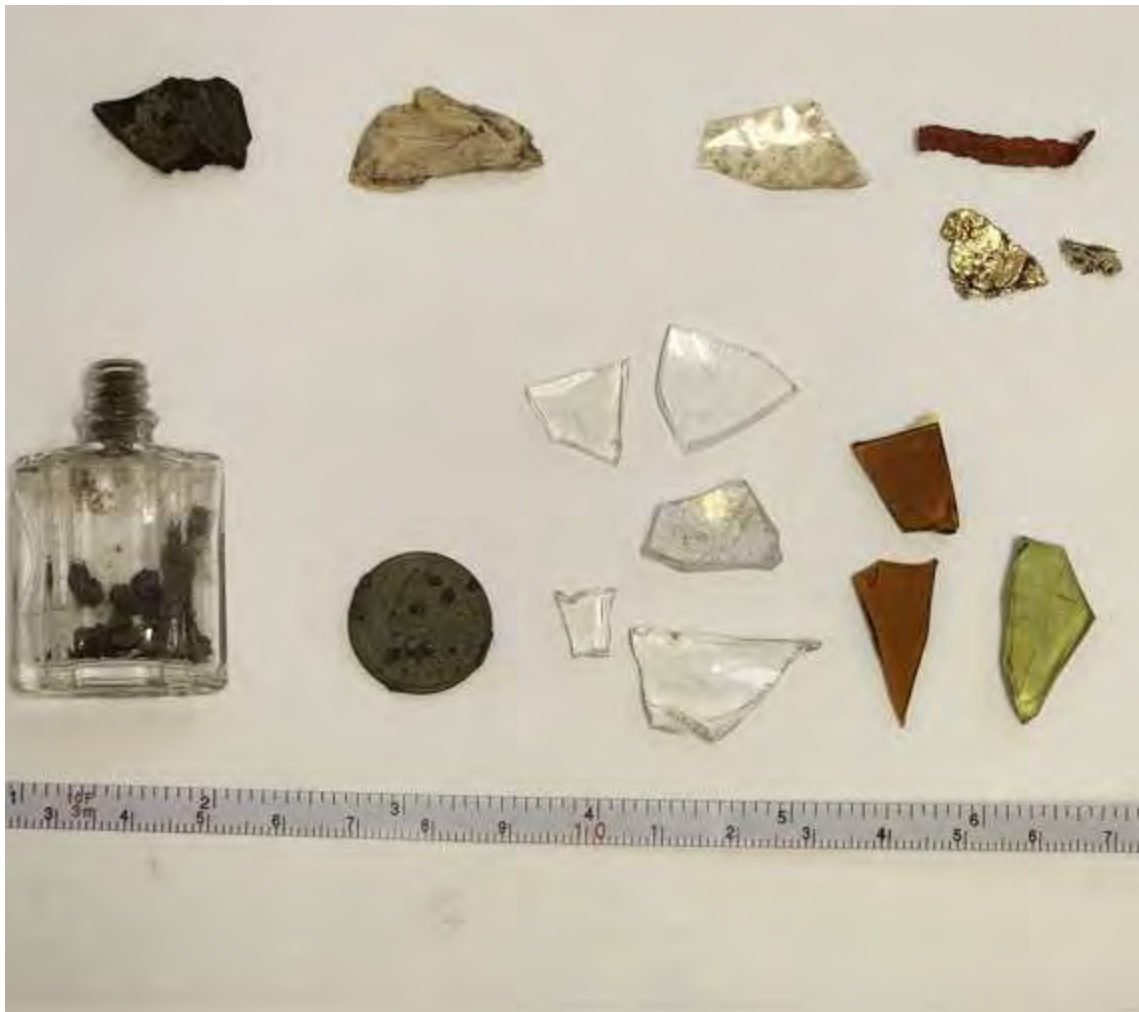
Figure 8. Historic and modern trash midden from Levels 3 and 4.
