Historic Cultural Properties Inventory (HCPI) Base Form (FORM 1)

1. Name of property: Plaza del Monte	2. Location: 118 Camino Santiago <i>Downtown and Eastside Historic District</i>	3. Local Reference Number: Santa Fe ID #: N/A Plaza del Monte Inventory 4. County: Santa Fe

6. Date of Survey: January 18, 2018		
7. Previous Survey Date(s): <input type="checkbox"/> Yes: <input checked="" type="checkbox"/> No:		
8. Name of Project: HDRB status review Plaza del Monte

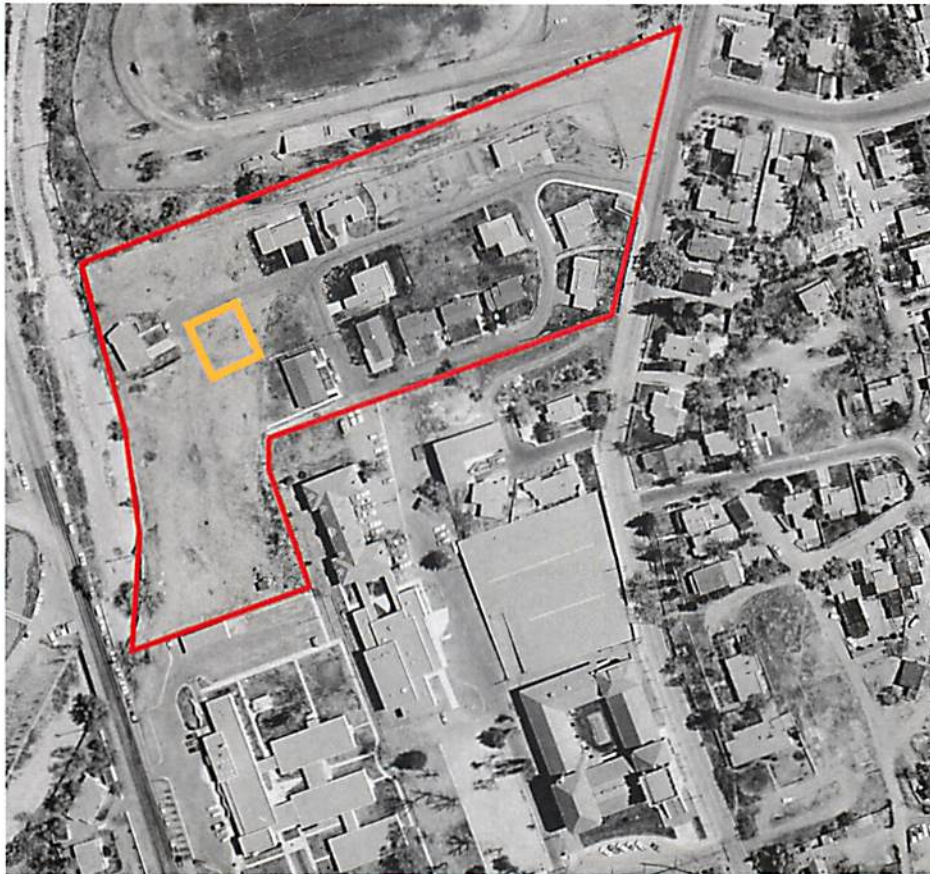
Figure 1: May 2, 1966 aerial photograph.
Building not present.
Courtesy NMDOT.

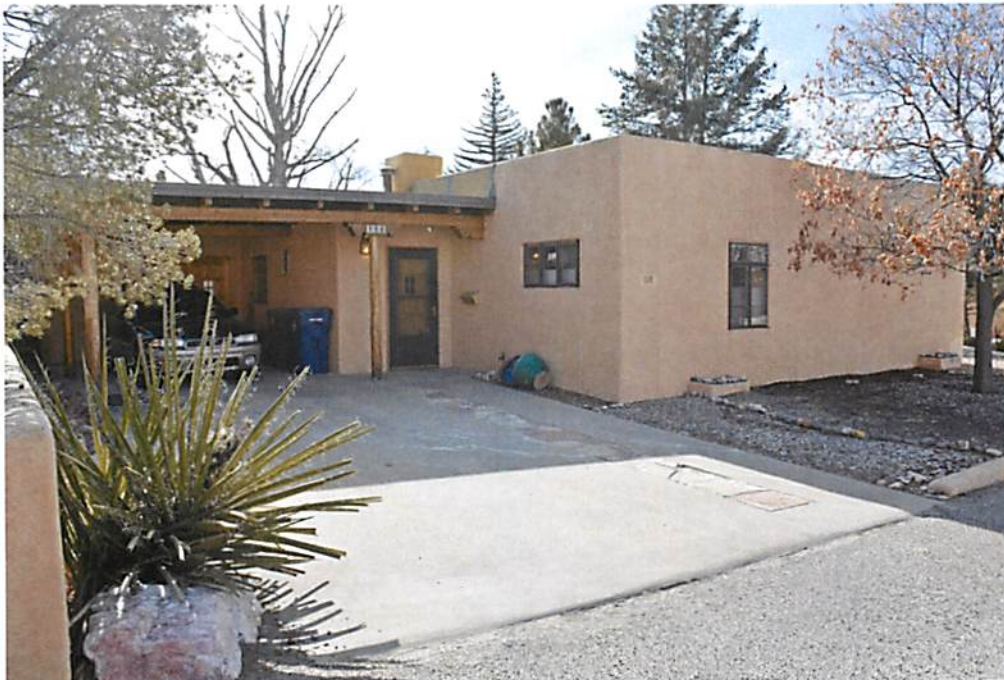
Photo 1: Street and east elevations, facing southwest.

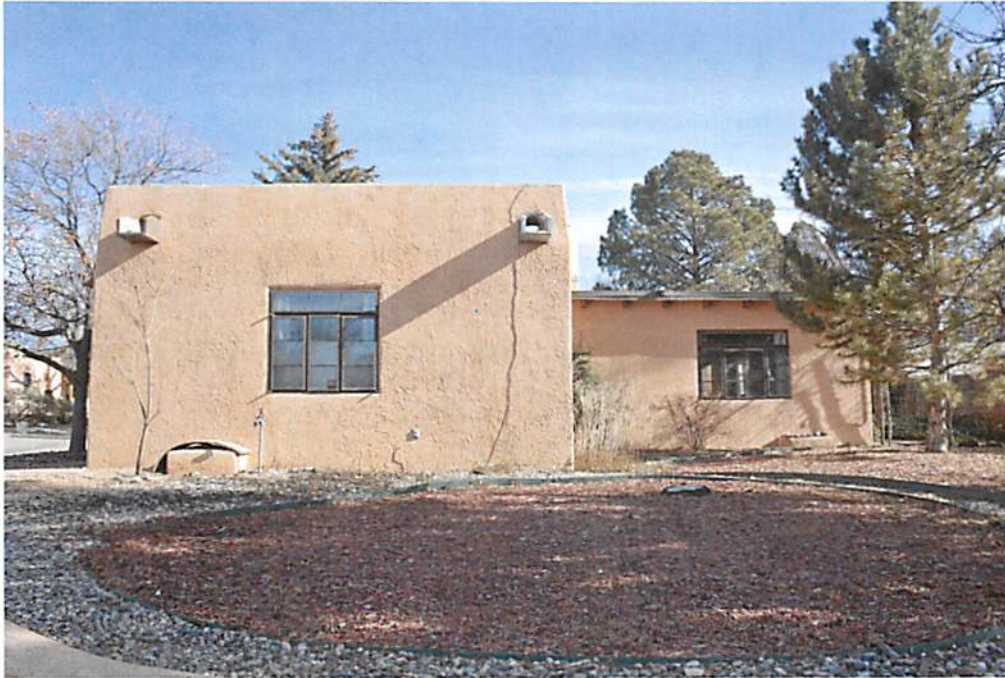
Photo 2: West elevation, facing east.

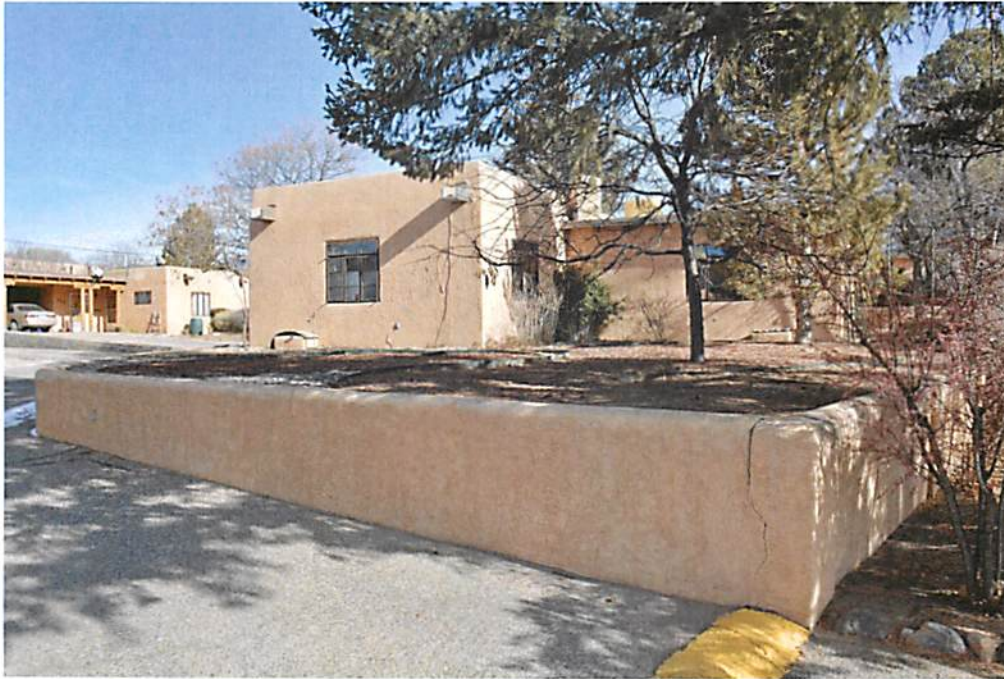
Photo 3: West and south elevations, facing northeast.
