Project description: Adalucia Quan, agent/owner, proposes to demolish non-contributing residential and garage structures.

Case number: H-16-030
Project Type: HDRB

PROJECT LOCATION (S): 911 Roybal Street

CASE # H-16-030

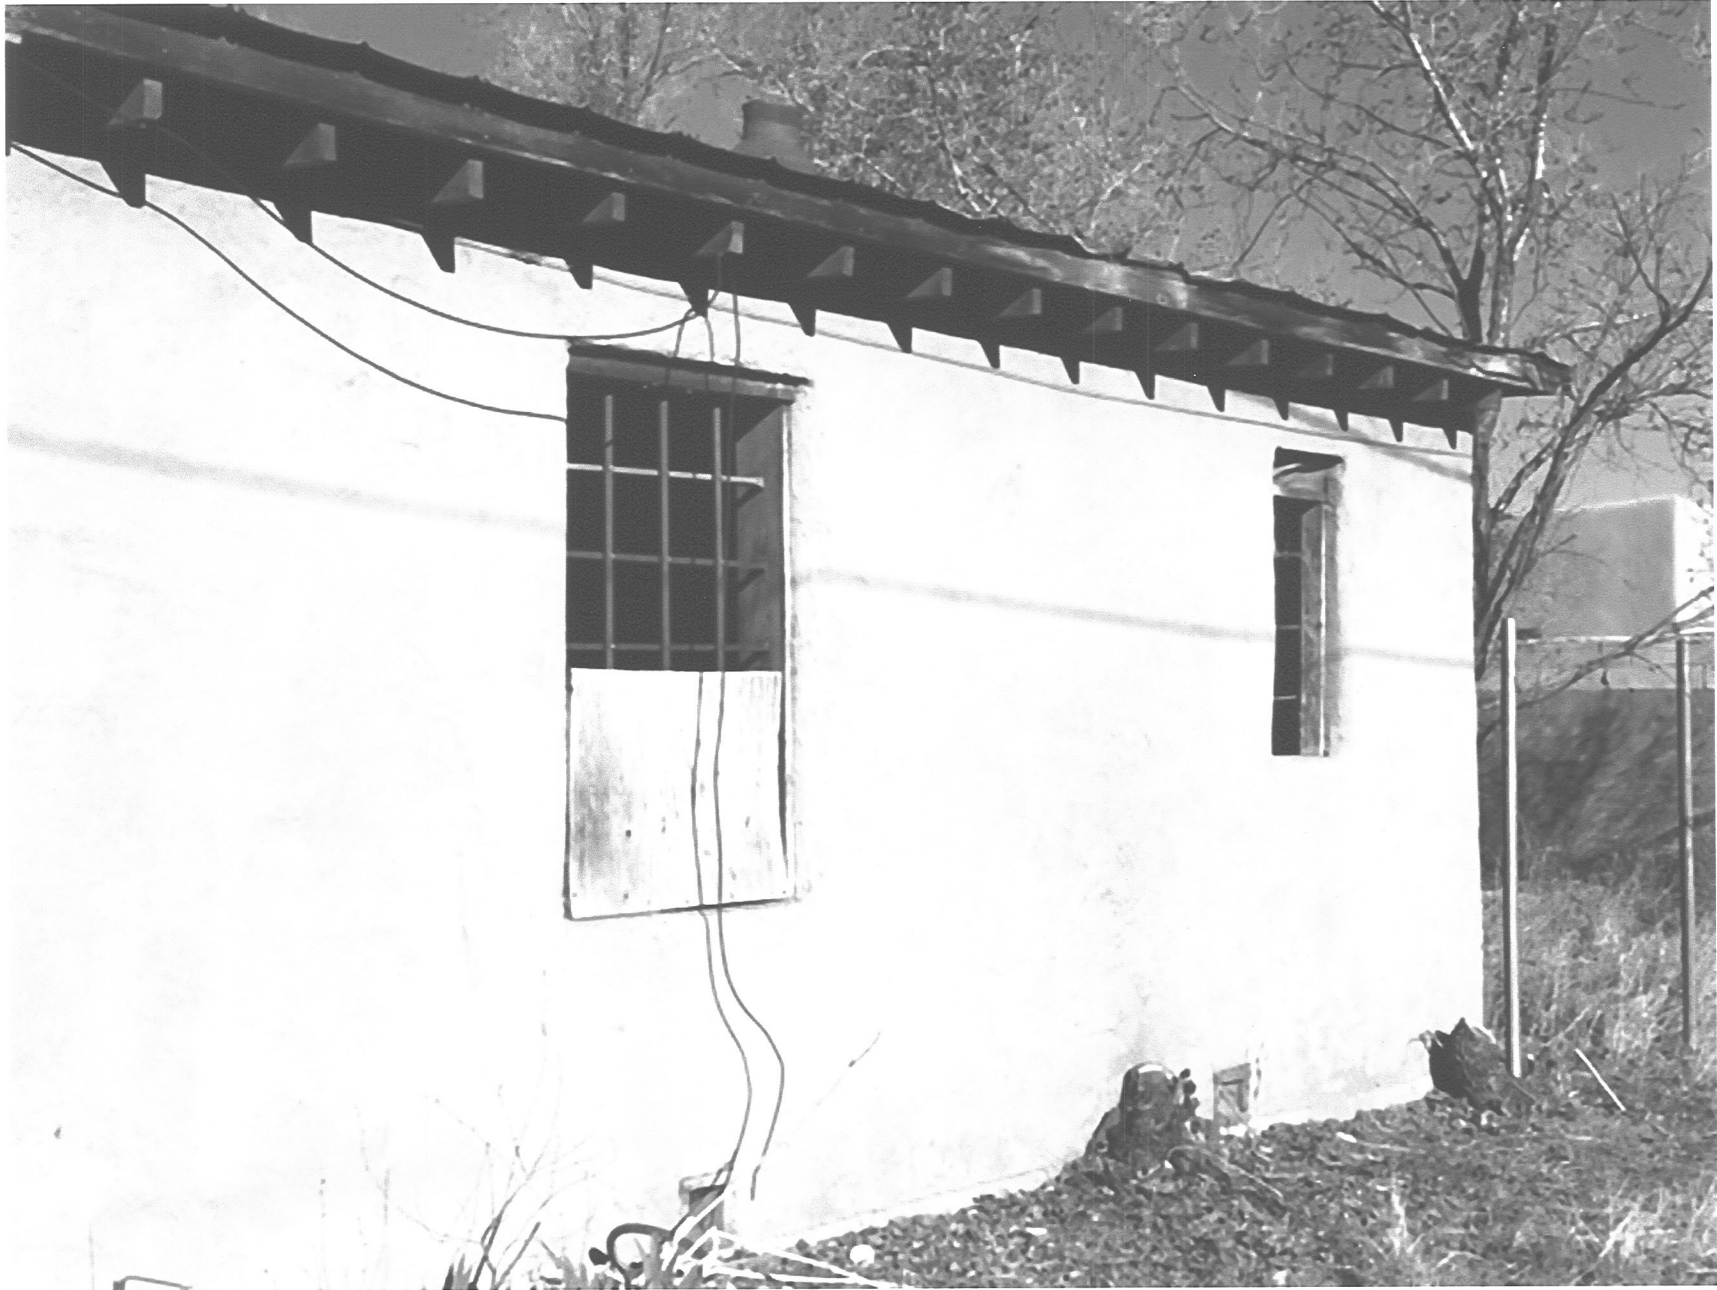
Side of house - 911 Roybal Street

East side (Trees were cut)

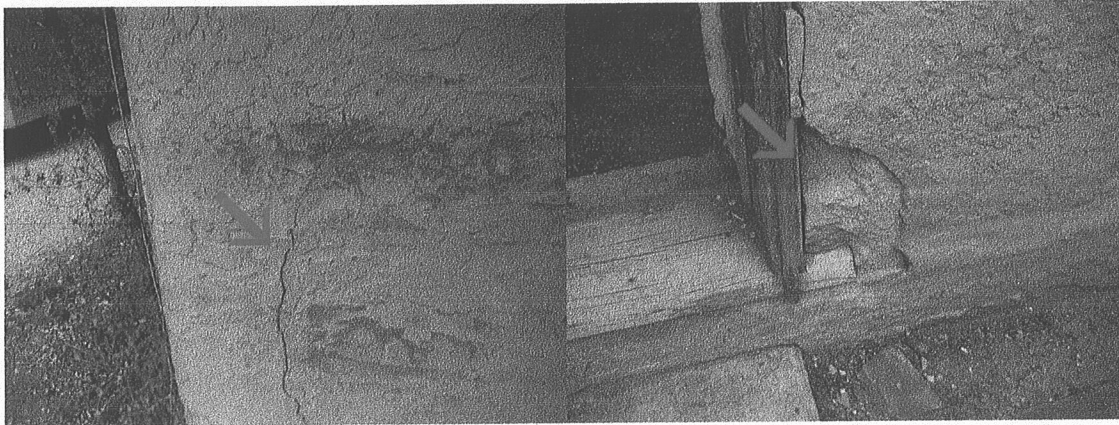
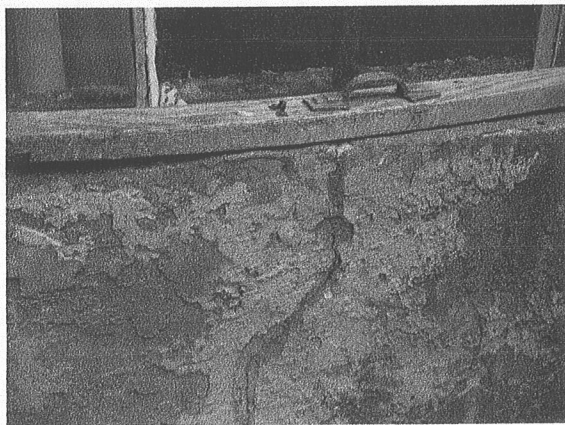
2.2.2 STUCCO CONDITION

THERE ARE LARGE CRACKS IN THE STUCCO OF THE STRUCTURE THAT SHOULD BE REPAIRED, SOME THROUGH BOTH THE COLOR AND THE SCRATCH COATS. SOME AREAS MAY NEED TO BE RE-LATHED AND STUCCOED,

SUCH AS THE NORTH WALL OF THE PORCH ADDITION. IT IS RECOMMENDED THAT A QUALIFIED STUCCO CONTRACTOR EVALUATE THE STUCCO FOR REPAIR. ESTIMATES FOR STUCCO REPAIRS SHOULD BE OBTAINED SO THE COSTS CAN BE ANTICIPATED.

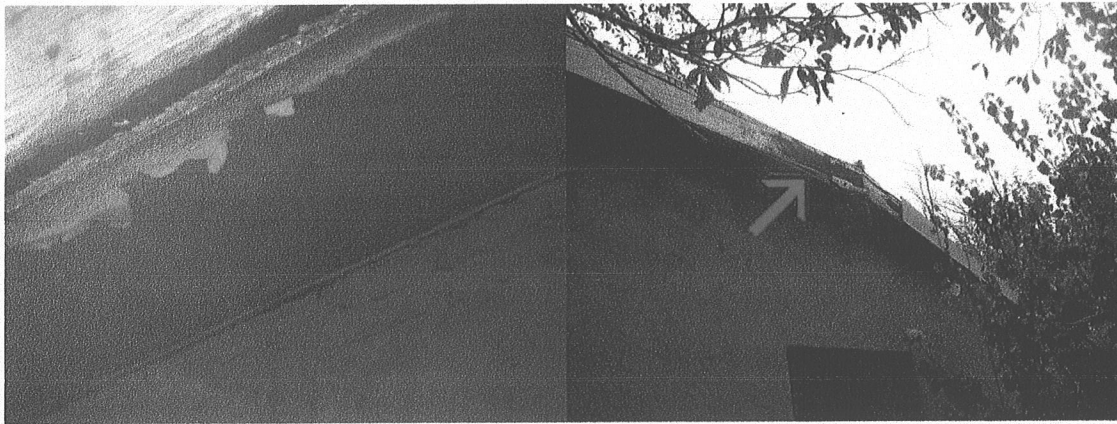
2.2.8 FASCIA BOARDS

THE EXTERIOR WOOD WORK OF THE ROOF IS DETERIORATED AND ROTTEN IN SOME LOCATION. EXTENSIVE REPLACEMENT OF EXTERIOR WOODWORK SHOULD BE ANTICIPATED, INCLUDING FASCIA BOARDS, SOFFITS AND EAVES.

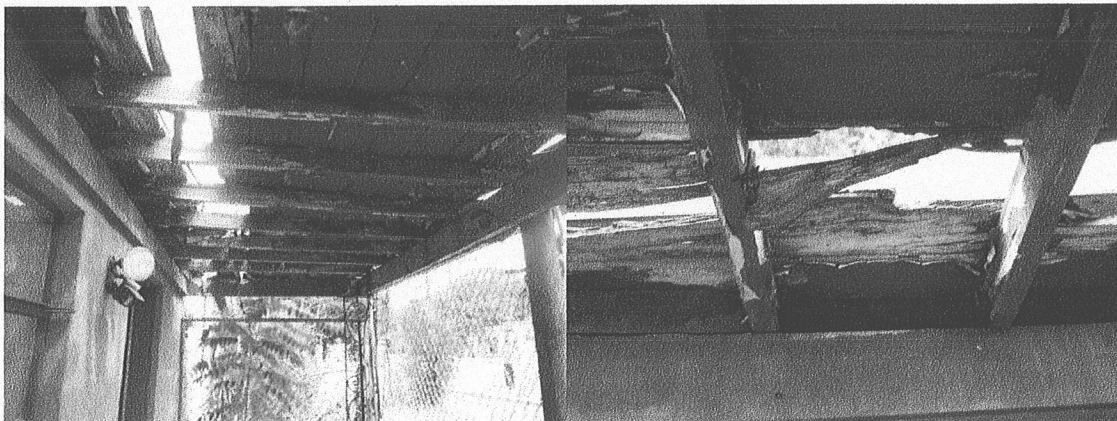
2.3.10 PATIO/DECK COVERS

THE FRONT PORTAL IS COMPLETELY DETERIORATED AND NEEDS TO BE REBUILT. ESTIMATES FOR REBUILDING THE PORTAL SHOULD BE OBTAINED FROM A QUALIFIED CONTRACTOR.

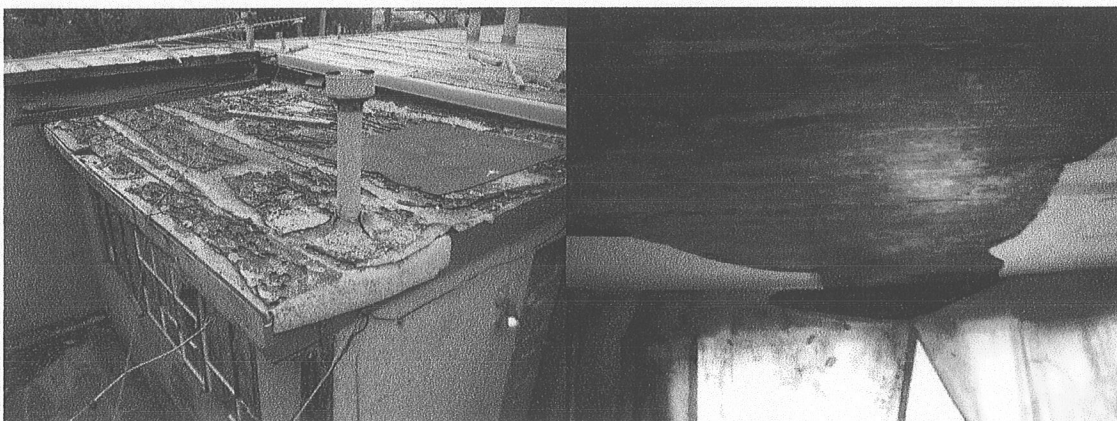
3.1.3 COVER MATERIAL CONDITION

THE FLAT ROOF OF THE PORCH ADDITION IS COMPLETELY DETERIORATED, INCLUDING THE RAFTERS AND SHEATHING. THE CEILING OF THE ROOM HAS COLLAPSED. REBUILDING AND RE-ROOFING OF THE PORCH ADDITION IS NEEDED. ESTIMATES FOR REBUILDING THE PORCH ADDITION SHOULD BE OBTAINED SO THE COSTS CAN BE ANTICIPATED.

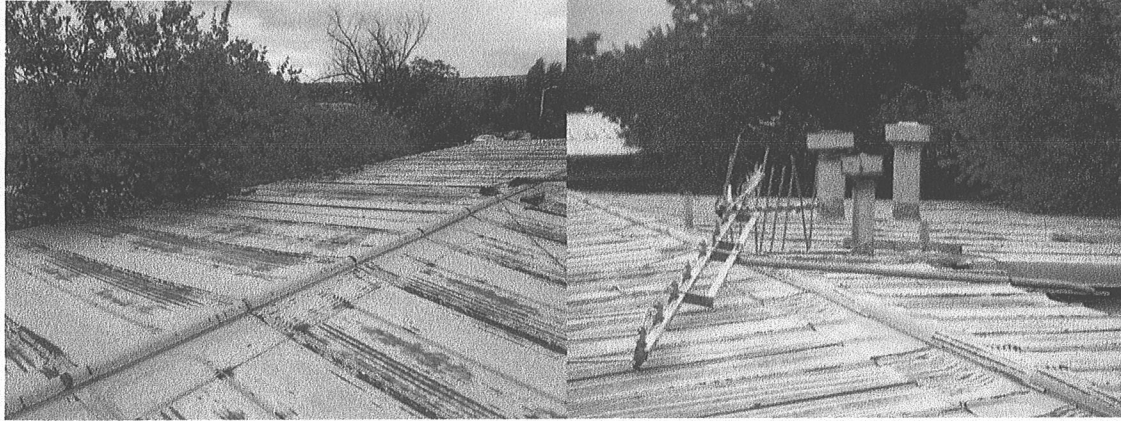
3.2.4 COVER MATERIAL CONDITION

THE ROOFING MATERIAL OF THE STRUCTURE (HOUSE AND DETACHED GARAGE) IS OLD AND RUSTED. THERE IS EVIDENCE OF LEAKAGE OF THE PITCHED ROOF IN SEVERAL LOCATIONS. THE HOUSE AND GARAGE SHOULD BE RE-ROOFED. REPLACEMENT OF ROOF SHEATHING AND RAFTERS MAY BE NEEDED AND COULD POSSIBLY BE EXTENSIVE. SHORING UP OF THE ROOF MAY BE NEEDED AND MAY ALSO BE EXTENSIVE. ESTIMATES FOR THE COMPLETE REROOFING OF THE STRUCTURE AND REPLACEMENT OF DETERIORATED ROOF FRAMING MEMBERS SHOULD BE OBTAINED FROM A QUALIFIED CONTRACTOR SO THE COSTS CAN BE ANTICIPATED.

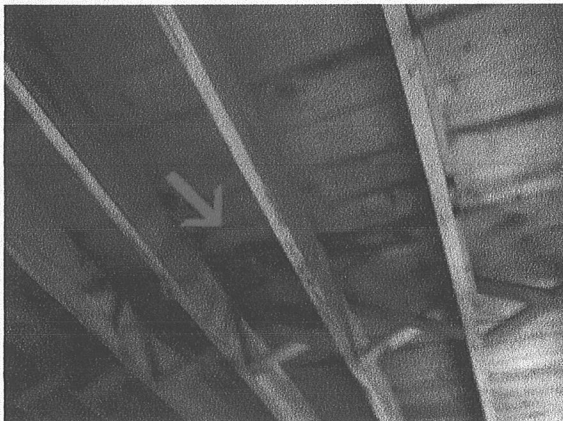
3.2.27 INDICATIONS OF LEAKING

EXTENSIVE REPAIRS TO THE ROOF SHEATHING DUE TO WATER DAMAGE SHOULD BE ANTICIPATED.

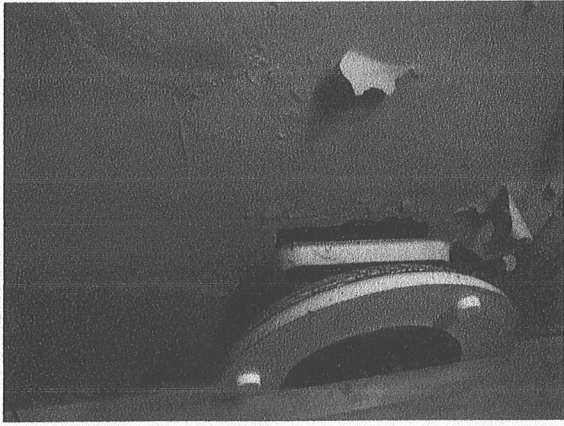
EXTENSIVE REPAIRS TO THE CEILINGS OF THE STRUCTURE DUE TO WATER DAMAGE SHOULD BE ANTICIPATED.

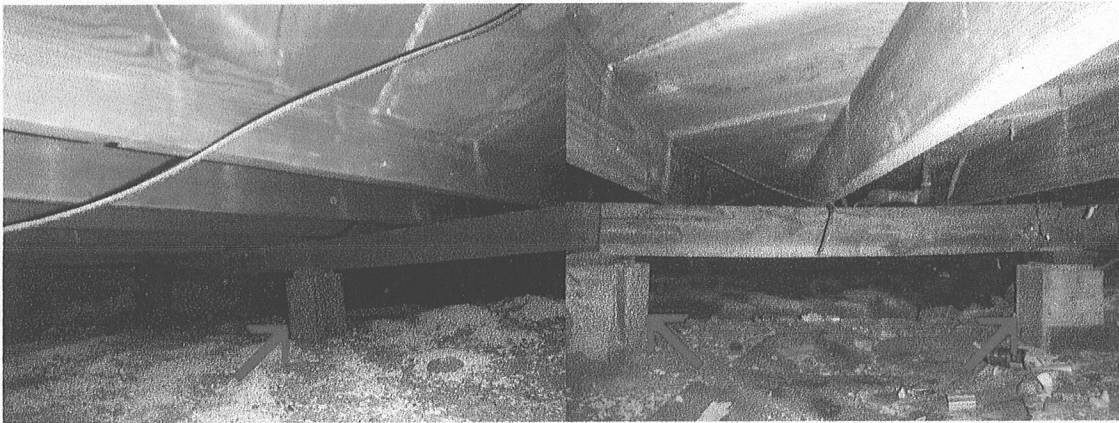
4.2.12 PROPER EARTH-WOOD CLEARANCE

THERE IS WOOD FORMING MATERIAL IN CONTACT WITH EARTH IN THE CRAWL SPACE. A PEST INSPECTION OF THE STRUCTURE IS HIGHLY RECOMMENDED.

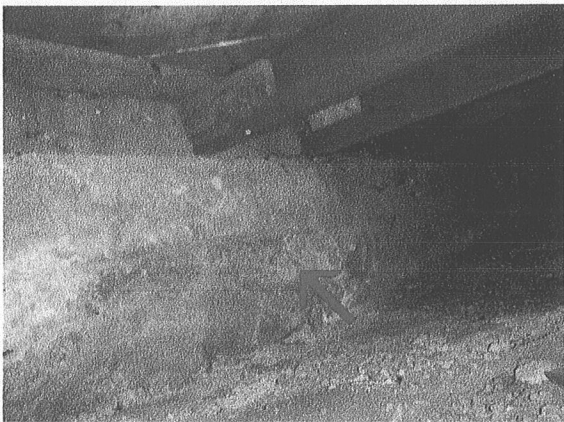
4.2.13 WOOD MEMBERS

NOTE: THE POURED FOUNDATION OF THE STRUCTURE APPEARS TO BE IN SATISFACTORY CONDITIOI

COMPLETE ENTRY OF THE CRAWL SPACE WAS NOT POSSIBLE, HOWEVER, NUMEROUS PHOTOS WERE TAKEN FROM THE ACCESS AND NO CRACKS IN THE FOUNDATION WERE OBSERVED (FURTHER OBSERVATION IS RECOMMENDED). THE WOOD MEMBERS APPEAR TO BE IN SATISFACTORY CONDITION, HOWEVER, FORMING MATERIAL IN CONTACT WITH EARTH WAS OBSERVED AND A PEST INSPECTION SHOULD BE CONDUCTED. SOME SHORING UP OF THE WOOD UNDERPINNING MAY BE NECESSARY. IT COULD NOT BE DETERMINED IF THE POSTS OF THE UNDERPINNING ARE ON A CONCRETE FOOTING. IF THE POSTS ARE NOT ON A CONCRETE FOOTING, SUCH A FOOTING IS RECOMMENDED.

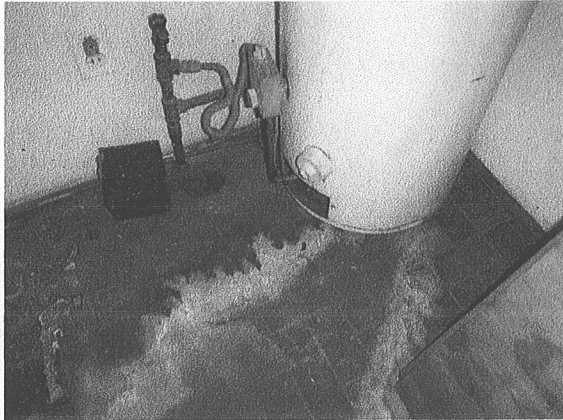
7.1.2 TYPE

THE GAS WATER HEATER IS OLD, LEAKING AND NEEDS TO BE REPLACED. ESTIMATES FOR REPLACEMENT OF THE WATER HEATER SHOULD BE OBTAINED SO THE COSTS CAN BE ANTICIPATED.

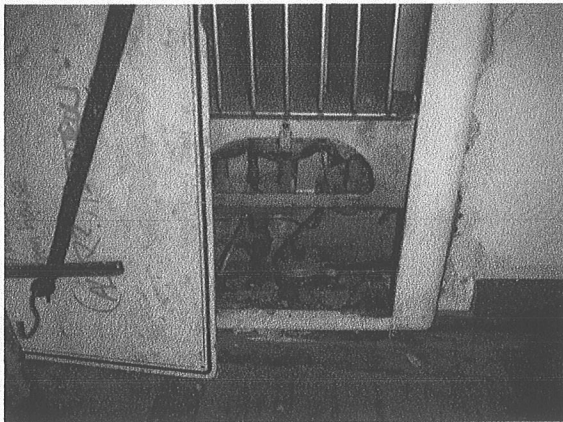
8.2.2 MANUFACTURER AND MODEL NUMBER

THE GAS WALL HEATERS OF THE STRUCTURE COULD NOT BE TESTED (GAS OFF). THE GAS HEATERS MAY BE OPERABLE. NEW GAS FLEX LINES, GAS VALVES AND GAS CONTROL VALVES ARE RECOMMENDED. THE HEATERS SHOULD BE EVALUATED FOR REPAIR BY A QUALIFIED HEATING TECHNICIAN. REPLACEMENT OF SOME OF THE UNITS SHOULD BE ANTICIPATED. ALTERNATIVE FORMS OF HEATING THE STRUCTURE SHOULD BE CONSIDERED.

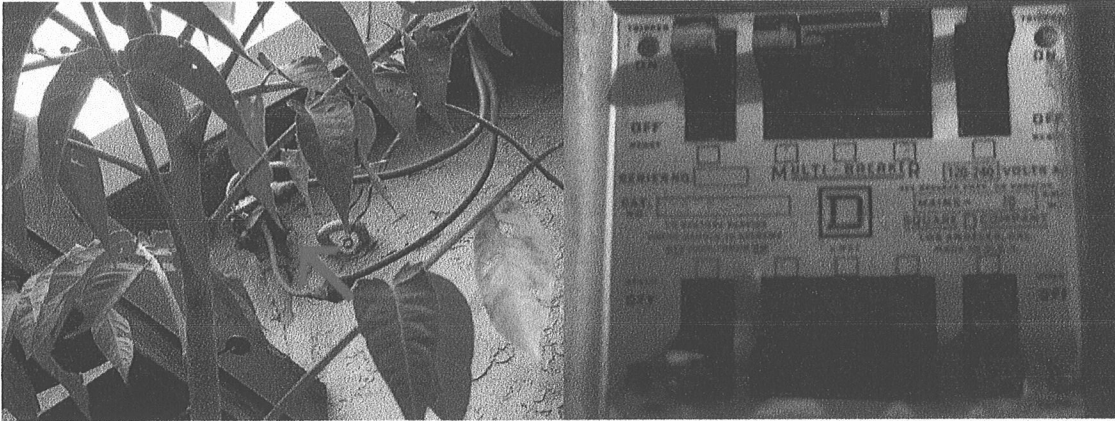
9.2.12 RECEPTACLE GROUND VERIFY

THE ELECTRICAL SYSTEM NEEDS TO BE UPDATED, INCLUDING, A NEW SERVICE DROP FROM THE POLE, A NEW WEATHER HEAD, AND AN UPDATED SERVICE PANEL WITH 100 AMPS MINIMUM. THE WIRE IN THE STRUCTURE IS THE ORIGINAL 2 WIRE WITH NO GROUND. THE WIRING IN THE STRUCTURE SHOULD BE UPDATED. IT IS RECOMMENDED THAT THE STRUCTURE BE EVALUATED BY A QUALIFIED ELECTRICIAN FOR COMPLETE UPDATING. ESTIMATES FOR UPDATING THE ELECTRICAL SHOULD BE OBTAINED SO THE COSTS CAN BE ANTICIPATED.

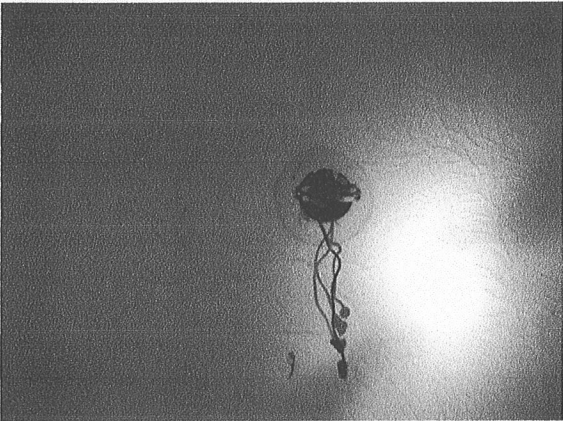
9.2.19 SWITCHES

SEVERAL OF THE ELECTRICAL FIXTURES IN THE STRUCTURE WERE MISSING. A COMPLETE UPDATING OF THE ELECTRICAL INCLUDING OUTLETS, SWITCHES, AND FIXTURES IS RECOMMENDED.

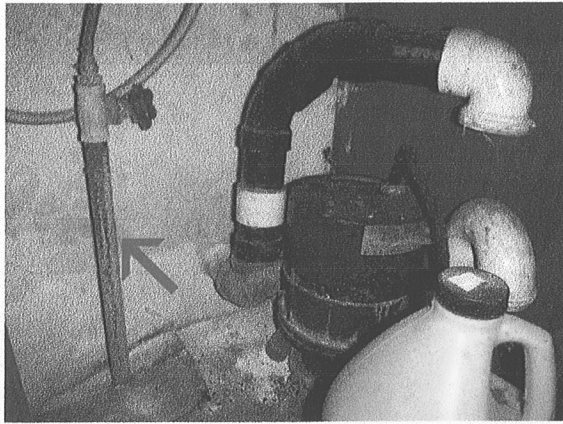
9.3.2 STRUCTURE PIPE MATERIAL

THE WATER SUPPLY PIPING IS GALVANIZED STEEL WHICH CORRODES OVER TIME, REDUCING THE DIAMETER OF THE PIPE AND FLOW. IT IS RECOMMENDED THAT THE CONDITION OF THE WATER SUPPLY PIPES BE EVALUATED BY A QUALIFIED PLUMBER. CONSIDERATION SHOULD BE GIVEN TO UPDATING THE SUPPLY PIPING. ESTIMATES FOR UPDATING SHOULD BE OBTAINED, BEFORE THE END OF THE INSPECTION CONTINGENCY PERIOD, SO THE COSTS CAN BE ANTICIPATED.

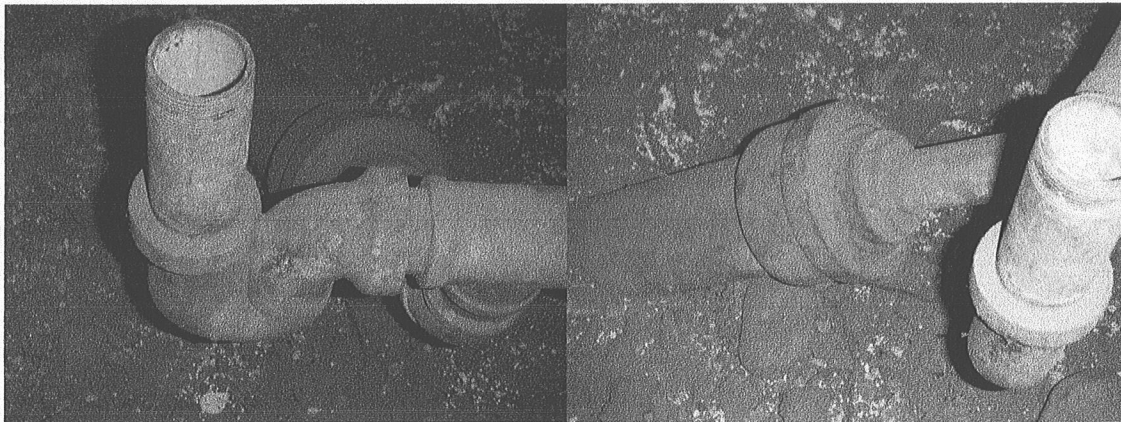
9.3.3 WASTE PIPING MATERIAL

THE WASTE PIPES ARE CAST IRON, WHICH CORRODES OVER TIME FROM THE INSIDE OUT, EVENTUALLY CAUSING LEAKAGE. IT IS RECOMMENDED THAT THE WASTE LINES BE EVALUATED BY A QUALIFIED PLUMBER TO DETERMINE THEIR CURRENT CONDITION. DUE TO THE AGE OF THE PIPES, CAMERA SCOPING OF THE WASTE PIPES AND THE SEWER LINES ARE RECOMMENDED TO DETERMINE IF DAMAGE OR A BLOCKAGE IN THE PIPES EXIST. ESTIMATES FOR REPAIRS, SHOULD BE OBTAINED SO THE COSTS CAN BE ANTICIPATED.

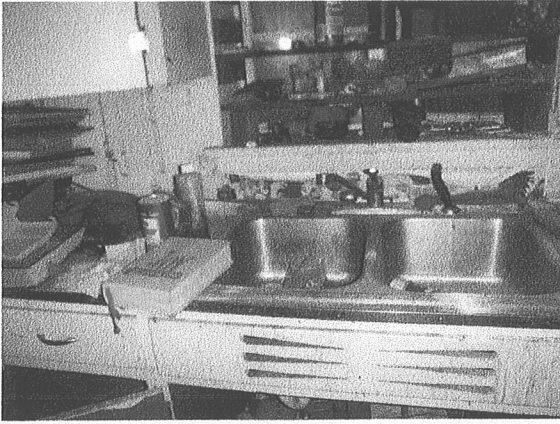
11.1.1 LOCATION

COMPLETE REMODELING OF THE KITCHEN INCLUDING NEW CABINETS AND PLUMBING FIXTURES SHOULD BE ANTICIPATED.

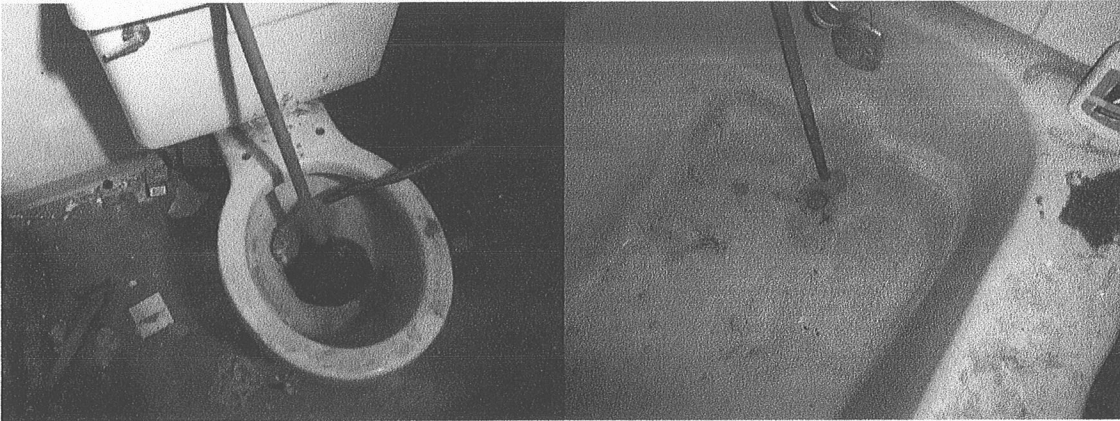
13.1.1 LOCATION

COMPLETE REMODELING OF THE BATHROOM INCLUDING NEW PLUMBING FIXTURES AND TILE REPLACEMENT SHOULD BE ANTICIPATED.

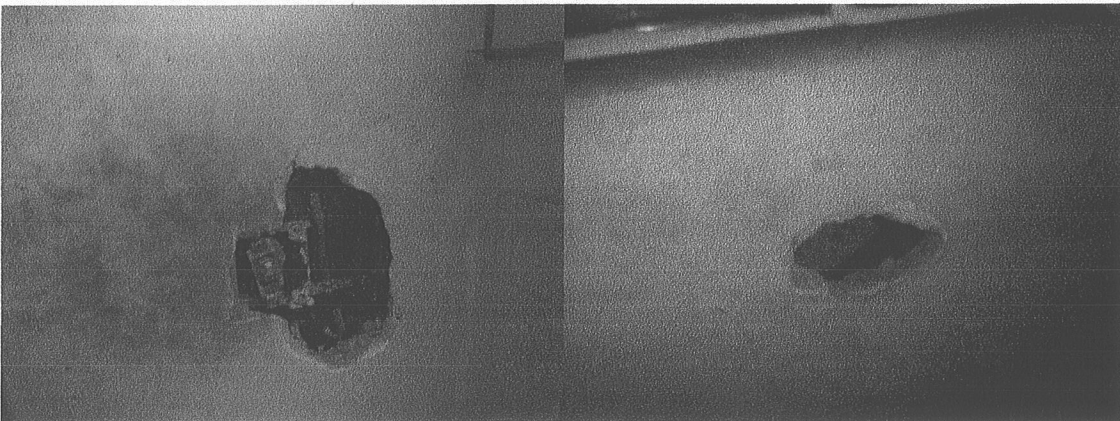
16.1.3 MOST COMMON INTERIOR WALL TYPE

THERE IS EXTENSIVE DAMAGE TO THE PLASTER OF THE INTERIOR WALLS, WHICH NEEDS TO BE REPAIRED. LATH AND RE-PLASTERING MAY BE NECESSARY IN SOME AREAS. ESTIMATES FOR PLASTER REPAIR SHOULD BE OBTAINED FROM A QUALIFIED PLASTER CONTRACTOR SO THE COSTS CAN BE ANTICIPATED.

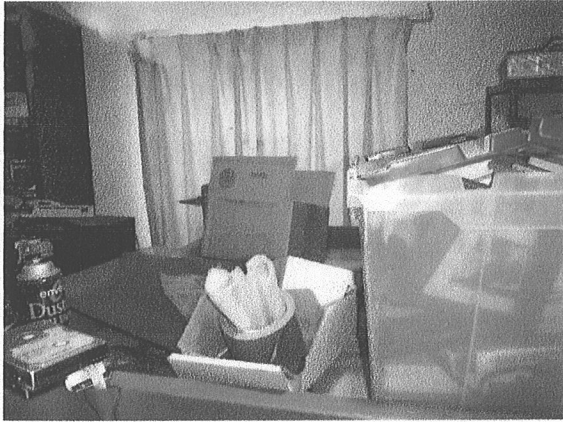
NOTE: EXTENSIVE PERSONAL ITEMS ON THE FLOORS AND AGAINST THE WALLS OF BOTH THE STRUCTURE AND THE GARAGE PREVENTED FULL EVALUATION. UNSEEN DAMAGE MAY EXIST IN THESE AREAS.

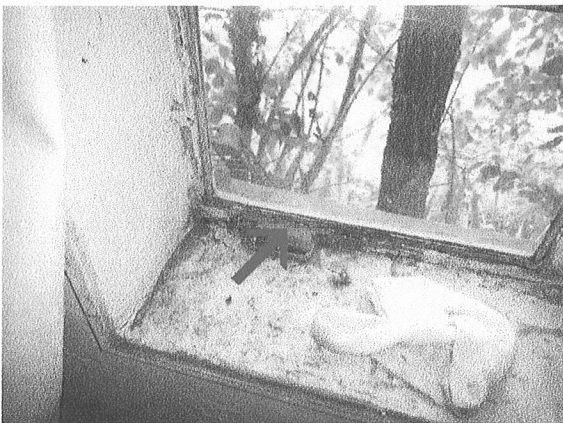
16.1.7 WINDOWS GENERAL OPERATION

THE WINDOWS IN THE STRUCTURE ARE THE ORIGINAL STEEL WINDOWS. THE GLASS IS BROKEN IN SEVERAL OF THE WINDOWS AND MOST ARE INOPERABLE. REPLACEMENT WINDOWS ARE NEEDED. IT IS RECOMMENDED THAT ESTIMATES FOR REPLACING THE WINDOWS BE OBTAINED FROM A QUALIFIED WINDOW COMPANY. ESTIMATES FOR INSTALLATION OF THE REPLACEMENT WINDOWS, INCLUDING RESTUCCOING, SHOULD BE OBTAINED FROM A QUALIFIED CONTRACTOR.

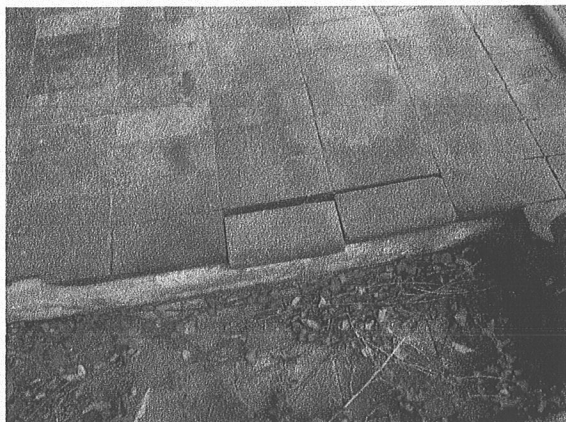
1.2.2 WALKWAYS

BRICKS ARE LOOSE AND SHOULD BE RESET WHERE NECESSARY ON THE FRONT WALKWAY AND PORCH TO PREVENT A TRIP HAZARD.

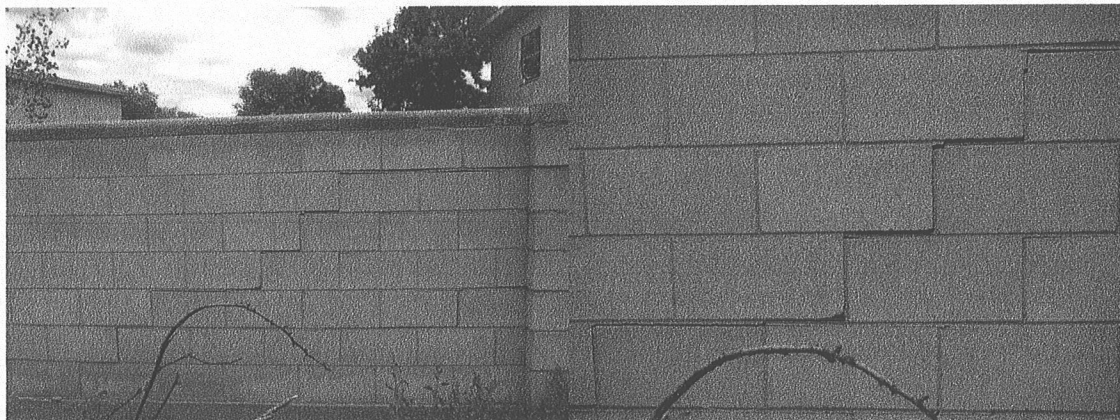
1.4.2 WALLS

NOTE: THERE ARE STEP CRACKS IN THE REAR CONCRETE BLOCK WALL, INDICATING SETTLEMENT IN THOSE AREAS. SOME CONCRETE BLOCKS IN THE WALL ARE BROKEN.

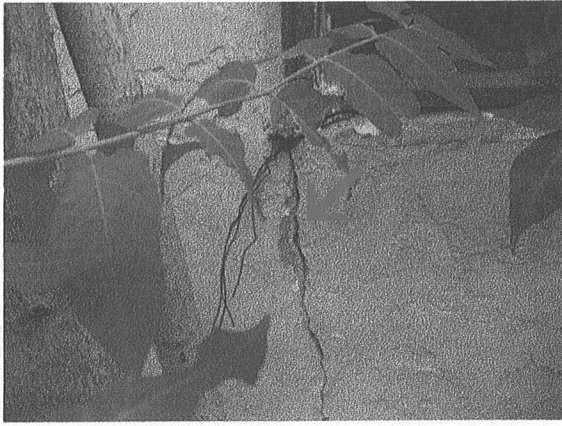
2.1.2 EVIDENCE OF SETTLEMENT

NOTE: THERE IS A LARGE SETTLING CRACK THROUGH THE STRUCTURE WALL ON THE WEST SIDE.

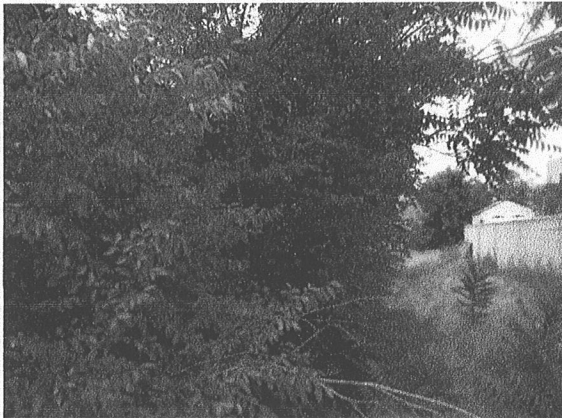
2.1.8 VEGETATION CLEAR FROM STRUCTURE

ALL VEGETATION SHOULD BE TRIMMED AWAY FROM THE STRUCTURE WALLS. ESTIMATES FOR TREE REMOVAL SHOULD BE OBTAINED SO THE COSTS CAN BE ANTICIPATED.

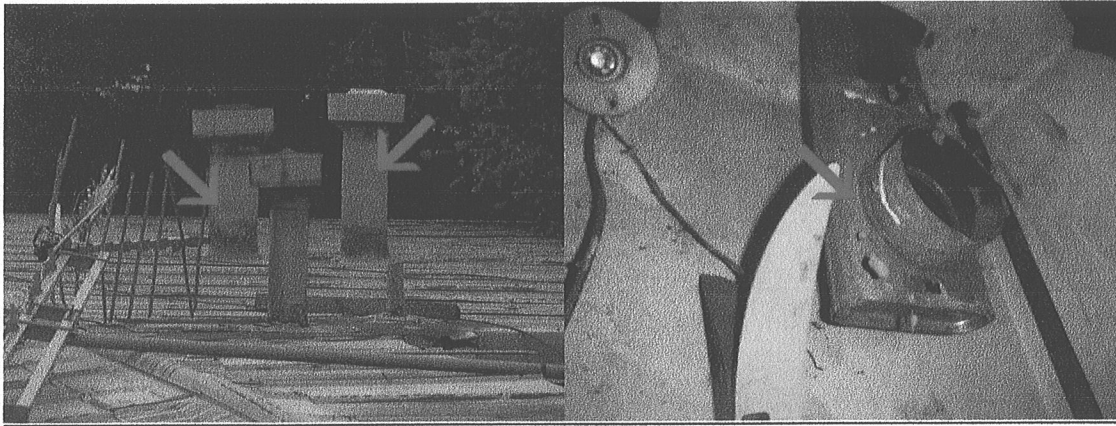
3.1.0 FLAT

THERE ARE GAS HEATER FLUES IN THE STRUCTURE WHICH MAY CONTAIN ASBESTOS. INSULATION IN THE PORCH ROOF MAY BE ASBESTOS CONTAINING. A QUALIFIED ASBESTOS EXPERT SHOULD BE CONSULTED REGARDING PROCEDURES OF REMOVAL OR CONTAINMENT OF ASBESTOS CONTAINING MATERIALS.

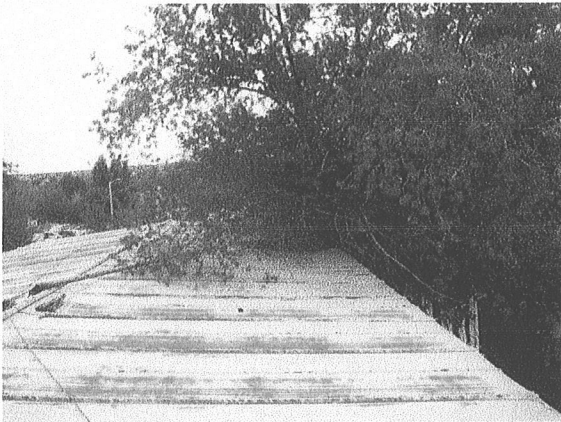
3.2.2 DEBRIS ON ROOF

TREE LIMBS SHOULD BE CUTBACK FROM THE ROOF SURFACE.

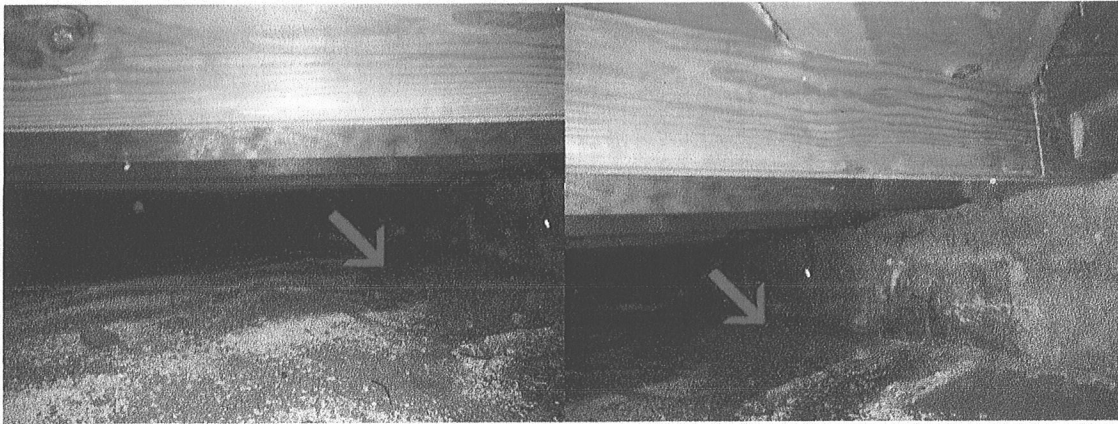
4.2.6 MOISTURE/DAMPNESS

THE SOIL IN THE CRAWL SPACE APPEARS DAMP FROM MOISTURE INFILTRATION DUE TO POOR DRAINAGE AT THE PERIMETER. MOISTURE BUILD-UP IN THE CRAWL SPACE CAN RESULT IN MOLD GROWTH WHICH CAN POSE A HEALTH HAZARD. DRAINAGE UPGRADES SHOULD BE INSTALLED, THE AREA THOROUGHLY DRIED AND NECESSARY TREATMENT MEASURES INSTALLED AS A HEALTH PRECAUTION.

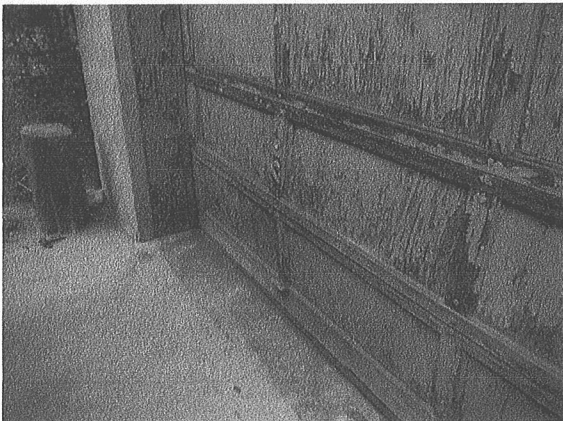
5.1.3 OVERHEAD DOOR(S)

THE OVERHEAD GARAGE DOOR IS VERY OLD AND MAY NEED REPLACEMENT. ESTIMATES FOR THE REPLACEMENT OF THE OVERHEAD GARAGE DOOR SHOULD BE OBTAINED.

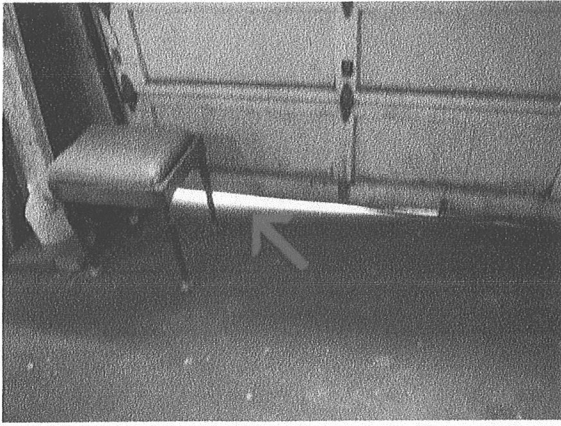
5.1.7 DOOR SEAL

THE SEAL ON THE BOTTOM OF THE OVERHEAD DOOR IS DAMAGED AND SHOULD BE REPLACED.

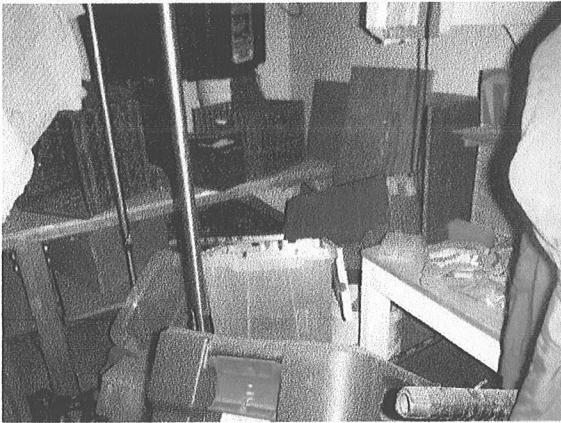
5.1.8 FLOOR

NOTE: EXTENSIVE PERSONAL ITEMS IN THE GARAGE PREVENTED A COMPLETE EVALUATION OF THE GARAGE FLOOR. THE VISIBLE AREAS OF THE CONCRETE FLOOR APPEARED TO BE IN GOOD CONDITION.

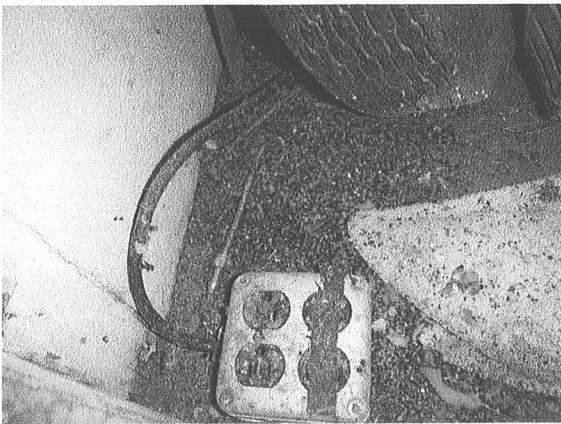
5.1.14 EVIDENCE OF INSECTS

THERE IS EVIDENCE OF UNDESIRABLE INSECTS IN THE GARAGE. THESE INSECTS ARE NOT NECESSARILY WOOD DESTROYING, BUT IT IS RECOMMENDED THAT A TERMITE/PEST INSPECTION BE PERFORMED.

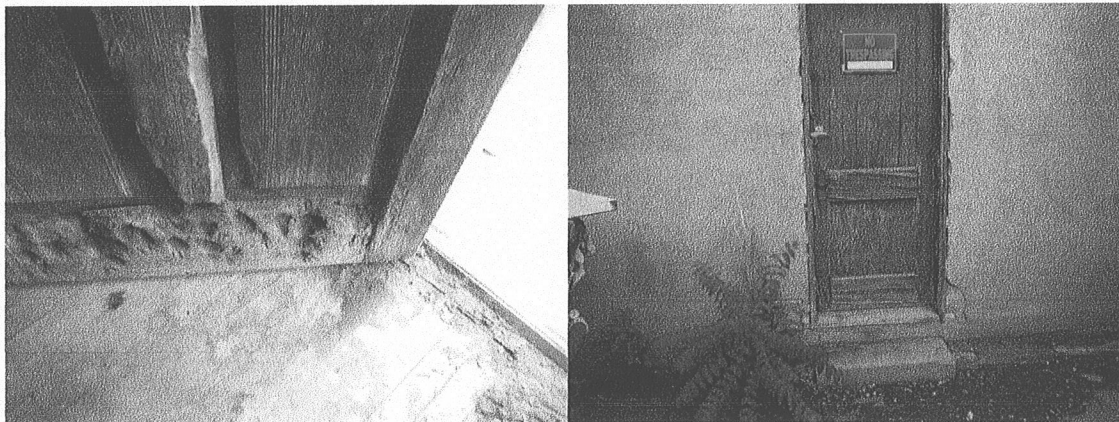
10.1.1 DOOR FITS

REPLACEMENT OF ALL EXTERIOR DOORS SHOULD BE ANTICIPATED. ESTIMATES FOR THE REPLACEMENT OF THE DOORS SHOULD BE OBTAINED SO THE COSTS CAN BE ANTICIPATED.
