RE: Status Review for 507 Coronado (currently non-contributing)

Historic Cultural Properties Inventory (HCPI) Base Form (FORM 1)

1. Name of property: Ted and Josephine Lopez Property	2. Location: 507 and 509 East Coronado Road Downtown and Eastside Historic District – Santa Fe	3. Local Reference Number: Santa Fe ID: N/A 4. County: Santa Fe Parcel # 910009184 & 910009187

8. Name of Project: HDRB Status Evaluation		
9. Lat/Long: 35.6747853,-105.9386578		
10. Photo Information: John W. Murphey, photographer. Photo 1: South (front) elevation, facing northeast.

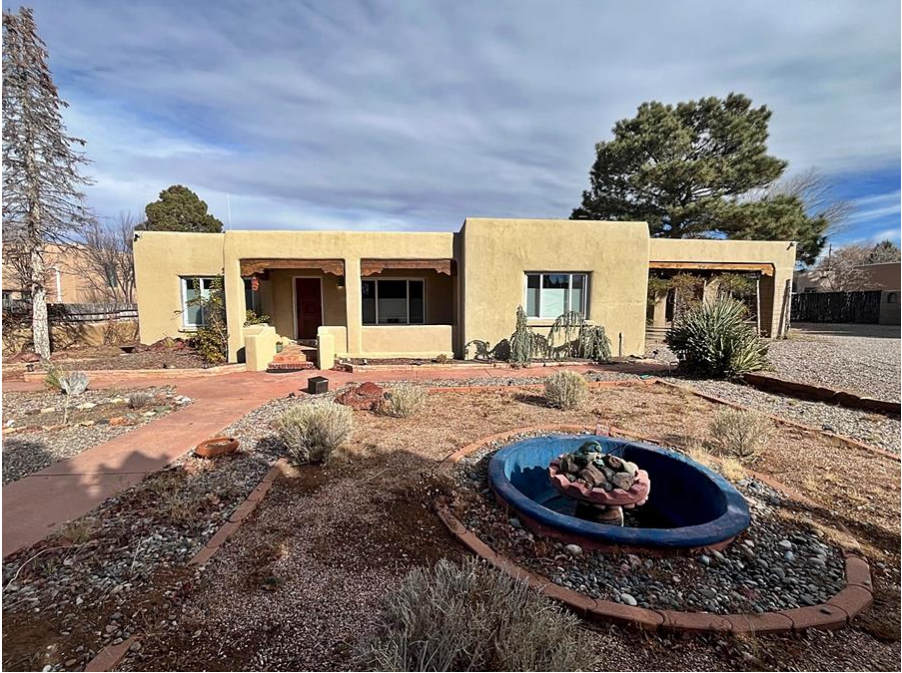
The front elevation presents a typical Pueblo Revival composition of a planar façade with a portal and a projecting cubic volume (Photos 1 & 6). In this case, the portal is slightly larger than typical proportions. The façade begins at the west with a combination window set above a heavy stuccoed lug sill serving the sitting room (Photo 7). The window unit, of vinyl-metal construction, likely replaced an earlier steel sash unit

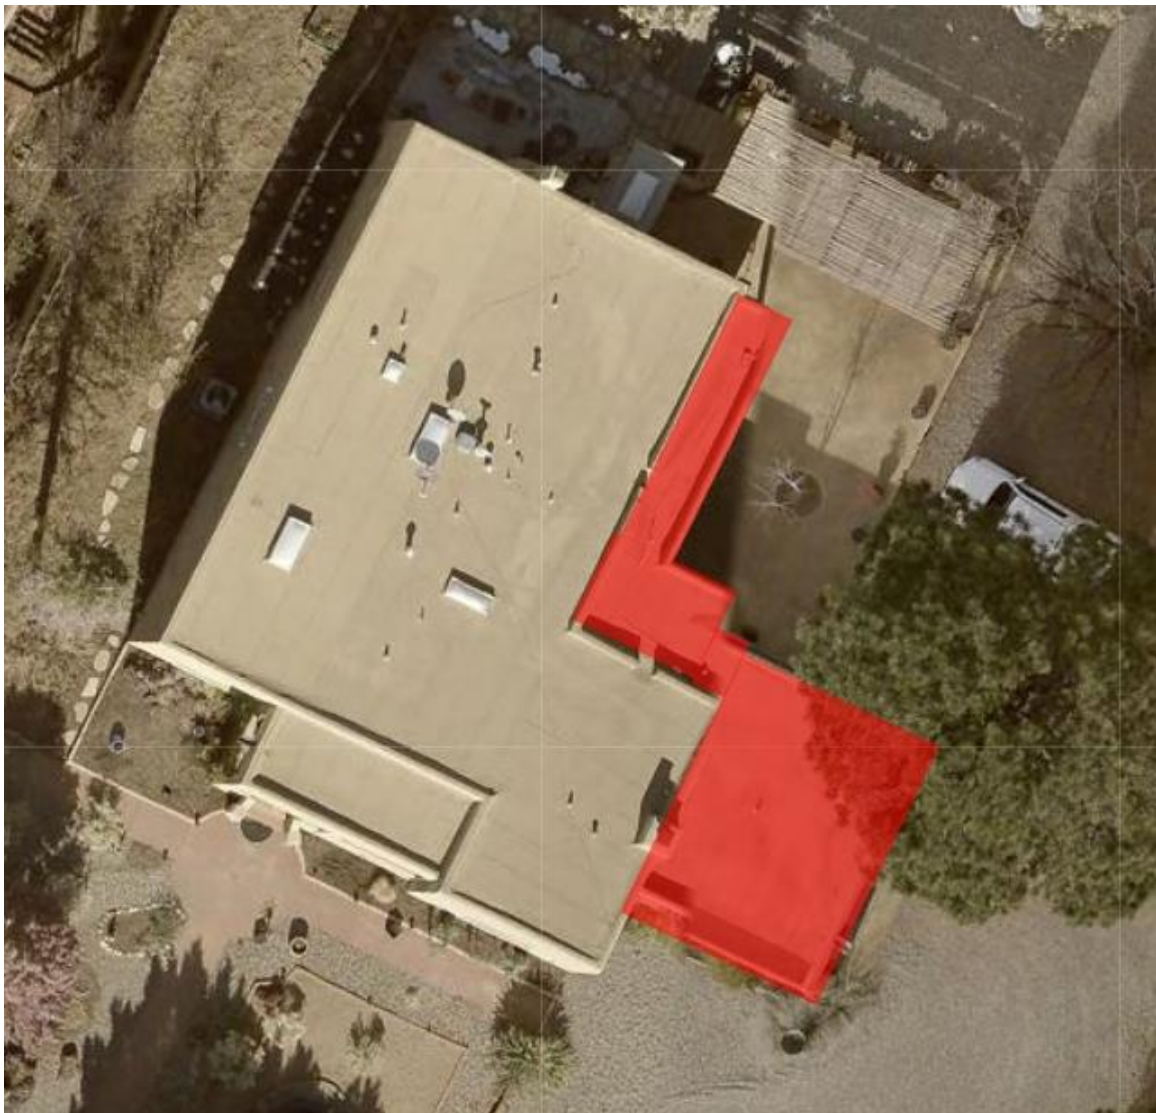
Figure 1: Alterations made after 1978 to building footprint (red).

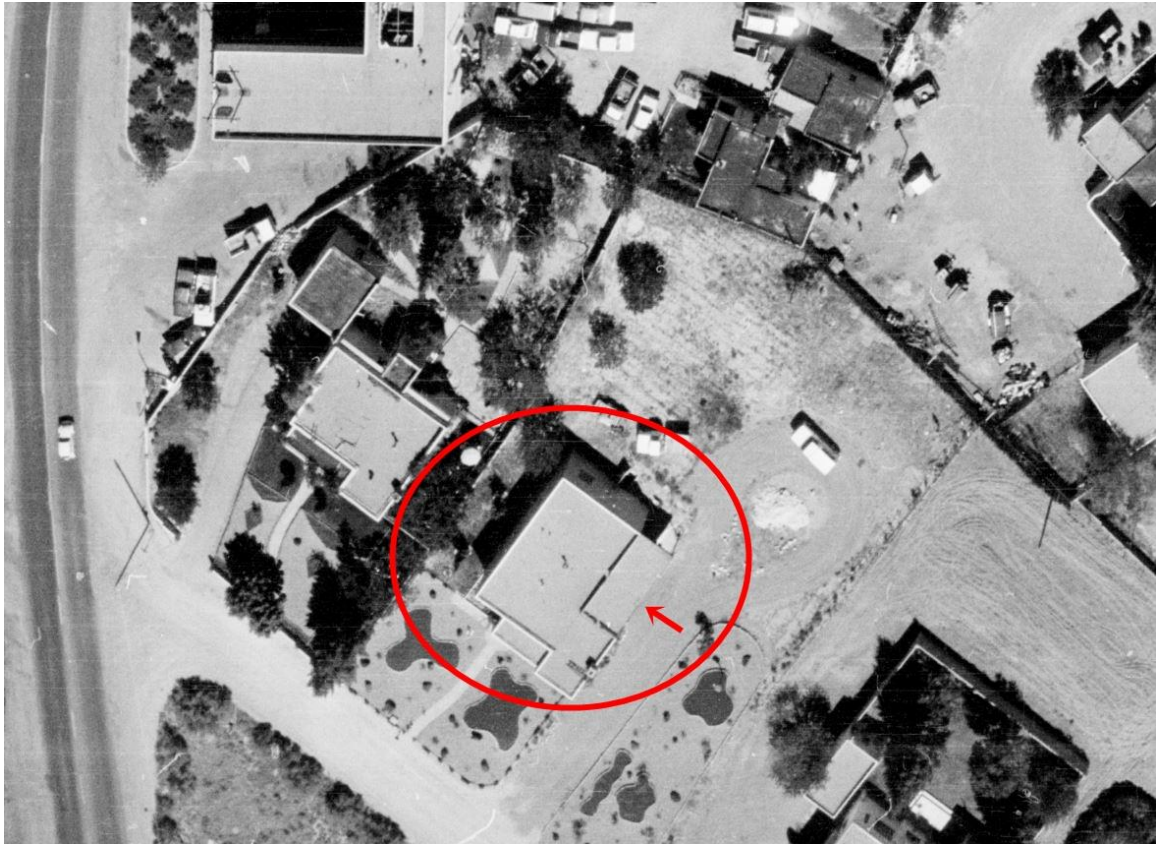
Figure 5: September 11, 1978, aerial photograph. First iteration of east portal has been added to east elevation. Note absence of casita and front privacy wall.

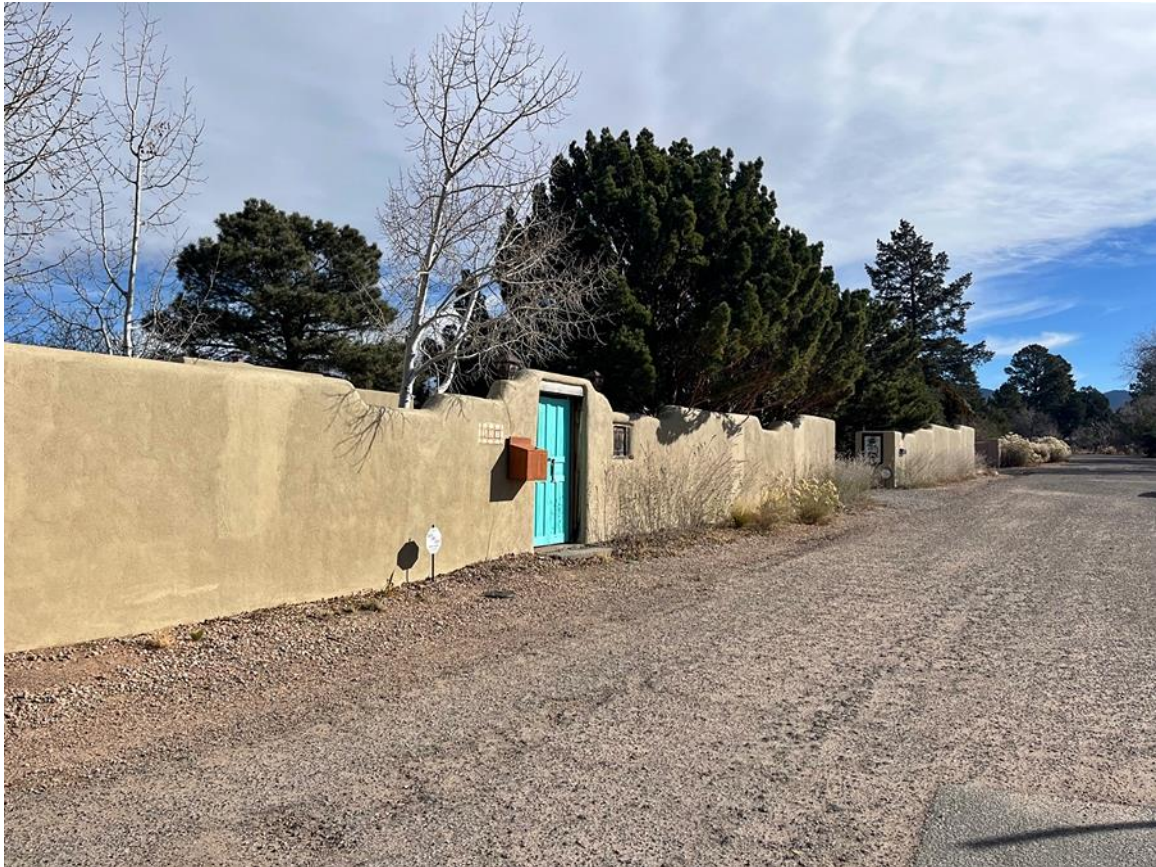
Built along the front property line is a tall stucco-on-block privacy wall arranged in two sections (Photo 5). The western section, in front of the primary dwelling, reaches a height of 83½ inches at its west end and includes a pedestrian entry gate (Photo 22). Near the center of the wall is a Corten-steel vehicular gate, set back approximately 20 feet. The wall terminates at the east at a height of 74 inches. The privacy wall is of recent construction and does not appear on a 1978 aerial photograph (Fig. 23)

Photo 5: Front privacy wall. Camera facing northeast.

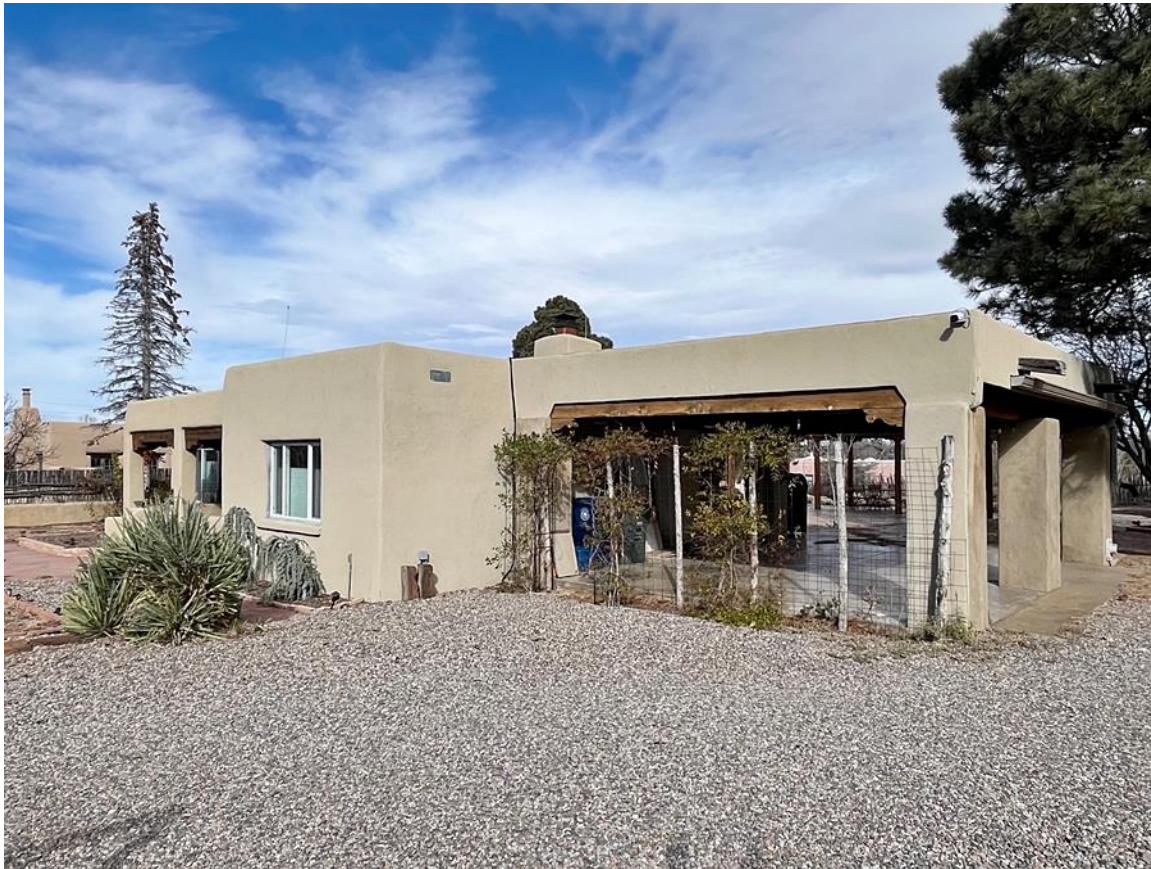
Photo 6: South elevation. Camera facing northwest.

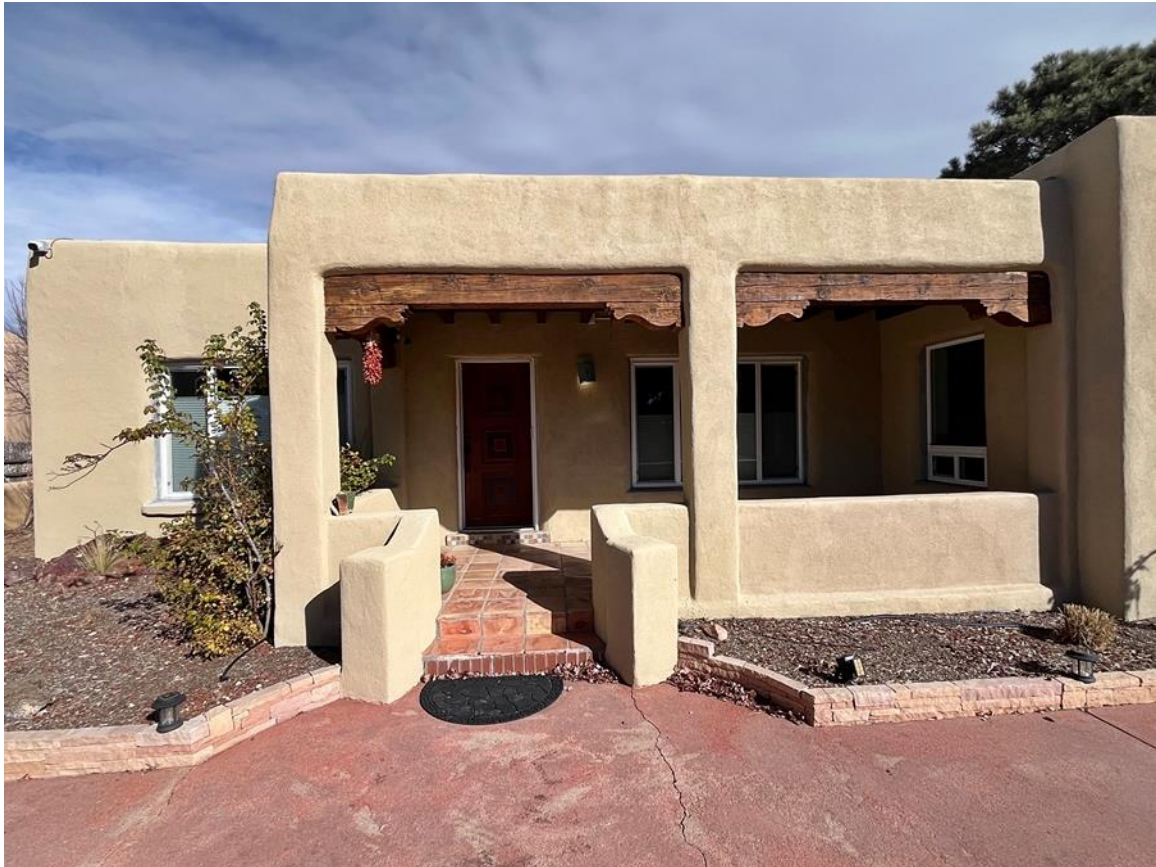
The house is approached by a short flight of steps flanked by a solid balustrade leading to the portal (Photo 8). The portal’s decking and floor have been replaced, and the exterior beams and corbels are overly rustic in character, also suggesting replacement. The decorative wood-panel entry door is of recent vintage (Photo 9). The projecting volume at the east end of the façade contains the living room and, like the rest of the house, is fitted with a vinyl-metal combination window (Photo 10).

Photo 8: South elevation. Portal. Camera facing northeast.

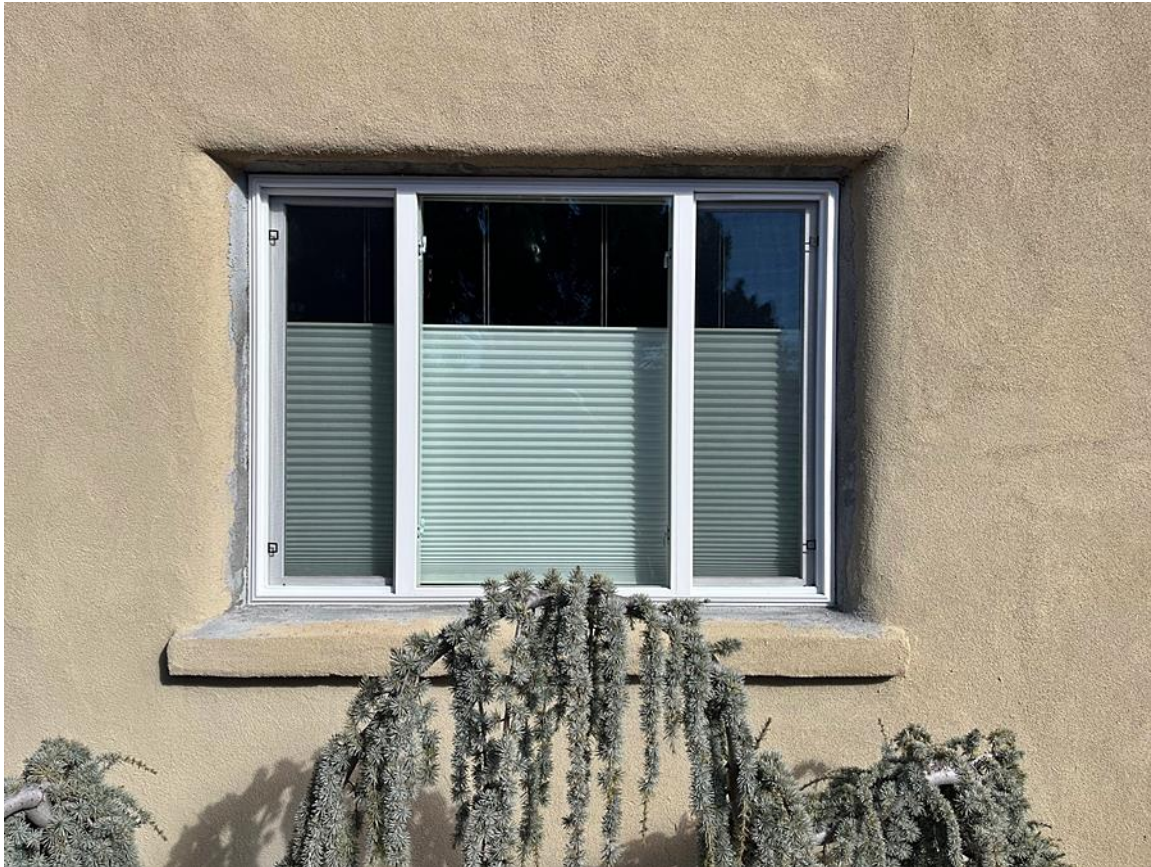
Photo 10: South elevation. Window at living room. Camera facing northeast.

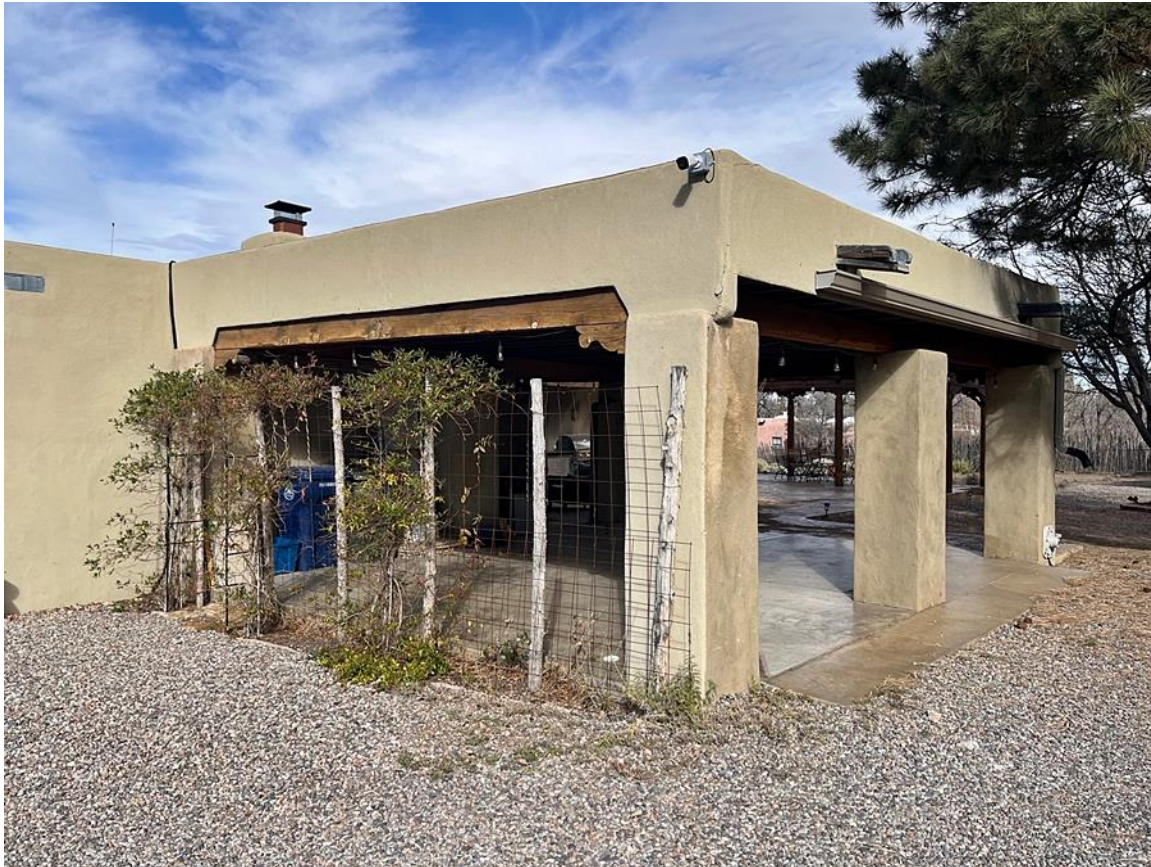
The carport, erected in 1983, is attached to the house at the roofline (Photo 11). The flat-roofed, parapeted structure rests on stout posts but incorporates undersized dimensional lumber for the decking. It is accessed from the east (Photo). In its shadow is the base of the home’s primary chimney.

Photo 11: South and east elevations. Carport. Camera facing northwest.

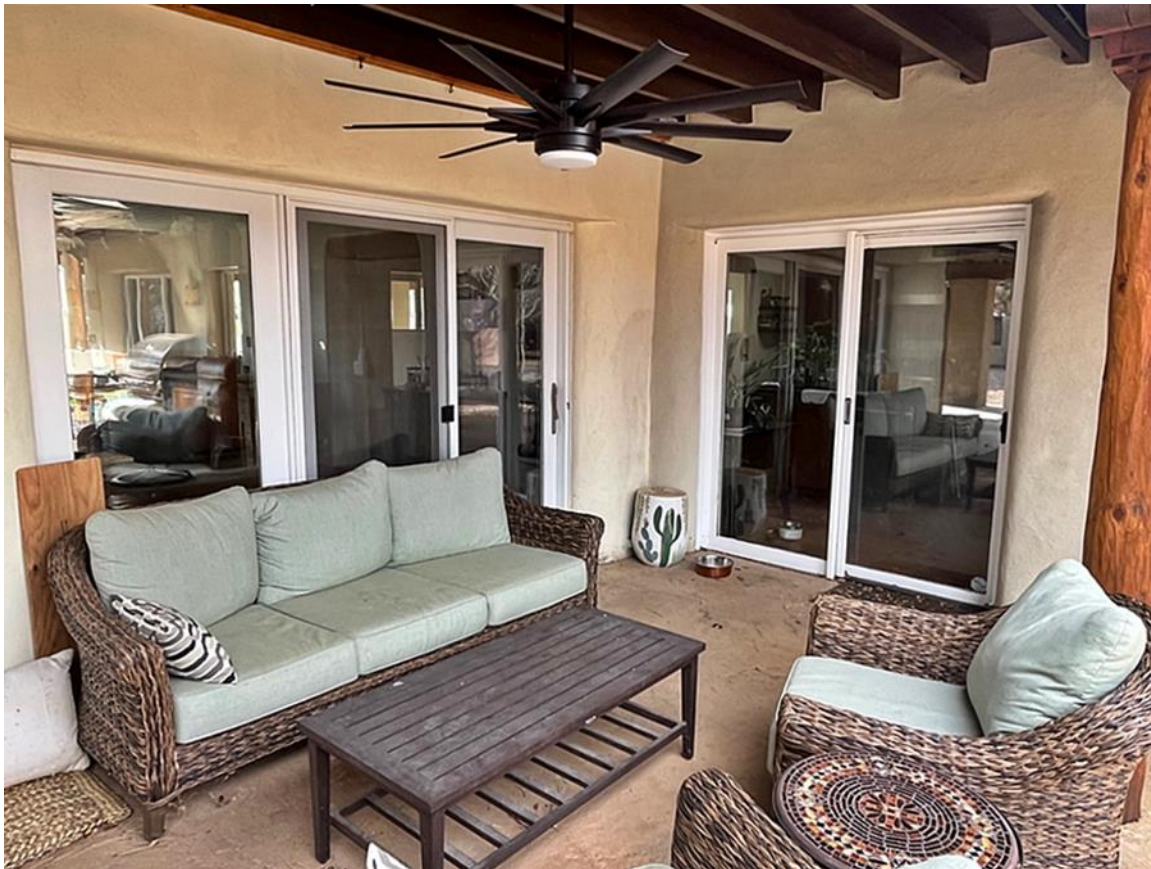
Photo 13: East elevation. Covered patio with non-historic openings. Camera facing southwest.

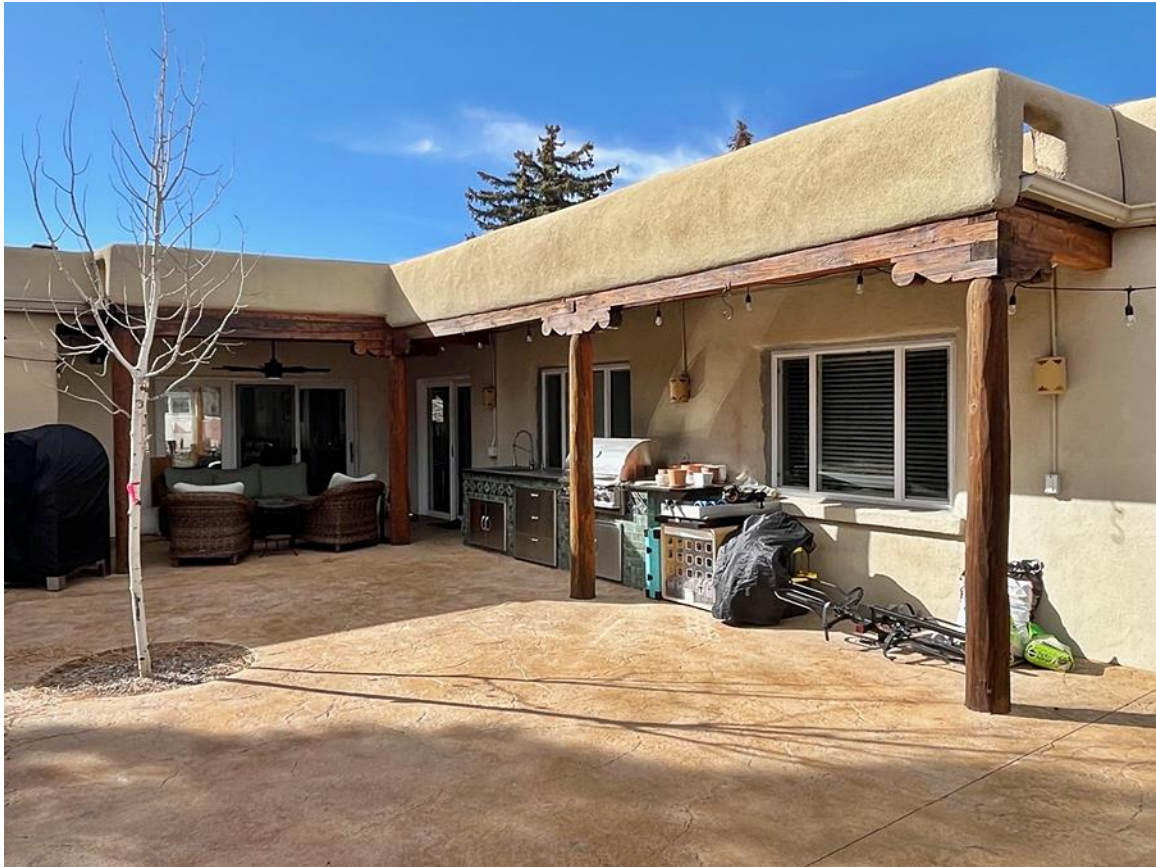
The east elevation is dominated by the carport and a long, shallow *portal* that was originally constructed in the 1970s and later modified, likely in conjunction with construction of the carport (Photo 12). The south end of the portal shelters a patio that is accessed from the house through two vinyl sliding doors (Photo 13). The design and placement of these doors are not characteristic of 1950s construction. The remainder of the elevation is fenestrated with vinyl-metal combination windows (Photo 14).

Photo 14: East elevation. Non-historic portal. Camera facing southwest.

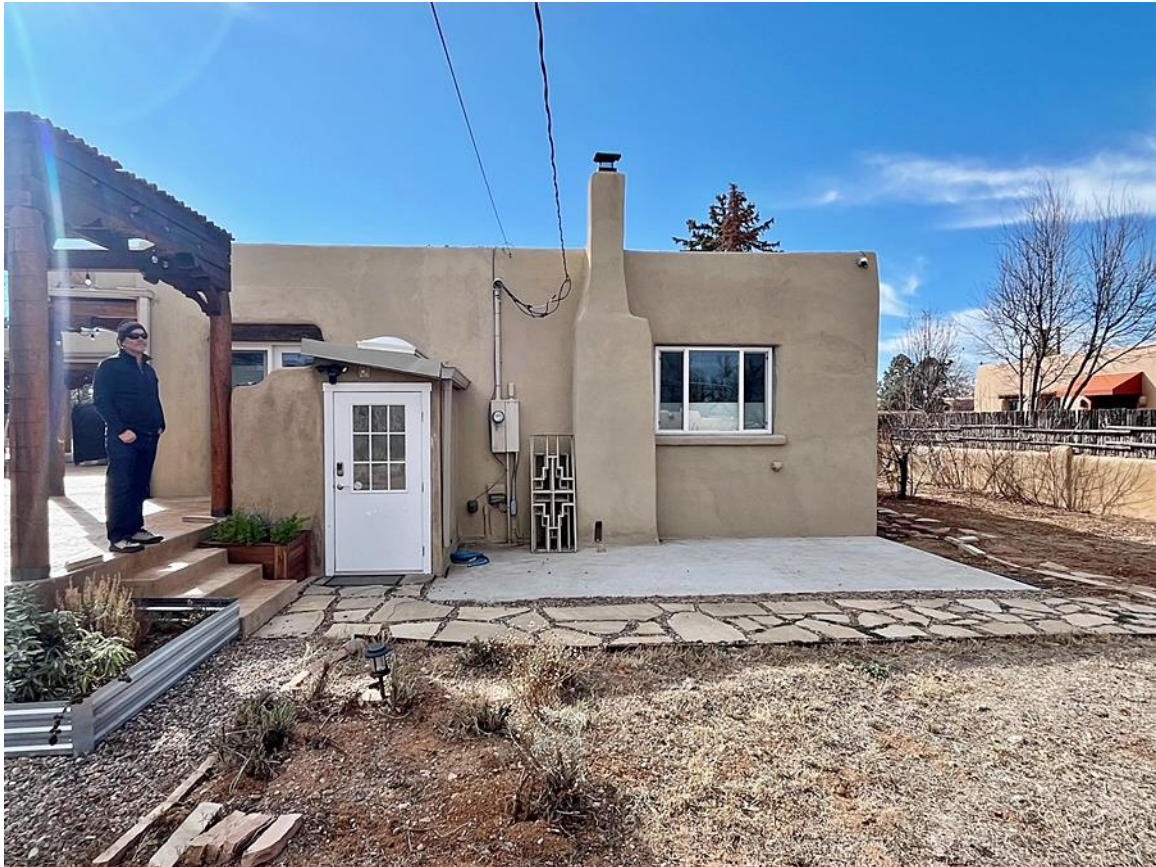
Based on aerial photographs, the short north elevation (Photo 15) was altered after 1978 with the insertion of glazed doors serving the primary bedroom (Photo 16) and the addition of a small bump-out providing exterior access to the basement (Photo 18). The remainder of the elevation retains one original opening and a secondary chimney introduced after 1978.

Photo 15: North elevation. Camera facing southwest.

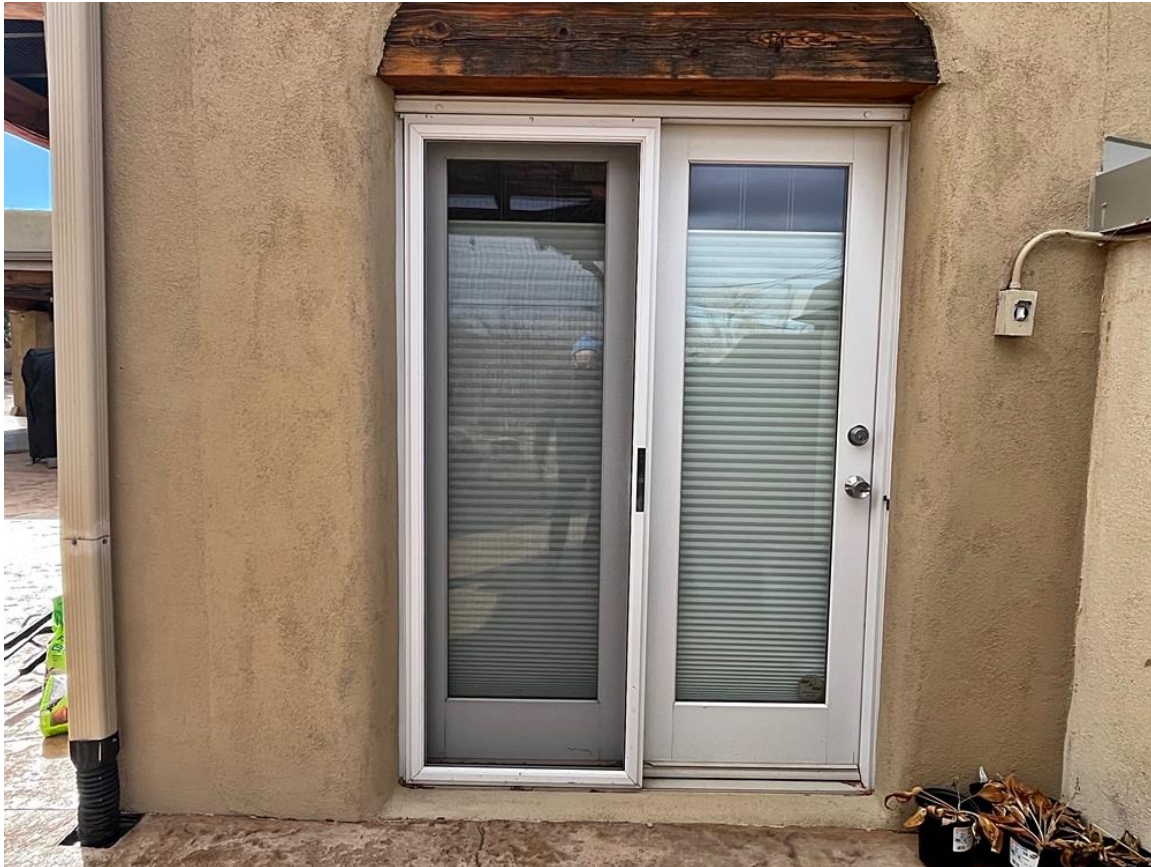
Photo 16: North elevation. Non-historic opening at primary bedroom. Camera facing southwest.

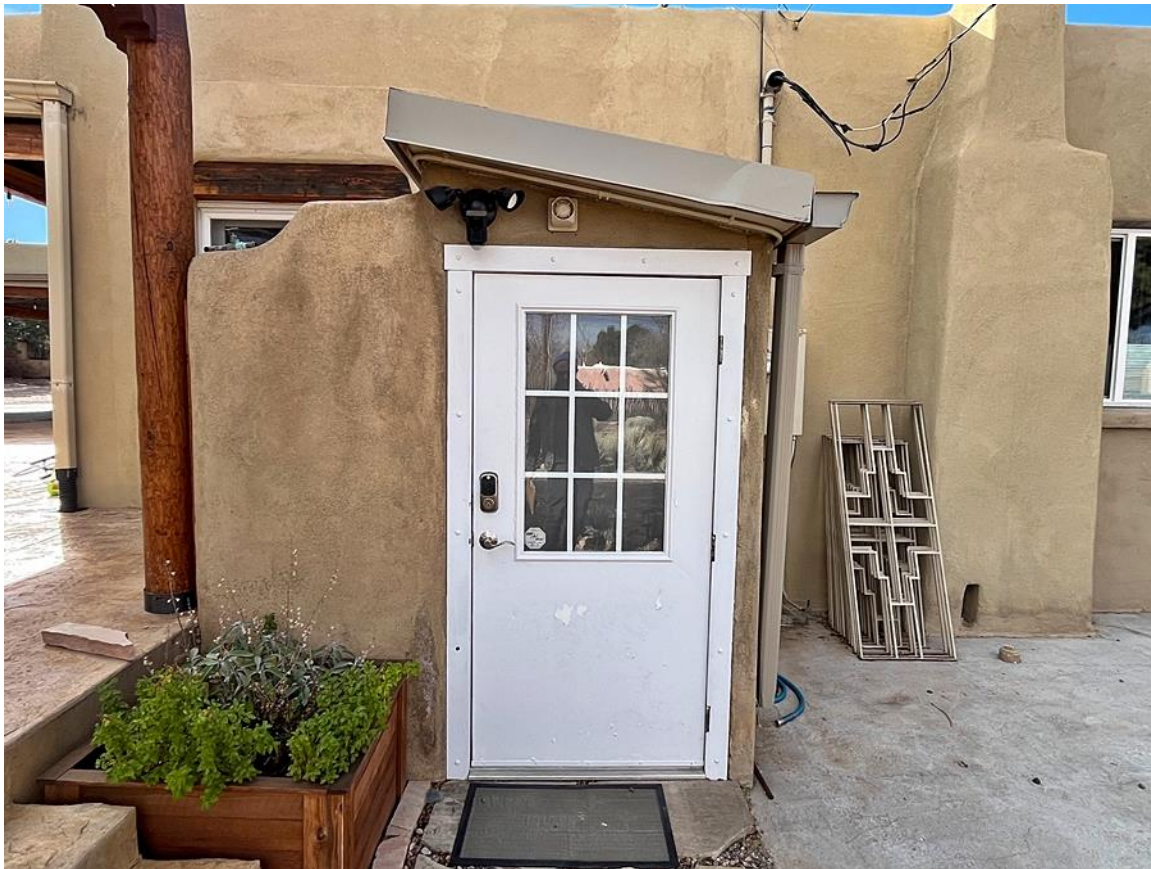
Photo 17: North elevation. Non-historic basement entry.

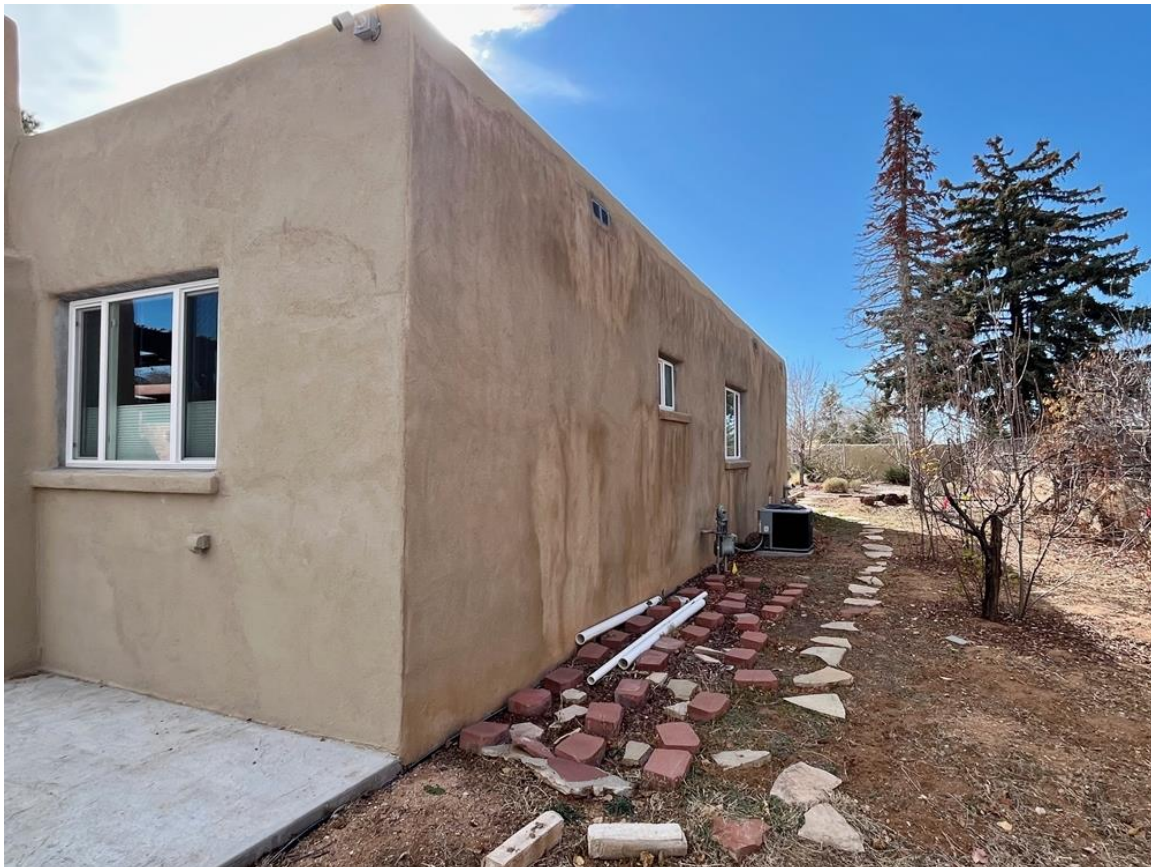
Facing a neighboring property, this elevation includes only two window openings, one serving a bathroom and the other, the guest bedroom (Photo 18). Like the other windows on the house, these units are of vinyl-metal construction.

Photo 18: West elevation. Camera facing southeast.

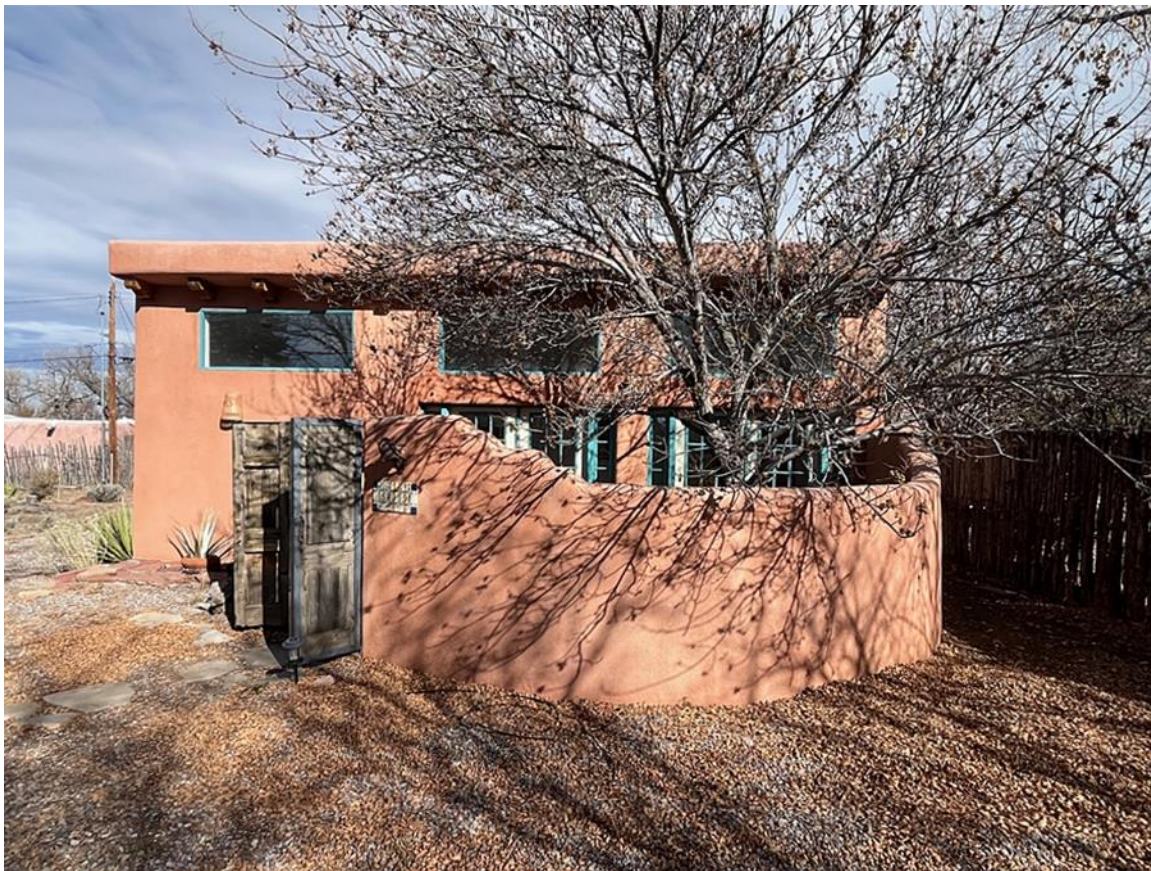
Situated in the northeast corner of the conjoined lots is a roughly 750-square-foot passive-solar guesthouse (Photo 19). The building exhibits a design typical of its period, with a tall, south-facing façade incorporating clerestory glazing and a roof overhang presumed to be designed to provide summer shading. Both the front and rear elevations are sheltered by walled patios that provide privacy and assist with climatic tempering (Photos 20). The windows are metal, and the front entry doors incorporate exterior plastic grids (Photo 21). Likely constructed in the late 1980s, the building was originally used as a studio-workshop and later converted to a guesthouse.

The guesthouse is too recent in construction to be considered Contributing and does not exhibit characteristics associated with the pioneering period of passive solar design in Santa Fe. It is therefore recommended as Non-contributing.

Photo 19: South elevation. Camera facing northeast.
