RPA & Associates, LLC.

JOB	DATE
528 – 530 CALLE CORVO, SANTA FE, NM 87501	09/04/2025

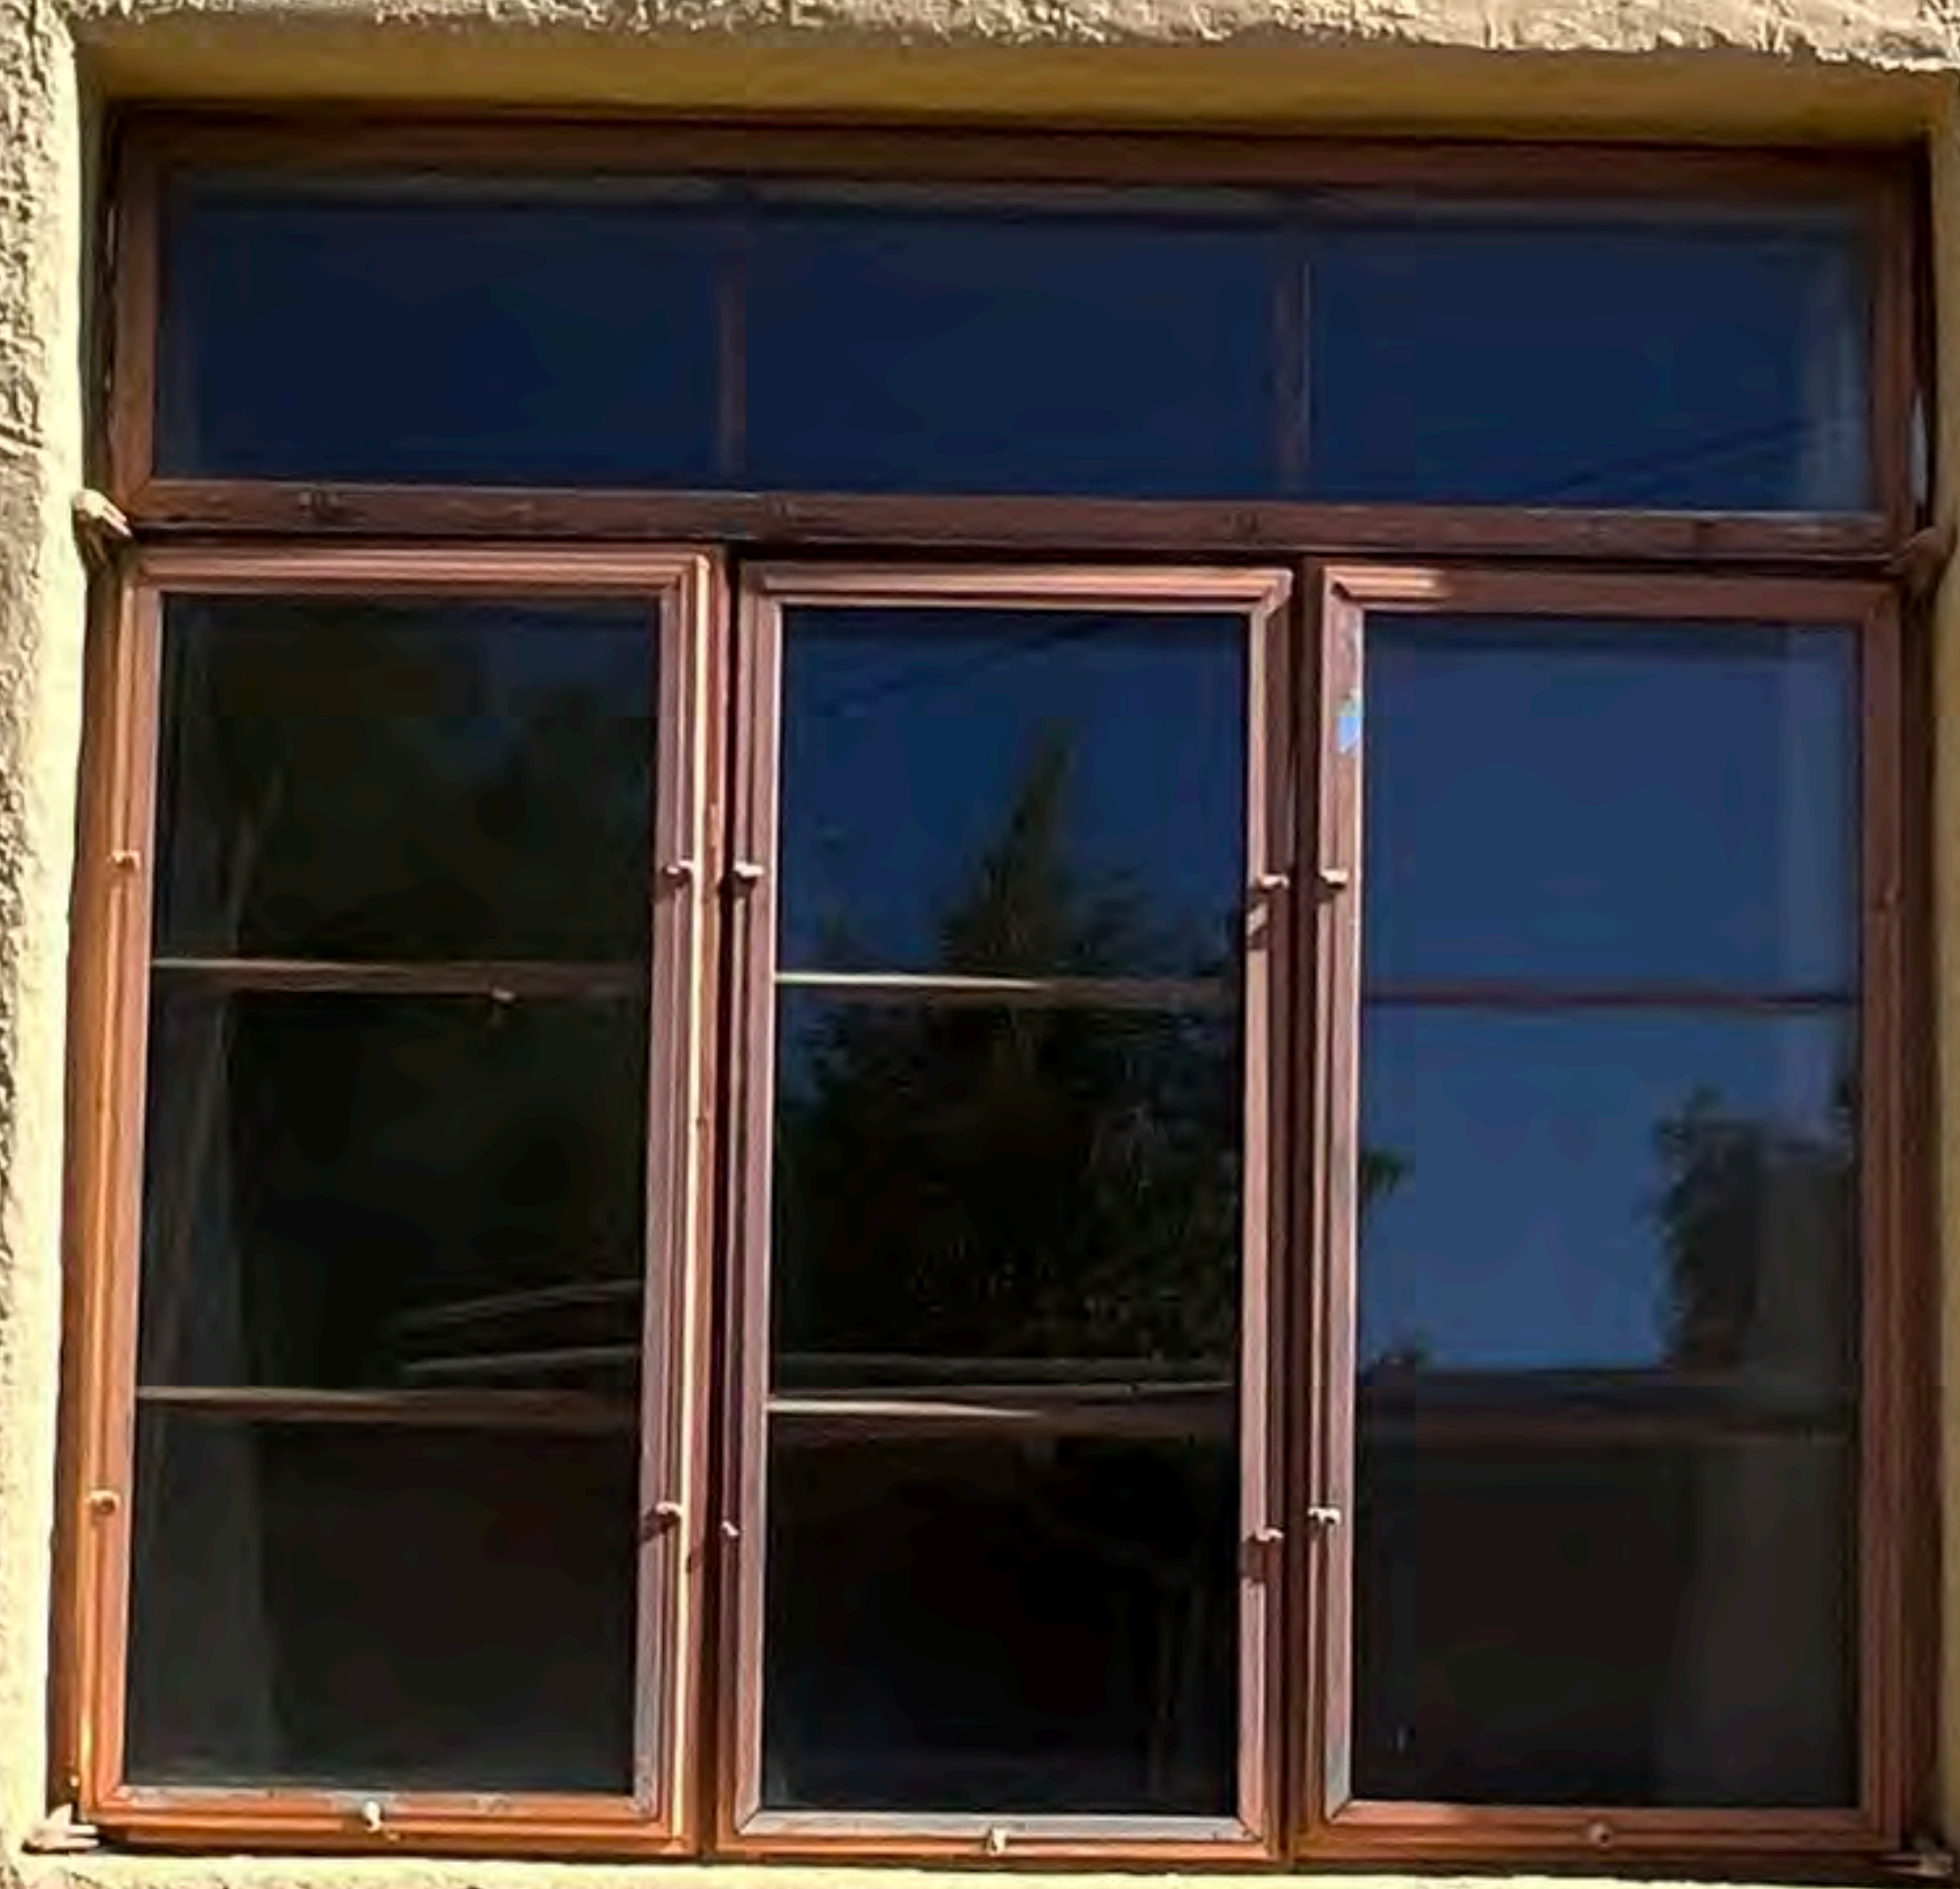
South
Elevation
Window
A

LABEL	WINDOW & DOOR DESCRIPTION	CONDITION & INTEGRITY CODE	HISTORIC/NON-HISTORIC - AGE
A	54" x 50" STEEL CASEMENT (54" x 38"/12 TRANSOM) 3W1H/1W3H/1W3H/1W3H	F	HISTORIC – METAL HAS RUSTED EXCESSIVE CONDENSATION TO THE STEEL CAUSING PLASTER DAMAGE. THERE IS EVIDENCE OF LEAKING IN THE WALL STRUCTURE.
B	38" x 38" GARDEN WINDOW 1-LT BRONZE ALUMINUM ALENCO	F	NON-HISTORIC – ALL THE INSULATED GLASS HAS FAILED (1998)
C	46" x 46" GARDEN WINDOW 1-LT BRONZE ALUMINUM ALENCO	F	NON-HISTORIC – ALL THE INSULATED GLASS HAS FAILED (1998)
DR #1	36" x 80" RH ALL WOOD DOOR 32-PANEL	S	NON-HISTORIC – FIR MANUFACTURED DOOR (1995)
D	17"/56"/17" x 62" LSR BRONZE COMPOSITE WINDOW – CASEMENT/PICTURE/CASEMENT JELD-WEN	P	NON-HISTORIC – (2015)
DR #2	36" x 80" RH ALL WOOD DOOR 32-PANEL	S	NON-HISTORIC – FIR MANUFACTURED DOOR (1995)
E	60" x 60" GARDEN WINDOW 1-LT BRONZE ALUMINUM ALENCO	F	NON-HISTORIC – ALL THE INSULATED GLASS HAS FAILED (1998)

It would be my opinion to allow the owners of this residence to replace with clad/wood and divided lite to match the configuration of the existing steel casements of that era.

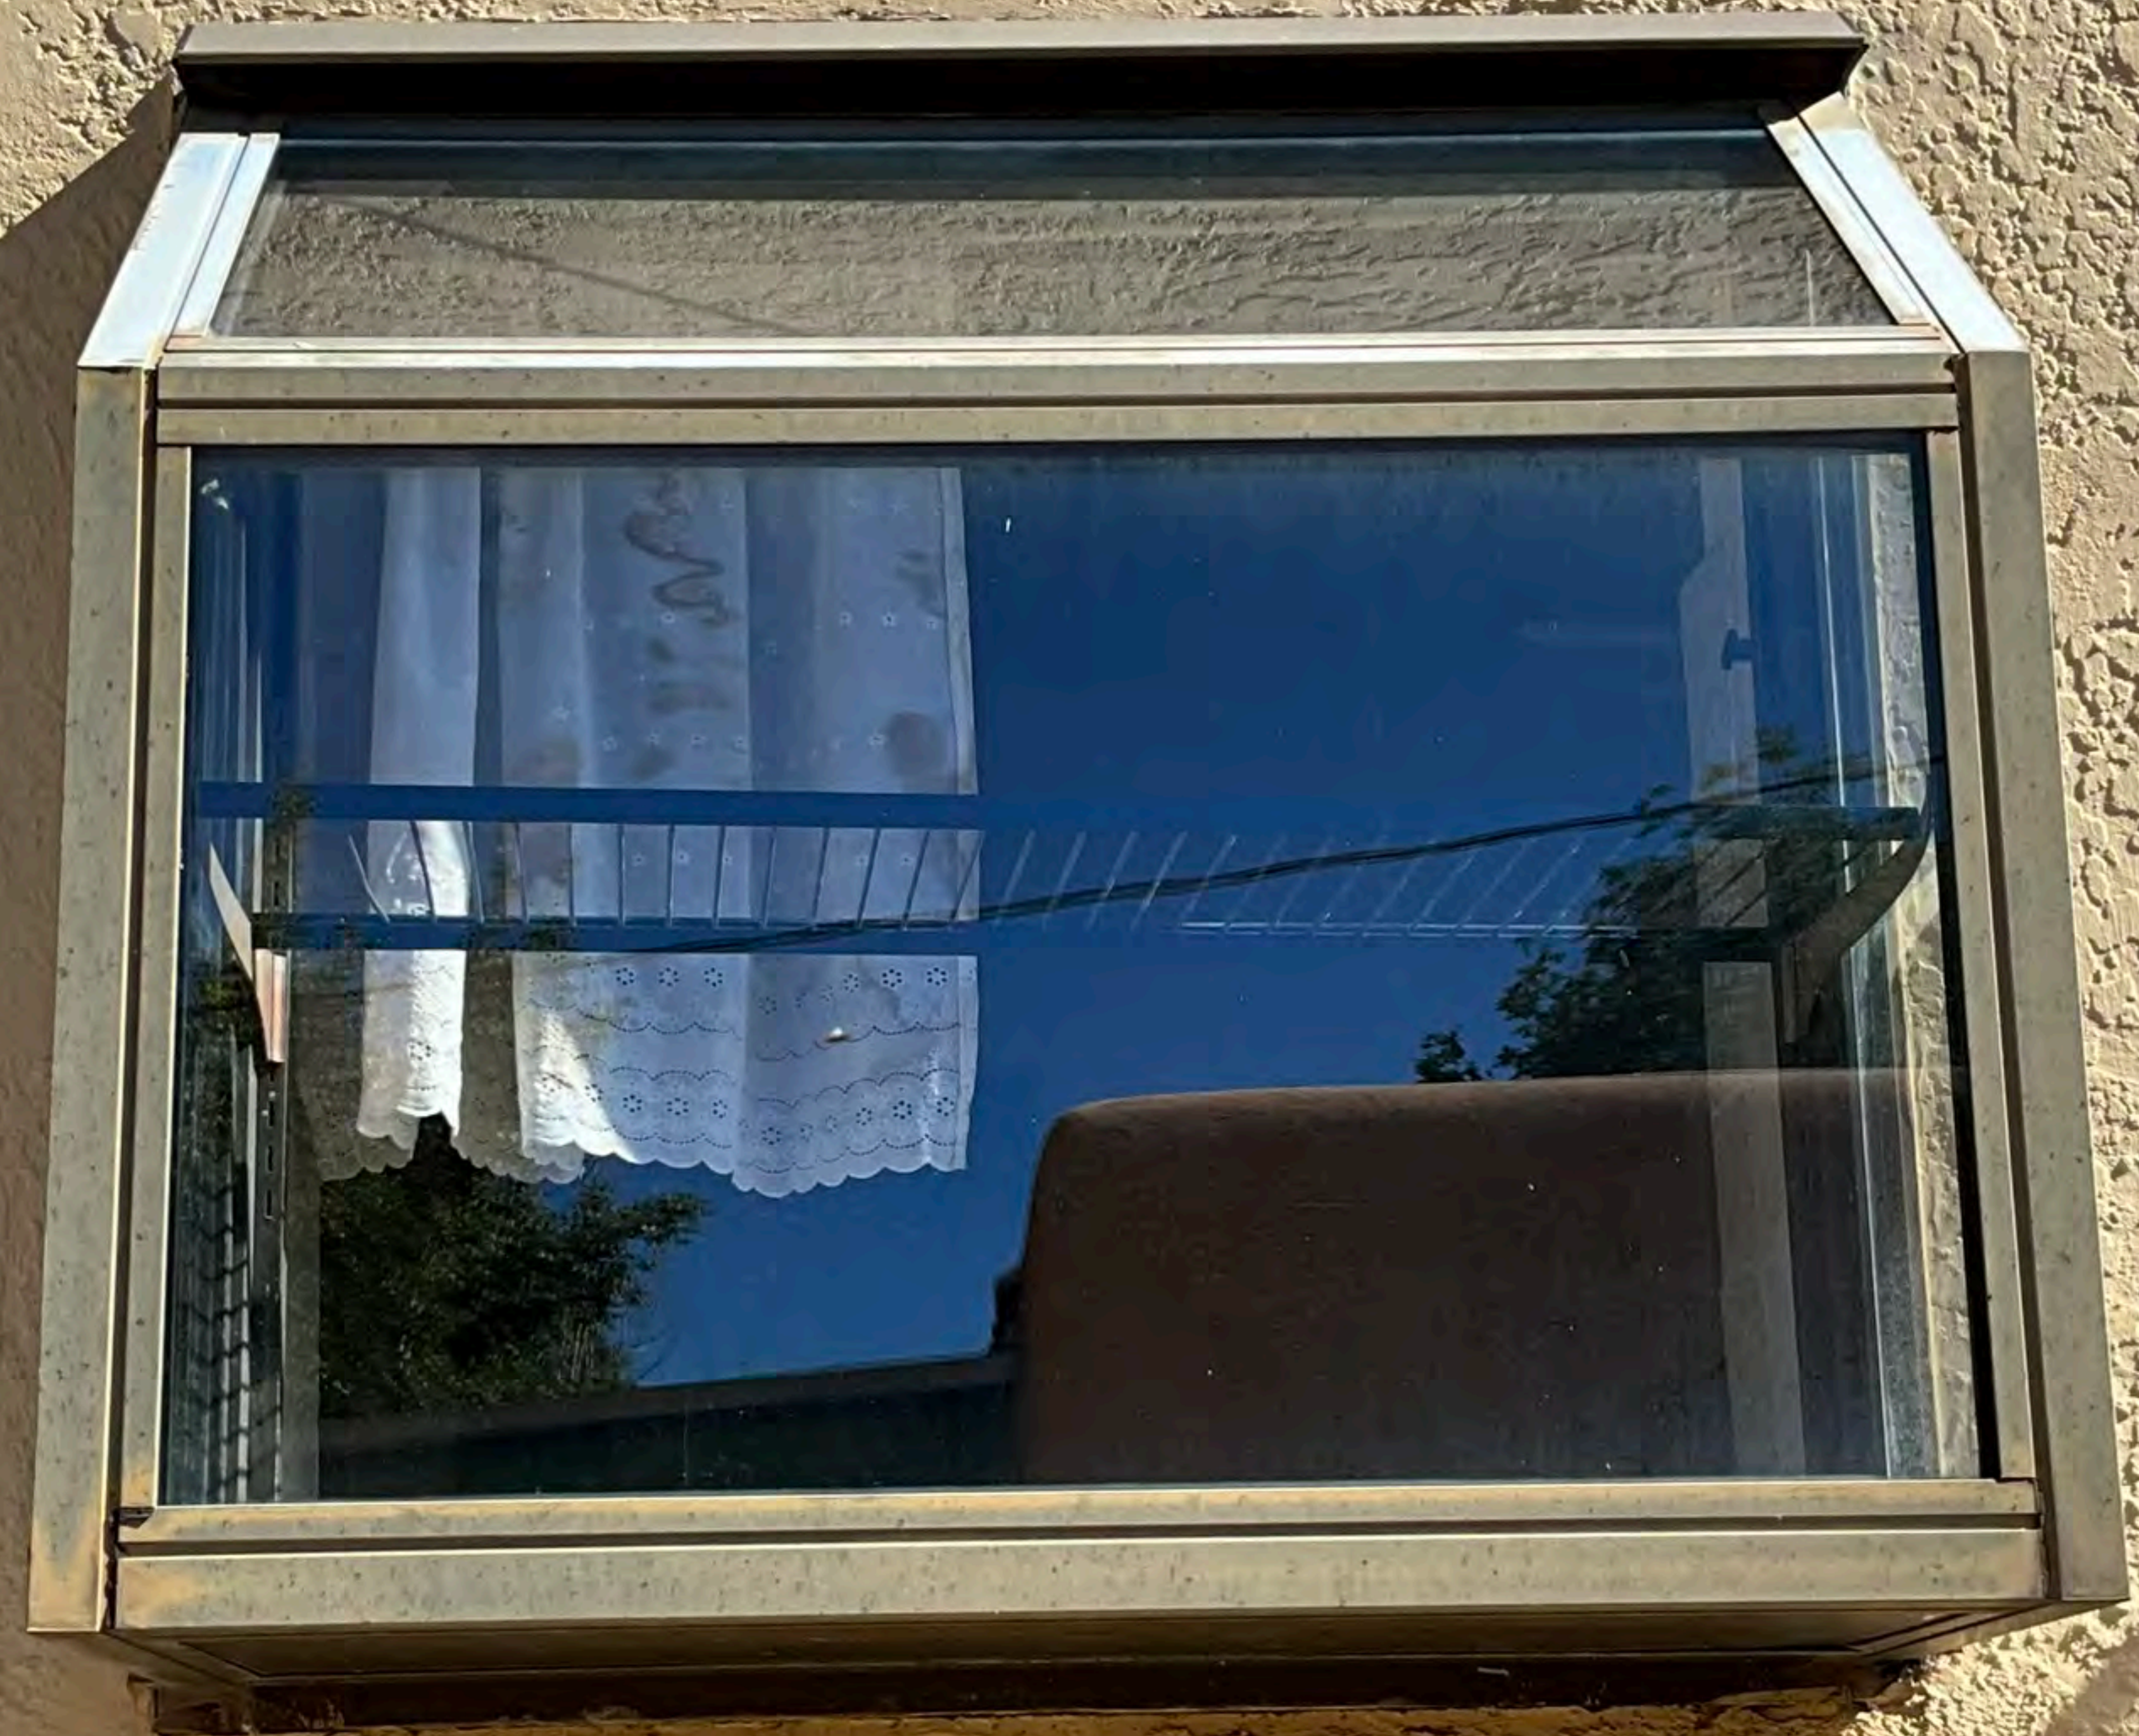
South
Elevation
Window
B

Windows B, C, D, E, Greenhouse, G-M, G-N, G-O are non-historic.

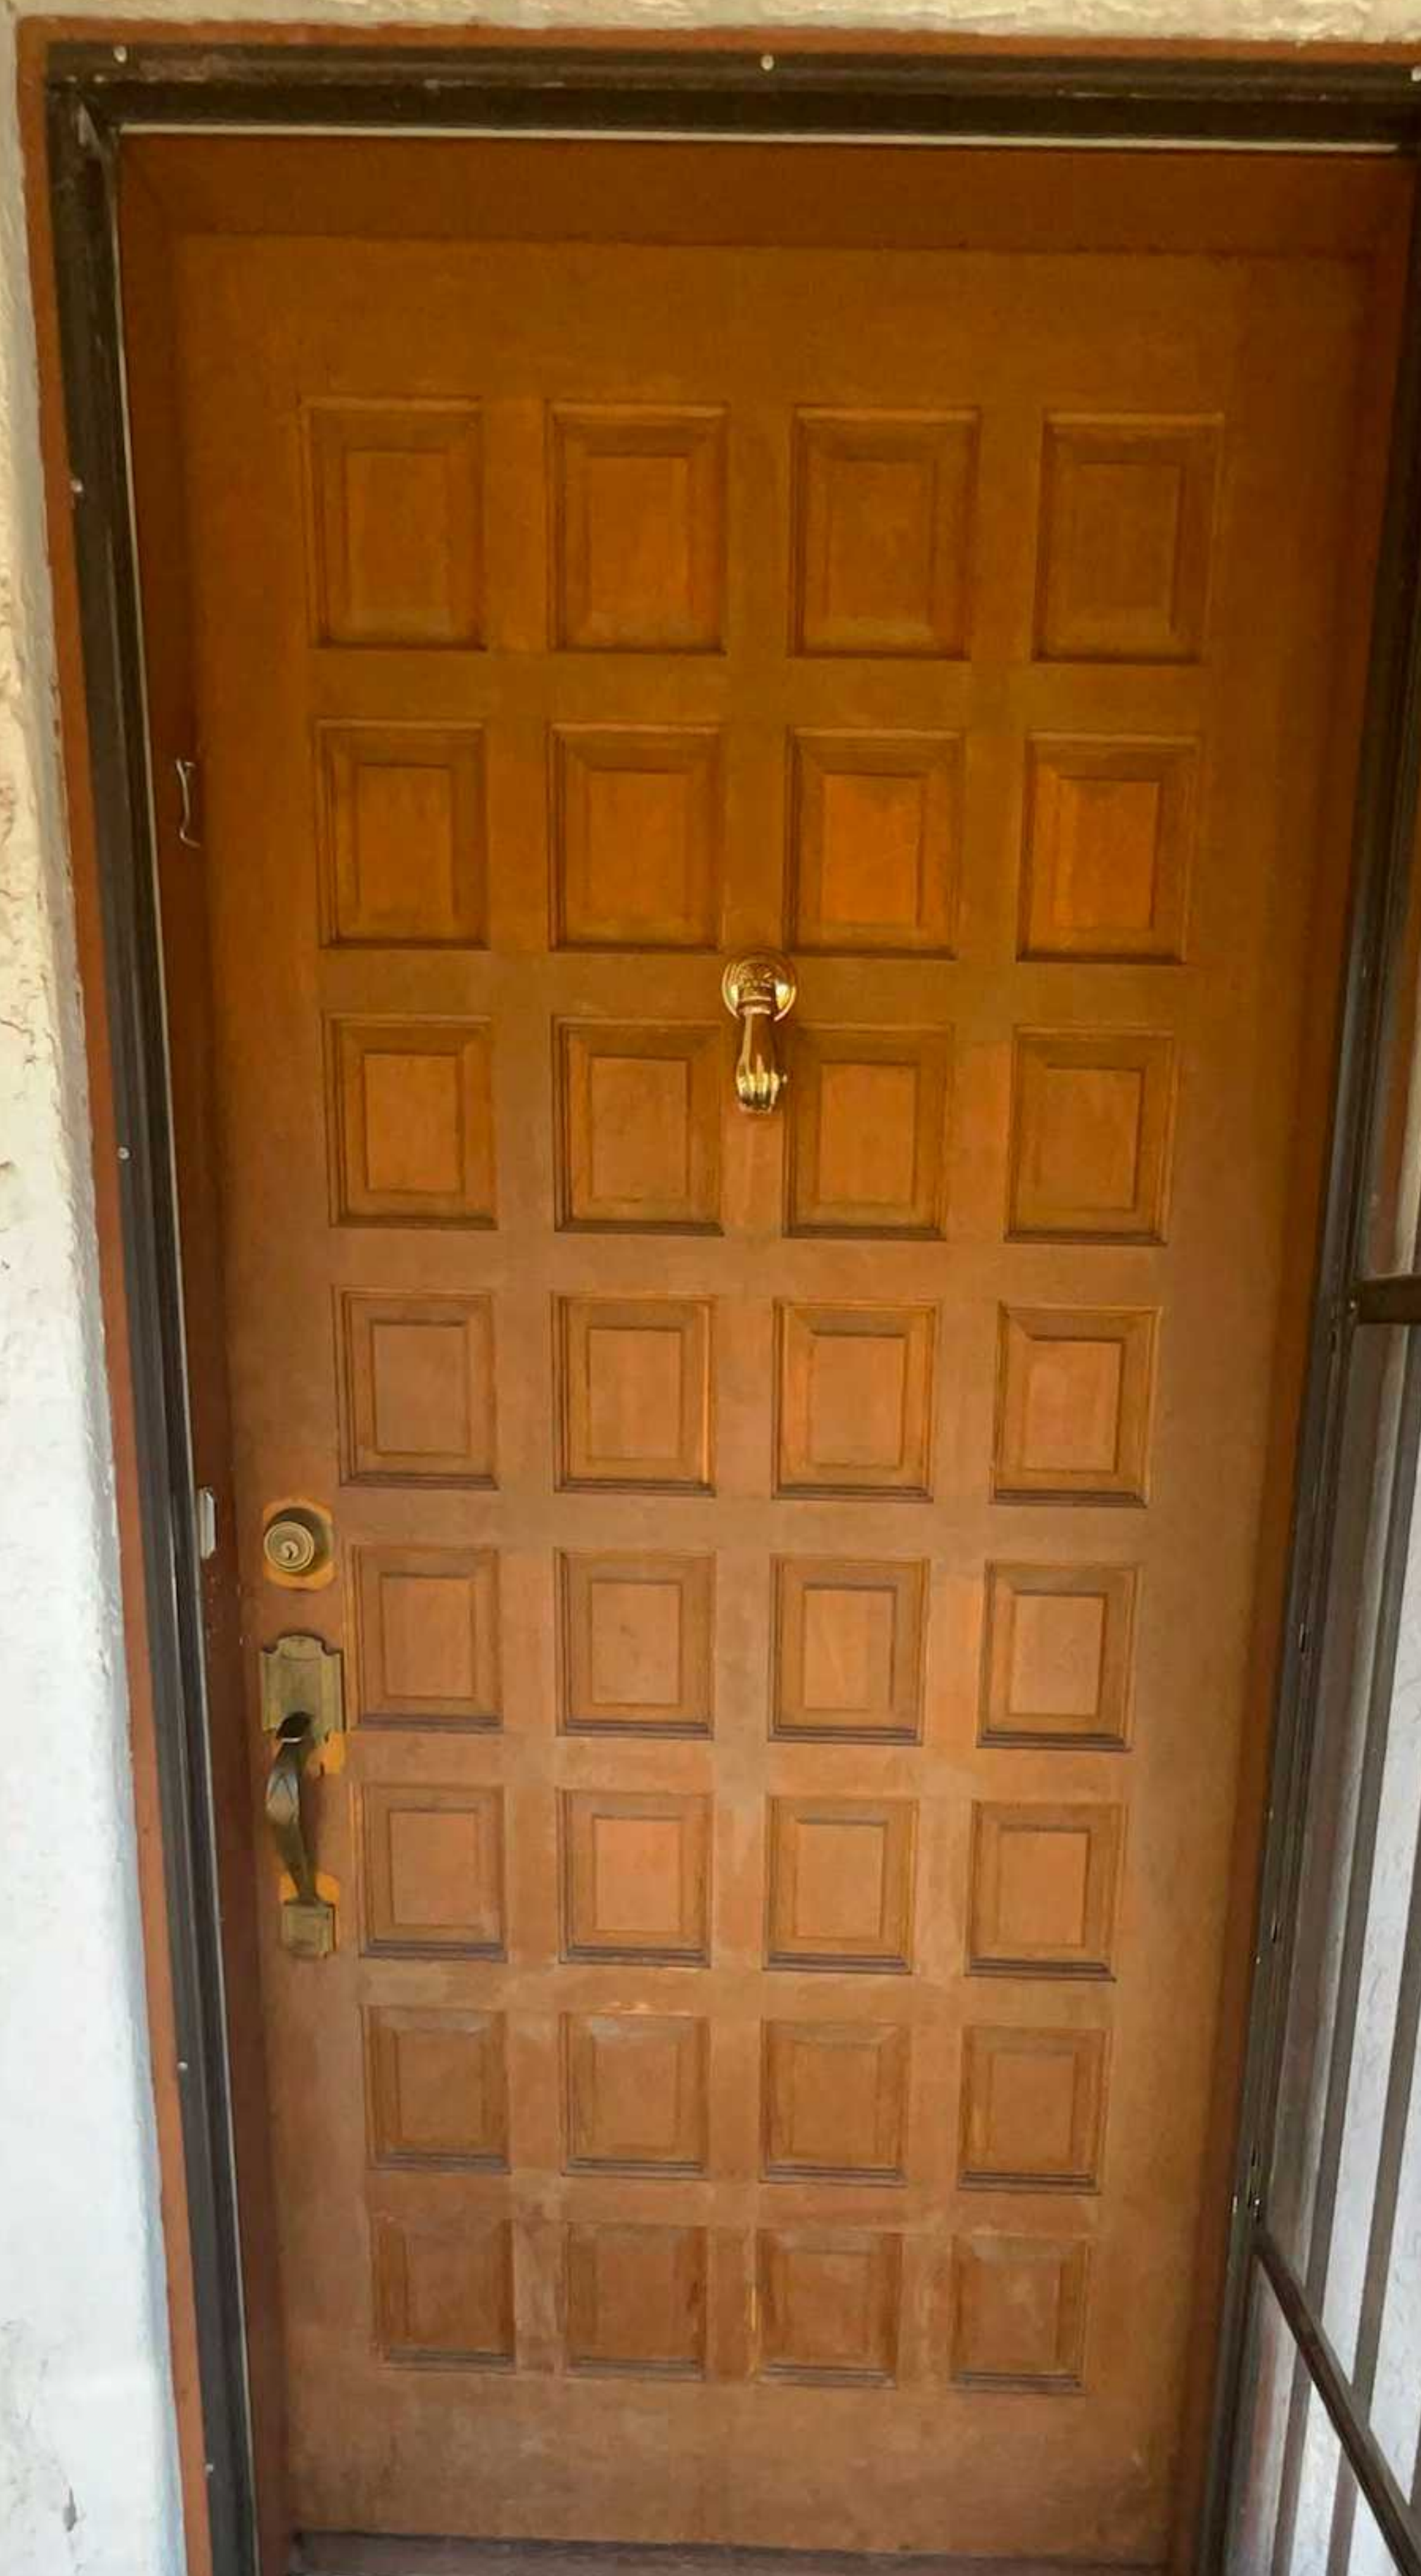
South
Elevation
Door #1

Doors #1, #2, #5, #6 and #7 are non-historic.

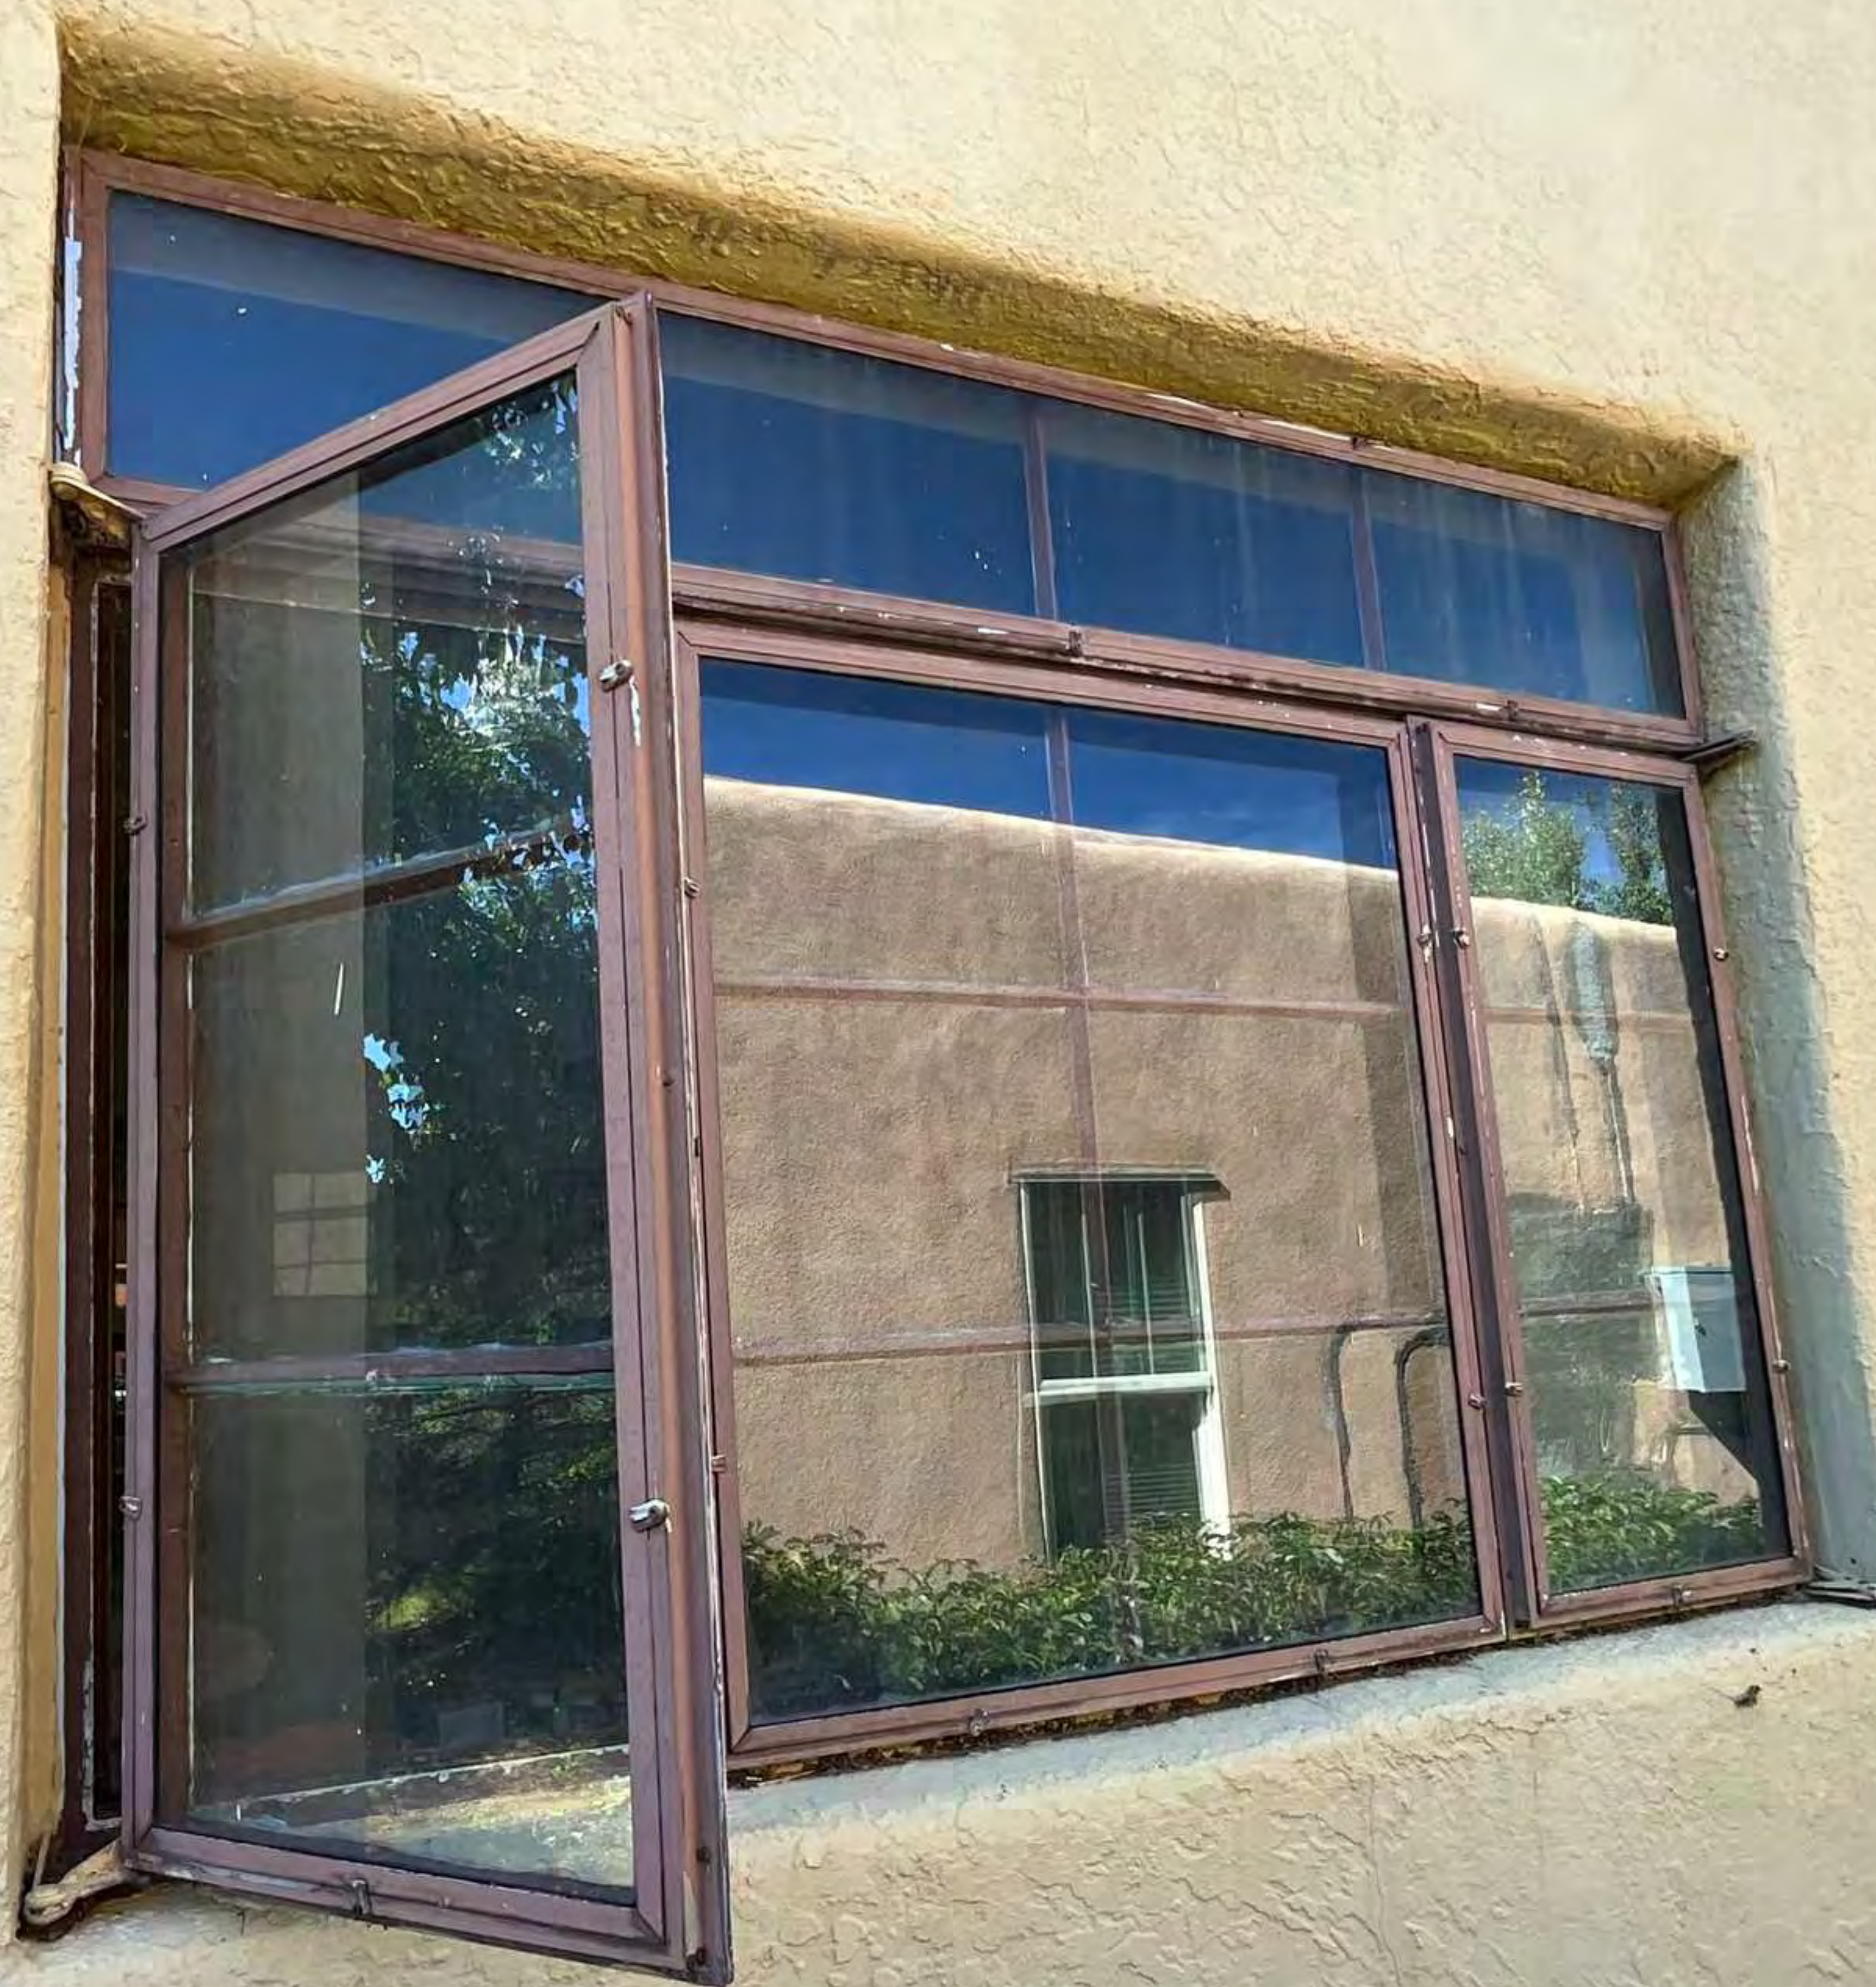
North
Elevation
Window
F

F	69" x 50 ½" STEEL CASEMENT (69" x 50 ½"/12 TRANSOM) 3W1H/1W3H/2W3H/1W3H	F	HISTORIC – METAL HAS RUSTED EXCESSIVE CONDENSATION TO THE STEEL CAUSING PLASTER DAMAGE. THERE IS EVIDENCE OF LEAKING IN THE WALL STRUCTURE.
G	38" x 38" LR STEEL CASEMENT (12L/20R) 1W3H	F	HISTORIC – METAL HAS RUSTED EXCESSIVE CONDENSATION TO THE STEEL CAUSING PLASTER DAMAGE. THERE IS EVIDENCE OF LEAKING IN THE WALL STRUCTURE.

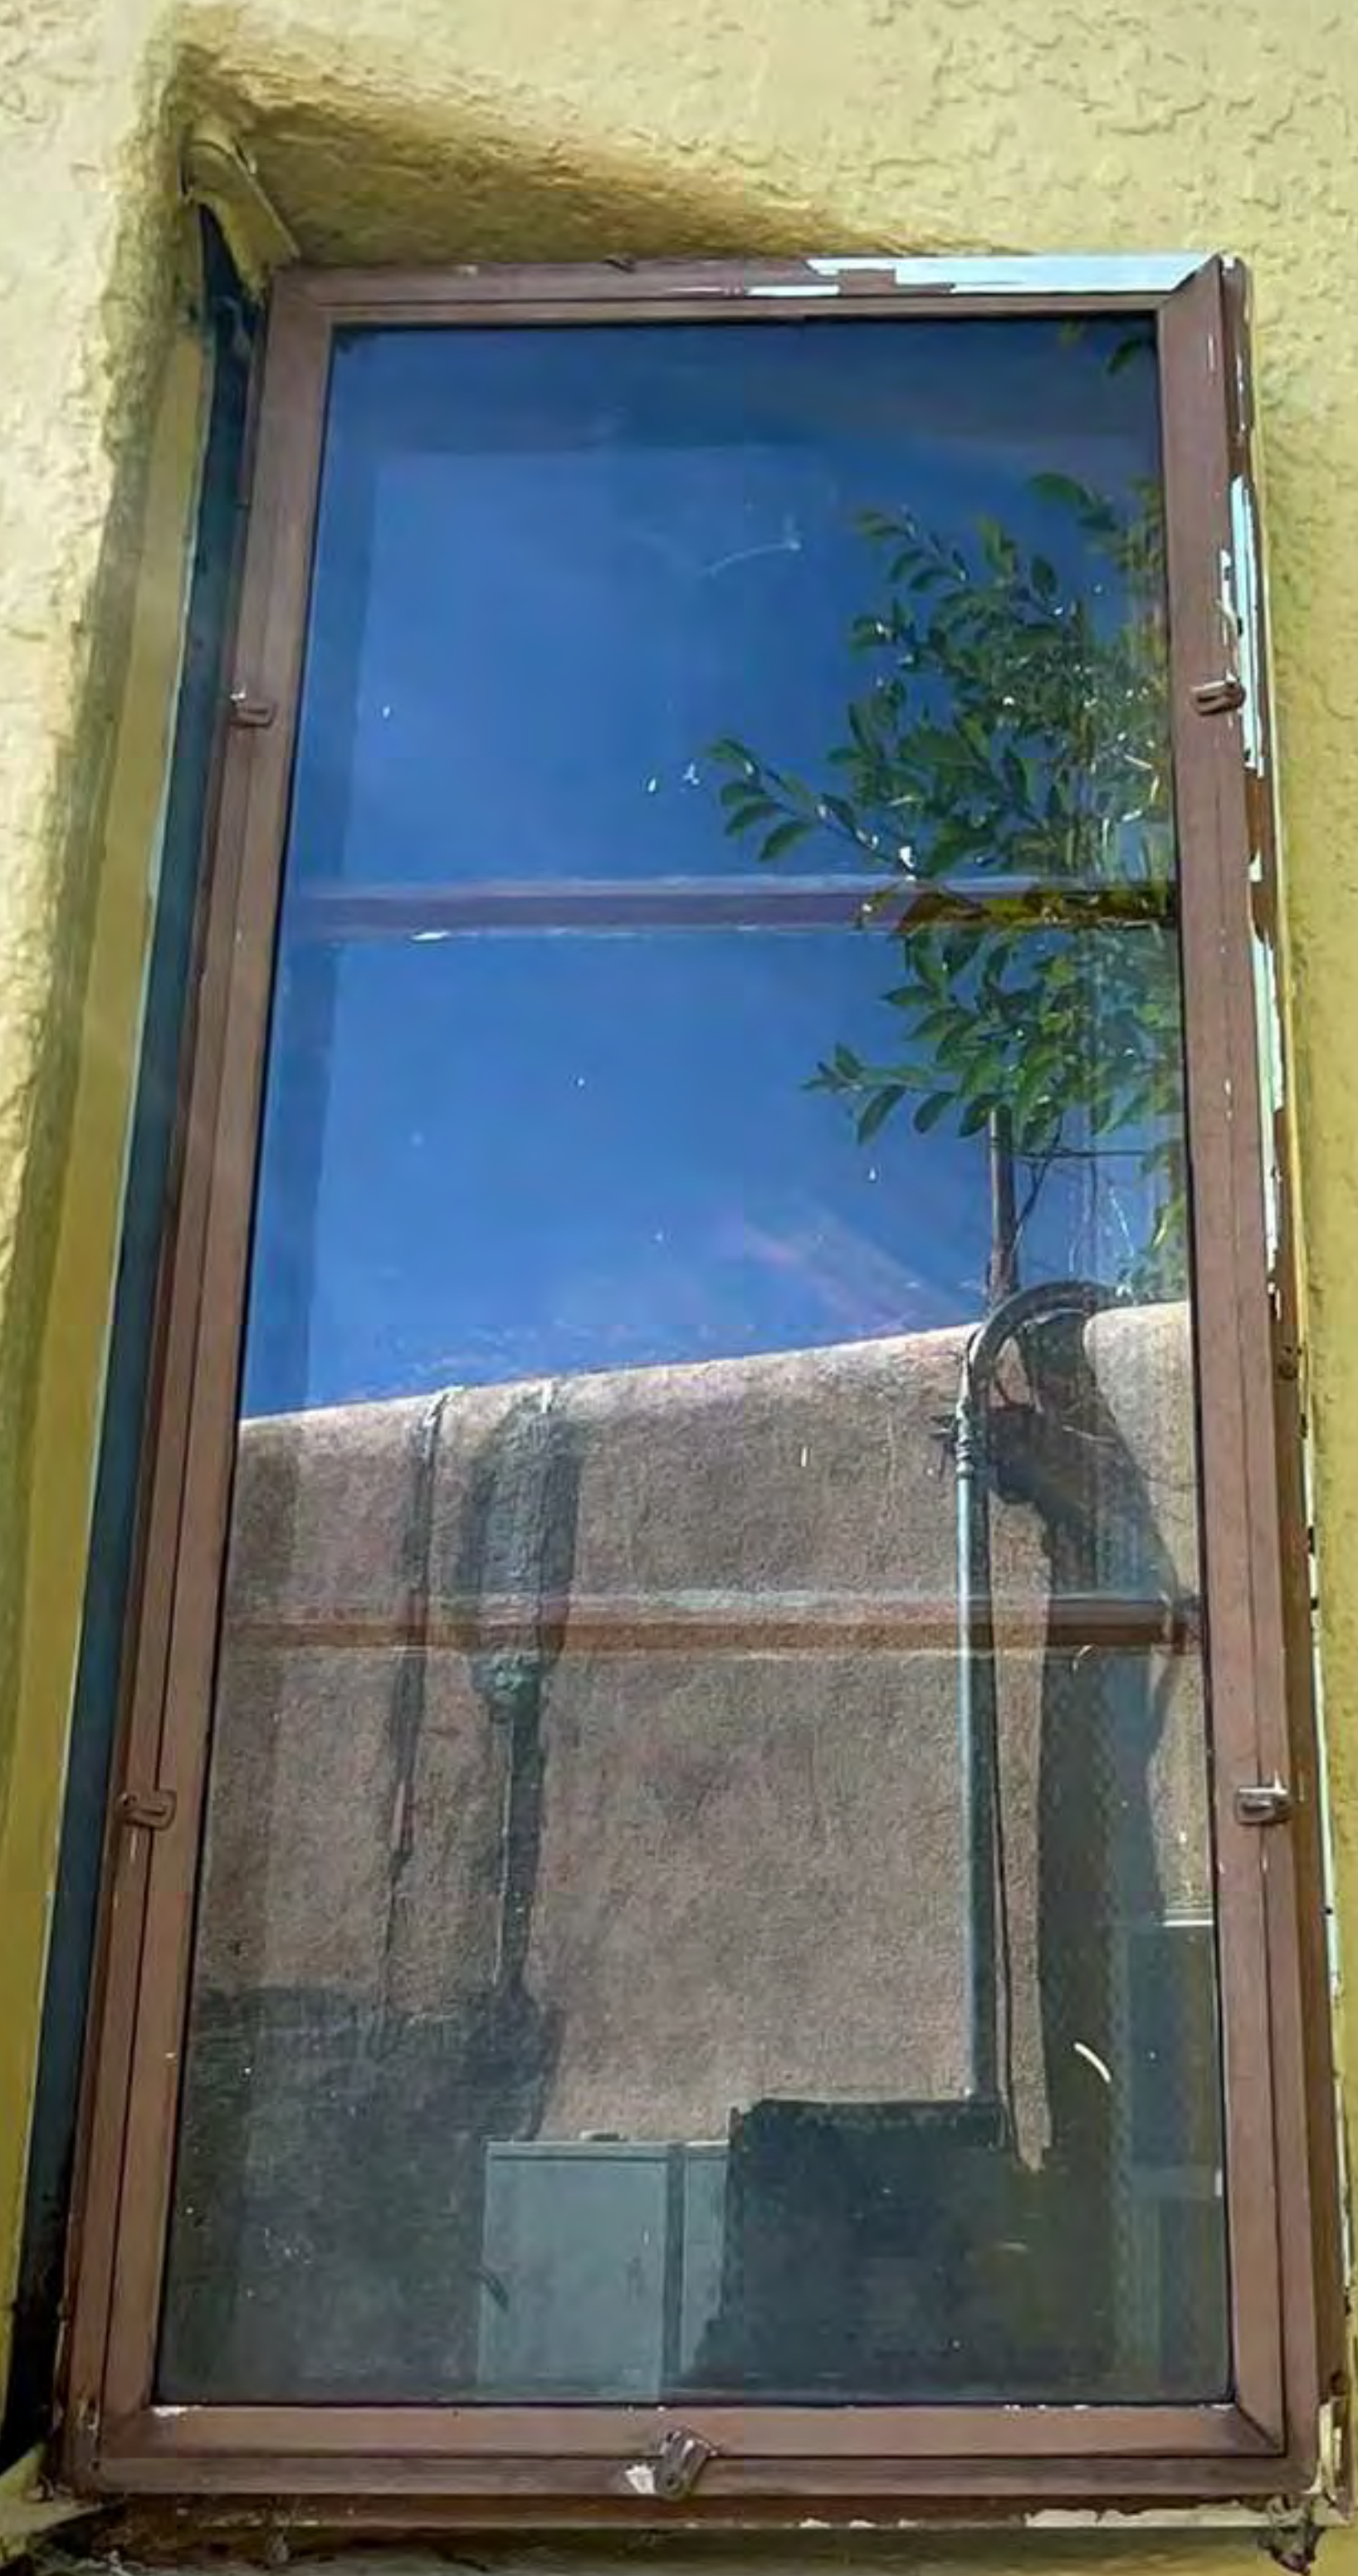
North
Elevation
Window
H

LABEL	WINDOW & DOOR DESCRIPTION	CONDITION & INTEGRITY CODE	HISTORIC/NON-HISTORIC – AGE
H	19" x 38" L STEEL CASEMENT 1W3H OBSCURE	F	HISTORIC – METAL HAS RUSTED EXCESSIVE CONDENSATION TO THE STEEL CAUSING PLASTER DAMAGE. THERE IS EVIDENCE OF LEAKING IN THE WALL STRUCTURE.
I	54" x 50" LSR STEEL CASEMENT (54" x 38"/12 TRANSOM) 3W1H/1W3H/1W3H/1W3H	F	HISTORIC – METAL HAS RUSTED EXCESSIVE CONDENSATION TO THE STEEL CAUSING PLASTER DAMAGE. THERE IS EVIDENCE OF LEAKING IN THE WALL STRUCTURE.
J	54" x 50" LSR STEEL CASEMENT (54" x 38"/12 TRANSOM) 3W1H/1W3H/1W3H/1W3H	F	HISTORIC – METAL HAS RUSTED EXCESSIVE CONDENSATION TO THE STEEL CAUSING PLASTER DAMAGE. THERE IS EVIDENCE OF LEAKING IN THE WALL STRUCTURE.
DR #3	32" x 80" RH ALL WOOD DOOR 1-HORIZONTAL/1-LT/3-HORIZONTAL PANEL	U	HISTORIC – PANEL CROSS RAILS CUT DOOR, WEAKENING THE STRUCTURE
K	38" x 50" LR STEEL CASEMENT (38"/12 TRANSOM) 2W1H/1W3H/1W3H	F	HISTORIC – METAL HAS RUSTED EXCESSIVE CONDENSATION TO THE STEEL CAUSING PLASTER DAMAGE. THERE IS EVIDENCE OF LEAKING IN THE WALL STRUCTURE.

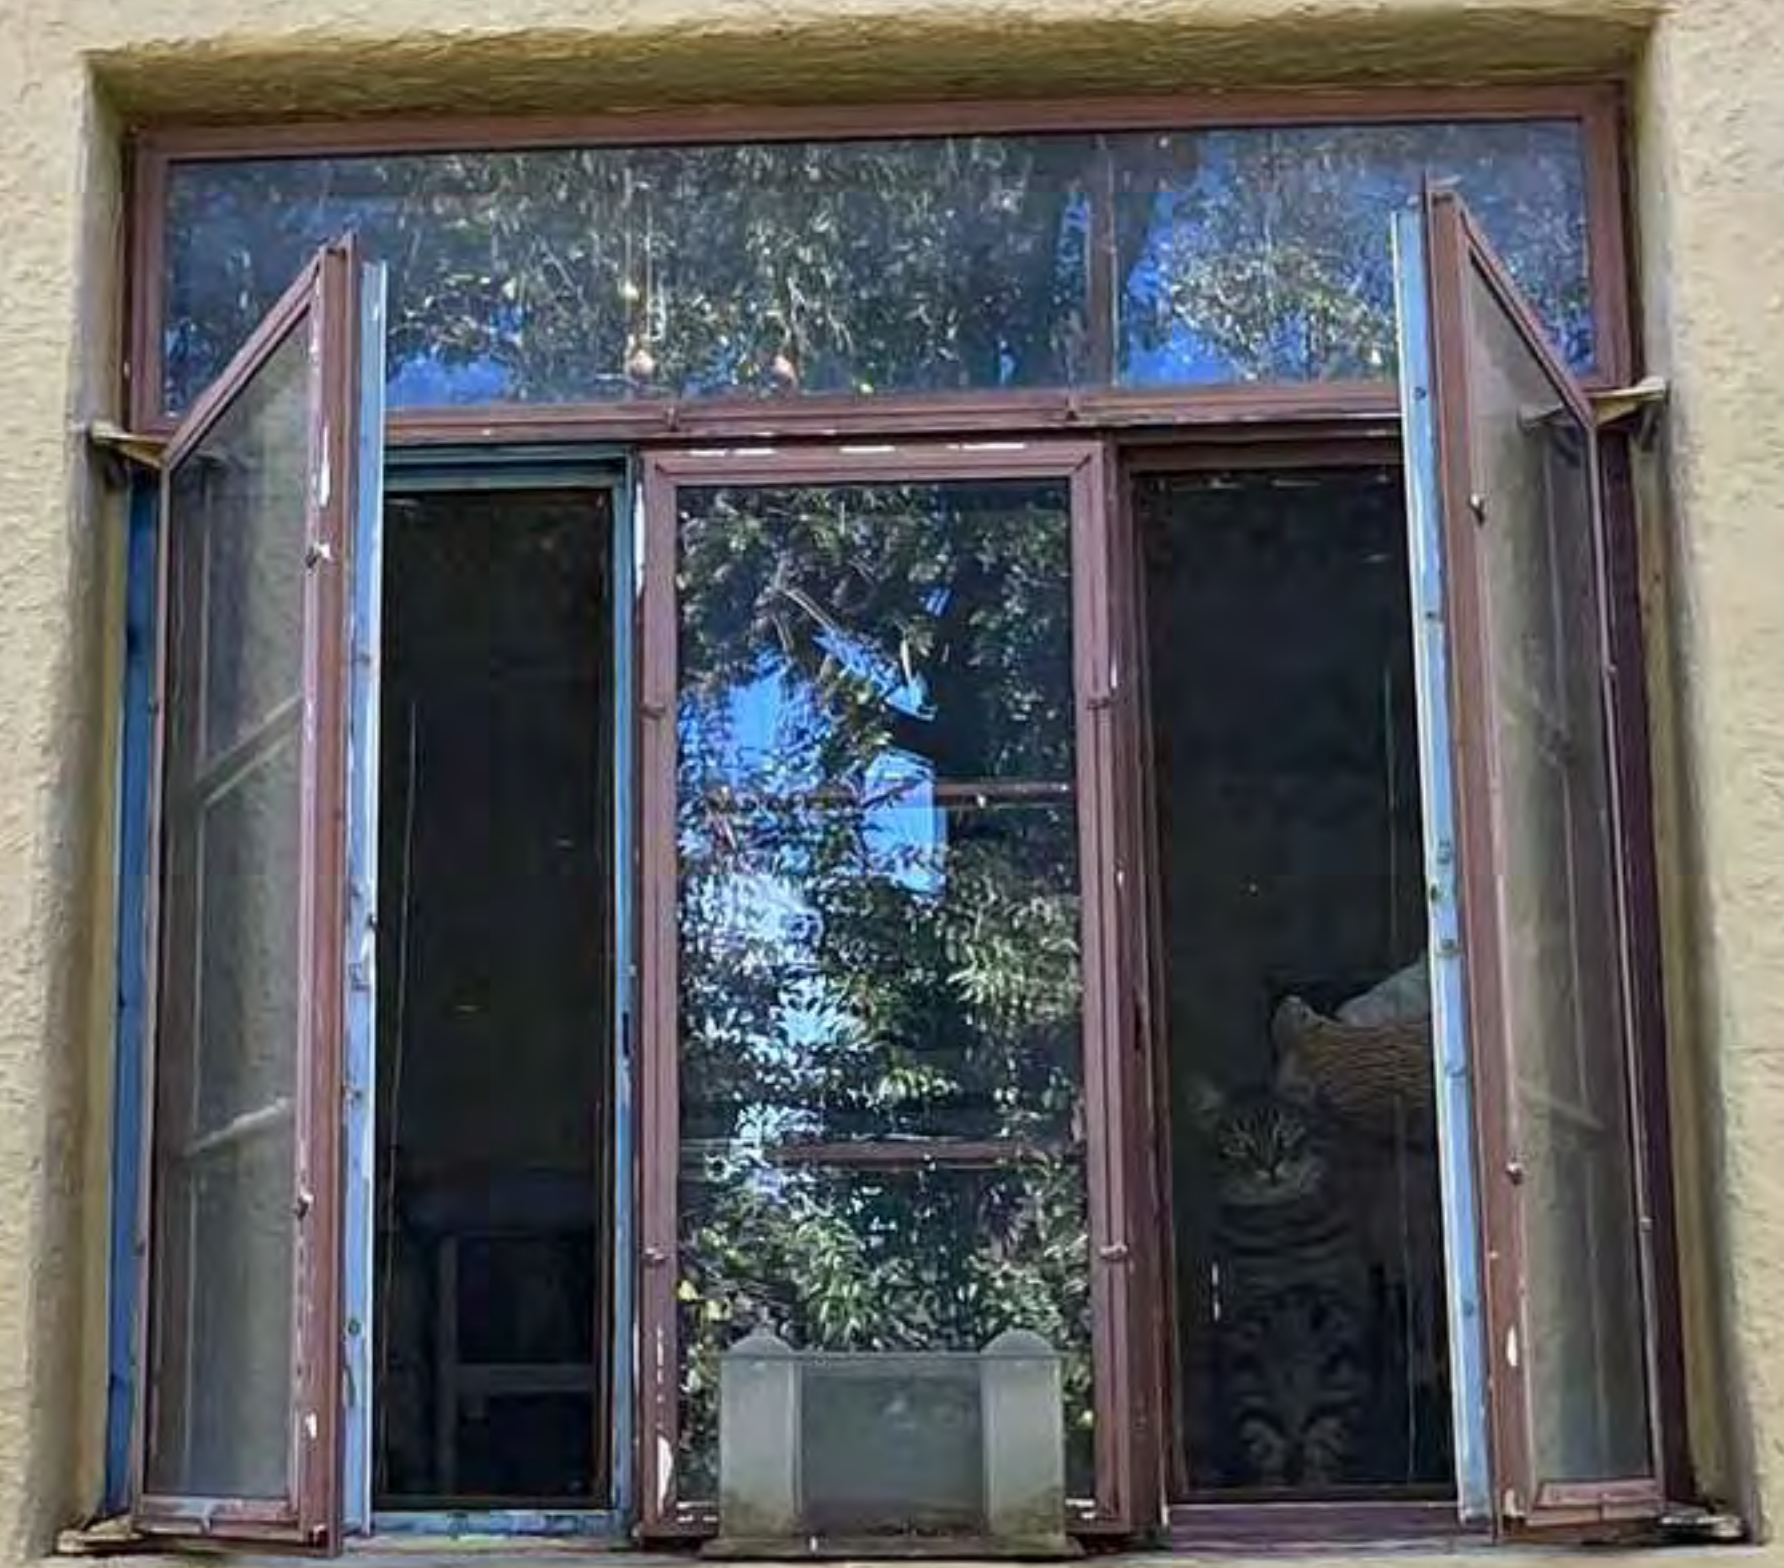
West
Elevation
Window
J

Windows A, F, G, H, I, J, K and L are historic, however they cause significant damage to the interior plaster and the structure.
